**A STUDY ON OPTIMIZING INFRARED HEATING
TECHNOLOGY FOR ASPHALT PAVEMENT
MAINTENANCE AND REHABILITATION**

A thesis
presented to the University of Waterloo
in fulfilment of the
thesis requirement for the degree of
Master of Applied Science
in
Civil Engineering

Waterloo, Ontario, Canada, 2019

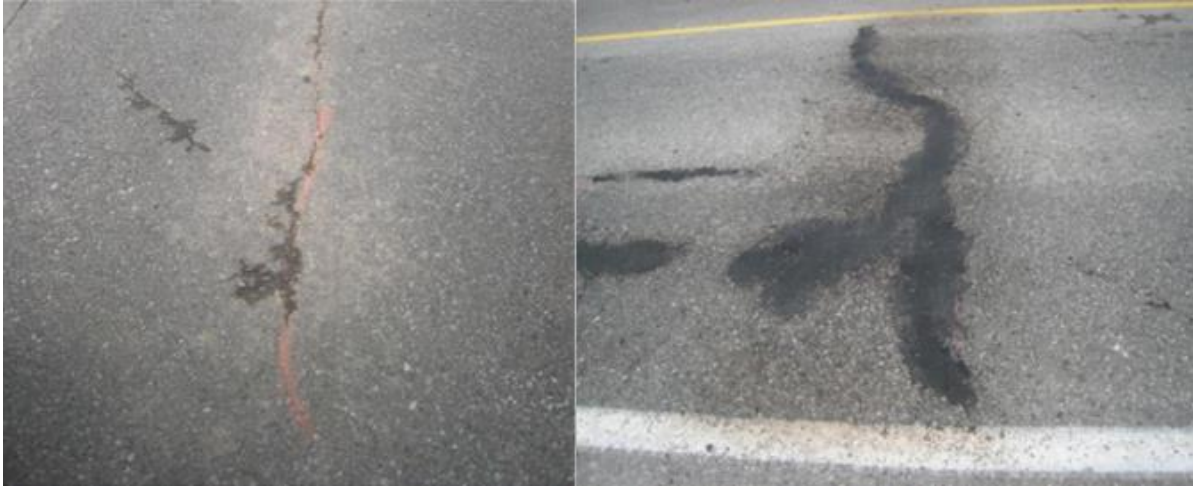
Figure 2.3: Left – Cracking on Bleams Road; Right – Repaired Cracking on Bleams Road (Uzarowski et al. 2011)

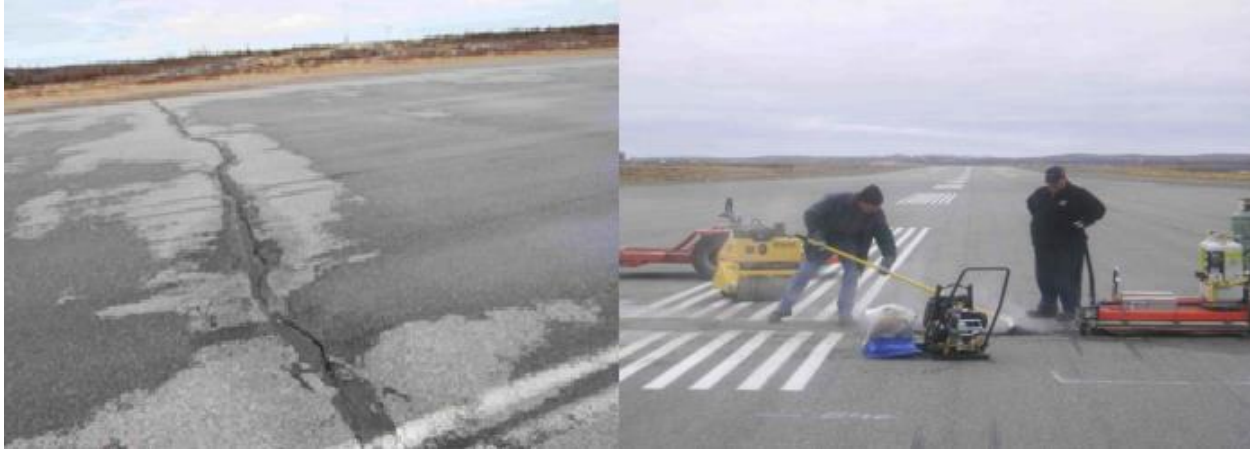
In Kuujjaq, Quebec, a large transverse crack in the middle of the runway was causing continual problems for aircraft taking off and landing. The crack had sealant applied in it many times but the repairs were not lasting long. In 2013, Kuujjaq Airport decided to implement infrared heating repairs as a long term repair solution for the large crack. When repairing a crack with infrared heating in which crack sealant has been applied in the past, the crack sealant must be removed before scarification. After the area has been heated, it is quick and easy to remove old crack sealant before adding rejuvenators to the heated asphalt and scarifying (Kieswetter 2013). Kuujjaq Airport has experienced success with the infrared heating patch, and has not considered additional repairs for this runway in the 6 years since. Figure 2.4 shows the crack in question before and during the infrared repair process.

Figure 2.4: Kuujuuaq Airport. Left: Crack Before Repairs; Right: Crack During Infrared Heating Repairs (Kieswetter 2013)

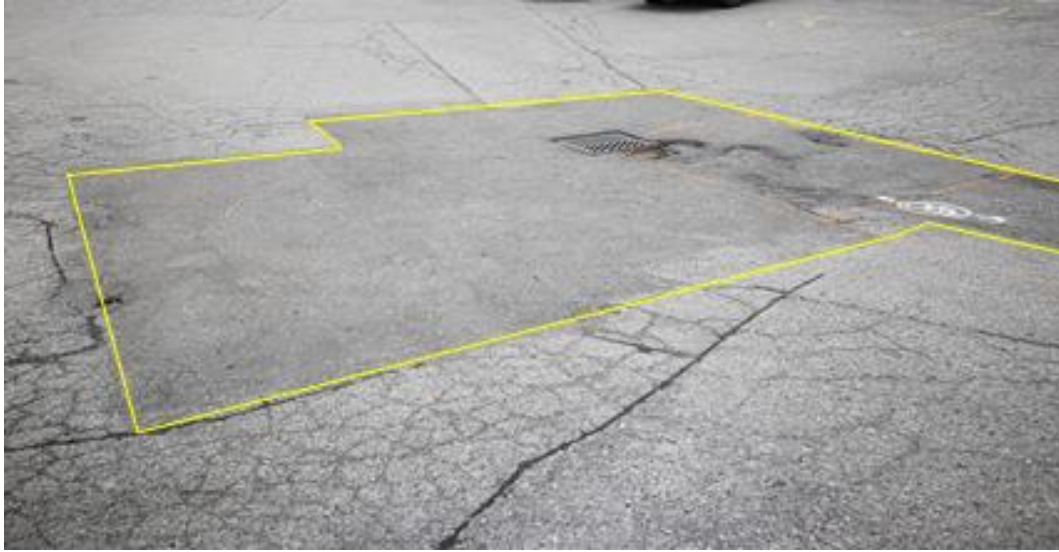
Figure 3.10: Storm Drain Region with Two Year Old Patch Marked for Repair

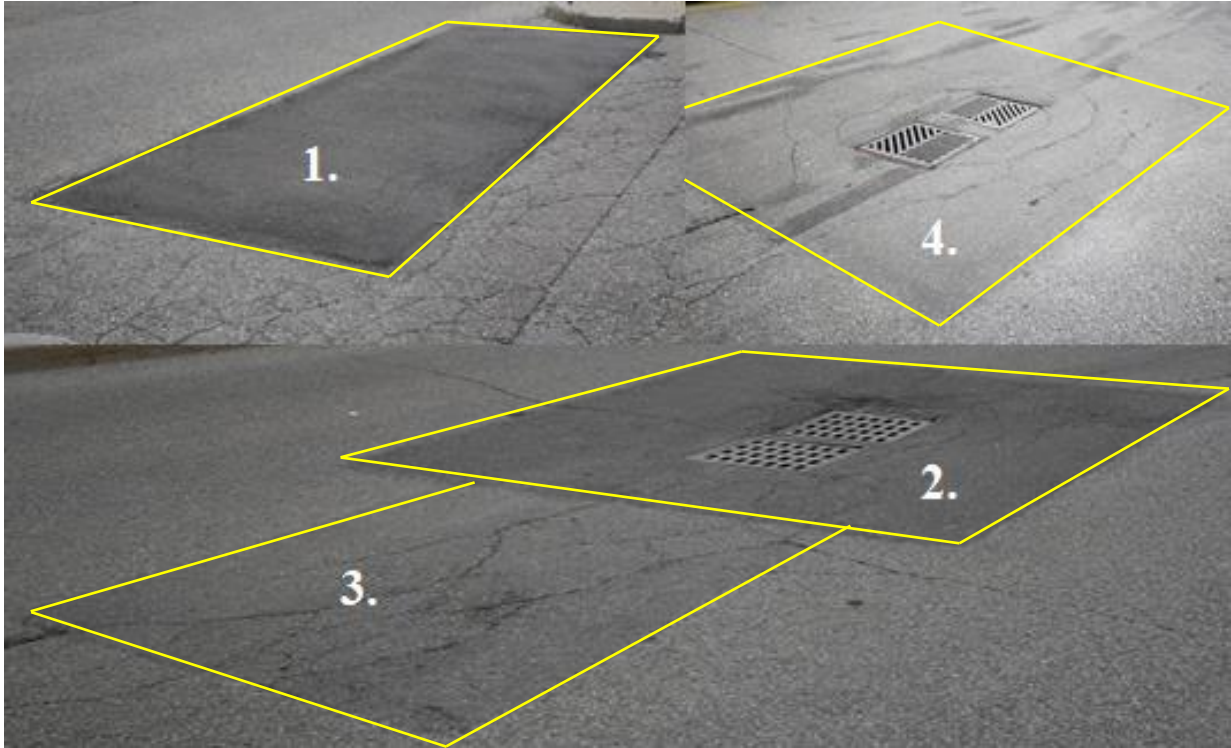
Figure 3.11: One, Two, Three, and Four Year Old Infrared Patch Repairs (As Labelled)

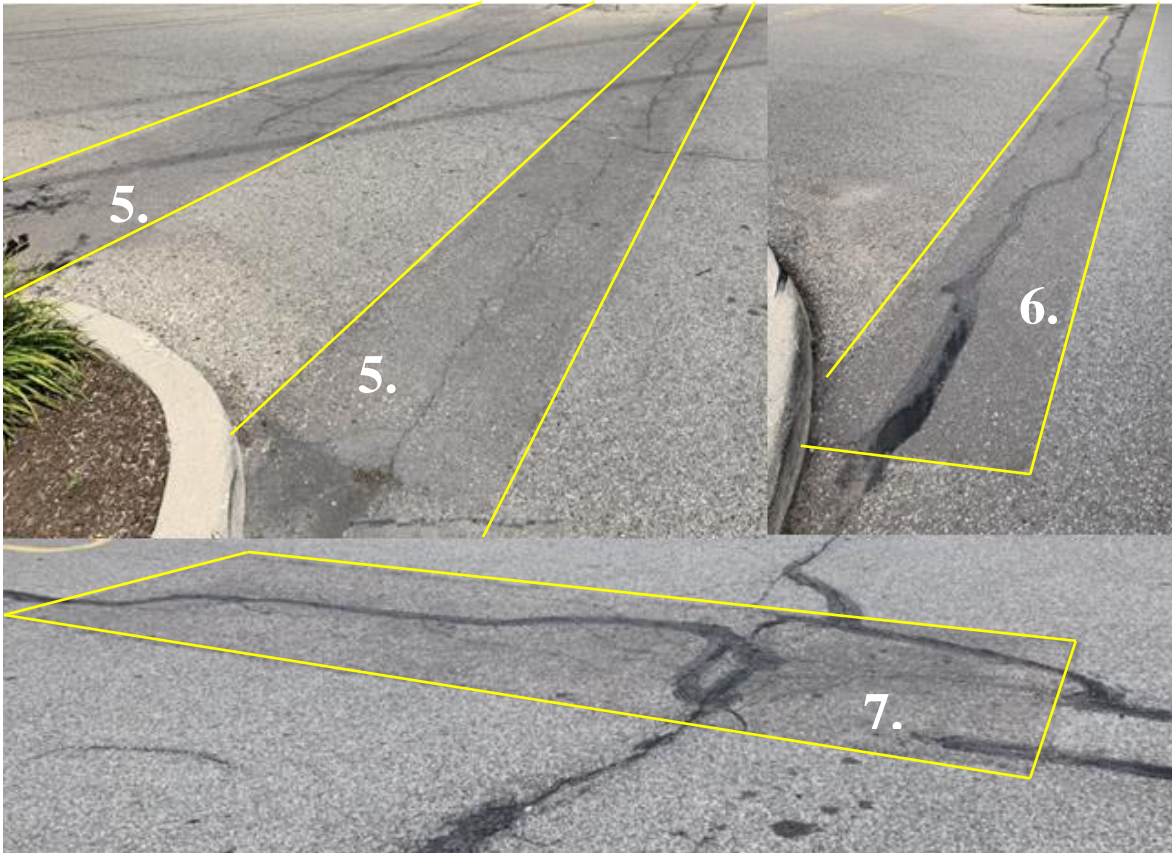
Figure 3.12: Five, Six and Seven Year Old Longitudinal Joint Infrared Patch Repairs (As Labelled)

The five year old patches displayed minor cracking along the longitudinal joints, mirroring the deficiencies originally repaired. The existing pavement structure is unknown, but if the original cracking occurred throughout the entire pavement depth, it is possible old cracking from the original pavement structure reflected up to cause this premature cracking. The six and seven year old patches have had crack sealant applied to some of the larger cracks which propagated throughout. The infrared patches themselves do appear to have held up along the patching joints, but the cracking throughout was deemed severe enough to require crack sealing maintenance. The oldest infrared patches observed at this site were nine to eleven years old, pictures of which are displayed in Figure 3.13 below.

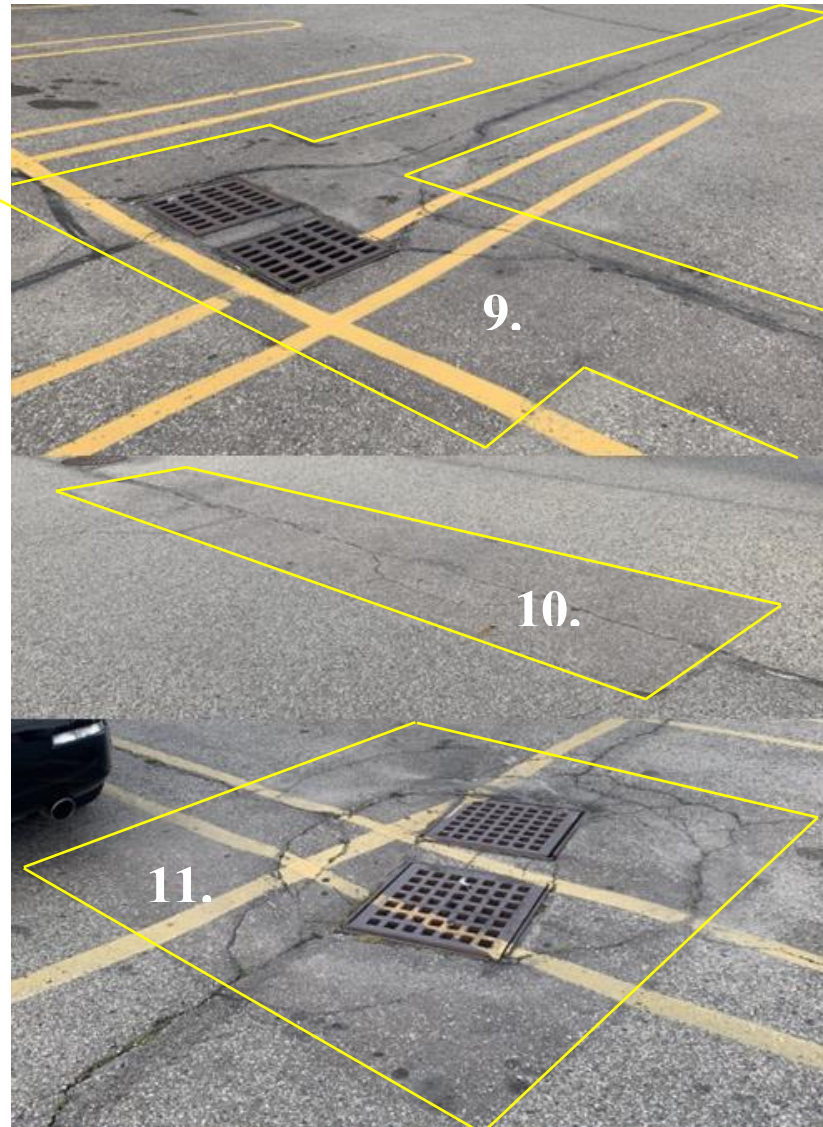
Figure 3.13: Nine, Ten and Eleven Year Old Longitudinal Joint Infrared Patch Repairs (As Labelled)

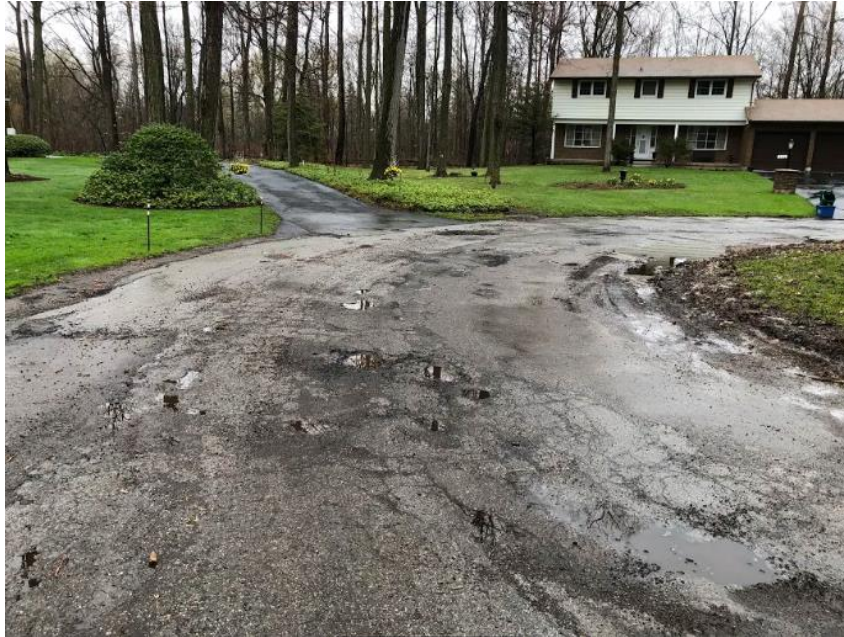
Various pavement distresses were present throughout the entire length of Sugarbush Drive and, to a lesser extent, throughout the rest of the Colonial Acres neighbourhood. These distresses included many potholes, extensive block cracking, and some pavement distortion along the street edges. Figures 4.3, 4.4, and 4.5 below display some of these features.

Figure 4.3: Potholes and Cracking Around Curve in Sugarbush Drive, Taken May 8th, 2019

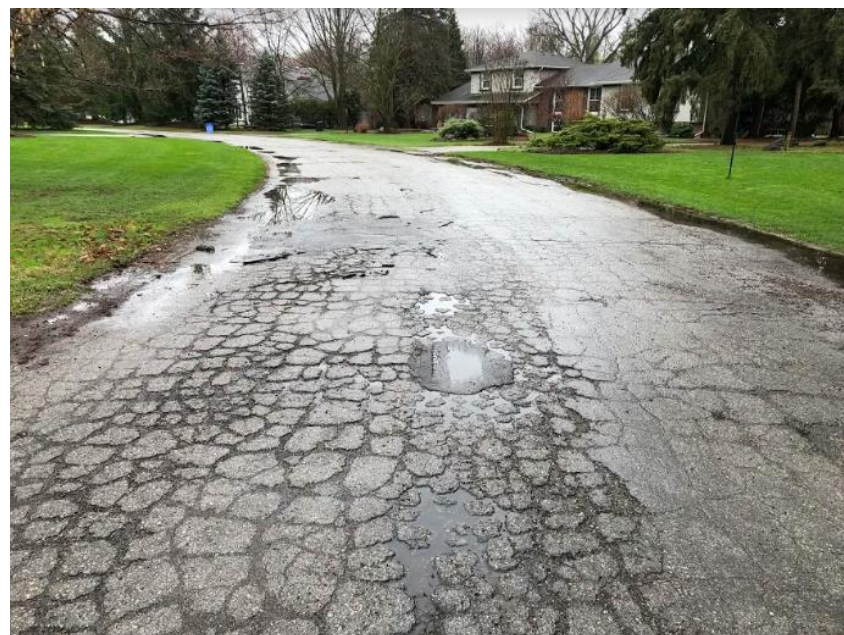
Figure 4.4: Block Cracking, Potholes, and Drainage Issues, Taken May 8th, 2019

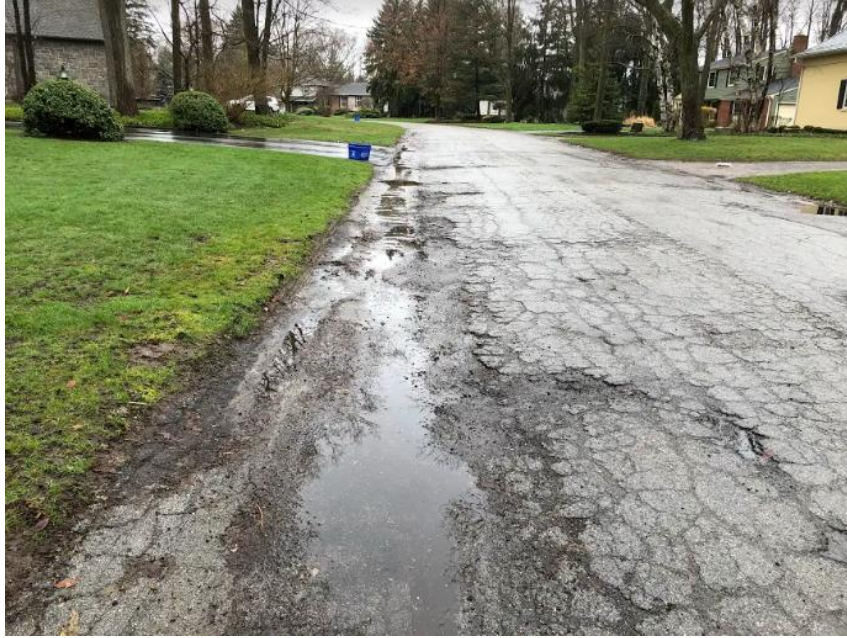
Figure 4.5: Pavement Distortion Along Sides of Sugarbush Drive, Taken May 8th, 2019

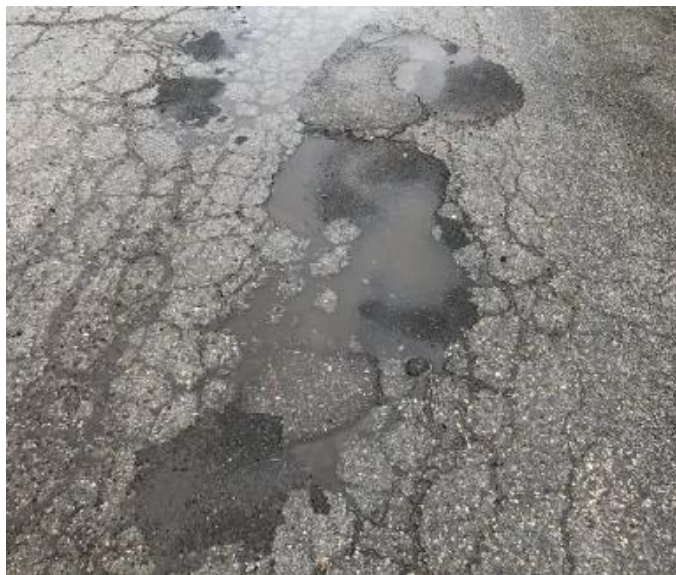
There was evidence of several previous repairs on Sugarbush Drive, including many spot repairs of potholes with both cold-patch and hot mix asphalt. Some larger areas had been saw-cut and filled with hot mix material. The level of effectiveness of these repairs was variable, most likely due in part to their respective ages. Figures 4.6 and 4.7 below display images of some of these repaired sections.

Figure 4.6: Patched Areas of Sugarbush Drive, Taken May 8th, 2019

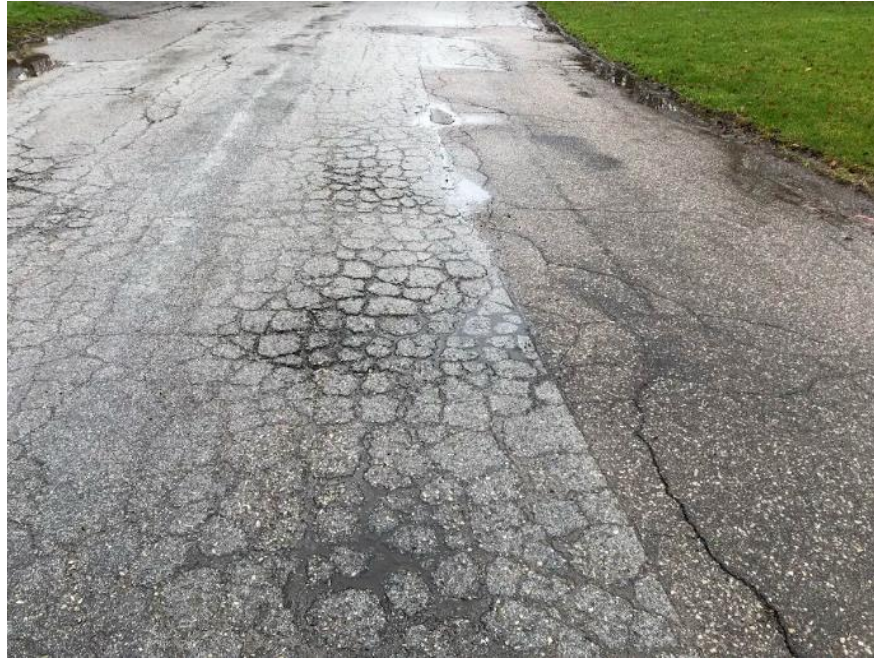
Figure 4.7: Saw-Cut and Repaired Area, Taken May 8th, 2019

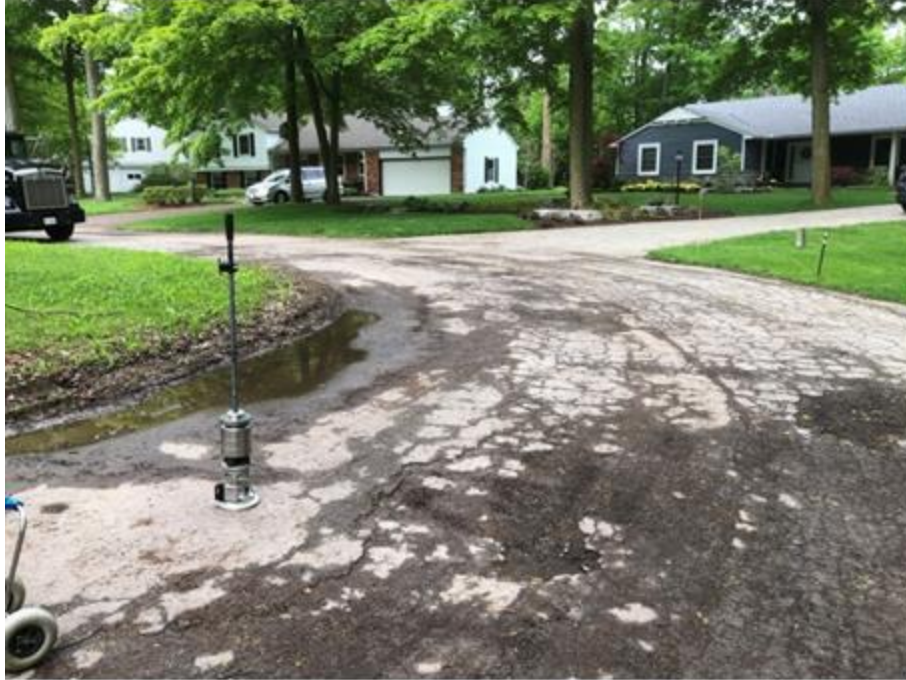
The testing indicates that the pavement throughout Sugarbush Dr. has a relatively consistent structural capacity. The two outliers which were noted were at Locations 1 and 13. Location 1 was at the intersection of Grant Crescent and Sugarbush Drive and the relatively high modulus may indicate a pavement built-up design at an intersection, or more recent construction on Grant Cres. Location 13 was located at the furthest extent of Sugarbush Dr. in the cul-de-sac portion of the street. This location (shown in Figure 4.12 below) showed severe degradation and standing water adjacent to the testing location. It is suggested that this portion of the street have more significant rehabilitation in order to address the apparent drainage problems and resulting low structural stiffness.

Figure 4.12: Testing Location 13 on Sugarbush Drive, Taken May 30th, 2019
