THE PERFORMANCE OF RAINSCREEN WALLS IN COASTAL BRITISH COLUMBIA

A thesis presented to the University of Waterloo in fulfillment of the thesis requirement for the degree of Master of Applied Science in Civil Engineering

Waterloo, Ontario, Canada, 2007

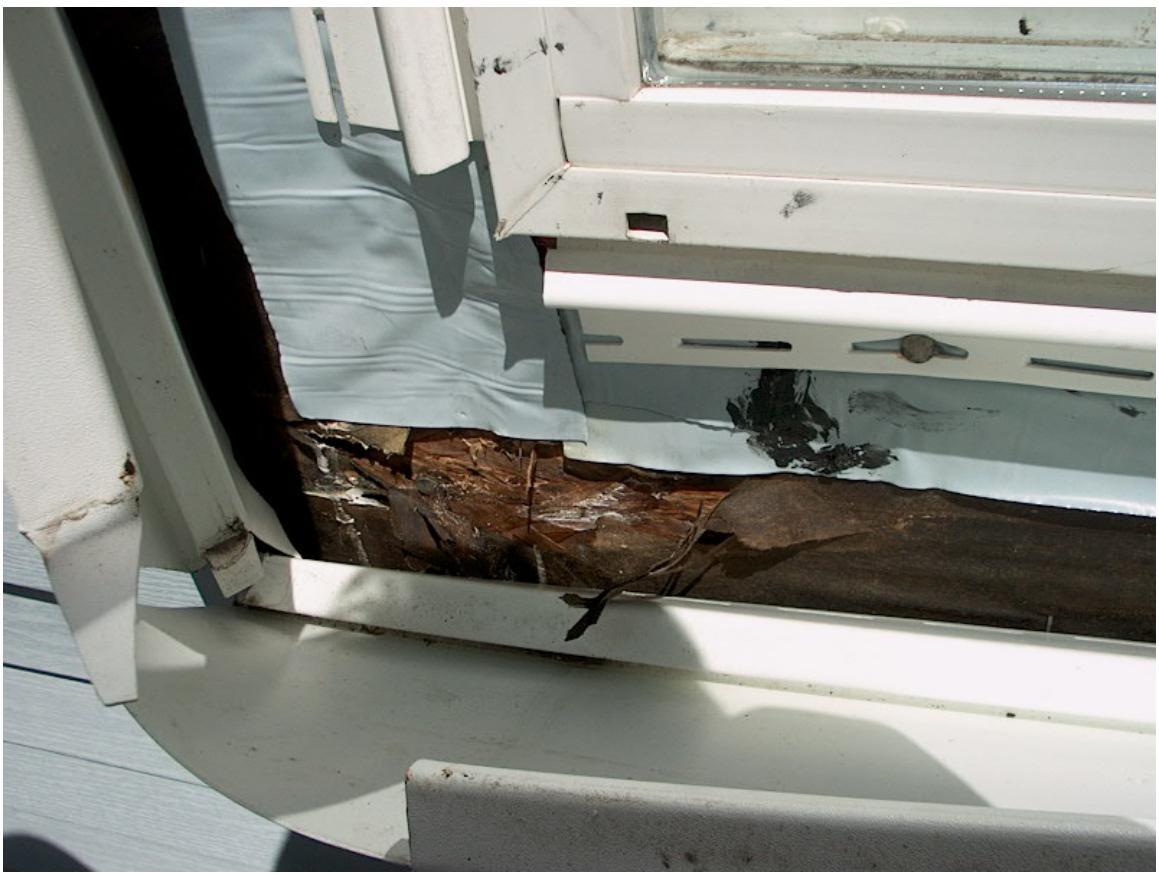
During the second building rehabilitation in 2000, the windows were replaced, however flashing details were found to be poor at shedding water from the walls. Peel-and-stick membrane was used around the window opening, correctly lapped over the building paper, however water was still able to penetrated the walls at some of the window openings. In addition the vinyl siding J-trim was found to be depositing large quantities of water into the cavity onto the building paper. The walls while not rainscreen, however consisted of vinyl cladding (drained, with some ventilation through perforated and loose jointed siding, however no vertical strapping was used). Typical damage as observed during test openings is shown in Figure 3-63.

Figure 3-63: OSB Sheathing Damage below a Rehabilitated Window with Poor Water Shedding Details (RDH Building Engineering)

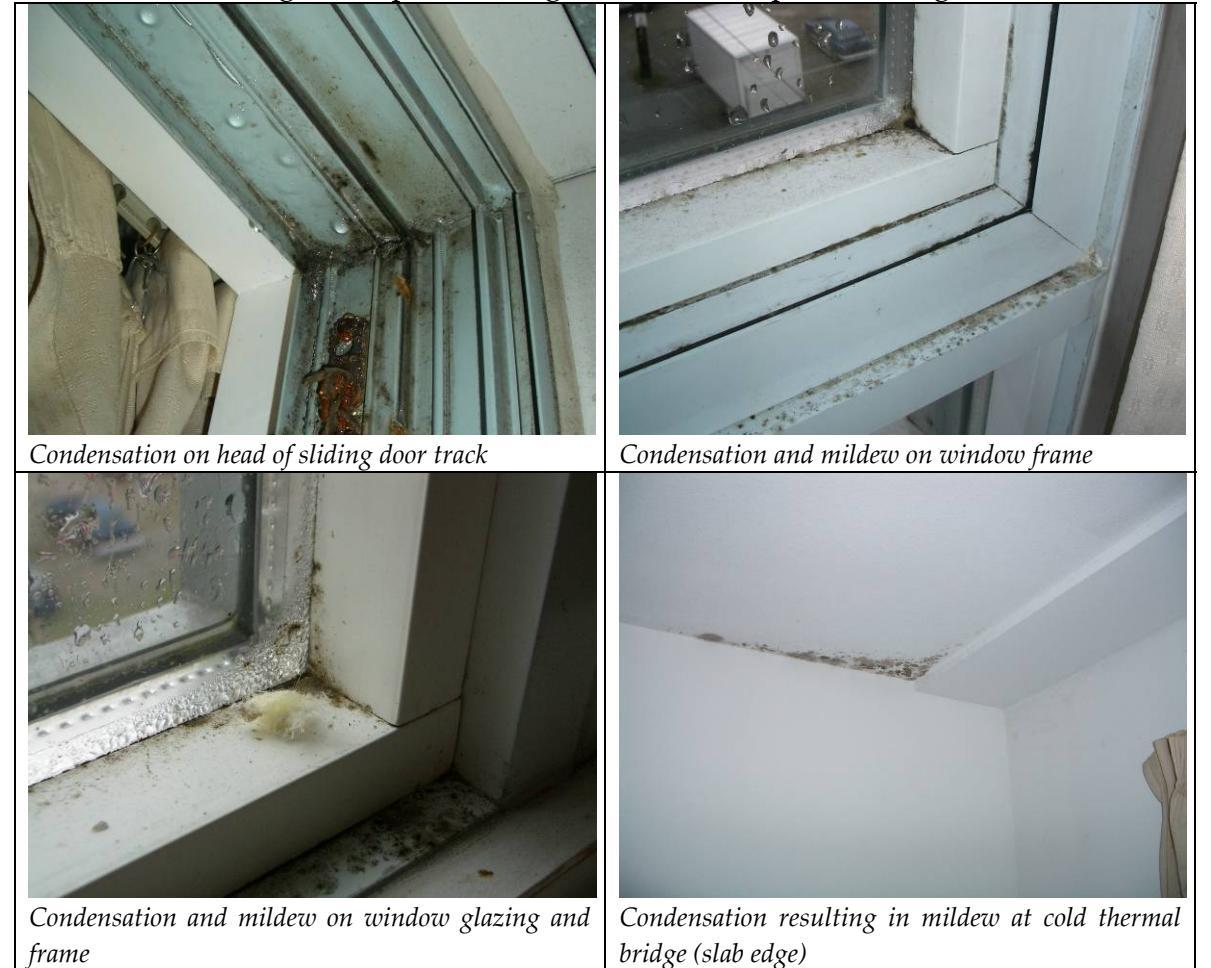
Typical observations of condensation and mould growth on surfaces are shown in Table 6-5.

Table 6-5: Building 3 – Impacts of High Interior Dewpoint during Winter Months

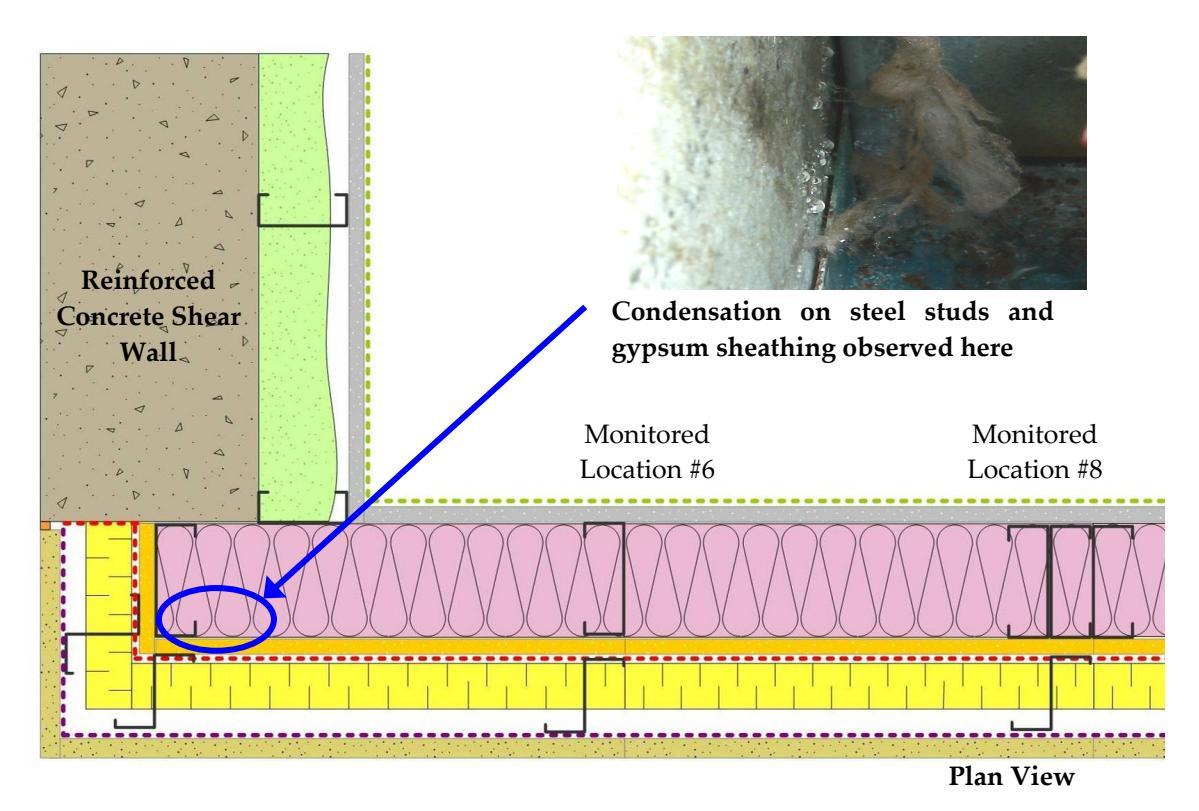
Figure 9-22: Plan View of Wall at Corner

The conditions within the stud cavity were significantly worse at the corner (also away from sensors). To determine the potential cause for this, a two-dimensional thermal model was made using THERM 5.2, which highlighted the lower corner temperatures and increased condensation potential (Figure 9-23).

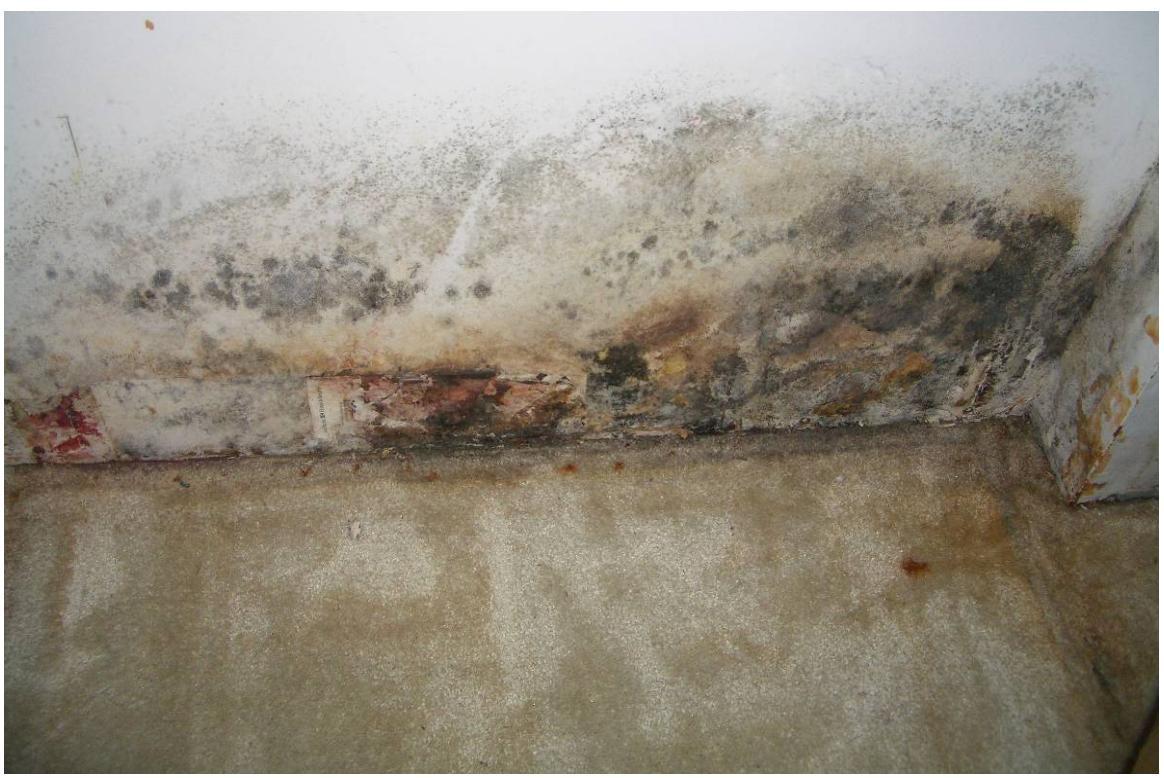
Figure 11: Mould Growth on Interior Gypsum Wallboard exposed to a water leak

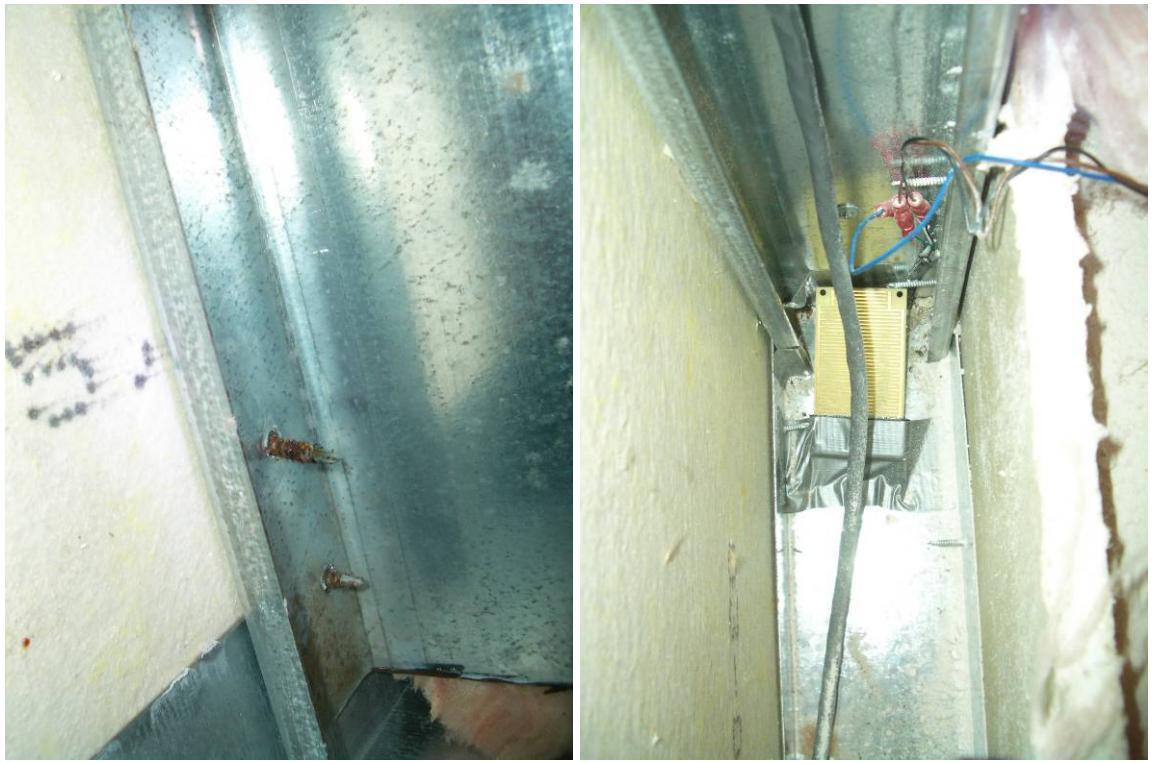
Building 3_ 63: Jan 31/06 Openings – Suite 311 opening 4 – below window inside stud cavity insulation removed. Corroded fasteners noted
