Fatigue Behaviour of GFRP-Reinforced UHPC Closure Strips in Prefabricated Bridge Deck Applications

Benjamin Dow

Master of Applied Science

Waterloo, Ontario, Canada, 2016

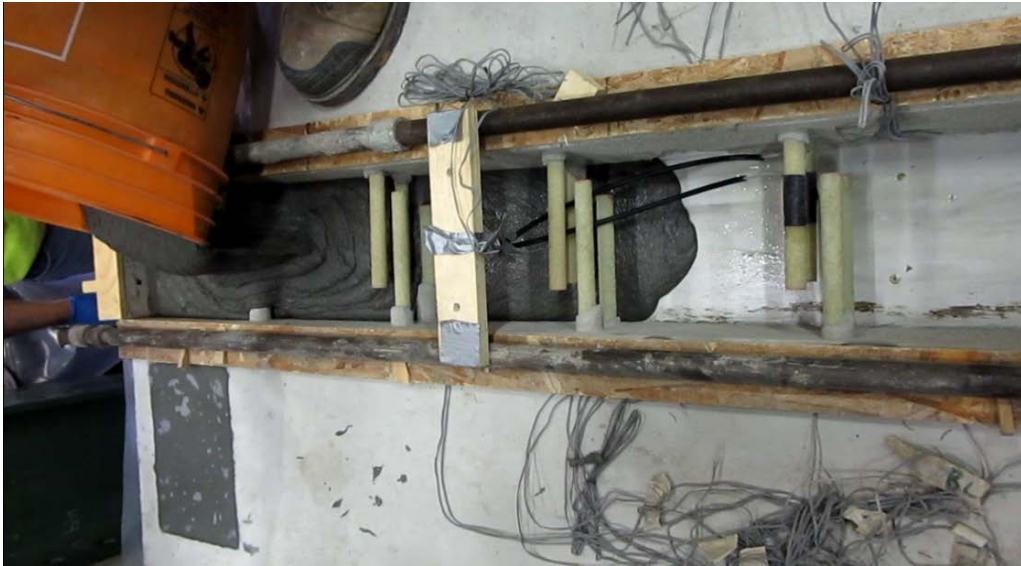
Figure 3-8. Pouring of UHPC into the closure strip.

casting method causes the steel fibres to align with the direction of the pour (transverse). This is not ideal, since it can result in a reduced tensile strength in the direction transverse to the closure strip direction. However, until now, no practical solution to this problem has been found, that does not result in other negative impacts. Following the pour, the strip is covered in plastic to prevent a thin crust forming on top of the UHPC. Due to this air escaping and plastic top, the joint finish was rough and pitted with air pockets, for this reason the joint was cast approximately 5 mm higher than the adjacent precast panel faces. The UHPC closure strip was then ground down to provide a level loading area. A photo of the joint casting in progress is shown in Figure 3-8 with the completed joint shown in Figure 3-9.

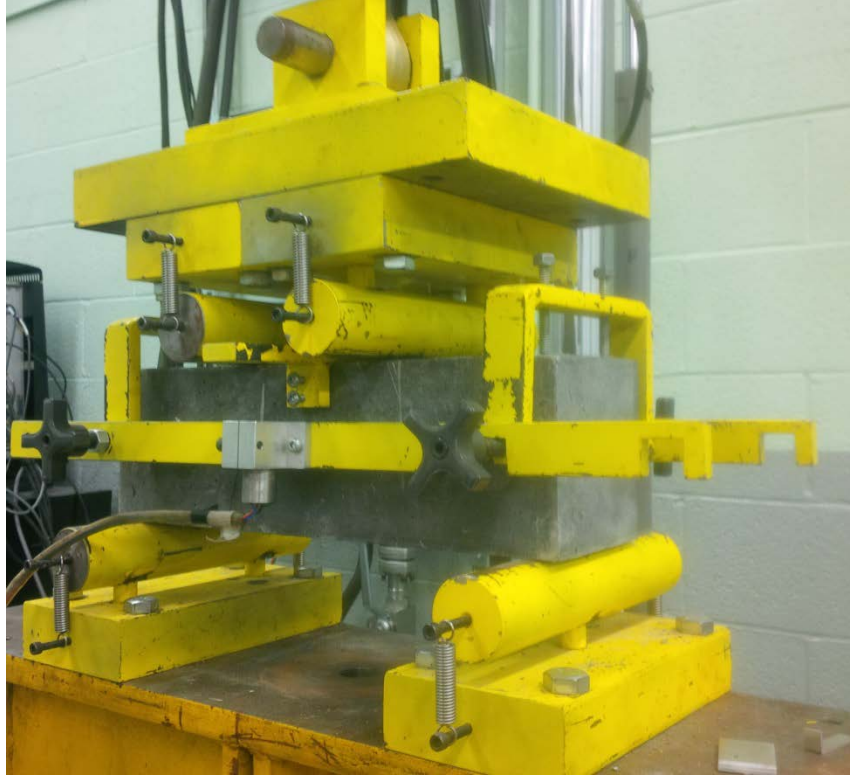
Figure 3-24. ASTM C1609 test setup.

Two types of flexural tests were performed on UHPC specimens. The first test was the standard ASTM C1609 (ASTM, 2013) test for the flexural performance of fibre-reinforced concrete prisms. This test utilized third-point loading to ascertain the flexural performance of a concrete prism by applying a constant displacement to the two loaded areas of 0.15 mm/min. This test was used to determine the toughness of the UHPC based on the area under the load-deflection curve. Figure 3-24 shows a specimen in the apparatus used for this test.

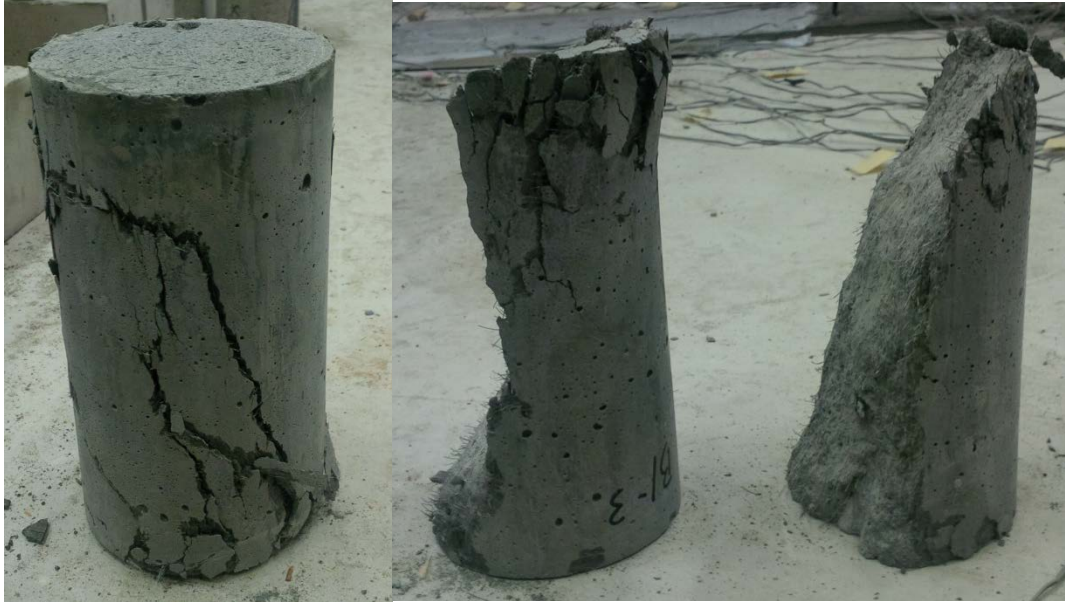
Figure 4-2. Broken UHPC cylinders following compressive cylinder tests. (Left: After failure, Right: After failure and sledge hammer)

When the cylinders were tested to determine the compressive strength of the UHPC, it was found that they did not break apart like typical concrete cylinders due to the fibres of the UHPC maintaining sufficient integrity to keep the cylinder together. Figure 4-2 shows a broken cylinder that did not break apart as well as half a cylinder that was broken by hitting a failed specimen with a sledge hammer.

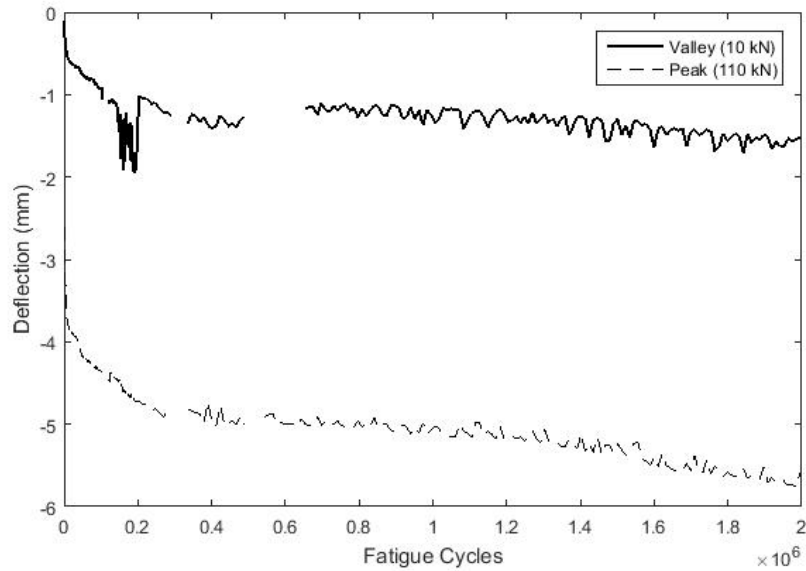
Figure 4-9. Specimen SB-3: Variation of peak and valley deflection response over time for centre of panel load location (deflection measured at load location).

Deflections were recorded throughout the fatigue testing at both the valley (10 kN) and peak (110 kN) of the sinusoidal wave loading pattern. Figure 4-9 shows the deflection versus cycle curves for the valley and valley of the loading applied on the centre of the panel. Figure 4-10 shows the deflection range versus cycle for fatigue loading at the centre of panel. Note that gaps or breaks in the plotted data occurred due to displacement transducer errors that occurred during the test.

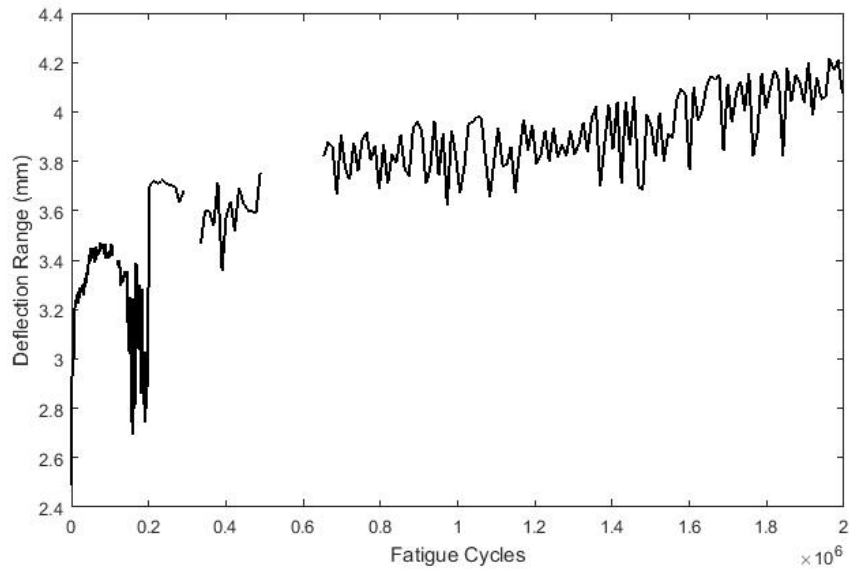
Figure 4-10. Specimen SB-3: Variation of deflection range (peak minus valley) over time for centre of panel load location.

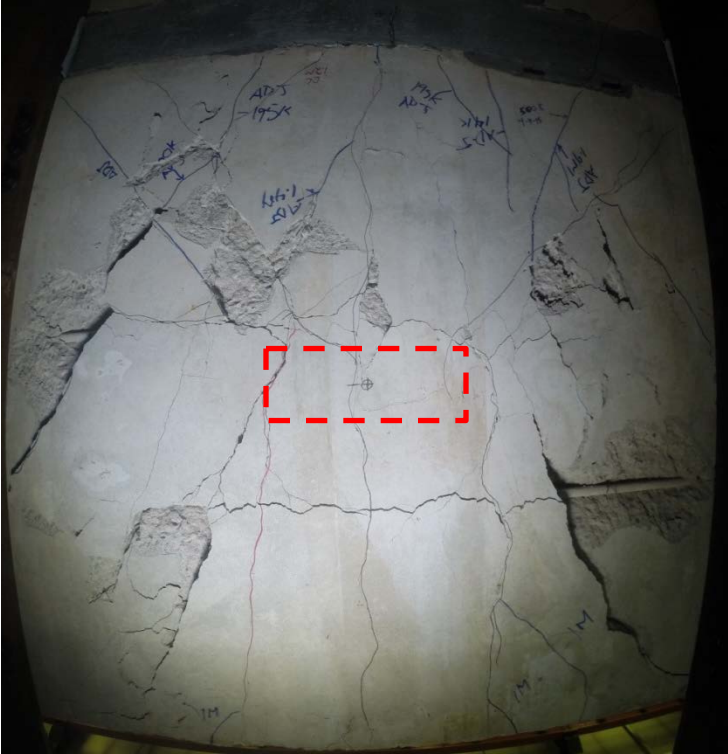
Figure 4-31. SB-3: Underside of slab following failure in centre of precast concrete panel. (Red line indicates load location)

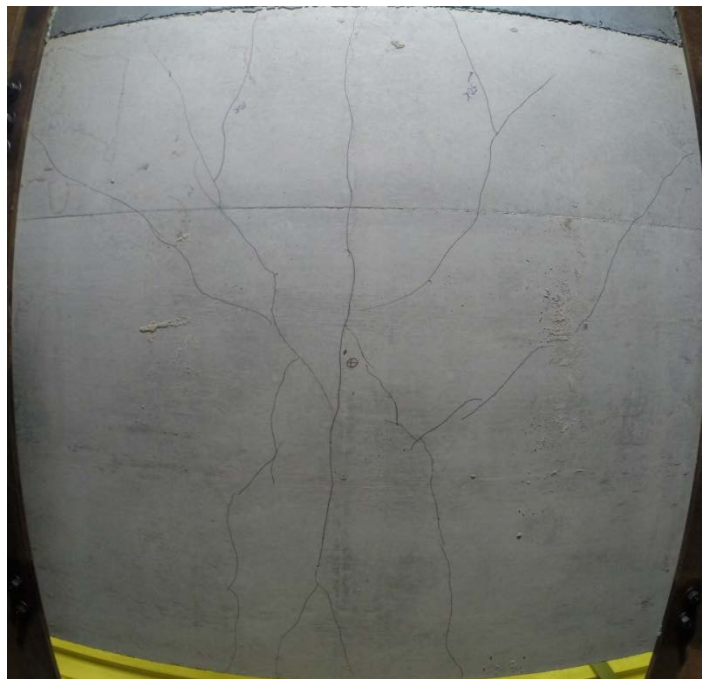
Figure 4-36. SB-1: Crack pattern on precast panel after initial static loads.

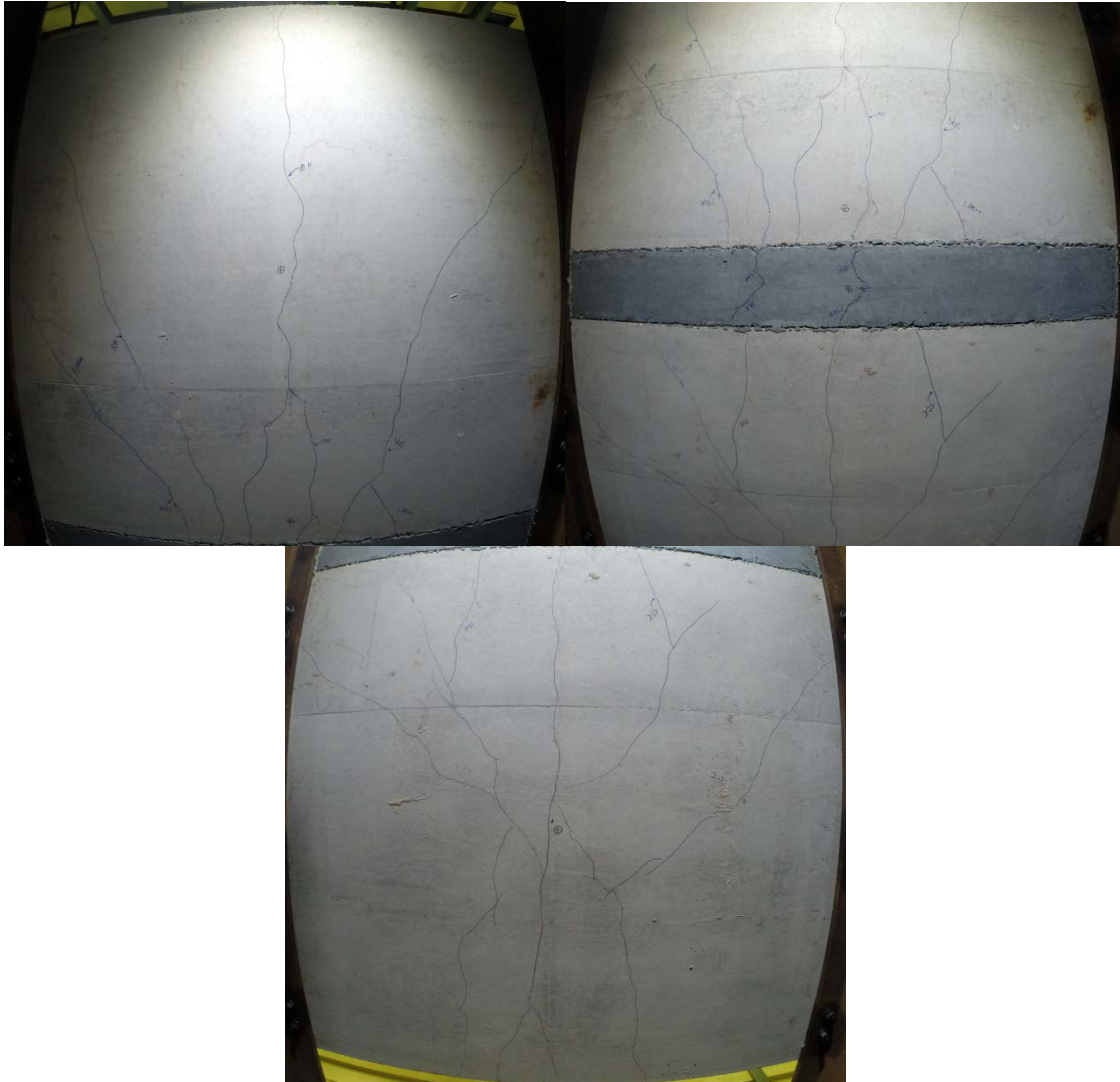
Figure 4-49. SB-1: Underside of slab after fatigue loading. (Top left: slab loaded adjacent to panel, Top Right: closure strip, Bottom: panel loaded in centre)

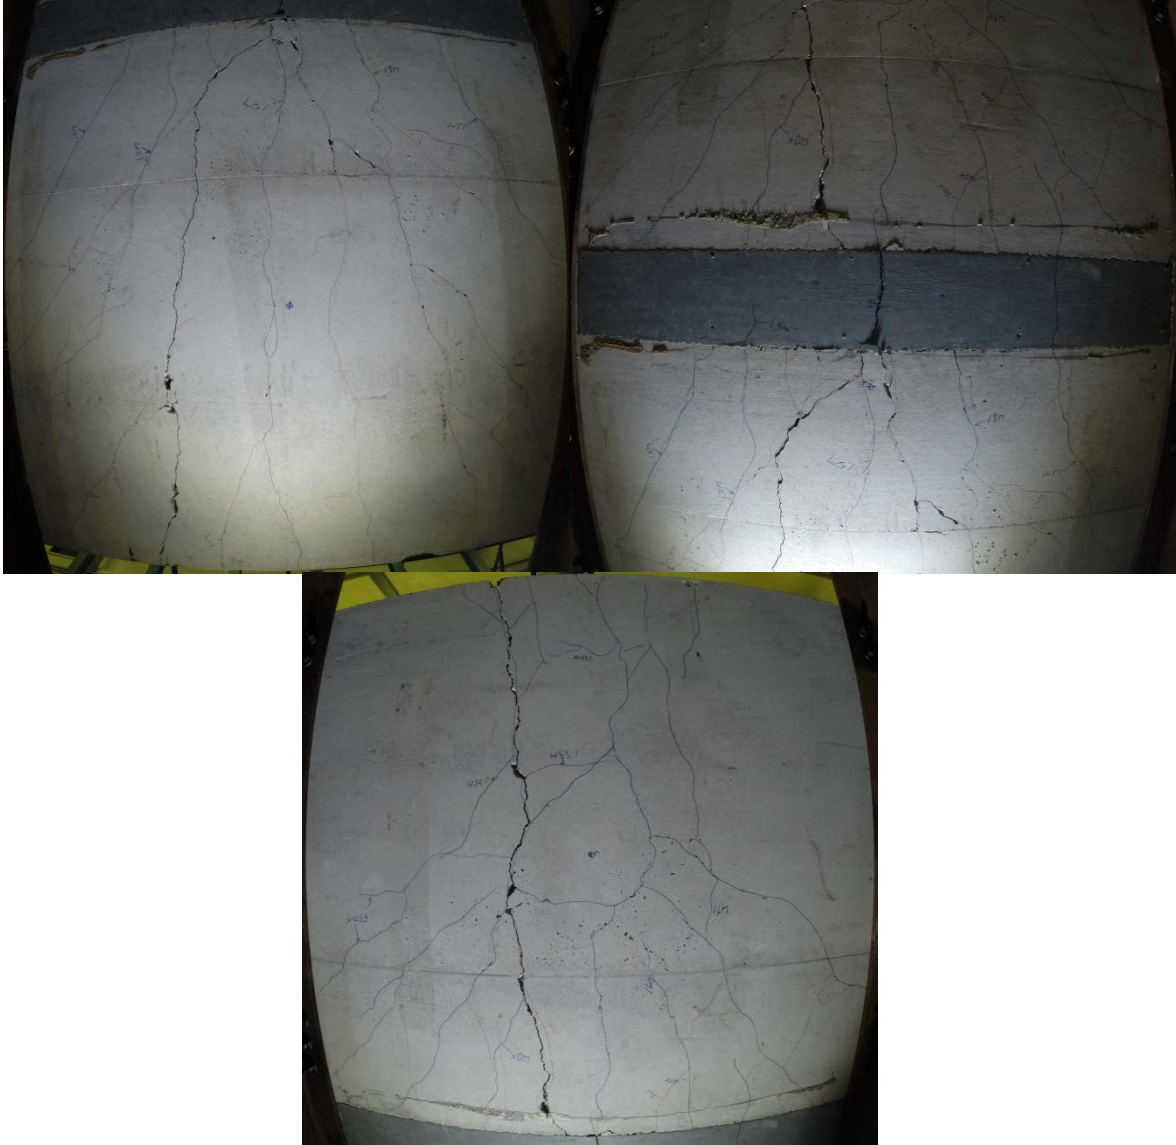
Figure 4-65. RB-3: Underside of slab after fatigue loading. (Top left: slab loaded adjacent to panel, Top Right: closure strip, Bottom: panel loaded in centre)

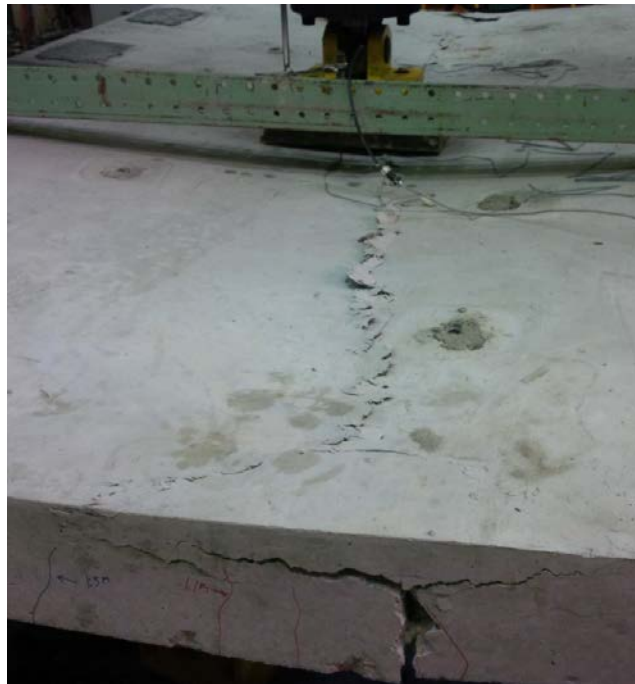
Figure 4-70. RB-3: Concrete crushing failure on top of slab.

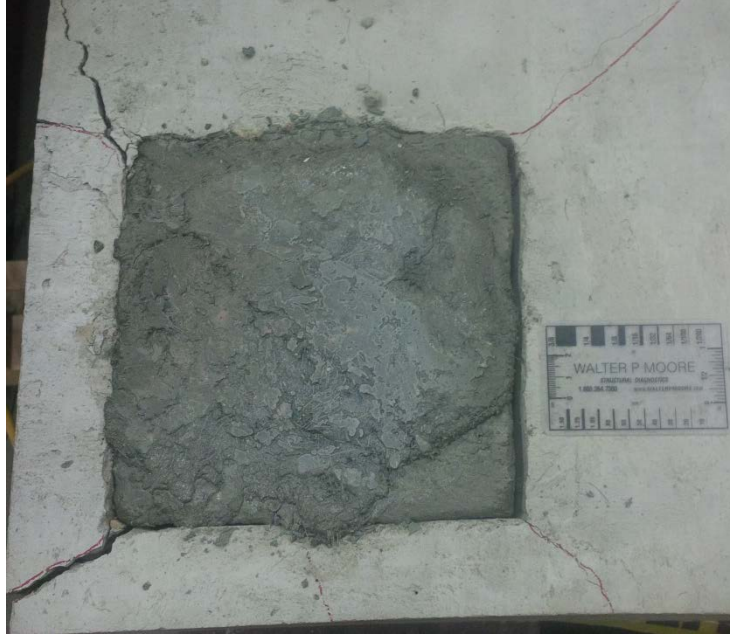
Figure 4-74. RB-3: Cracking and slip of slab near corner shear pocket.

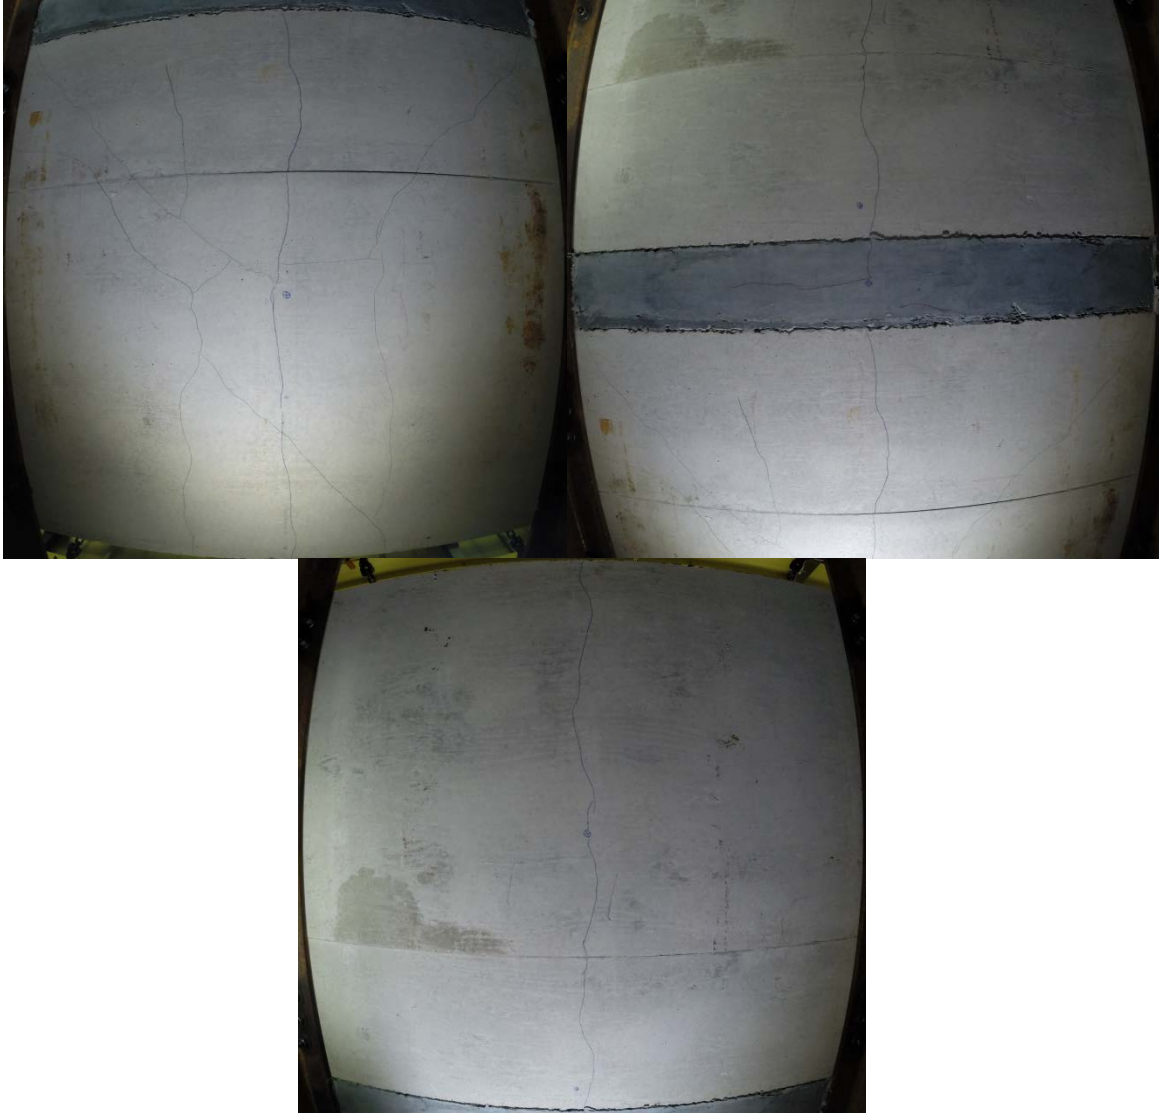
Figure 4-78. RB-1: Underside of slab after initial static loading. (Top left: slab loaded adjacent to panel, Top Right: closure strip, Bottom: panel loaded in centre)

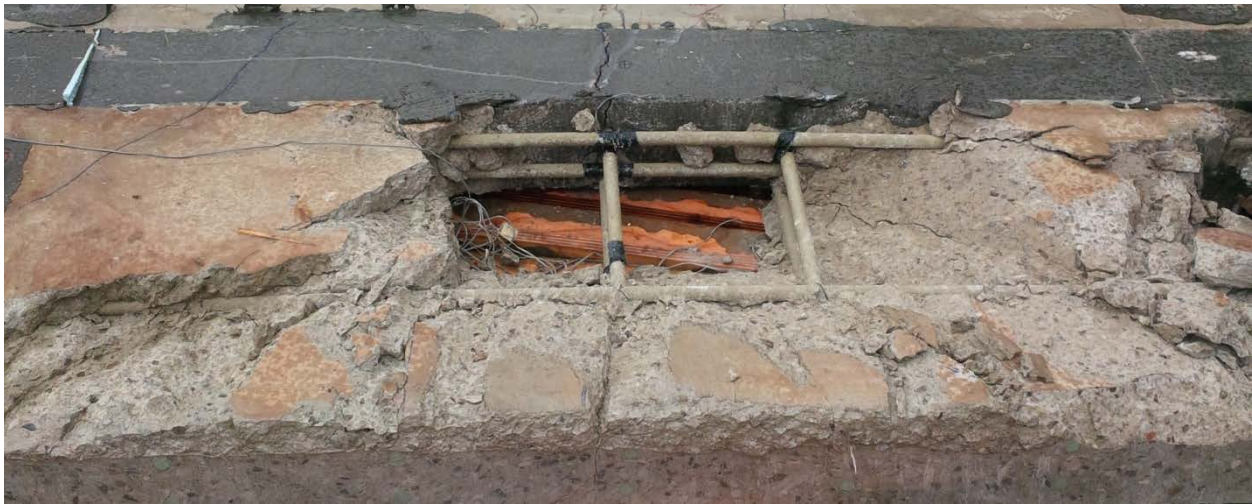
Figure 4-95. SB-3: Underside of panel after failure adjacent to the panel with concrete removed.

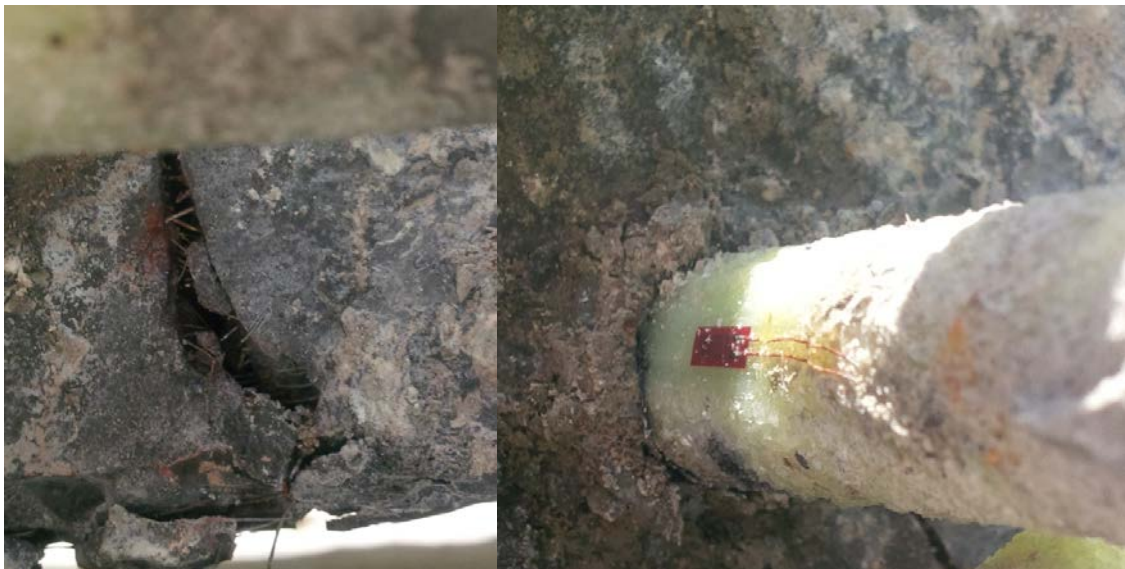
Figure 4-98. SB-1: Crack through the UHPC and longitudinal bar embedded in the UHPC.

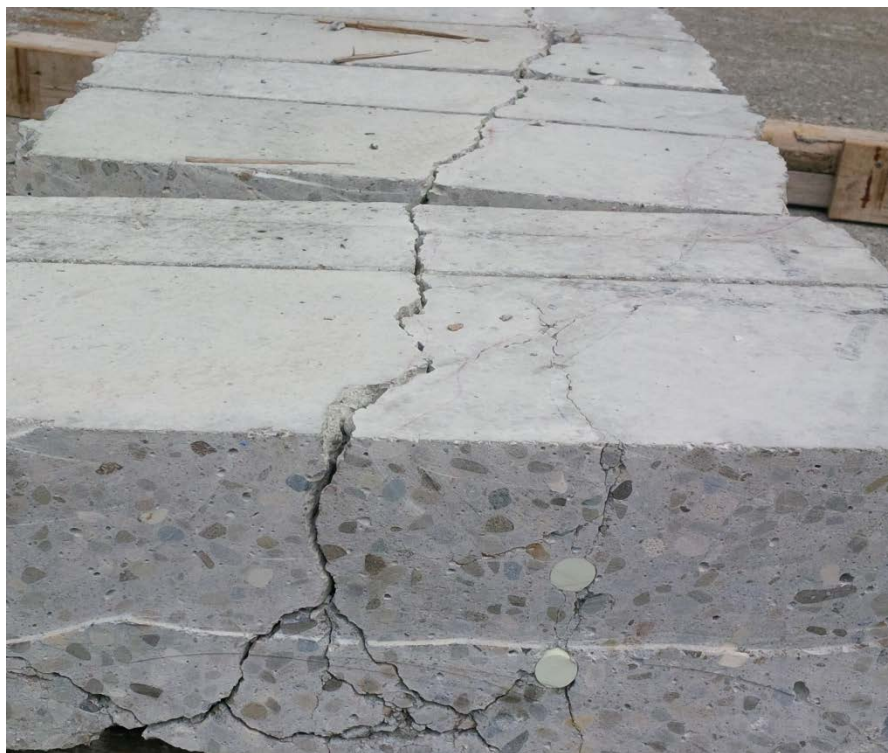
Figure 4-99. RB-3: Crack through the underside (shown up) of the slab and seen through a transverse cut through the slab.

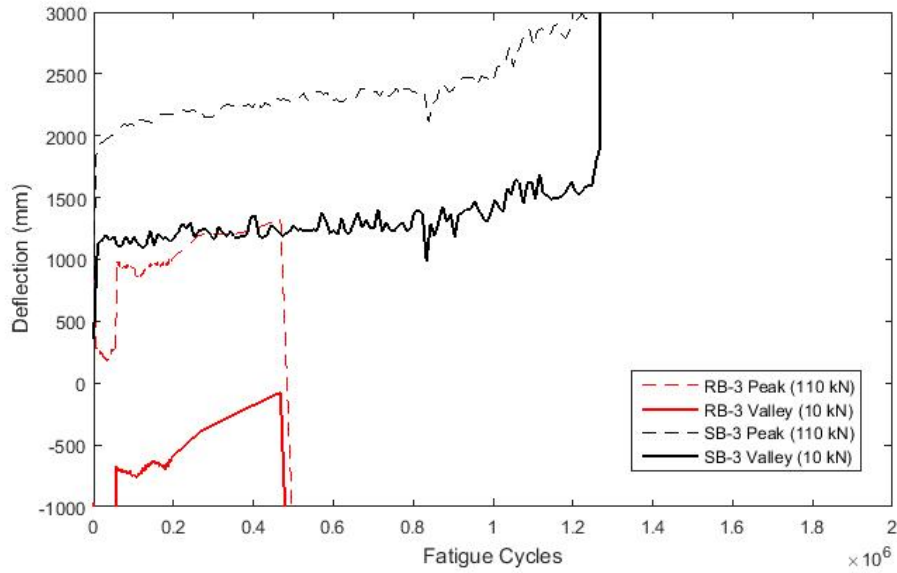
Figure 6-5. Strain peak and valley variation for bottom transverse bar below load on centre of panel.
