Evaluation of the Corrosion Behaviour of Continuously Galvanized Rebar

A thesis

presented to the University of Waterloo

Master of Applied Science

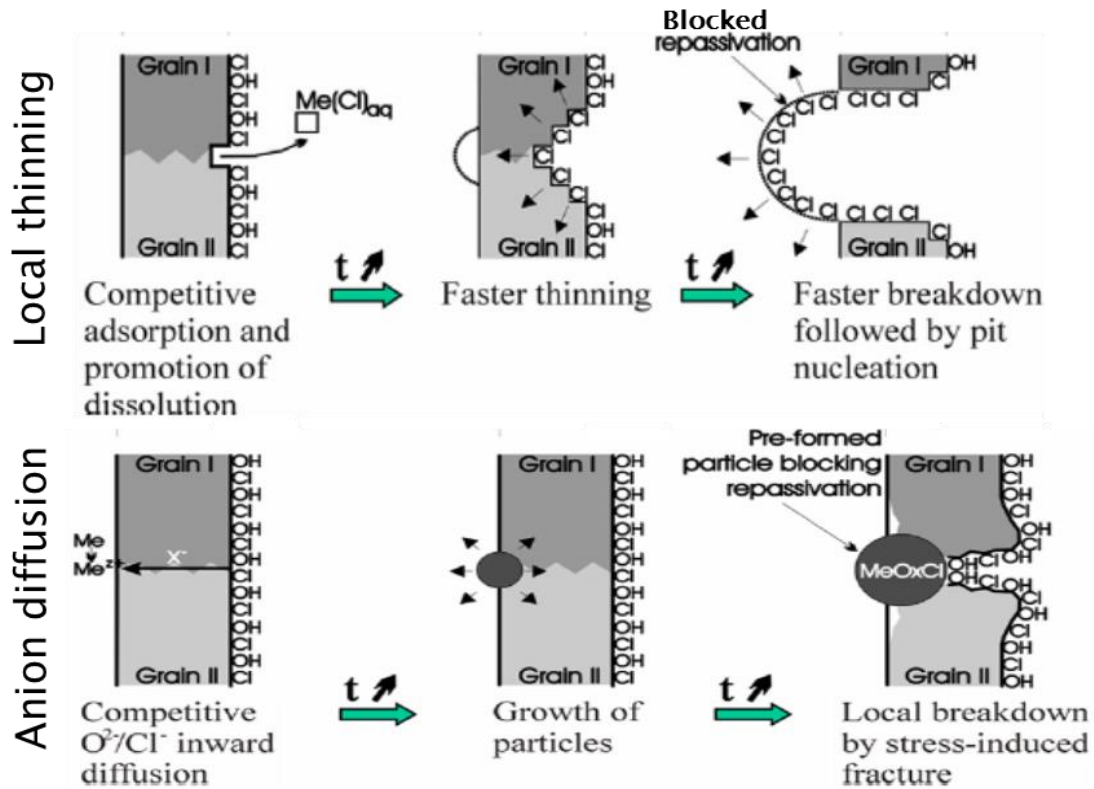
Figure 2-4: Mechanism of passivity breakdown on steel in the presence of chloride [7].

For a country like Canada that experiences a harsh winter season, salts are typically sprayed on walk-ways, bridges, parking lots etc. to melt the ice, securing the safety of road users. As a result, susceptibility of concretes in this part of the world to chloride attack is a major concern. Marcus et al. [7] proposed two mechanisms for passive film breakdown in the presence of chloride: local thinning and anion diffusion. They hypothesized that passive films are polycrystalline in nature and the grain boundaries act as sites for thinning and diffusion. In the local thinning model, diffused Cl^- and OH^- in the concrete compete for adsorption on the passive metal surface, with Cl^- being more superior due to its higher affinity towards Fe. This forms aqueous chloride compound that dissolves after a while, leaving the chloride free for continued reaction, and the process becomes autocatalytic. In the anion diffusion model, the diffused Cl^- penetrates the passive film to form a compound at the steel/passive film interface that exert pressure on the film and delaminates it, Figure 2-4.

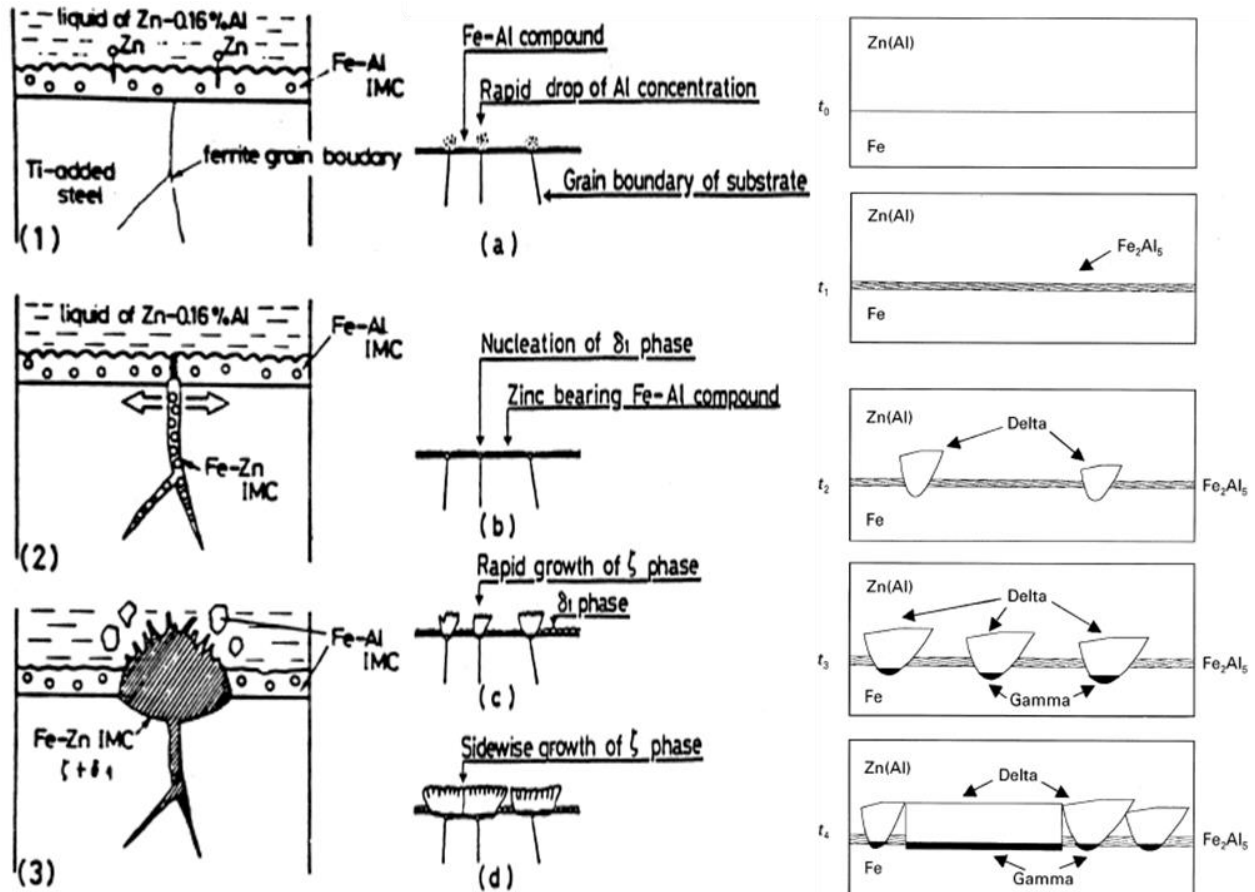
Figure 2-17: Mechanism of Fe-Zn outburst [18].

Several models were proposed for the breakdown of the inhibition layer. These include: 1) diffusion of Zn through the inhibition layer as illustrated in Figure 2-17 (left); 2) a drop in Al concentration in the inhibition layer and a subsequent formation of Fe-Zn IMC, Figure 2-17 (middle) and; 3) enrichment of the inhibition layer by Zn or Al until the solid solubility limit is reached Figure 2-17 (right). The first mechanism seems to be the most agreed upon mechanism of Fe-Zn outburst. In this mechanism, Zn atoms find its way through to the substrate via grain boundaries (GB) to react with Fe in the high-angle region - where a grain boundary of the inhibition layer aligns with that of the substrate, Figure 2-18 (left). This causes nucleation and growth of the Fe-Zn compounds at the substrate/ Fe_2Al_5 interface which burst the inhibition layer apart into the surrounding bath, making the rest of that region vulnerable to Fe-Zn formation. Guttmann et al., 1995 [31] found the average diffusion coefficient of Zn to be $5 \times 10^{-11} \text{ cm}^2/\text{s}$, making it possible for Zn to diffuse through a 70nm thick Fe_2Al_5 layer in a second and a 250nm

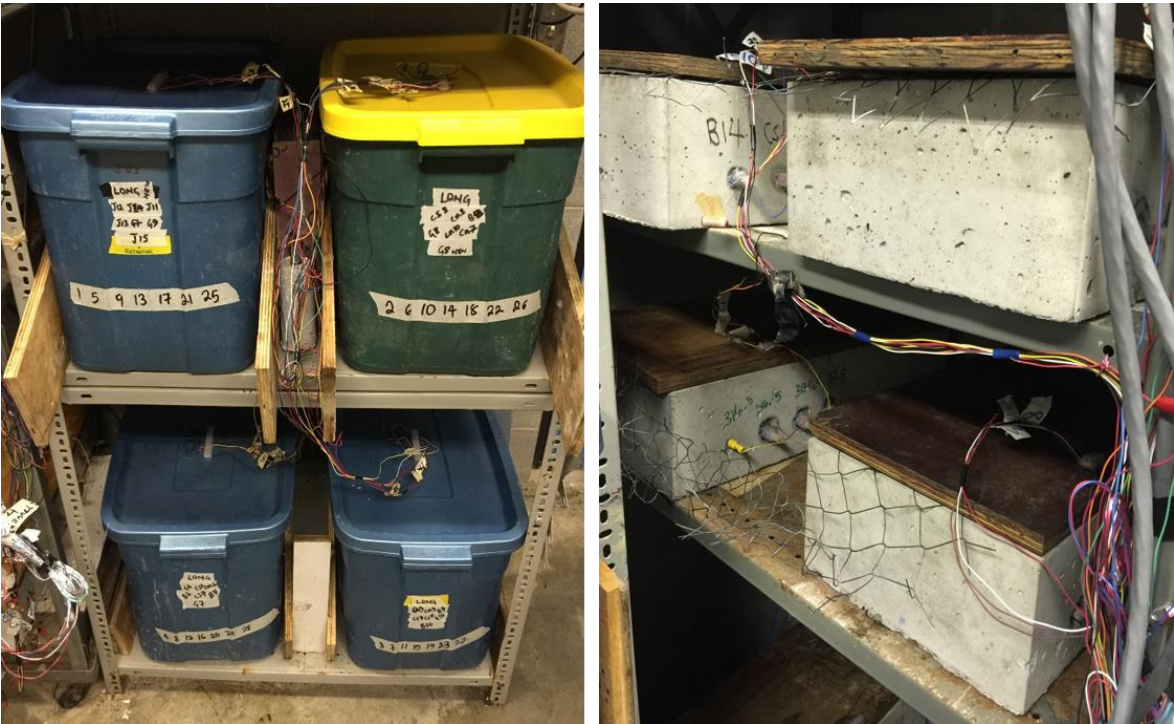
Figure 3-10: Cracked specimens closed in tubs (left), and sound beams closed with plywood (Right).

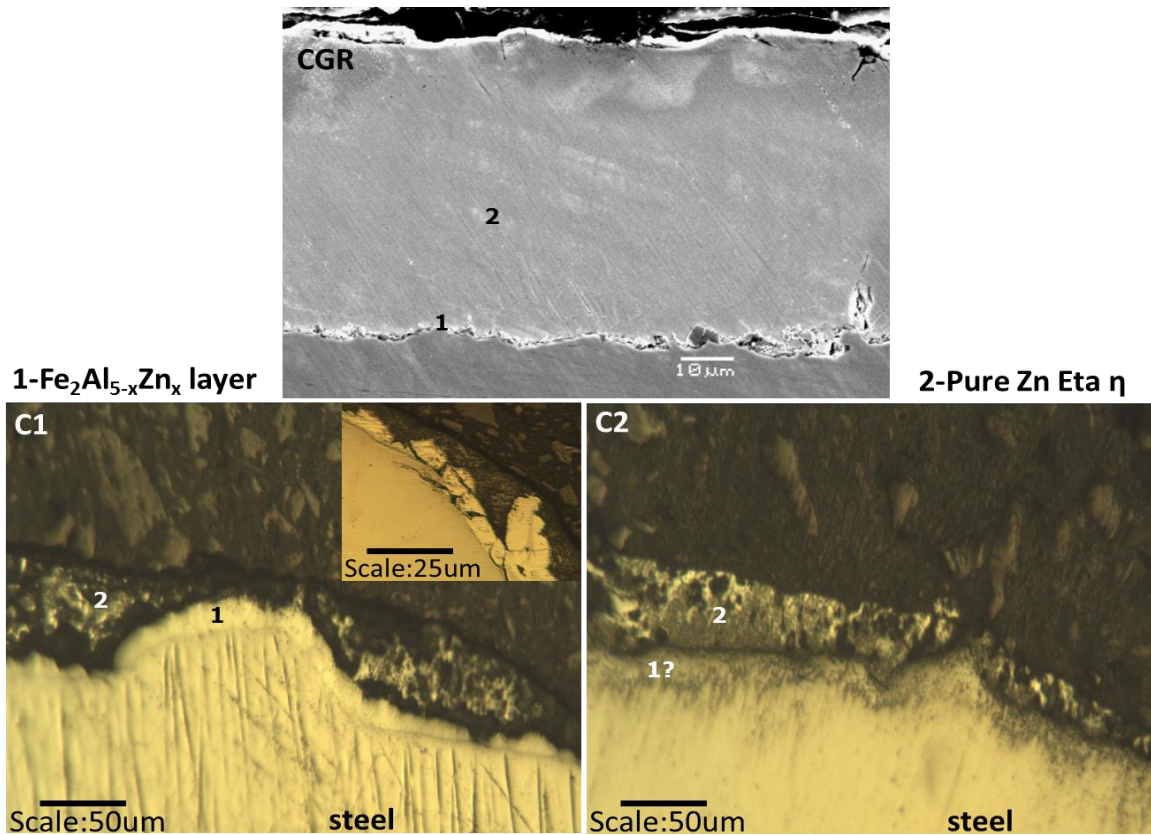
Figure 4-2: Comparison of C1 and C2 specimens with CGR [47]. Note the thicker layer 1 in C1 and the diffuse or absent layer 1 in C2. Insert shows the broken layer 1 in C1 bar.

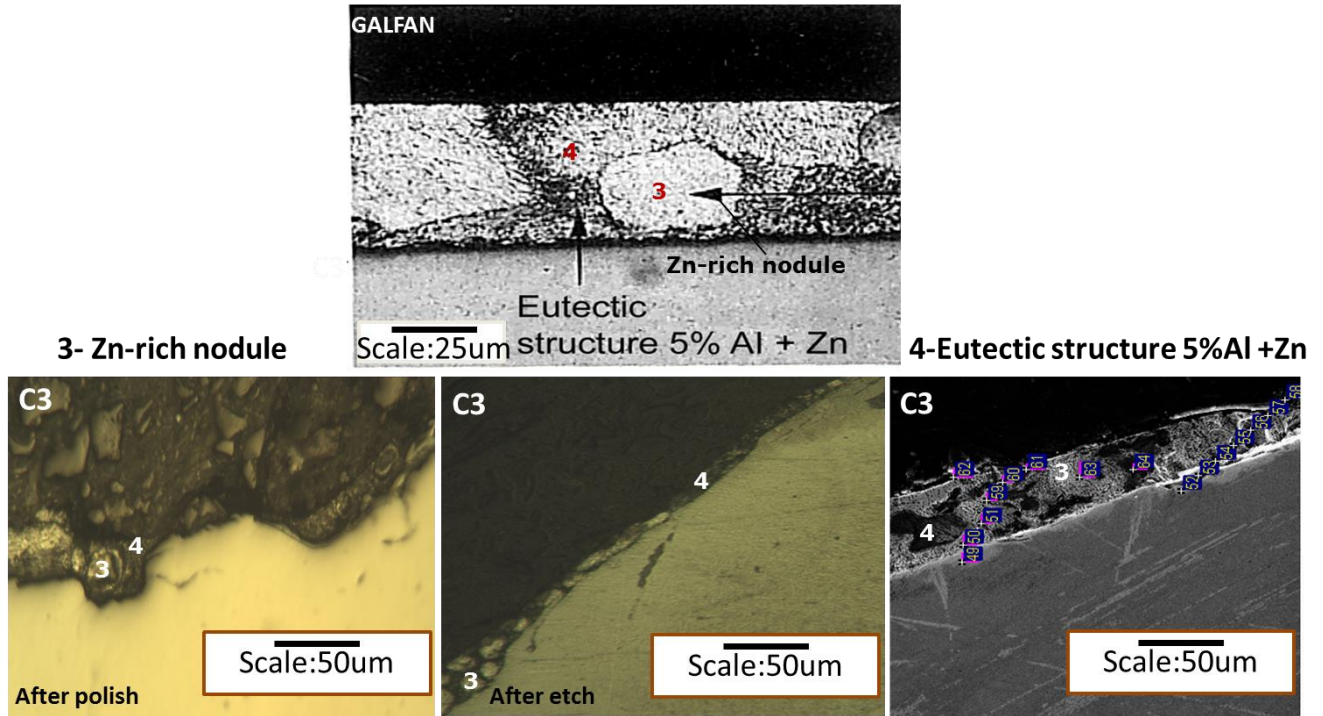
Figure 4-3: Comparison of C3 with Galfan coating from [62]. The Zn-rich nodule and eutectic structure of aluminum and zinc can be seen in both photos.

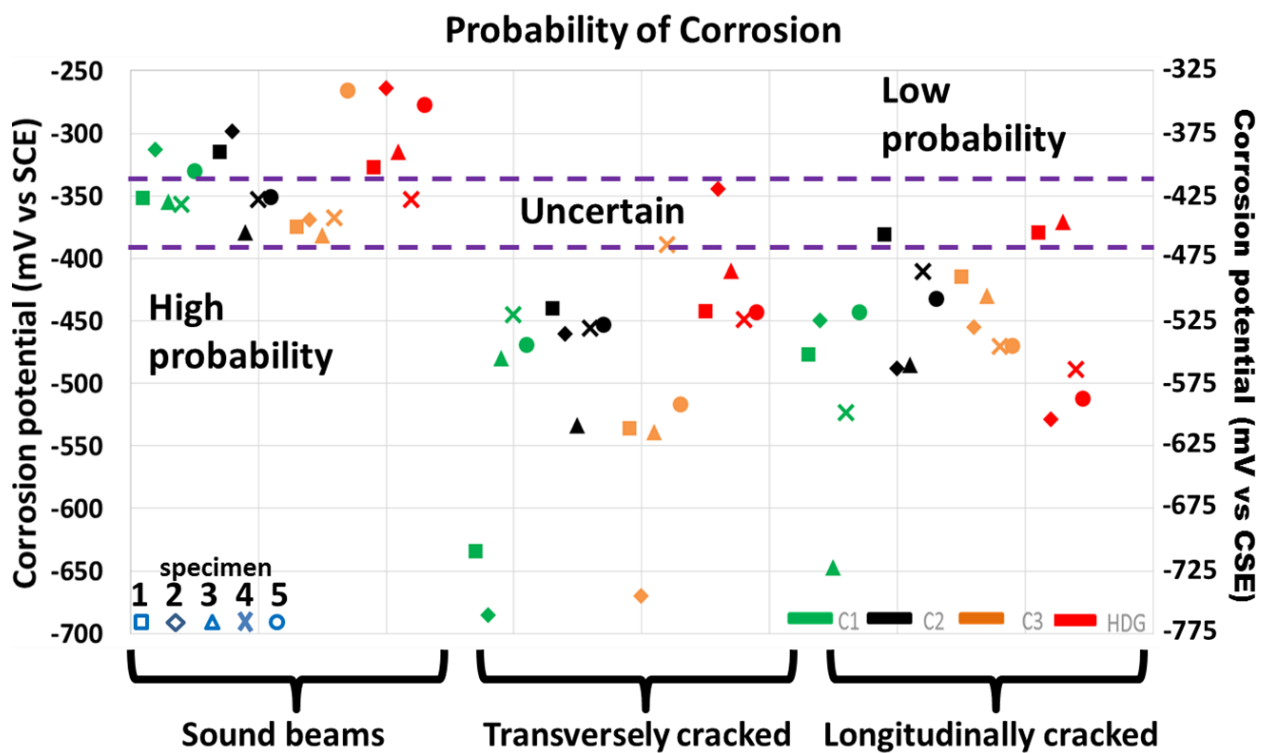
Figure 4-27: Potential guideline for assessing the probability of corrosion of galvanized steels in concrete.

potential guidelines for assessing galvanized steel should be related to concrete exposure condition (e.g. similar degree of saturation of the concrete). As such, a new potential guideline is recommended, Figure 4-27. In developing this guideline, as observed in the black bars (Table 4-5), some of the potentials from the cracked specimens fall in the uncertain region (between -125 and -275 mV vs SCE) of the ASTM C876 (Figure 1-1), despite visually observing corrosion on the bars. Similarly, in the galvanized bars, some of the potentials from bars in the cracked specimens are similar to those passive bars in the sound beam specimens, despite visually observing corrosion on the bars. As a result, the regions where they overlap is used to generate the “uncertain region” in Figure 4-27.

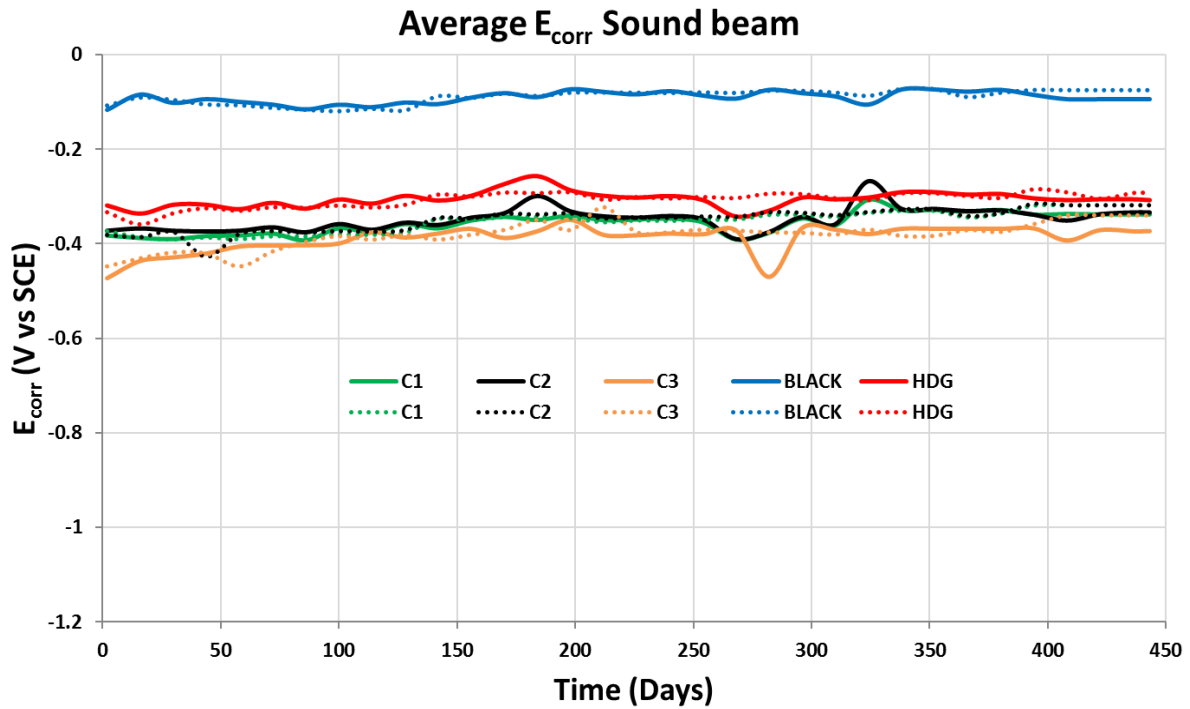
Figure A1.1: Average E_{corr} Sound (non-cracked) concrete specimen.

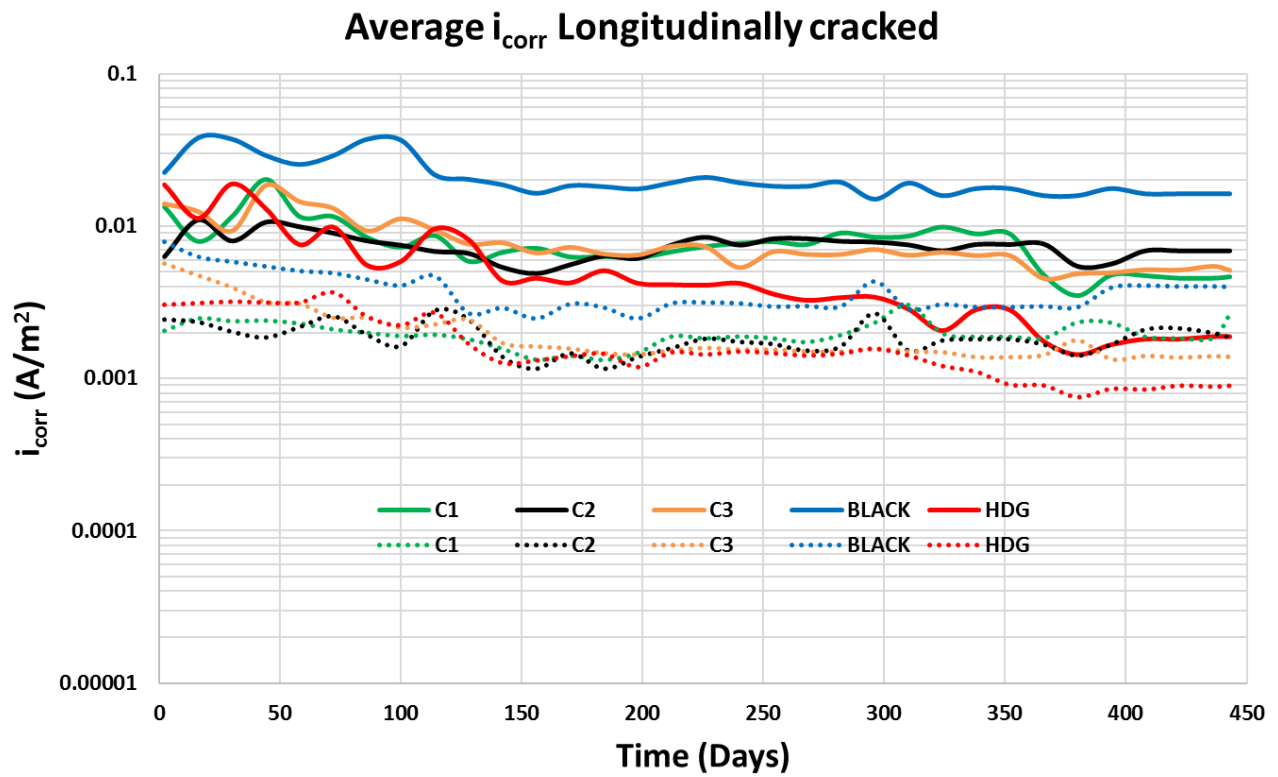
Figure A2.3: Average i_{corr} longitudinally cracked concrete specimen.

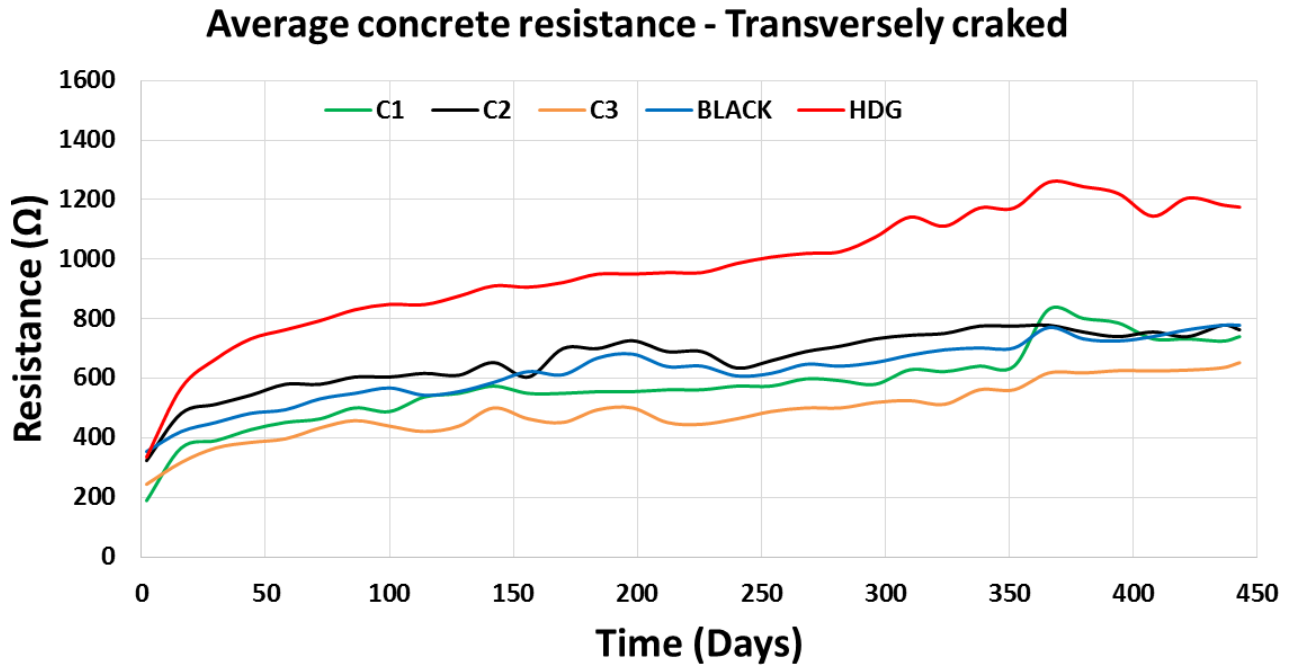
Figure A3.2: Average concrete resistance for transversely cracked concrete specimen.

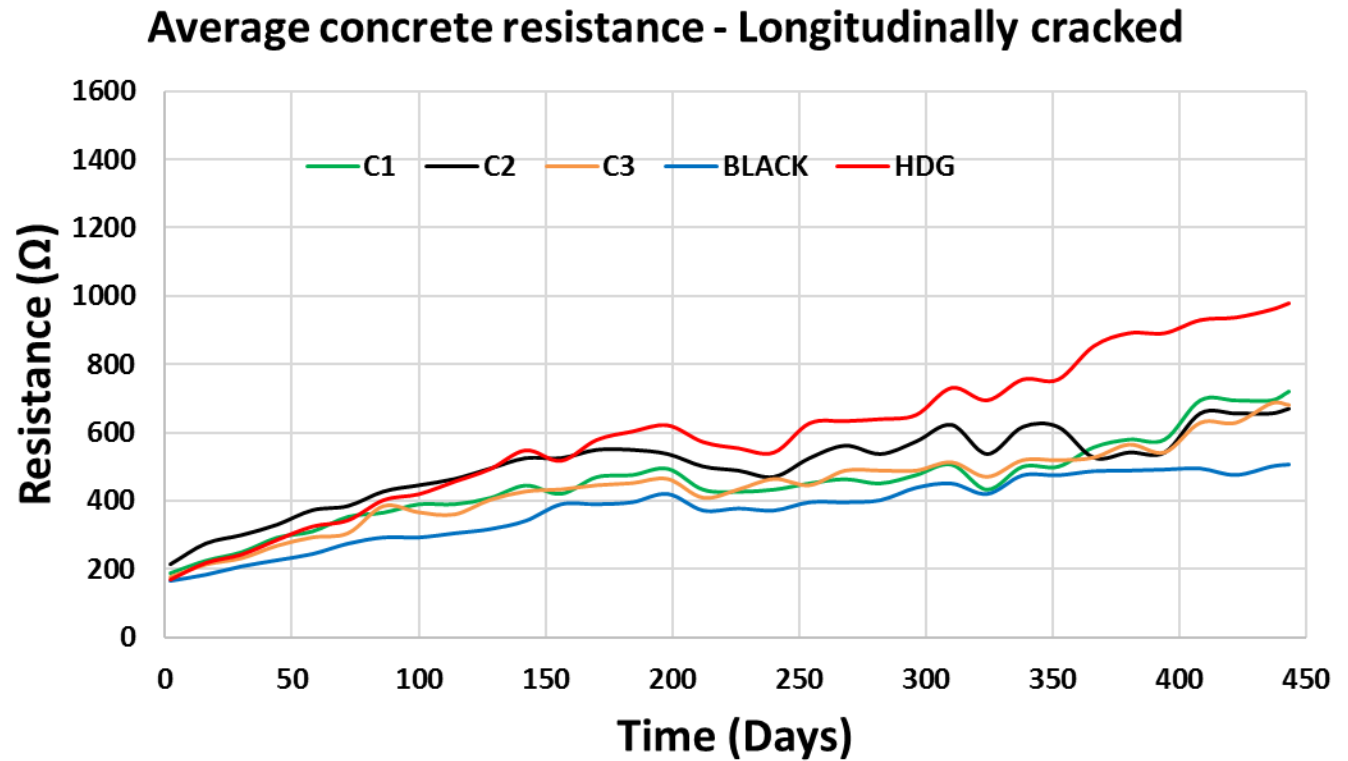
Figure A3.3: Average concrete resistance for longitudinally cracked concrete specimen.

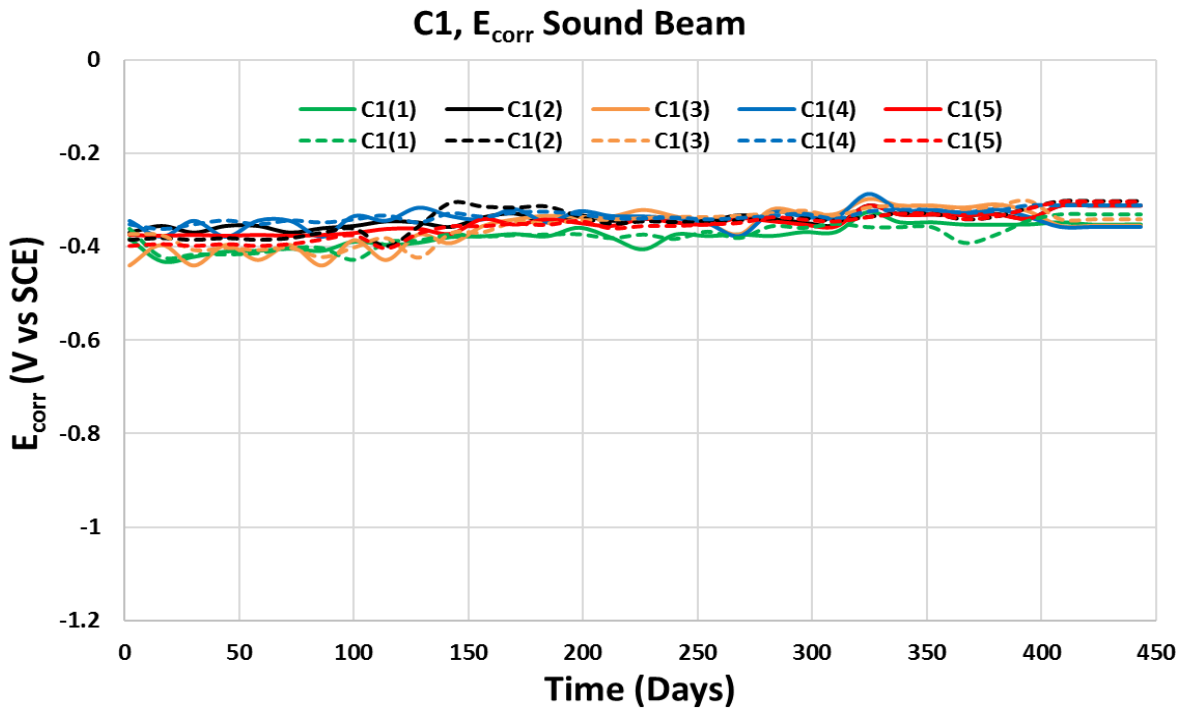
Figure C1.1: Sound (non-cracked) concrete beam.

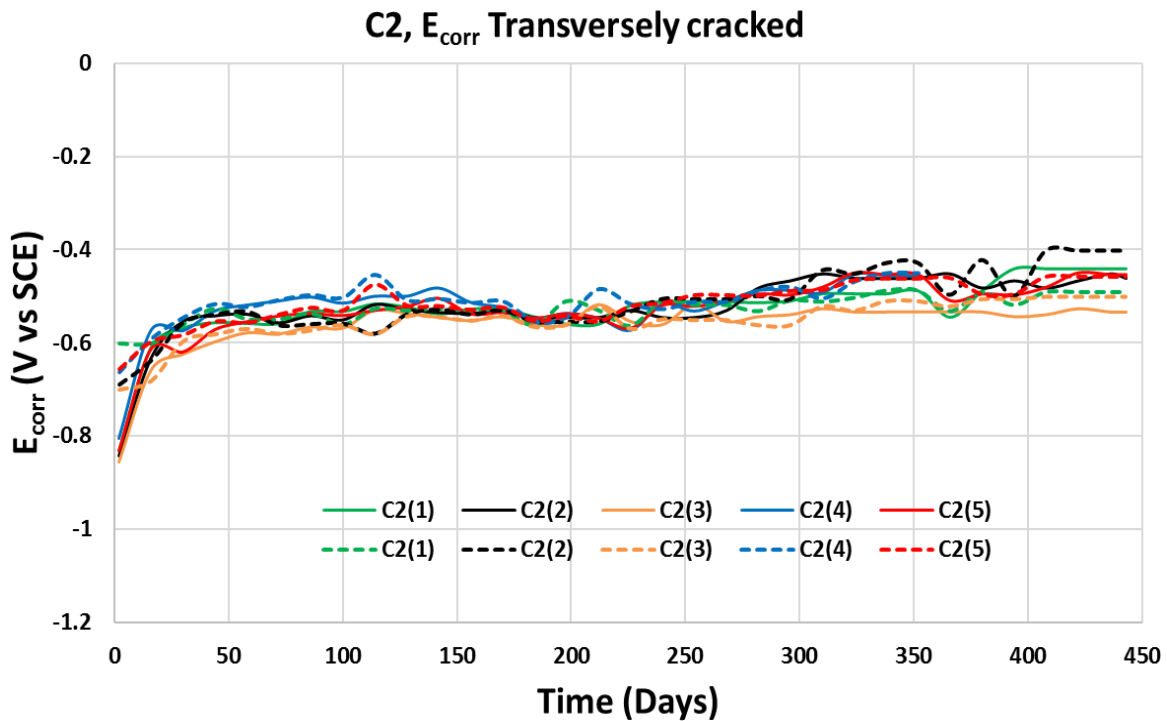
Figure C1.5: Crack width \rightarrow C2(1) = 0.2, C2(2) = 0.25, C2(3) = 0.2, C2(4) = 0.13, C2(5) =

0.2.

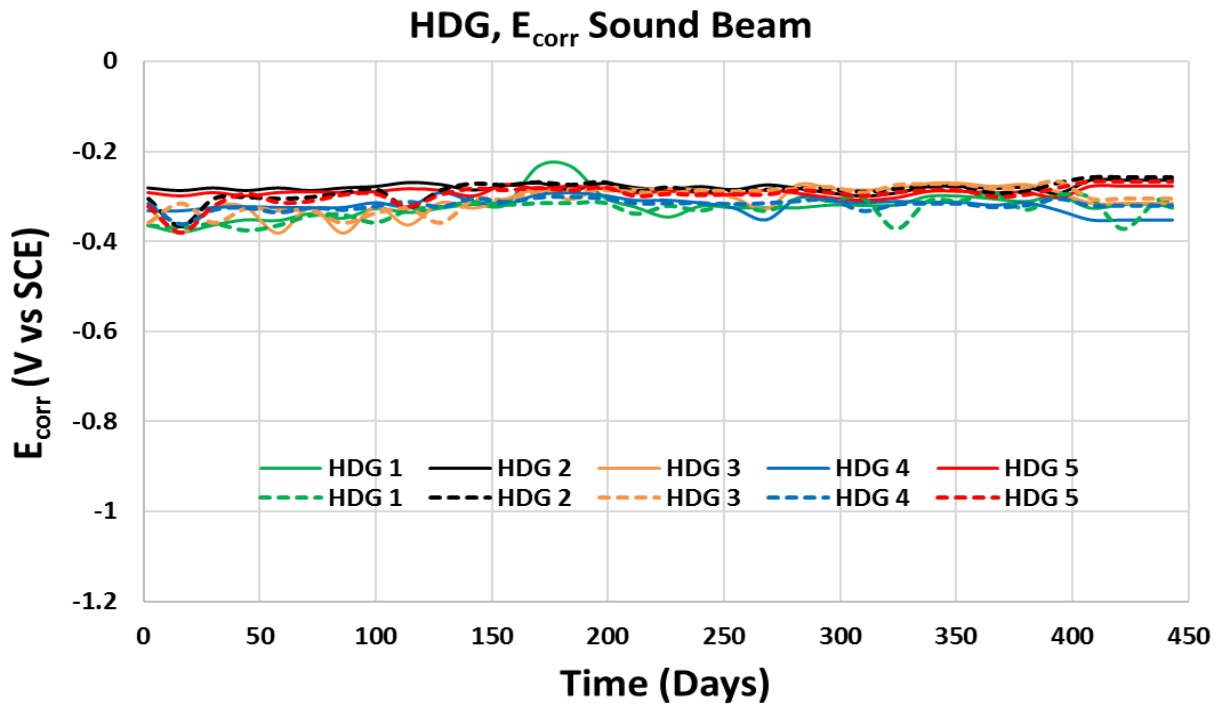
Figure C1.10: Sound (non-cracked) concrete beam.

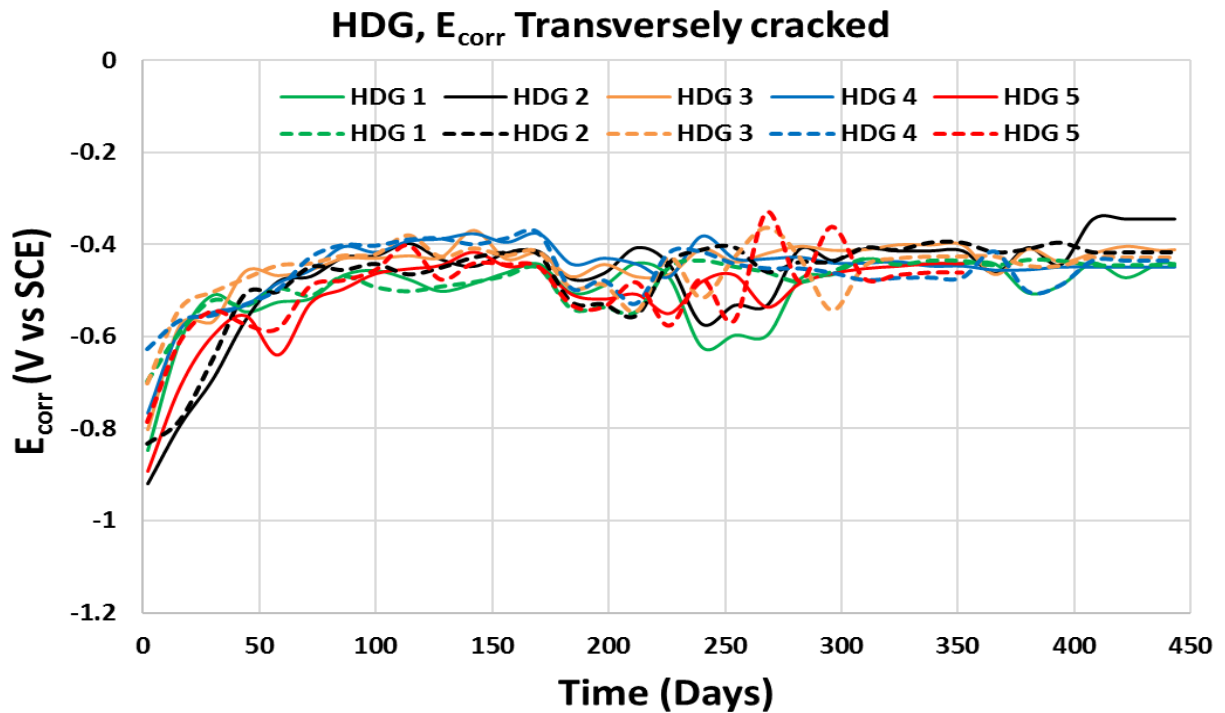
Figure C1.11: Crack width \rightarrow HDG1 = 0.25, HDG2 = 0.3, HDG3 = 0.25, HDG4 = 0.15, HDG5 = 0.3.

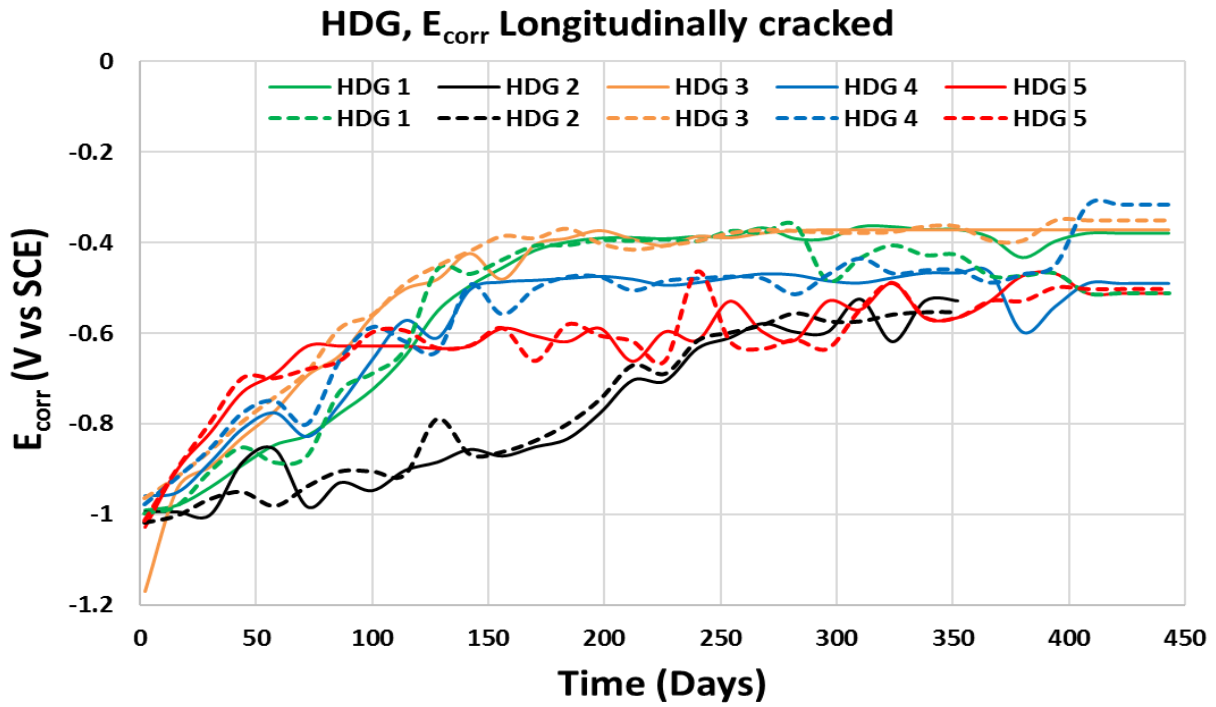
Figure C1.12: Crack width \rightarrow HDG1 = 0.15, HDG2 = 0.25, HDG3 = 0.14, HDG4 = 0.15, HDG5 = 0.2.

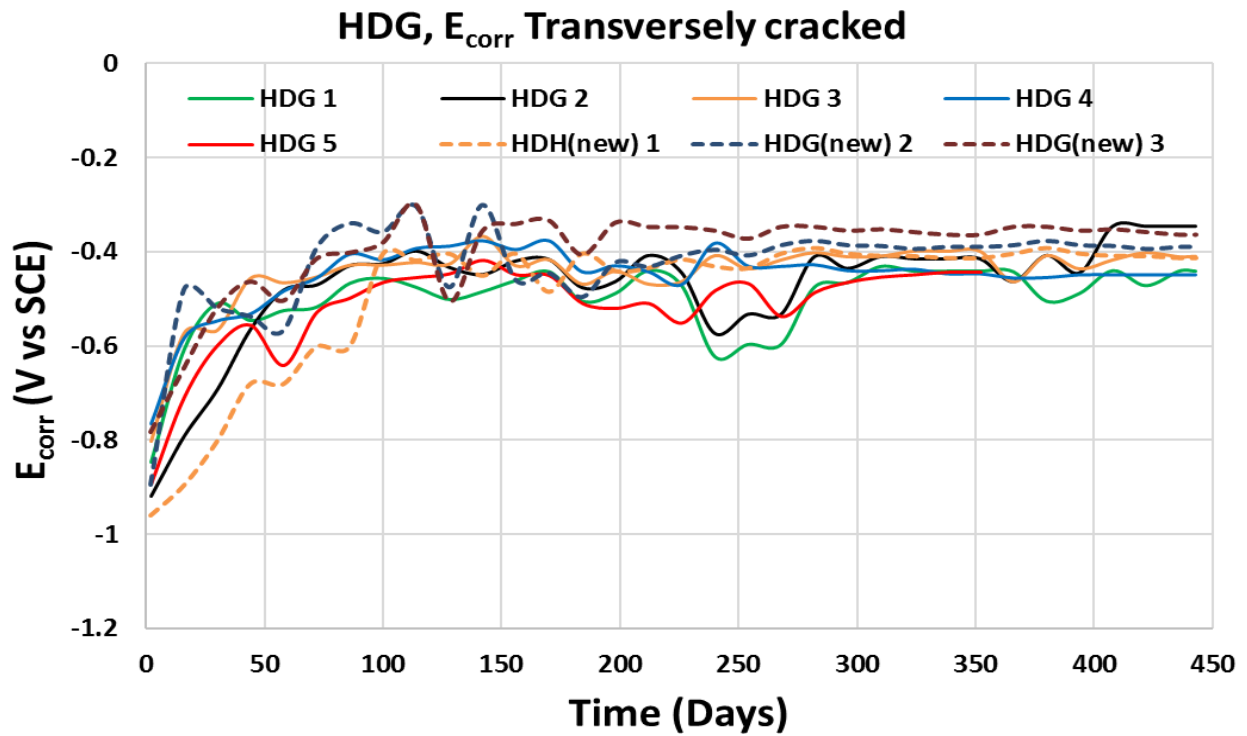
Figure C1.14: GP result of transversely cracked specimens from Cast 1 and 2.

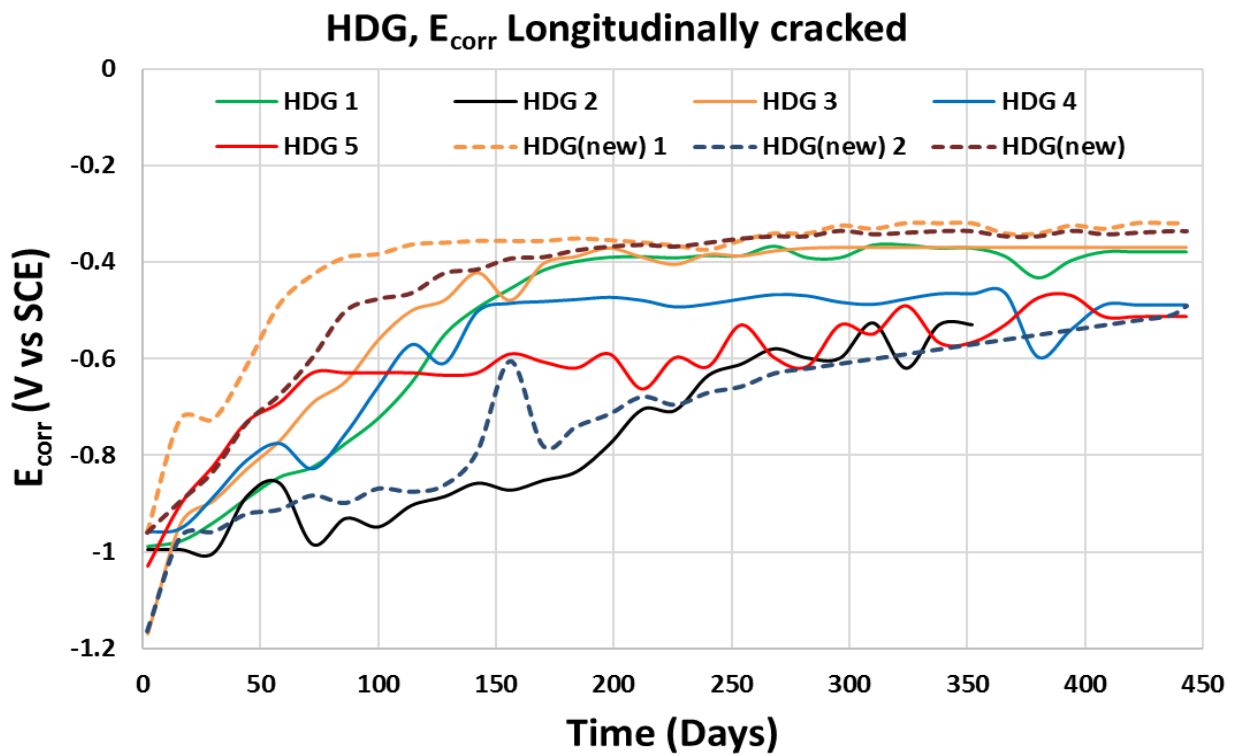
Figure C1.15: GP result of longitudinally cracked specimens from Cast 1 and 2.

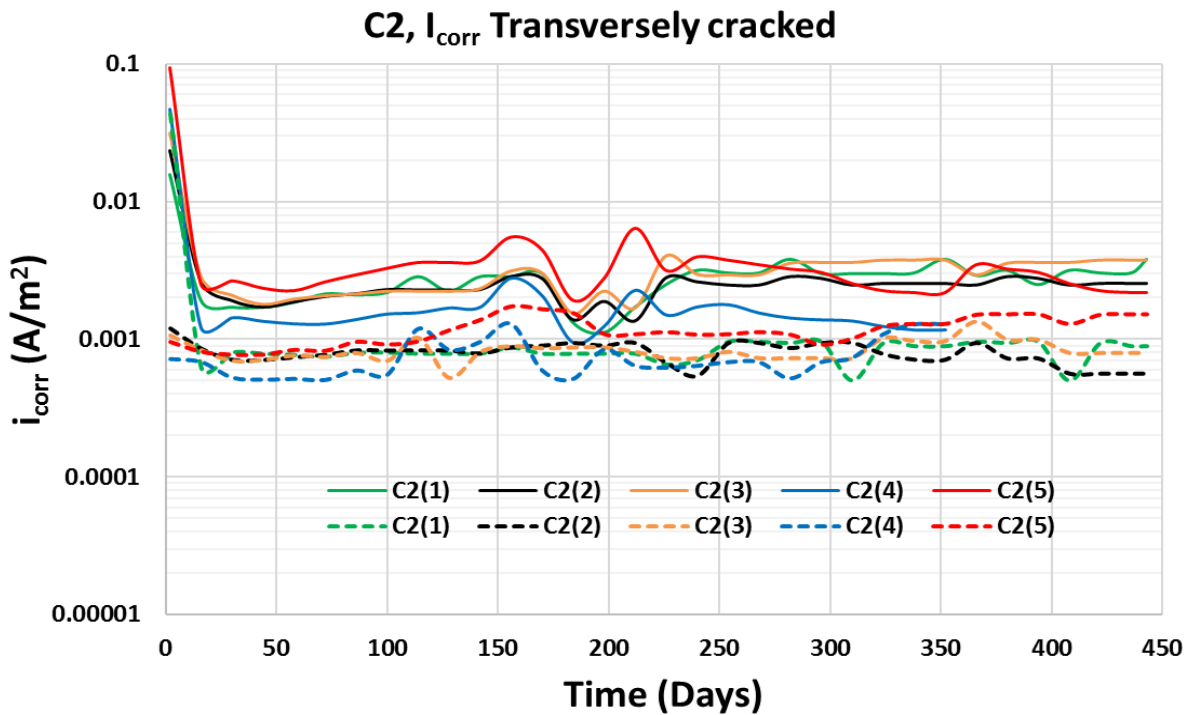
Figure C2.5: Crack width \rightarrow C2(1) = 0.2, C2(2) = 0.25, C2(3) = 0.2, C2(4) = 0.13, C2(5) = 0.2.

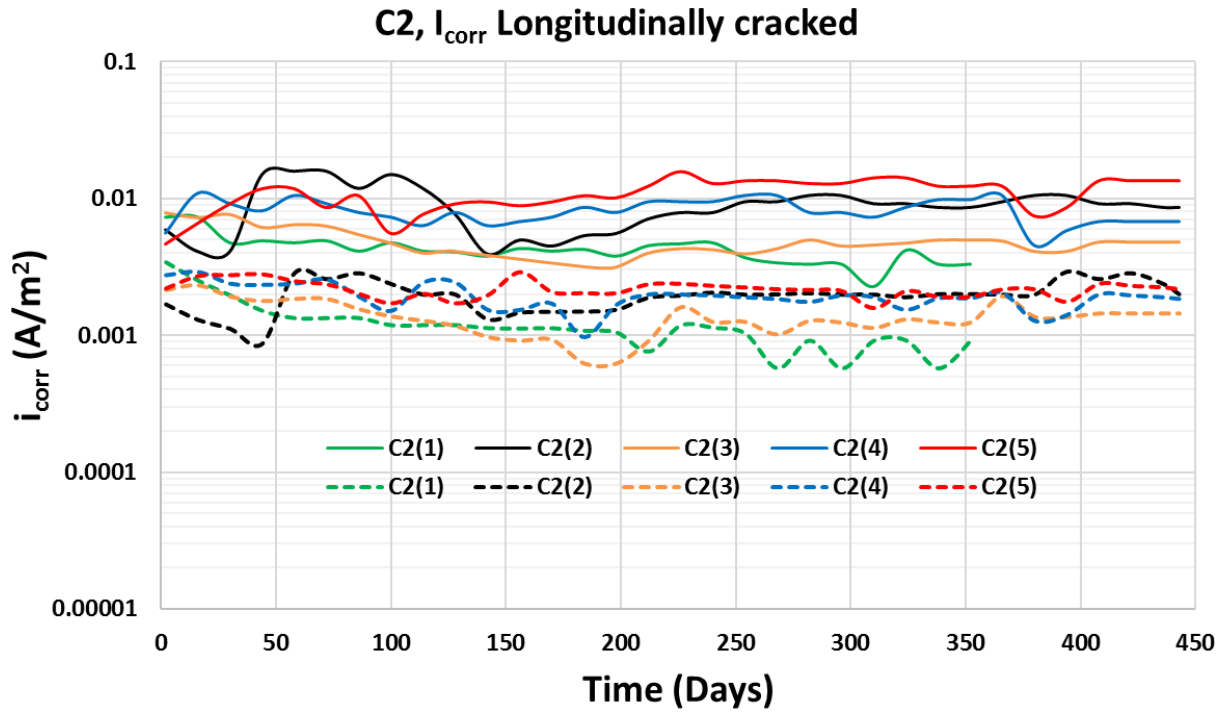
Figure C2.6: Crack width \rightarrow C2(1) = 0.14, C2(2) = 0.25, C2(3) = 0.14, C2(4) = 0.2, C2(5) = 0.2.

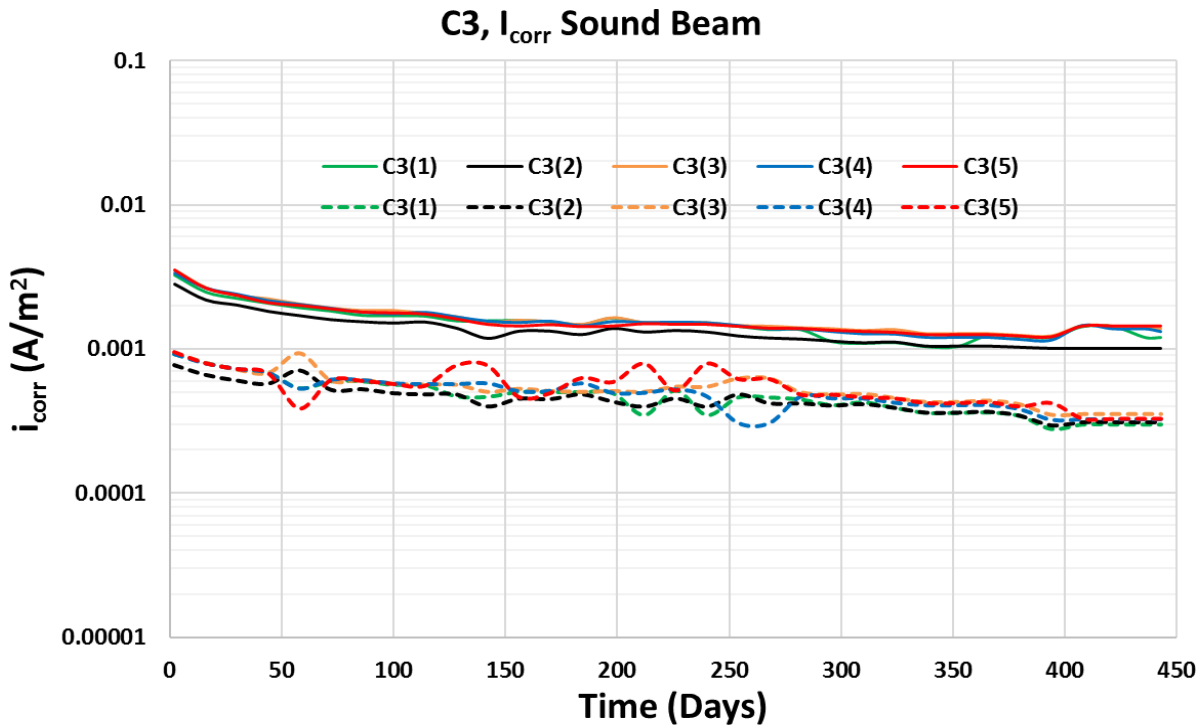
Figure C2.7: Sound (non-cracked) concrete beam.

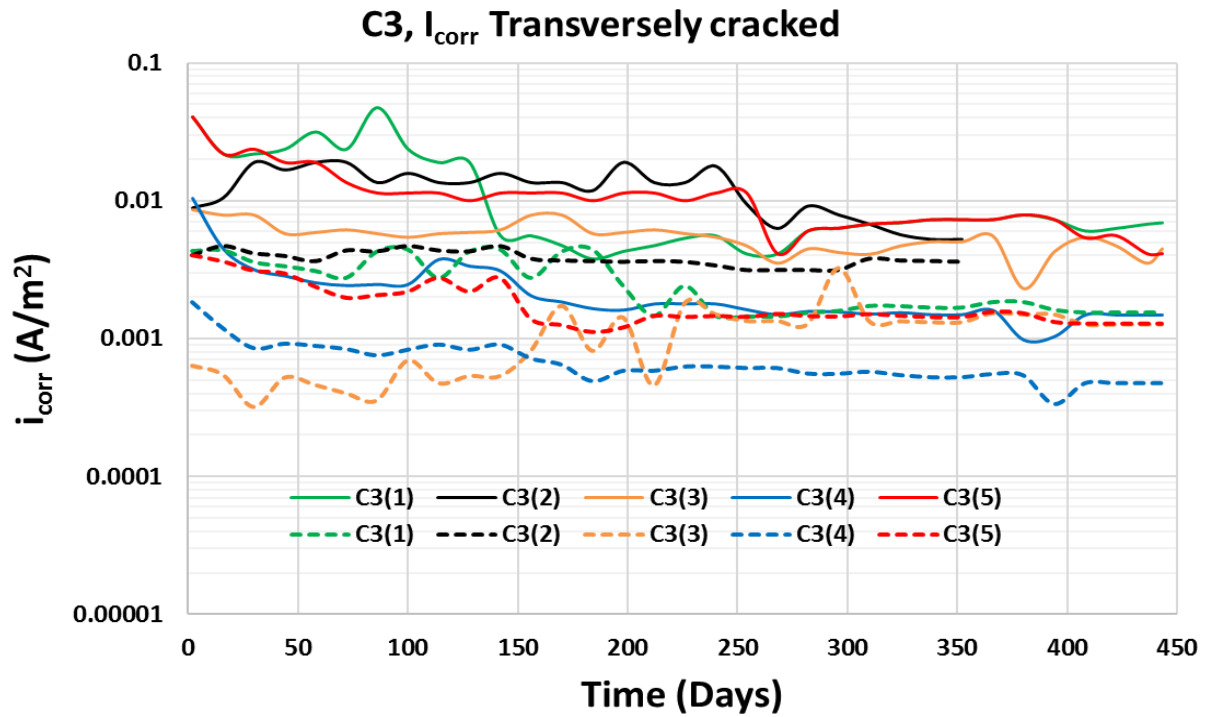
Figure C2.8: Crack width \rightarrow C3(1) = 0.3, C3(2) = 1.5, C3(3) = 0.3, C3(4) = 0.2, C3(5) = 0.25.

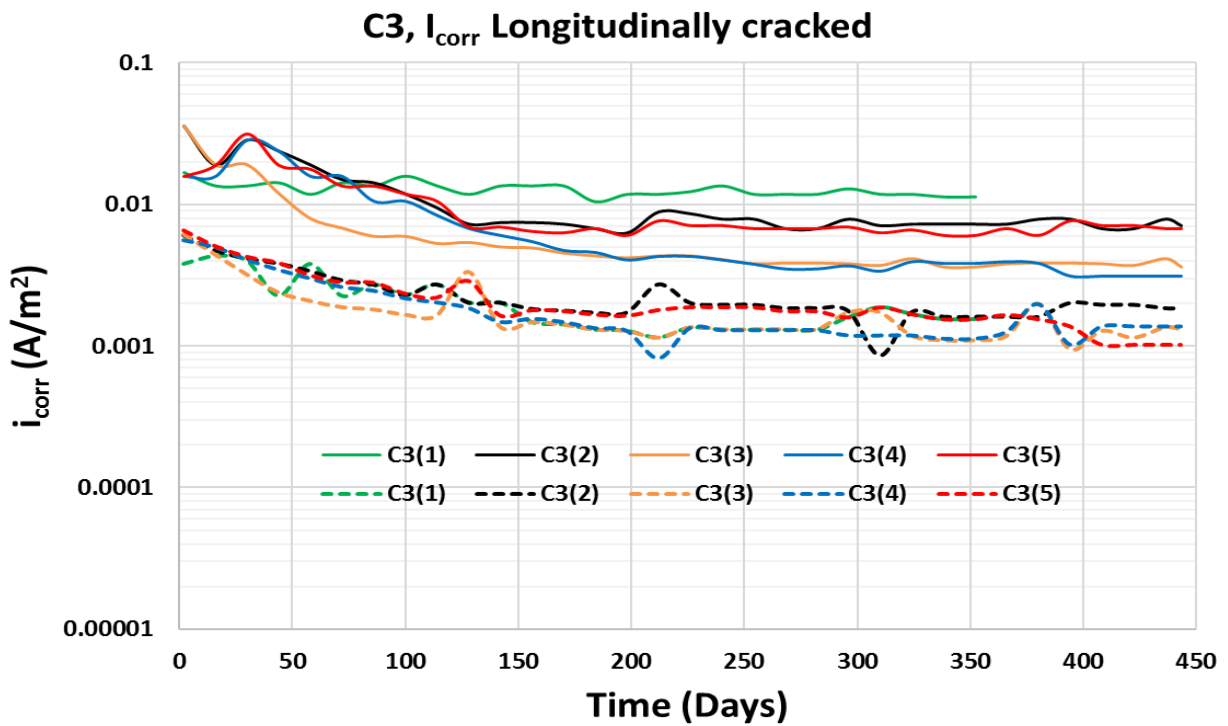
Figure C2.9: Crack width \rightarrow C3(1) = 0.25, C3(2) = 0.2, C3(3) = 0.15, C3(4) = 0.15, C3(5) =

0.2.

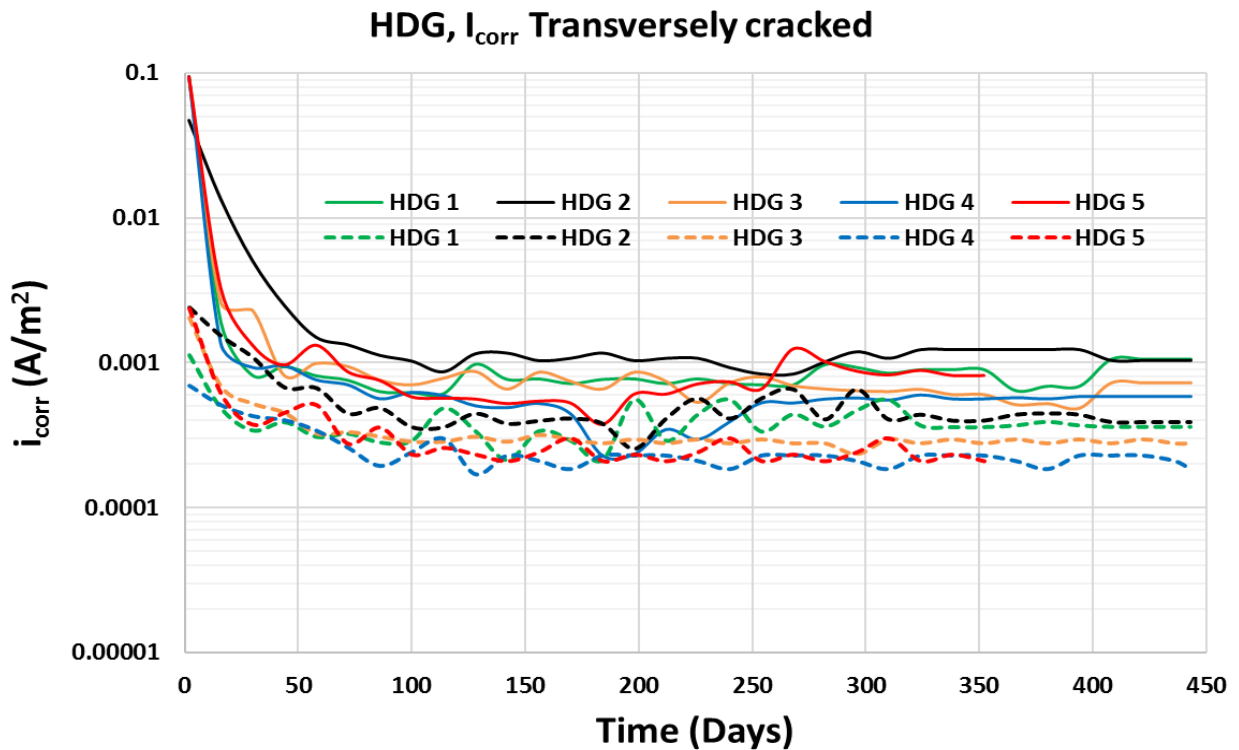
Figure C2.11: Crack width \rightarrow HDG1 = 0.25, HDG2 = 0.3, HDG3 = 0.25, HDG4 = 0.15, HDG5 = 0.3.

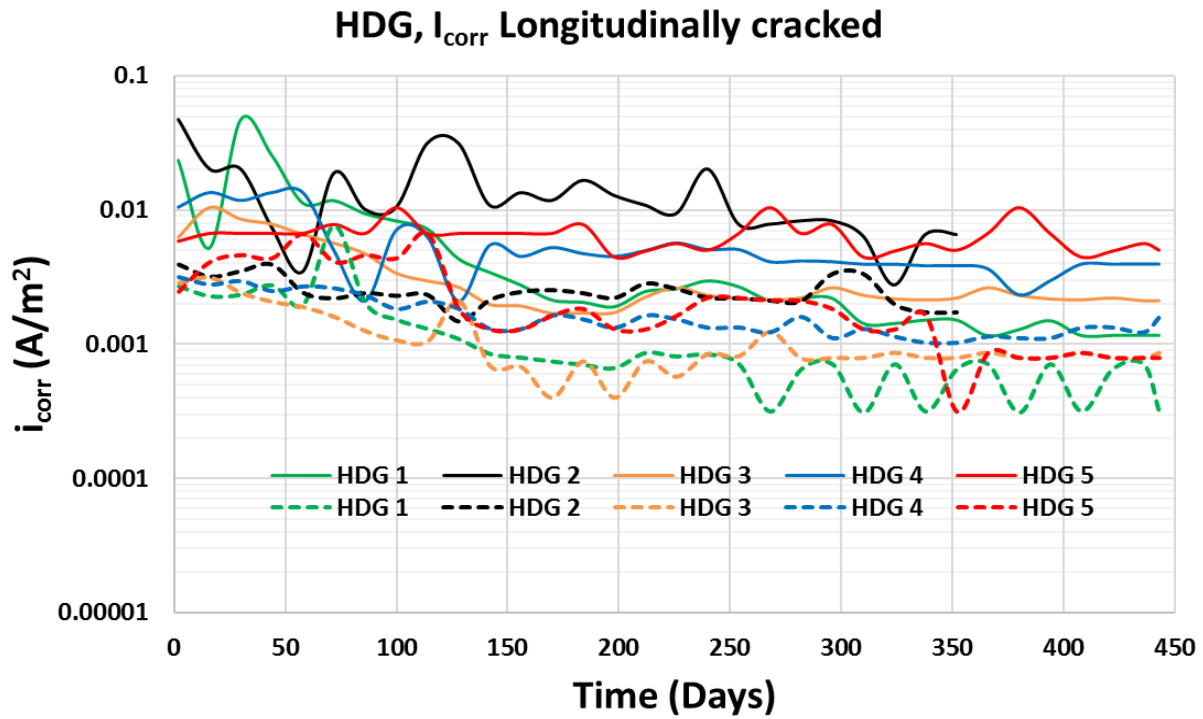
Figure C2.12: Crack width - HDG1 = 0.15, HDG2 = 0.25, HDG3 = 0.14, HDG4 = 0.15, HDG5 = 0.2.
