Evaluation of the Corrosion Behaviour of Continuously Galvanized Rebar

A thesis

presented to the University of Waterloo

Master of Applied Science

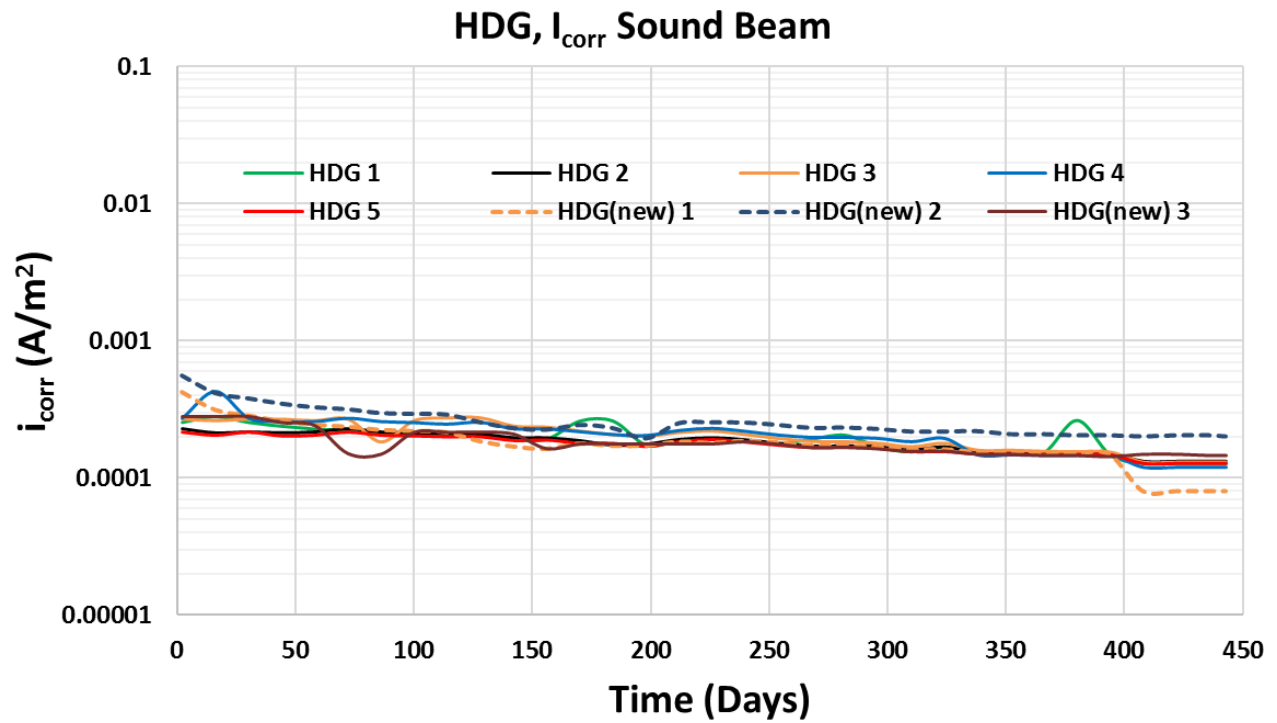
Figure C2.13 – Sound (non-cracked) concrete specimens from Cast 1 and 2.

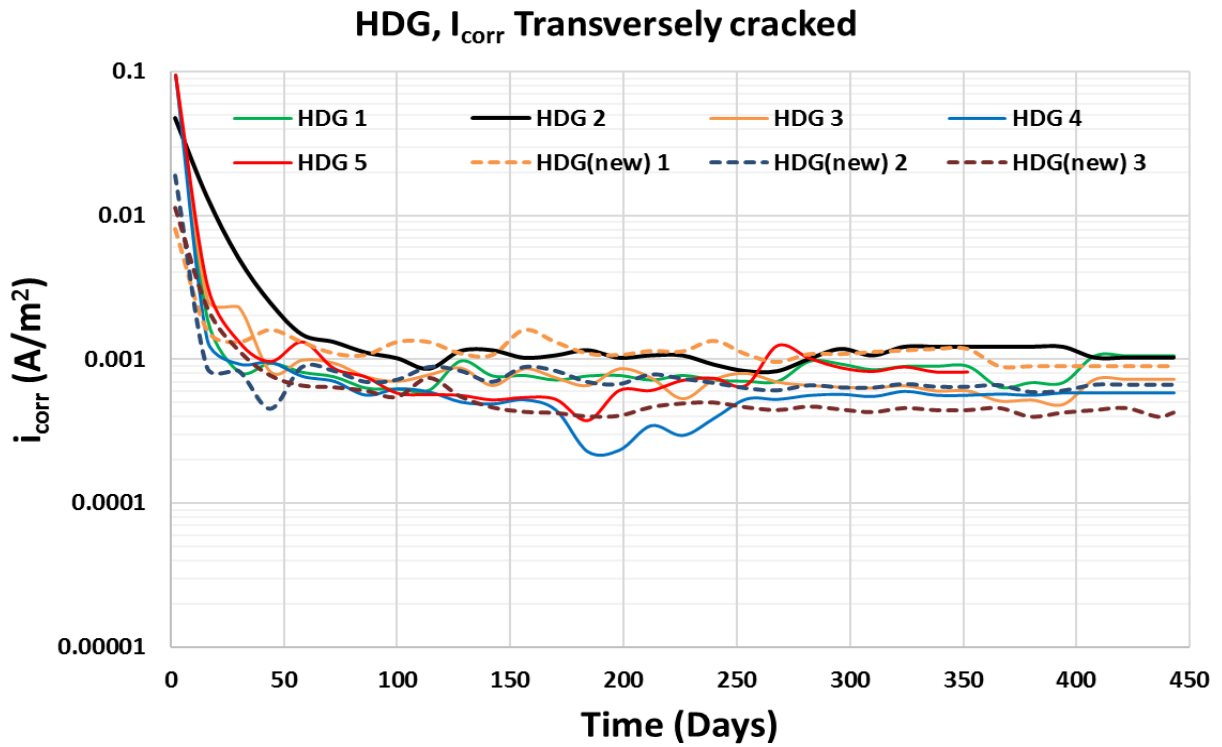
Figure C2.14 – GP result for transversely cracked specimens from Cast 1 and 2.

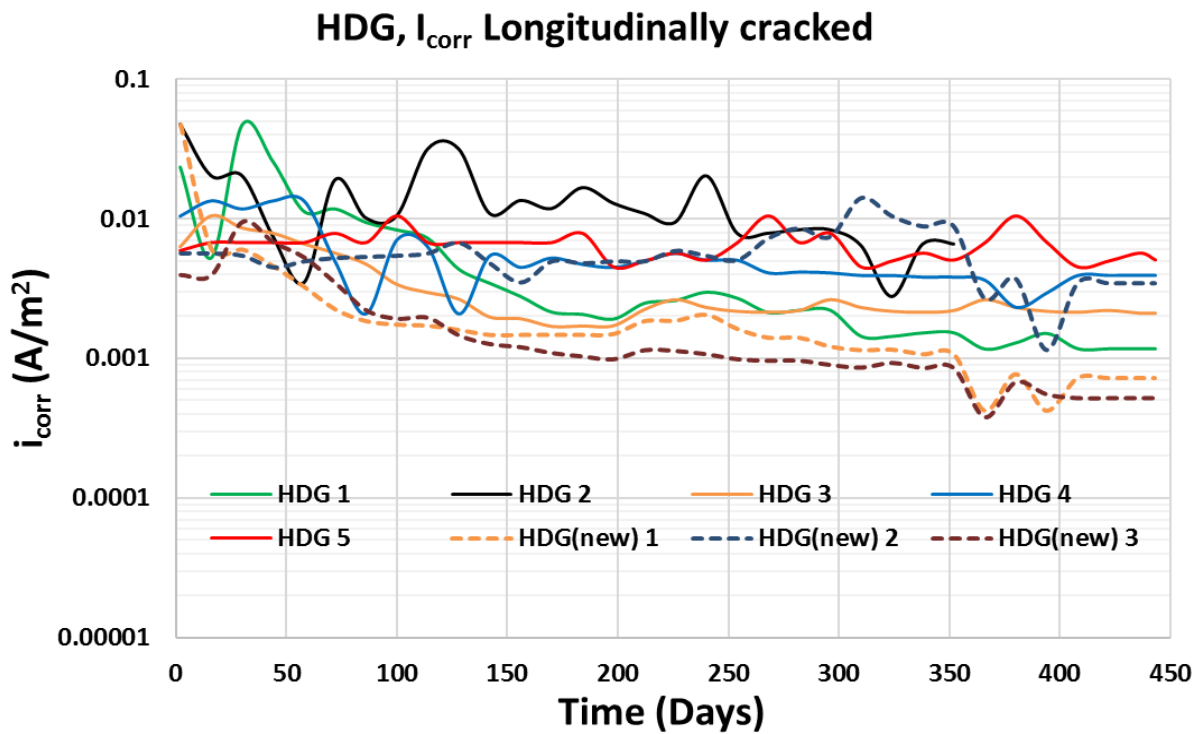
Figure C2.15 – GP result for longitudinally cracked specimens from Cast 1 and 2.

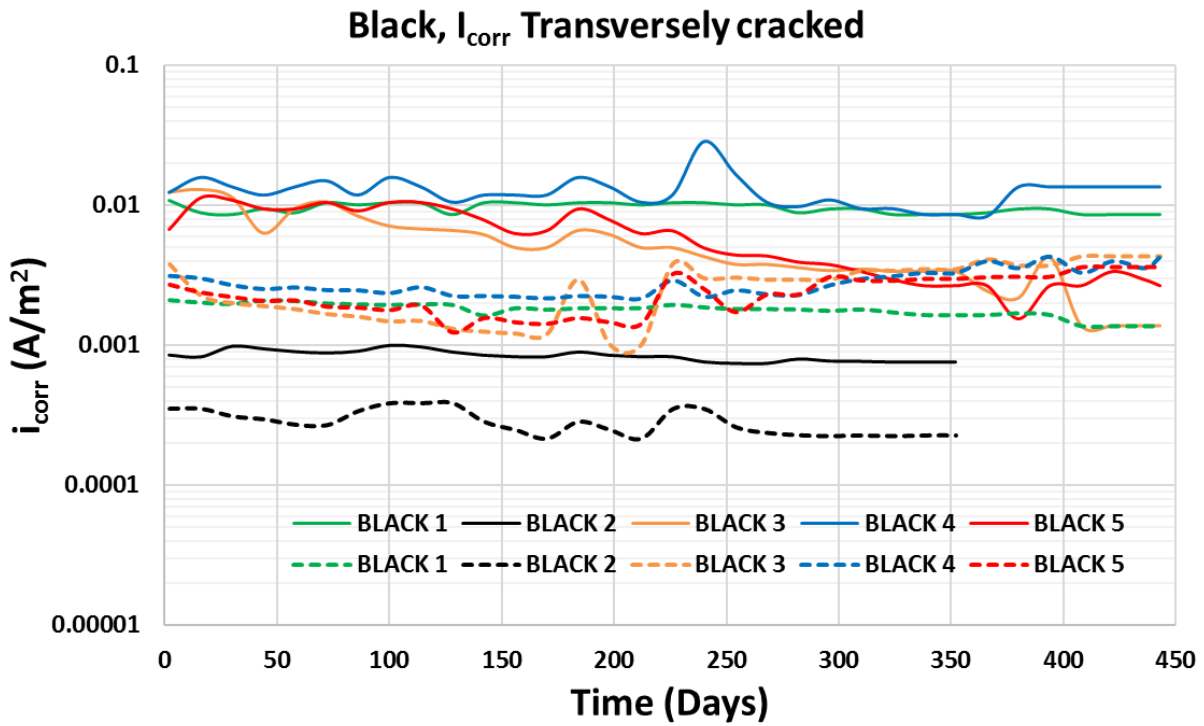
Figure C2.17 – Crack width \rightarrow BLK1 = 0.15, BLK2 = 0.13, BLK3 = 0.26, BLK4 = 0.24, BLK5 = 0.15.

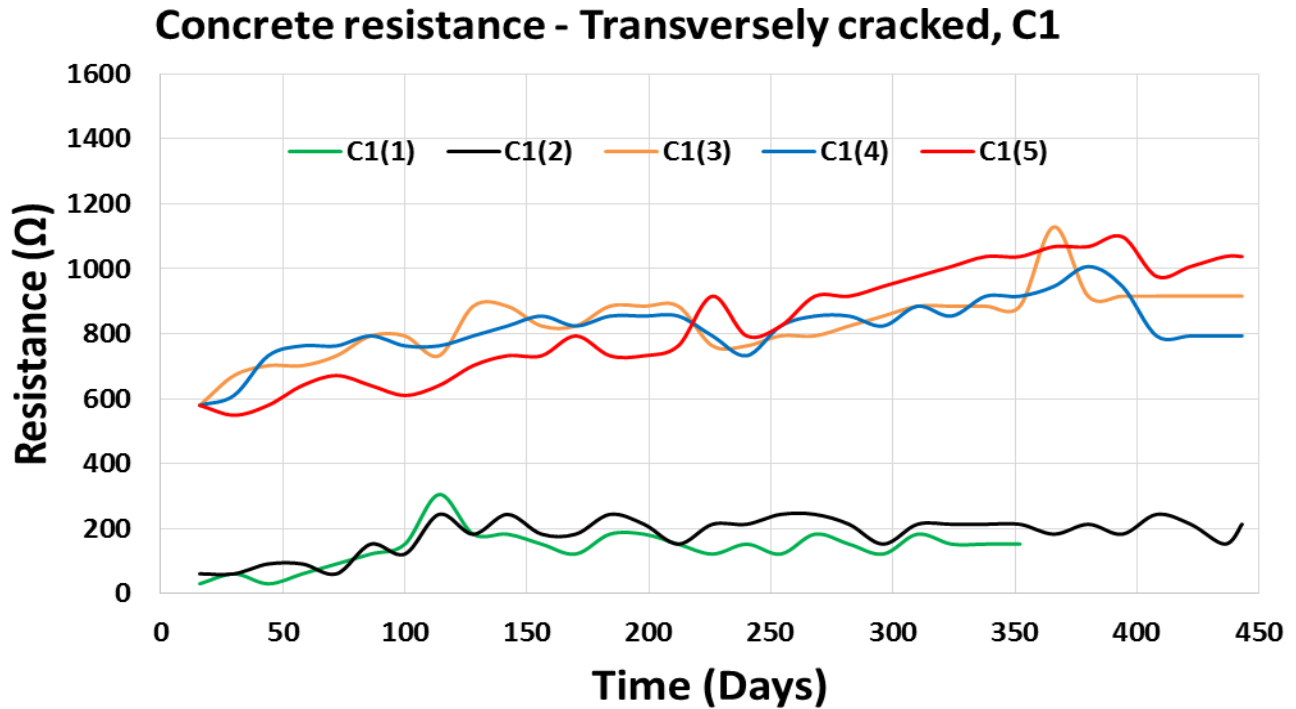
Figure C3.2: Crack width → C1(1) = 0.5, C1(2) = 0.5, C1(3) = 0.13, C1(4) = 0.26, C1(5) = 0.2.

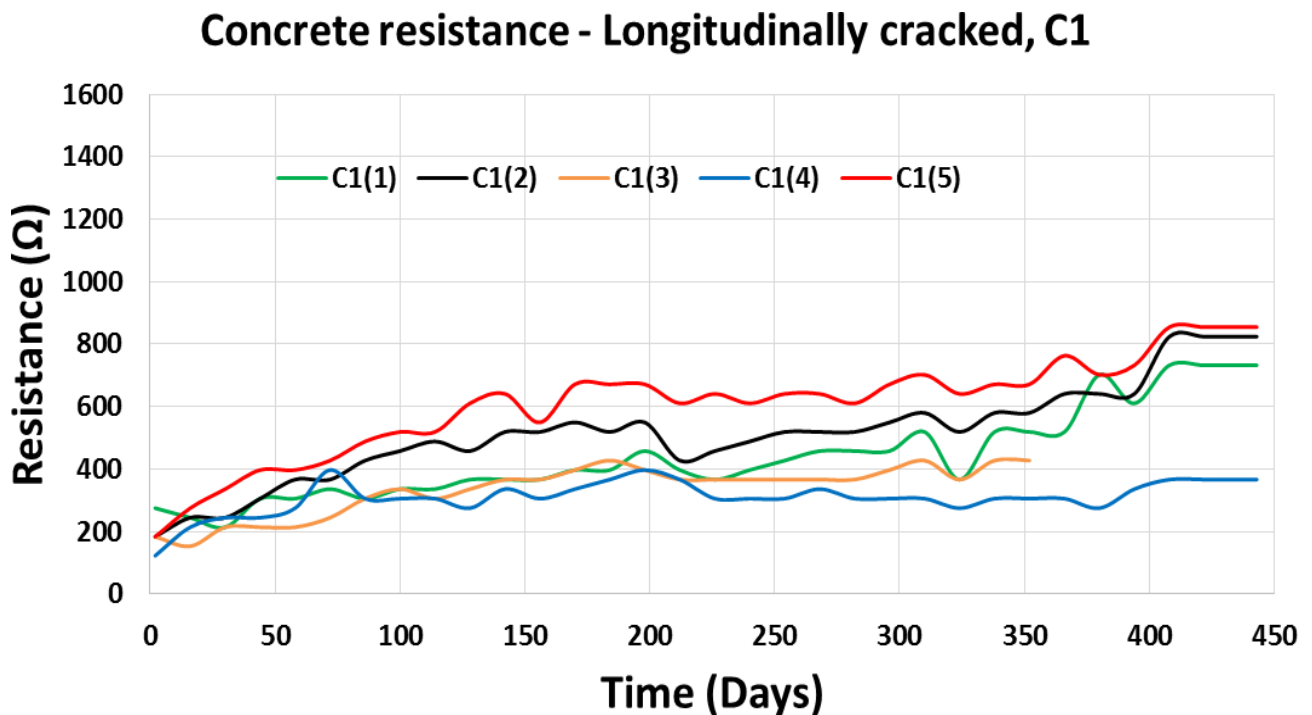
Figure C3.3: Crack width → C1(1) = 0.2, C1(2) = 0.15, C1(3) = 0.18, C1(4) = 0.23, C1(5) = 0.2.

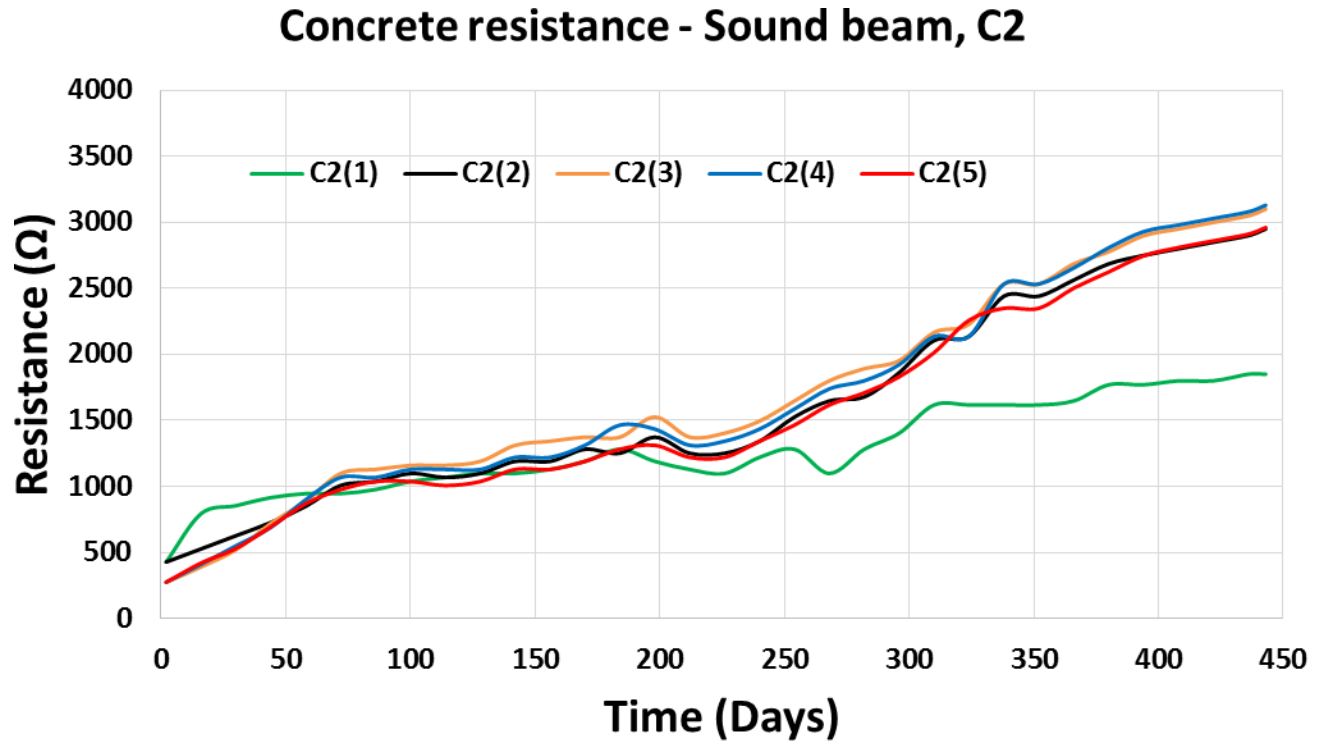
Figure C3.4: Sound (non-cracked) concrete beam.

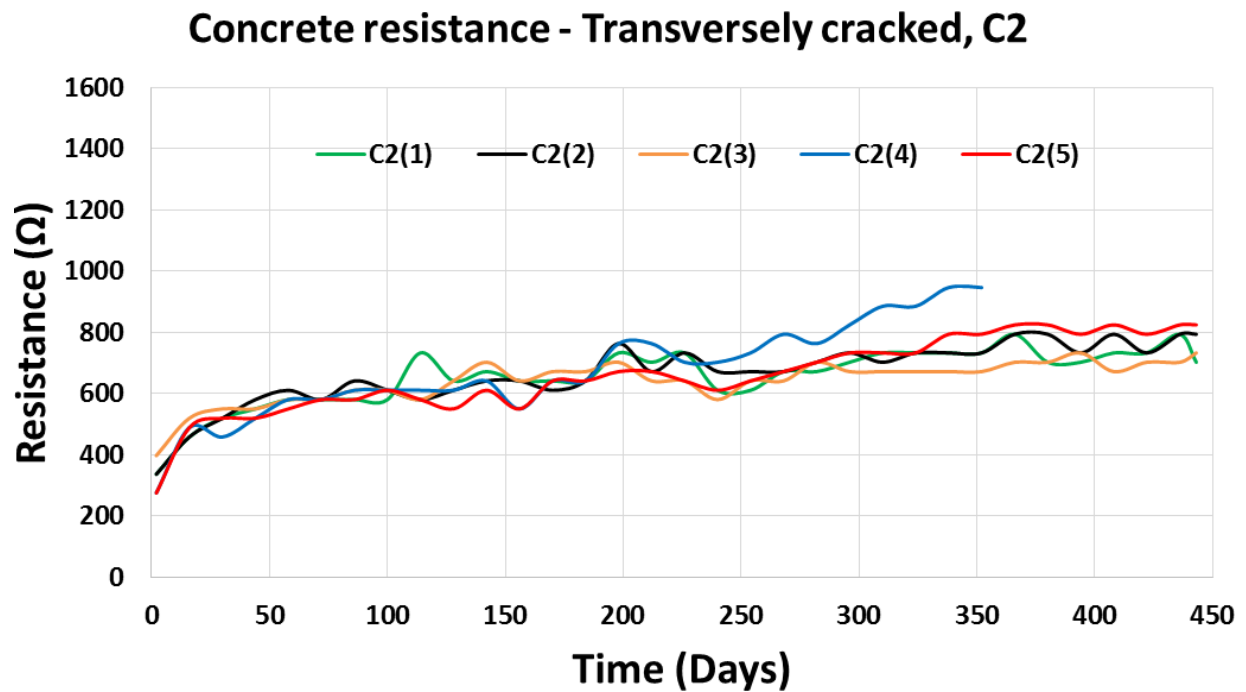
Figure C3.5: Crack width \rightarrow C2(1) = 0.2, C2(2) = 0.25, C2(3) = 0.2, C2(4) = 0.13, C2(5) = 0.2.

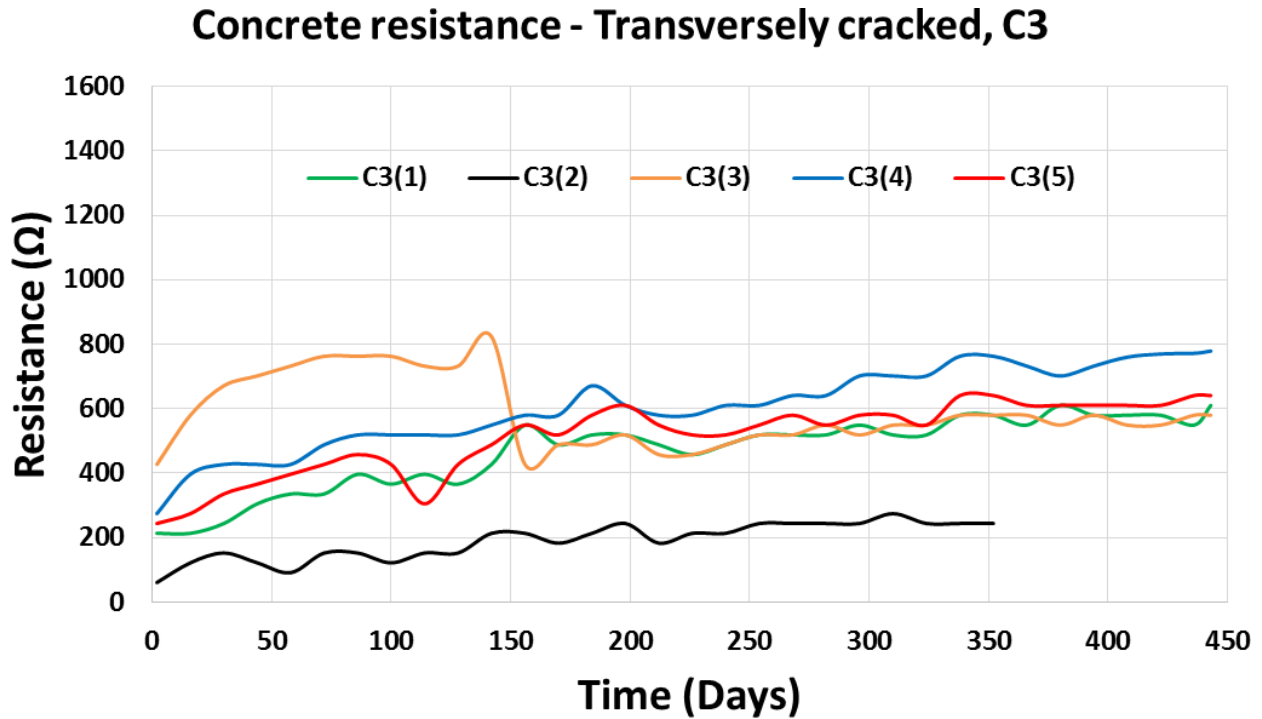
Figure C3.8: Crack width → C3(1) = 0.3, C3(2) = 1.5, C3(3) = 0.3, C3(4) = 0.2, C3(5) = 0.25.

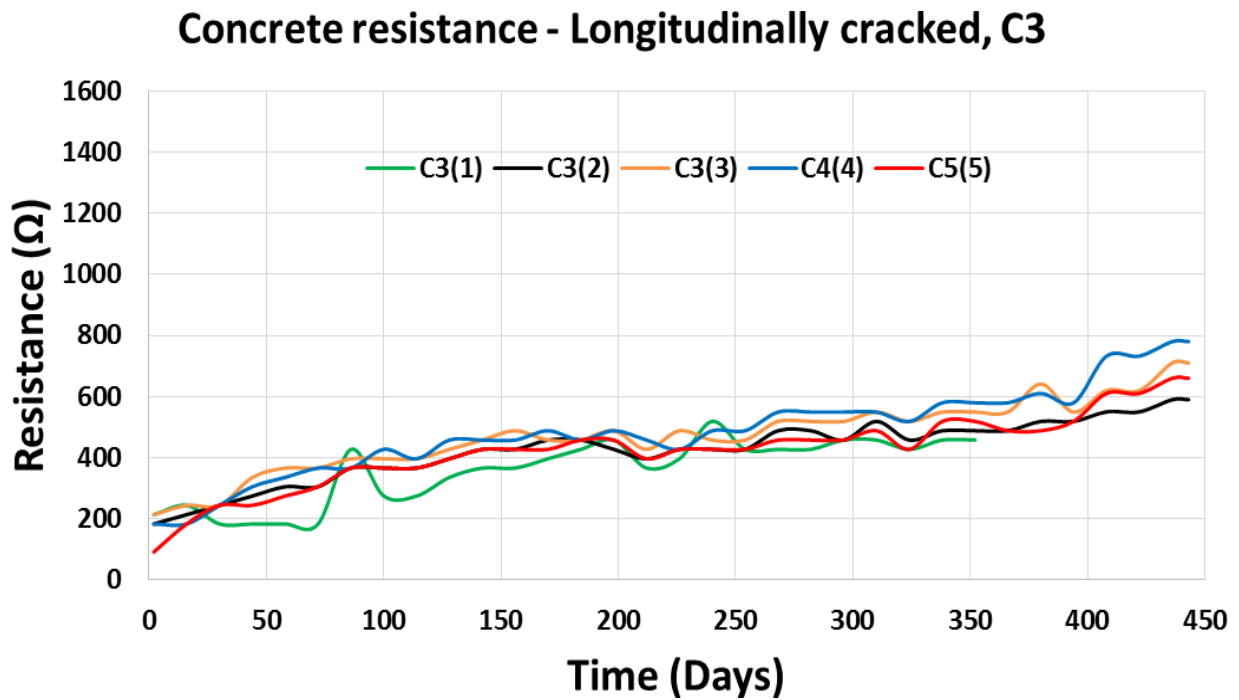
Figure C3.9: Crack width → C3(1) = 0.25, C3(2) = 0.2, C3(3) = 0.15, C3(4) = 0.15, C3(5) = 0.2.

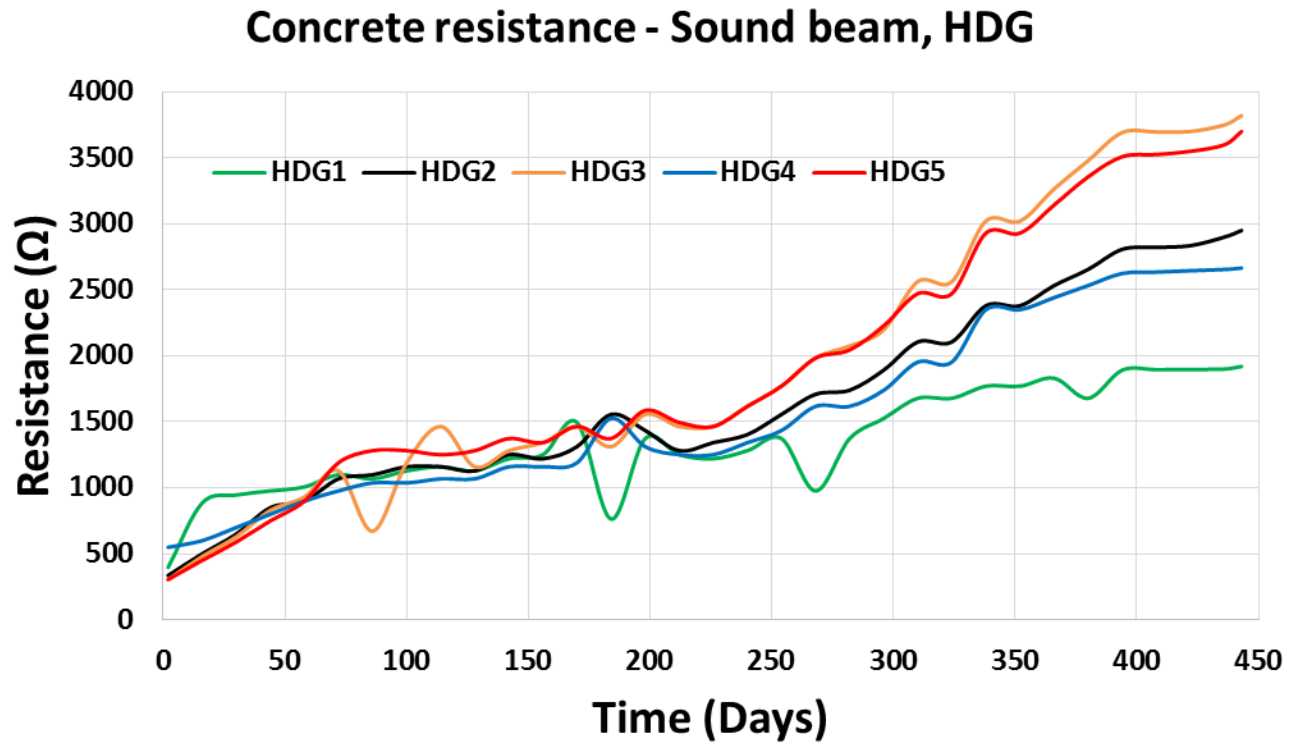
Figure C3.10 – Sound (non-cracked) concrete beam.

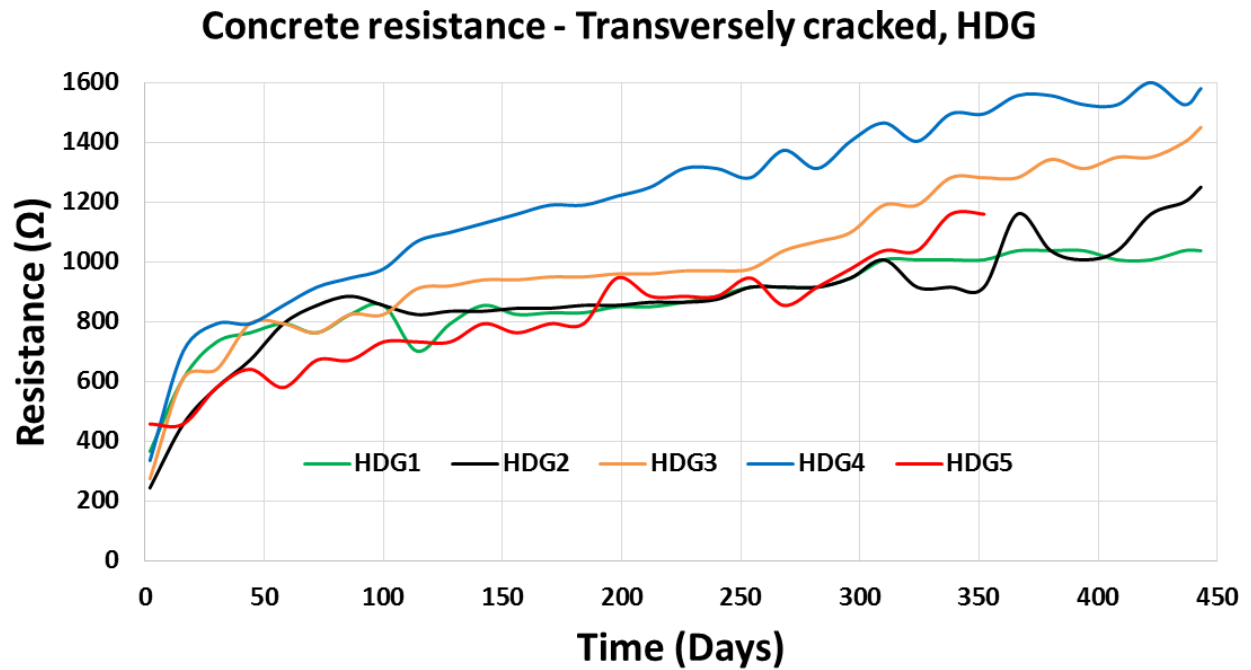
Figure C3.11: Crack width → HDG1 = 0.25, HDG2 = 0.3, HDG3 = 0.25, HDG4 = 0.15, HDG5 = 0.3.

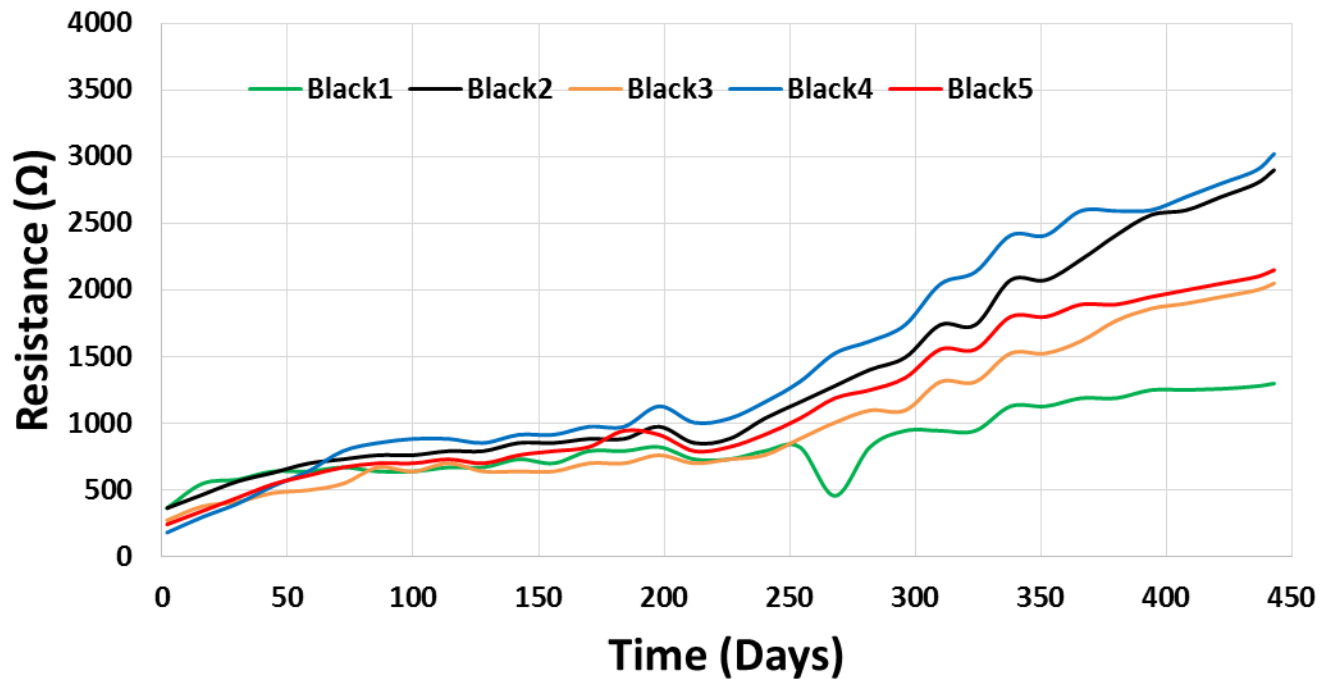
Figure C3.13: Sound (non-cracked) beam.

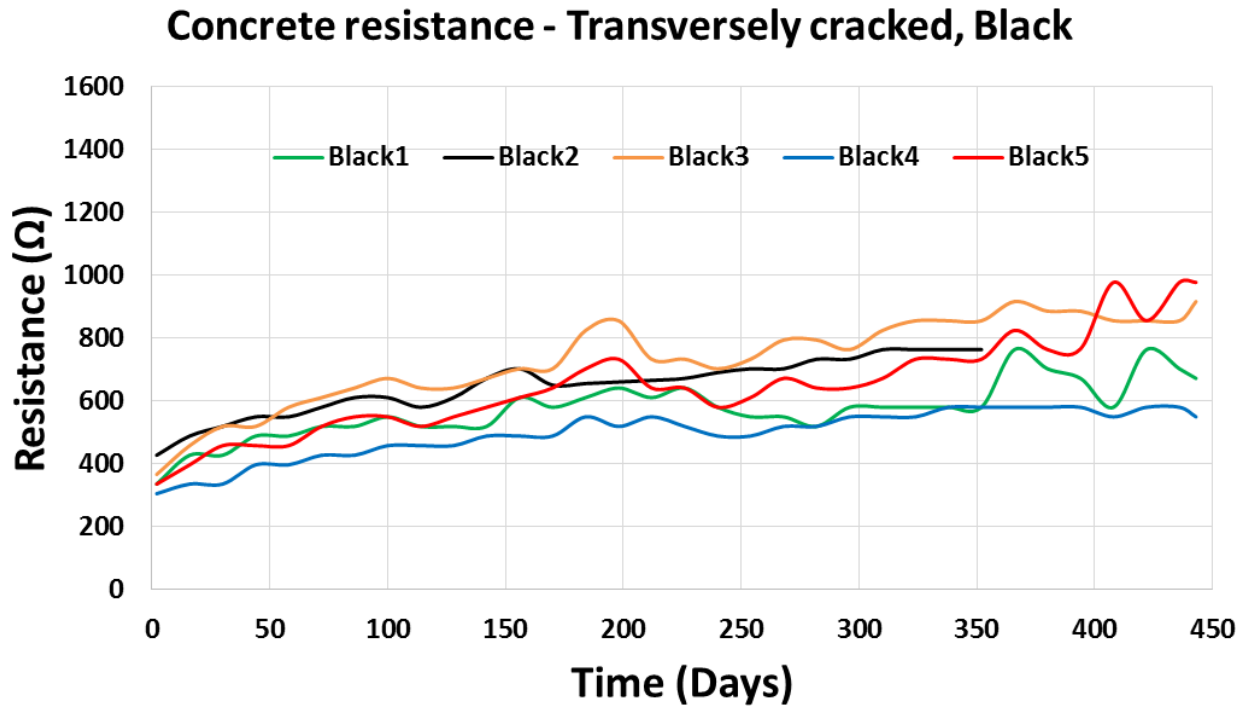
Figure C3.14 – Crack width → BLK1 = 0.15, BLK2 = 0.13, BLK3 = 0.26, BLK4 = 0.24, BLK5 = 0.15.

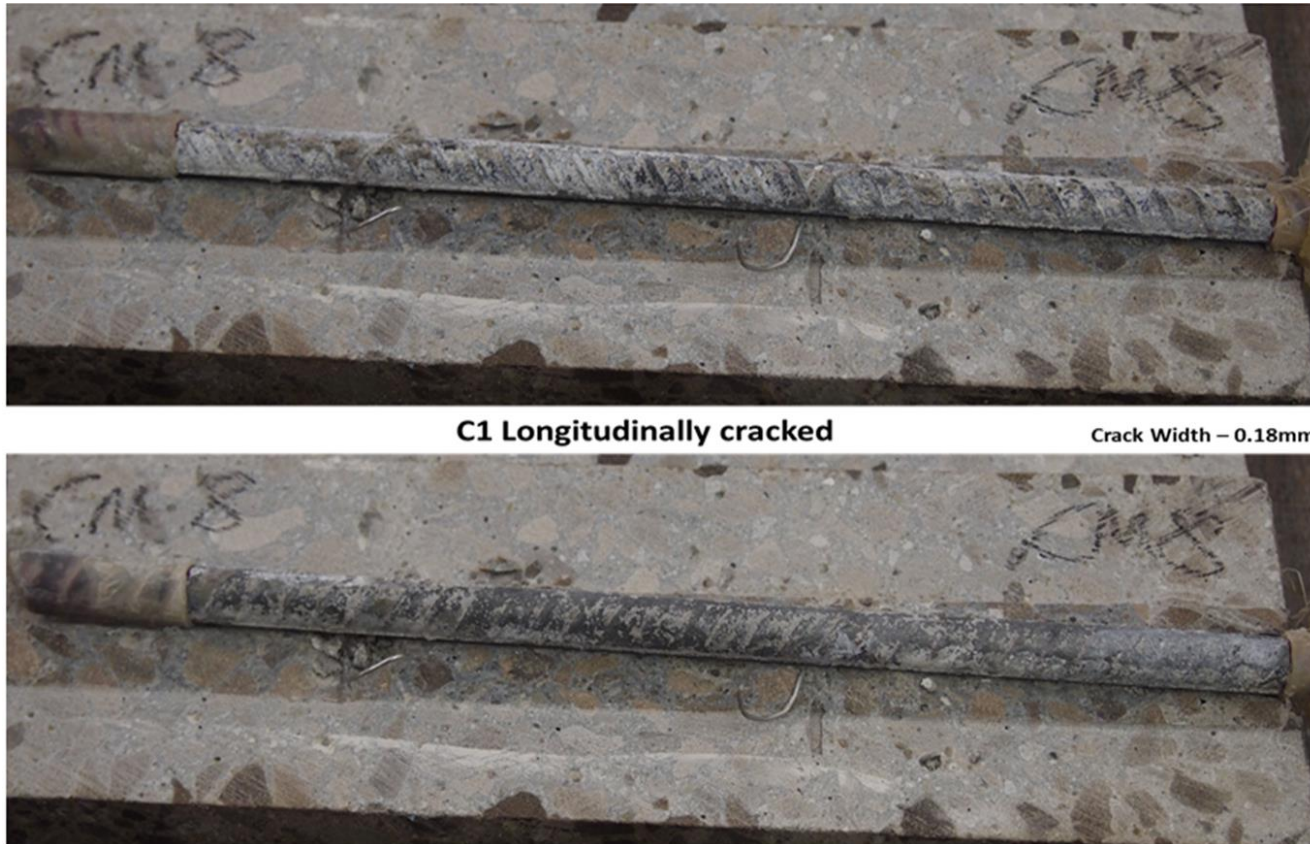
Figure E1.1.1: Concrete specimen of autopsied longitudinally cracked C1 specimen

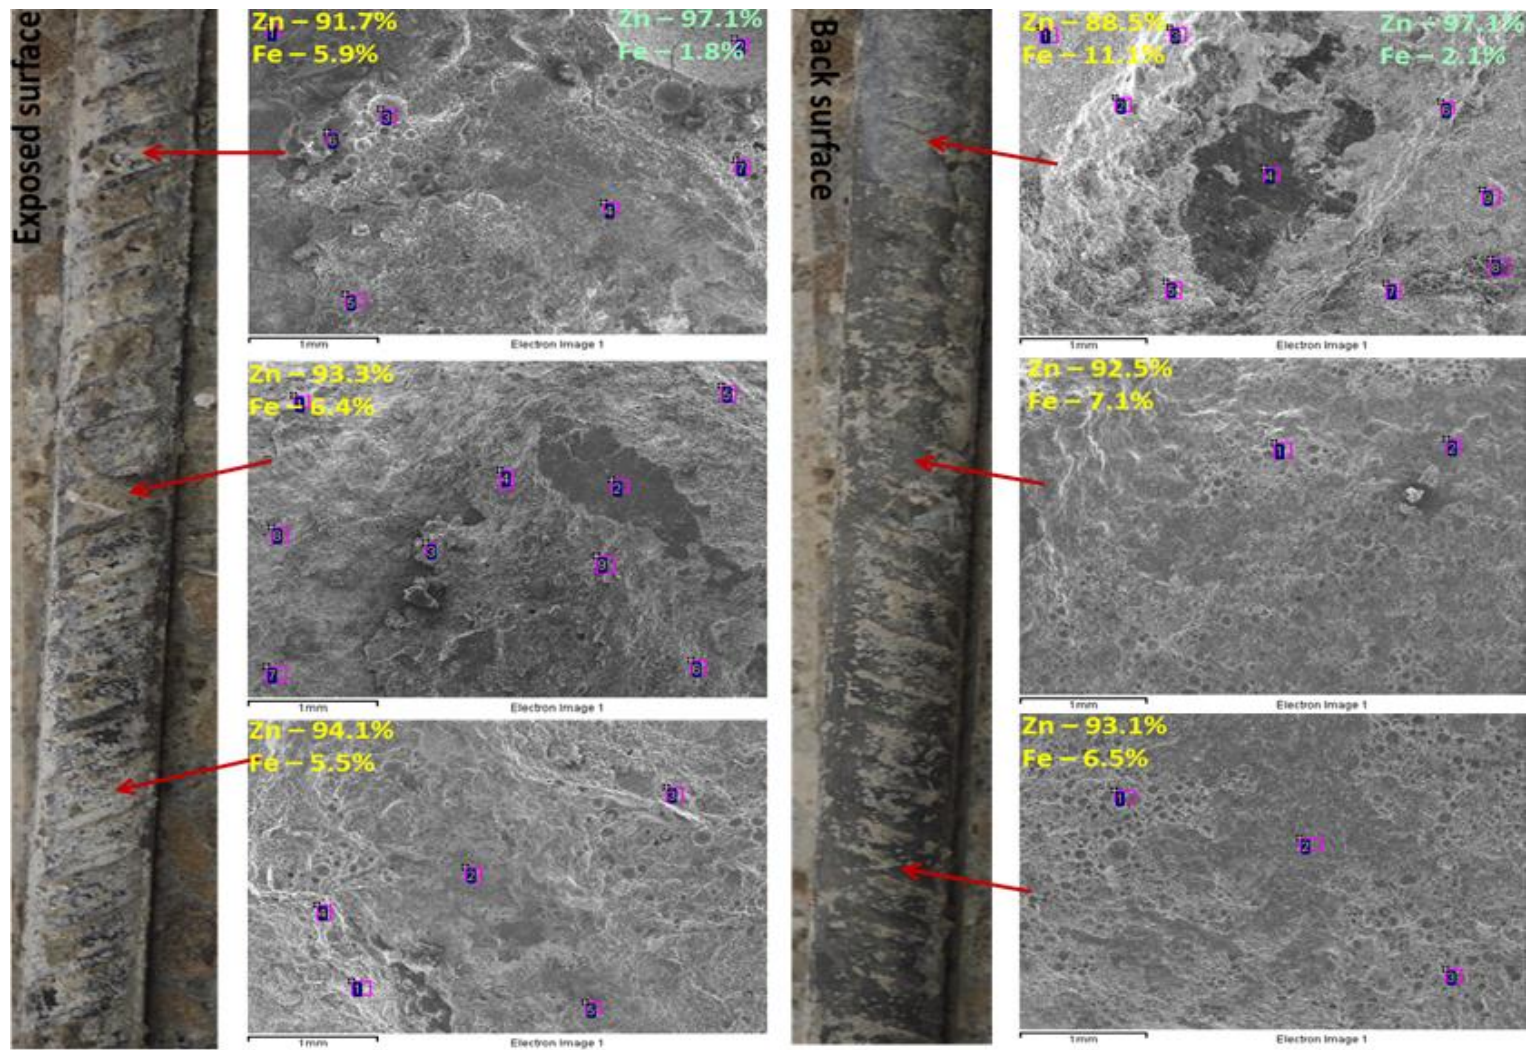
Figure E1.1.3: XRF analysis of autopsied C1 steel specimen. Note: values in green and yellow are before and after corrosion testing.

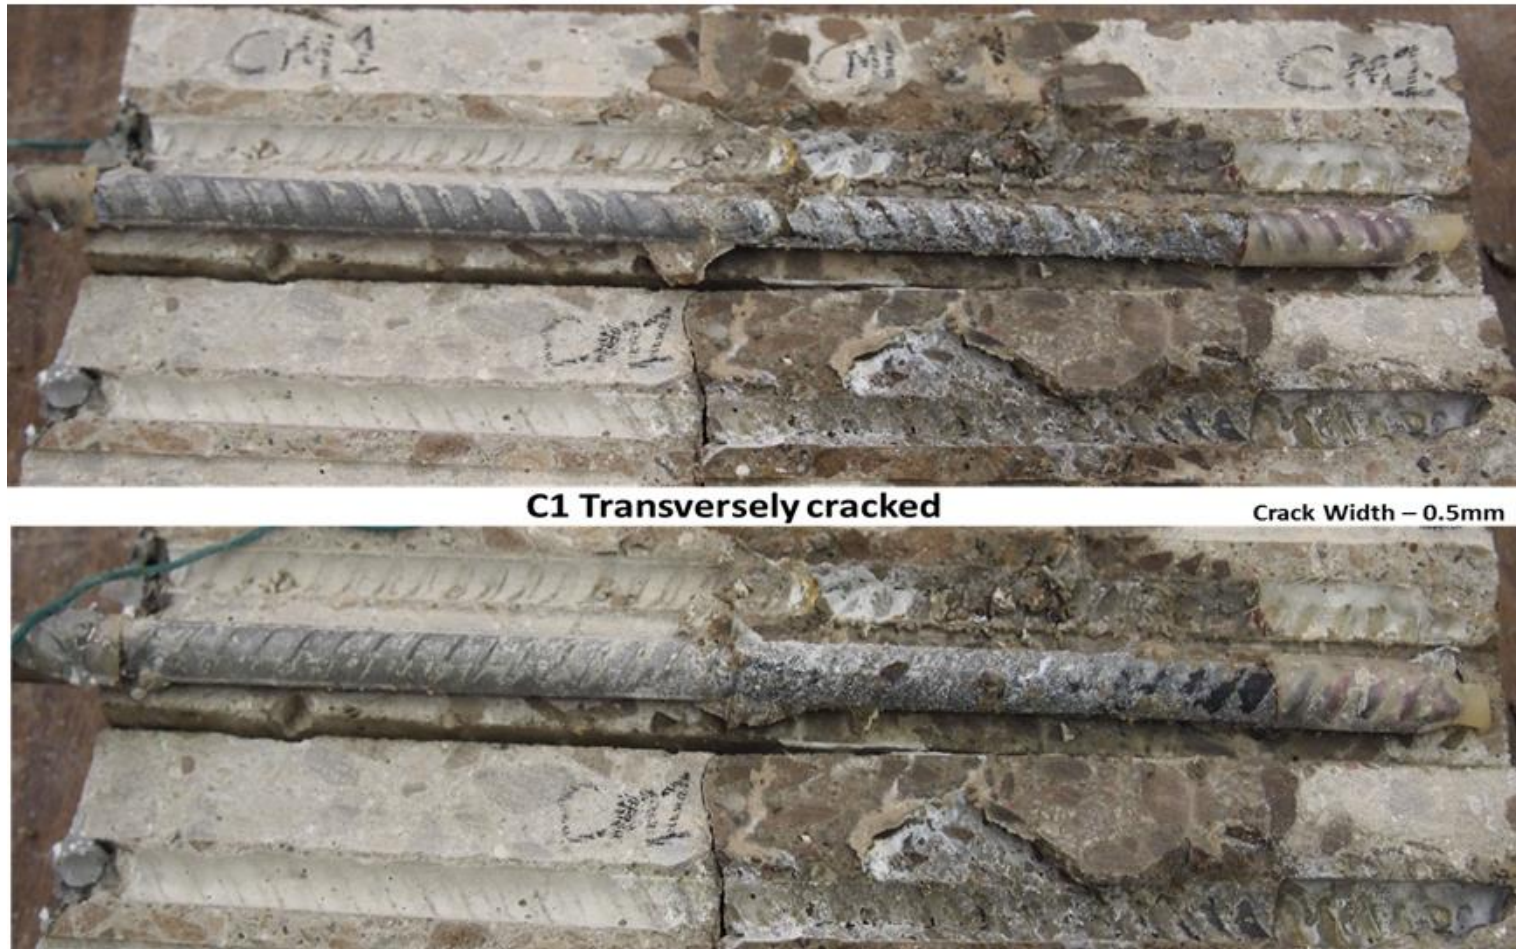
Figure E1.1.4: Concrete specimen of autopsied transversely cracked C1 specimen

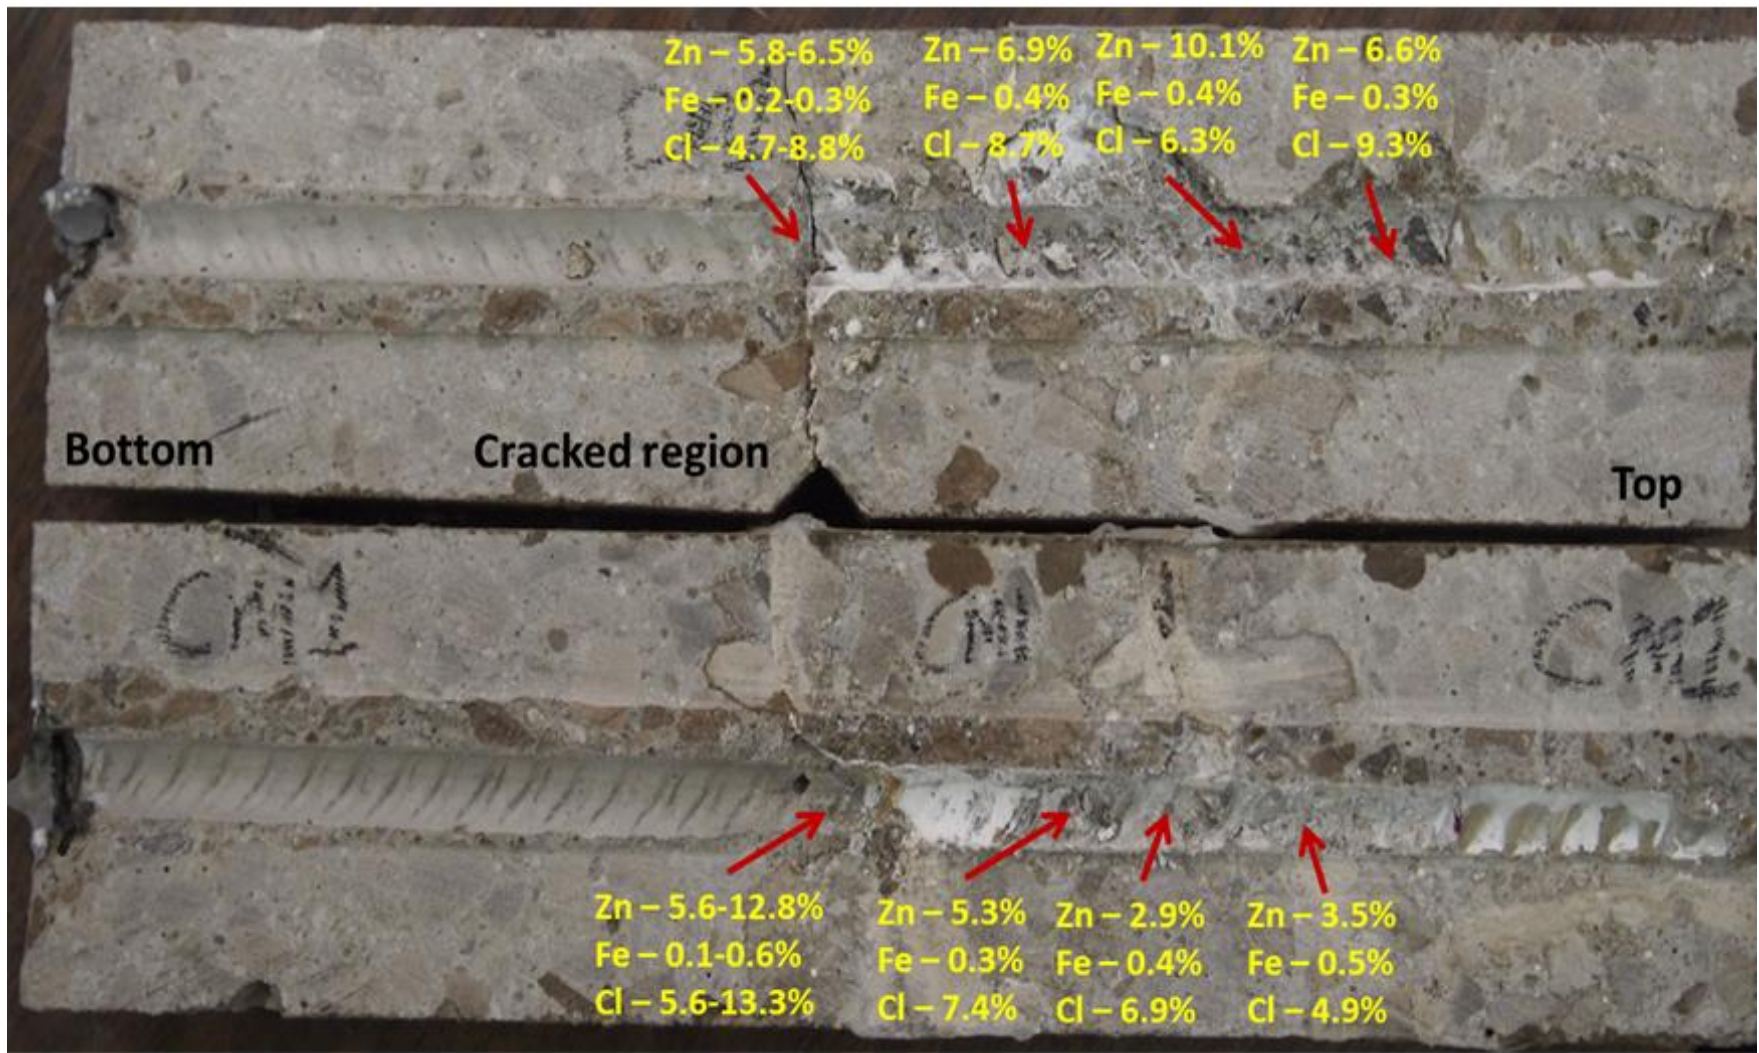
Figure E1.1.5: XRF analysis of autopsied transversely cracked C1 concrete specimen

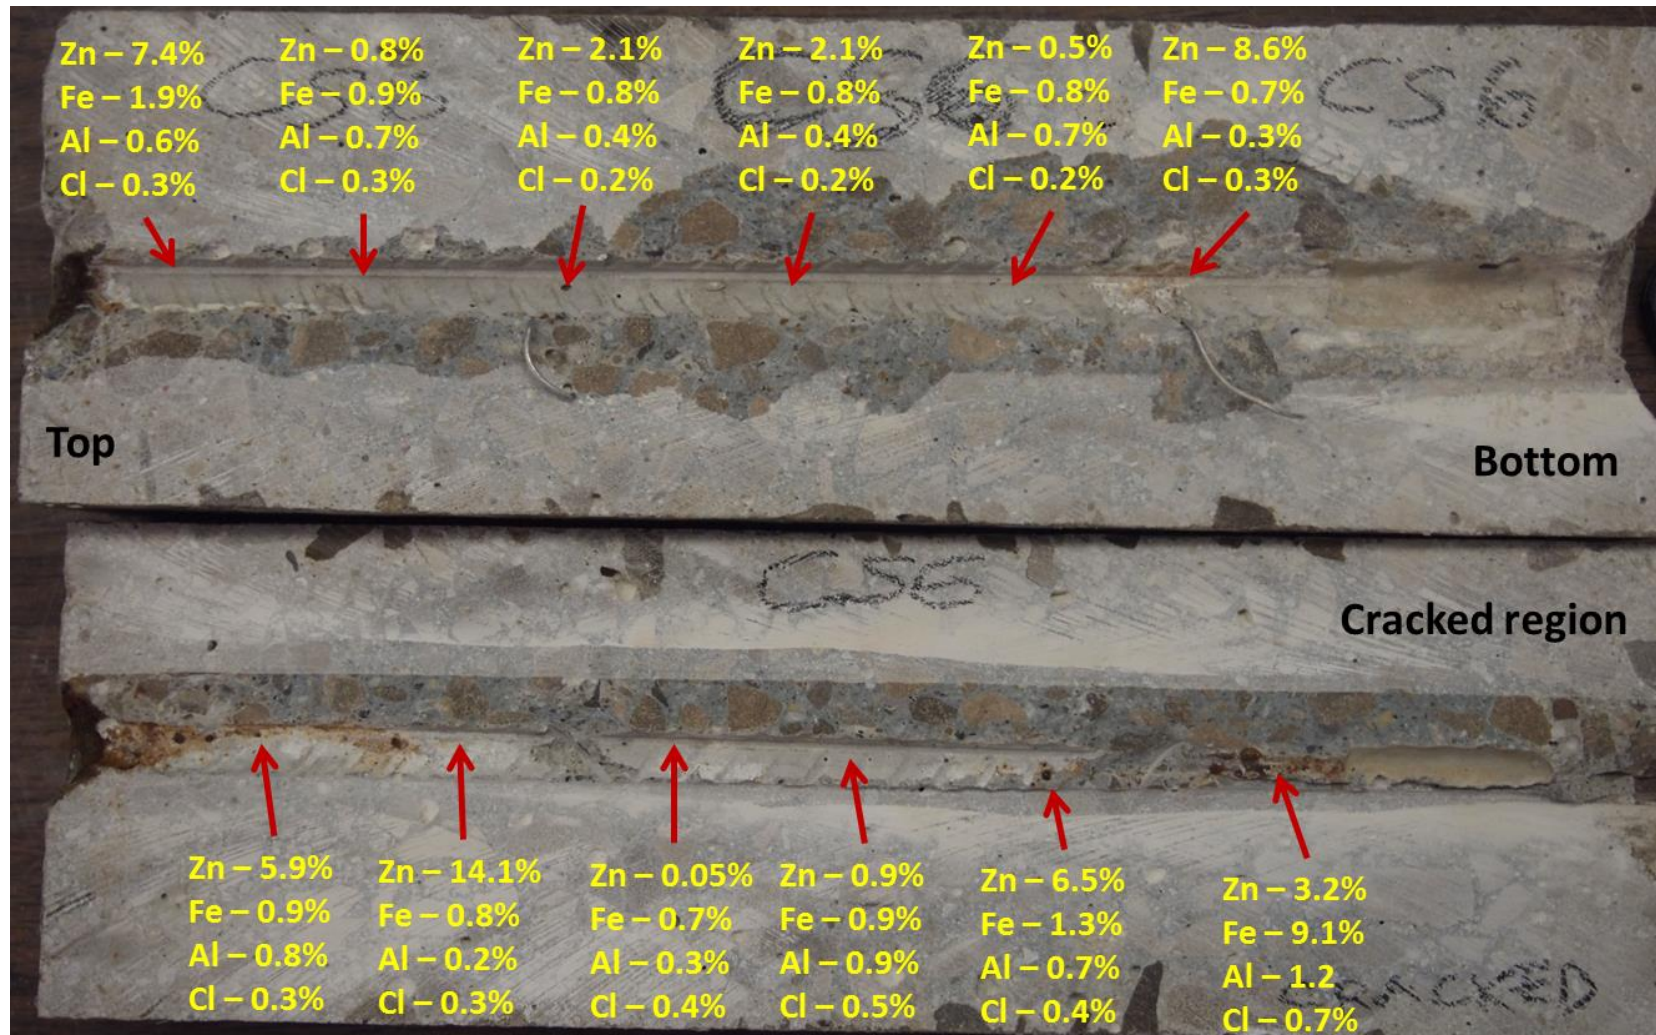
Figure E1.2.2: XRF analysis of autopsied longitudinally cracked C2 concrete specimen

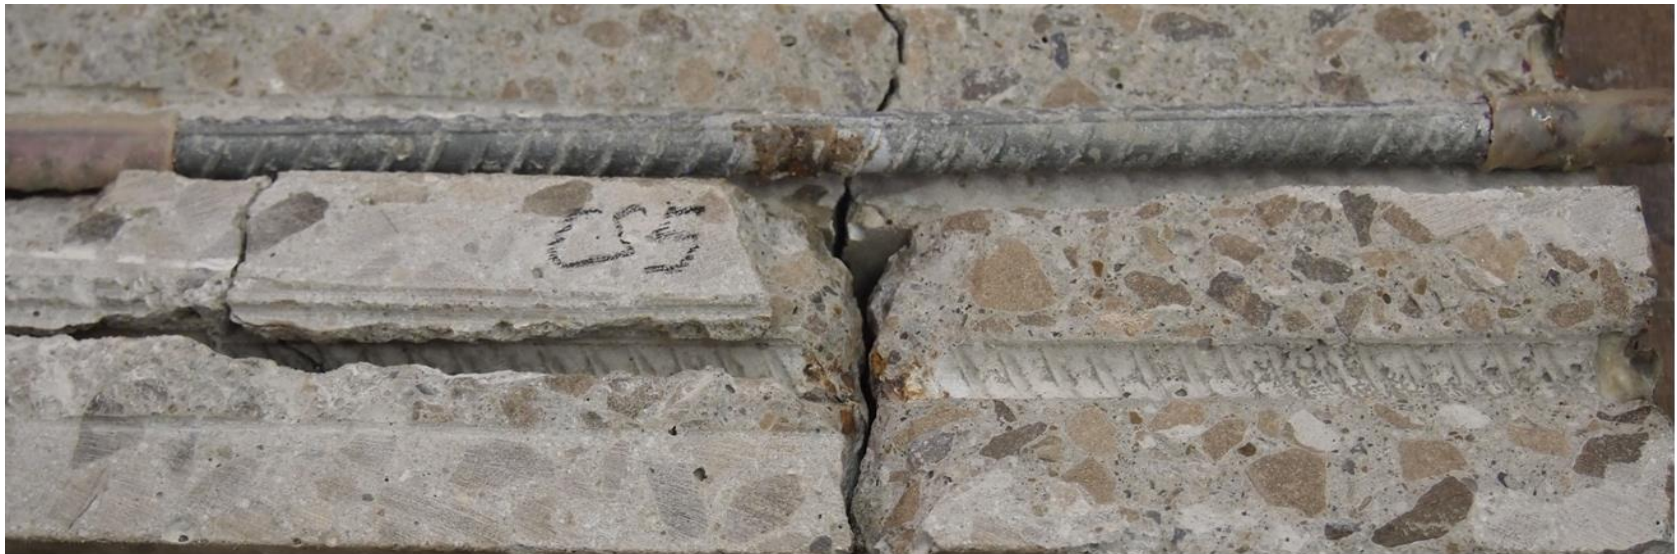
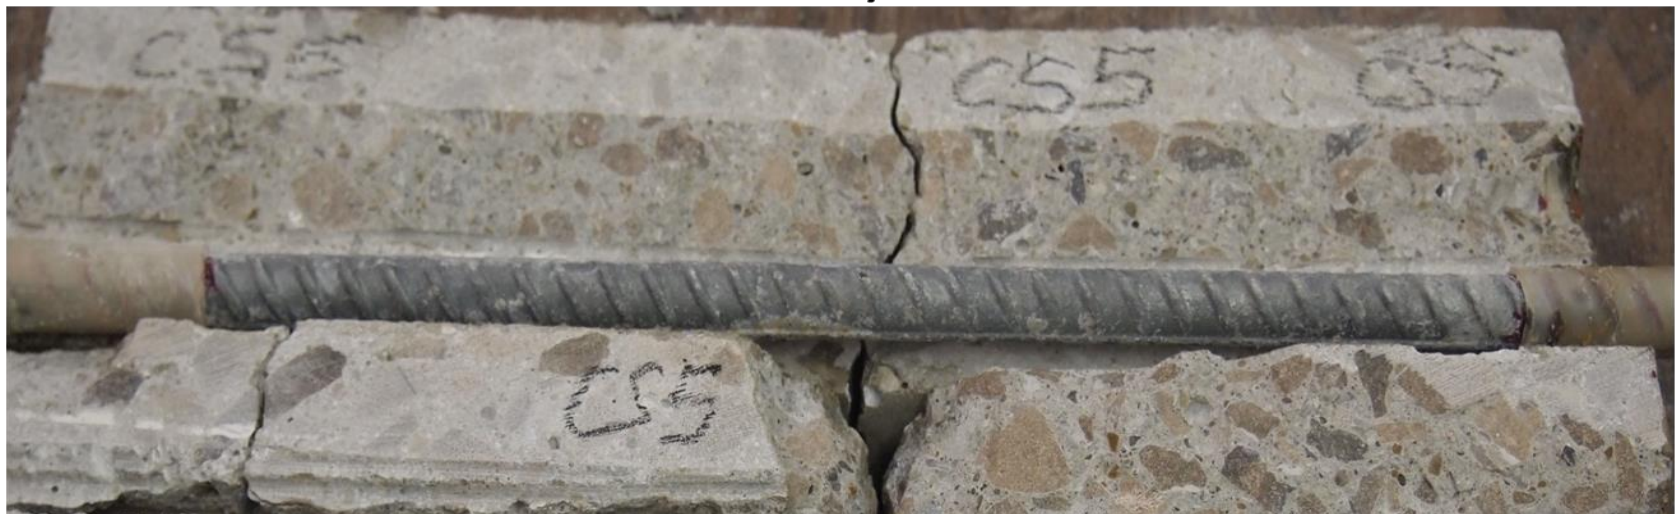
C2 Transversely cracked

Crack Width – 0.13mm

Figure E1.2.4: Concrete specimen of autopsied transversely cracked C2 specimen.
