Evaluation of the Corrosion Behaviour of Continuously Galvanized Rebar

A thesis

presented to the University of Waterloo

Master of Applied Science

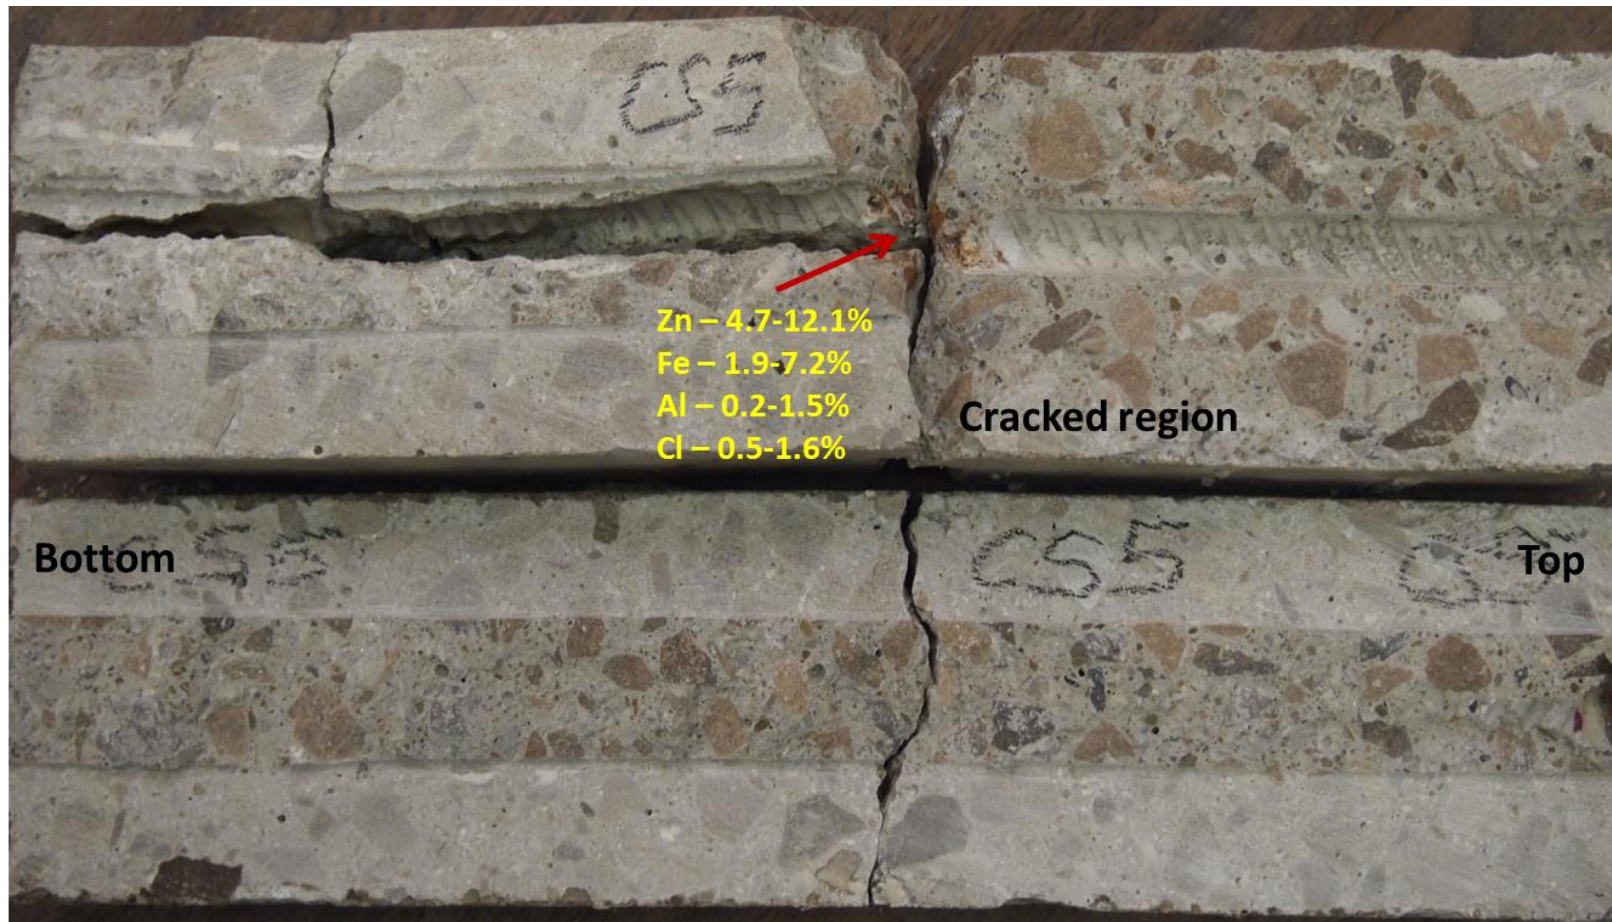
Figure E1.2.5: XRF analysis of autopsied transversely cracked C2 concrete specimen

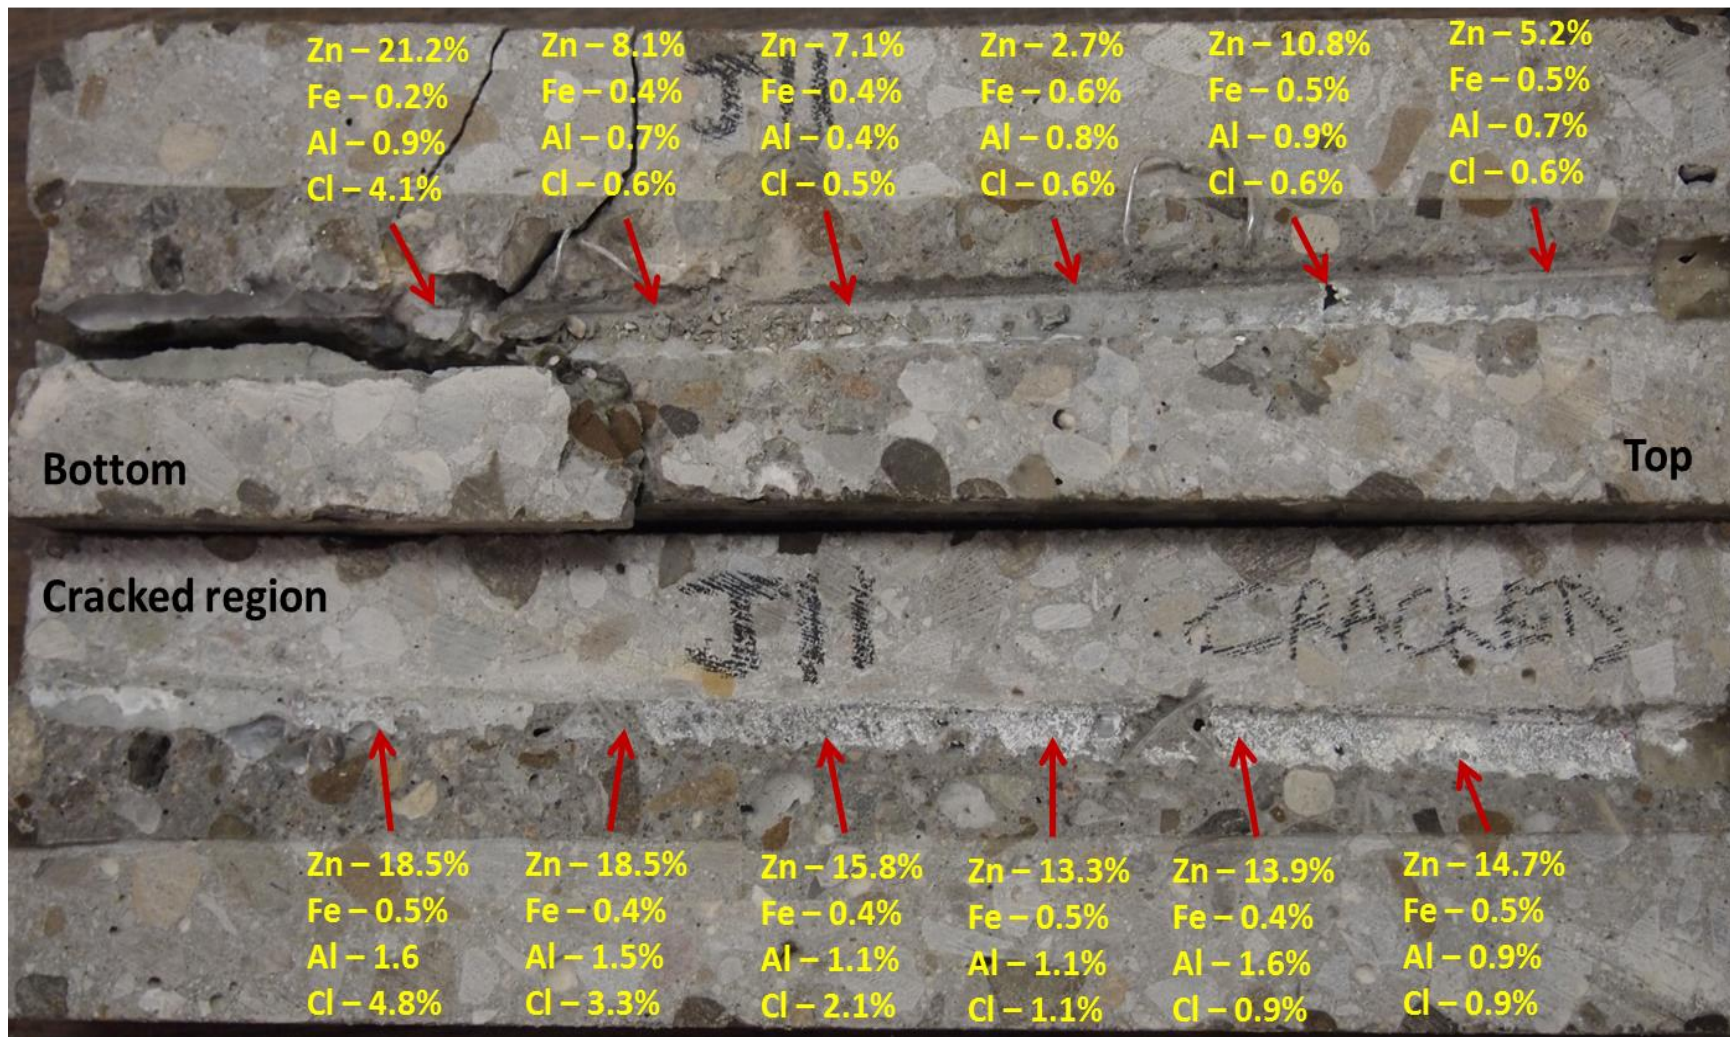
Figure E1.3.2: XRF analysis of autopsied longitudinally cracked C3 concrete specimen

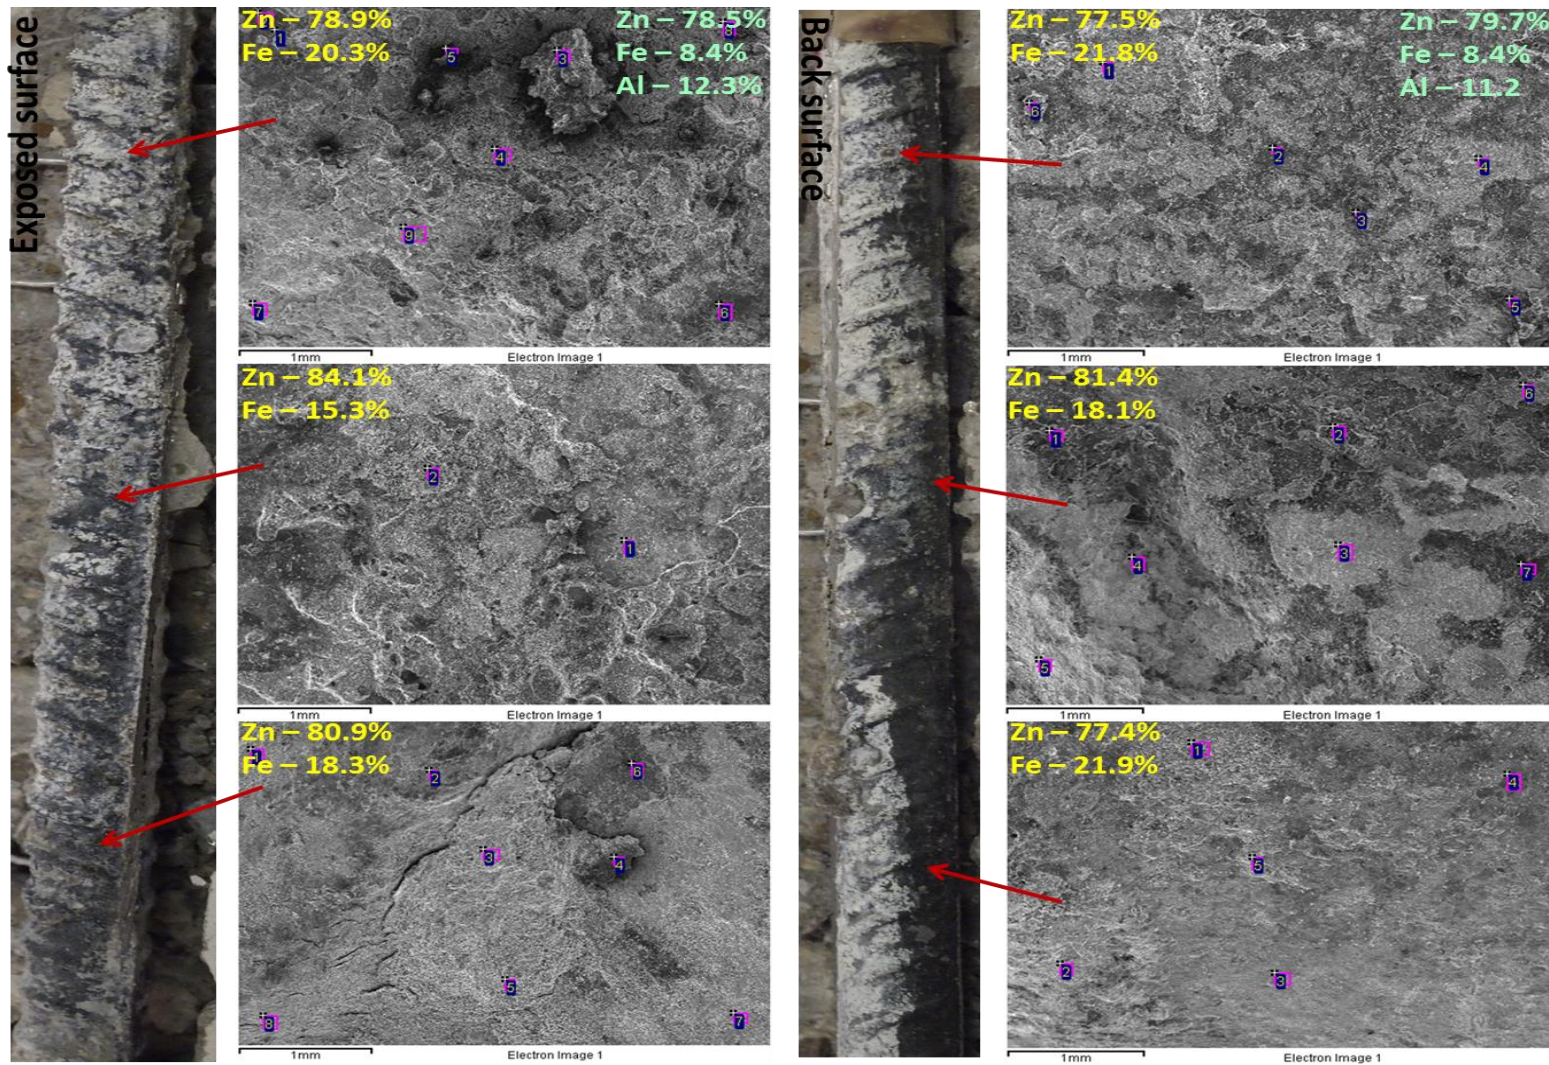
Figure E1.3.3: XRF analysis of autopsied C3 steel specimen. Note: values in green and yellow are before and after corrosion testing.

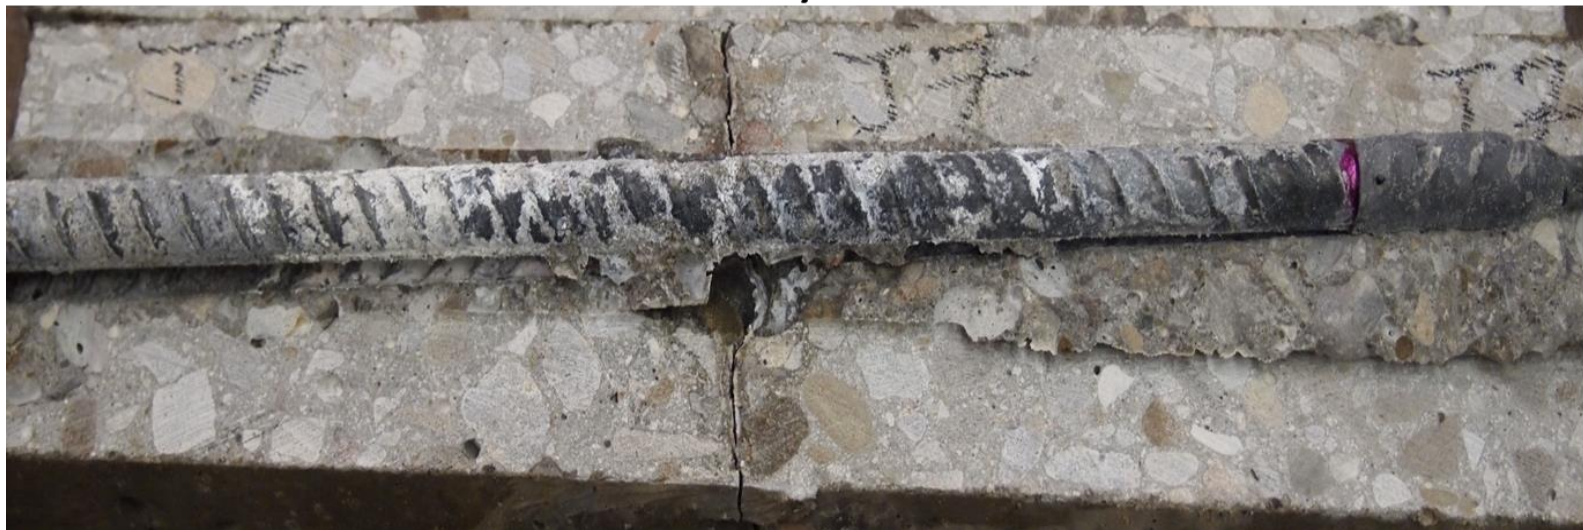
C3 Transversely cracked

Crack Width – 1.5mm

Figure E1.3.4: Concrete specimen of autopsied transversely cracked C3 specimen.

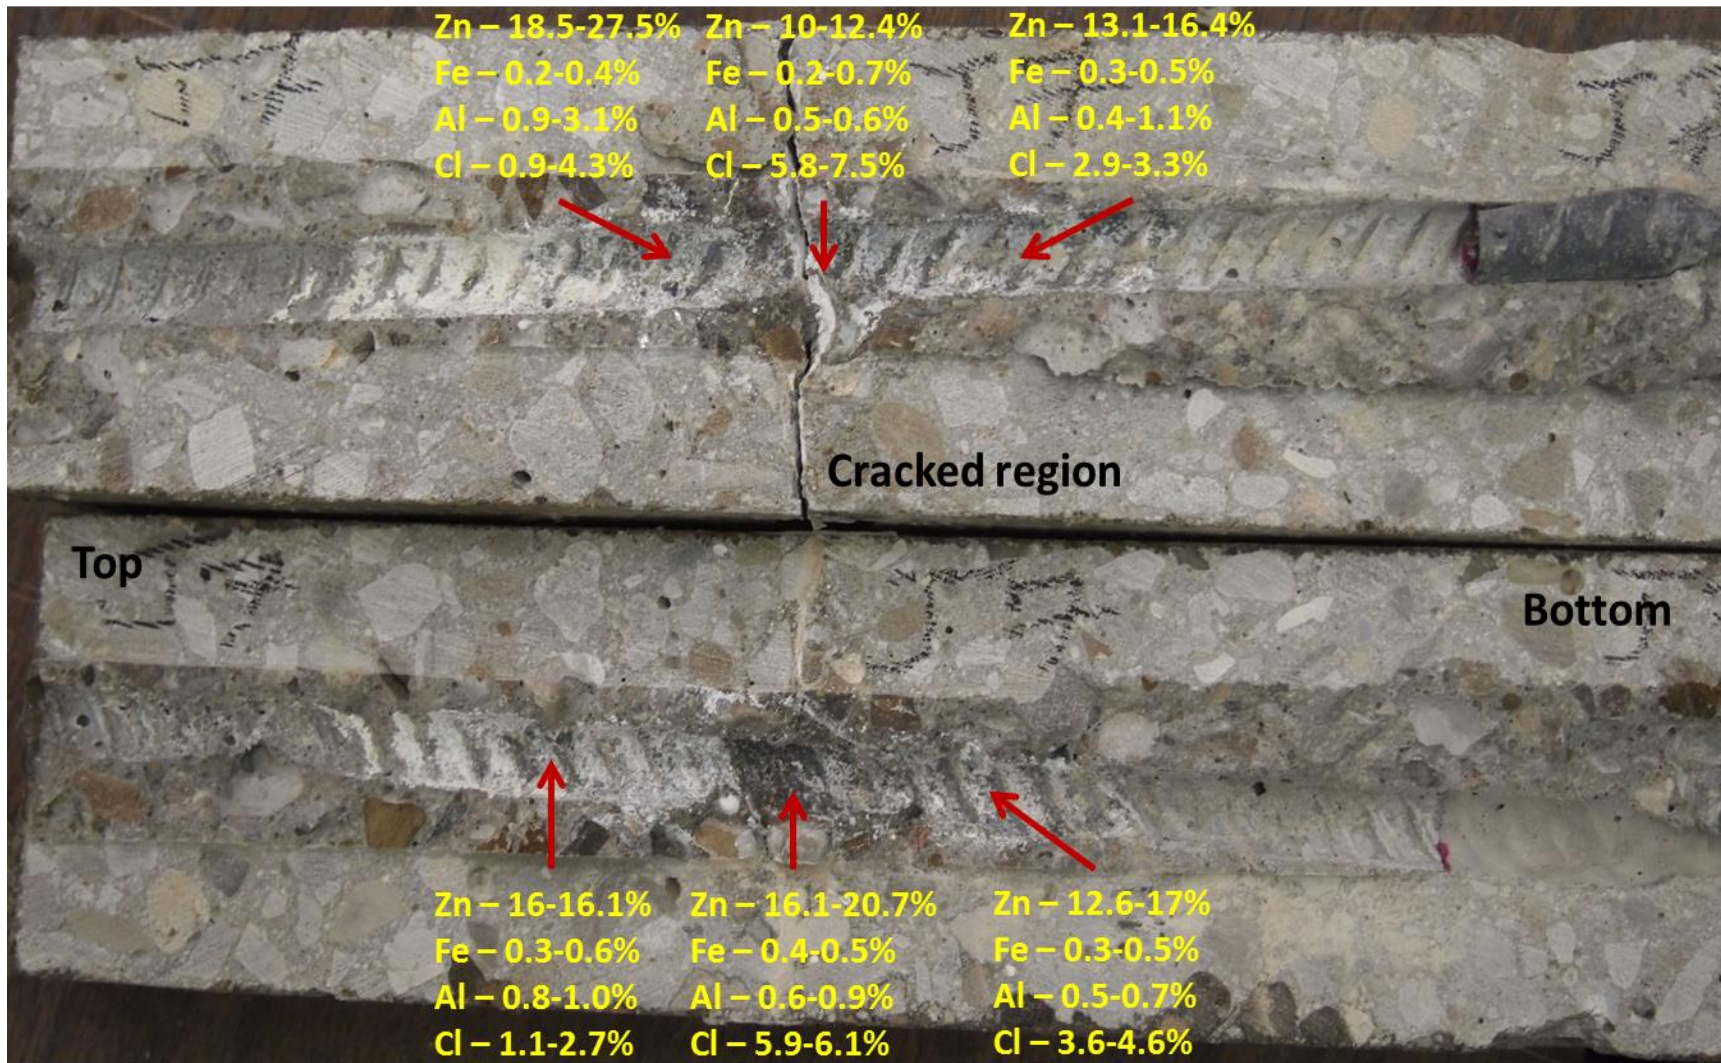
Figure E1.3.5: XRF analysis of autopsied transversely cracked C3 concrete specimen

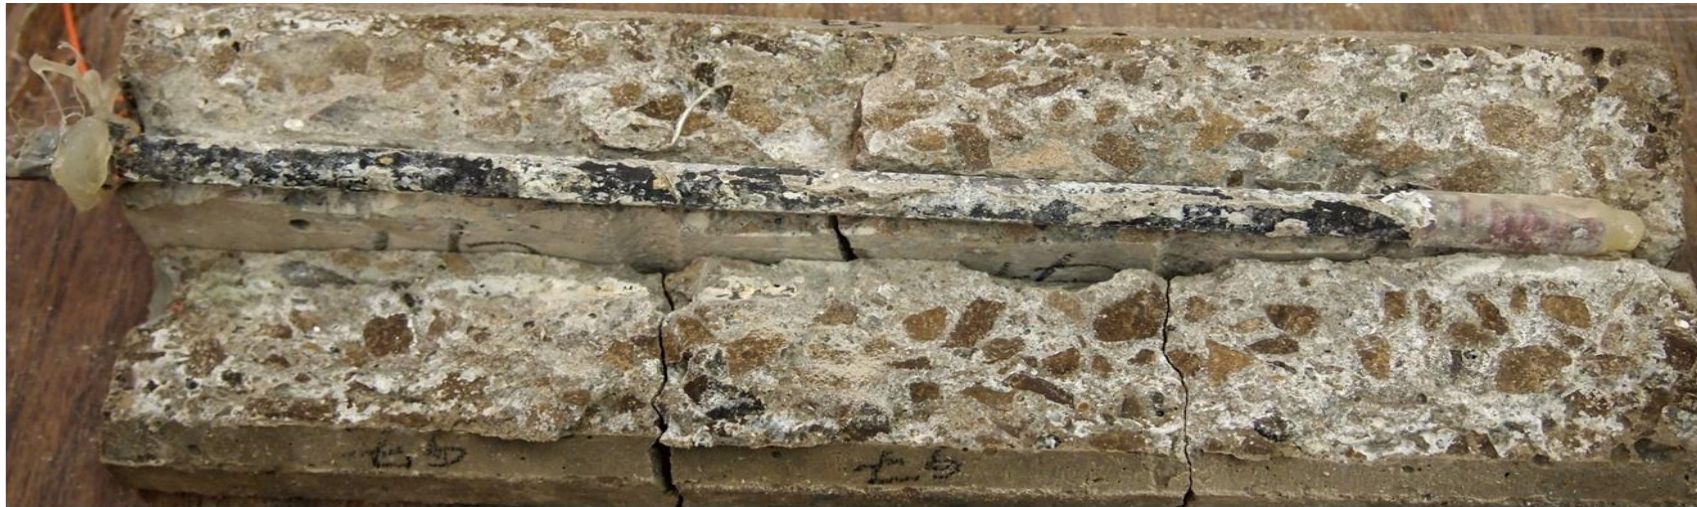
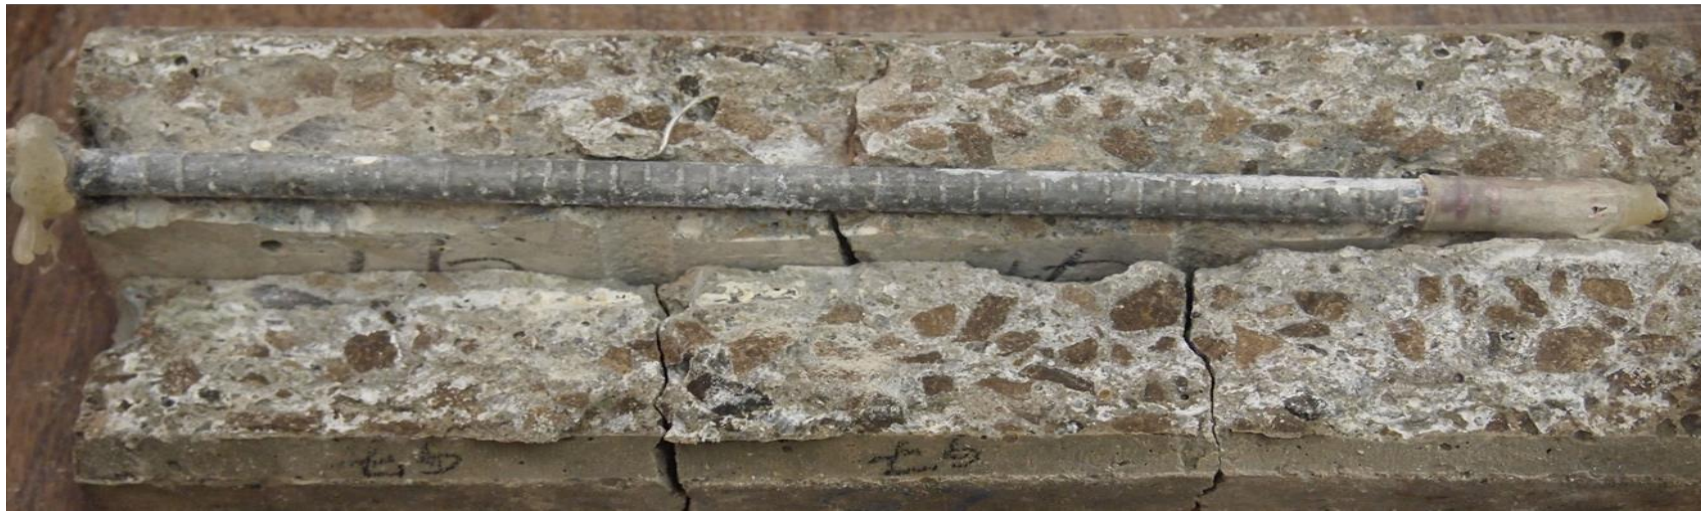
HDG Longitudinally cracked

Crack Width – 0.25mm

Figure E1.4.1: Concrete specimen of autopsied longitudinally cracked HDG specimen.

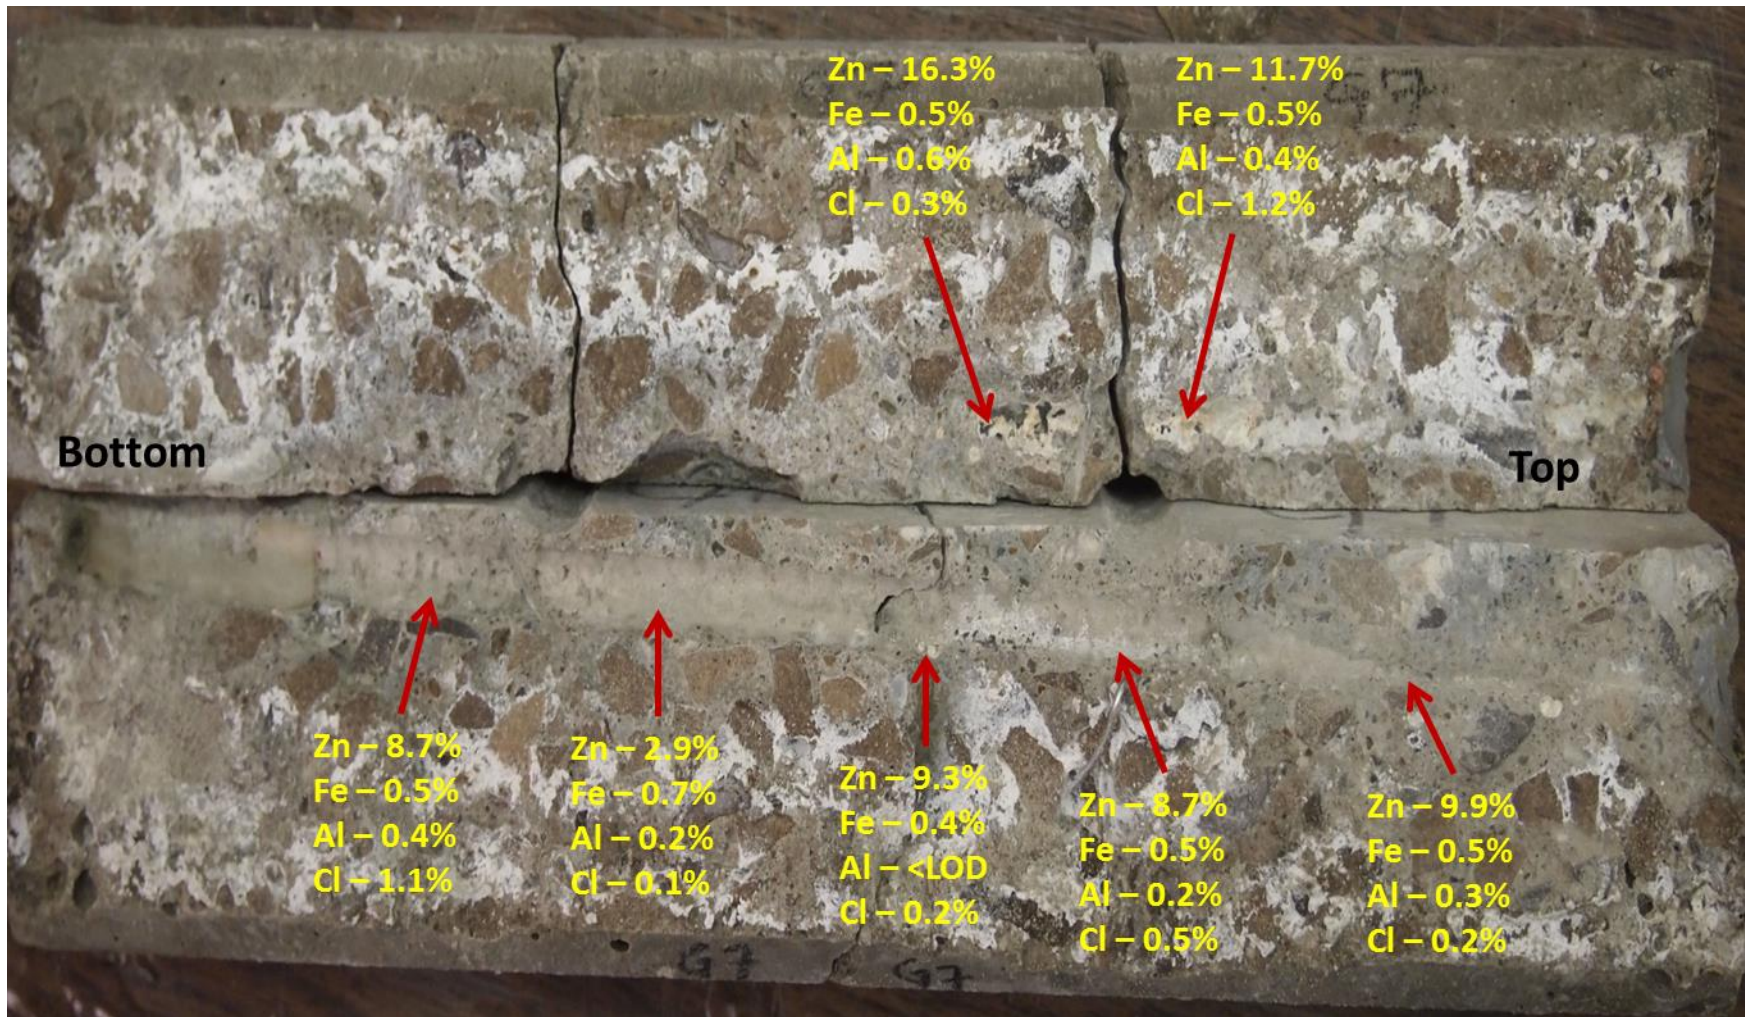
Figure E1.4.2: XRF analysis of autopsied longitudinally cracked HDG concrete specimen.

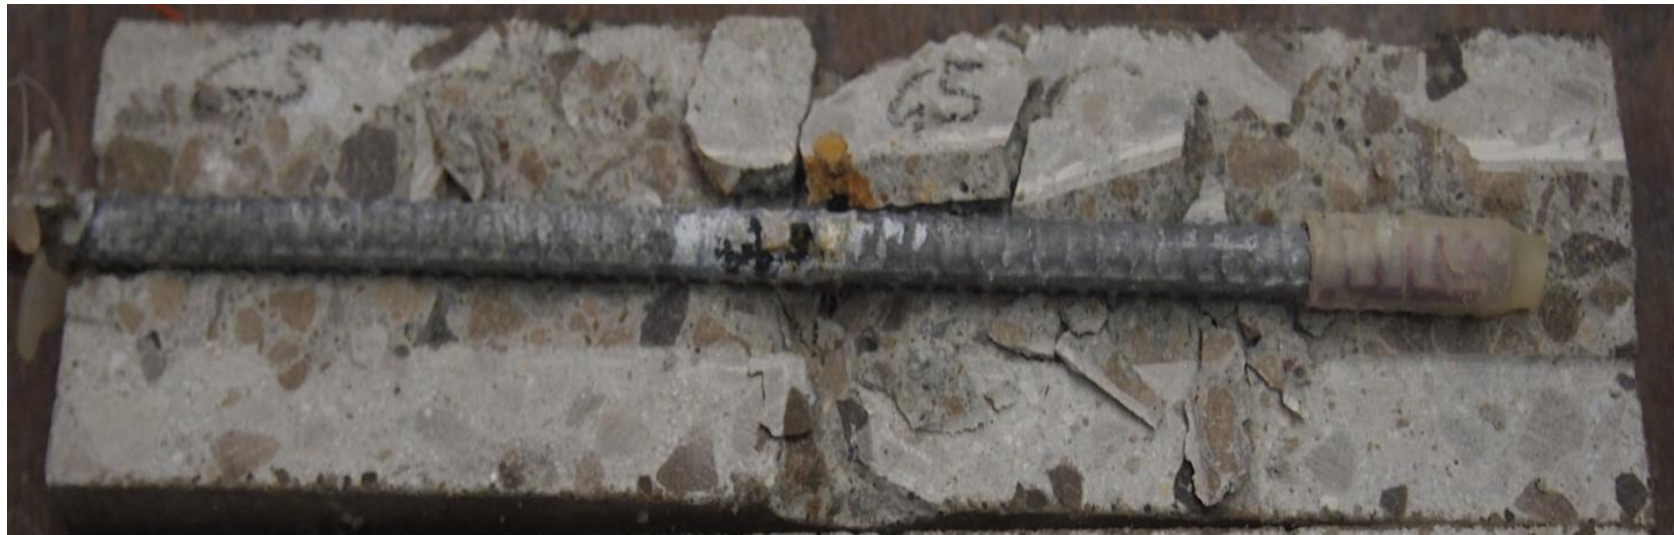
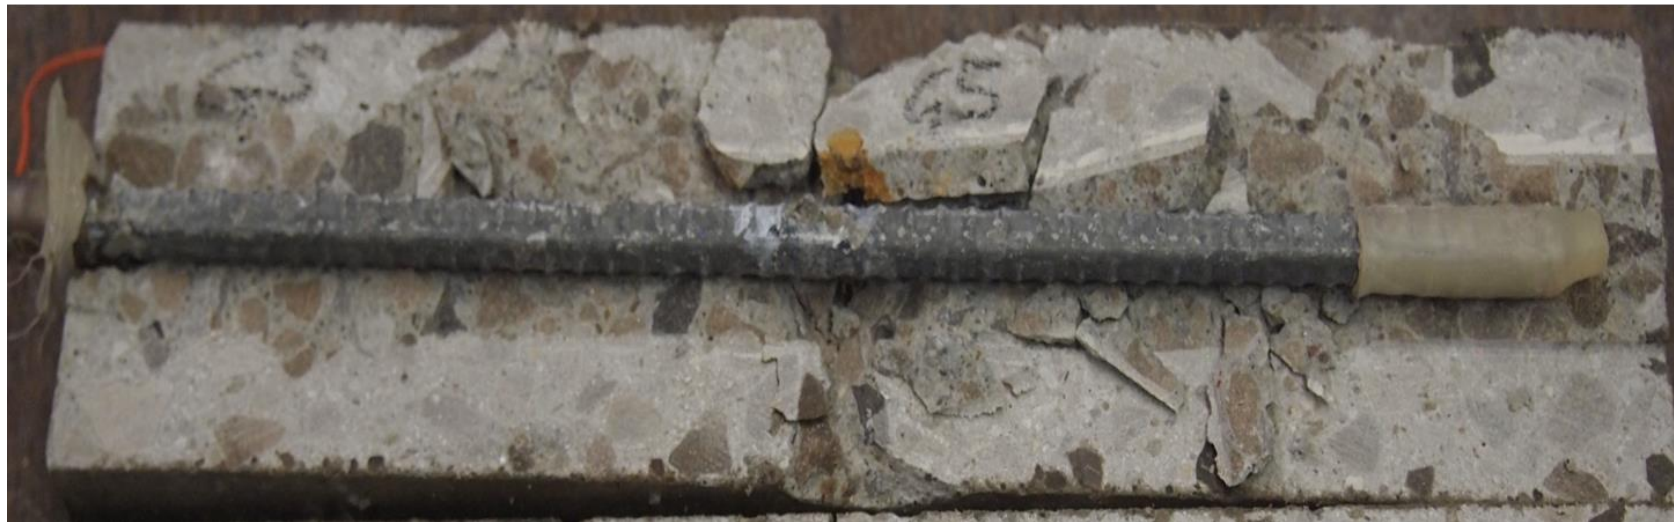
HDG Transversely cracked

Crack Width – 0.3mm

Figure E1.4.4: Concrete specimen of autopsied transversely cracked HDG specimen.

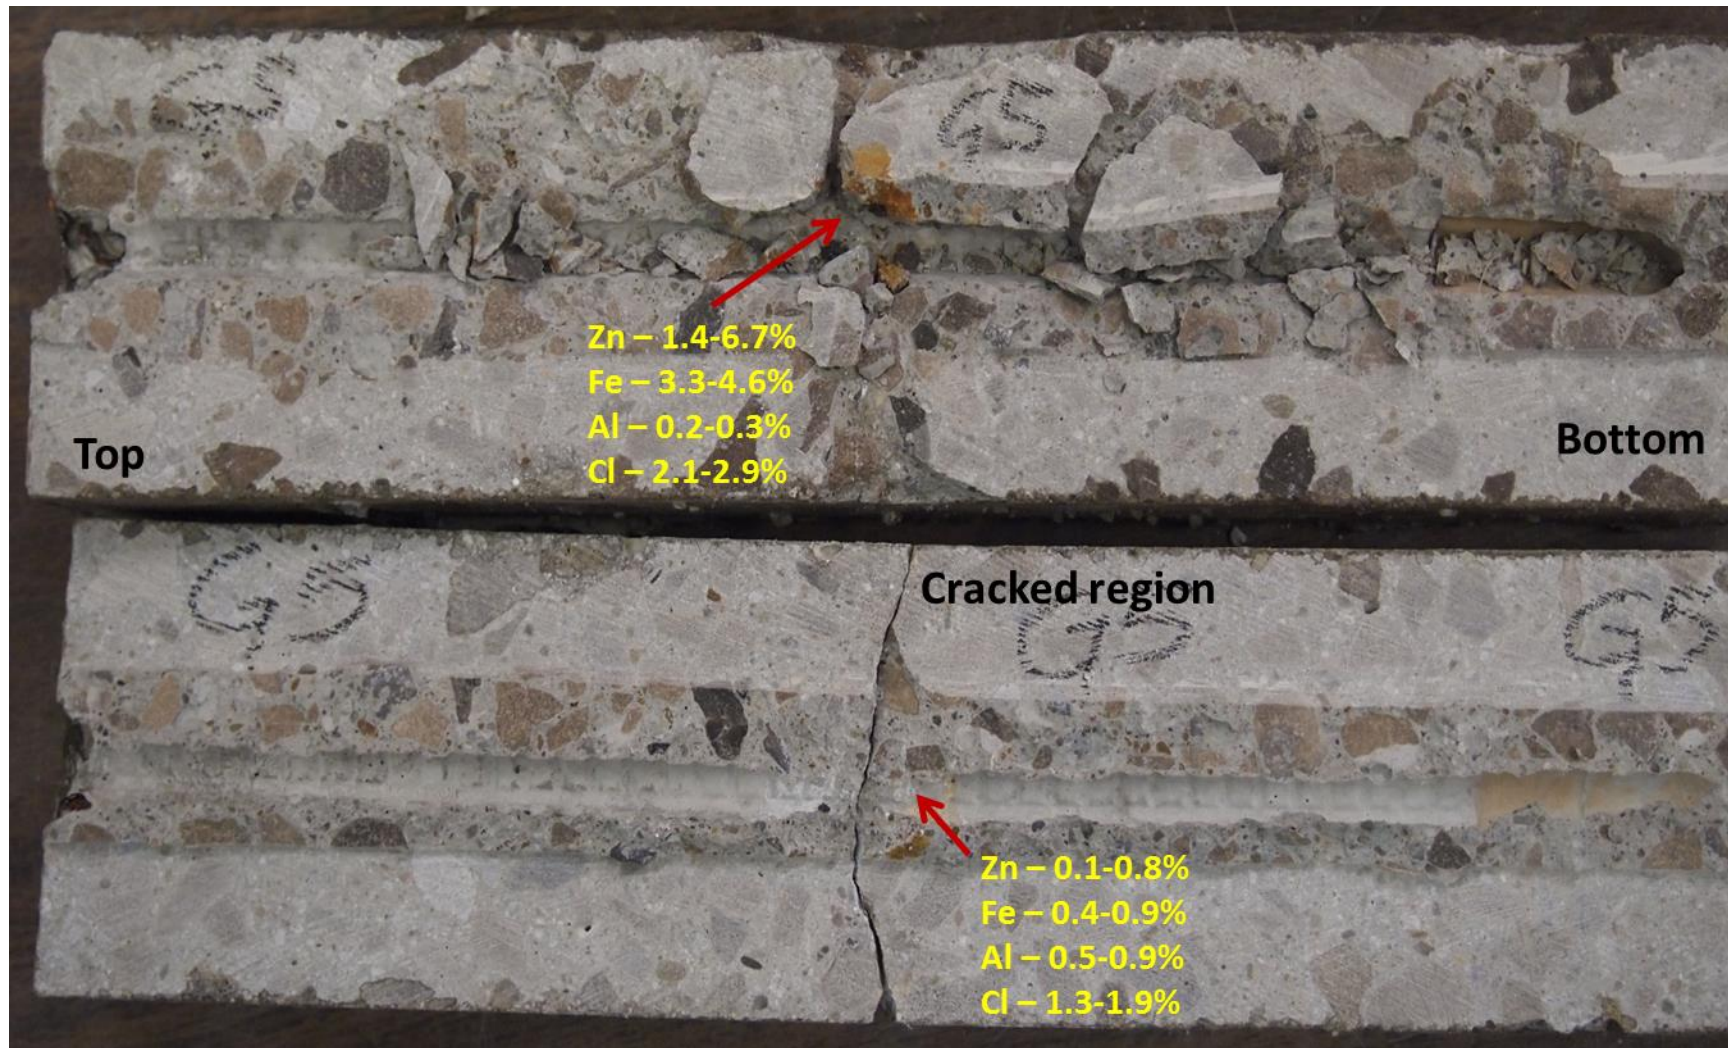
Figure E1.4.5: XRF analysis of autopsied transversely cracked HDG concrete specimen.

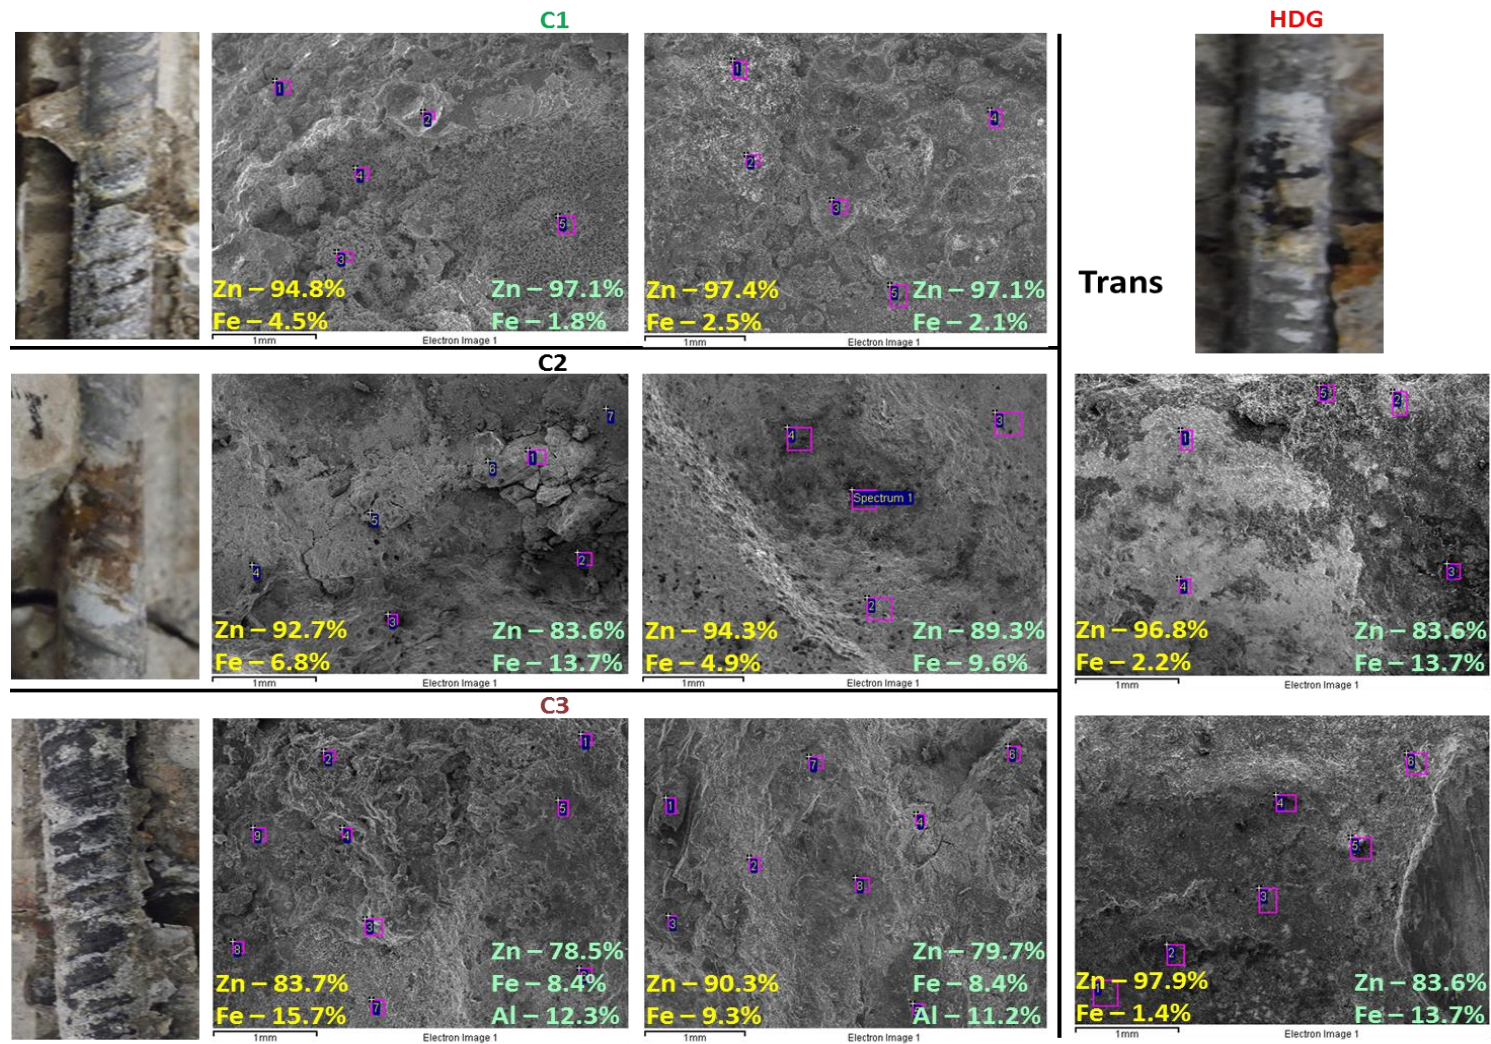
Figure E1.4.6: XRF analysis of autopsied transversely cracked steels. Note: values in green and yellow are before and after corrosion testing

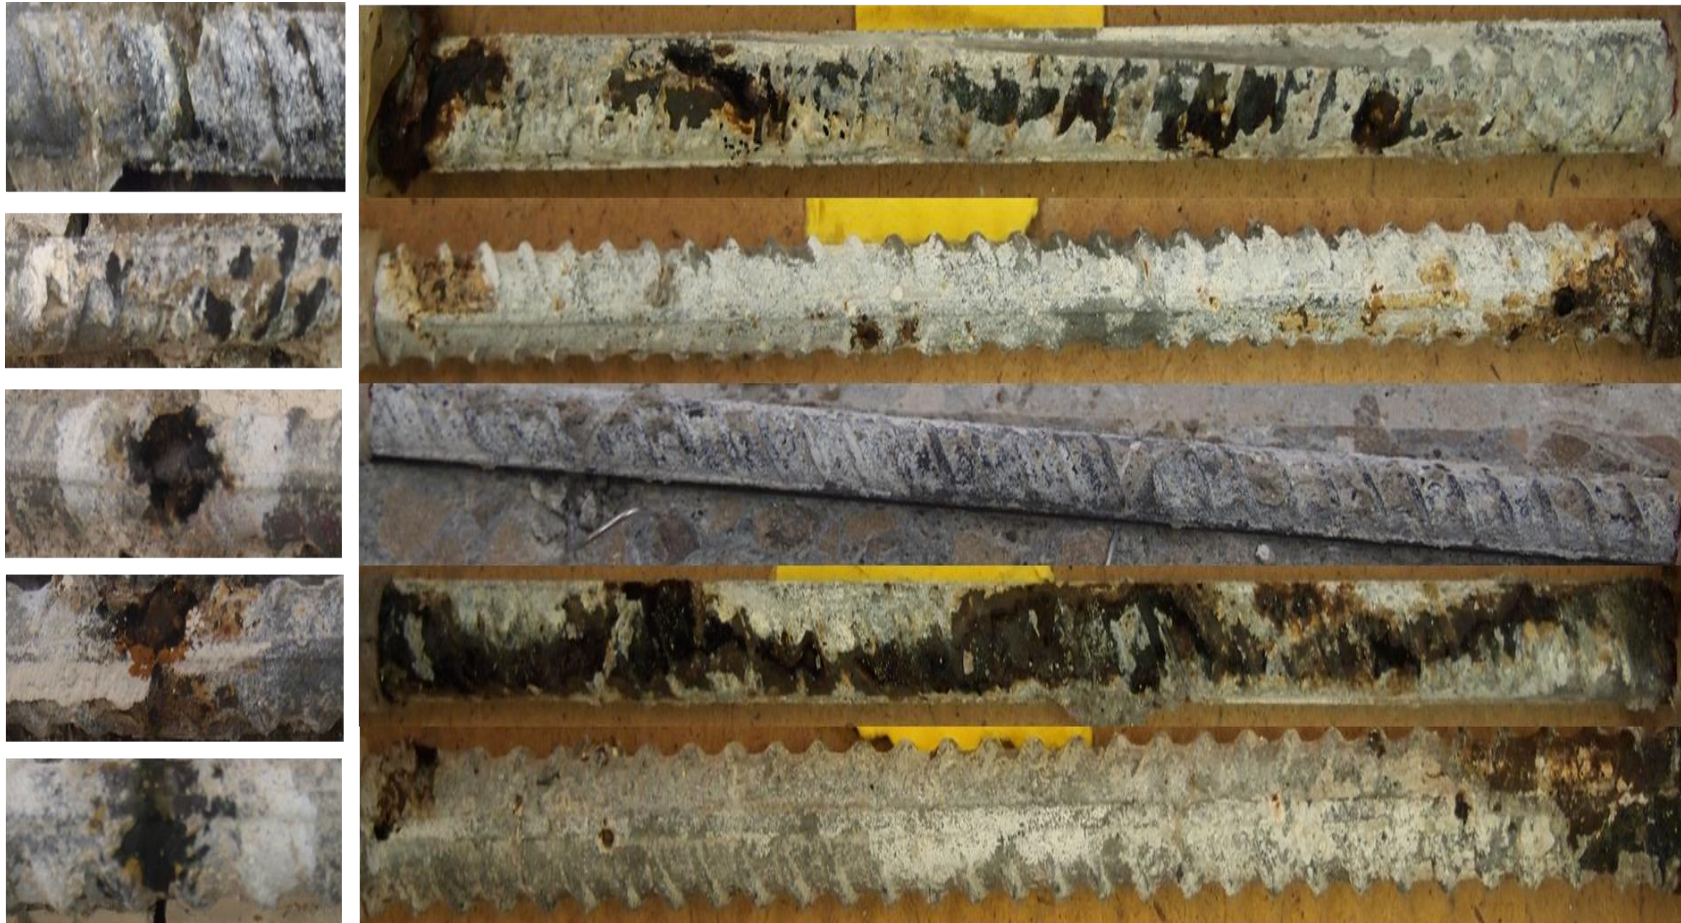
Figure E2.1.1: Exposed surface (to concrete crack) of transversely- (left) and longitudinally- (right) cracked C1 steel specimen

1 to 5.

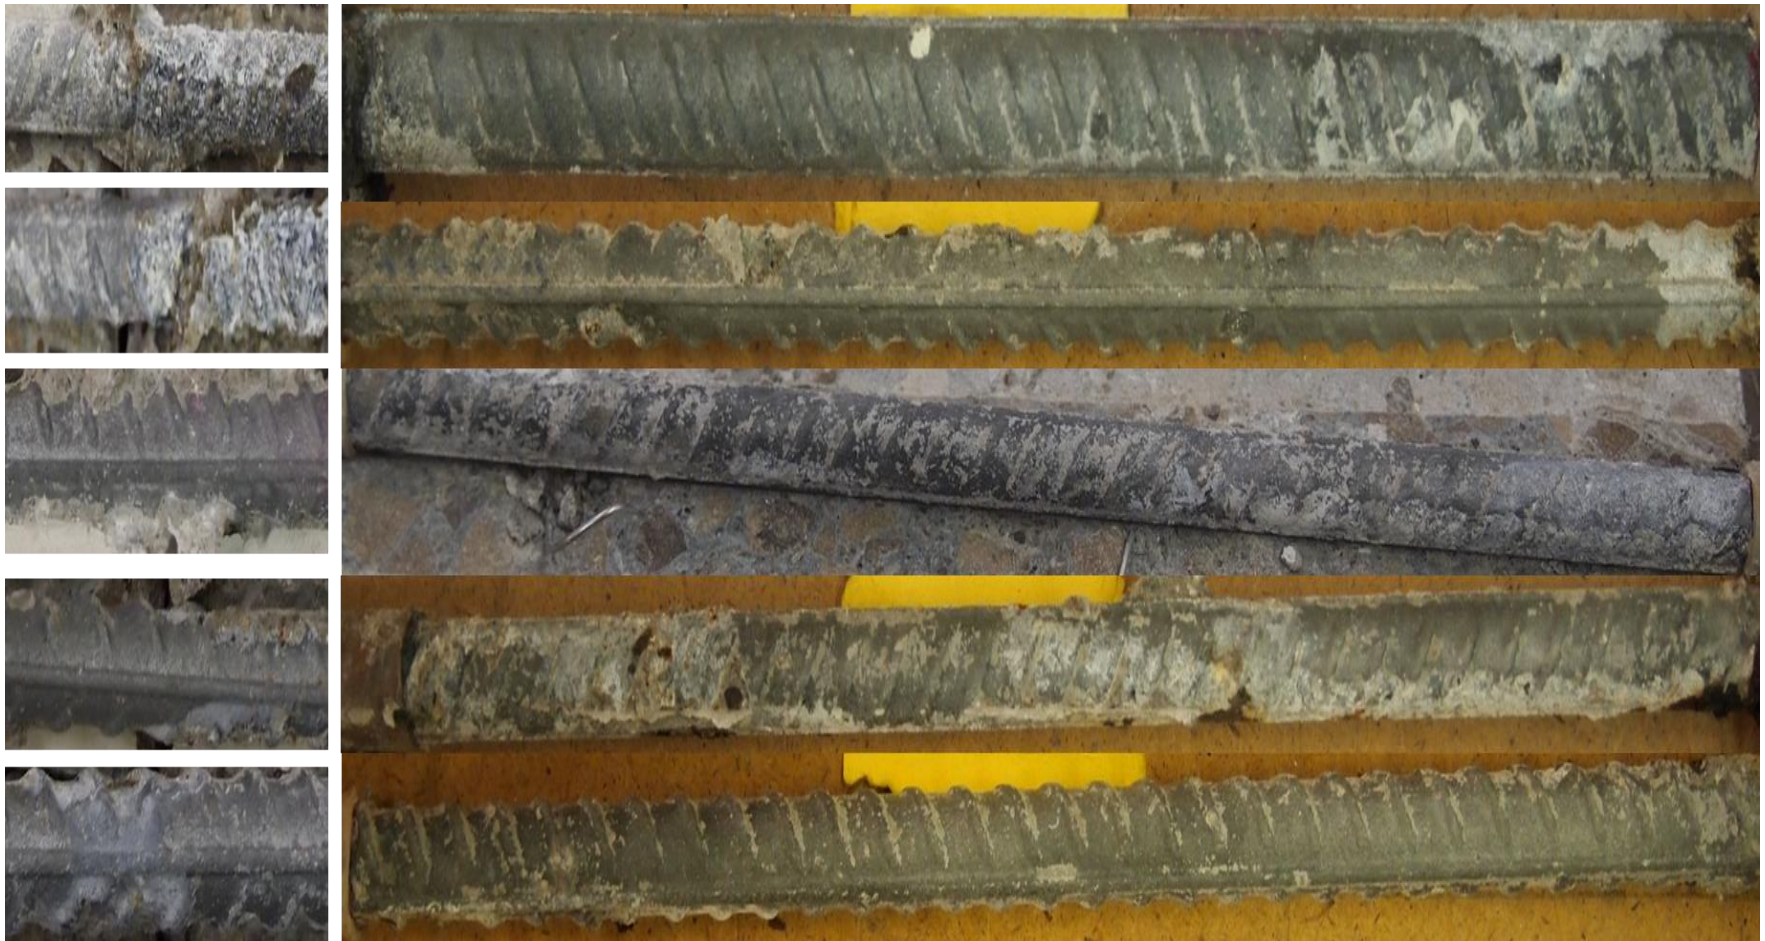
Figure E2.1.2: Non-exposed surface (to concrete crack) of transversely- (left) and longitudinally- (right) cracked C1 steel specimen 1 to 5.

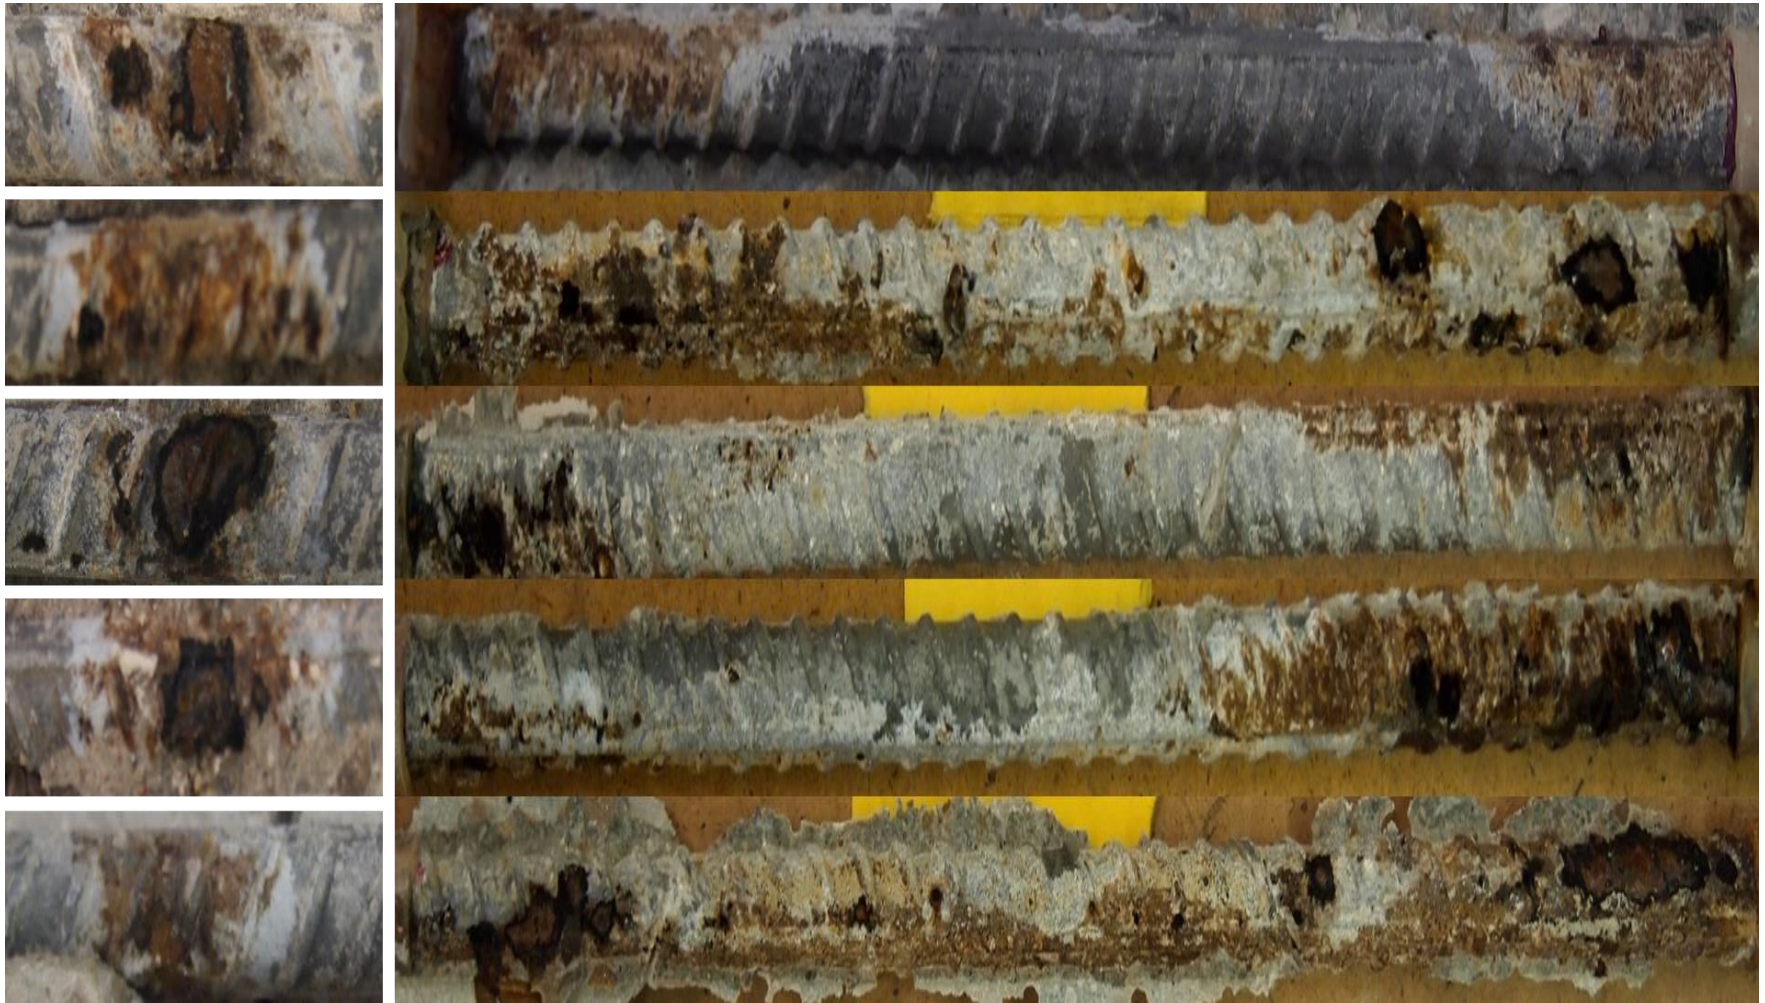
Figure E2.2.1: Exposed surface (to concrete crack) of transversely- (left) and longitudinally- (right) cracked C2 steel specimen

1 to 5.

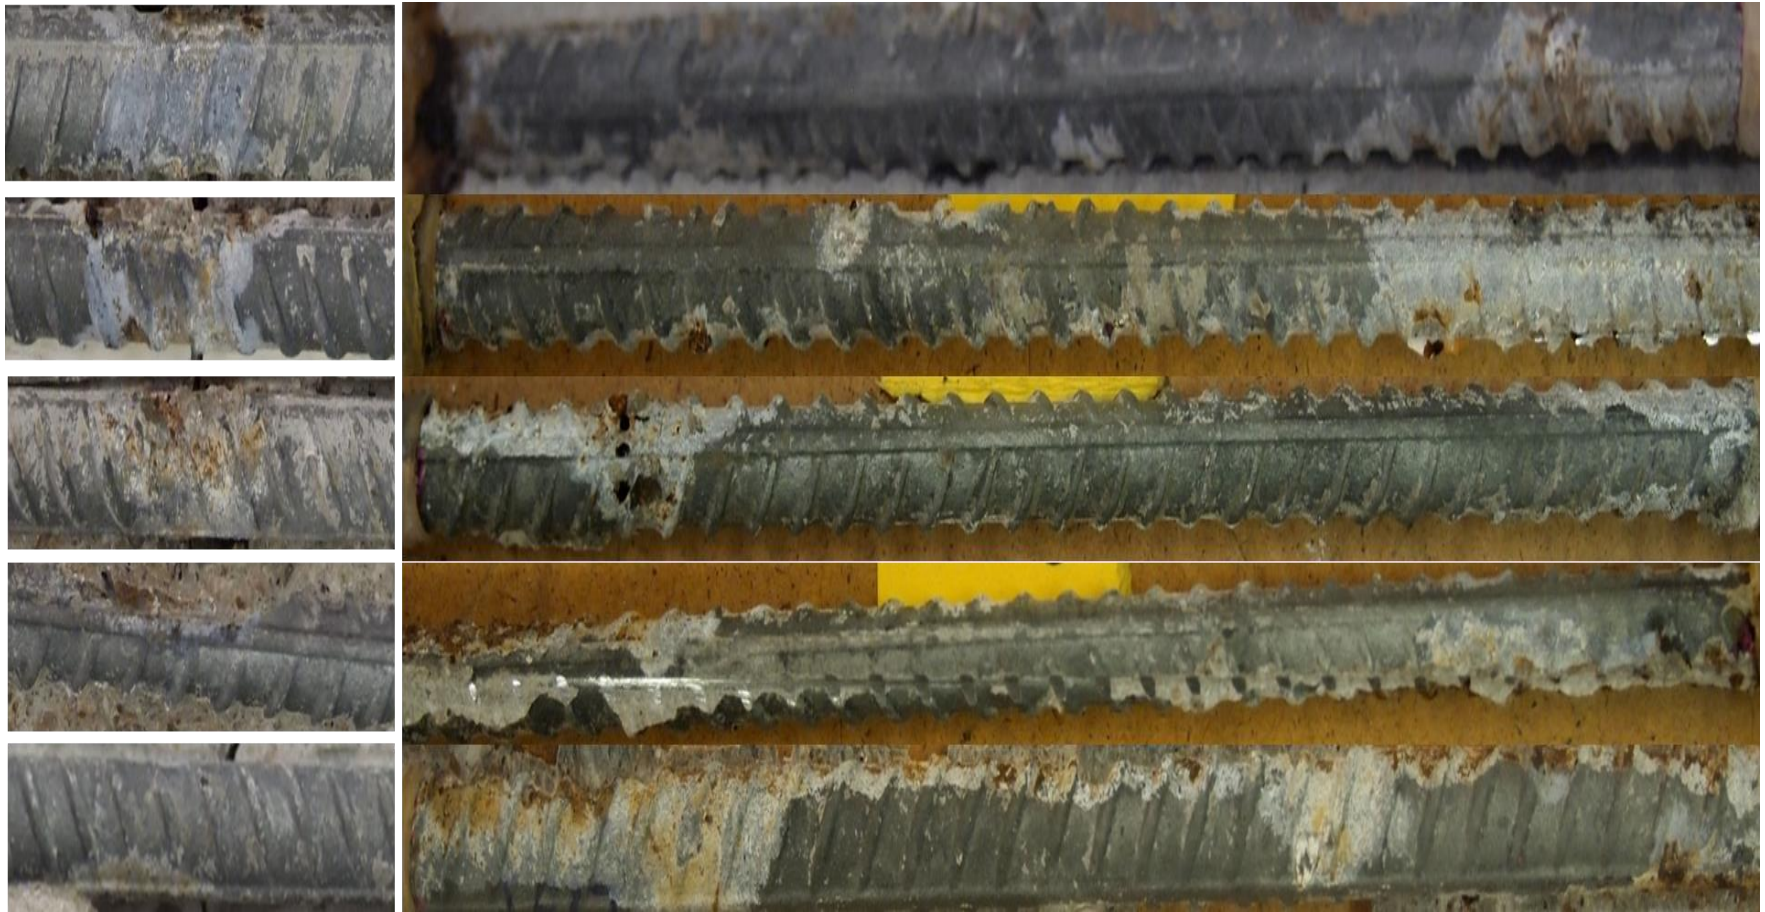
Figure E2.2.2: Non-exposed surface (to concrete crack) of transversely- (left) and longitudinally- (right) cracked C2 steel specimen 1 to 5.
