Evaluation of the Corrosion Behaviour of Continuously Galvanized Rebar

A thesis

presented to the University of Waterloo

Master of Applied Science

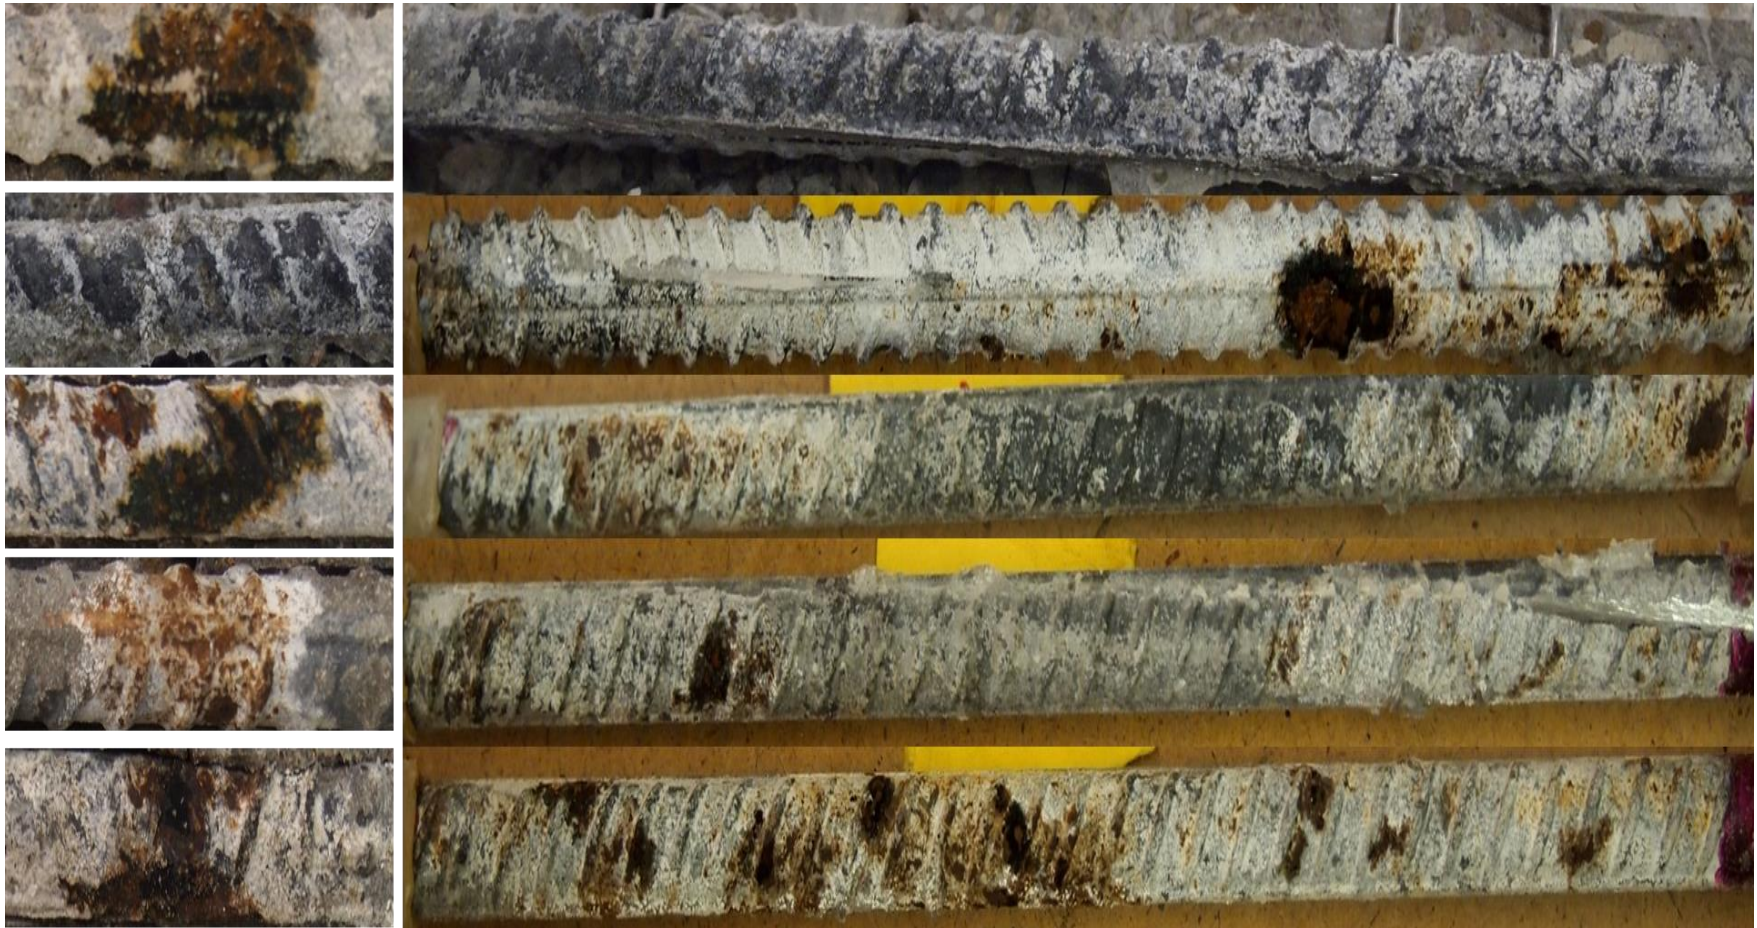
Figure E2.3.1: Exposed surface (to concrete crack) of transversely- (left) and longitudinally- (right) cracked C3 steel specimen 1 to 5.

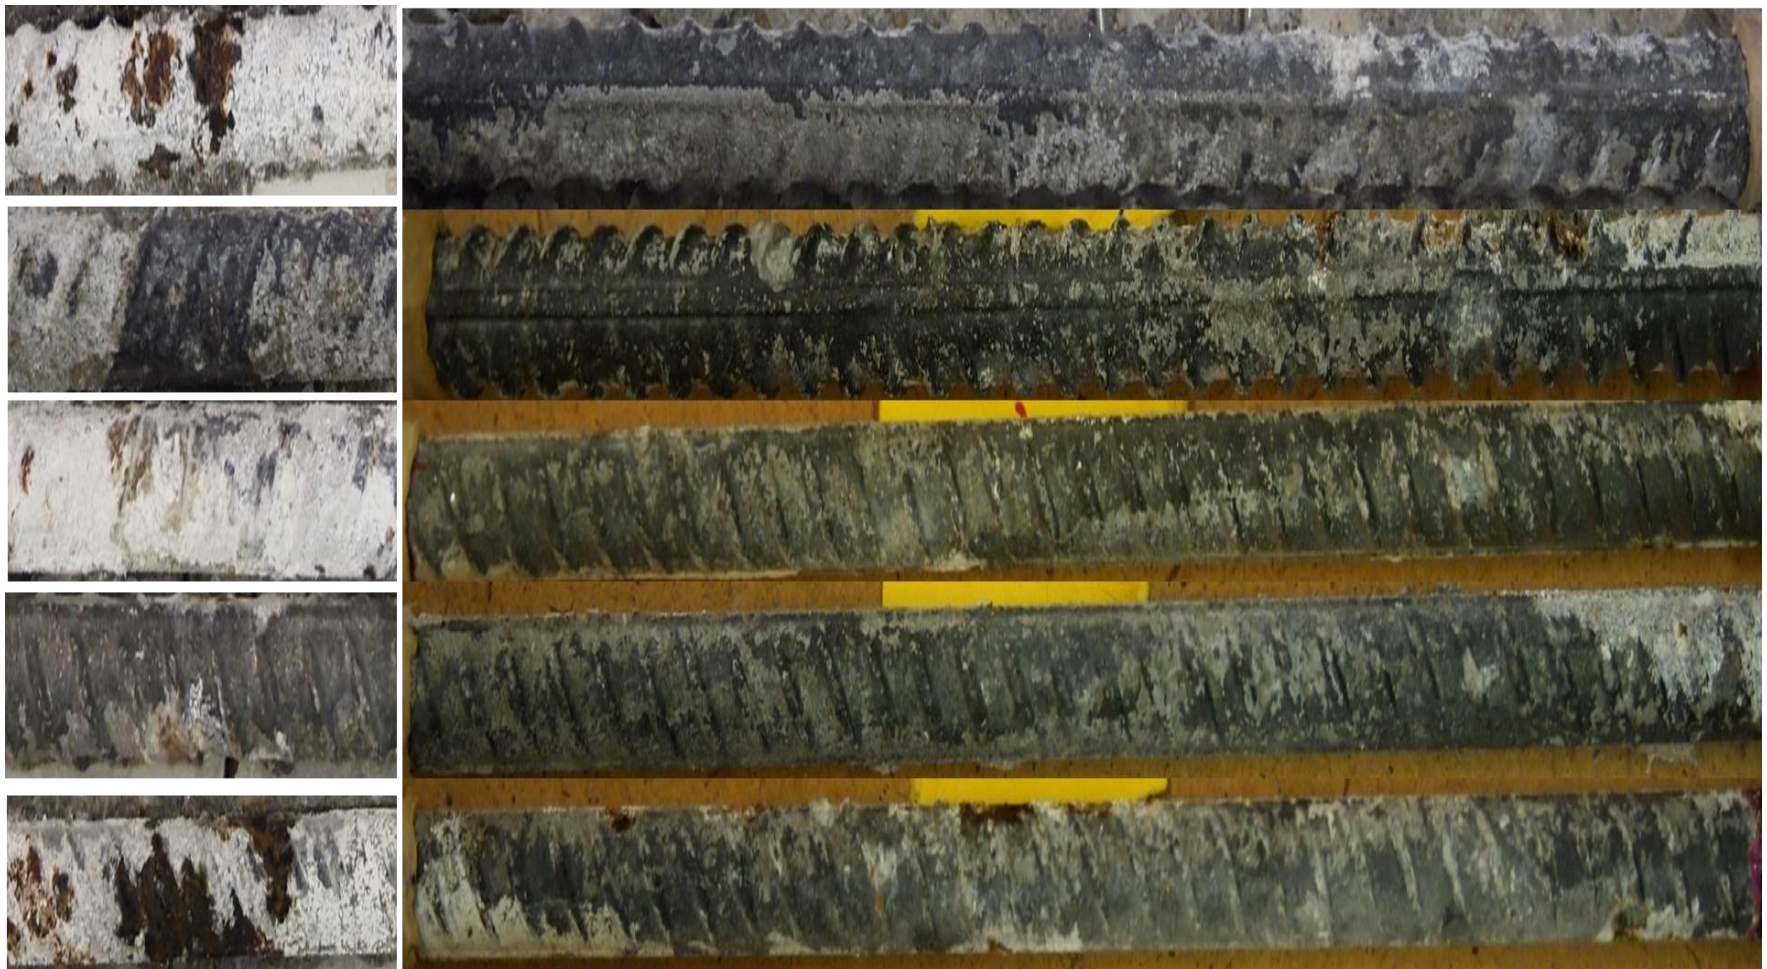
Figure E2.3.2: Non-exposed surface (to concrete crack) of transversely- (left) and longitudinally- (right) cracked C3 steel specimen 1 to 5.

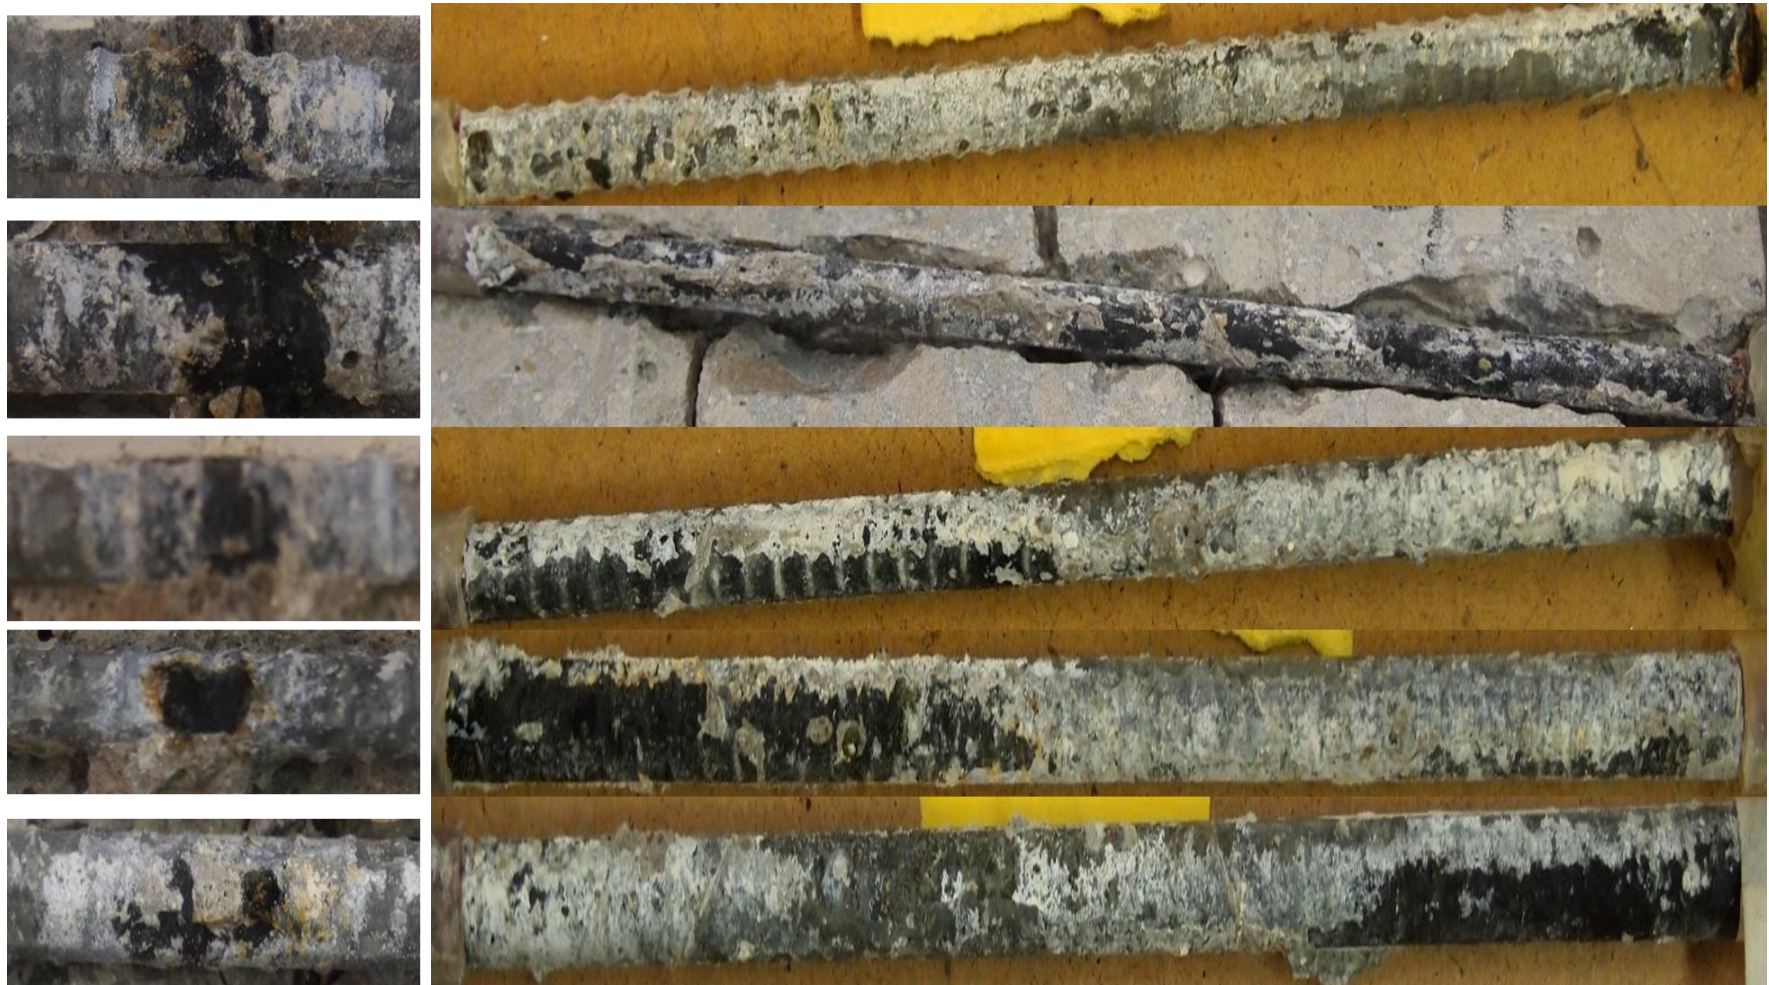
Figure E2.4.1: Exposed surface (to concrete crack) of transversely- (left) and longitudinally- (right) cracked HDG steel specimen 1 to 5.

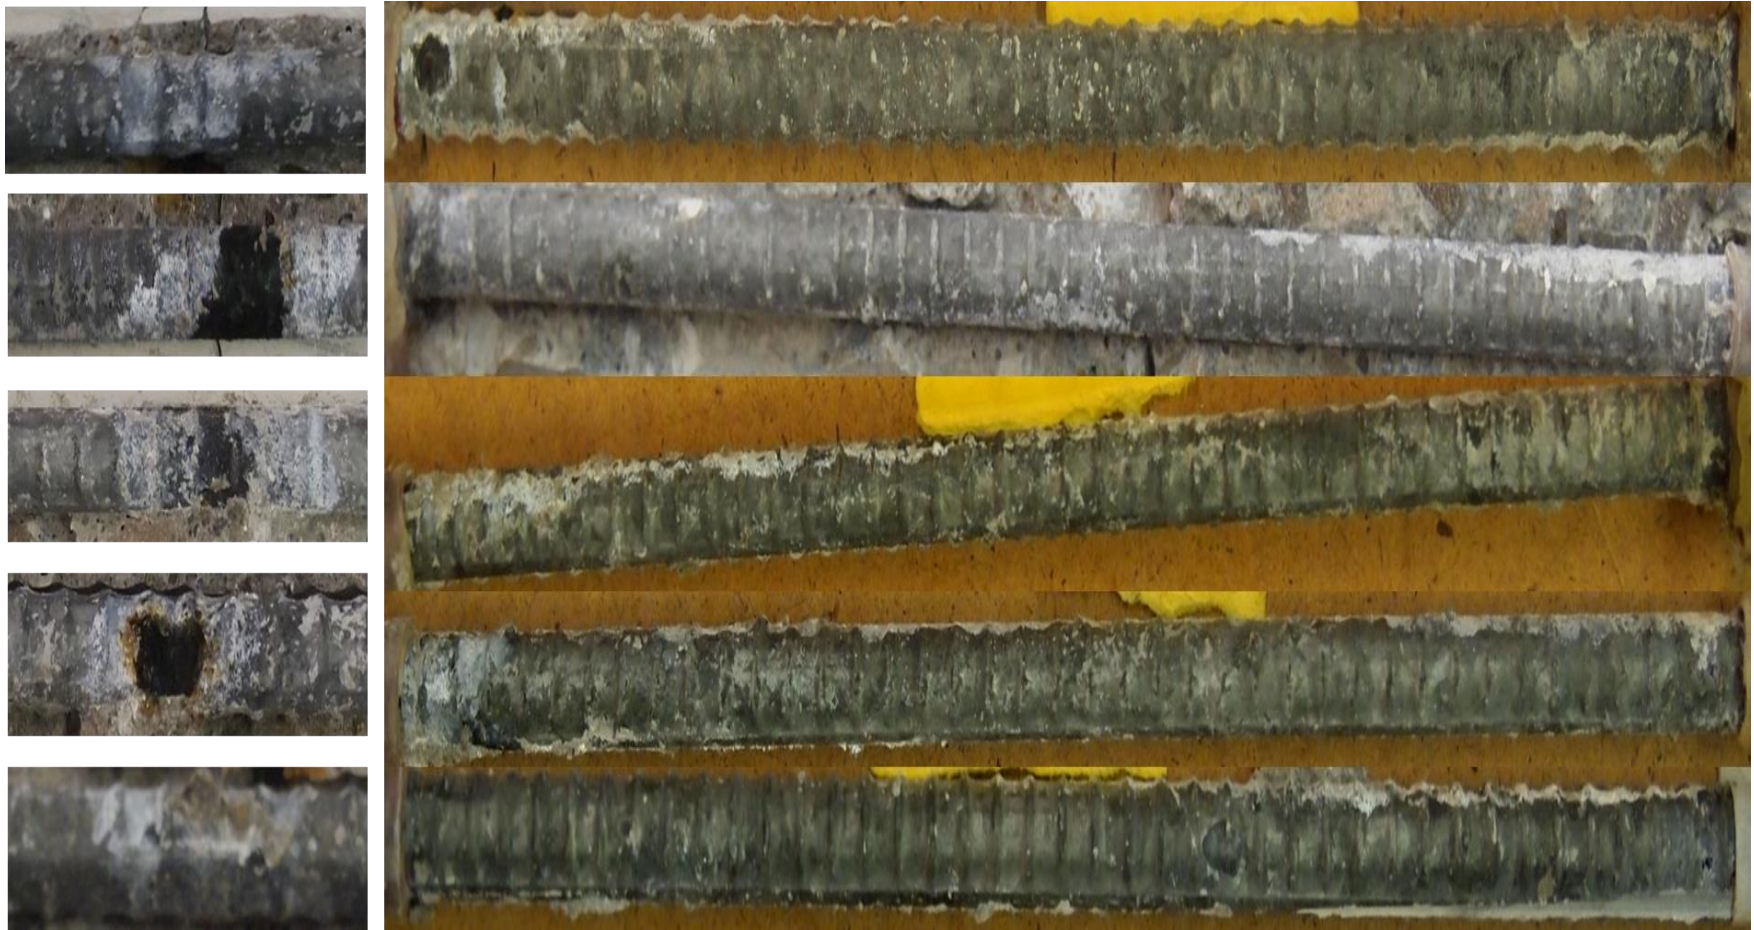
Figure E2.5.2: Non-exposed surface (to concrete crack) of transversely- (left) and longitudinally- (right) cracked C1 steel specimen 1 to 5.
