The Fatigue Resistance of Headed Shear Stud Connectors in Steel-Precast Composite Girders

Taylor Kenneth Porter

Master of Applied Science

Waterloo, Ontario, Canada, 2017

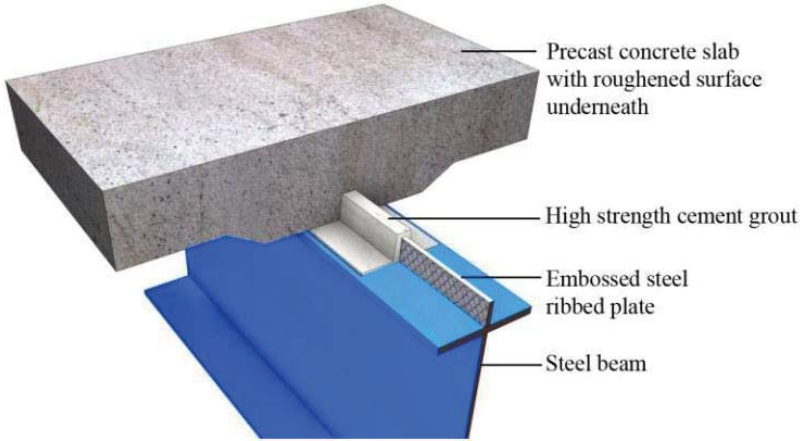
Connections by chemical adherence are a shear connection type that has been studied in the past decade. They transfer longitudinal shear through friction by adhesion between the steel and concrete deck to facilitate composite behaviour (Bowser, 2010). This type of shear connection has been researched by Dauner (2005), Thomann (2005, 2008), and Lebet (2008) with the hopes of developing a rapid alternative for installing precast slabs. The detail is presented in Figure 2-4. Direct shear testing completed on this connection found the performance to have a very high stiffness, however, demonstrated very low ductility. Despite the low ductility, Thomann and Lebet (2008) confirmed that composite sections with chemical adherence for shear connection can provide full plastic flexural resistance in both positive and negative moment regions.

Figure 2-4: Detail of a chemically adhered shear connection (Papastergiou & Lebet, 2010).

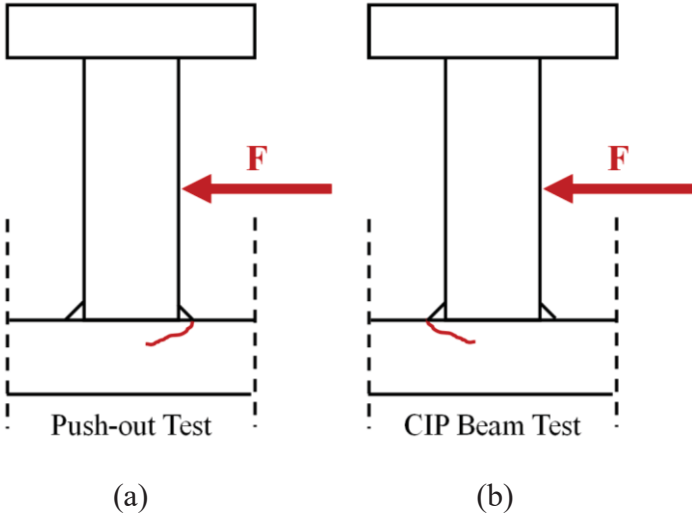
Typical modes of failure in cyclic push-out tests include fracture at the stud shank, failure at the flange heat affected zone, or the failure of the weld. The crack initiation location has been found to be dependent on the degree of initial geometric imperfection, the diameter of the stud, and the thickness of the flange to which it is attached (Yu-Hang et al. 2014). For push-out tests, the fatigue crack is typically found to initiate at the weld toe on the side that the transverse shear load is applied to the studs. Similar modes of failure have been recorded in beam tests, however, the fatigue crack has been found to initiate at the opposite side. Justifications for this behaviour have been accredited to concrete shrinkage, where the effect is greatest in the studs closest to the ends of the beam (King et al.1965). Schematics of typical fatigue crack failures for both push-out and beam tests are illustrated in Figure 2-8.

Figure 2-8: Typical fatigue failures for (a) push-out test and (b) beam test.

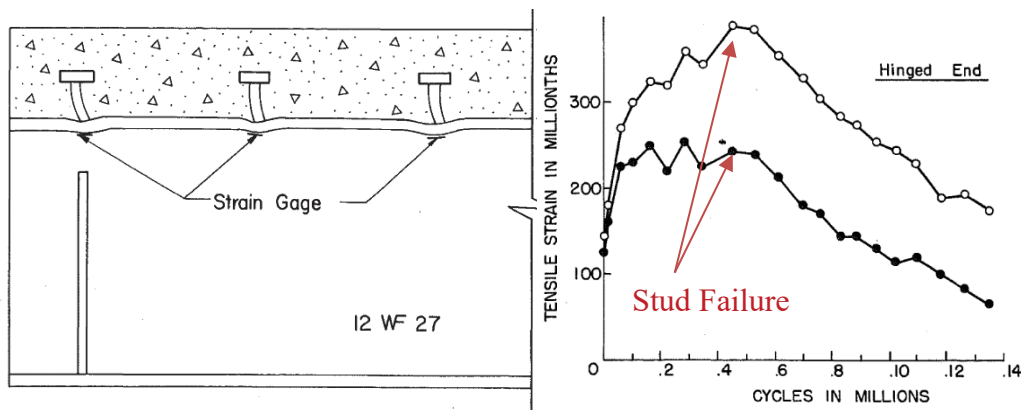
Static loading tests were performed at regular intervals throughout the cyclic testing to collect deflection, interfacial slip, and strain gauge readings. From the data collected, King et al. (1965) determined that detecting connector failure from the trends in profile strain, deflection, and interfacial slip was insufficient to make any direct conclusions on the exact number of cycles to failure. The research group did, however, have success in determining the number of cycles until failure by measuring the change in local distortion strains at the studs. These strain gauges were installed on the underside of the top flange, directly beneath where the stud is located as shown in Figure 2-9. The resistive forces produced by the stud result in local bending stresses in the top flange and are sensitive to any changes in the stiffness/condition of the connector. King et al. (1965) found that once a crack forms and begins to propagate, the connection becomes less stiff, and the strains caused by the local distortions decrease in magnitude. For the purpose of defining a failure criterion, the number of cycles to failure for the beam was established once any of the local distortion strains reached a peak and started to descend. It was noted that the cracks initiated at the weld toe on the outside face, near the end of the beam, and propagated towards the midspan through the heat affected zone (HAZ). This phenomenon was explained by having fluctuating tensile stresses on the outside face due to the effects of concrete shrinkage.

Figure 2-9: Local distortion strain gauge location and sample results (King et al., 1965).

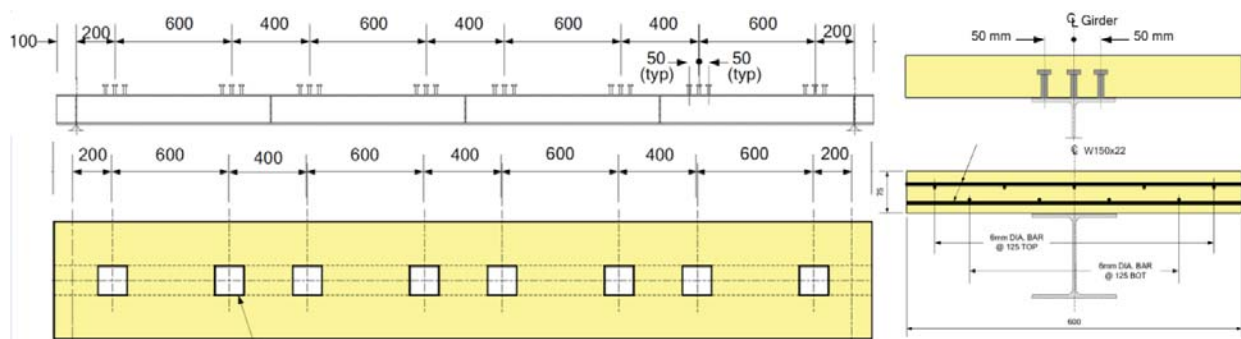
The Ministry of Transportation of Ontario (2010) published a paper titled “The Effect of Shear Stud Clusters in Composite Girder Design”. This research was conducted by authors Huh, Lam, and Tharmabala in the hopes of determining the long-term reliability and effectiveness in maintaining composite action of stud clusters subject to cyclic loading. This goal was achieved by studying the ultimate flexural behaviour of four 4 m long beam specimens subject to 3 million fatigue cycles each. The specimens were constructed as per the drawings provided in Figure 2-15, which includes the geometrical layout of the stud clusters.

Figure 2-15: Precast-steel composite beam specimen geometry (Huh et al., 2010).

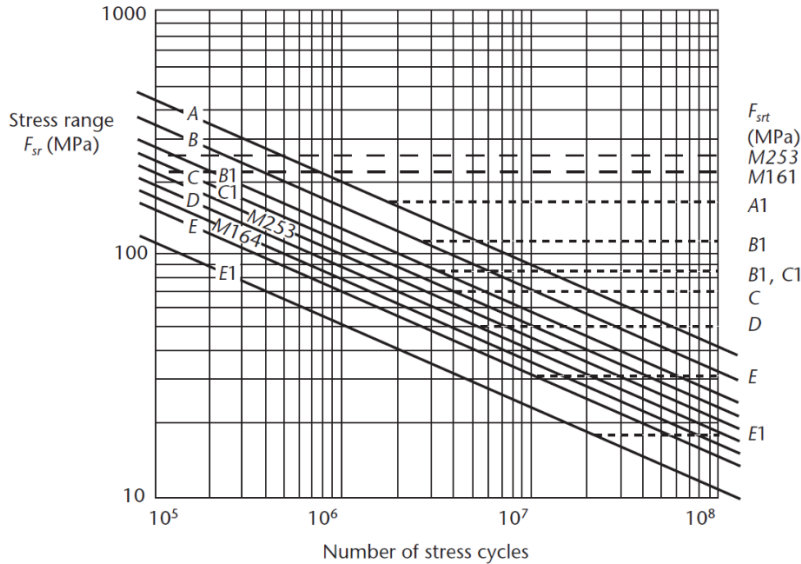
stress range represented by the inequality in Equation 2-16. Figure 2-17 provides the S-N plot for the various fatigue detail categories prescribed in the CHBDC. The horizontal dashed lines represent the constant amplitude threshold for each of the categories.

Figure 2-17: S-N plot for the different fatigue detail categories as defined in the CHBDC Commentary (CSA S6.1, 2014).

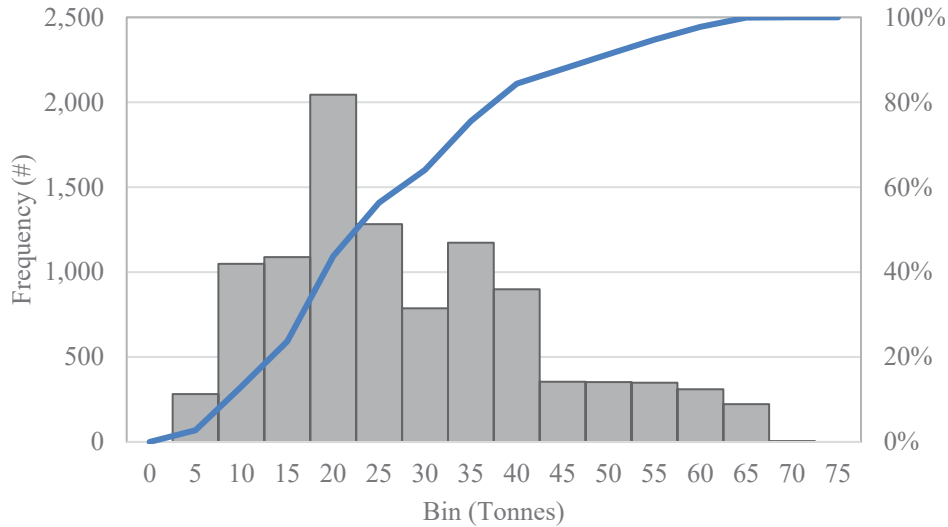
Most fatigue tests on shear connectors conducted to date have been under constant amplitude loading conditions. The effects on fatigue performance of connector slip during infrequent overload cycles (i.e., due to very heavy trucks or convoys) may be significant. For this reason, a variable amplitude loading history was used for the fatigue testing, simulating typical in-service loading for a bridge subjected to Ontario highway truck traffic. The foundation of the variable amplitude loading history utilized in this experiment was a study completed by the Ministry of Transportation Ontario (MTO) in 1995. This study involved surveying the weights of 10,198 trucks that were randomly selected while travelling on the road network. The results from this survey are presented in the form of a histogram in Figure 3-2.

Figure 3-2: Ontario highway truck traffic surveyed by the MTO in 1995.

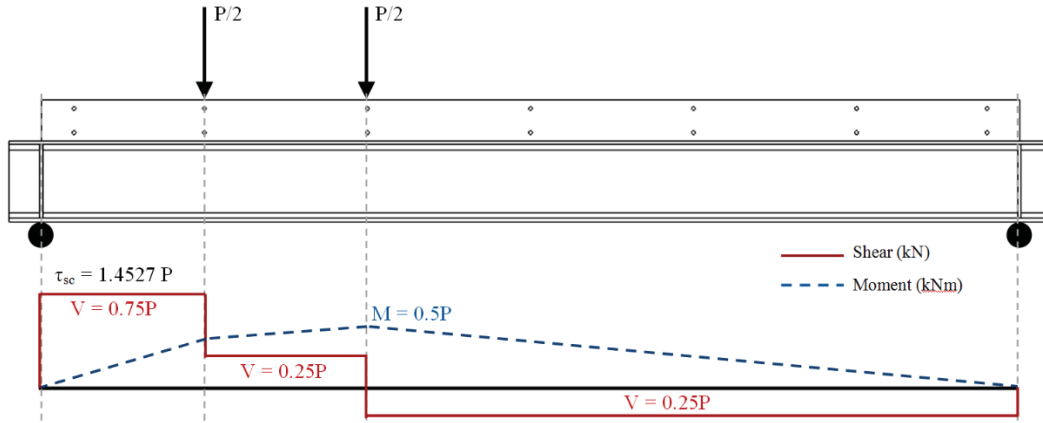
Figure 3-4: Shear force and bending moment diagrams for the test specimen.

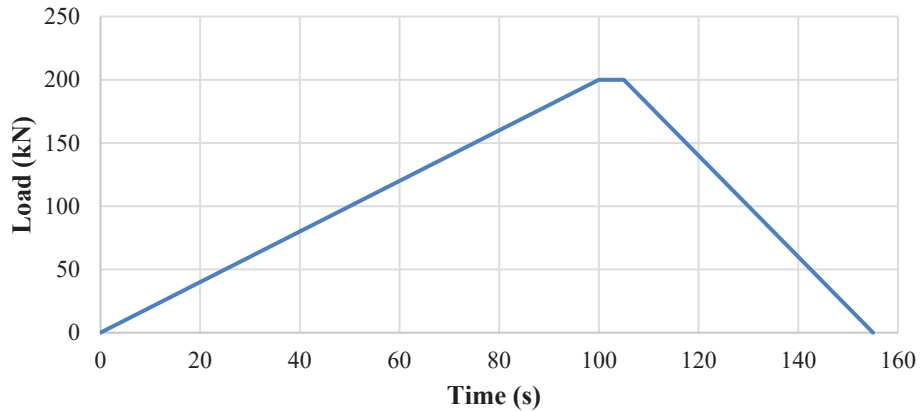
A static loading step was completed initially, and at the 100% and 1000% theoretical fatigue lives for each of the specimens. The initial static loading test was completed to break the chemical bond adhering the concrete to the top of the steel flange upon casting, and to collect data before any damage occurs from the subsequent cyclic loading phase. The data collected in the static tests included the strain profiles, max deflection, and interfacial slip. For comparison purposes, a load of 200 kN was selected as a standard load, corresponding to a 291 MPa stud stress in Stud Pairs 1 and 2. The 200 kN load was applied at a rate of 2 kN/s under load control conditions. The 200 kN load was then held statically for 5 seconds, followed by a 4 kN/s load retraction rate. The static loading history is graphically shown in Figure 3-5. Additionally, the data was collected at a rate of 2 Hz during each of the static tests.

Figure 3-5: Static loading history.

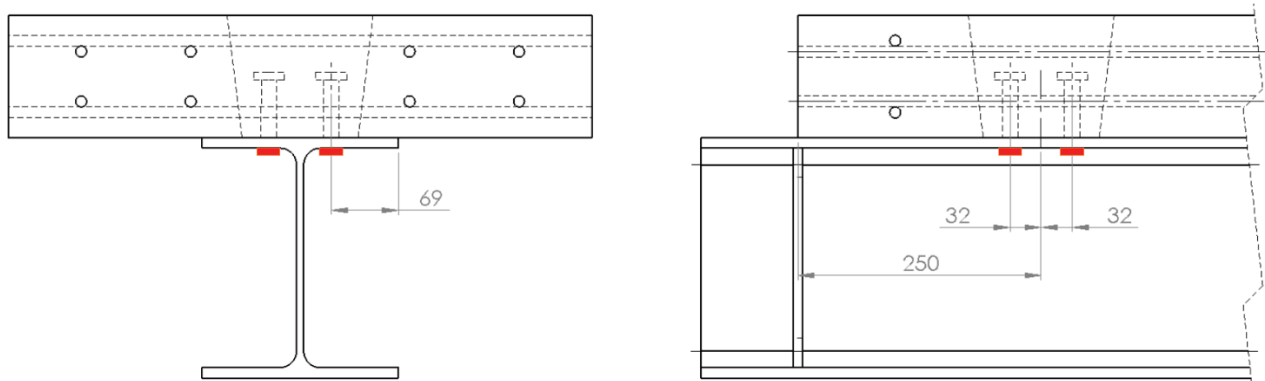
Capturing the change in local strain under the stud provided a means of determining the time of fatigue crack initiation and subsequent stud failure. The measured strain is induced by the local distortion of the top flange due to the horizontal force resisted by the stud. Since the placement of these gauges largely affected the magnitude of the strain readings, only the general trend of the data was used in formulating the failure criterion, which was then used to determine the number of cycles to failure for each stud. Specifically, it was observed that the strains due to the local distortion of the top flange caused by the stud were seen to increase during fatigue cycling up until they reached a peak, after which they decreased. The number of cycles at which the peak strain occurred was then assumed to be the number of cycles to failure. This is a similar instrumentation approach taken by King et al. (1965). One of the secondary objectives of this research was to determine the accuracy of this instrumentation method and to confirm that these peaks in the local strain data correspond to a stud failure by autopsying the specimens after testing. The gauges were installed directly beneath the studs 50 mm or 69 mm from the outside edge of the flange for the CIP and precast members, respectively. An example illustrating the placement of these gauges on a precast specimen is shown in Figure 3-6.

Figure 3-6: Example locations of the local distortion gauges for a precast specimen (N1, N2, S1, and S2).

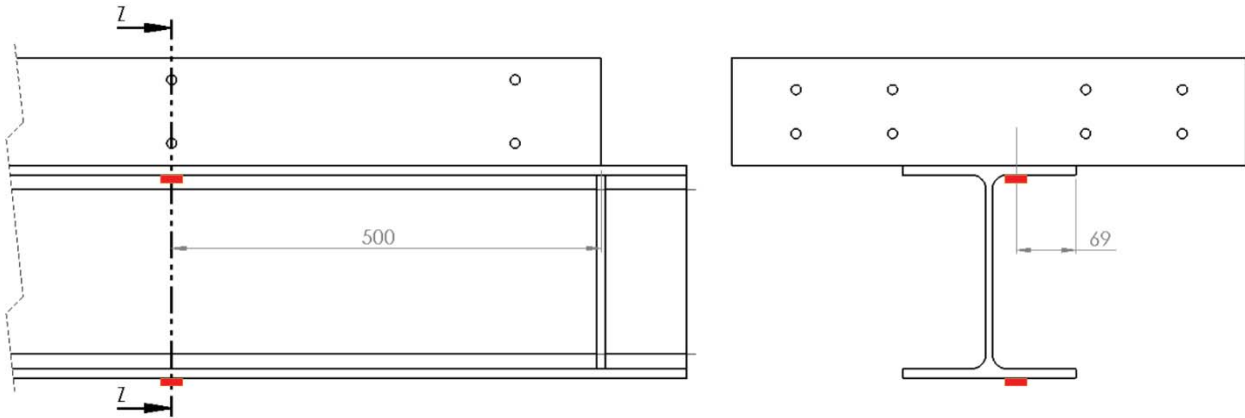
approach zero when the studs have completely sheared off. This data provides information on the actual stress experienced by the studs over time and offers insight on the redistribution of stresses over the specimen's fatigue life. The 10 mm strain gauges were installed on a single side, measuring 69 mm from the edge of the flanges as illustrated in Figure 3-7.

Figure 3-7: Example strain profile at Profile Z for both the precast and CIP specimens.

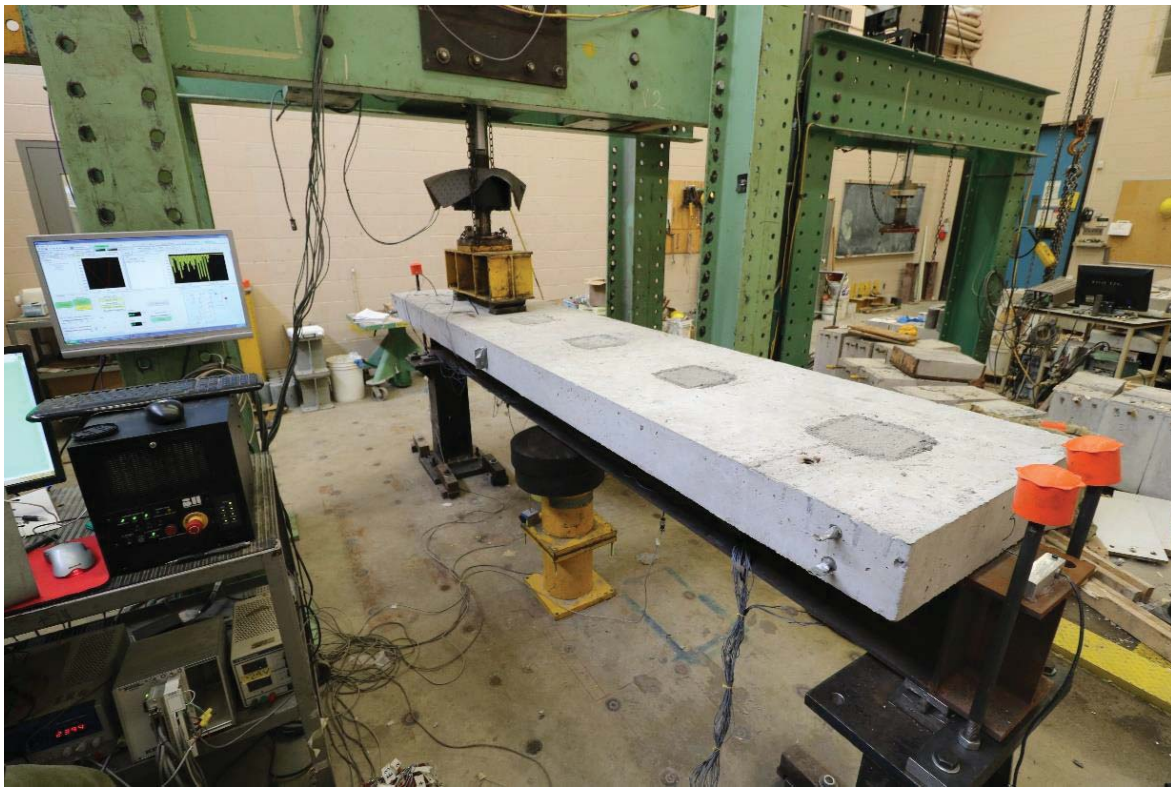
The laboratory frame and setup depicted in Figure 3-20 was utilized for the testing of the beam specimens. The testing frame utilizes a unidirectional hydraulic actuator that has a maximum capacity of 500 kN. The actuator is equipped with a load cell to measure the applied force and a LVDT to measure stroke. A spreader beam was attached to the bottom of the load cell to disperse the force between the two loading points equally. The loading points consisted of two pin connectors and a 2 mm thick neoprene pad. The neoprene pads ensured an equal force distribution over the loading point in the case of an uneven concrete surface.

Figure 3-20: Laboratory testing frame and setup.

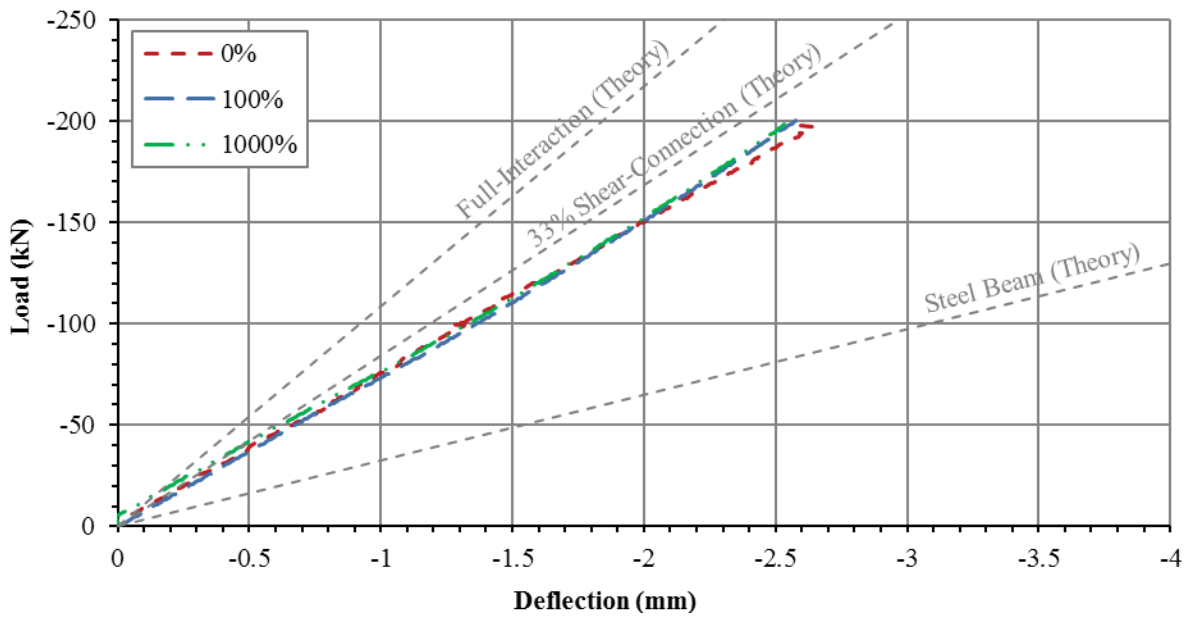
fatigue testing. However, the load-deflection trends for the C300 and P300 specimens did display a significant decrease in stiffness over the course of fatigue loading. It is interesting to note that the response of Specimens C300 and P300 at 3000% and 3700%, respectively, did not behave in a linear fashion. First, the stiffness was similar to a steel beam during the initial loading phase, and increased in stiffness at an applied load of 25 kN. This type of behaviour may suggest that most of the studs have sheared off and a 25 kN load was required to engage the shear connection through mechanical action and bearing.

Figure 4-1: Load-deflection results for C140.

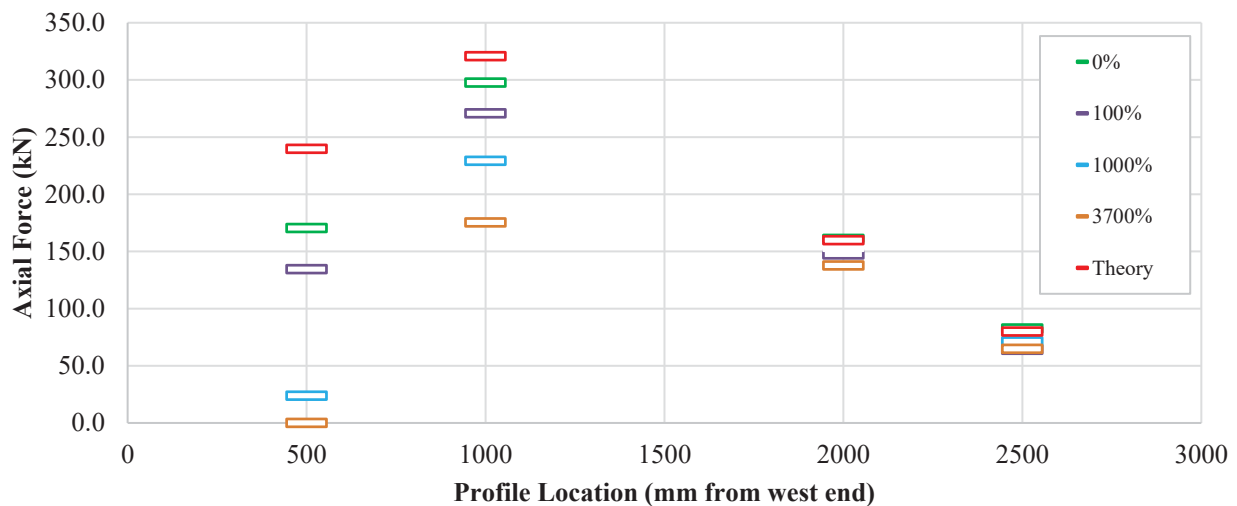
Figure 4-10 demonstrates a large decrease in axial slab force at Profiles A and B as the studs were damaged by the fatigue loading, eventually decreasing the force at Profile A to zero. This behaviour is expected as the applied fatigue loading had an equivalent stress of 300 MPa on Stud Pairs 1 and 2, making this the largest stress level tested. Similar behaviour was seen in the CIP equivalent, C300.

Figure 4-10: Concrete slab axial force diagram for Specimen P300 at an applied load of 200 kN.

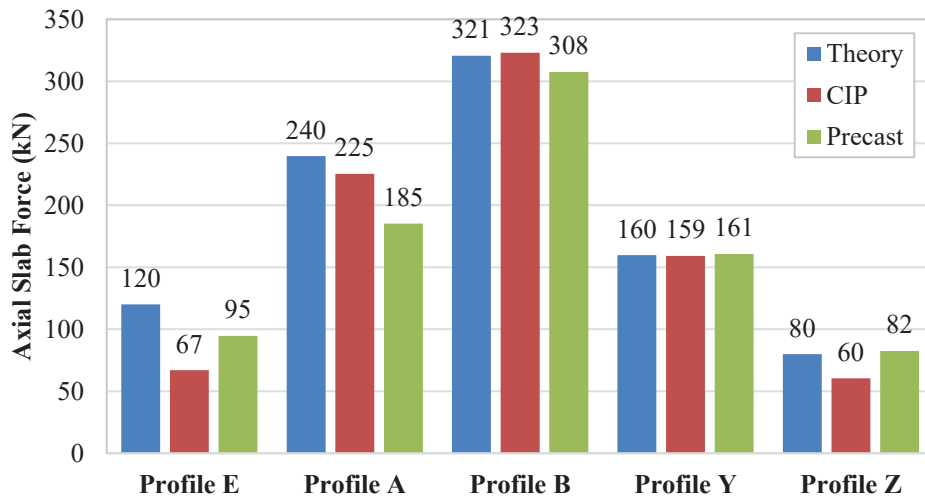
Figure 4-11: Average compressive force in the slab for each of the specimen types at P = 200 kN.

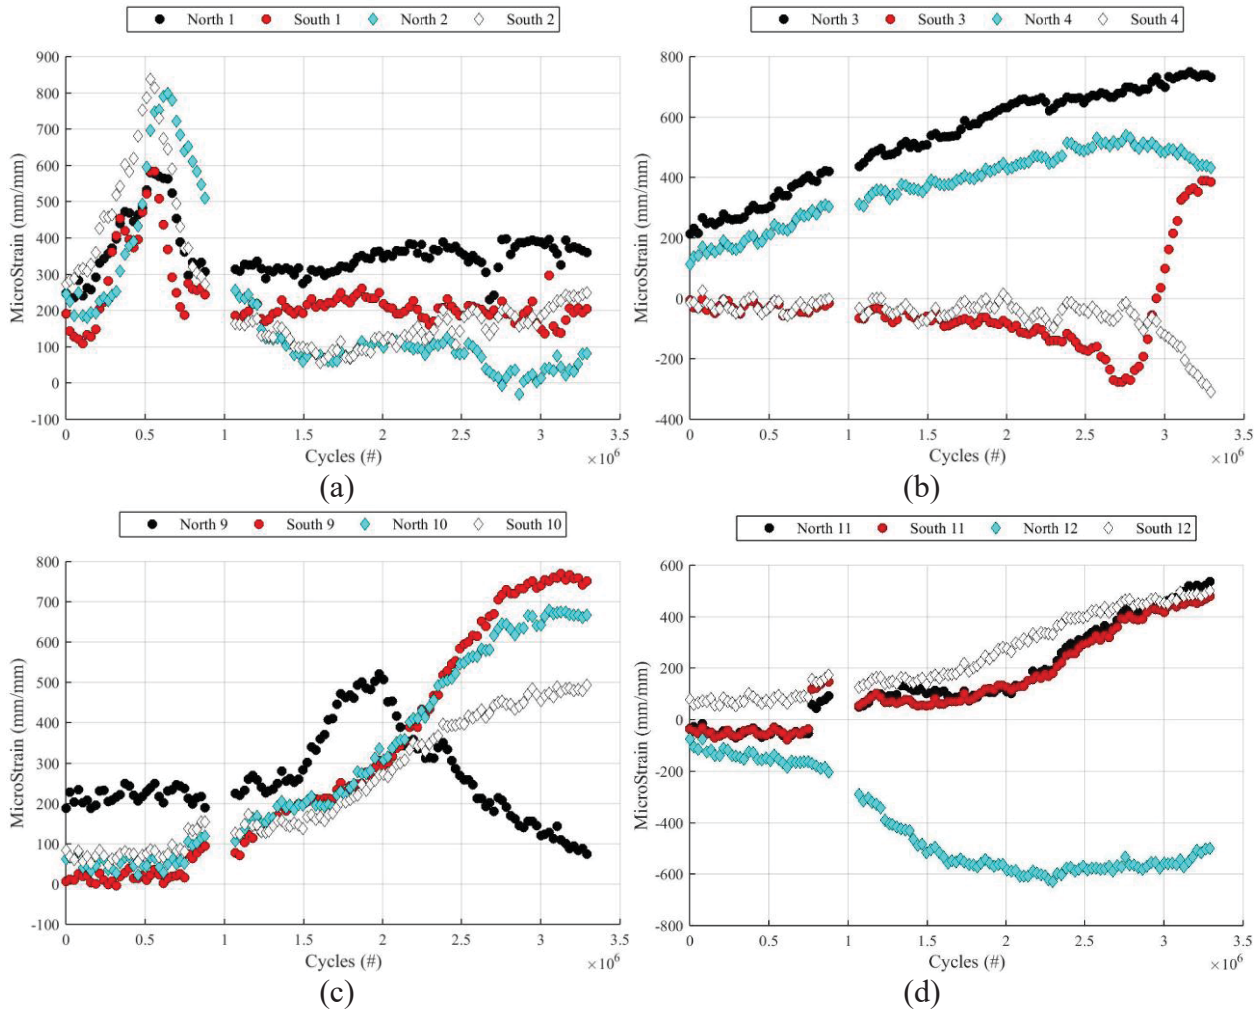
Figure 4-14: Local distortion strain data versus cycles for Specimen P200. (a) Stud Pairs 1 and 2, (b) 3 and 4, (c) 9 and 10, (d) and 11 and 12.

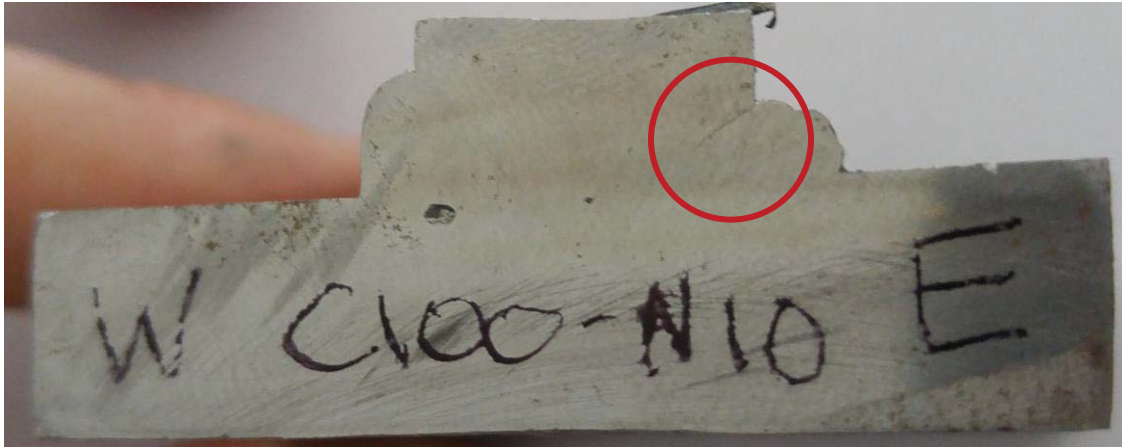
Figure 4-16: Cross-sectional cut made longitudinally through Stud N10 in Specimen C100.

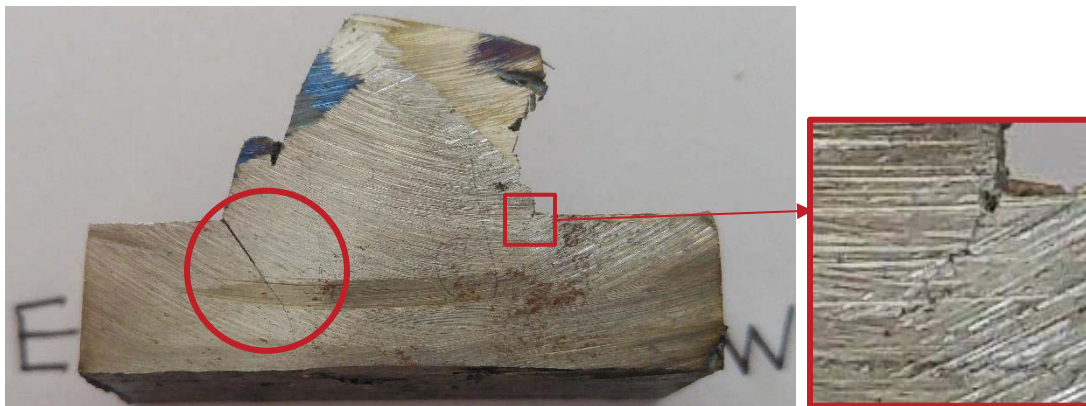
Figure 4-17: Cross-sectional cut made longitudinally through Stud S1 in Specimen P120.

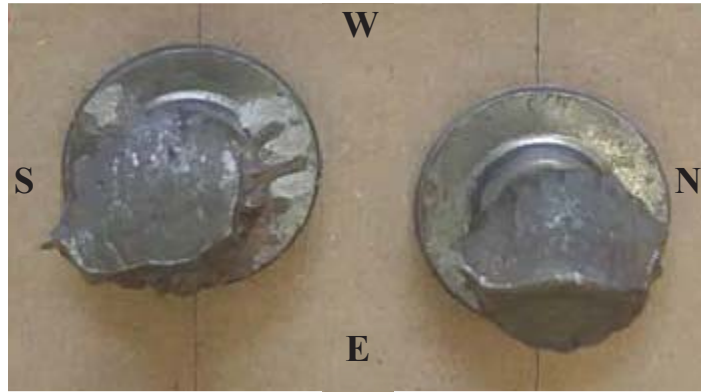
Figure 4-18: The bottom of N1 (right) and S1 (left) from Specimen C140 depicting the fatigue crack propagation.

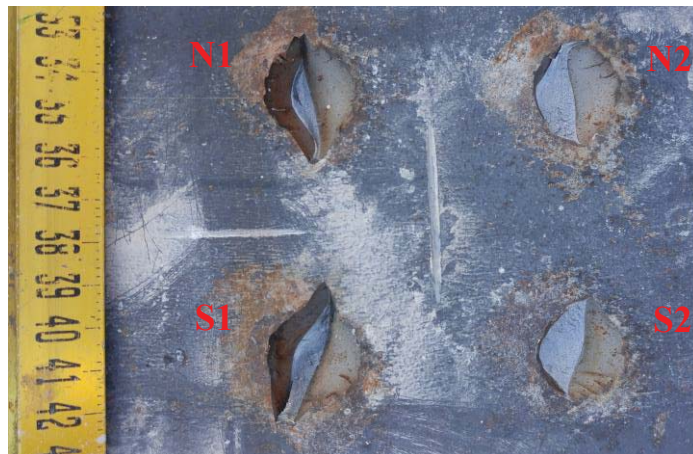
Figure 4-19: Fatigue cracking into the top flange of Specimen P140.

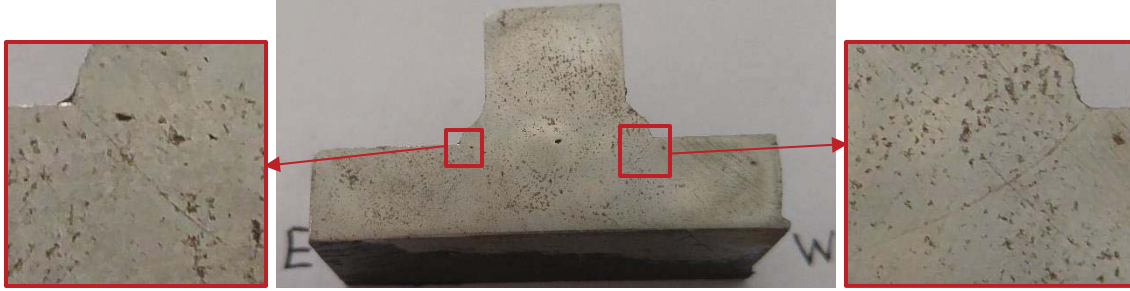
Figure 4-21: Cross-sectional cut made longitudinally through Stud S11 in Specimen P200.

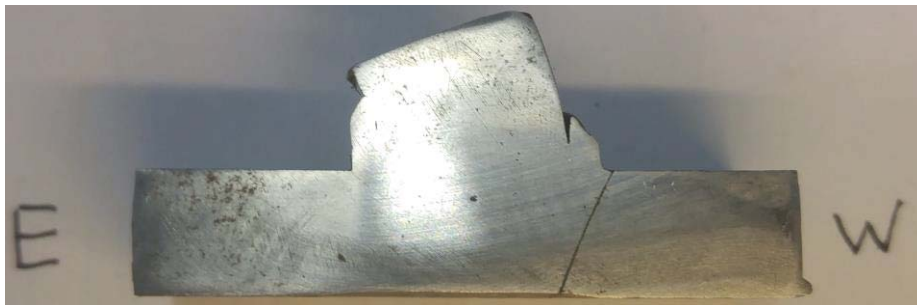
Figure 4-22: Cross-sectional cut made longitudinally through Stud S4 in Specimen C300.

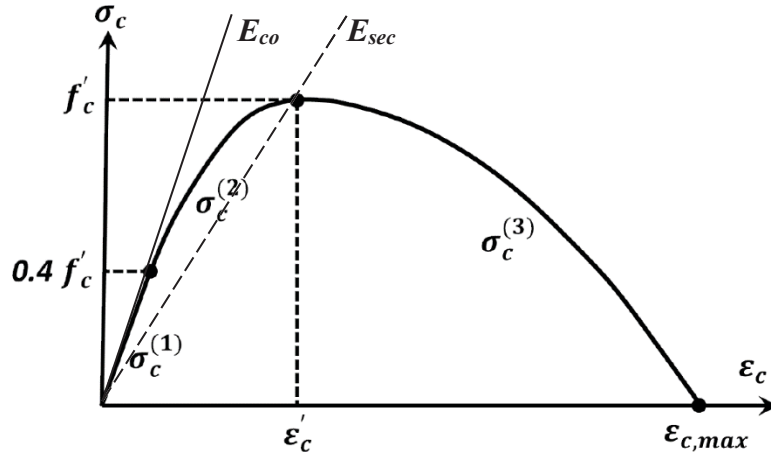
Figure 5-1: The stress-strain relationship defining the uniaxial compressive behaviour (Stoner, 2015).

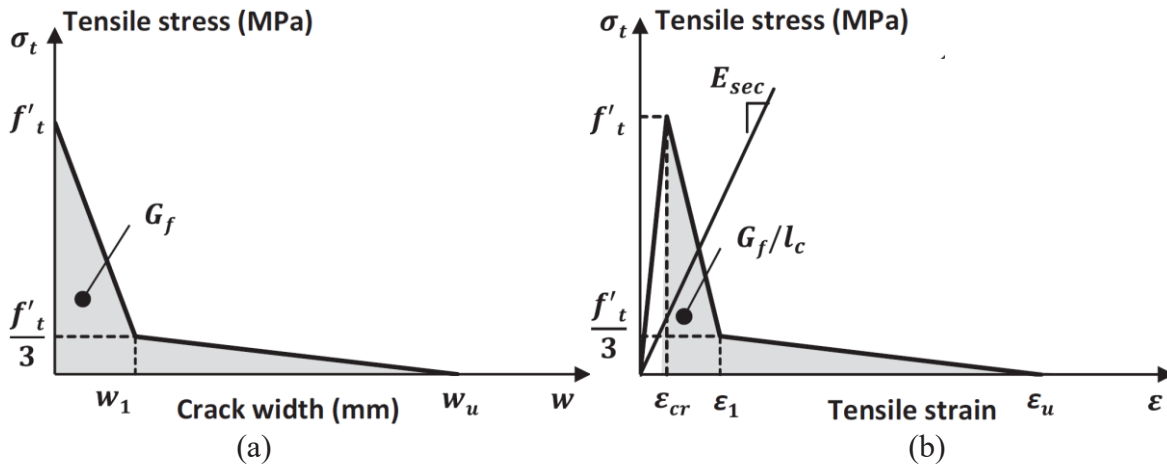
Figure 5-2: (a) Uniaxial tensile stress-crack opening displacement and (b) stress-strain relationship for concrete (Genikomsou & Polak, 2015).

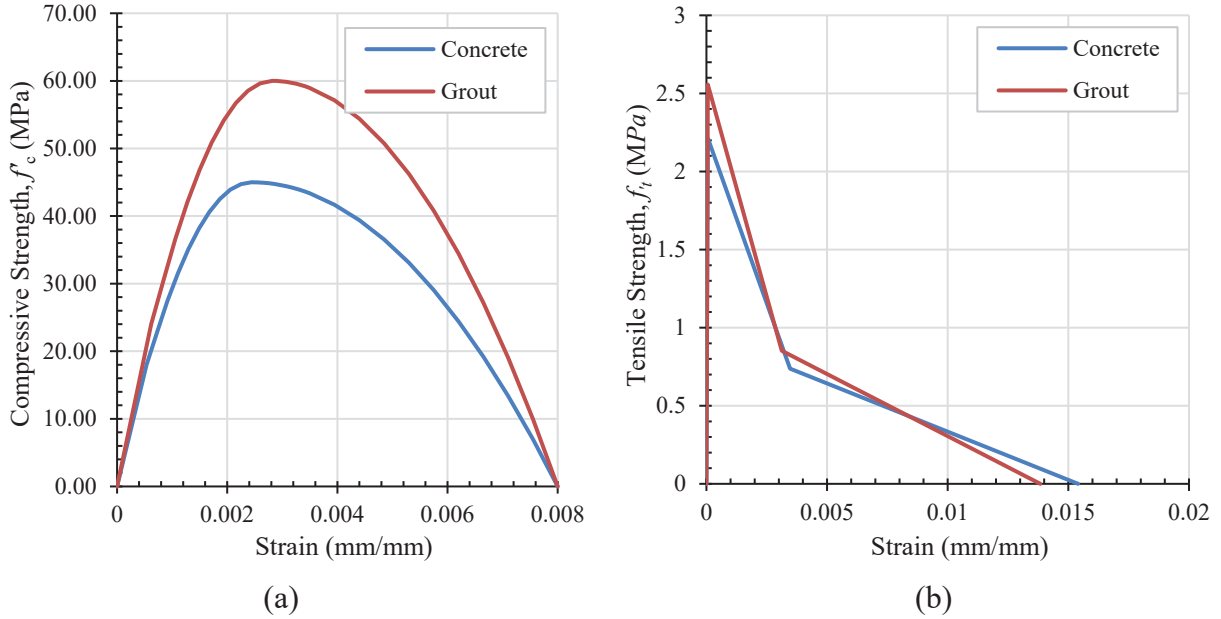
Figure 5-3: (a) Compressive strength and (b) tensile strength for the concrete and grout.

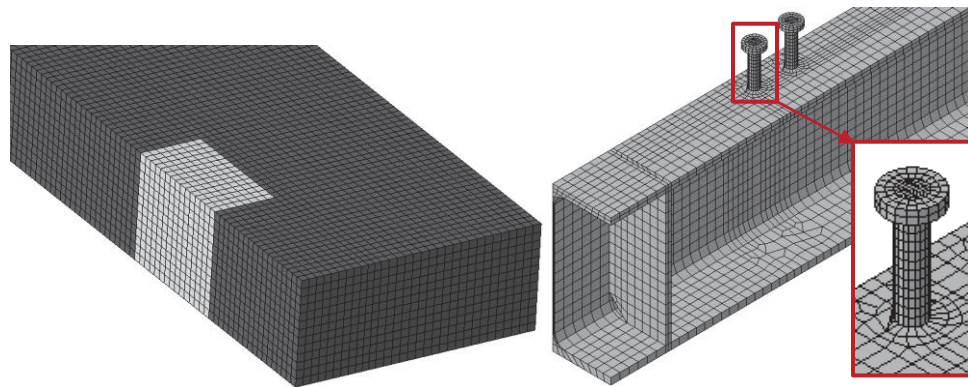
Figure 5-5: Mesh density for the concrete slab, grout pocket, steel beam, and shear studs.

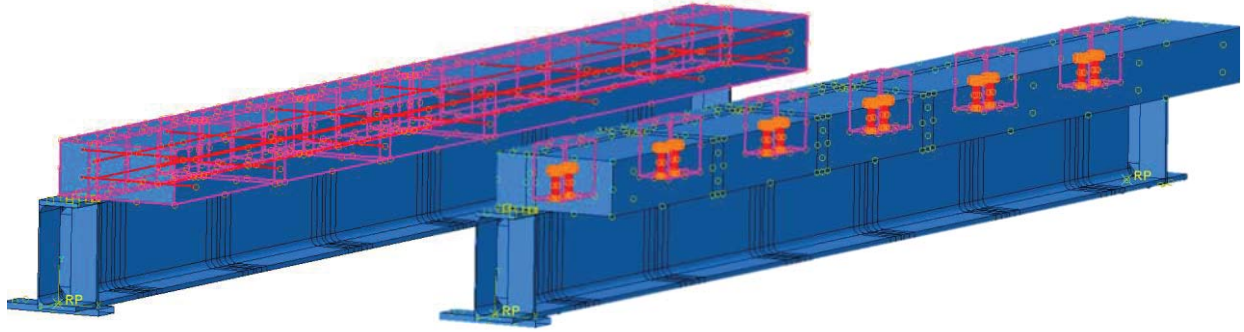
Figure 5-6: Reinforcement and stud embedment constraints.

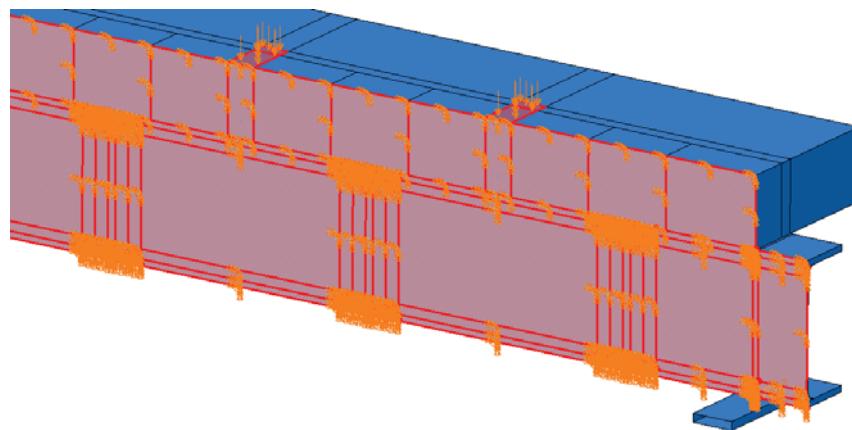
Figure 5-8: Symmetry boundary condition and the two loading points applied to the FEA model.

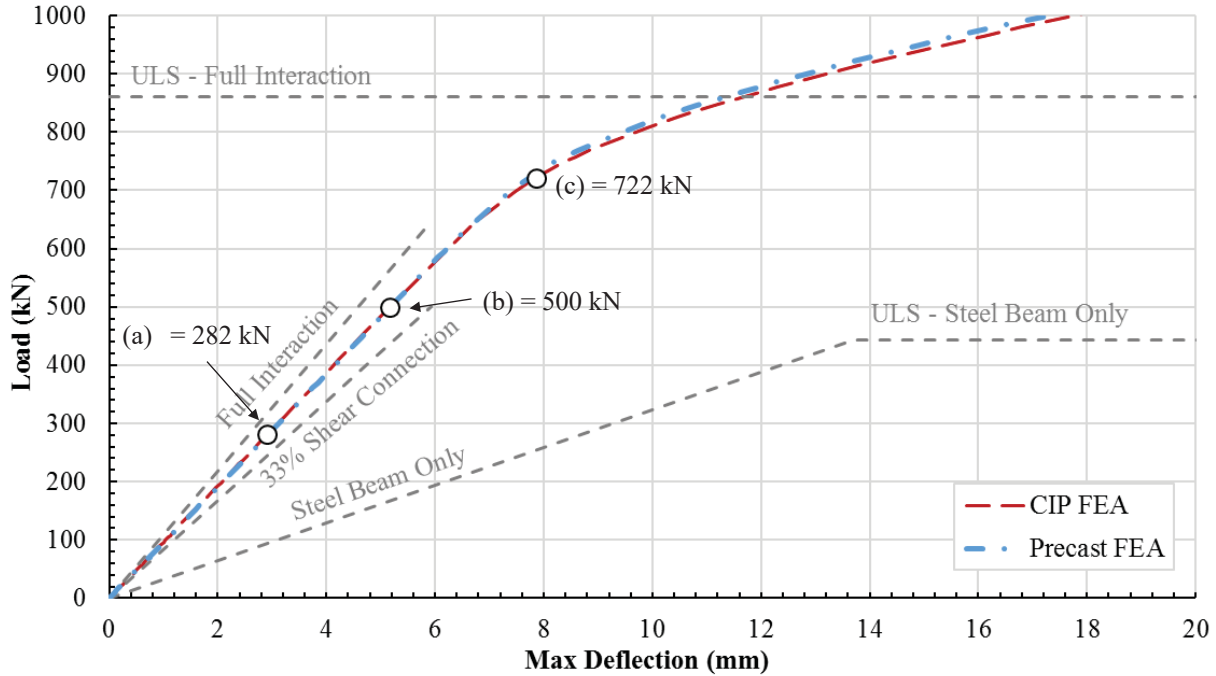
Figure 5-9: Non-linear load-displacement response of the CIP and Precast FEA model. (a) Stud Pair 1 demonstrating localized yielding in CIP, (b) web near west support yields in CIP, and (c) bottom flange at max moment yields in CIP.

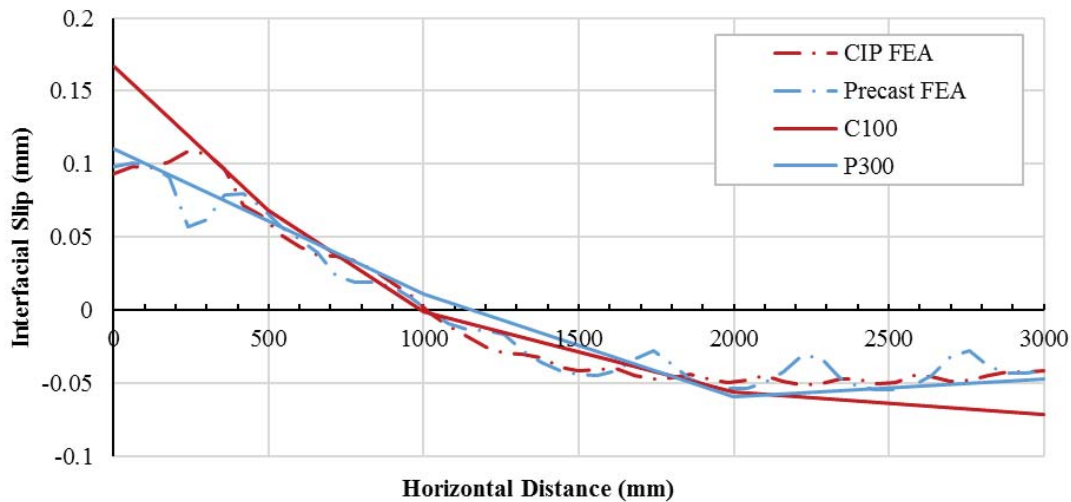
Figure 5-15: Comparison of experimental and FEA slip profile results at an applied load of 200 kN.

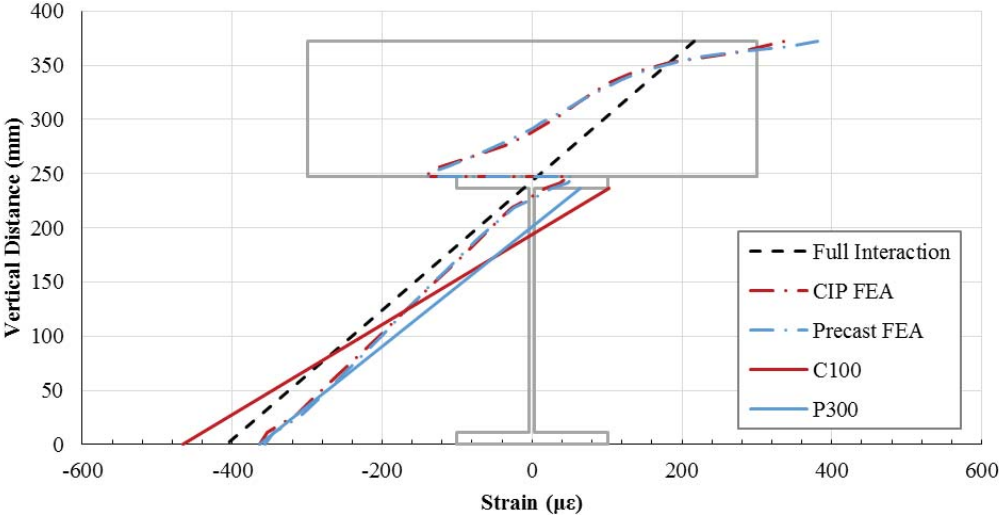
Figure 5-16: Comparison of experimental and FEA strain results at Profile A for an applied load of 200 kN.

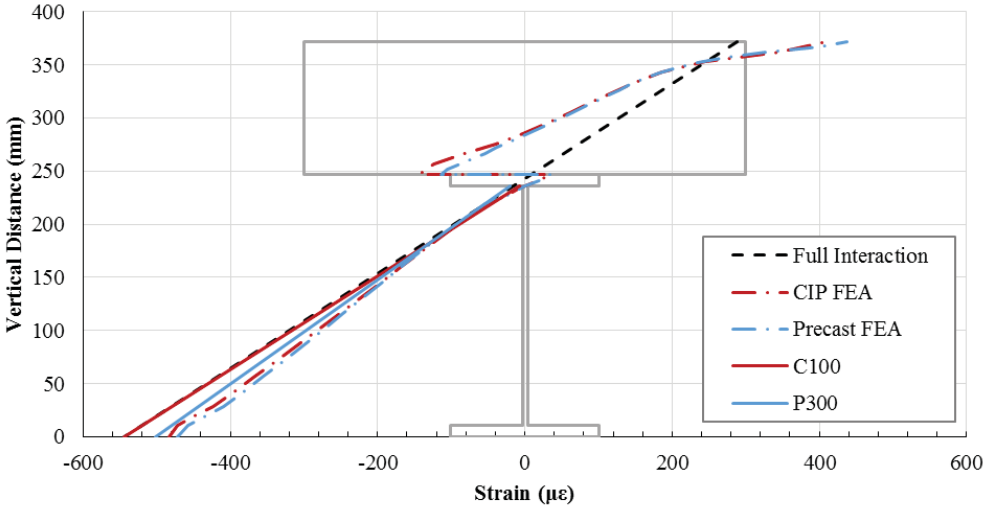
Figure 5-17: Comparison of experimental and FEA strain results at Profile B for an applied load of 200 kN.

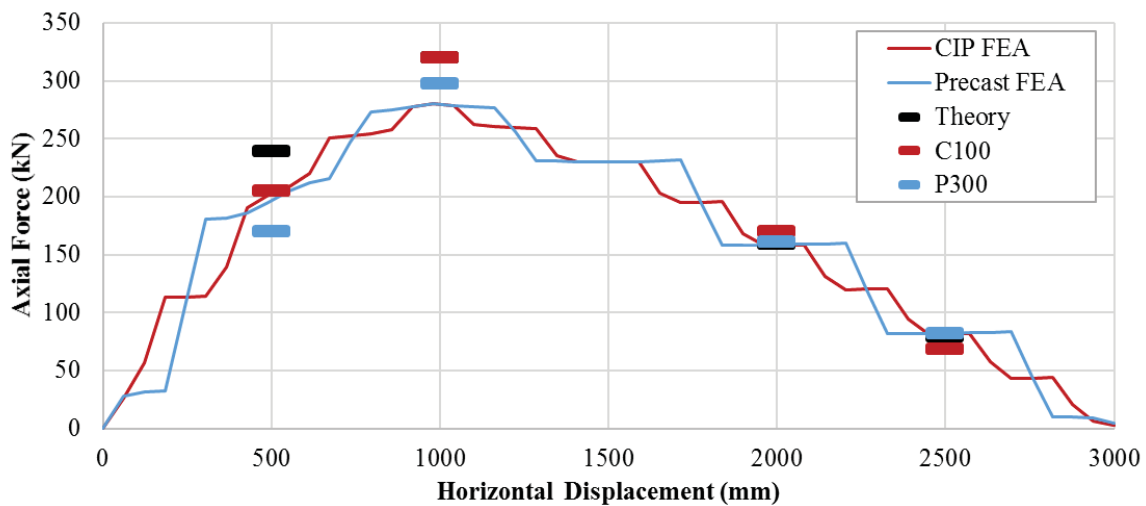
Figure 5-18: Comparison of experimental and FEA axial slab force results at an applied load of 200 kN.

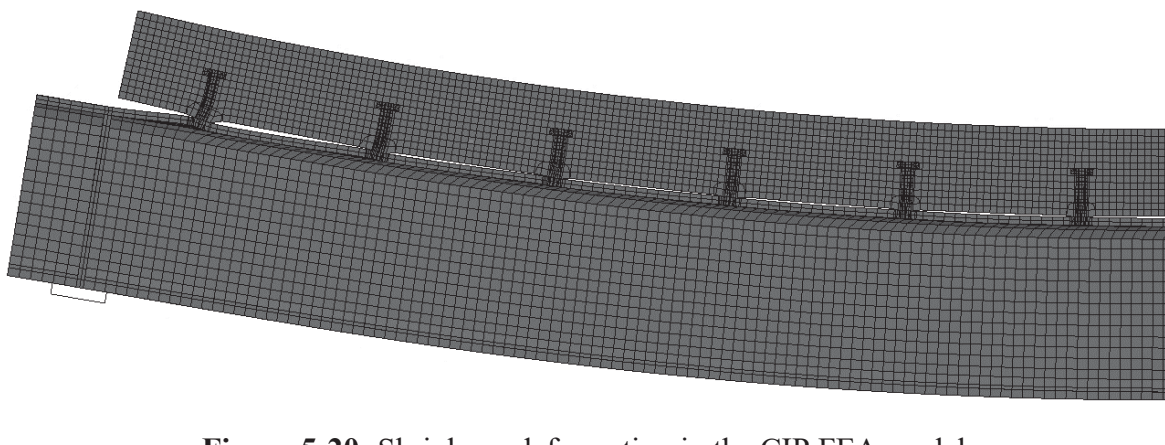
Figure 5-20: Shrinkage deformation in the CIP FEA model.

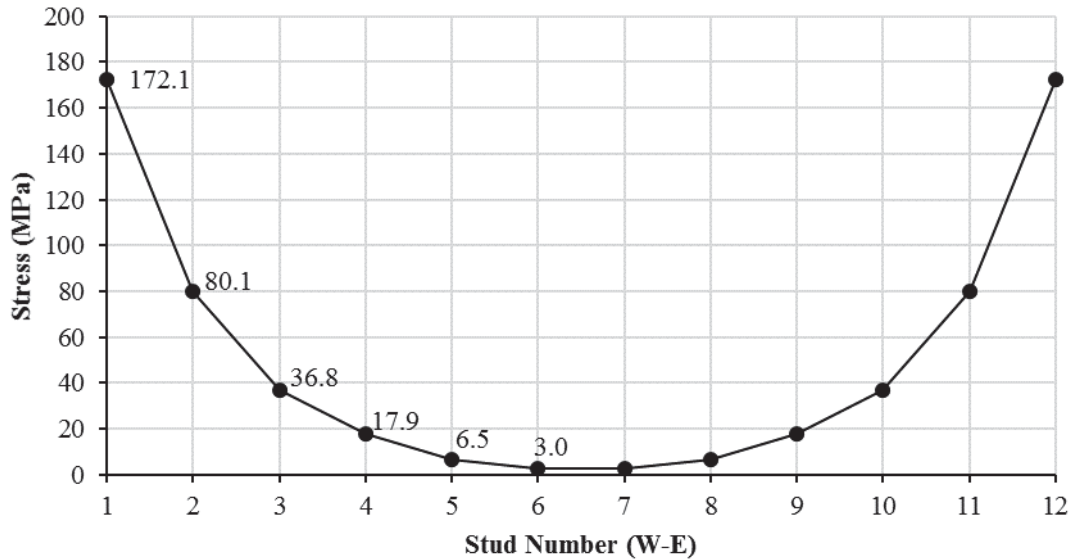
Figure 5-21: Longitudinal shear stresses acting on the studs (positive is towards the centerline of the beam).

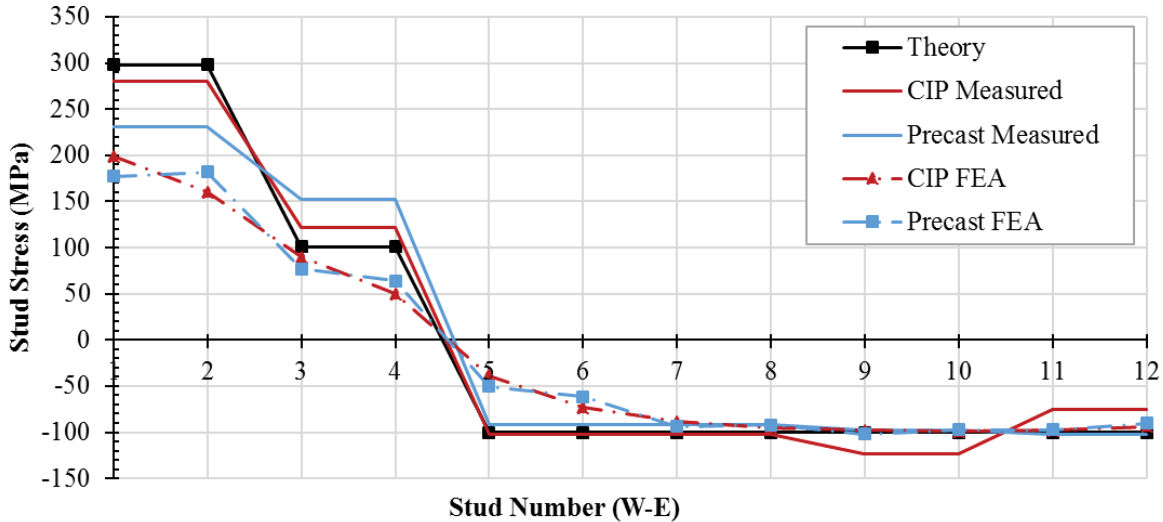
Figure 6-1: Theoretical, measured, and FEA stud stresses at P = 200 kN.

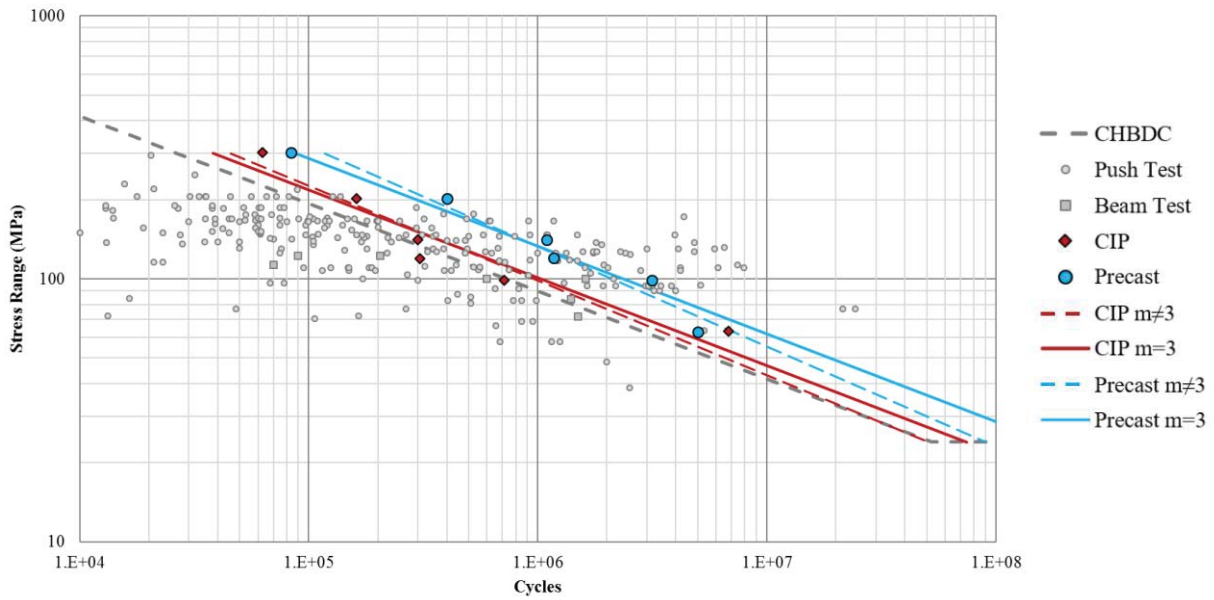
Figure 6-2: S-N plot for first stud failure and theoretical equivalent stress range.

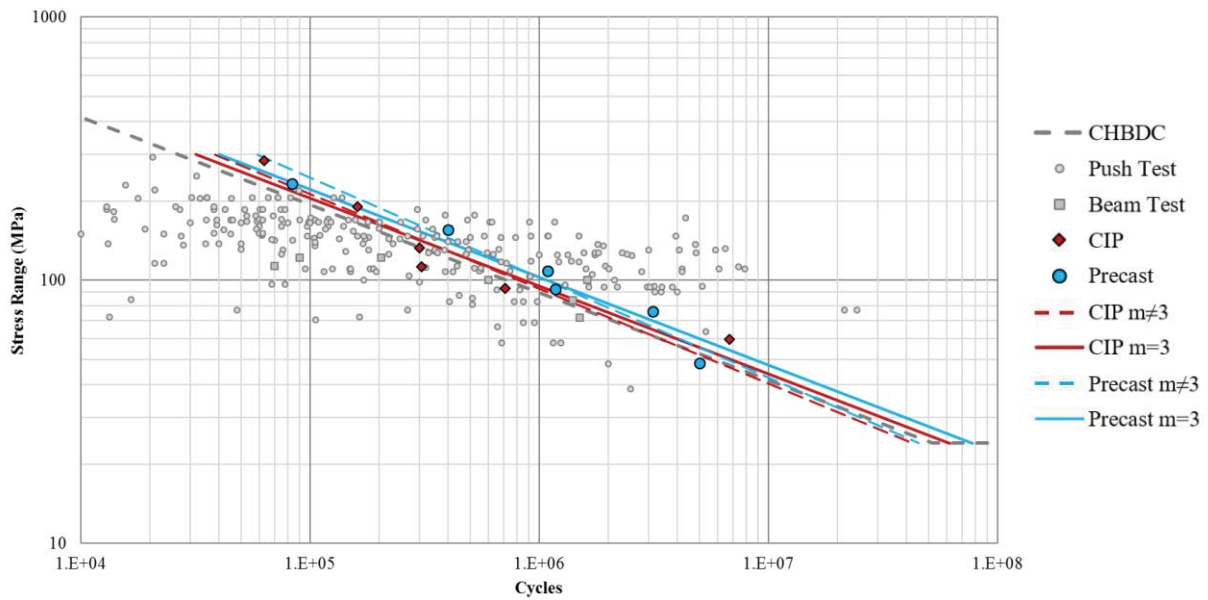
Figure 6-3: S-N plot for first stud failure and measured equivalent stress range.
