The Fatigue Resistance of Headed Shear Stud Connectors in Steel-Precast Composite Girders

Taylor Kenneth Porter

Master of Applied Science

Waterloo, Ontario, Canada, 2017

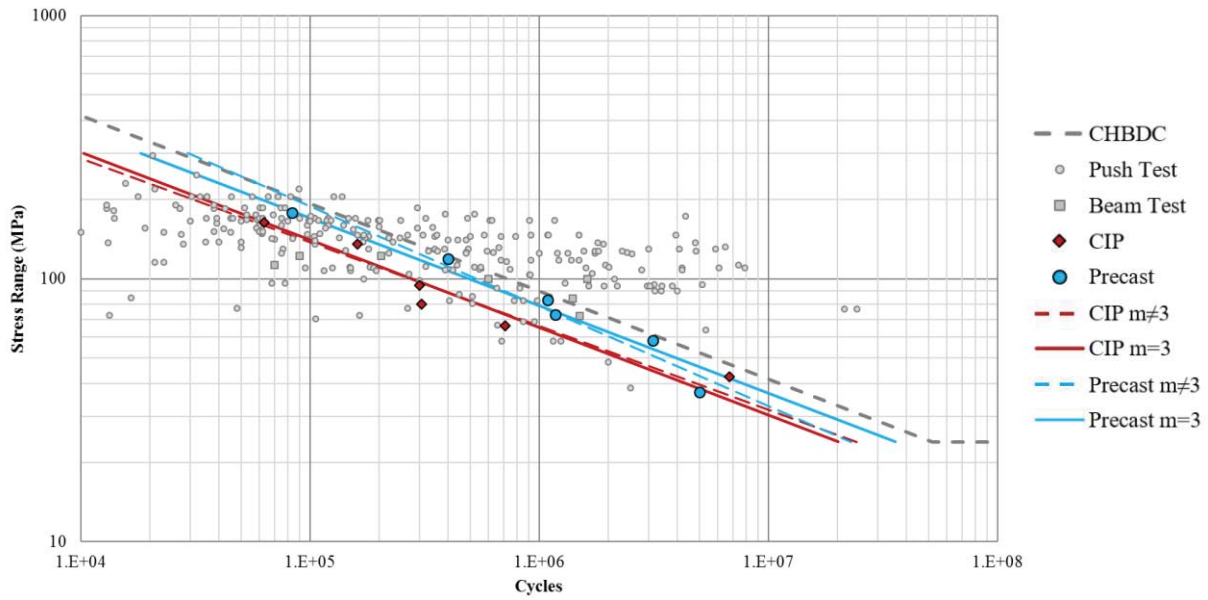
Figure 6-4: S-N plot for first stud failure and FEA equivalent stress range.

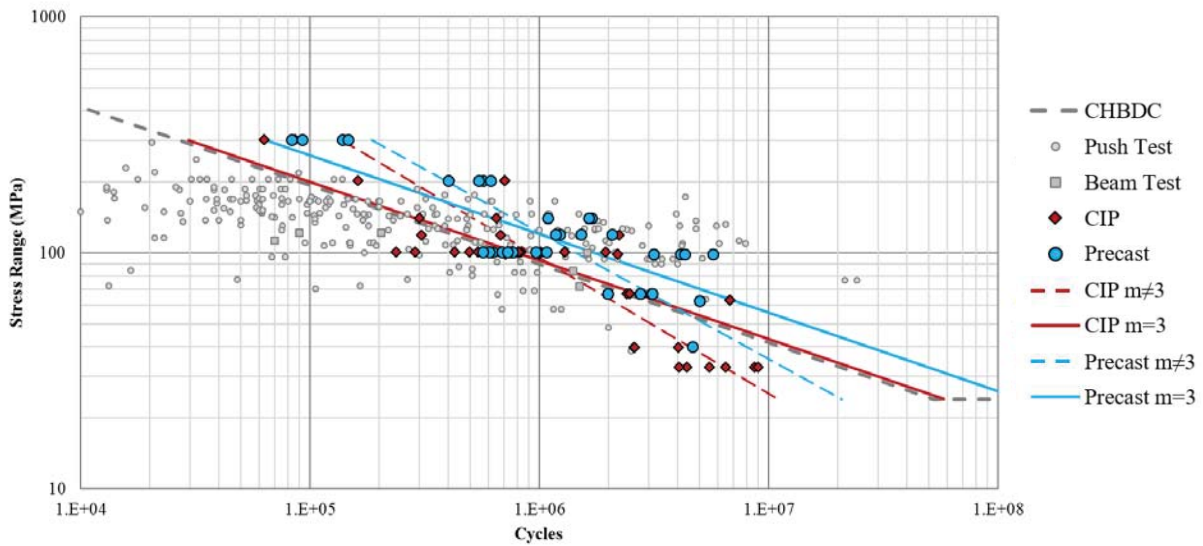
Figure 6-5: S-N plot for all stud failures and theoretical equivalent stress range.

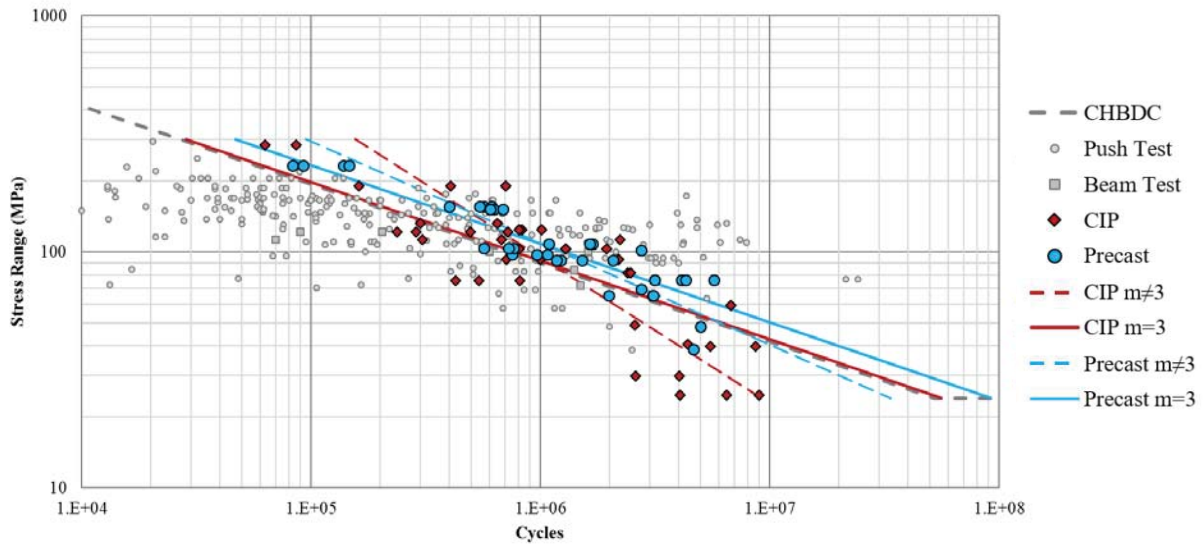
Figure 6-6: S-N plot for all stud failures and measured equivalent stress range.

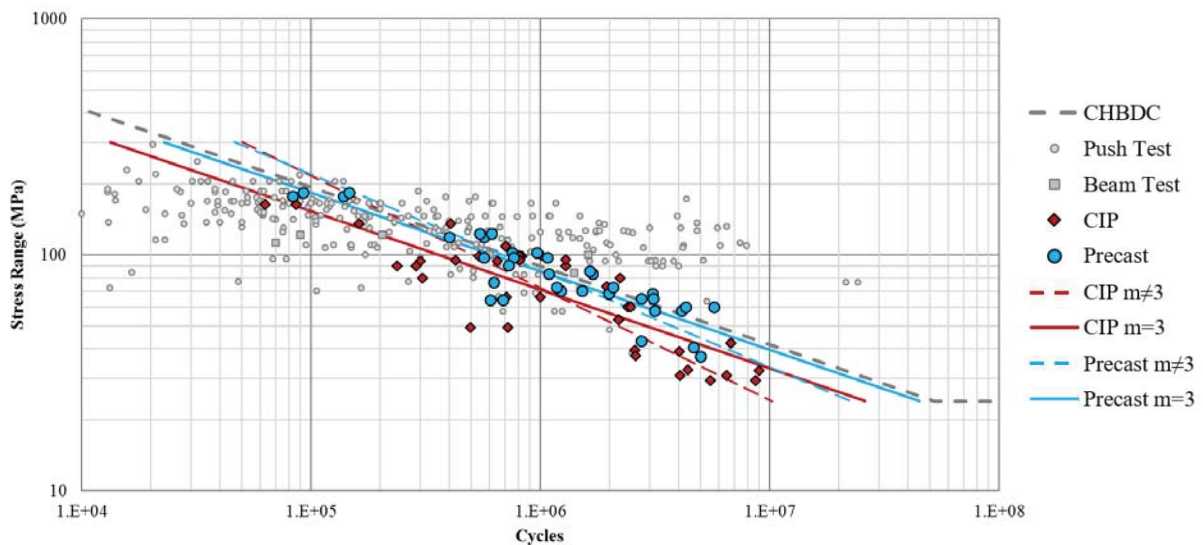
Figure 6-7: S-N plot for all stud failures and FEA equivalent stress range.
