Tests on GFRP Reinforced Concrete Knee-Joints Subjected to Negative Moments

A thesis
presented to the University of Waterloo
in fulfillment of the
thesis requirement for the degree of
Master of Applied Science
in
Civil Engineering

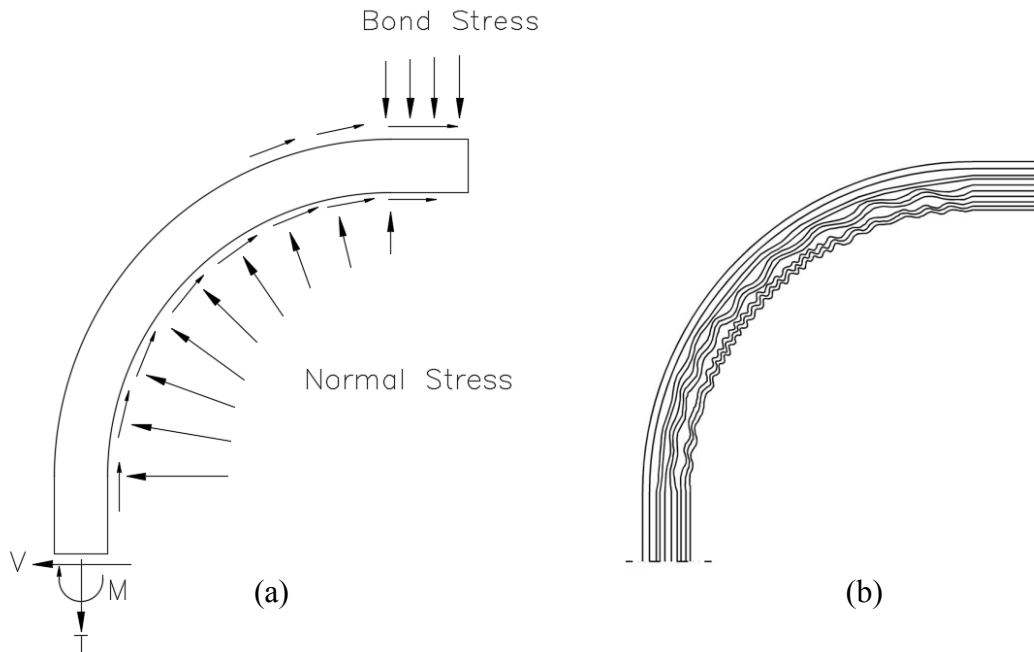
Figure 2.2: (a) Stresses and (b) Kinking of Fibres Occurring at the Bend (Ahmed et al. 2010)

It is no surprise that the strength of the bend is less than the straight portion. The high strength of FRP bars comes from the load carrying ability of the bars parallel to the fibres. At the bend, these fibres are experiencing loads transverse to their orientation. The process of bending also introduces kinking of the innermost fibres which also reduces the strength of the bend, shown in Figure 2.2.

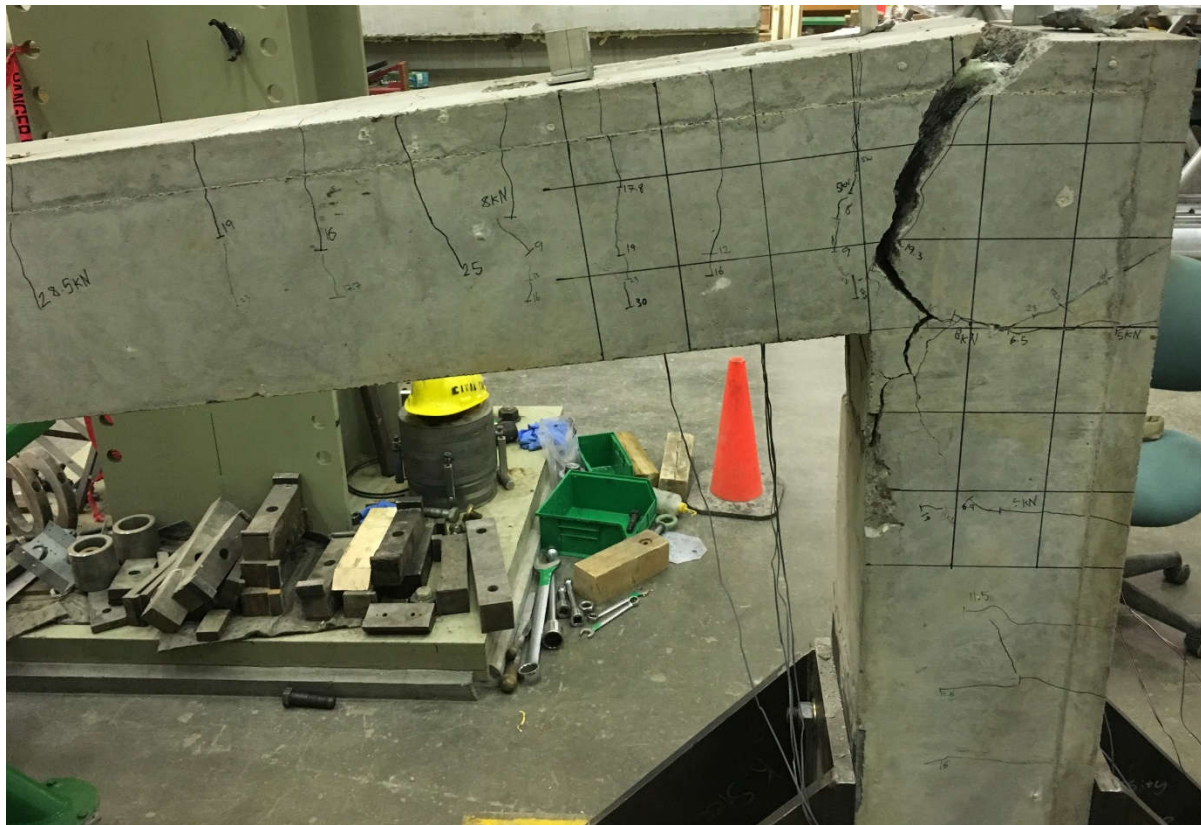
Figure 4.7: Crack Patterns on East Face, UA-2-6

UA-2-6 was reinforced with two No. 6 tension bars with no confinement stirrups in the joint having a reinforcement ratio to balanced reinforcement ratio $\rho/\rho_b = 2.64$. The geometry of the corner was type A. Failure of this specimen occurred by rupture of both GFRP bars at the onset of the bend near the beam side. Failure occurred within the joint and can be seen in Figure 4.7.

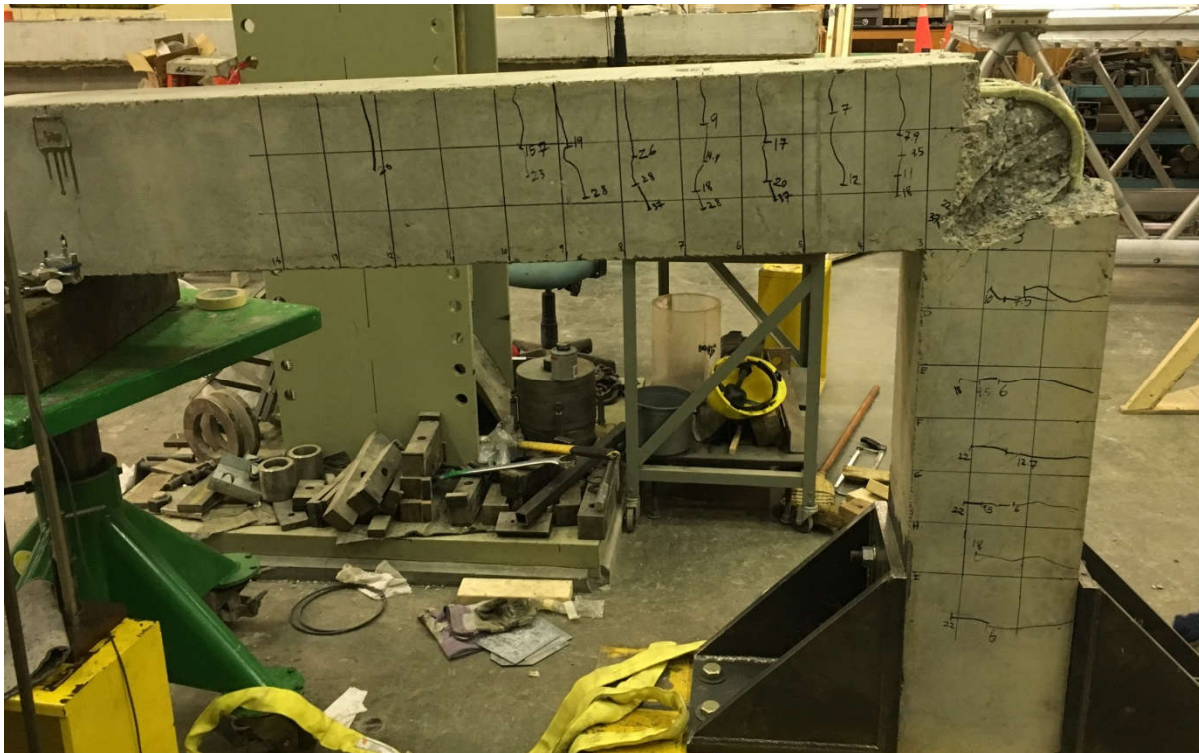
Figure 4.11: Cracking Patterns on East Face, UA-3-6

UA-3-6 was reinforced with three No. 6 tension bars with $\rho/\rho_b = 5.30$. No confinement stirrups in the joint and the corner geometry was type A. Similar to UA-4-6, failure of this specimen occurred by tensile failure of the concrete diagonal strut. The failure was sudden and occurred within the joint as shown in Figure 4.11. This failure was characterized by the lateral ejection of cover concrete.

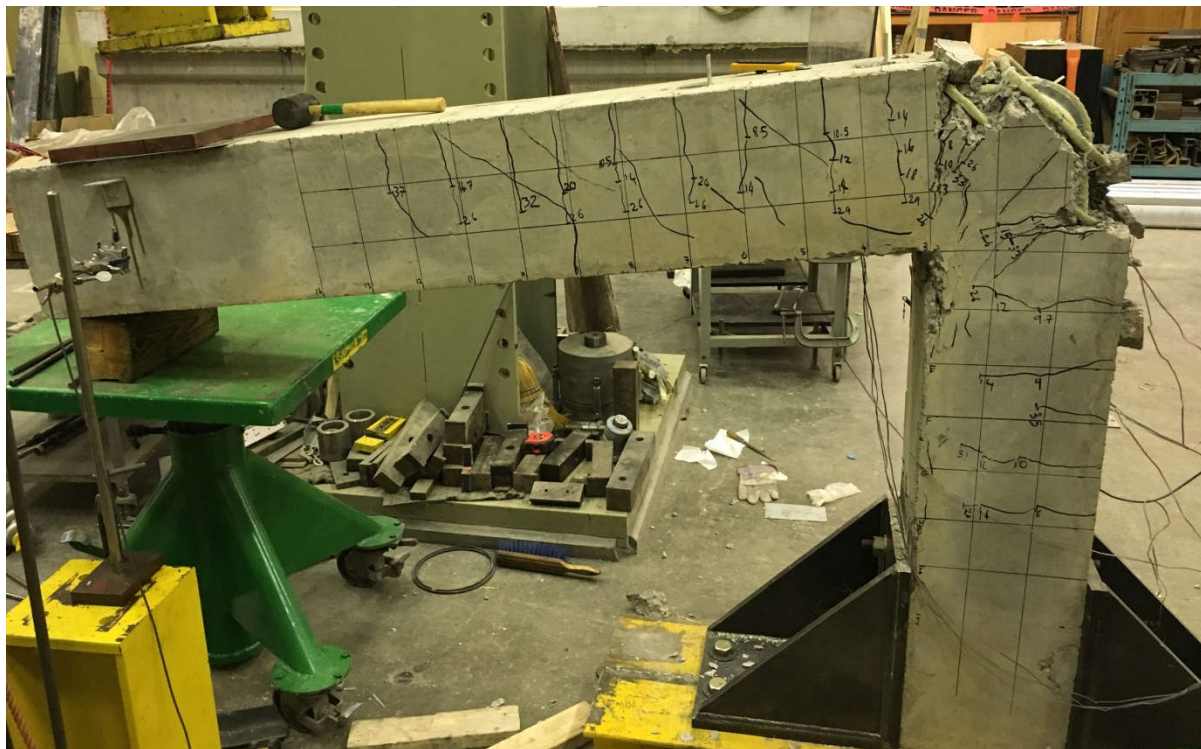
Figure 4.19: Crack Patterns on East Face, CA-3-6

CA-3-6 was reinforced with three No. 6 tension bars with $\rho/\rho_b = 4.39$. Confinement stirrups were installed in the joint and the corner geometry was type A. The failure of this specimen initiated through crushing of concrete in the interior corner; however, final failure occurred suddenly in the joint and was characterized by ejection of concrete. The specimen at failure can be seen in Figure 4.19.

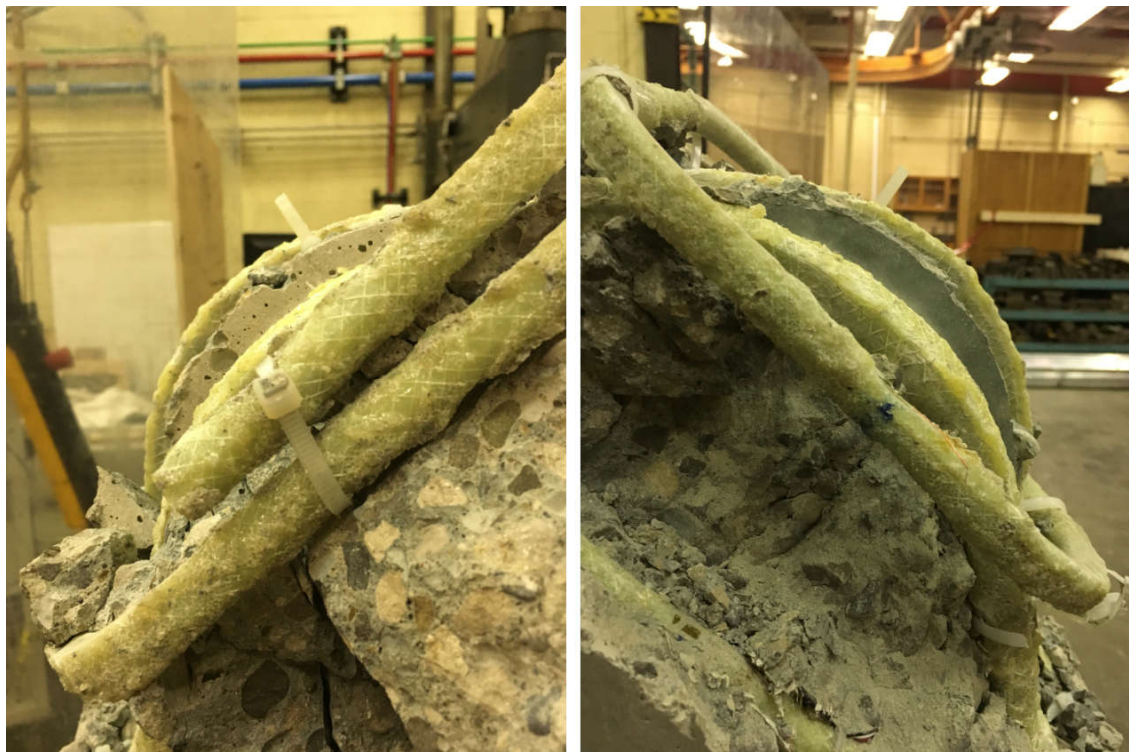
Figure 4.21: Slip of Longitudinal Bars towards Adjoining Members, CA-3-6

Rupture of the middle tension bar occurred at failure. Typical kinking/bending of fibres within the bends was seen in all tension bars. Lateral displacement of the bars at the bend occurred, which is described in section 5.3. Unruptured bars appear to be pulled inwards towards the adjoining members, shown in Figure 4.21.

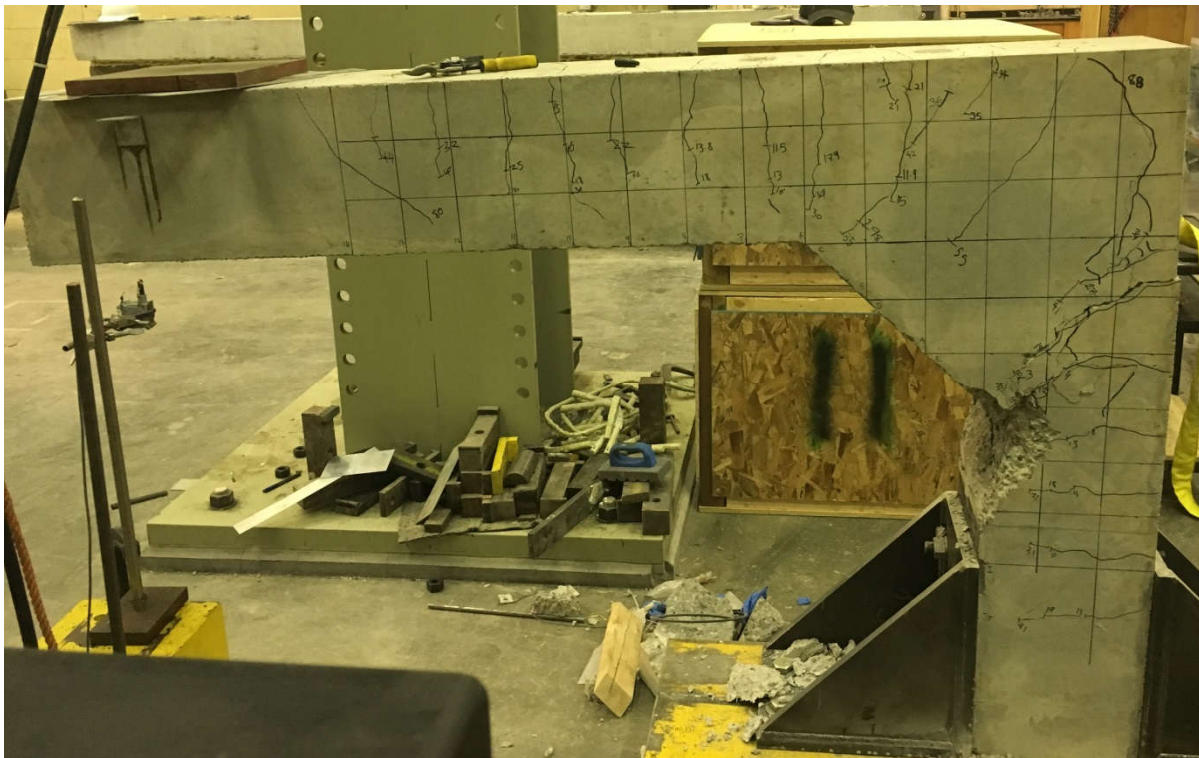
Figure 4.24: Crack Patterns on East Face, CB-3-6

CB-3-6 was reinforced with three No. 6 tension bars with $\rho/\rho_b = 4.39$. Confinement stirrups in the joint were used and the corner geometry was type B. Failure of specimen 8 occurred by crushing of concrete on the compression face of the column/chamfer interface, and can be seen in Figure 4.24.

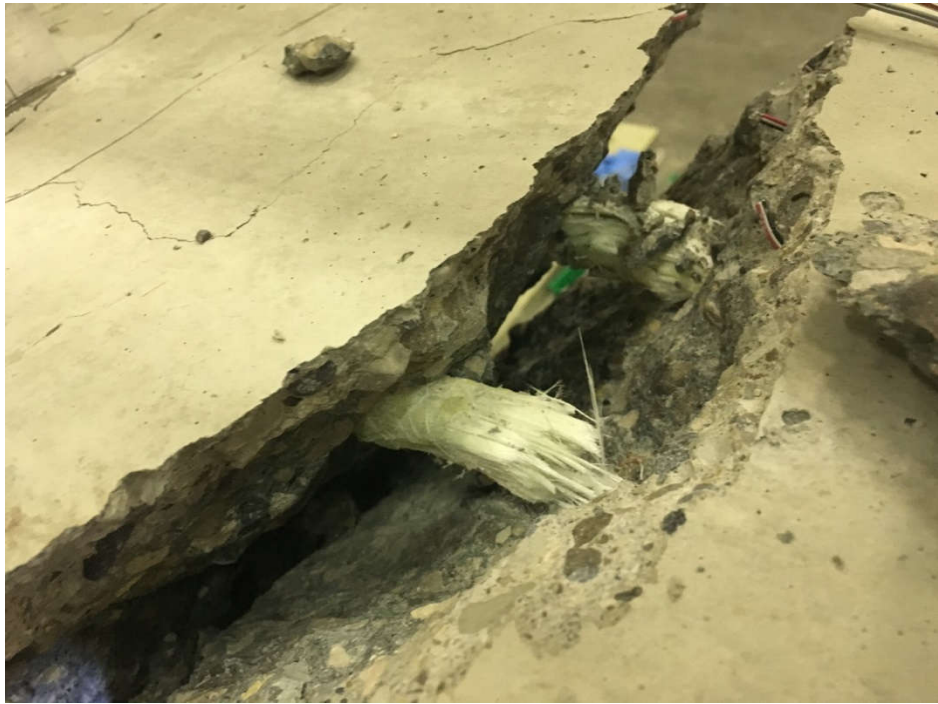
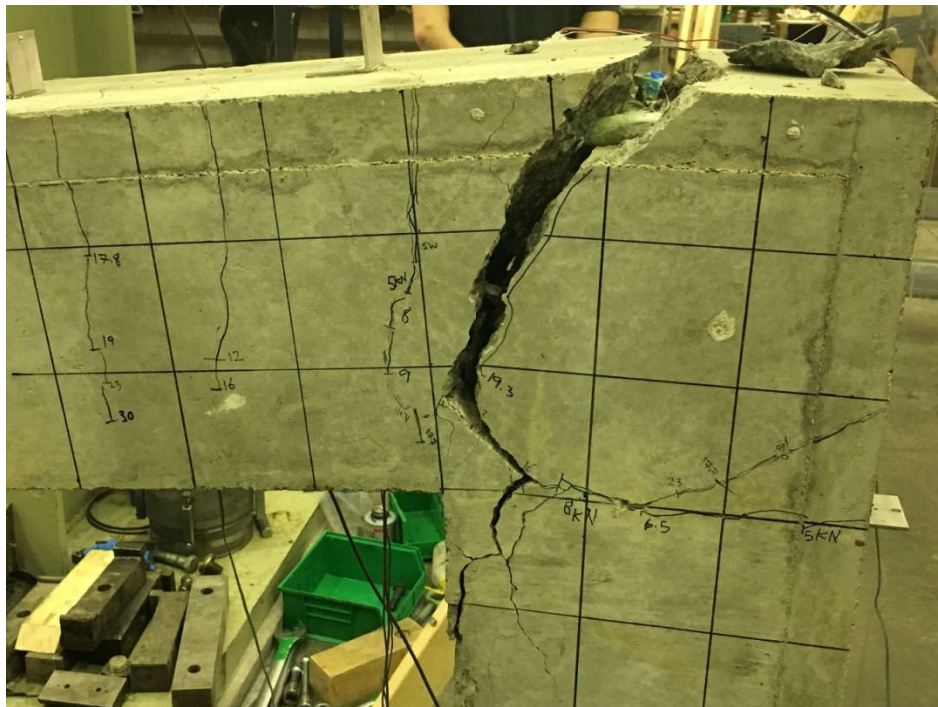
Figure A.6: Closeup Shots of the Failed Specimen, UA-2-6

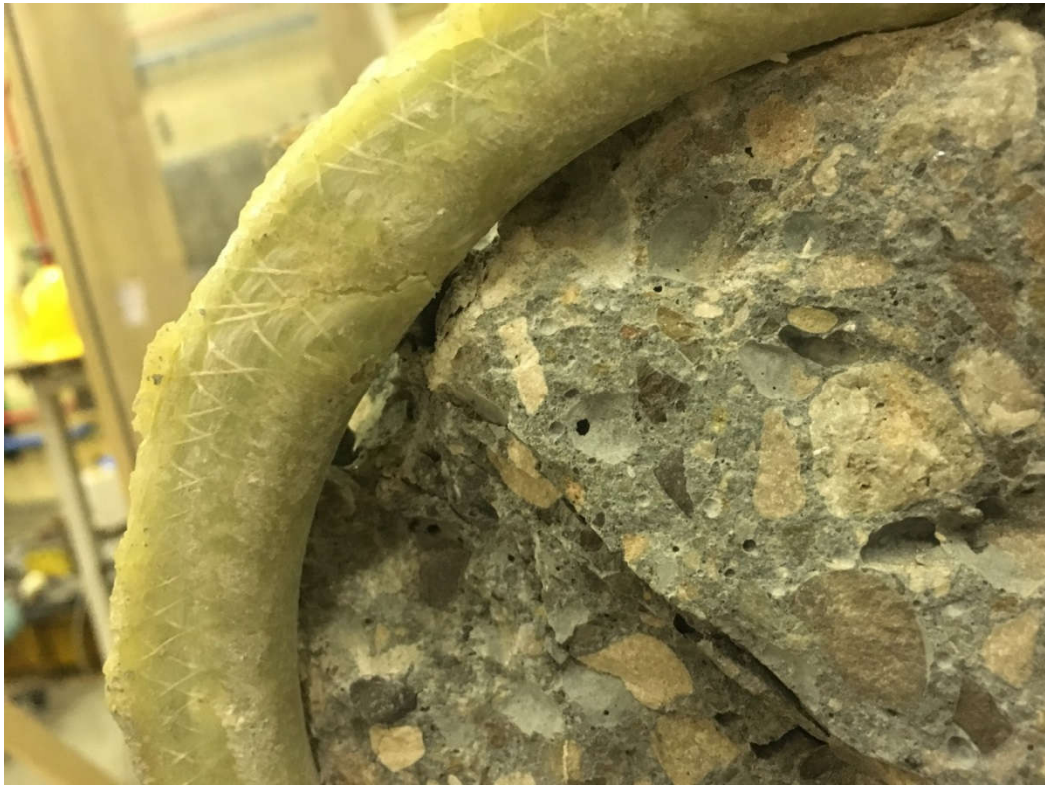
Figure A.14: Crack in Bent Portion with Waving Also Visible, UA-4-6

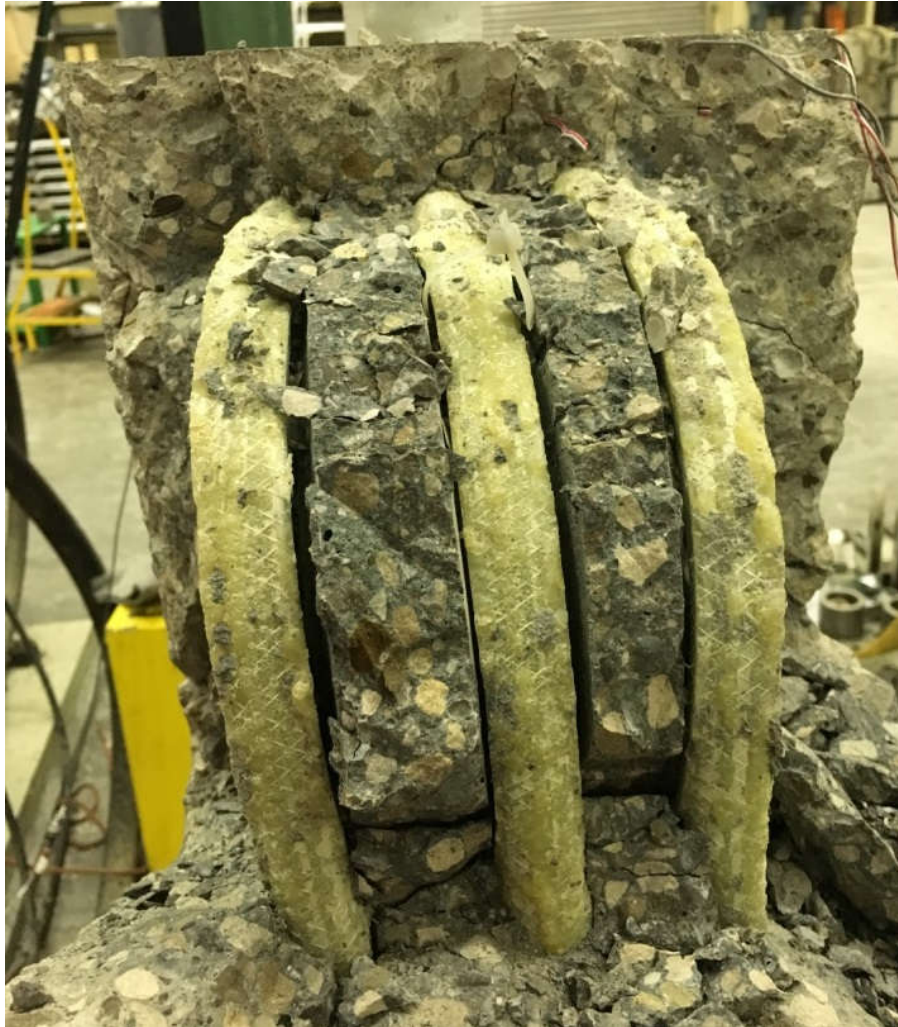
Figure A.21: North Side of Failed Joint, UA-3-6

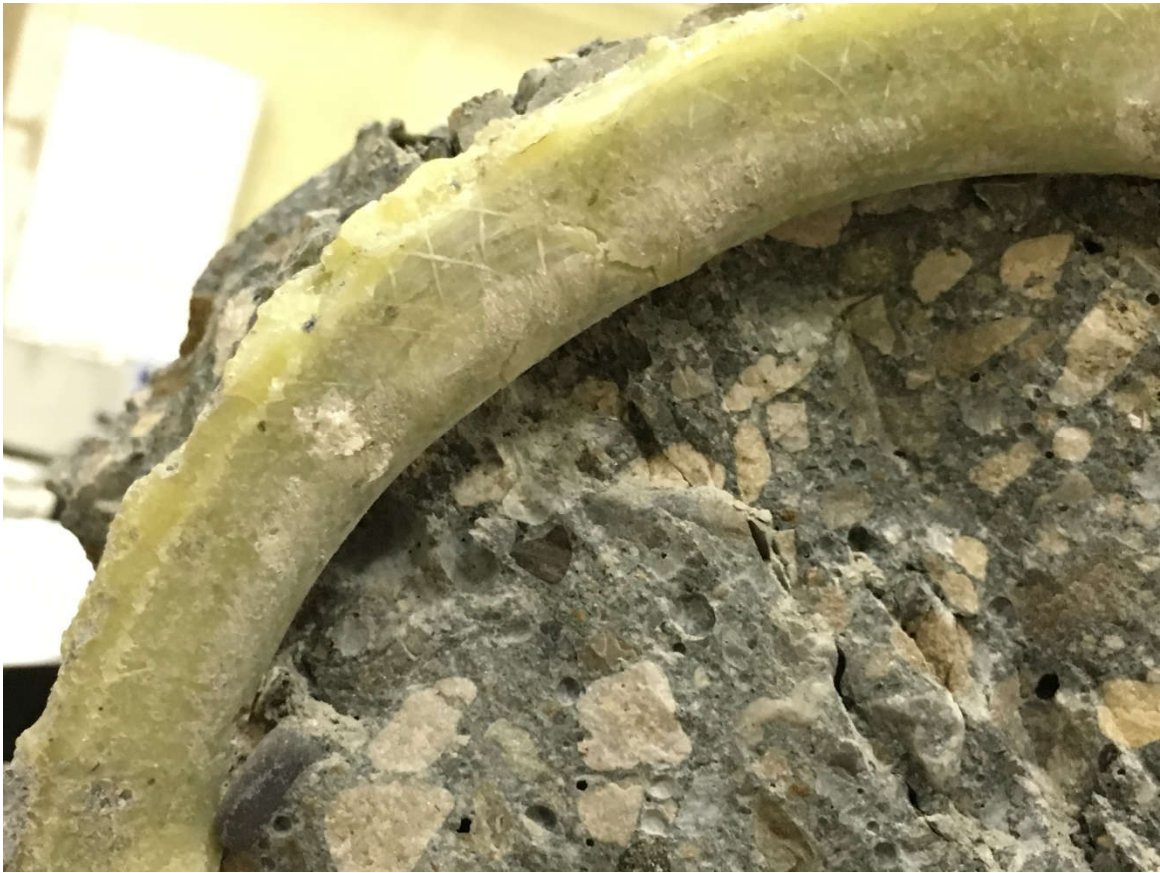
Figure A.22: Crack in Bend, UA-3-6

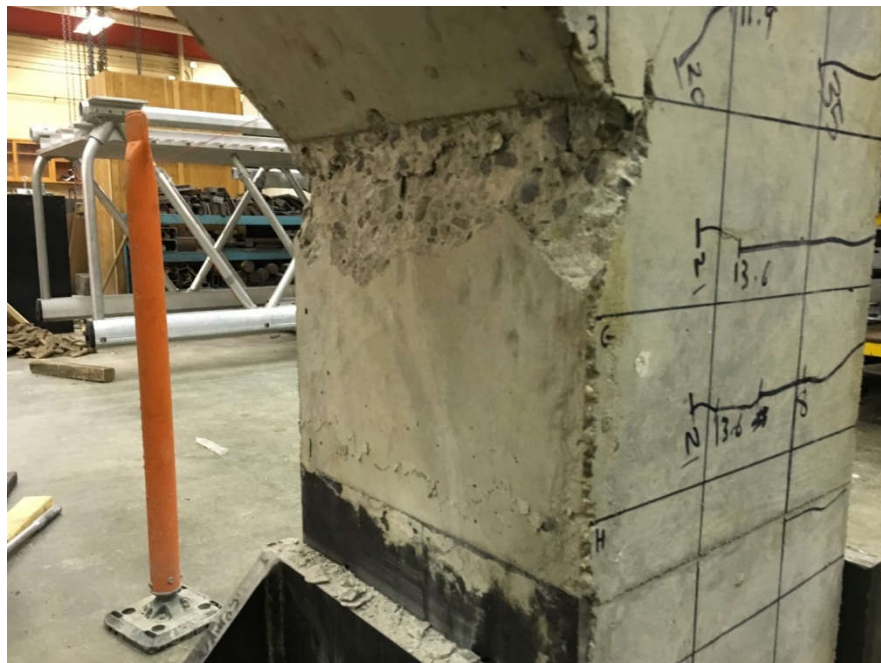
Figure A.30: Extent of Crushing, UB-3-6

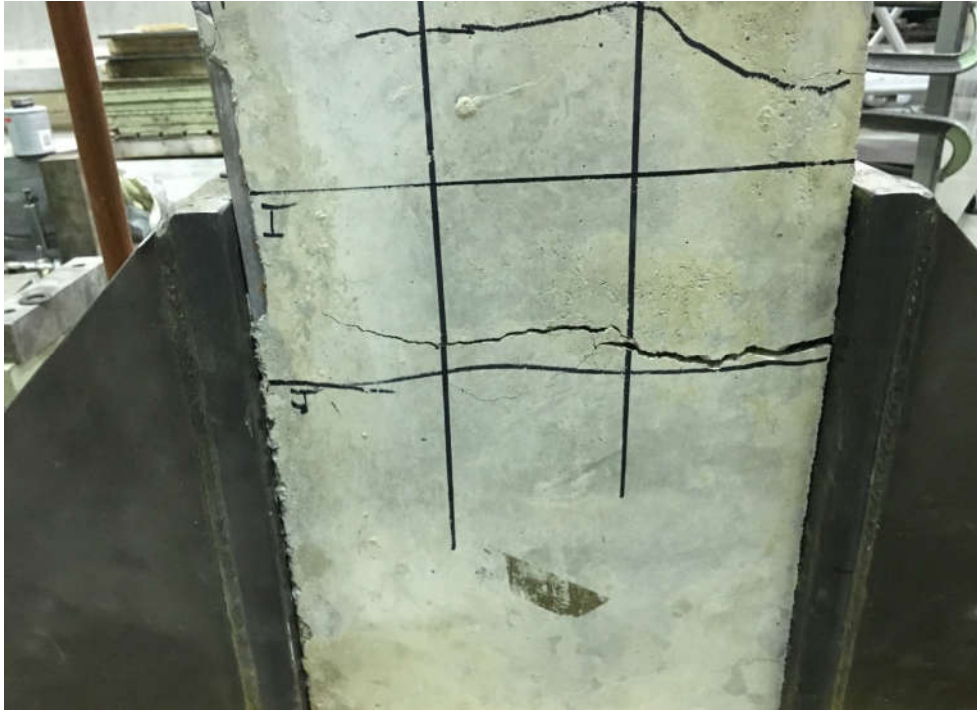
Figure A.36: Wide Crack in Column Base Causing Debonding. CA-2-6

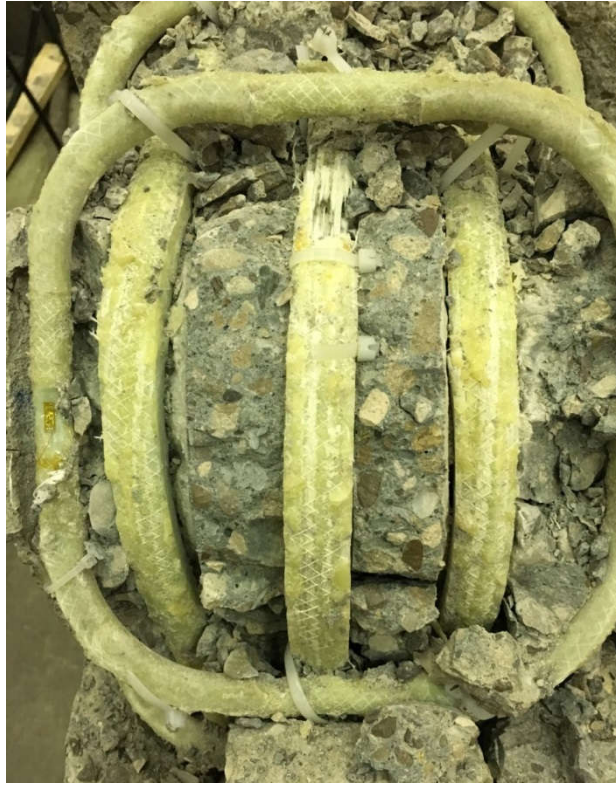
Figure A.44: Bar Rupture and Bar Shifting, CA-3-6

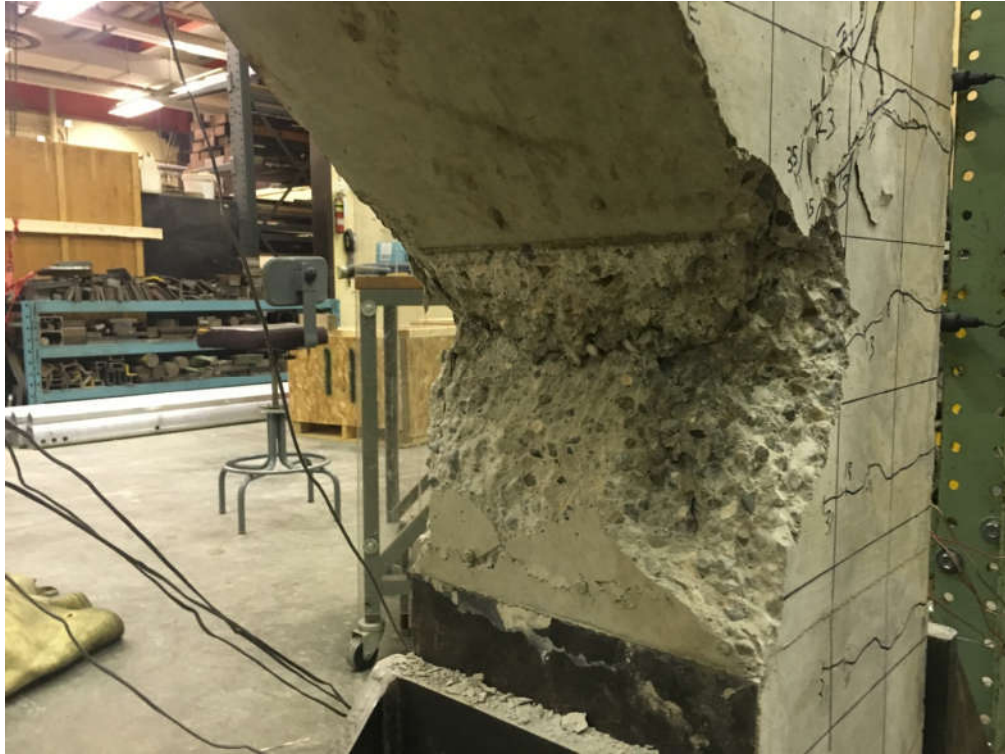
Figure A.56: Extent of Crushing on Interior Corner, CB-3-6
