**Evaluation of Early In-Place Concrete Performance Based on Test Results of
Cores and Cylinders**

A thesis

presented to the University of Waterloo

Master of Applied Science

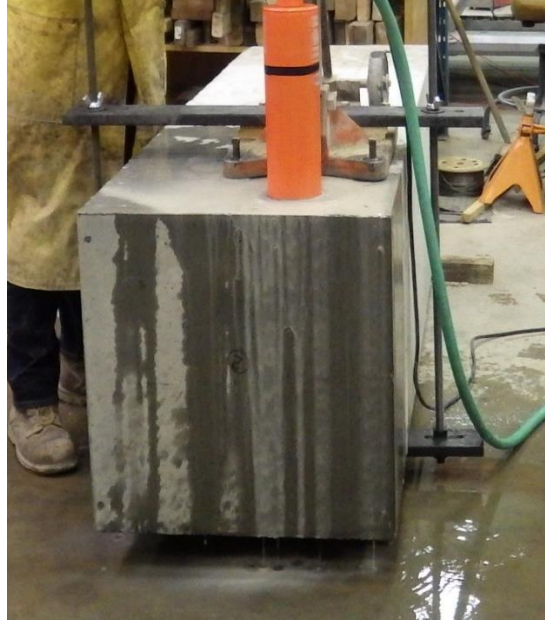
Figure 3.3 Coring drill clamping assembly for UW lab beams

Coring and testing was completed on days 3, 7, and 28 for both sets of beams. Due to the large number of cores required on any given day, a clamping assembly was developed using steel bars and rods to ensure the drill bases were appropriately fastened to the beams for coring, as shown in Figure 3.3. All coring was completed using two water-cooled drills with two diamond tipped coring barrels.

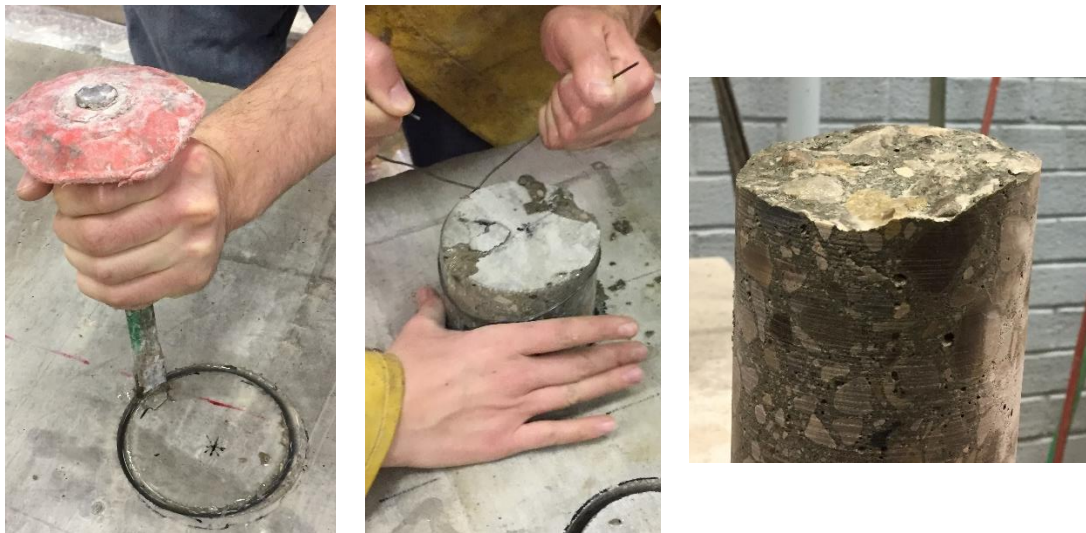
Figure 3.4 Core Removal Process

The core samples were still attached at their bottom after coring and a chisel was used to gently break the core out of the core hole and a steel wire was used to extract the core. This process is shown in Figure 3.4, as well as the bottom of the core after breaking.

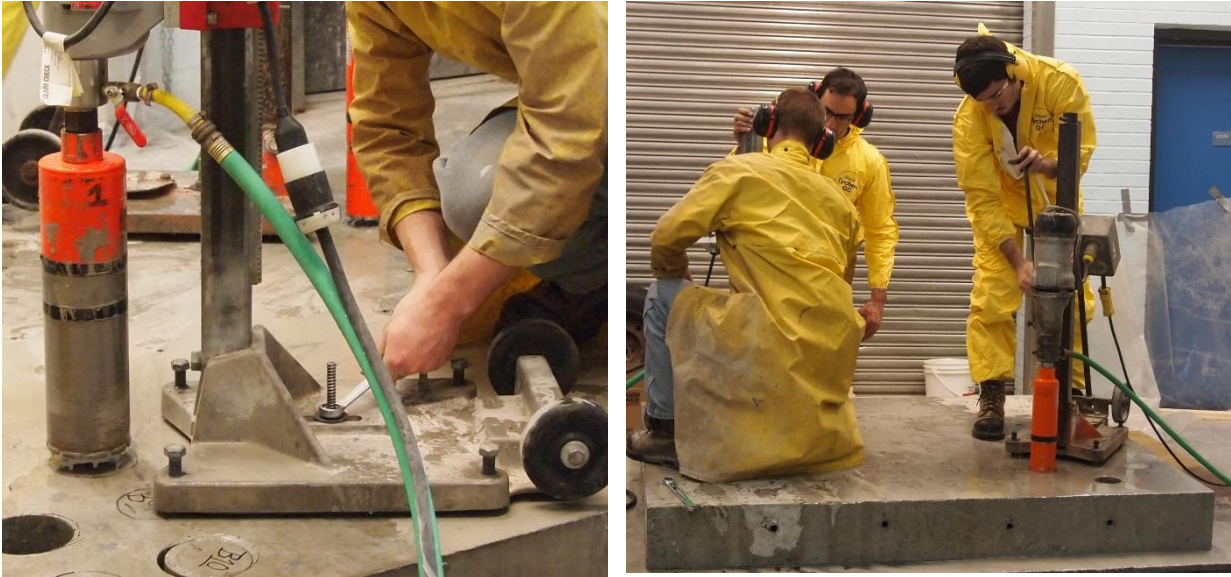
Figure 3.10 Anchored coring drill for coring of G1 girder webs

Coring and testing was carried out on days 3, 7, and 28. All coring was completed using two water-cooled drills which were attached with embedded anchors within the girder webs. The girder webs were placed flat on plywood boards and coring was conducted in a vertical orientation as shown in Figure 3.10. The girder webs were cored through the web thickness and the purpose of the plywood boards underneath was to prevent popout of the core on the opposing side. The two previously used 100 mm diameter coring barrels were inspected and confirmed to be in sufficiently good condition for further coring during this testing. Additionally, two new 75 mm diameter coring barrels were used. The coring was divided evenly between the four coring barrels over the three coring days and coring barrels were inspected each time to assess their condition. No coring issues were encountered on days 3 and 7, but on day 28 coring, 3 of the 40 cores were not able to be used due to contact with steel reinforcement during drilling.

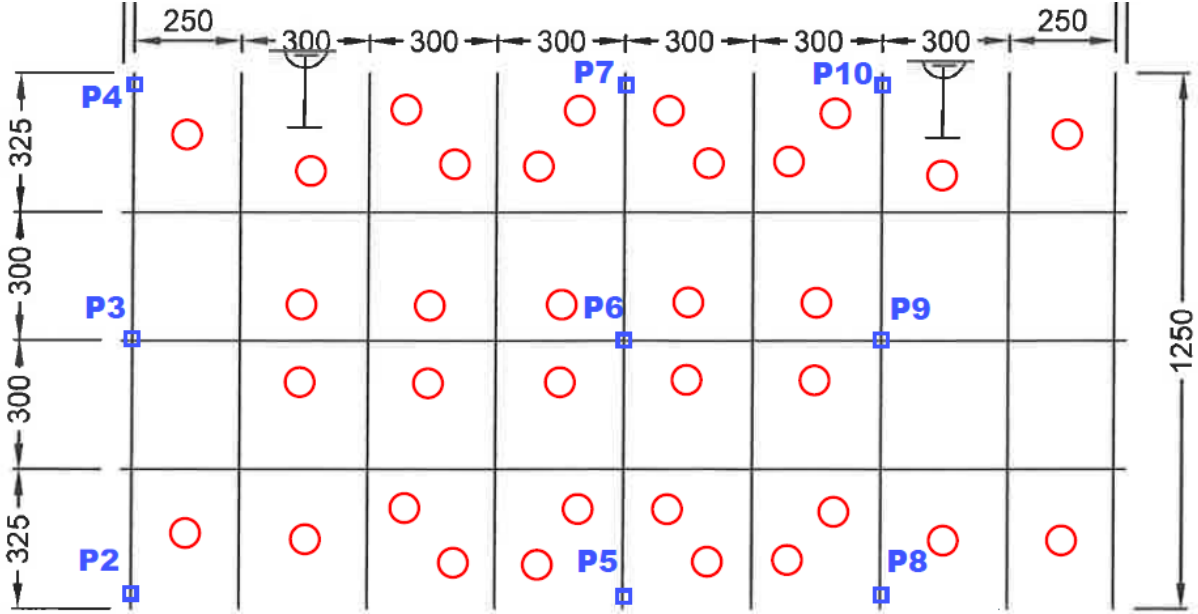
The formwork was made of steel forms welded together. The reinforcement cage was lowered into the formwork and plastic rebar chairs were used to achieve approximately 60 mm cover from the two large walls of the web. The temperature during concrete hydration was monitored using 9 probes in a grid pattern attached to the reinforcement cage (Figure 3.13).

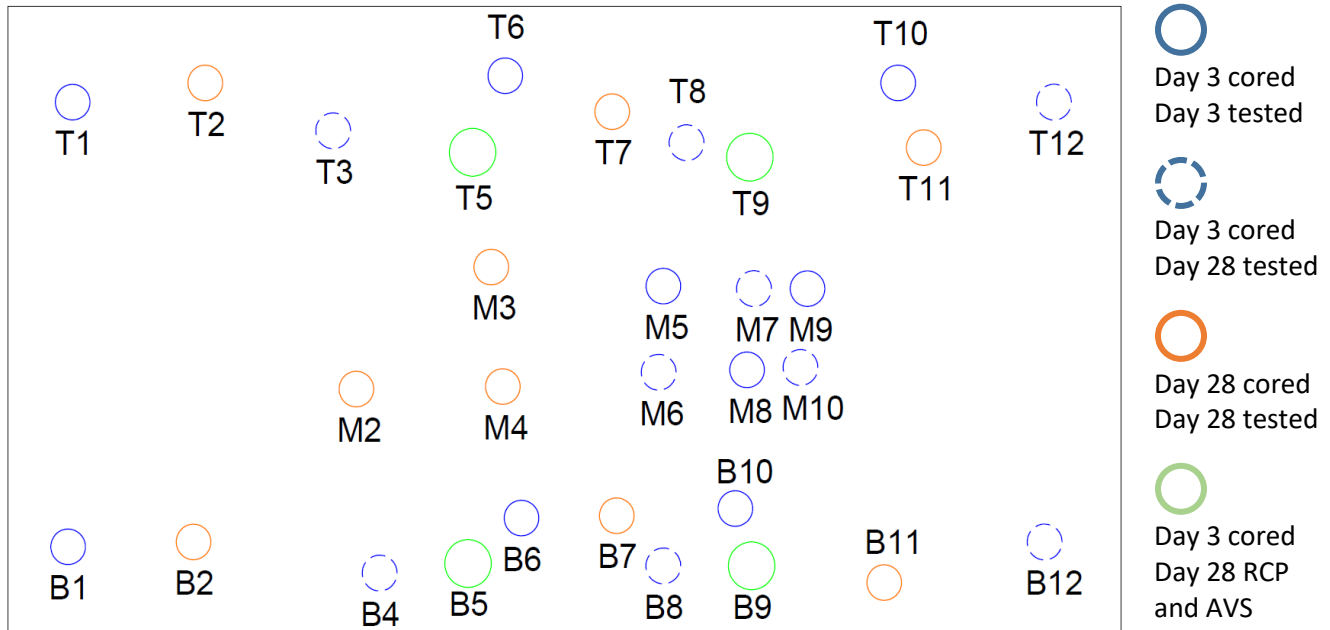
Figure 3.14 G2 Girder Web Core Locations Colour Coded by Day Cored and Tested

extracted. Examples of the labelling scheme used for G2 girder web cores and cylinders are shown in Table 3.5 and Table 3.6.

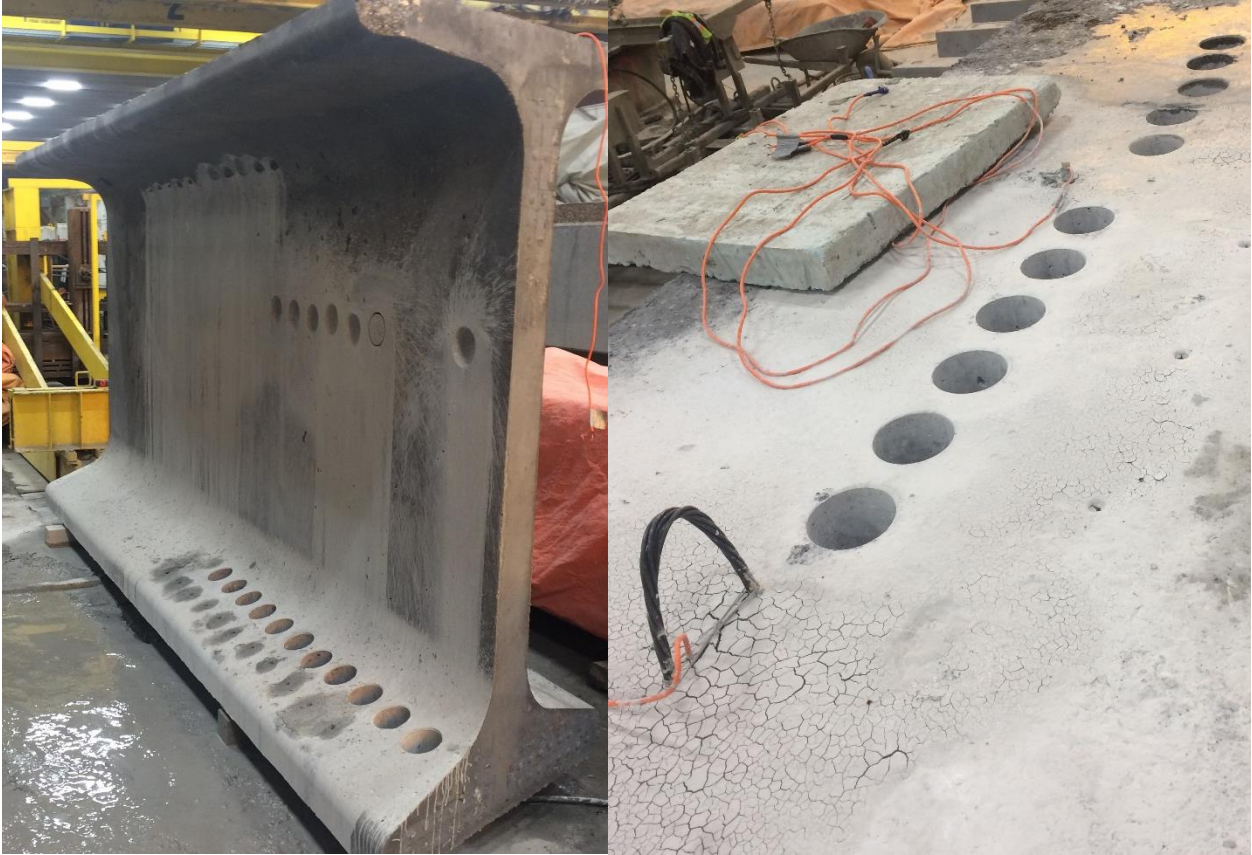
Figure 3.17 Day 3 Core locations in G3 Girder

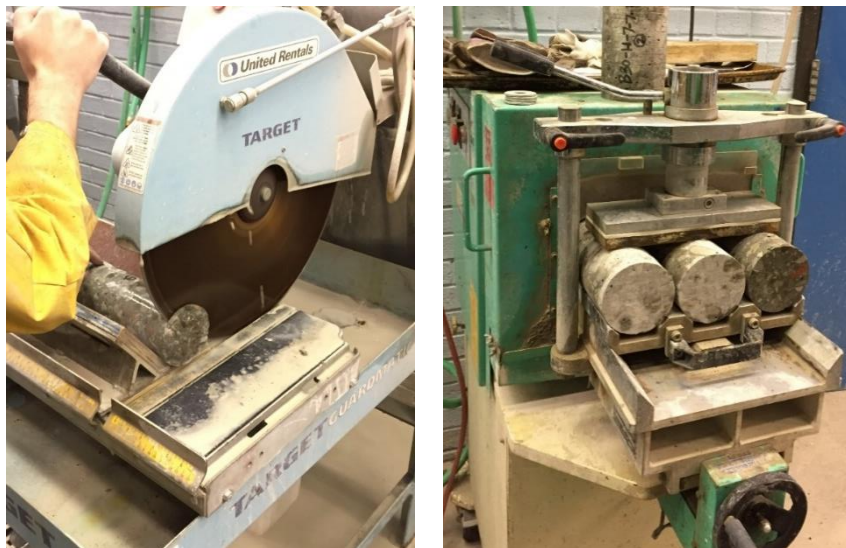
Figure 3.23 Cutting and end-grinding of cores

The lab structures were cored in the UW lab and, therefore, no transportation was involved in sample preparation. Immediately after coring, cores were cut using a concrete saw to their appropriate length based on desired L/D ratio and the ends were ground to ensure two flat, parallel surfaces for testing. The prefabricated structures were cored at their respective plants and then cores were transported back to the lab for testing. Cores from the G2 and VC structures were placed in plastic bags, transported to the UW lab where they were cut to their appropriate length and the ends were ground. Some of the cores from the G3 girder were cut and ground at the plant for testing at the plant. The remaining G3 cores were wrapped in bubble wrap and shipped to an MTO lab where they were cut to length and end-ground. Cylinders for all testing were end-ground to an L/D ratio of 2.0. The cored lengths and cut lengths of all tested cores are shown in Figure 3.22 and the cutting and grinding process of cores is shown in Figure 3.23.

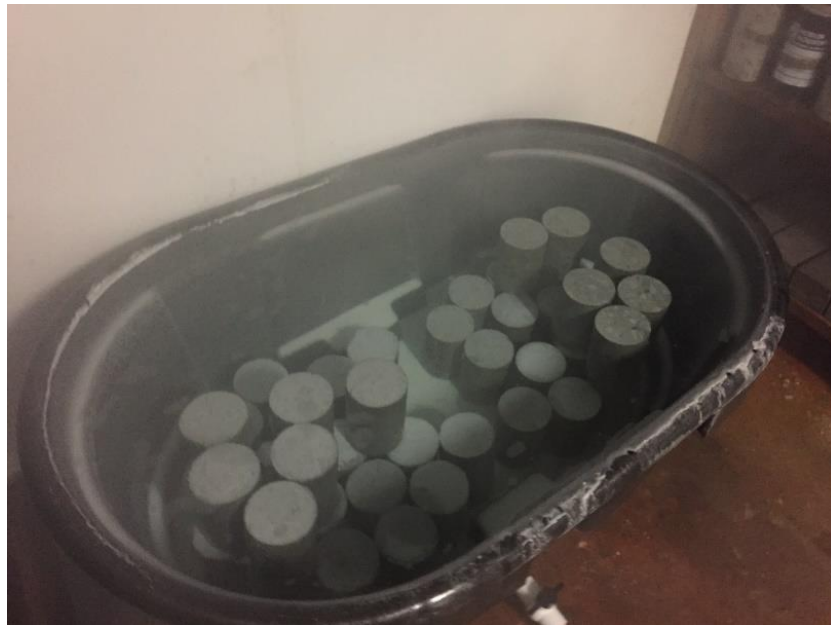
Figure 3.24 Sealed and Soaked Conditioning of Cores

The cores which were not being tested on the same day as coring, were cut and end-ground, and then placed in a tub containing calcium hydroxide solution (lime water) to maintain a fully saturated state of the cores (Figure 3.24). The cylinders were kept in their moulds until day 3 and then placed in the calcium hydroxide solution alongside the cores.

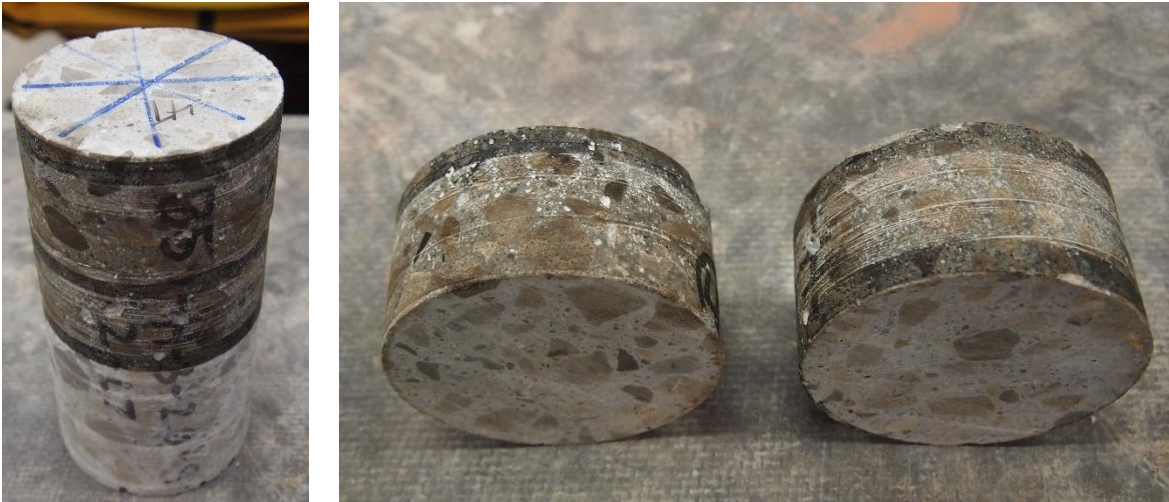
Figure 3.26 Rapid Chloride Permeability Test Samples from B2 Beams

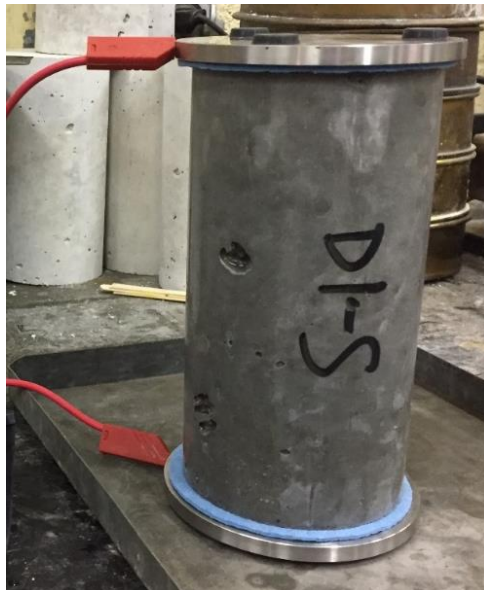
Figure 3.27 Bulk Resistivity Measurement

An alternative to the RCP testing procedure is an electrical resistivity measurement of the concrete. The bulk resistivity of the concrete can be measured using a uniaxial method where the concrete sample is placed between two parallel metal plates (electrodes) with moist sponge contacts at the interfaces to ensure an electrical connection. An AC current is applied between the electrodes and the potential difference is measured (Layssi et al. 2015). The resistivity, ρ , is calculated using a relationship between the resistance, R , and a geometry factor, k , which depends on the length and cross-sectional area of the sample being tested (Equation 1). The bulk resistivity measurement set-up is shown in Figure 3.27.

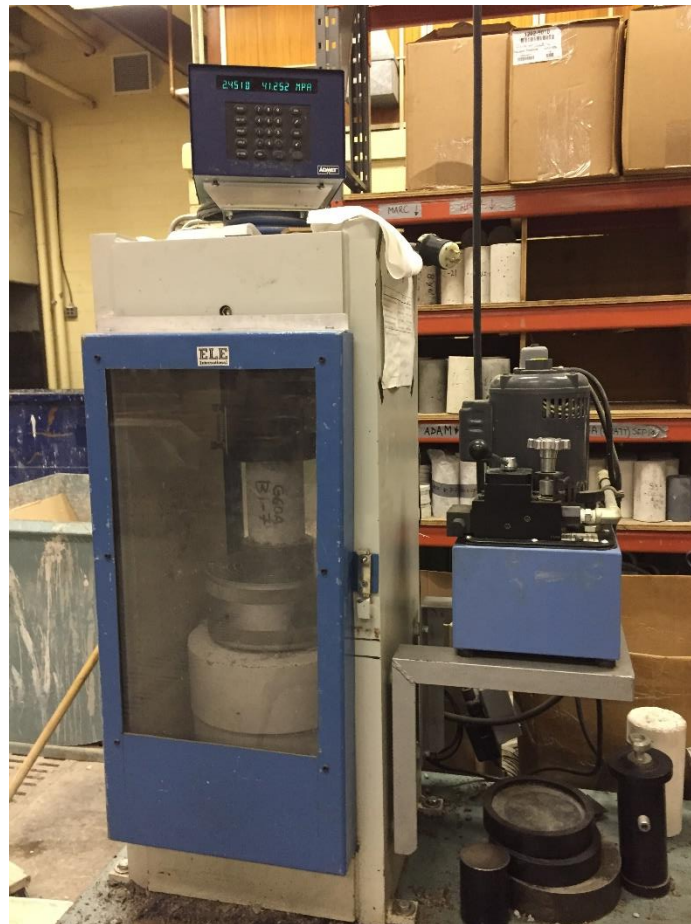
Figure 3.28 Hydraulic Compressive Testing Machine in the UW Lab

After the samples were measured, described, and tested for electrical resistivity, they were tested for compressive strength following CSA A23.2-9C – Compressive Strength of Cylindrical Concrete Specimens (CSA A23.1 / CSA A23.2 2015). The samples were tested in a hydraulic compression testing machine (Figure 3.28), using the loading rates specified in CSA A23.2-9C. Peak loads of each sample were recorded, as well as the failure type.

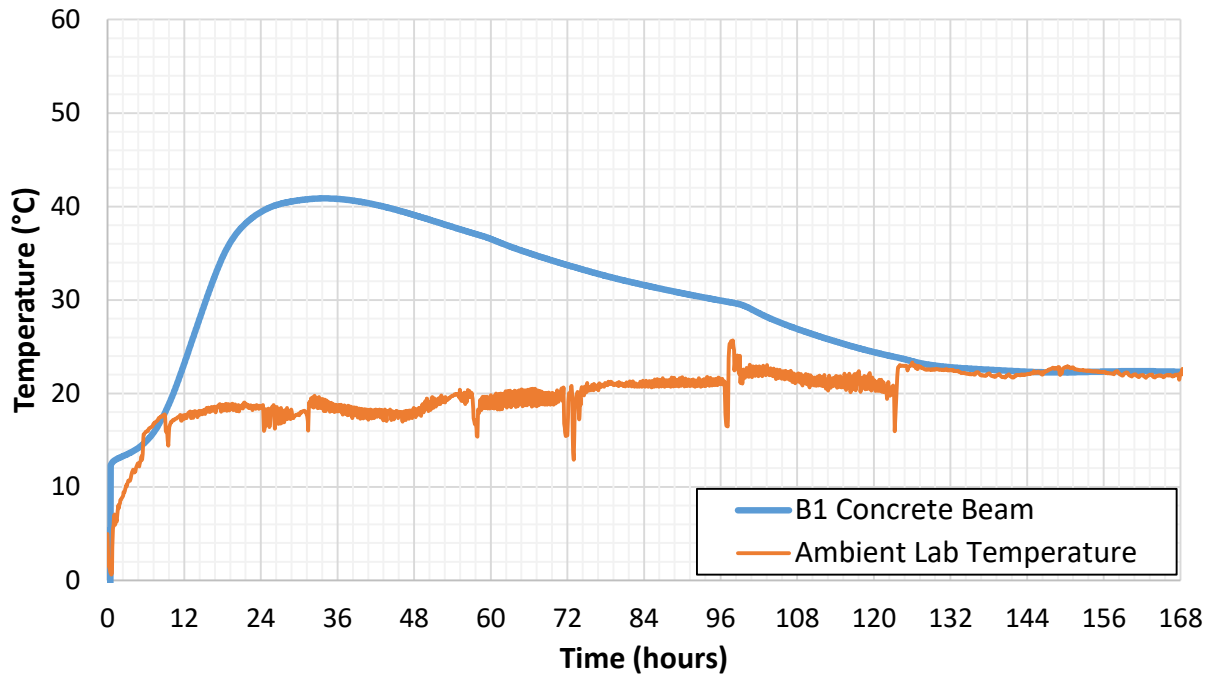
Figure 4.1 Temperature Profile for B1 Beam

The temperature change due to heat of hydration for B1 and B2 beams is shown in Figure 4.1 and Figure 4.2. The center of the B1 beam reached 41°C after approximately 36 hours and the center of the B2 beam reached 56°C after approximately 26 hours. The concrete for B2 beams contained silica fume which caused a faster reaction as well as the higher hydration temperature compared to the concrete for B1 beams. Unfortunately only one thermocouple was used in the beams and it would have been beneficial to place more along the length. During the B2 beam cast, thermocouples were also placed inside some concrete cylinders to measure the difference between the much larger beams and the cylinders. In Figure 4.2, it is seen that the cylinders peaked at approximately 24°C and then began to follow the ambient temperature after 24 hours. Based on the temperature profiles of the cylinders from the B2 concrete, it is safe to assume the cylinders from the B1 concrete would not have exceeded 24°C since the B1 concrete contained a lower total cementitious content and would have a lower heat of hydration temperature than the B2 concrete. This leads us to conclude that the difference in temperature between the center of the B1 beam and the cylinder would be approximately 15°C compared to the difference between the B2 beam and the cylinders which is close to 30°C. This effect of temperature on the early and late day compressive strength is discussed in Chapter 4.2. Both sets of beams were stripped of their formwork after 72 hours (3 days) and the sharp dip in the temperature

profile of the B2 beam is due to the beam being cored close to the thermocouple with a water-cooled drill on day 3.

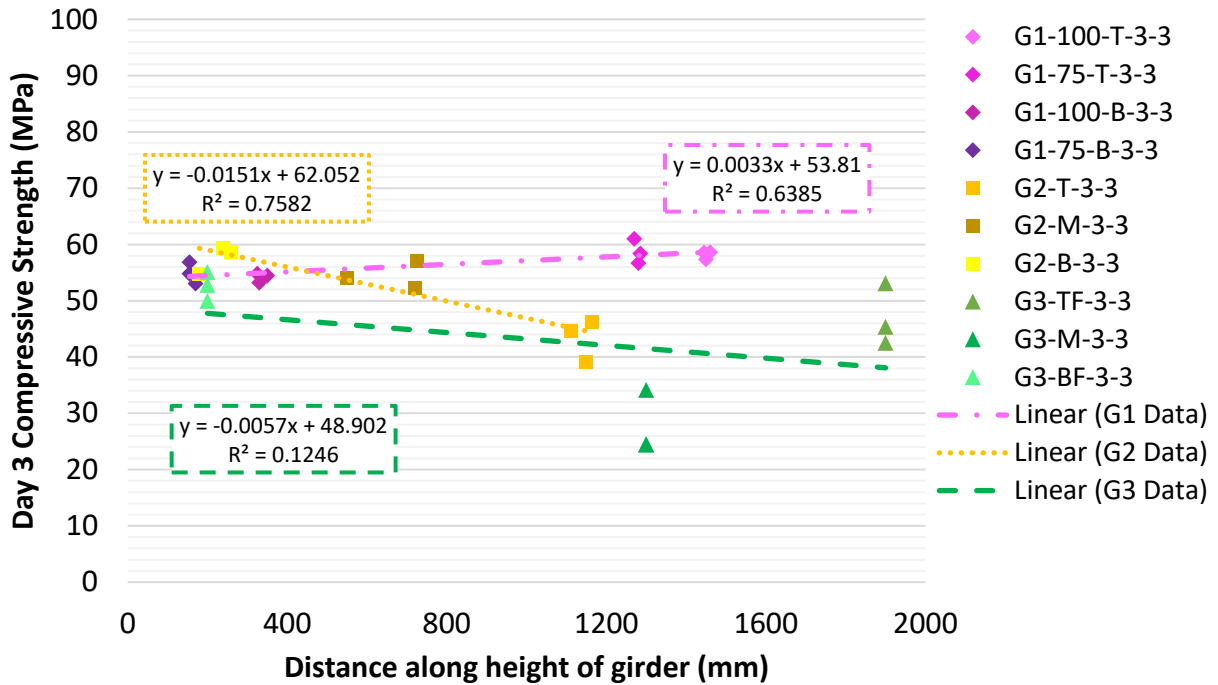
Figure 5.9 Variation in Day 3 Compressive Strength with Height

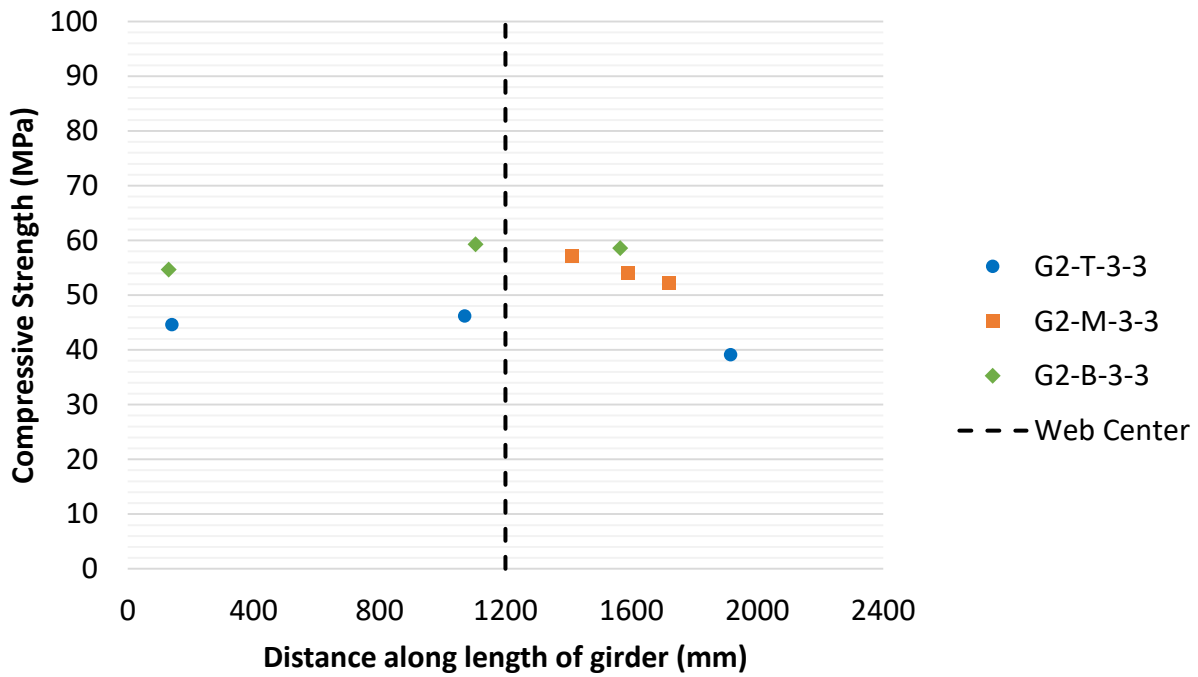
Figure A.6 Day 3 Compressive strength of individual cores versus length of G2 Girder Web

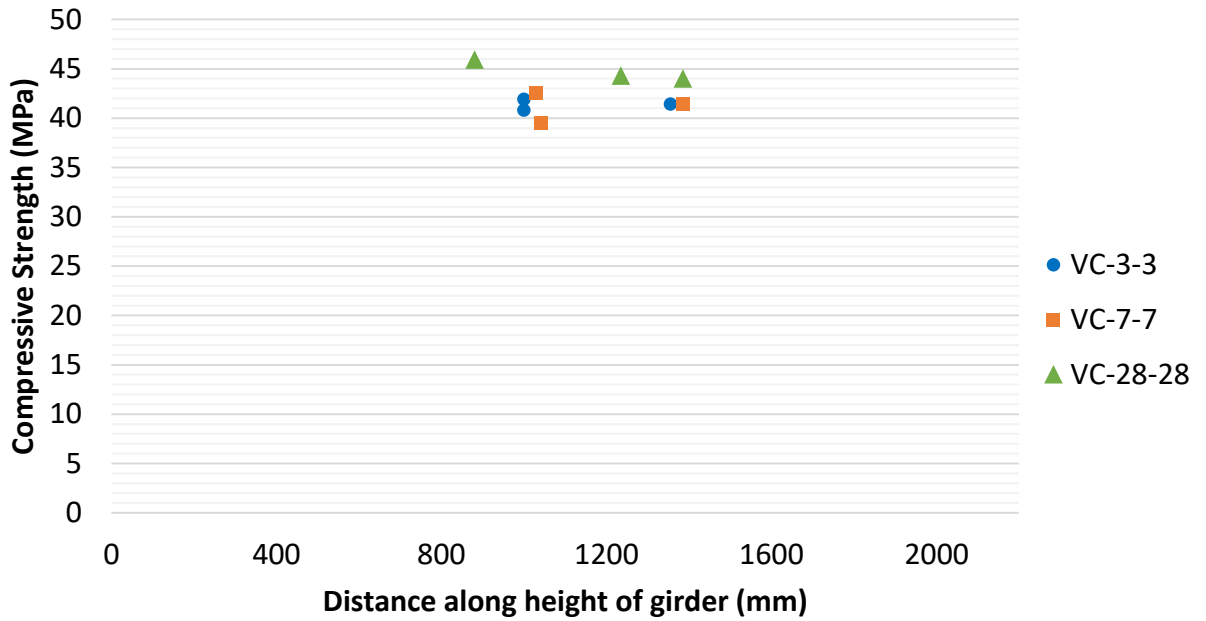
Figure A.10 Compressive strength of individual cores versus height of VC Chamber
