# Effect of Quality Control Parameter Variations on the Fatigue Performance of Aluminum Friction Stir Welded Joints

Shihui Guo, Luqman Shah, Rakesh Ranjan, Scott Walbridge\*, Adrian Gerlich

Department of Civil and Environmental Engineering, University of Waterloo, Waterloo, ON, Canada

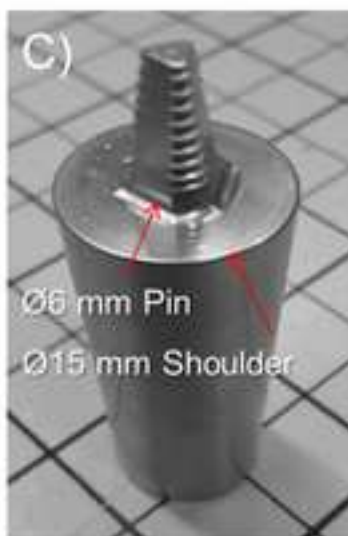
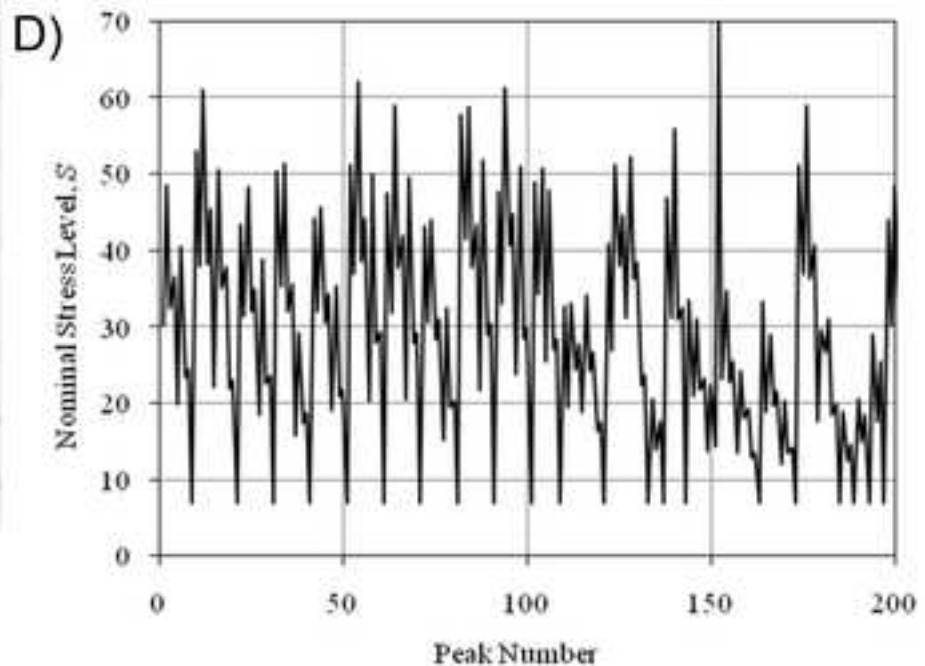
Figure 1: Specimen fabrication and loading details: (A) welding process setup, (B) specimen layout, (C) FSW tool, and (D) tested VA loading history.

10° tapered, M6 threaded three flats H13 steel tool

The employed FSW tool was made from H13 steel, quenched and tempered to 46-48 HRC. The pin geometry is 10° tapered and M6-threaded with three flats (see Figure 1(C)). In general, the penetration

Following the CA loading tests, specimens were tested under a variable amplitude (VA) loading history for the support reaction on a 15 m long simply-supported beam subjected to measured highway traffic loading (see Figure 1(D)). This history was found in previous work to be a relatively severe one for aluminum welds in bridges [23].

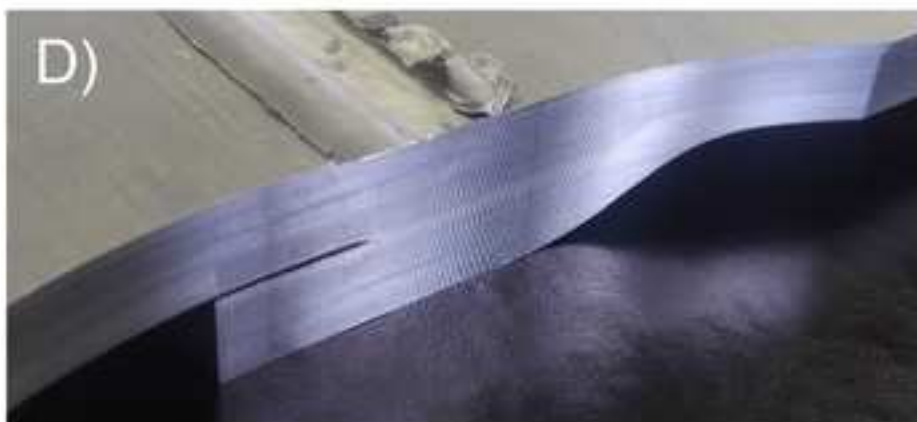
Figure 2: Specimen profiles: (A) 6061 proper weld profile, (B) 6061 toe flash / undercut weld profile, (C) lap joint detail, and (D) lap joint weld profile.

For most of the specimens, the welding resulted in a butt joint between the plates. In addition to the butt joint specimens, a special lap joint detail was also investigated, which simulates a lap joint between extrusions in (for example) a multi-extrusion vehicular bridge deck panel. The lap joint is a convenient way to provide built in backing material for a one sided weld. On the other hand, it results in a crack-like gap, which runs parallel to the loading direction. One of the objectives of testing this detail was to assess the performance of this complex joint type. The lap joint specimens were fabricated by milling 19.05 mm (3/4") 6061-T651 aluminum plates to half of their thickness at one end with a filleted transition in the weld region. A profile of the lap joint detail is shown in Figure 2.

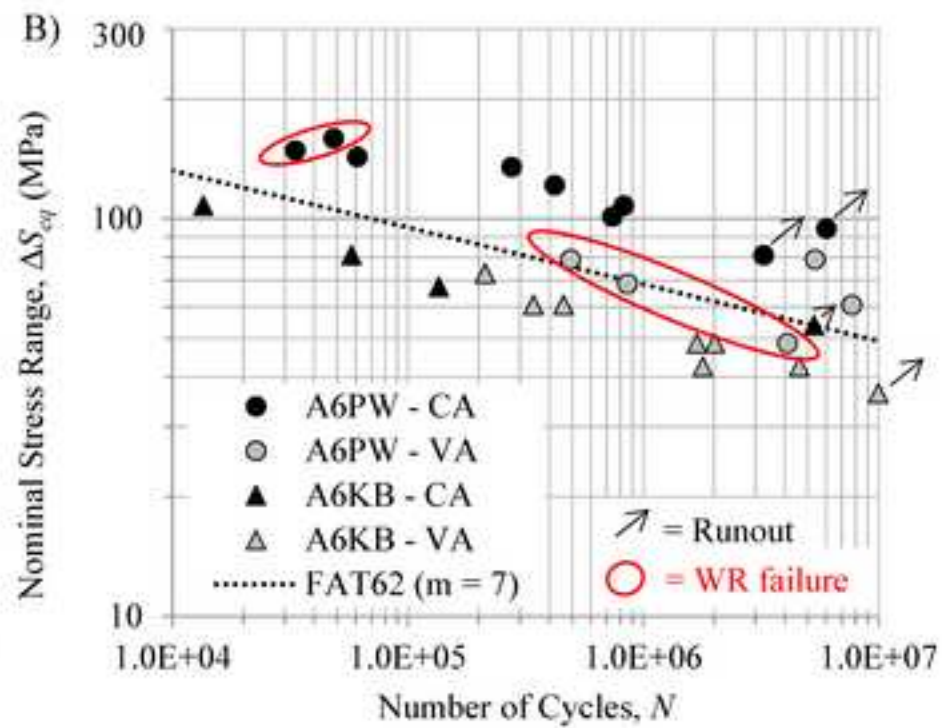
Figure 3: Fatigue test results for 6061 PW and KB specimens compared with: (A) ADM Cat. B design curve, and (B) FAT 62 ( $m = 7$ ) design curve from [14].

Figure 3(A) presents the results for the “properly welded” 6061 specimens, along with the specimens fabricated with significant kissing bond defects, compared to the ADM Cat. B design curve. Looking at this figure, it can be seen that the results for the properly welded (PW) specimens all fall above the curve, whereas the specimens with kissing bond (KB) defects mostly fall below. It is concerning that there is considerable scatter in the PW data, and a number of PW points fall close to the design curve, contradicting the previous findings of others that this design curve is overly conservative. Further review revealed that the PW specimens exhibited a mixture of failure modes, and that the lower results in the data set can all be attributed to weld root (WR) failures. These results are circled in Figure 3.

A subsequent metallurgical analysis revealed that these specimens had KB defects with a depth of up to 344  $\mu\text{m}$  at the weld root, even though they were fabricated with welding parameters established to avoid this. Thus, the results in Figure 3 could be considered as three data sets – PW specimens with top side (AS, RS, or BM) crack initiation sites, PW specimens with WR failures from small KB defects, and specimens with large, intentionally fabricated KB defects. In general, it can be seen that the CA and VA results line up reasonably well for each other for each of these three data sets.

In Figure 3(B), a similar comparison is made with the FAT 62 ( $m = 7$ ) design curve proposed in [14]. Note that this design curve gets its name from the fact that it passes through a stress range of 62 MPa at  $N = 2$  million cycles. Looking at this figure, it can be seen that all of the PW specimens with top side failures fall above the design curve. The PW specimens with WR failures straddle this design curve, and the KB specimens all fall below this design curve.

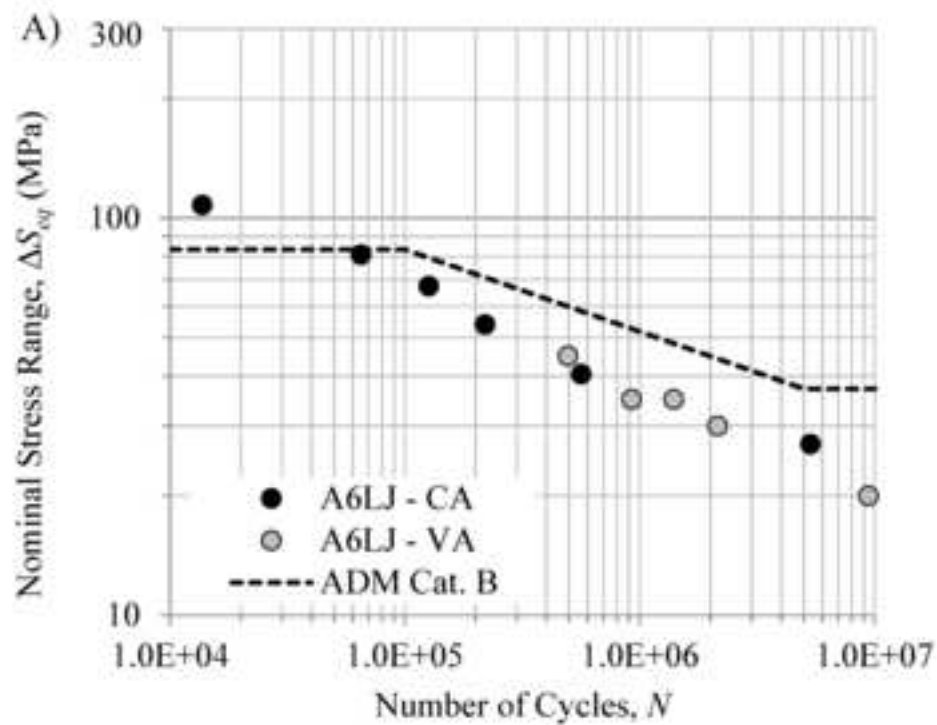
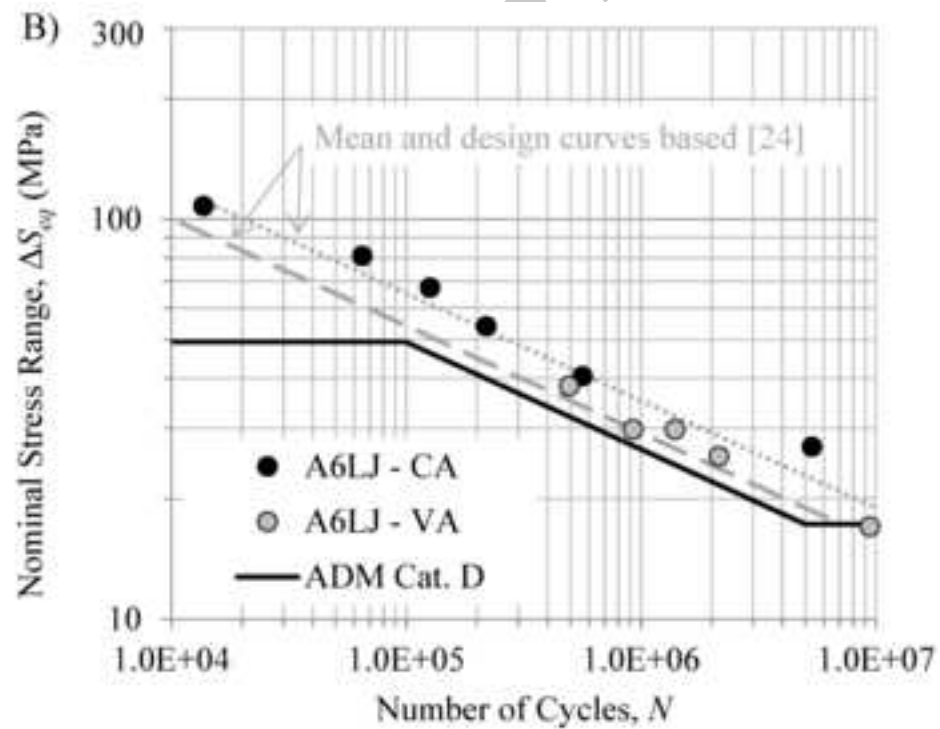
Figure 4: Fatigue test results for 6061 LJ specimens compared with: (A) ADM Cat. B design curve, and (B) ADM Cat. D design curve.

Figure 4 presents similar results for the 6061 lap joint (LJ) specimens. Looking at Figure 4(A) it can be seen that the results for the specimens in this series generally fall below the ADM Cat. B design curve. For this test series, the results can also be seen to exhibit minimal scatter, with the CA and VA results lining up well with each other. In Figure 4(B), the results are compared with the ADM Cat. D design curve ( $m = 3.73$ ). Qualitatively, it seems that this curve would be a more satisfactory one for use with

this detail, as all of the data points except one fall above it. To confirm this, a statistical procedure recommended by the International Institute of Welding (IIW)[24] was used to establish mean and design S-N curves for this detail, for which relatively little test data currently exists. Looking at Figure 4(B), it can be seen that the calculated design (95% survival probability) curve is slightly above the ADM Cat. D design curve.

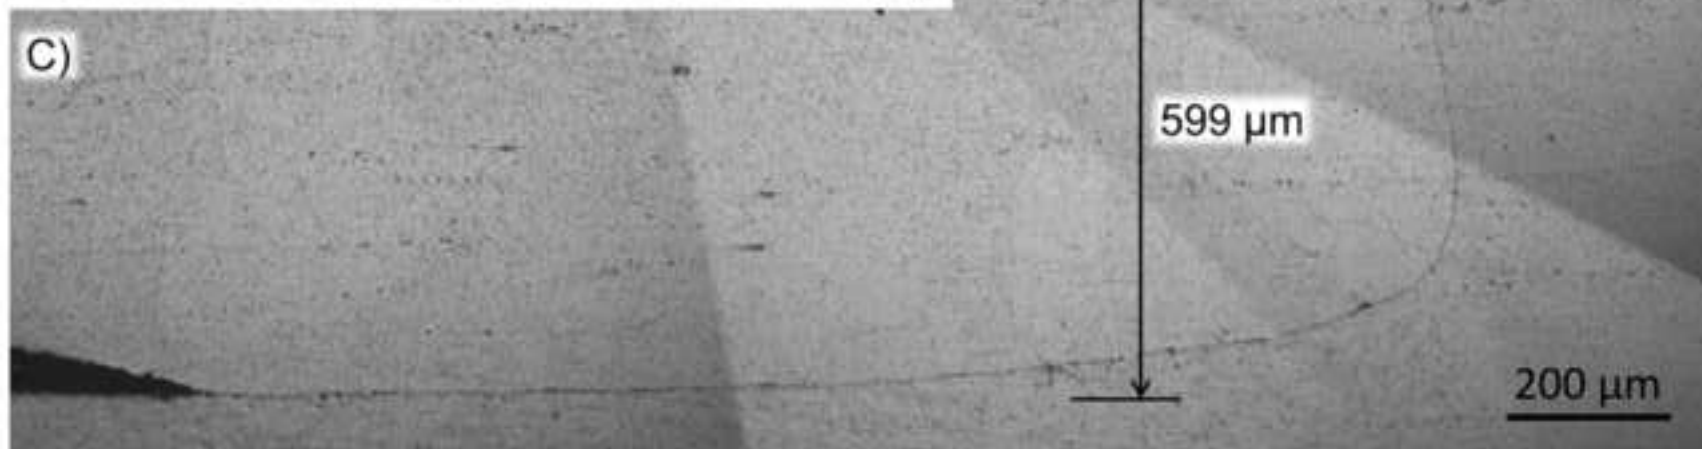
Figure 10: Weld profile of specimen with toe flash defect.

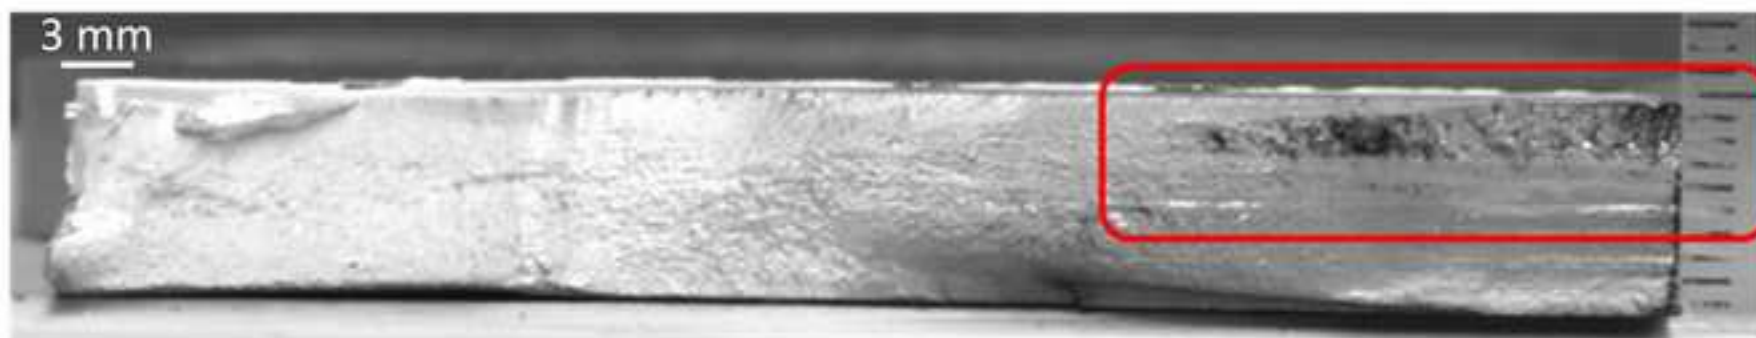
Figure 12: Wormhole defects in specimens (A) A5WH01A, (B) A5WH01C, and (C) A5WH01D.

Figure 12 presents fracture surface photos for the three A5WH specimens with detectable WH defects. In this figure, the defect irregularity can be seen. While the original goal was to produce subsurface defects, the produced defects broke the surface, which means they are more severe from a fatigue perspective and likely would be detected by visual inspection. In Table 3, WH depths are estimated for each specimen, based on microscope images of the fracture surfaces. While the results of this study show the effect that WH defects can have on fatigue performance, further study would be needed to establish a relationship between WH severity and fatigue performance.
