Partial Discharge Classification Using Acoustic Signals and Artificial Neural Networks and its Application in detection of Defects in Ceramic Insulators.

A thesis
presented to the University of Waterloo
in fulfillment of the
thesis requirement for the degree of
Masters of Applied Science

In
Electrical and Computer Engineering

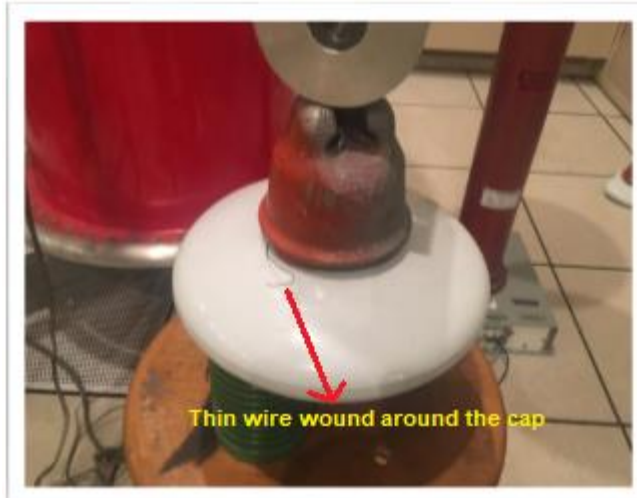
Fig. 3.3 shows a healthy insulator with a thin wire wound around the cap that is used to replicate a hardware corona. This kind of discharge is very common in power systems, but hard to distinguish from other types of severe discharge using the regular online monitoring techniques currently available.

Fig.3.3. Hardware corona generated using a thin wire wound around the cap of a line insulator.

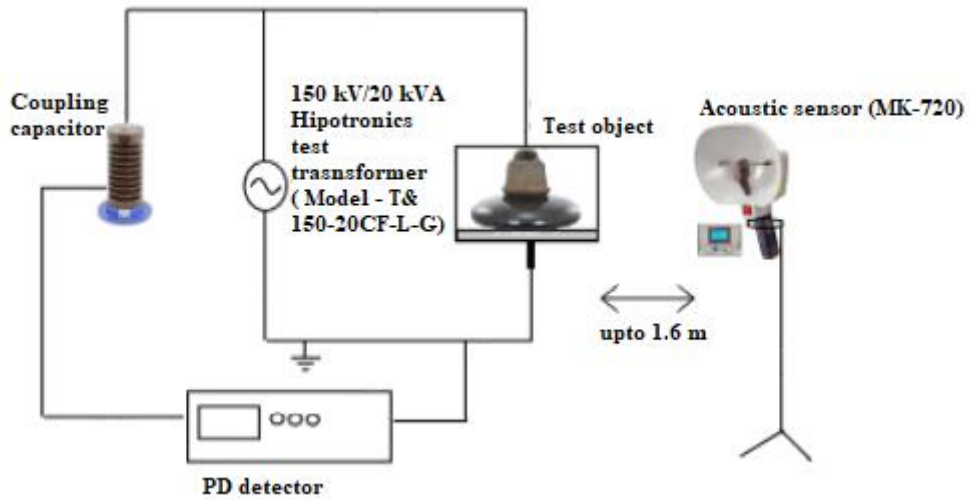
As per the vendor provided datasheet, the acoustic sensor is not sensitive at distances above 2 m from the source of discharge. With consideration of the sensitivity factor and also laboratory safety standards, the sensor was placed 1.6 m from the test setup. Fig. 3.5 shows the arrangement used for testing the porcelain disc insulator.

Fig.3.5. Schematic of simultaneous PD measurements using a coupling capacitor and an acoustic sensor.

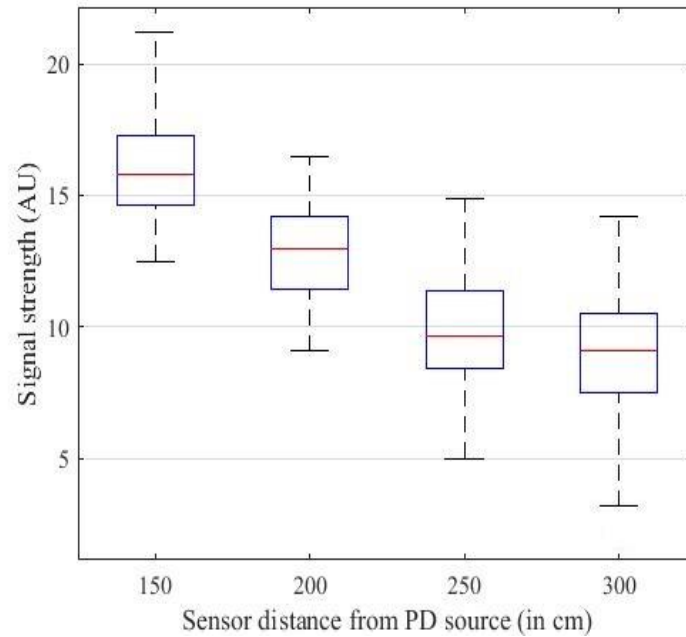
Fig.4.2. Attenuation of the signal strength with distance for a 60 Hz component with corona discharge.

The results reveal that a decreasing trend in the amplitude of the acoustic signal strength can be observed in the corona with the 60 Hz component. A similar trend with the signal strength was noted with 120 Hz and 180 Hz components.

The results related to the attenuation rate of the measured acoustic signal frequency components with discharges from a sharp electrode in air (corona) and from a dielectric medium (surface discharge) are shown in Fig. 4.2 and Fig. 4.3, respectively.

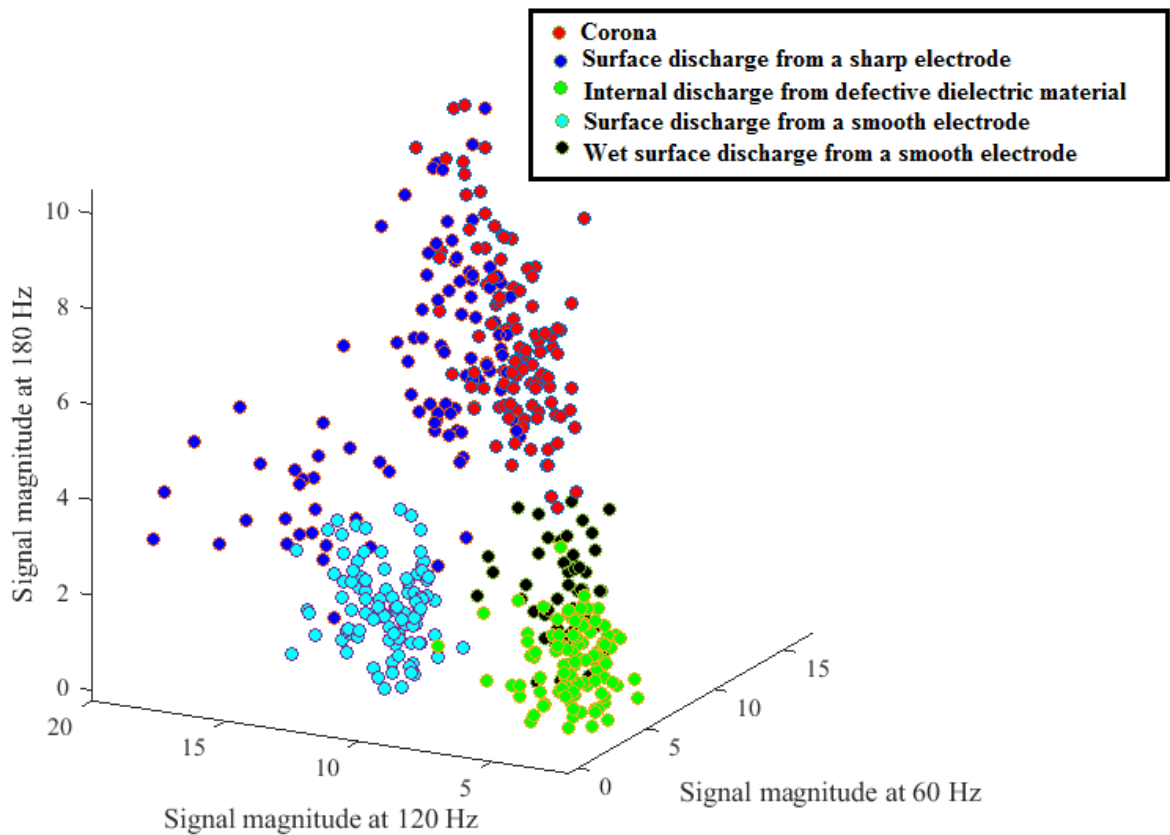
These plots clearly indicate that the different classes are nonlinearly separable, which means that a nonlinear classifier is required to distinguish among them. As well, the 3-D plots for both single and string insulators also exhibit some similarity with respect to class distribution. It should be noted that the defective sample in the string insulators was always connected to the high voltage end.

Fig. 4.6. Signal magnitudes for 60 Hz, 120 Hz, and 180 Hz frequency components in controlled PD sources.
