Experimental Investigation of the Shear Behaviour of Slender Concrete Beams Reinforced with GFRP

A thesis

presented to the University of Waterloo

Civil Engineering

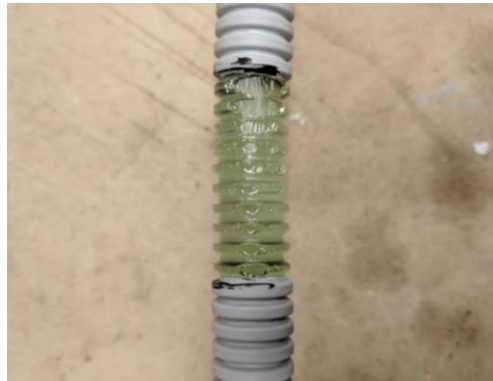
Figure 3.1 – GFRP stirrup with bend protector removed

The transverse reinforcement was supplied by B&B FRP. The stirrups are produced using E-CR glass and a vinylester resin. The stirrups are manufactured by filling a High Density Polypropylene sheath with the fibres and resin. This sheath is then wound around a jig to provide the desired shape. Individual stirrups are cut from the continuous wound bar. The ribs are produced by the pressure from the sheath. An example stirrup with the sheathing removed at one portion to show the underlying bar can be seen in Figure 3.1.

A test regimen was carried out by Mohamed and Benmokrane (2016) that found a straight portion strength and stiffness to be 800 MPa and 45 GPa respectively. Additionally, the bent portion strength was approximately 70% of the straight portion strength.

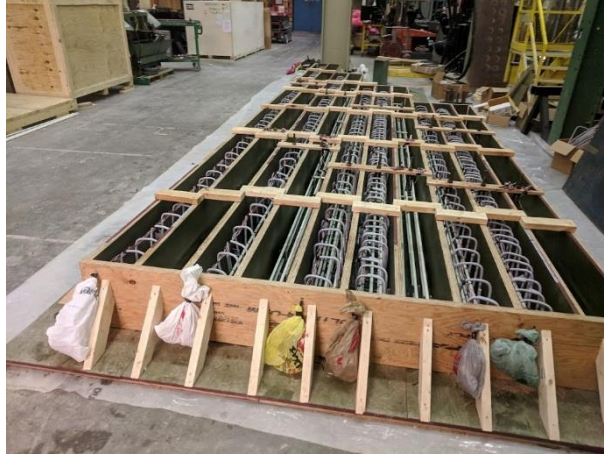
Figure 3.3 – Gang form for specimen casting

A single gang-form was constructed for the specimen casting. This form can be seen in Figure 3.3. Forms were constructed to an out of straightness tolerance of 1/500. Forms were constructed from 3/4" one-sided formply, with all walls being double sheathed to allow lap splicing and provide strength. A floor and subbase was constructed from standard 4'x8' plywood sheets covered with formply. 2x4 kickers were provided at one foot intervals around the exterior of the form to brace against movement and form-buckling. Every specimen was formed with an additional one meter overhanging portion on either side of the support to ensure full anchorage of the longitudinal reinforcement.

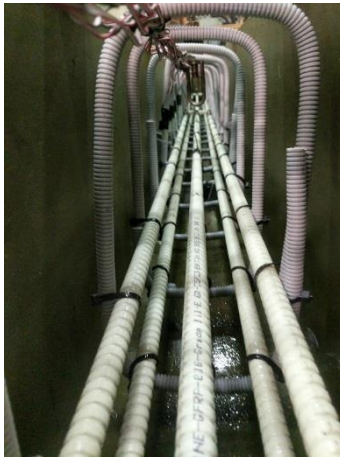
Figure 3.4 – GFRP cage in formwork with instrumentation

The reinforcement cages used plastic ties to conform to procedures followed by Krall (2014) and general industry best practices for GFRP cages (Figure 3.4). Black-nylon zip ties were utilized. These ties largely performed as expected, though occasional breakages occurred due to the brittle nature of black nylon. These observations are in line with those recorded by Krall.

Cages with stirrups were tied without the use of compression reinforcement. While this is not the standard construction practice, the two layers of tension reinforcement allowed for cage rigidity and the lack of compression reinforcement allowed for easy specimen post-mortem investigation.

Cages without stirrups used short, evenly spaced transverse pieces of GFRP bar to tie each row of longitudinal reinforcement. These bars were added after a significant lack of rigidity was observed with the longer cages. Due to the remedial nature of these additions, the bars were tied with standard steel tie wire. Neither of these changes from the original design program are expected to have significant impact on the results of the experiments.

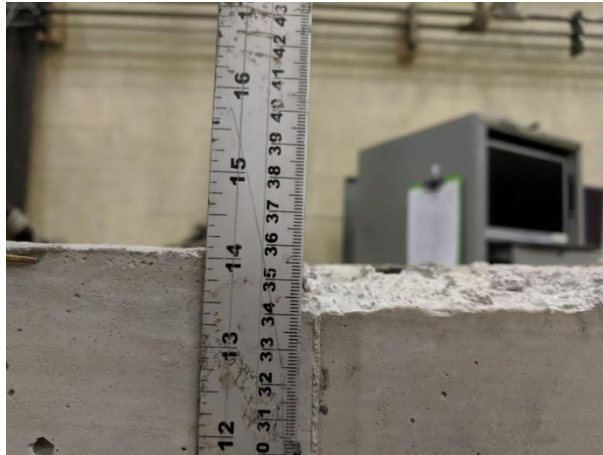
Figure 3.5 – Increase in specimen size

reasonable limits and did not affect the final behaviour of the beams during testing. Additionally, the form joints were sealed with a silicone based caulking to prevent the accidental joining of specimens and the loss of concrete or water through leaks. The lasting effect of these irregularities is that the specimen height was approximately 5-10 mm greater than designed, as seen in the image of BM 10.5-90 below. This change in specimen geometry (and associated change in depth) was taken into account in the analysis of the beams and the expected capacities were recalculated.

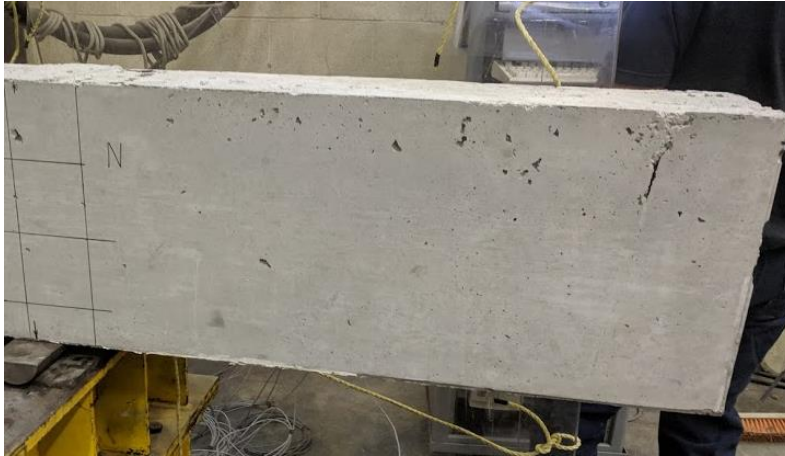
Figure 3.6 – Areas of localized cavities due to lack of consolidation in BM 4.5-N

Also, due to the length of the pour, the concrete was significantly less viscous by the end of the pour. As such, two primary issues occurred. The first was improper concrete consolidation. This was due to concrete stiffening as well as misapplication of concrete vibration. This was observed on the end cantilevers of BM 4.5-N (Figure 3.6). However, as these portions of these beams lie outside the critical shear span area, the effect of the cavities can be ignored.

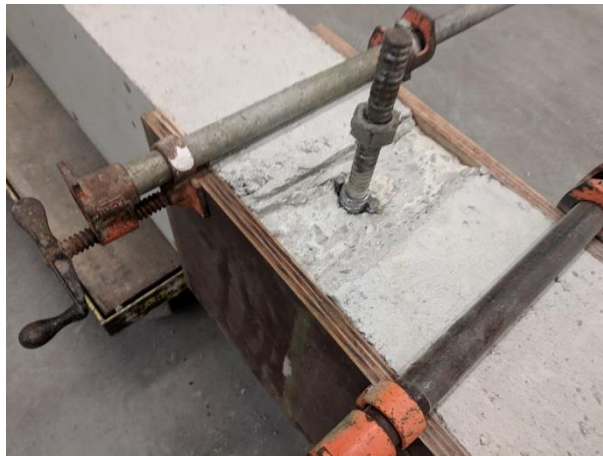
Figure 3.7 – Missing compressive concrete in BM 4.5-N

The second, more critical, issue observed was the reduction in concrete area around anchor points and strapping. During finishing, concrete strapping was not removed due to concerns about form wall buckling. This led to trapped air pockets beneath the strapping resulting in a reduction of concrete on the compression surface of the beams. This issue could have been avoided with proper vibration and the removal of strapping as the concrete set. For the majority of the beams, these problem areas lie outside the shear span. However, for BM 4.5-N patch repairs were required (Figure 3.7). The affected area was first ground down to the matrix, all dust and material was removed, and a non-shrink grout patch was set in place of the missing concrete.

Patches were only required for BM 4.5-N. The patch was not observed to have failed during testing.

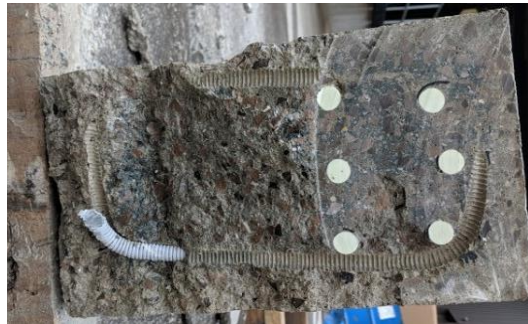
Figure 4.1 – Typical post-failure section at critical shear region

Beams generally followed expected trends for failure modes with a transition from shear-controlled to flexure-controlled failure being observable. No longitudinal or transverse reinforcement was observed to fail. After testing, all beams that contained transverse reinforcement and that failed in a brittle manner were dissected to determine if the transverse reinforcement was intact. In all cases, transverse reinforcement was found intact with no evidence of slippage or fracture. A typical section from BM 6.5-150 at the critical region is shown in Figure 4.1. The sections were made by cutting through the beams with a handheld concrete saw and the stirrup was removed from this section. Before removal, the stirrup showed no evidence of rupture or of bond breaking. Additional, examination of the concrete around the stirrup location showed no evidence of crushing, cracking or deformation indicative of localized bond failure.

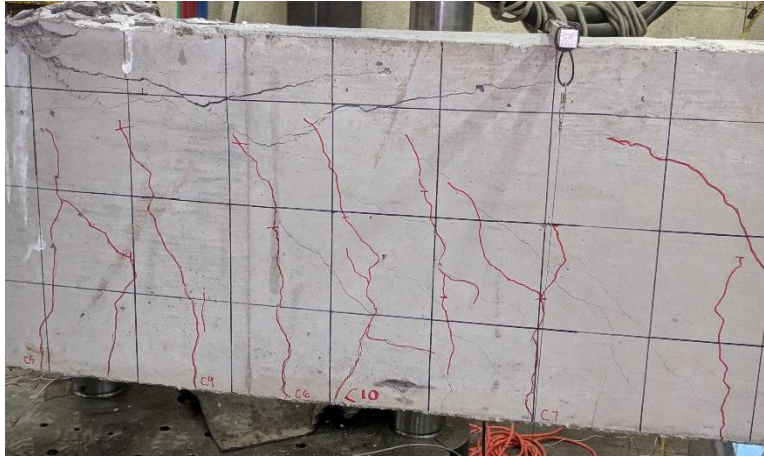
Figure 4.6 – BM 4.5-90: Crack patterns at failure

BM 4.5-90 had a shear span of approximately 1.22m and a 10M GFRP stirrups spaced at 90 mm. The specimen failed due to concrete crushing and shear crack propagation next to the load application. BM 4.5-90 failed in a combined shear-flexural mode as evidenced by the crack pattern in Figure 4.6. The sudden loss of strength in the load-displacement curve at failure indicates that the failure was initiated by shear mechanisms. The angle of inclination of the critical shear crack corresponding to the angle of the principal compressive stress was measured at 45°.

BM 4.5-90 reached a peak load of 222.5 kN with a corresponding displacement of 27.0 mm.

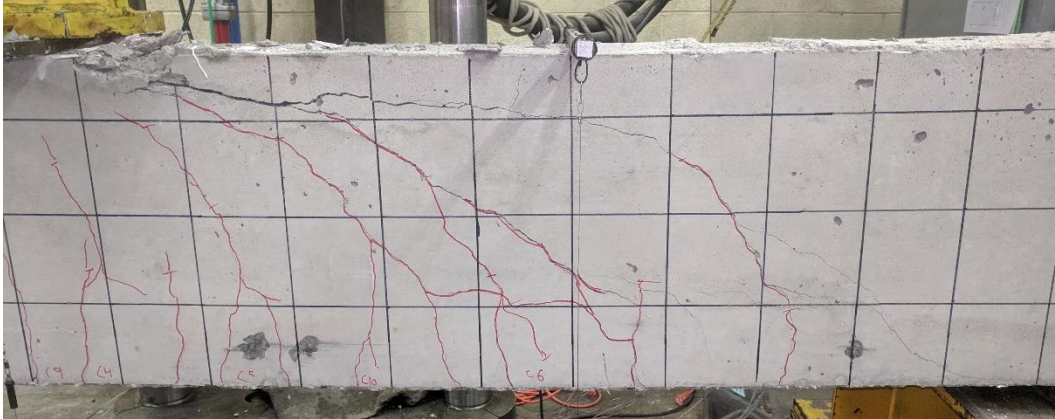
Figure 4.11 – BM 4.5-150: Crack patterns at failure

BM 4.5-150 had a shear span of approximately 1.22m and a 10M GFRP stirrups spaced at 150 mm. The specimen failed due to the widening of the critical shear crack and concrete crushing next to the load application. BM 4.5-150 failed in a shear dominated mode as evidenced by the crack pattern in Figure 4.11. The angle of inclination of the critical shear crack corresponding to the angle of the principal compressive stress was measured at 41° .

BM 4.5-150 reached a peak load of 171.2 kN with a corresponding displacement of 20.4 mm. The specimen displayed bilinear bending stiffness with a cracking load of approximately 25 kN (Figure 4.12). During testing, sounds indicated that some longitudinal bar slip occurred though there was no evidence of extensive bar slip.

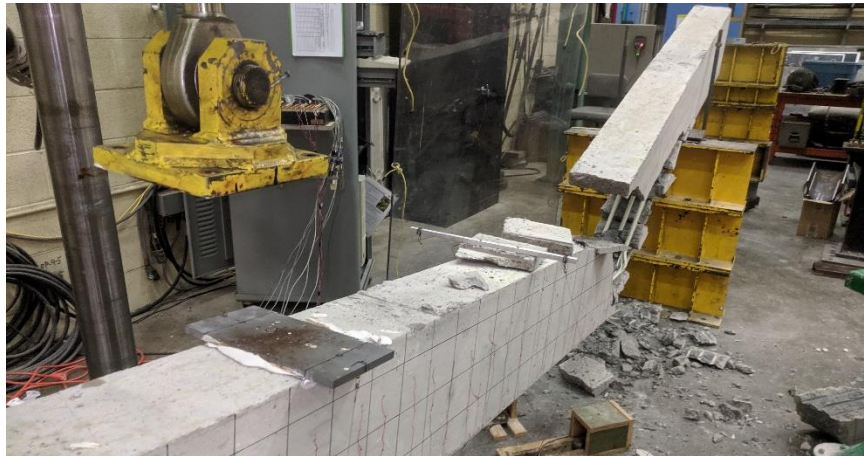
Figure 4.38 – BM 10.5-N: Catastrophic shear failure

BM 10.5-N had a shear span of approximately 2.84 m and no transverse reinforcement. The specimen failed due to the sudden formation and widening of a shear crack. This crack ran from the compression zone down through the section and then above and parallel to the longitudinal reinforcement (Figure 4.38). This shear crack caused a sudden and catastrophic failure. The angle of inclination of the critical shear crack corresponding to the angle of the principal compressive stress was measured as 69°.

BM 10.5-N reached a peak load of 93.0 kN with a corresponding displacement of 97.1 mm.

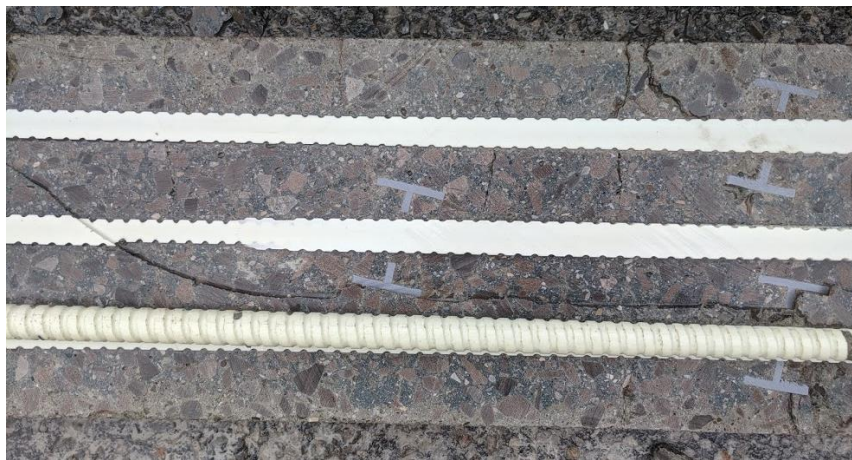
Figure 4.47 – Longitudinal cut through BM 8.5-150

In order to investigate the behaviour of the GFRP reinforcement, beams BM 4.5-150, BM 6.5-150, BM 8.5-N, BM 8.5-150 and BM 10.5-150 were dissected using a concrete saw. Cuts were made at every stirrup that crossed the failure zone for beams with stirrups. BM 8.5-N was cut longitudinally to reveal the bottom row of reinforcement (Figure 4.47).

The purpose of the autopsy was to determine if the brittle failure of any of the beams was due to stirrup rupture and to determine where the bond between the GFRP reinforcement (longitudinal and transverse) was maintained throughout testing.

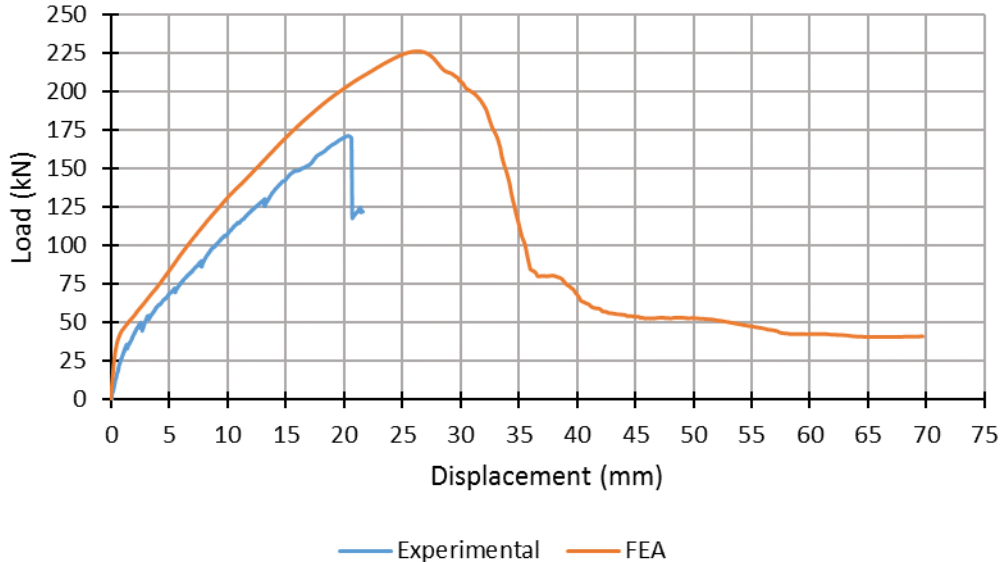
the majority of specimens the deflections are estimated within 15% for a given load. The models display a more parabolic load-displacement curve similar to steel RC beams. Testing found that the real load-displacement curves are more bilinear due to the concrete delamination at peak load and the lack of pronounced crushing behaviour.

Figure 5.8 – Comparison of experimental and FEA modelled load-displacement for BM 4.5-150
