Effect of Post-Rolling Surface Condition on the Corrosion Resistance of UNS 32205 Stainless Steel Rebar

A thesis
presented to the University of Waterloo
in fulfillment of the
thesis requirement for the degree of
Master of Applied Science
in
Civil Engineering

Waterloo, Ontario, Canada, 2022

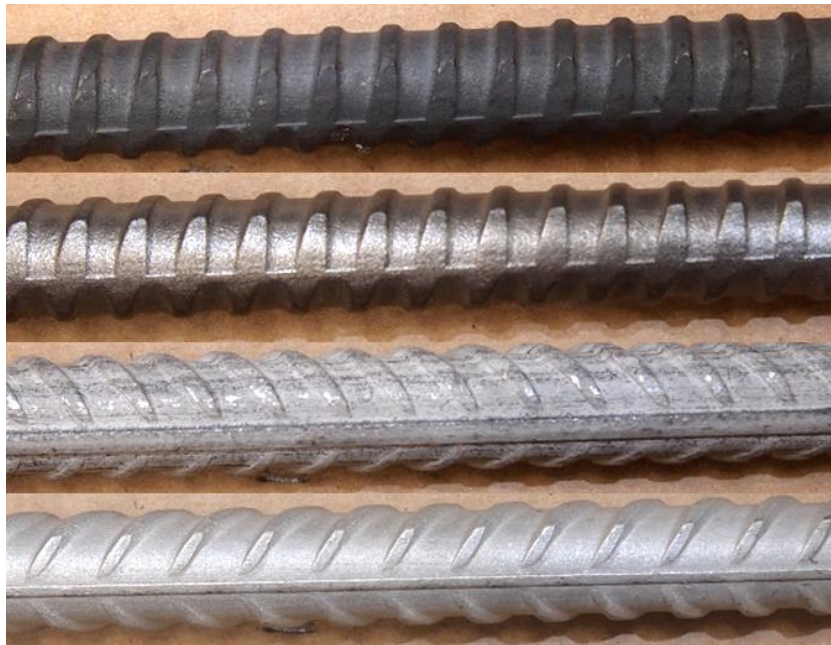
Figure 3-1: Rebar with different surface treatments – (from top) as-rolled, shotblasted-only, pickled-only, pickled-and-shotblasted

The as-rolled rebar was tested as received from the supplier. The shotblasted-only rebar received a shotblasting treatment using chips of carbon steel. The pickled-only rebar received an acid bath treatment which contained a mixture of hydrofluoric acid, HF and nitric acid, HNO₃. Meanwhile, the shotblasted-and-pickled are first shotblasted and then pickled, as per typical stainless steel treatment procedure [44].

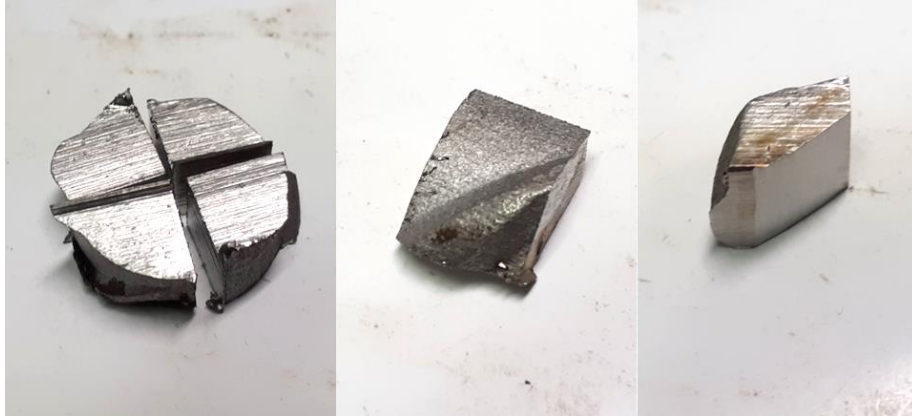
Figure 3-7: (from left) rebar cut into half-hemispheres; top view of curved surface of a single specimen; and isometric of specimen with sharp corner ground flat

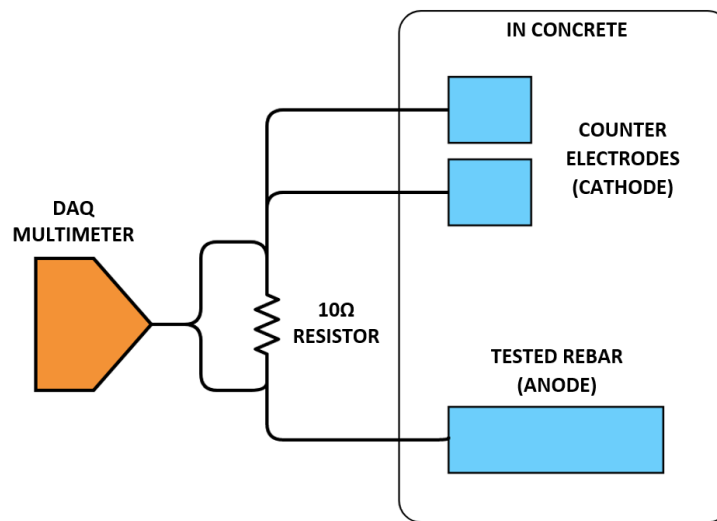
Figure 3-11: Electrical schematic of wiring between rebar, resistor, and multimeter

current in the system to be monitored by measuring the potential difference across the resistor.

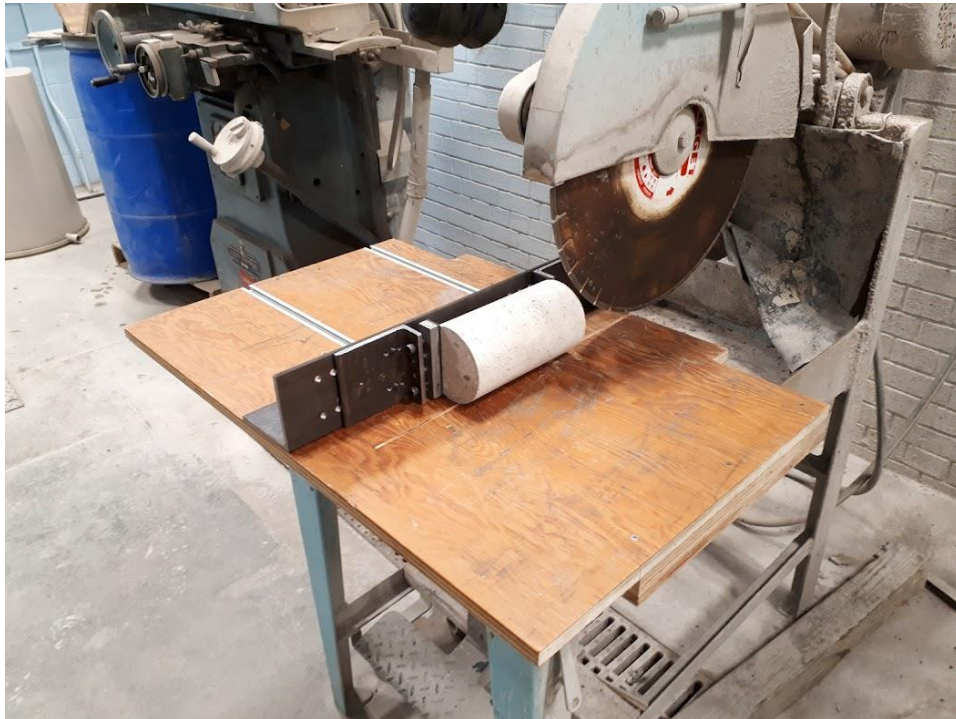
Figure 3-14: Specimen clamp frame for concrete saw, with a concrete cylinder as a cutting sample

The specimens were cut open at the end of the project in order to examine the condition of the rebar. The specimens were cut open using a concrete saw. A specimen clamp frame was designed and fabricated in order to safely restrain the specimen while cutting with the saw. The design and construction of the frame were carried out in collaboration with Richard Morrison and Shelley Yang. The completed jig is shown with the concrete saw on Figure 3-14.

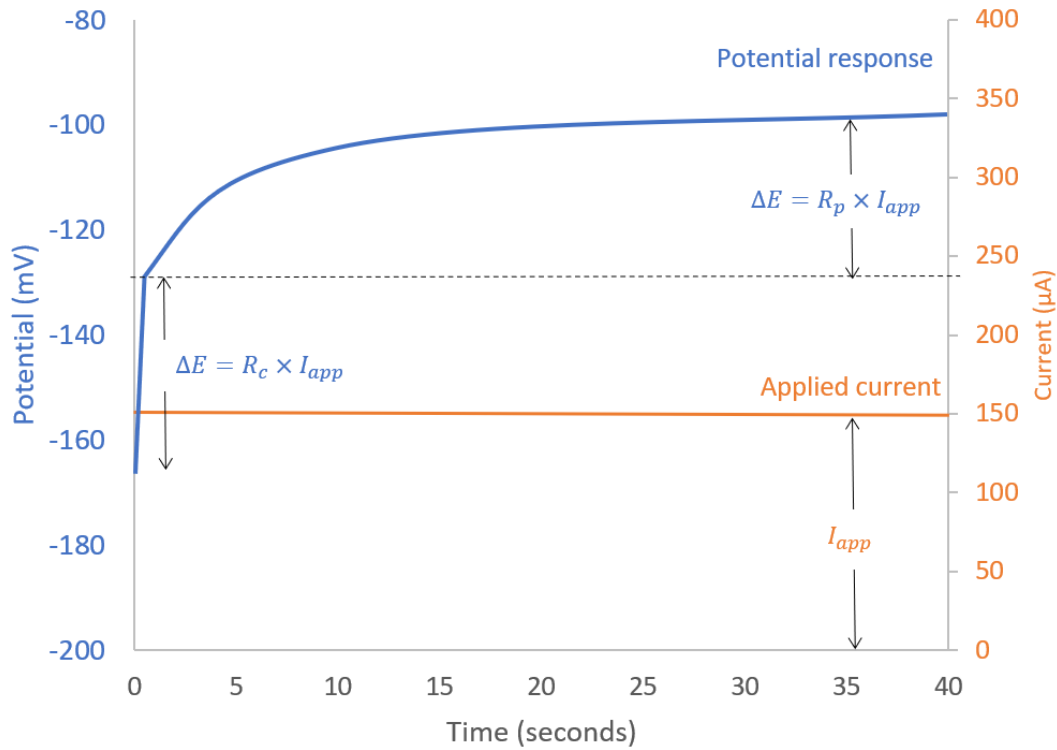
Figure 3-17: Theoretical galvanostatic pulse polarization and response

the change in potential measured from the polarization. This presents a more accurate value of polarization resistance of the rebar sample. Equation 3-3 and Equation 3-4 were used to calculate the polarization resistance and subsequently corrosion current density.

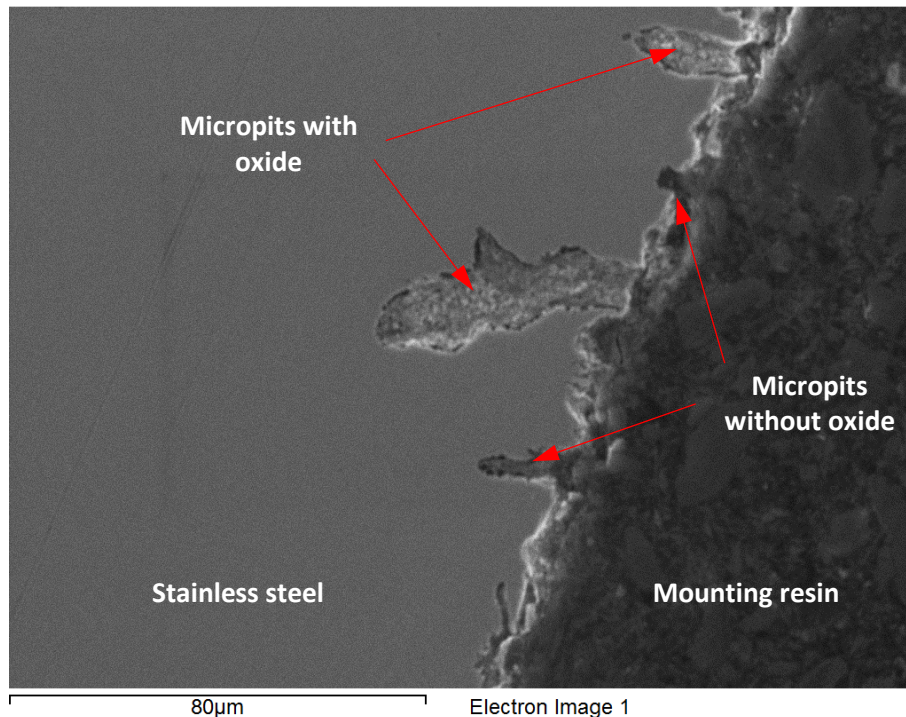
The shotblasted-and-pickled rebar had no significant mill scale layer on the surface. However, micro-pits of oxides were observed as shown in Figure 4-11. These correlate with the dark lines observed on the rebar surface in Figure 4-3. EDS analysis confirms the presence of oxygen in these locations which indicates that they are area of entrapped mill scale. However, the surface was not smooth and had micropits without any mill scale. These micropits have been observed in work by others and are attributed to the pickling process [45]. The micropits observed on this sample were much fewer and not as severe those as seen in other studies.

Figure 4-11: SEM micrograph of shotblasted-and-pickled rebar with micropits containing oxide and micropits without oxide

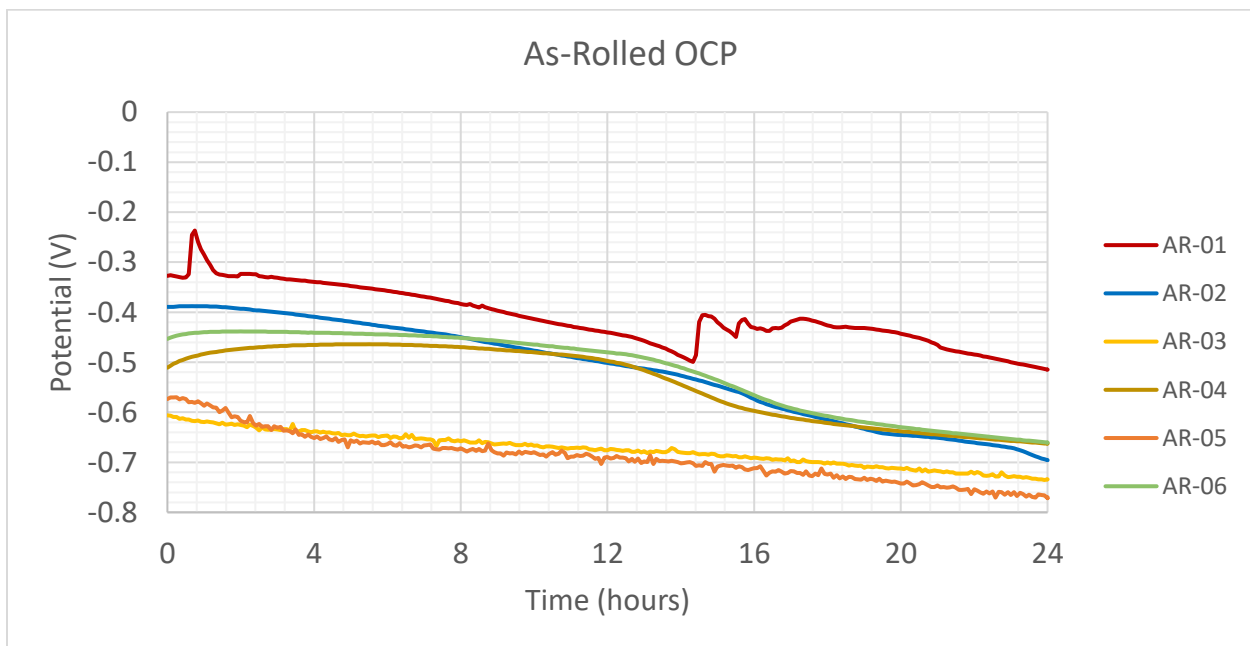
Figure 4-17: Plot of open circuit potential for as-rolled rebar

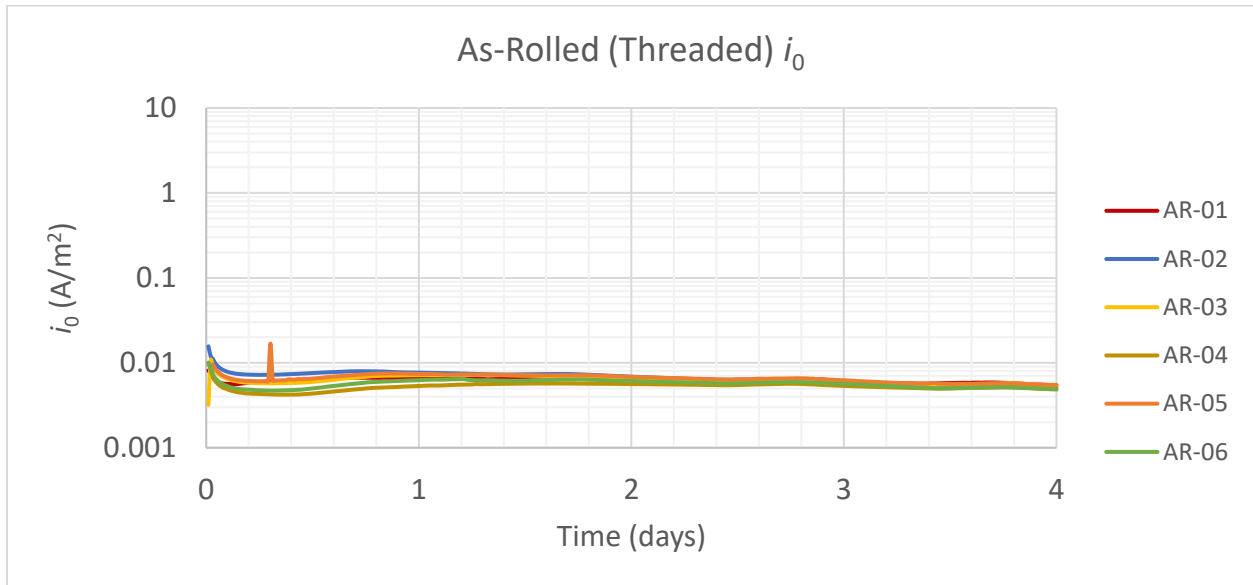
Figure 4-22: Plot of corrosion current density for as-rolled rebar

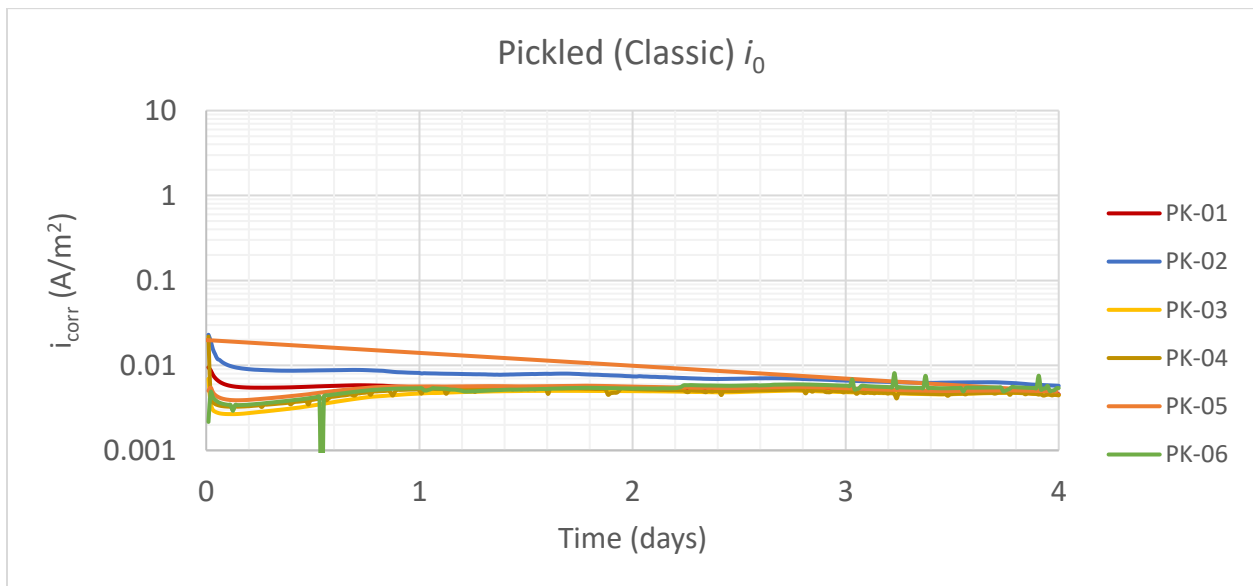
Figure 4-23: Plot of corrosion current density for pickled-only rebar

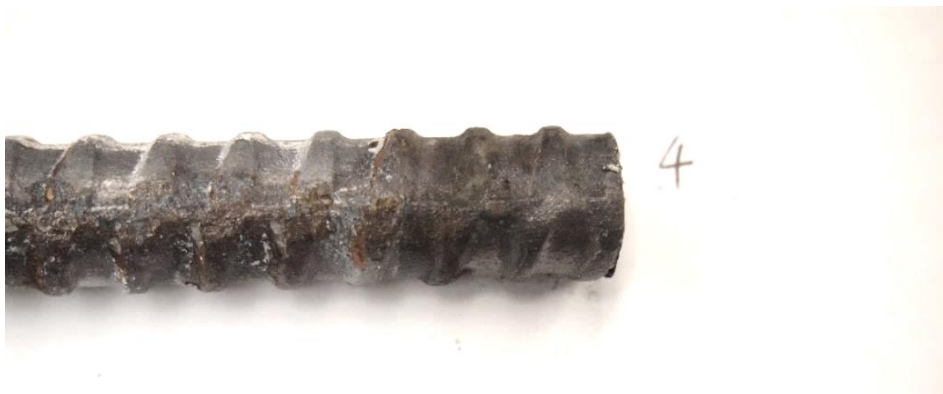
Figure 4-28: Corrosion product found under lacquer at the end of rebar SBO-04

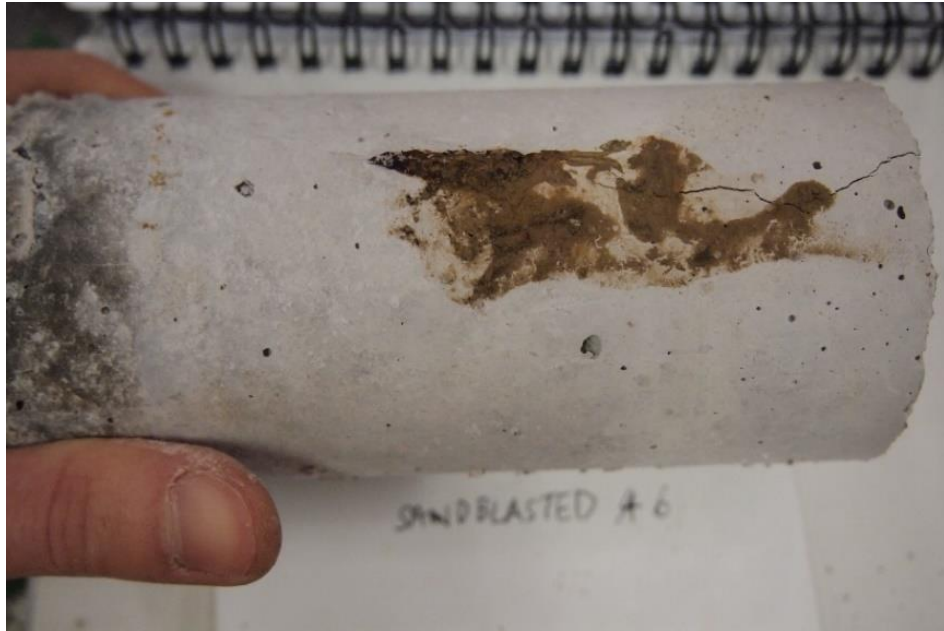
Figure 4-29: Cracked concrete cylinder containing SB06 with rust on surface

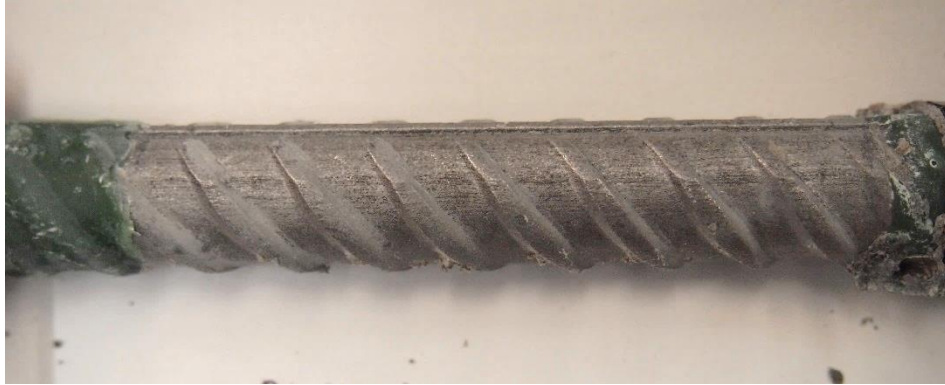
Figure 4-31: PKSB-04 after test

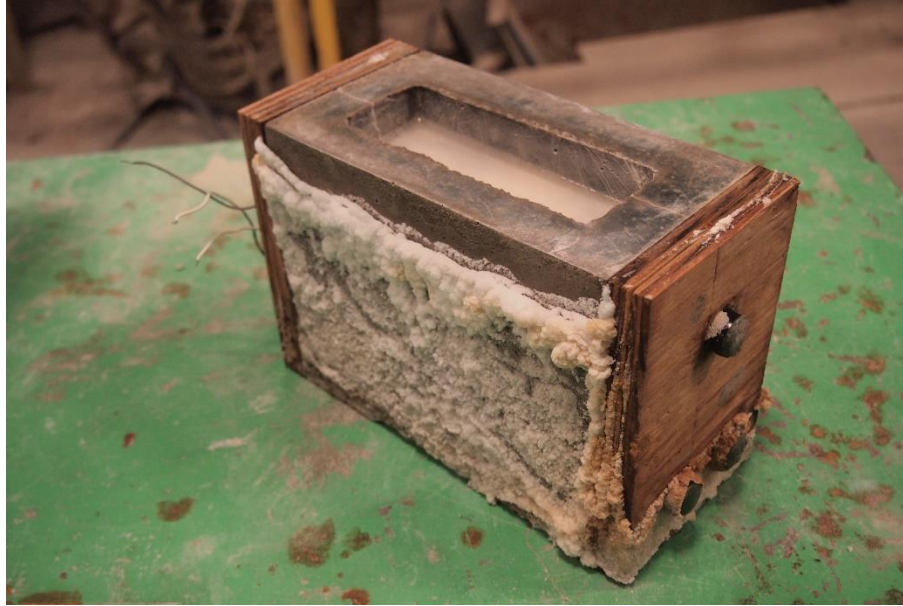
Figure 4-32: Mortar specimen with sodium chloride crystals on surface

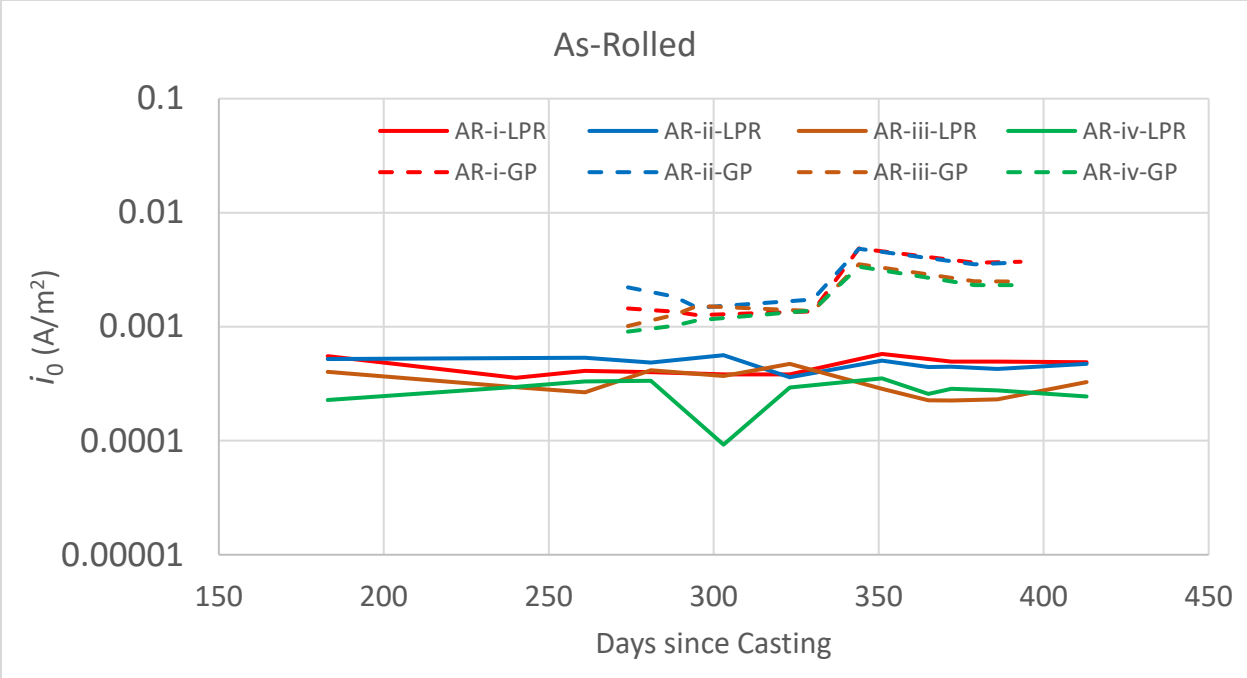
Figure 4-43: Plot of corrosion current density, i_0 over time from LPR and GP tests for as-rolled rebar

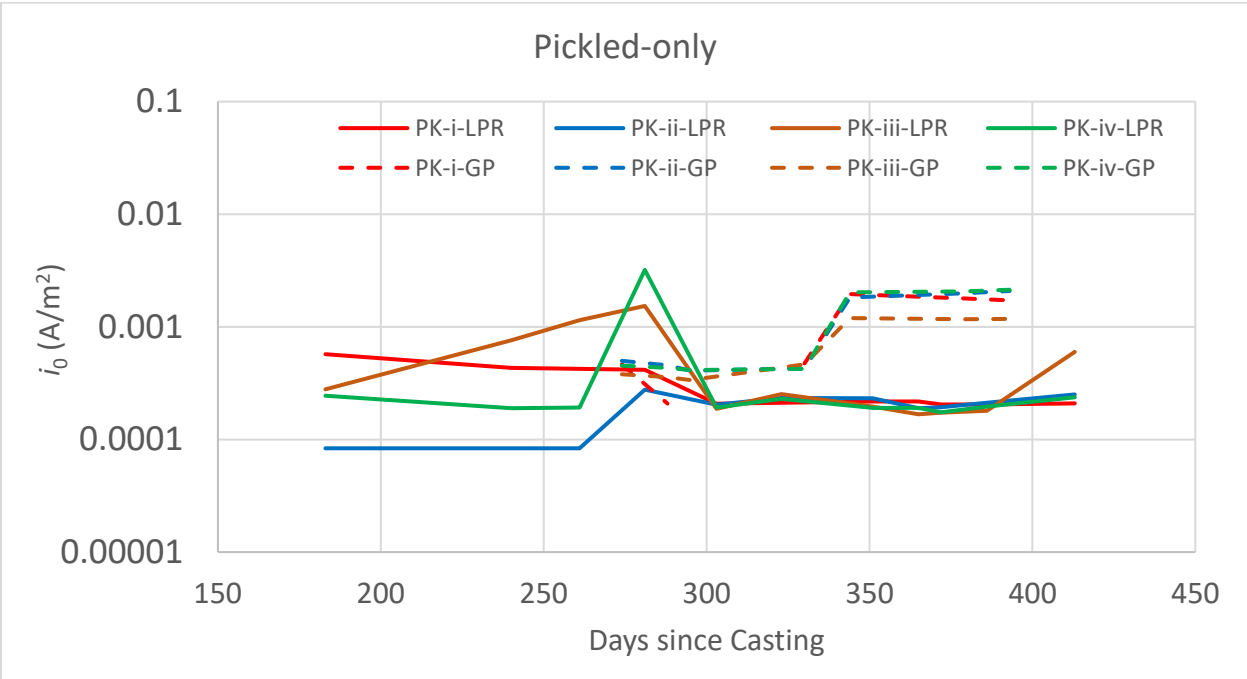
Figure 4-44: Plot of corrosion current density, i_0 over time from LPR and GP tests for pickled-only rebar

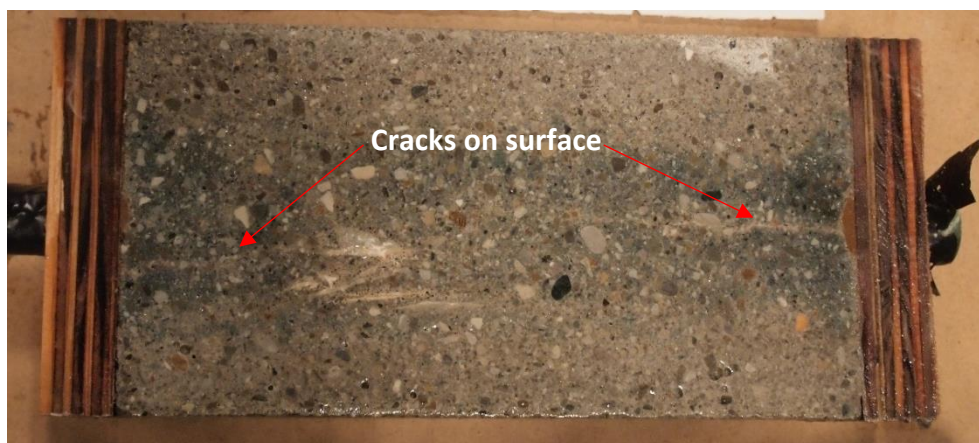
Figure 4-48: Specimen PK-iv with cracks at the bottom of the ponding well. Walls of the well had been removed

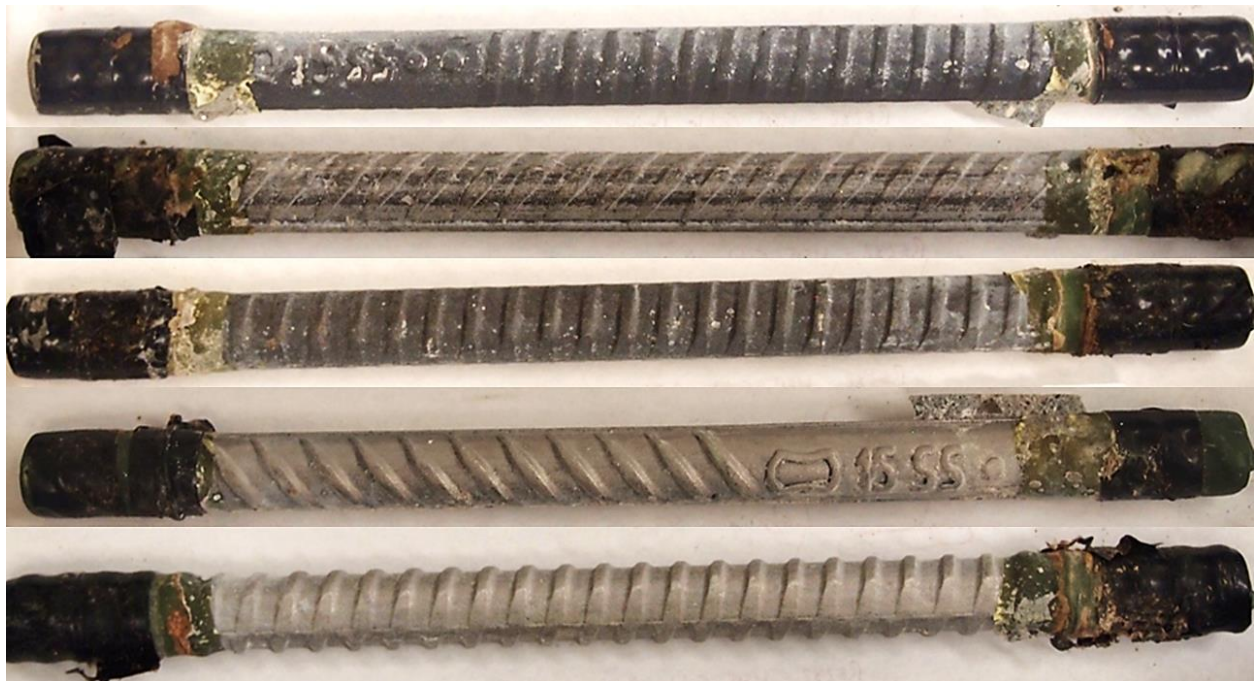
Figure 4-50: Autopsied rebar from mortar specimens. From top: as-rolled, pickled-only, shotblasted-only, shotblasted-and-pickled (classic), shotblasted-and-pickled (threaded)

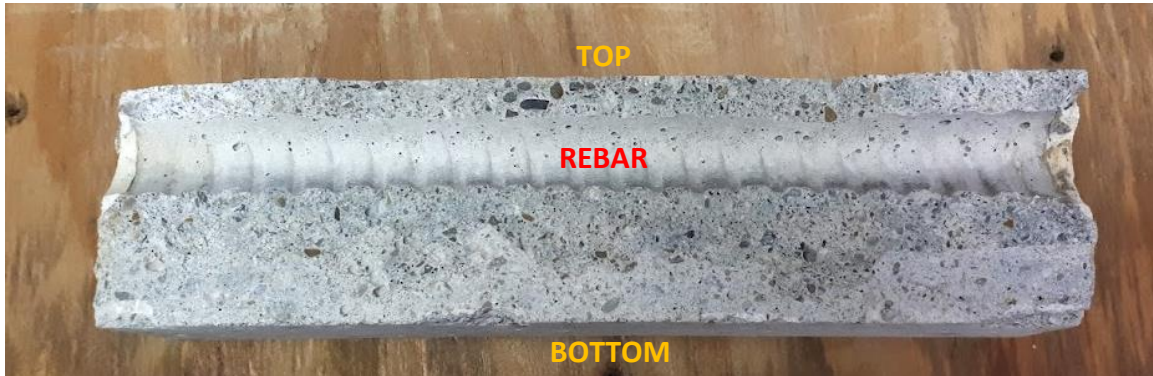
Figure 4-51: Split mortar prism from longer-term corrosion test

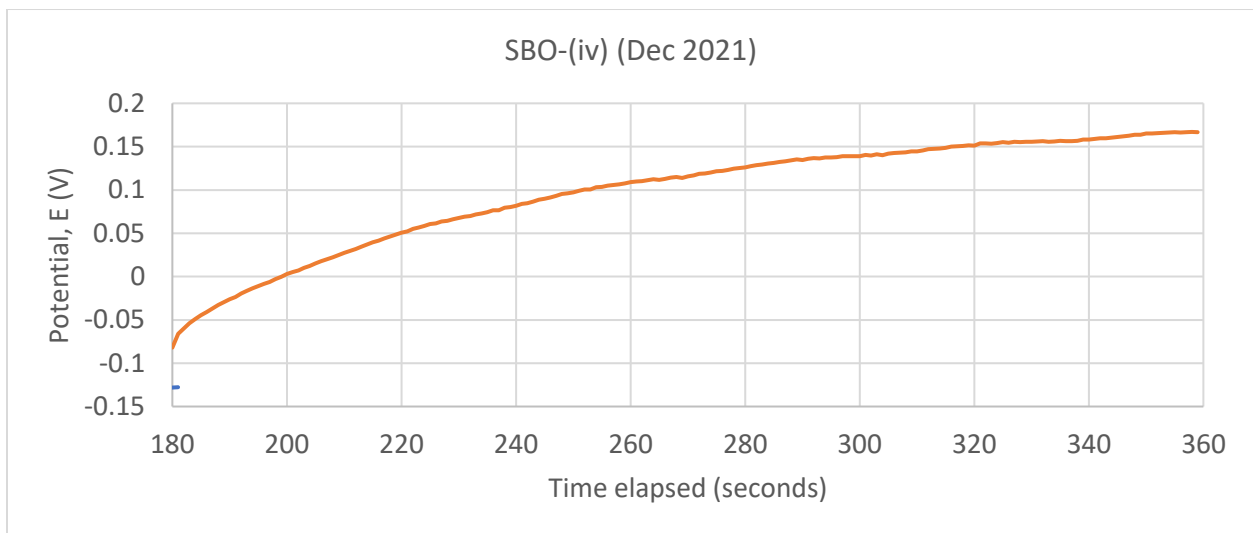
Figure 5-4: Plot of potential measurement in specimen SBO-(iv) during a galvanostatic potential test

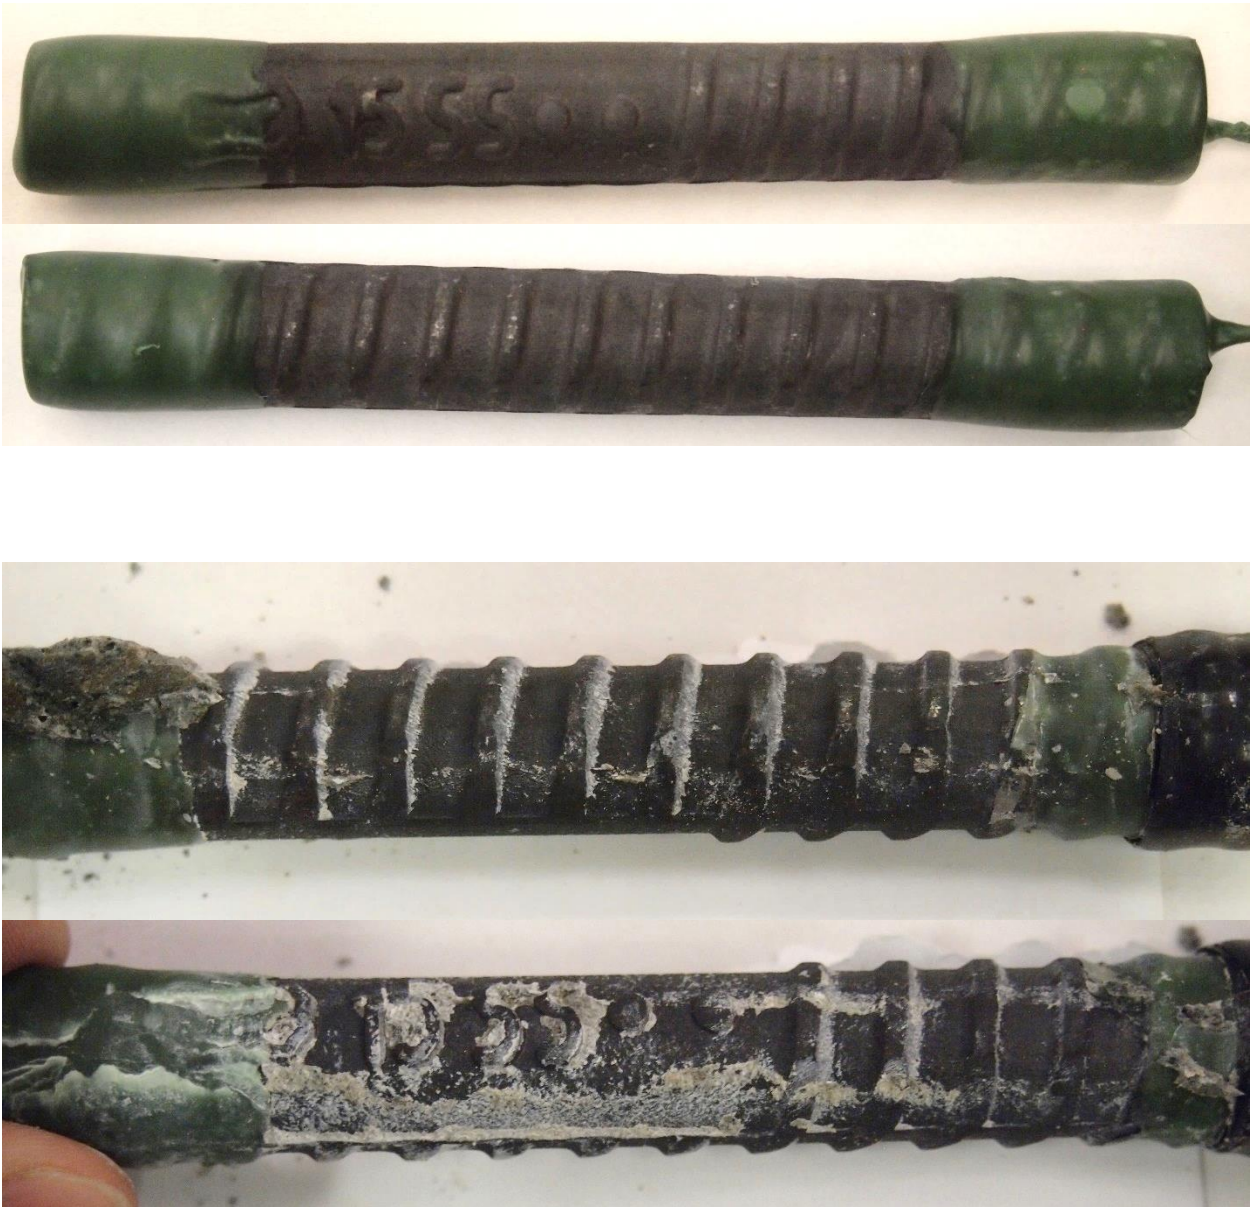
Figure C-1: Specimen AR-03 before testing (top) and after testing (bottom)

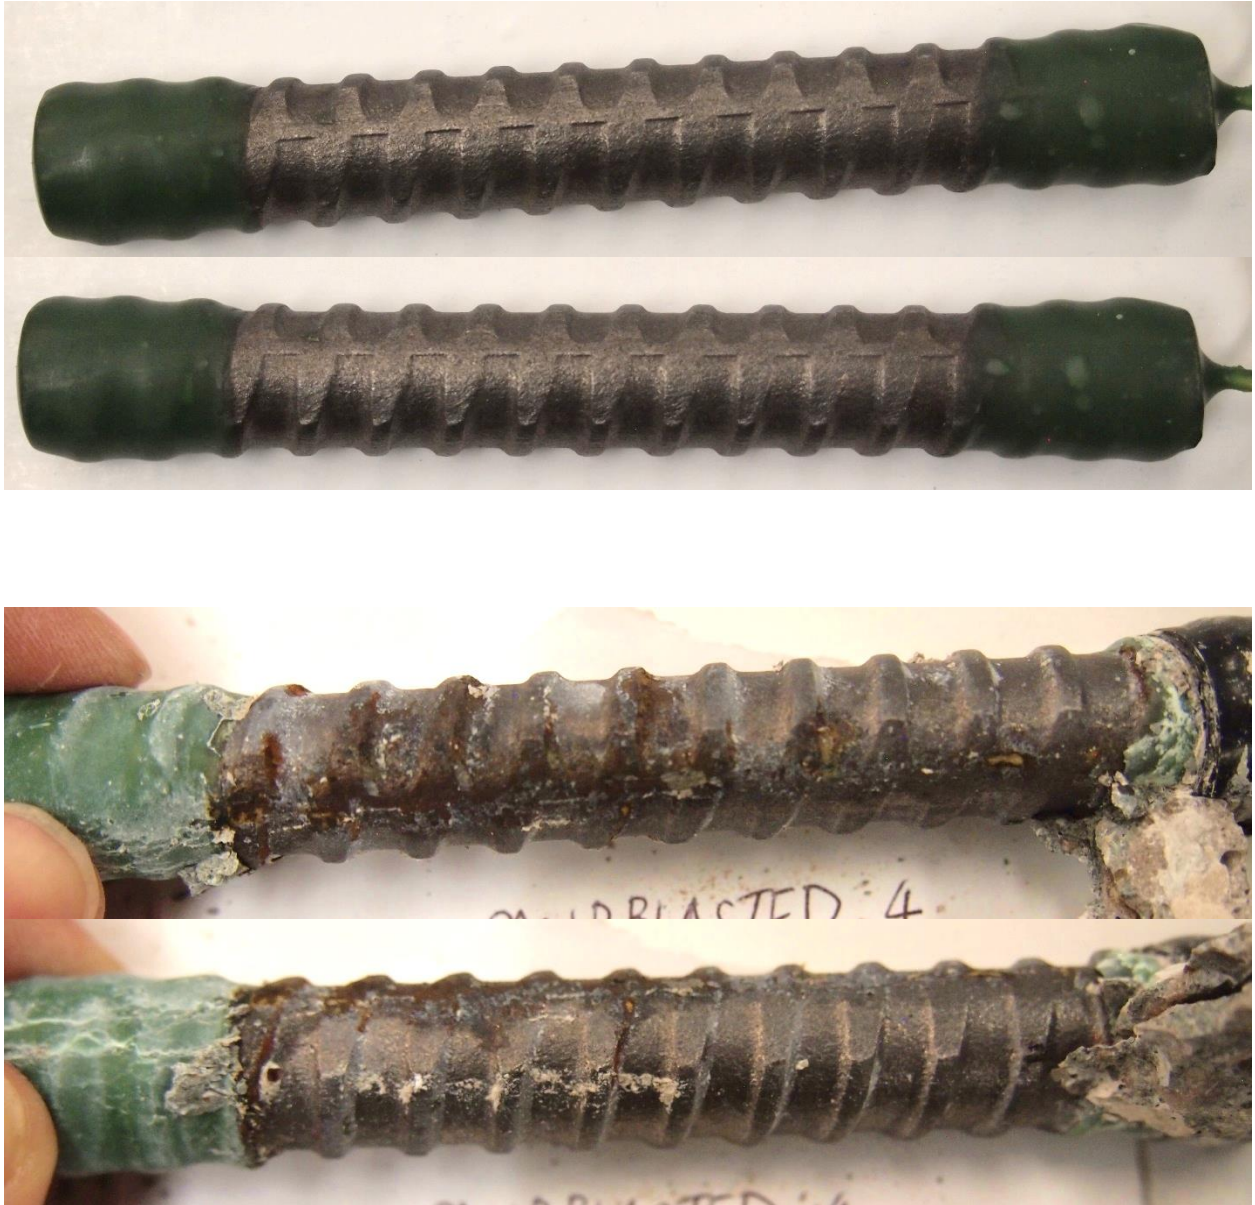
Figure C-18: Specimen SBO-04 before testing (top) and after testing (bottom). Corrosion product observed on rebar surface after testing

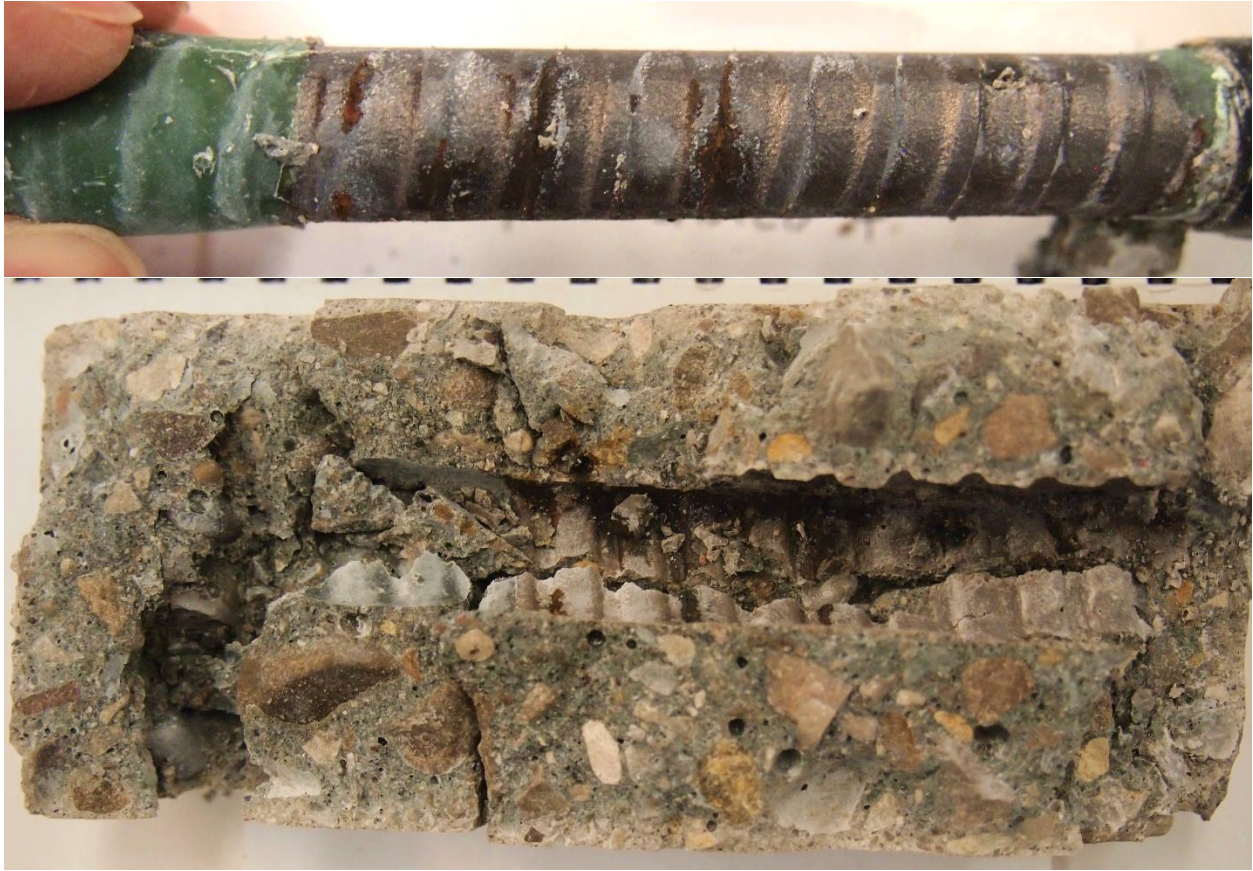
Figure C-19: Corrosion product observed on SBO-04 (top) and (bottom) some corrosion product observed on concrete

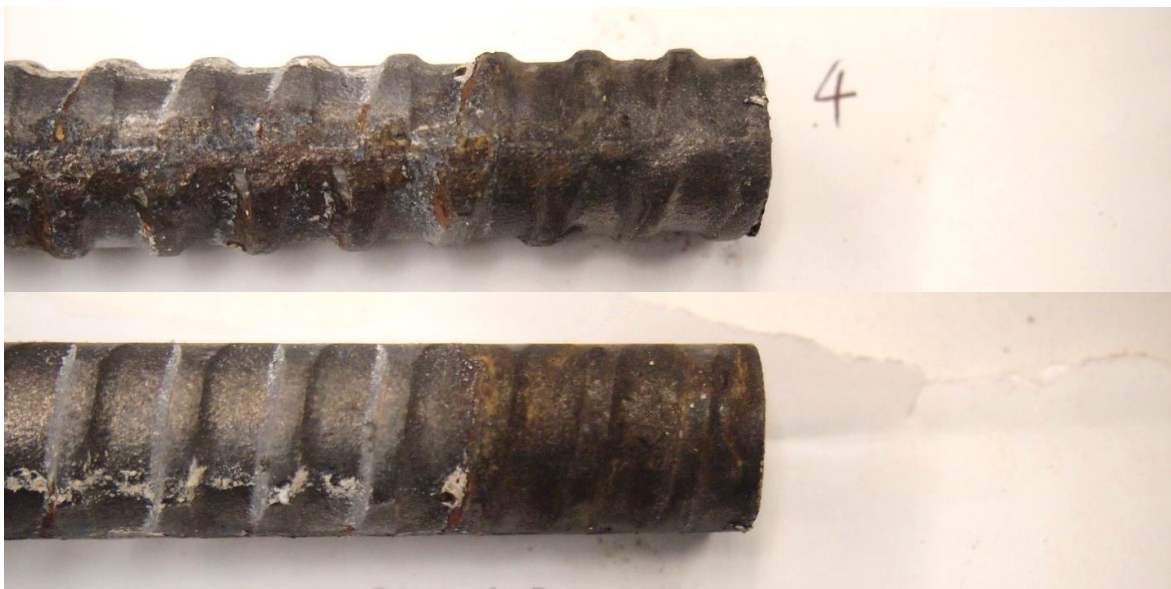
Figure C-20: Corrosion product found under the lacquer at rebar ends on SBO-04 due to crevice corrosion

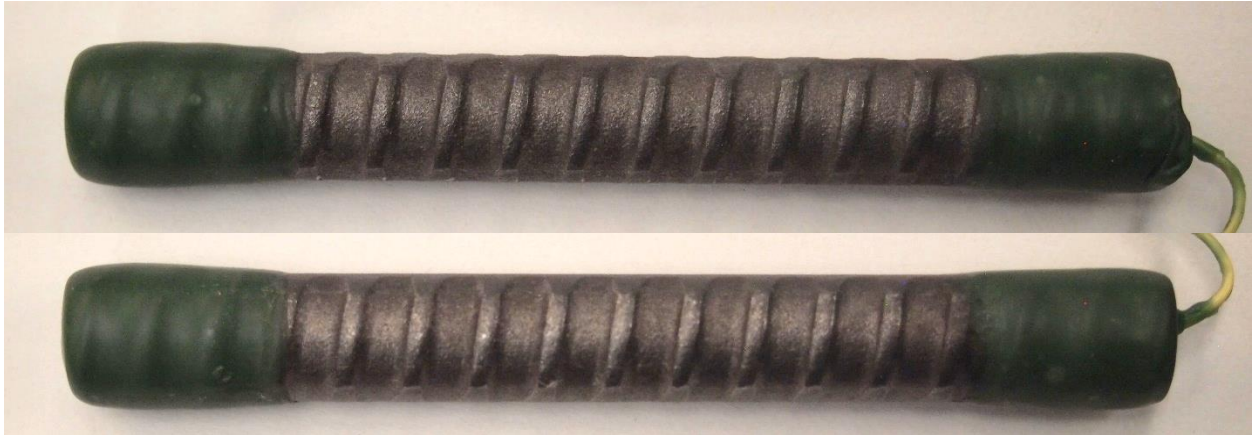
Figure C-21: Specimen SBO-05 before testing (top) and after testing (bottom)

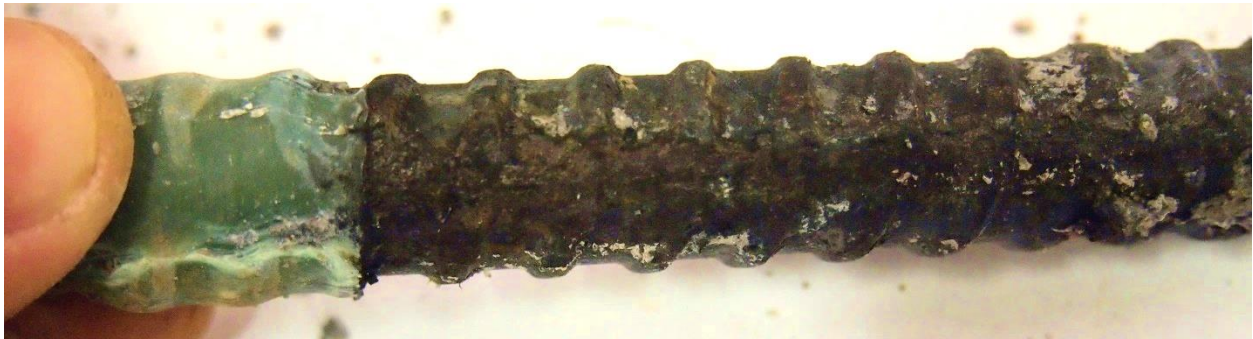
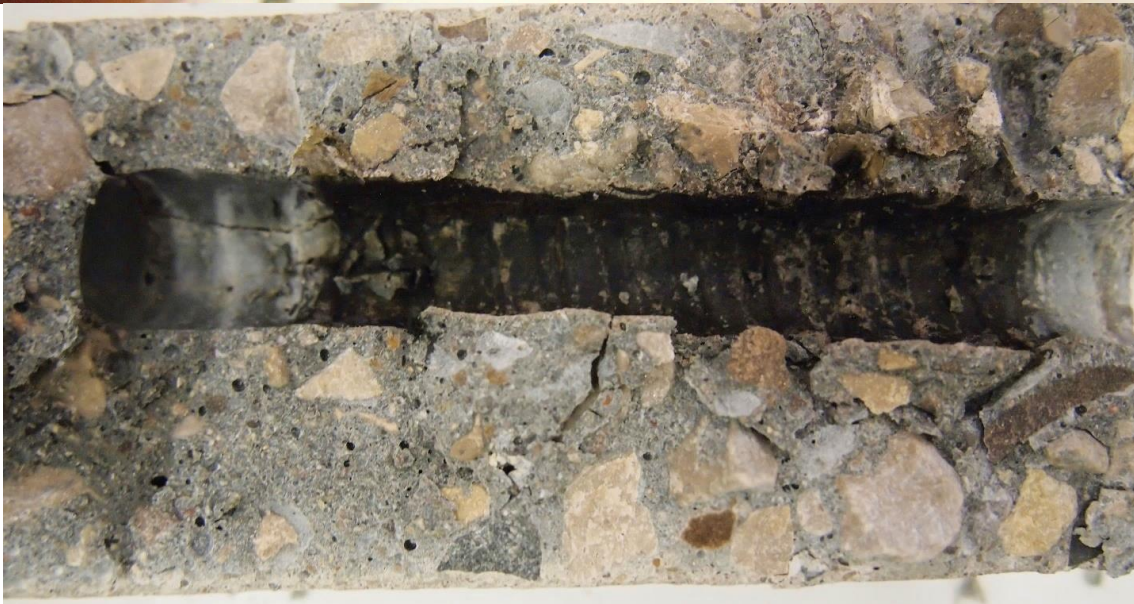
Figure C-22: Specimen SBO-06 before testing (top) and after testing (bottom). Corrosion product observed on rebar and on concrete surface in contact with rebar

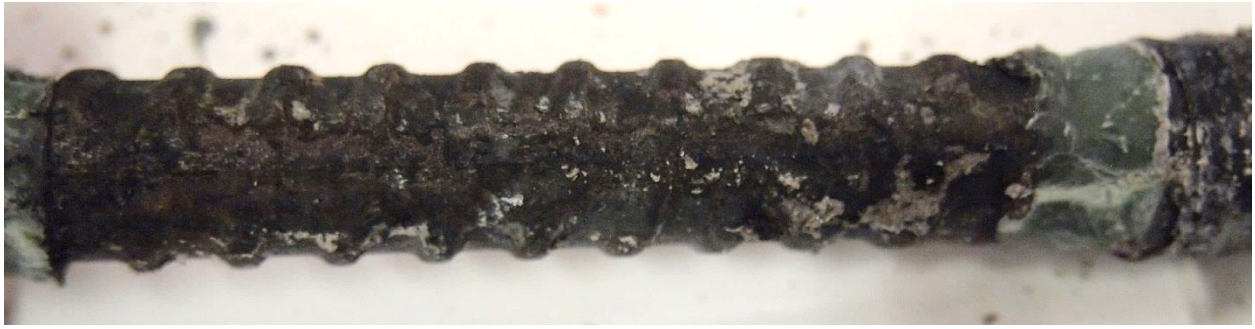
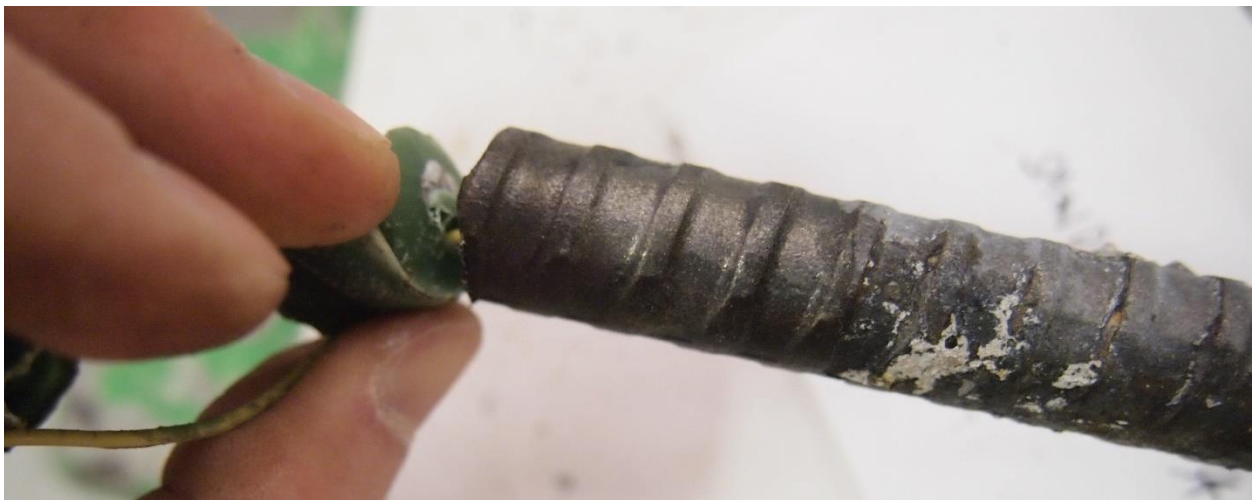
Figure C-23: Corrosion product observed on surface of SBO-06 (top). No corrosion product was found when lacquer at rebar ends were removed
