Quasi-Static, Cyclic, and Fracture Characteristics of Plasma Transferred Wire Arc
(PTWA) Thermal Sprayed AlSi Cylinder Bores

A thesis

presented to the University of Waterloo

Waterloo, Ontario, Canada, 2022

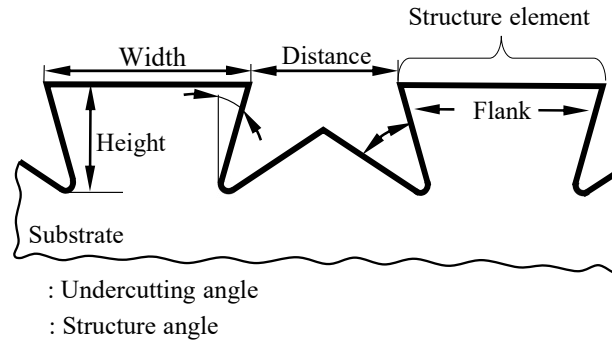
Fig. 3 Geometry of dovetail profile surface activation pattern [17].

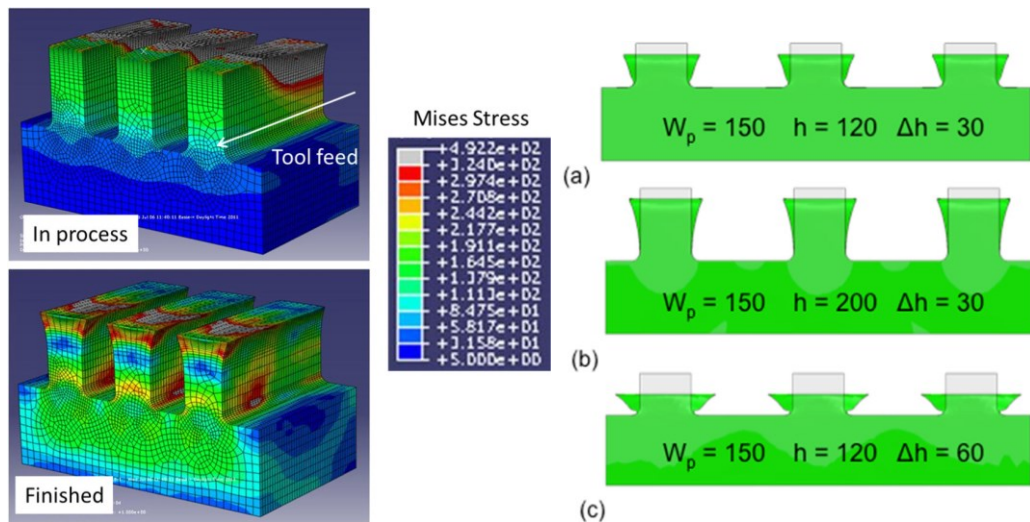
Fig. 4 Mises stress during/after deformation for 10 um peak width, 200 um peak height, 15 um crush and different profile parameters (a), (b), and (c) with FEA shape predictions [18].

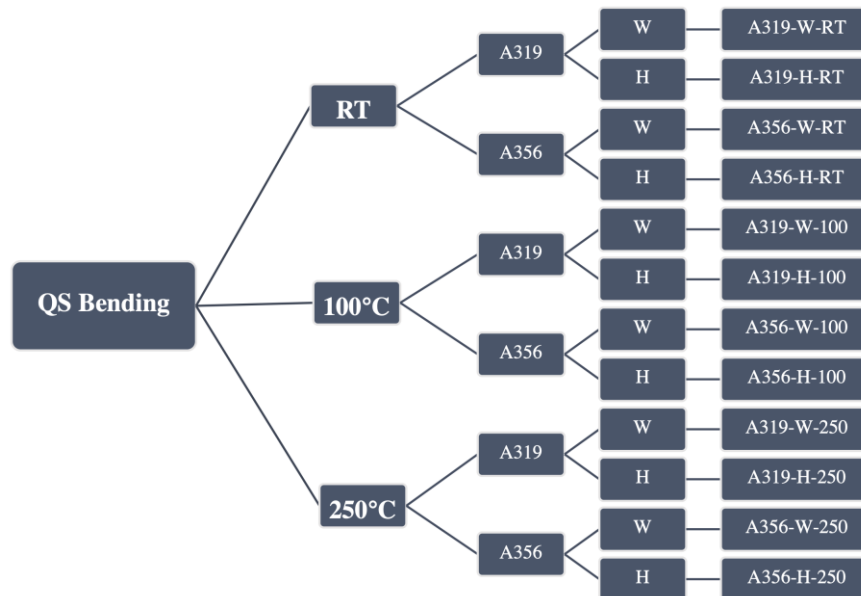
Fig. 20 Test plan showing the twelve combinations of the two substrates, two orientations, and three temperature conditions.

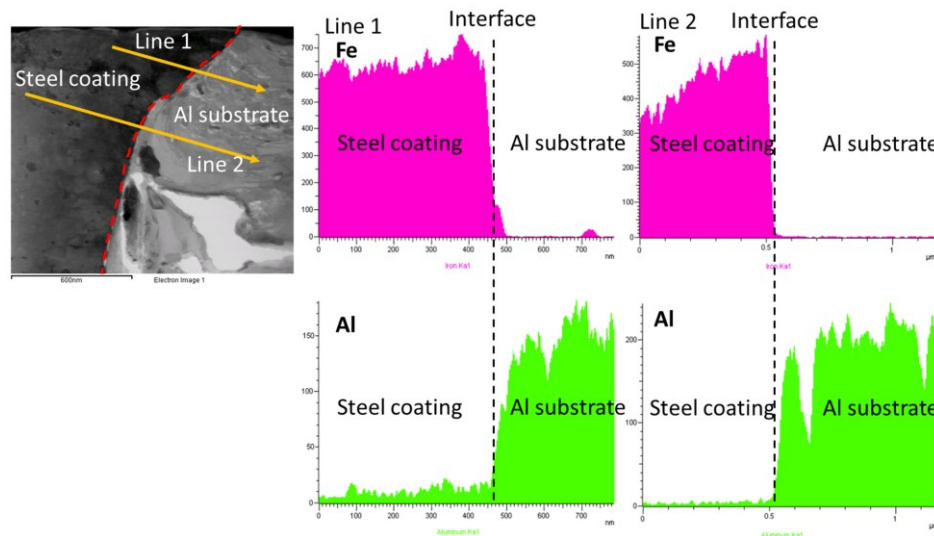
Fig. 29 EDX line scanning across the steel coating and Al substrate interface.

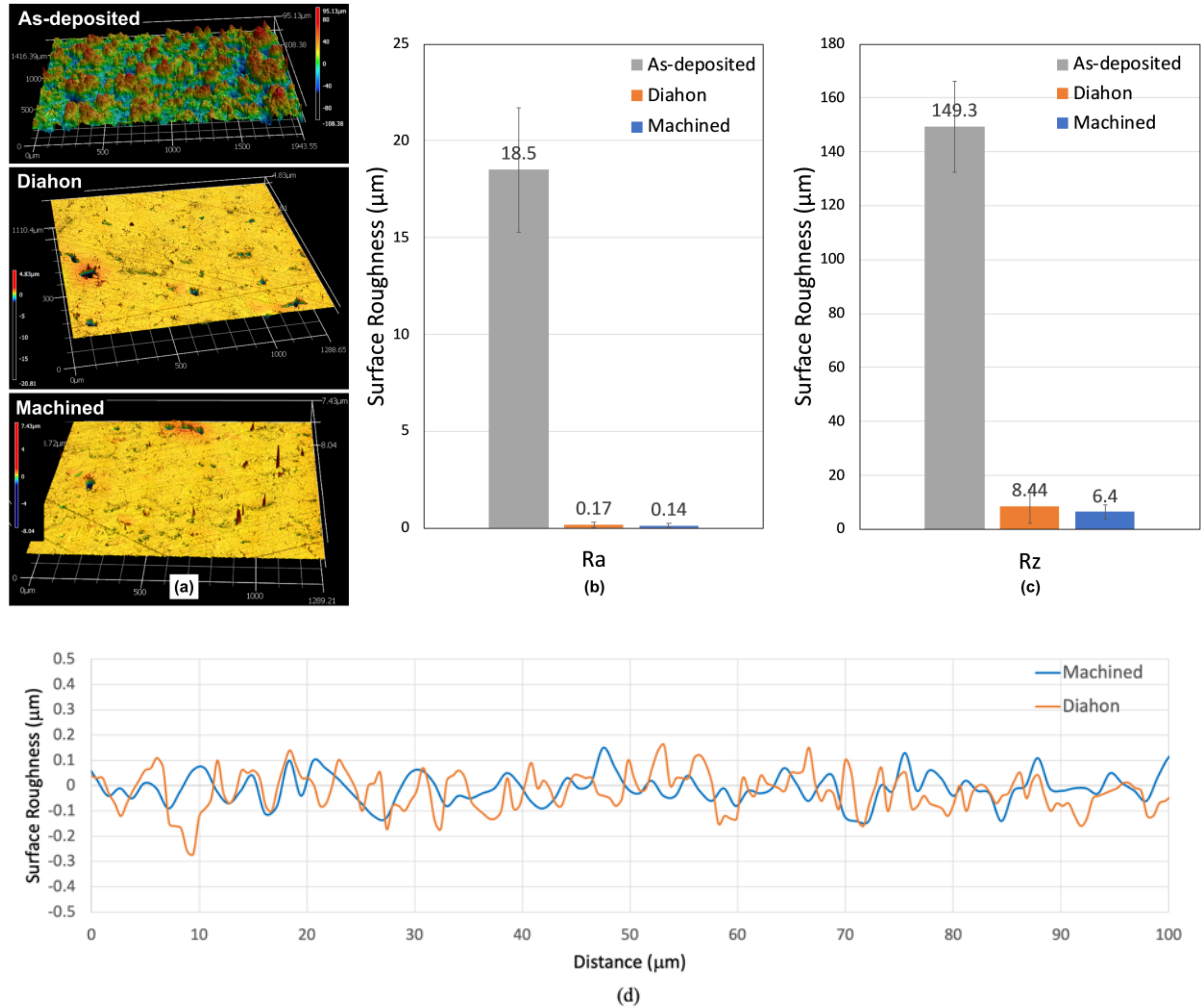
Fig. 30 Comparison of as-deposited, diahon, and machined samples in terms of (a) surface roughness, (b) average surface roughness (R_a), (c) difference between tallest peaks and deepest valleys at the surface (R_z), and (d) trace of surface roughness line profiles excluding large pores.

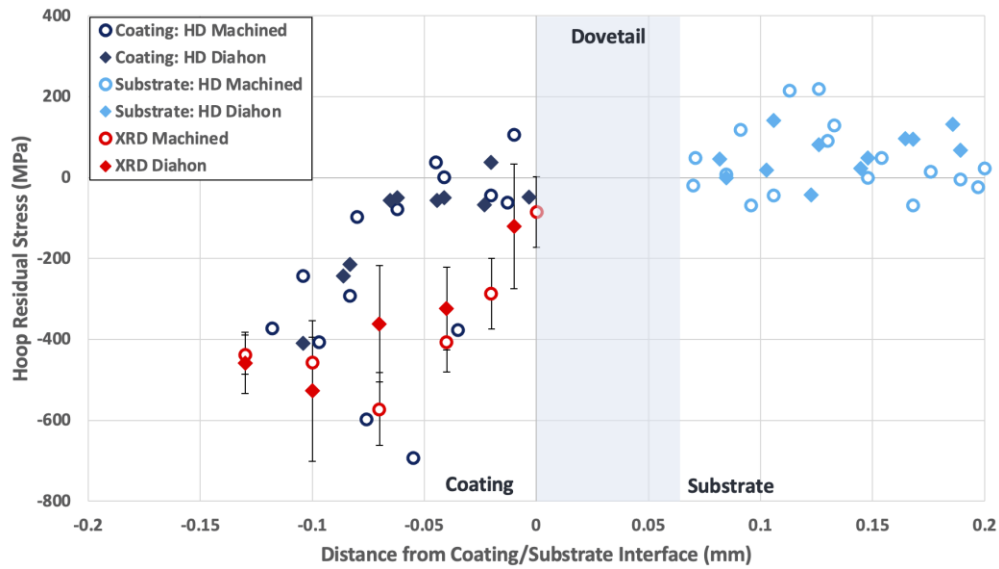
Fig. 33 Residual stress distribution across the coatings using hole-drilling method and XRD methods, and substrate using hole-drilling for machined and diahon samples.

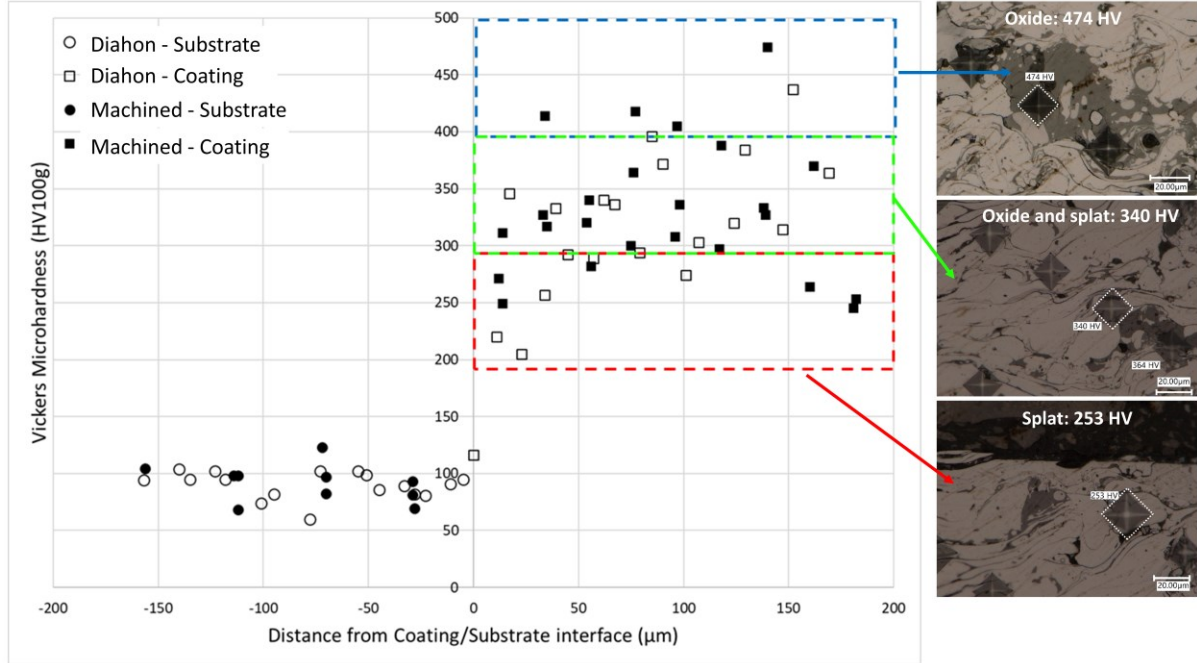
Fig. 34 Vickers micro-hardness distribution across the coating thickness of the post-processed samples.

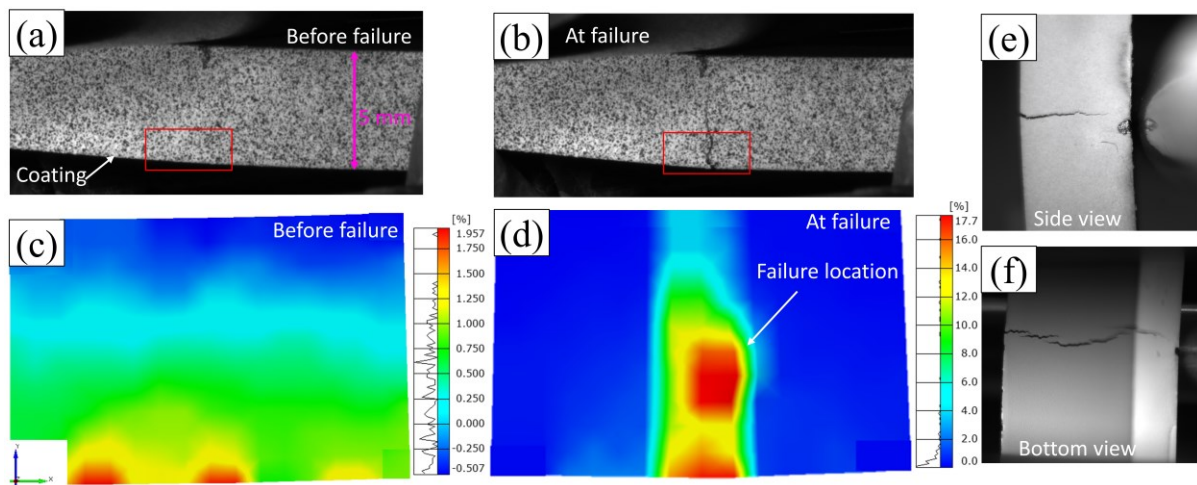
Fig. 52 Three-point bending tests using DIC and video camera system showing (a) the sample before failure, (b) the sample at the time of failure, (c) strain distribution along x-direction before failure, (d) strain distribution along x-direction at the time of failure, (e) side view of the fracture location, and (f) bottom view of the fracture location.
