# On the Fire Performance of Exterior Wall Materials and Assemblies

A thesis  
presented to the University of Waterloo  
in fulfillment of the  
thesis requirement for the degree of  
Master of Applied Science  
in  
Mechanical Engineering

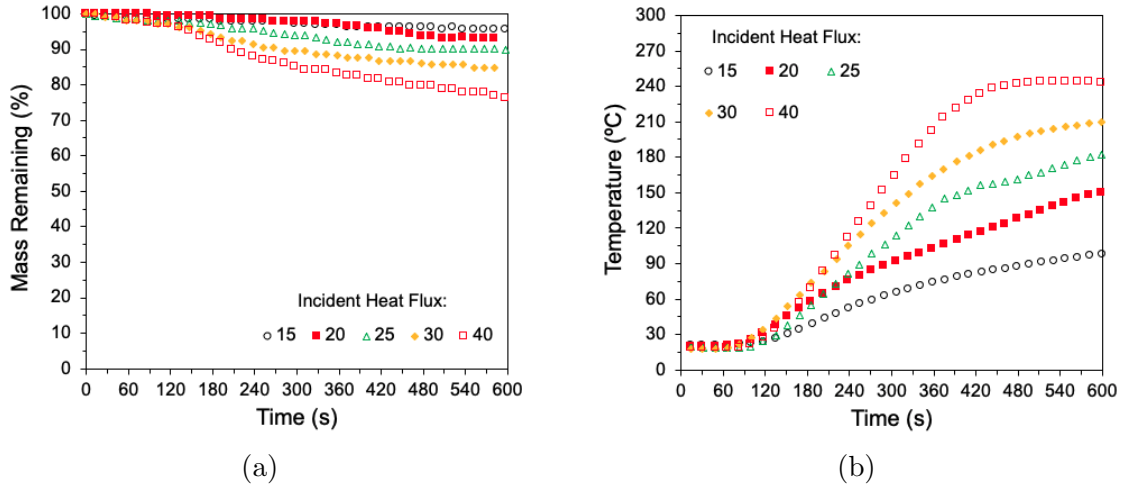
Figure 3.9: Averaged time–resolved traces of a) mass remaining and b) slab centre temperature profiles for polyisocyanurate insulation tested in the cone calorimeter below 50 kW/m<sup>2</sup> flux

The results of cone calorimeter testing of polyisocyanurate insulation specimens under incident heat flux exposures of 15 kW/m<sup>2</sup> through 40 kW/m<sup>2</sup> are presented in Figure 3.9, where time–histories of mass loss and temperatures recorded at the specimen’s mid–depth are shown separately in Figures 3.9a and 3.9b, respectively.

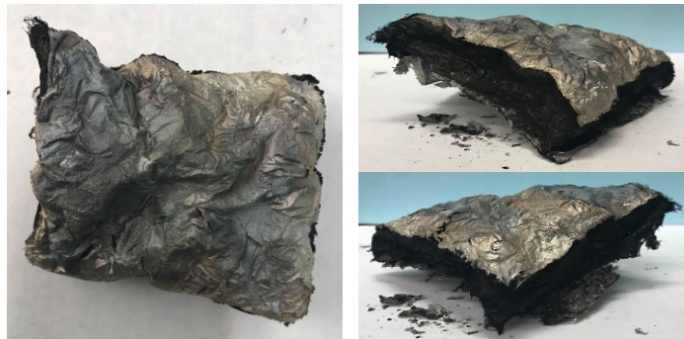
Figure 3.12: The state of exposed surface and lateral sides of polyisocyanurate insulation samples after exposure to (a) 50 kW/m<sup>2</sup>, (b) 60 kW/m<sup>2</sup> and (c) 75 kW/m<sup>2</sup> of external incident heat flux in the cone calorimeter

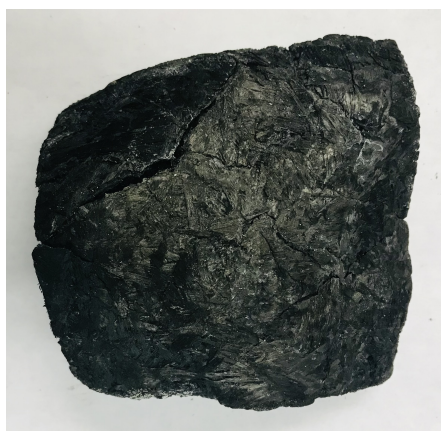
Figure 3.19: The state of the oriented strand board sample post exposure to 25 kW/m<sup>2</sup> incident heat flux in the cone calorimeter

As the test progressed, degradation of the oriented strand board sample surface continued, marked by partial delamination of wood strands on the exposed face and dark brown and black discoloration. Near the end of the 900-second radiant heating period, a carbon layer had also formed on the exposed face of the strand board, leading to post-test samples similar to that depicted in Figure 3.19 for exposure to 25 kW/m<sup>2</sup> heat flux. The residual char encompassed almost all of the exposed surface; due to this, not all of the specimen mass was consumed by the end of the experiments. Instead, the total mass loss calculated at the end of each test was 64.6%, 80.2%, and 87.6% for exposure to 15 kW/m<sup>2</sup>, 20 kW/m<sup>2</sup>, and 25 kW/m<sup>2</sup> heat flux, respectively.

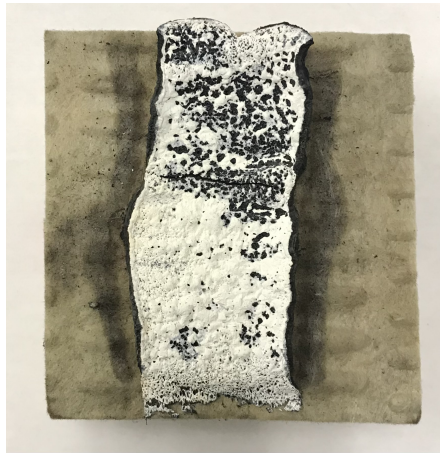
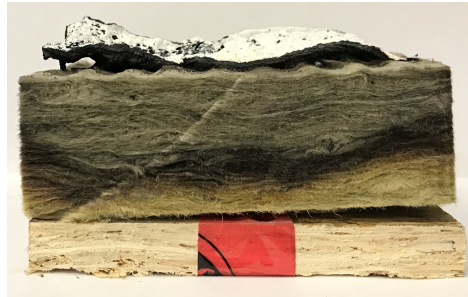
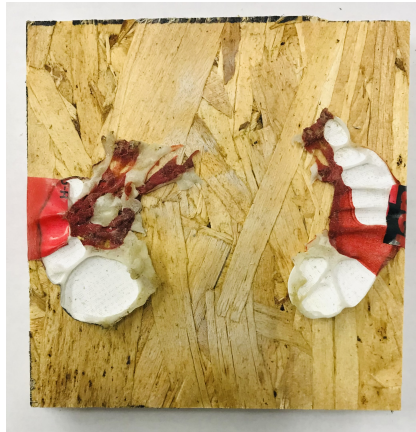
Figure 3.23: The state of Sandwich #1 assembly following the exposure  $50 \text{ kW/m}^2$  flux in the cone calorimeter, photographs of a) the exposed sandwich surface, b) its lateral side, and c) exposed surface of the underlying house wrap and oriented strand board

In contrast to heating with the lower heat fluxes discussed above, Sandwich #1 samples ignited and burned when subjected to an incident heat flux of 50 kW/m<sup>2</sup>. At these levels of heat flux, the vinyl siding first softened, buckled, and shrunk while releasing pyrolysis gases. Under continued exposure char began to form. Subsequently, the pyrolysis gases ignited with sustained flaming confined to the vinyl siding layer of the sandwich. Thus, the sequence of events leading to ignition of the siding material was identical to that discussed for tests conducted on individual samples of the siding material under the same external irradiance. Following ignition, the vinyl siding continued to char and by the end of the test, a charred residue was left behind on the exposed sandwich surface as depicted in Figure 3.23a. Under the combined influence of increased external irradiation and flame heat feedback from the burning vinyl siding above, the underlying layer of stone wool insulation discoloured significantly, with brown–to–taupe tones across the exposed surface and down the sides. This can be seen in Figures 3.23a and 3.23b. The variations in colour and sequence of discolouration patterns were indicative of thermal degradation processes such as binder decomposition and oxidation of organic and siliceous content in the insulation. Due to the higher level of heating throughout the sandwich, the weather resistant barrier melted significantly, depicted in Figure 3.23c, although no noticeable changes were observed on the exposed surface of the underlying oriented strand board sheet. Thus, it appears that the levels of thermal penetration through stone wool insulation were high enough to result in melting of house wrap, but still too low to promote surface charring in the underlying oriented strand board.

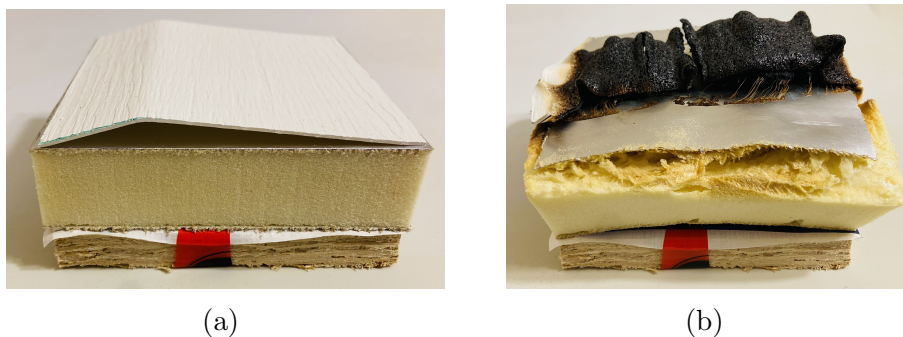
Figure 3.25: The state of Sandwich #2 samples (a) before and (b) after exposure to 15 kW/m<sup>2</sup> external incident heat flux in the cone calorimeter

The after test state of a Sandwich #2 sample following exposure to incident heat flux of  $15 \text{ kW/m}^2$  is shown in Figure 3.25. Consistent with expectations, the layer of vinyl siding on the exposed sandwich surface charred leaving behind a carbon–rich residue similar to that presented for tests on individual samples of vinyl siding under the same imposed irradiance. The behaviour of the siding material under thermal heating was consistent in both cases as well. The siding initially shrunk buckling towards the centre of the exposed sandwich surface as can be seen from Figure 3.25b. This left the underlying polyisocyanurate insulation face partially exposed to heating from the conical heater within a minute after the onset of exposure. As the test progressed, thermal degradation of the polyisocyanurate intensified and the material expanded, creating a series of gaps in the foam core under the exposed foil facer. Interestingly, the integrity of the foil layer was not compromised as it was still attached to the foam core beneath. Upon closer examination of the after test state of the insulation, it was found that the foam expanded by about 10.5 mm (on–average) beyond the perimeter of the foil; this is shown in Figure 3.26 where the perimeter of the foil layer is marked with the thick white border. In addition to cracking and expansion of the foam, significant orange–to–brown tones of discolouration were observed within an area measuring approximately  $45 \text{ mm} \times 100 \text{ mm}$  at the centre of the exposed insulation surface. This area matched the footprint of the charred residue from the vinyl siding above, suggesting that the heat conducted through the upper layers was sufficient to initiate and sustain pyrolysis of the foam just below the foil facer. Slight surface charring of the polyisocyanurate foam can also be noticed at each end of the discoloured strip where the expanded foam was in direct contact with (and under) the edges of the charred siding residue.

Unlike the vinyl siding and polyisocyanurate insulation, there were no noticeable changes in the weather resistant barrier and oriented strand board layers, again likely due to the insulating effect of the polyisocyanurate foam which slowed the rate of thermal penetration to those bottom layers.

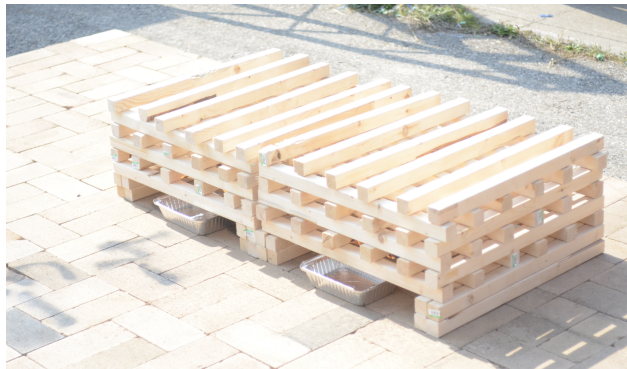
Figure 4.7: Two wood cribs placed side by side representing a 500 kW design fire

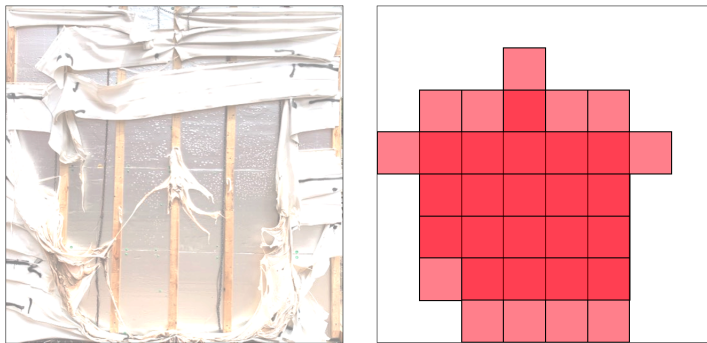
Figure 4.9: Damage contour observed on Wall #2

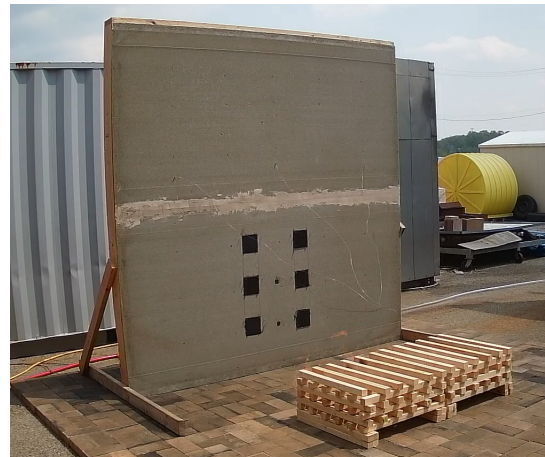
(b) “Blank” Wall Photograph

Figure 4.14: Placement of heat flux gauges on the fire-side surface of the “blank” wall: a) schematic diagram and b) photograph of the instrumented wall

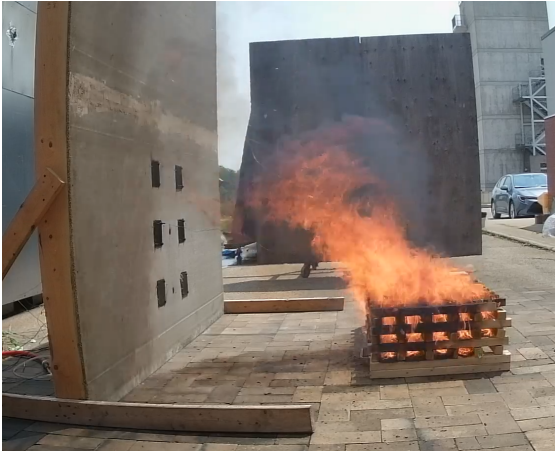
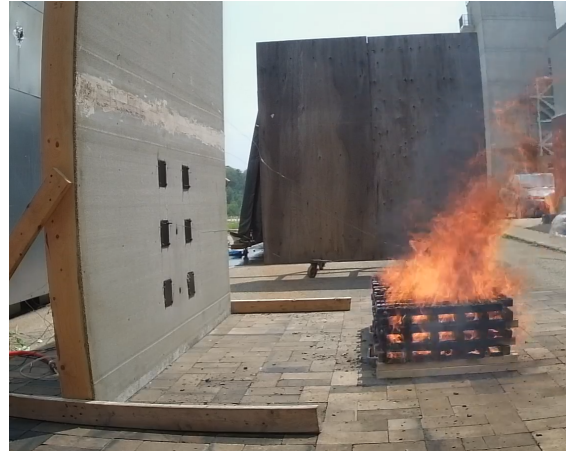
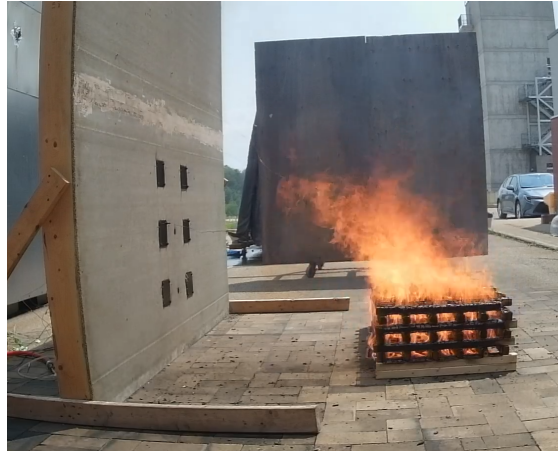
Figure 4.17: The proximity of the design fire flame tilt relative to the fire-side wall face at test times of a) 10 minutes, b) 12.5 minutes, and c) 15 minutes

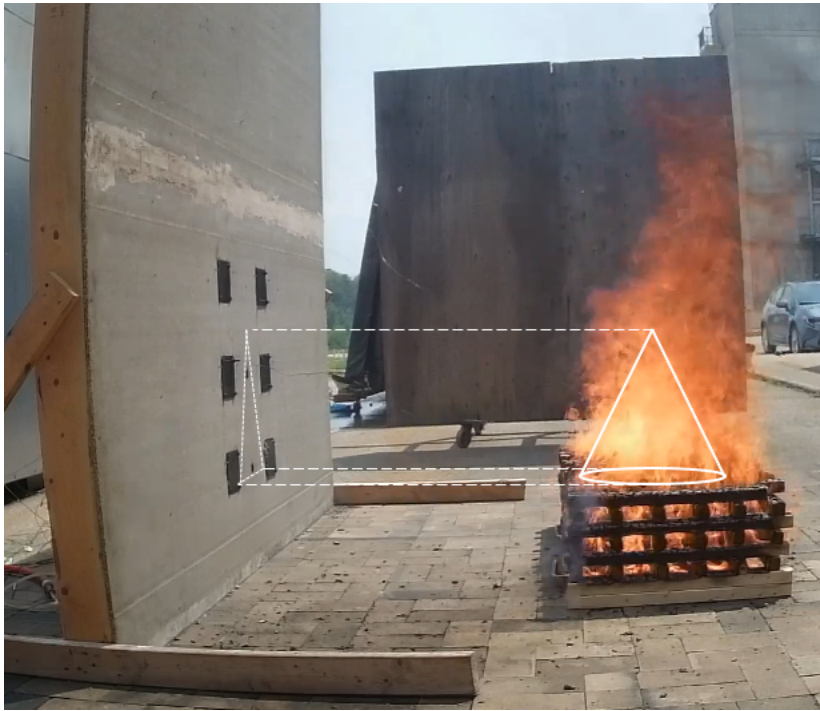
Figure 4.20: The design fire plume core and its projection onto the exposed wall surface

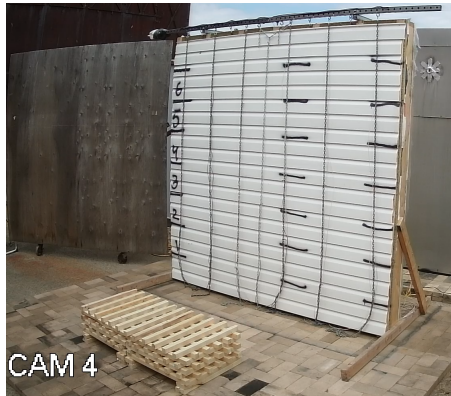
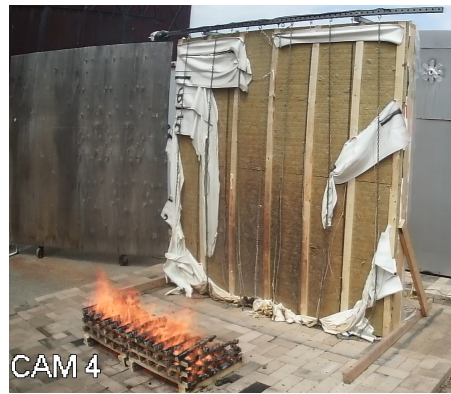
Figure 4.21: The extent of damage on fire-side Wall #1 face at select times for events listed in Table 4.5

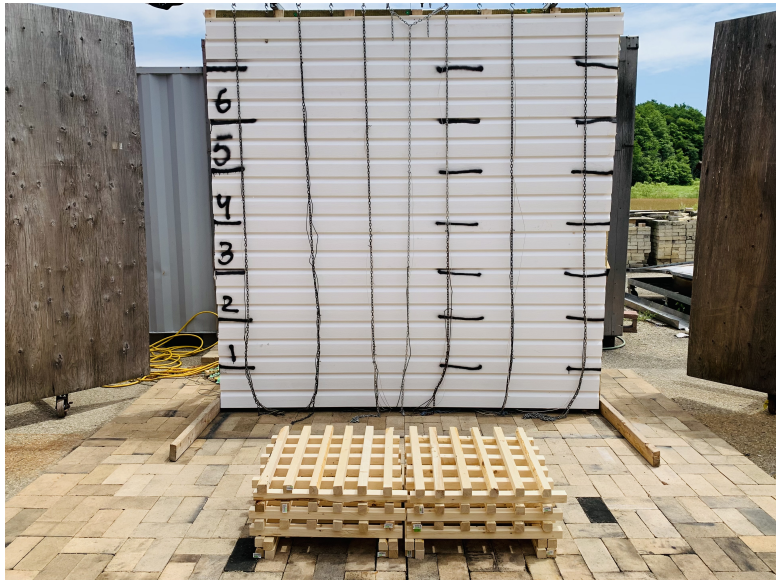
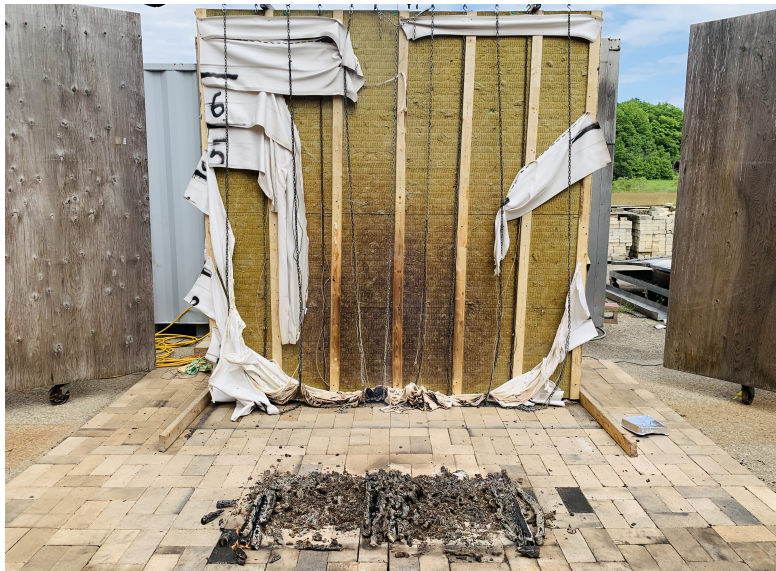
Figure 4.22: The state of exposed Wall #1 face (a) before and (b) after exposure to the total incident heat flux from the design fire

The state of the fire-side (exposed) face of Wall #1 before and after exposure is shown in Figure 4.22. Consistent with small-scale results seen for vinyl siding when tested in Sandwich #1 (Section 3.4.2) scaled assemblies, the layer of vinyl siding on the exposed wall surface softened and buckled shortly after the onset of exposure to radiant heat from the wood crib fire. Under continued exposure, the siding material started to melt and sag towards the bottom of the wall assembly, detaching at the nails. This left the underlying stone wool partially exposed to the incident heat flux from the design fire. As a result, the bottom central portion of stone wool insulation face discoloured on the fire-side, seen as tones of orange to brown in Figure 4.22 and indicating significant thermal degradation following the exposure. The thermal damage was consistent with signs of binder decomposition noted previously in post exposure samples of stone wool insulation tested in the cone calorimeter under similar values of heat flux. As can be seen from Figure 4.22, thermal damage for both the siding material and stone wool insulation was greatest across the bottom half of the exposed wall surface. This was because the value of total heat flux from the fire to the exposed wall face, around  $14 \text{ kW/m}^2$  at the peak, was highest across this region (Section 4.6.1). There were no noticeable changes in colour or geometry and charring was not evident in the post-exposure state of either the weather resistant barrier or oriented strand board layers due to the presence of the 32 mm thick continuous slab of stone wool insulation that remained intact throughout the test and shielded these under layers from exposure to the fire.

The accelerated increase in temperature at the mid-depth of the stone wool which began at 10 minutes following ignition corresponded with the collapse of the vinyl siding panels on the outer face of the wall and resulted in the stone wool face being exposed to the fire. This was supported by the photograph of the fire-side wall face taken at 13 minutes and 22 seconds after ignition (Figure 4.21e). Interestingly, this time also marked the onset of temperature rise at the mid-depth of the underlying oriented strand board, possibly suggesting that heat conducted into and retained in the stone wool began slowly penetrating further into the bulk of the wall assembly towards the unexposed side. This was further supported by the temperature-time traces “B” and “C” in Figure 4.23 recorded after 15 minutes and 48 seconds, where temperatures measured at the stone wool mid-depth gradually decayed due to decay of the fire, while the interior temperature of oriented strand board continued to rise. Thermal penetration through the bulk of the wall assembly appeared to continue after nearly complete consumption of the wood cribs (30 minute mark), as the stone wool temperature dropped from 102°C to 72°C, while temperature in the oriented strand board rose from around 42°C to 47°C between 30 and 45 minutes following ignition, respectively. To further visualize the two dimensional variation of temperature at various depths into the wall, contour plots of temperature are contained in Figures 4.25a and 4.25b for the mid-planes of the stone wool insulation and oriented strand board, respectively, at 45 minutes following ignition. Please note the difference in the colourbar scale limits on the subplots of Figure 4.25. As can be seen, maximum thermal penetration into all layers of wall assembly aligned with the highest incident heat flux across the lower region of the wall and temperatures varied both horizontally and vertically across both planes. On the backside of the wall, at the mid-depth of the in-cavity batt insulation and mid-depth of the wood studs, average temperature increases were minimal; at the end of the test these temperatures had risen only 0.4°C and 0.6°C, respectively, consistent with these layers remaining insulated from any incident radiation by the stone wool insulation.

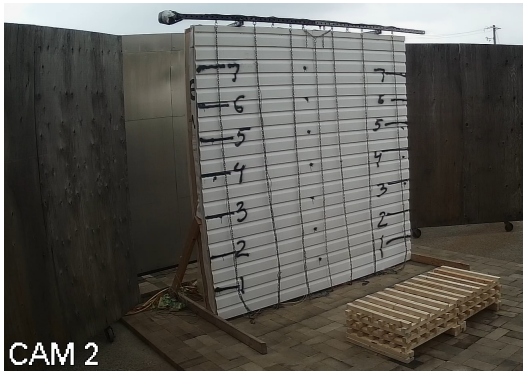
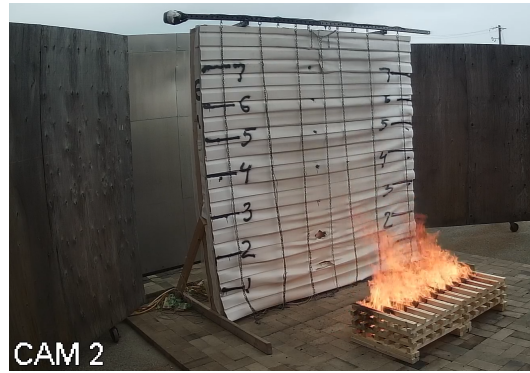
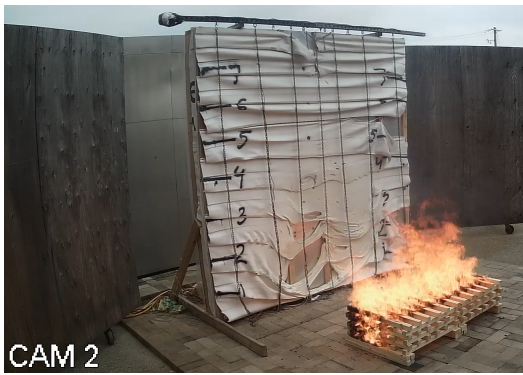
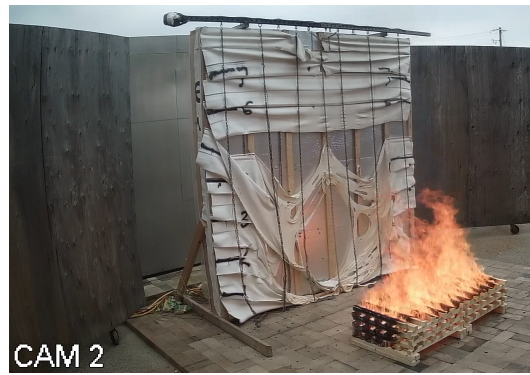
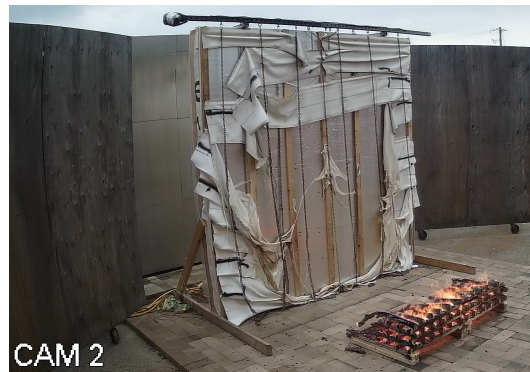
Figure 4.27: The extent of damage for Wall #2 at select times for events listed in Table 4.7

Table 4.7 lists the timeline of experimental observations (events) recorded during the test. These describe the thermal response of the wall as observed on the fire-side surface. Events marked in **bold** in Table 4.7 are paired with video images and still camera photographs that depict the extent of thermal damage in Figure 4.27.

Test Time (mm:ss)	Event
00:00	Ignition of fuel trays marked the beginning of the test. The initial state of the wall assembly is depicted in Figure 4.27a.

Test Time (mm:ss)	Event
<b>08:15</b>	Softening of siding panels at the top of the wall assembly. Tears in the melted siding film appeared as panels affixed at 915 mm wall height receded towards the edges of the wall melting away from the wall centre. Tears in the melted siding film at 305 mm and 610 mm wall heights extended significantly revealing the face of the underlying polyisocyanurate insulation. The state of the wall at this time is depicted in Figure 4.27b.

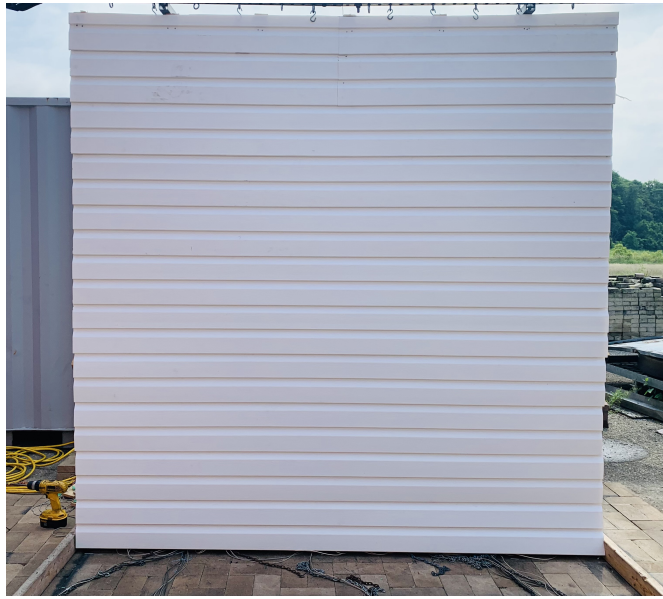
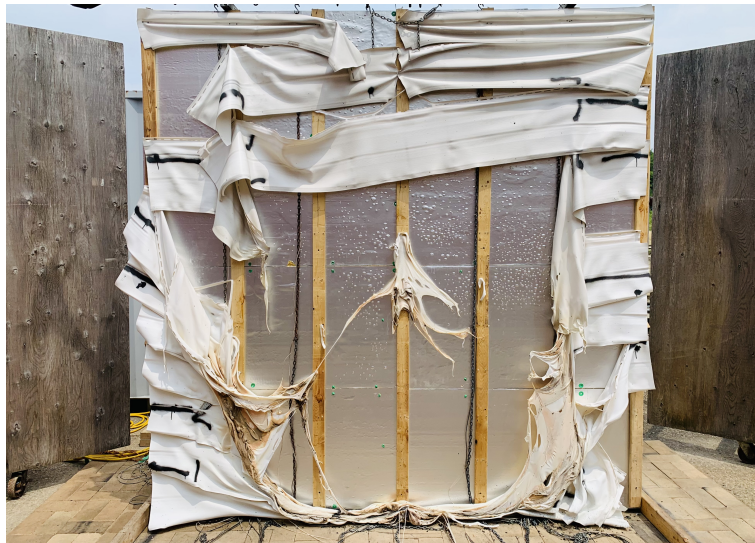
Figure 4.28: The state of exposed Wall #2 face (a) before and (b) after exposure to the total incident heat flux from the design fire

The state of the fire-side (exposed) face of Wall #2 before and after exposure is shown in Figure 4.28. Consistent with small-scale results seen for vinyl siding when tested in Sandwich #2 (Section 3.4.2) scaled assemblies, the layer of vinyl siding on the exposed wall surface softened and buckled shortly after the onset of exposure to radiant heat from the wood crib fire. Under continued exposure, the siding material started to melt and sag towards the bottom of the wall assembly, detaching at the nails. As can be seen from Figure 4.28b, melted siding panels left the underlying polyisocyanurate insulation face partially exposed to the incident heat flux from the design fire, especially along the bottom and middle central portions of the fire-side wall surface. Thermal damage for the siding layer appeared to be greatest across the bottom half of the exposed wall surface supported by significant charring of the melted panels. This was because the value of total heat flux from the fire to the exposed wall face, around 14 kW/m<sup>2</sup> at the peak, was highest across this region (Section 4.6.1). Interestingly, the state of post-exposure wall face also showed a frequent spotting of bubbles beneath the surface of the protective foil facer on the polyisocyanurate insulation board in the middle and upper central portions of its exposed face. This could possibly suggest that the foam core of the insulation material degraded under heating which resulted in expansion of the material and release of gaseous volatiles that remained trapped underneath the foil facer. Similar observations were noted previously when this material was tested under low levels of incident heat flux in the cone calorimeter (Section 3.4.1). There were no noticeable changes in colour or geometry and charring was not evident in the after test state of either the weather resistant barrier or oriented strand board layers since they were shielded from exposure to the fire by to the presence of the 25 mm thick continuous slab of polyisocyanurate insulation that remained intact throughout the test.

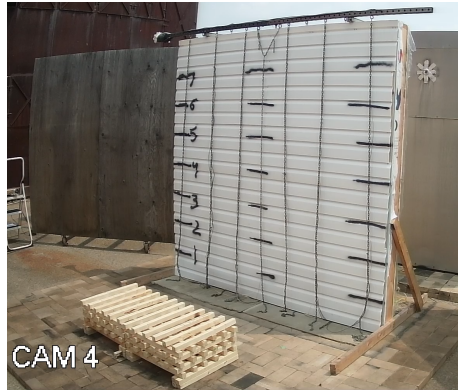
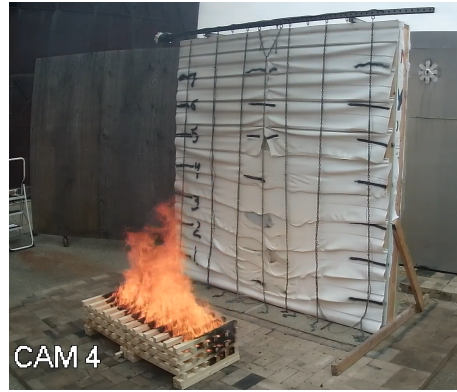
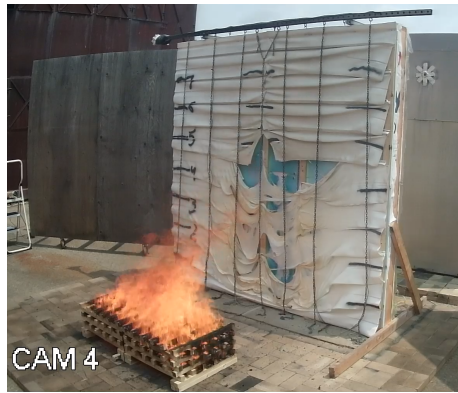
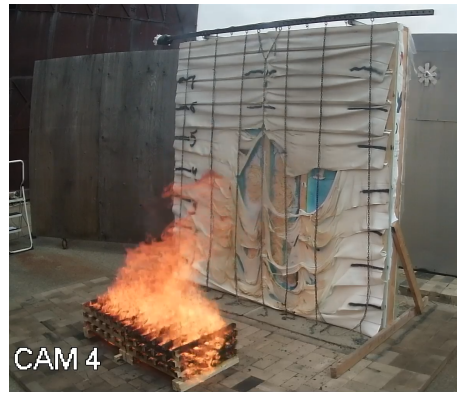
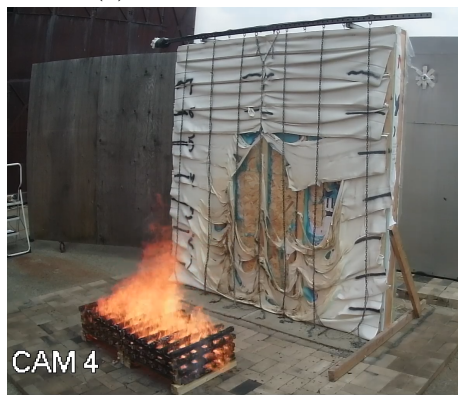
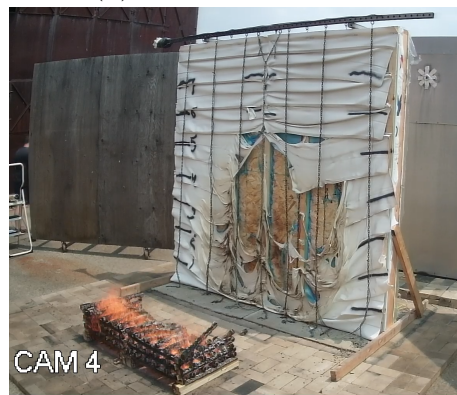
Figure 4.35: The extent of damage for Wall #3 at select times for events listed in Table 4.9

12:58	<p>Surface charring of the exposed strand board face extended to the wall mid-level.</p>
<b>15:50</b>	<p>No further change in the state of the wall regarding thermal damage.</p> <p>The final state of the wall assembly is depicted in Figure 4.35f.</p>

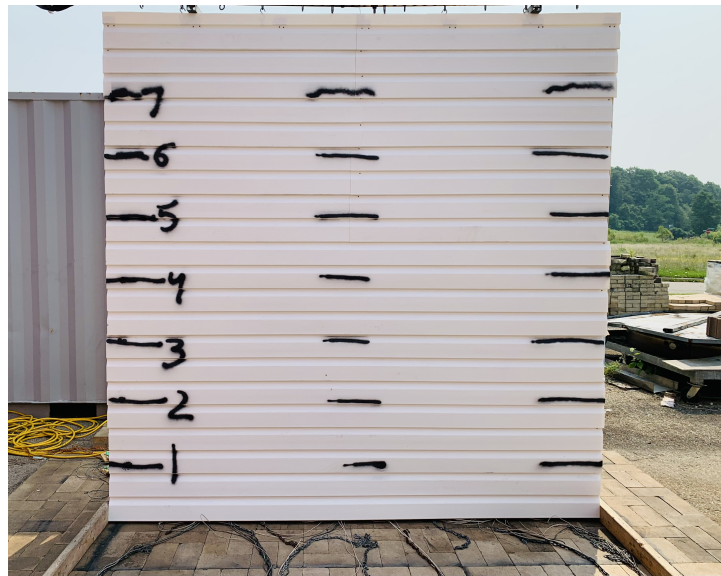
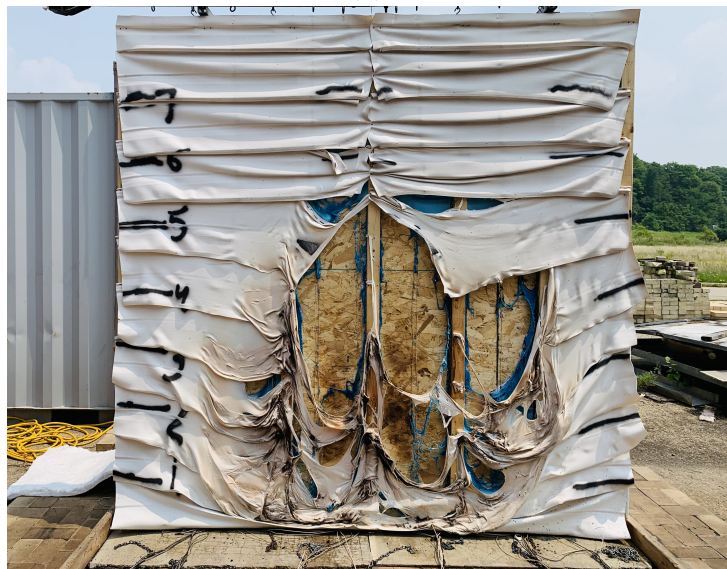
Figure 4.36: The state of exposed Wall #3 face (a) before and (b) after exposure to the total incident heat flux from the design fire
