**Renewal of Potable Water Systems Using Cement
Mortar Lining; an Investigation into Corrosion
Reduction and Water-loss Prevention**

A thesis

presented to the University of Waterloo

Civil Engineering

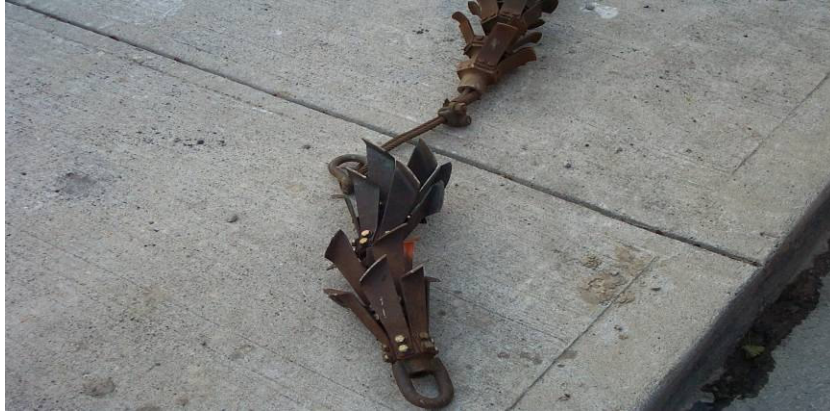
Figure 2-3: Mechanical scraping tool used to clean internal corrosion products.

When access to the watermain has been obtained the process of cleaning the interior of the watermain begins. This is normally done by mechanical scraping of the interior of the pipe. This mechanical scraping is done using the tool shown in Figure 2-3. The mechanical scraping can also coincided with a process of water-jetting to remove the larger tuberculation build up inside of the pipe. After the mechanical scraping has been completed a hard sponge, referred to as a swab, is pulled or pushed through the pipe to remove any remaining tuberculation products as well as standing water in the pipe.

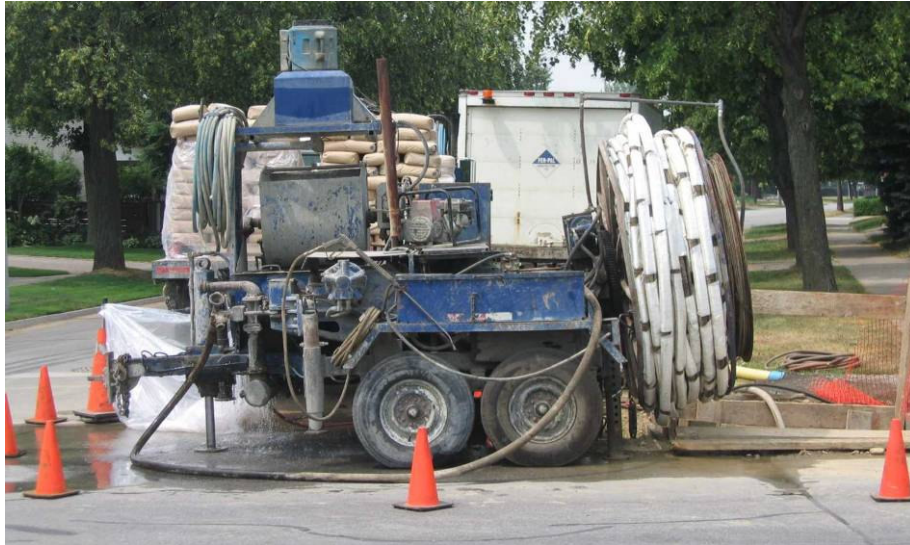
Figure 2-4: Pumping machine where mortar is mixed and pumped into the watermain.

Once the pipe has been cleaned and excess water in the pipe has been removed, the process of applying the cement mortar lining begins. The cement mortar is mixed on the pumping rig (Figure 2-4) where water is added to bring the cement mortar to the desired consistency. The pumping tube is pulled to the receptor pit where lining will begin. Cement mortar is pumped to the receptor pit and once it reaches the required consistency the tube with the trowelling device shown in Figure 2-5 is pulled back through the watermain to the pumping rig. This process of pumping mortar into the pipe just ahead of the mechanical trowel which places it on the pipe wall in the required thickness is the core of the cement mortar lining process. Once the main has been lined and has undergone a significant curing process (usually about 24 hrs) water or air is blown backwards from the house connections to remove the lining from the service taps on the watermain. This must be done while the lining is in the initial stages of curing.

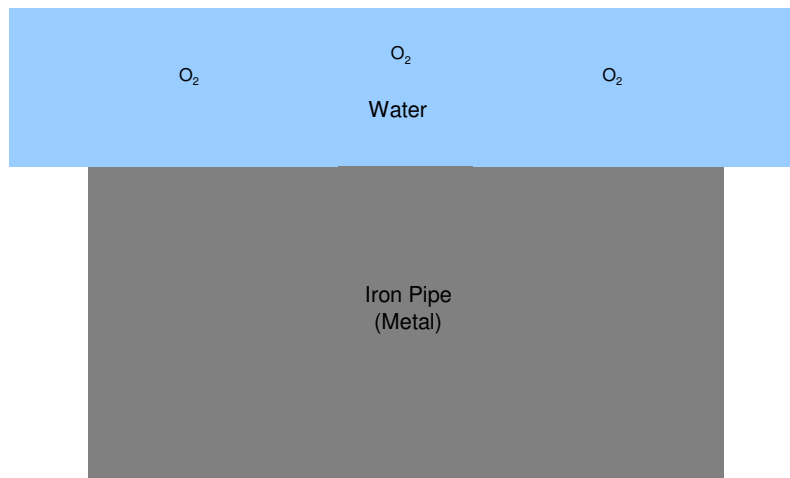
Figure 2-6: Under Deposit Corrosion Process Stage 1. Oxygen content is the same along the pipe. No bacterial growth has occurred. Under-deposit corrosion is not occurring, however, general corrosion is occurring.

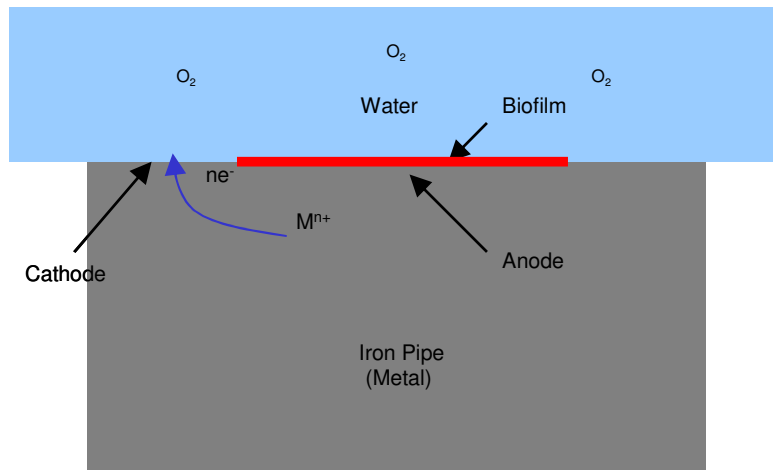
Figure 2-7: Under Deposit Corrosion Process Stage 2: Biofilm of aerobic bacteria forms over portions of the pipe surface. The area under the biofilm becomes deficient in oxygen compared to the surrounding metal. Hence, the area under the biofilm becomes anodic with respect to the uncovered areas. General corrosion is still occurring.

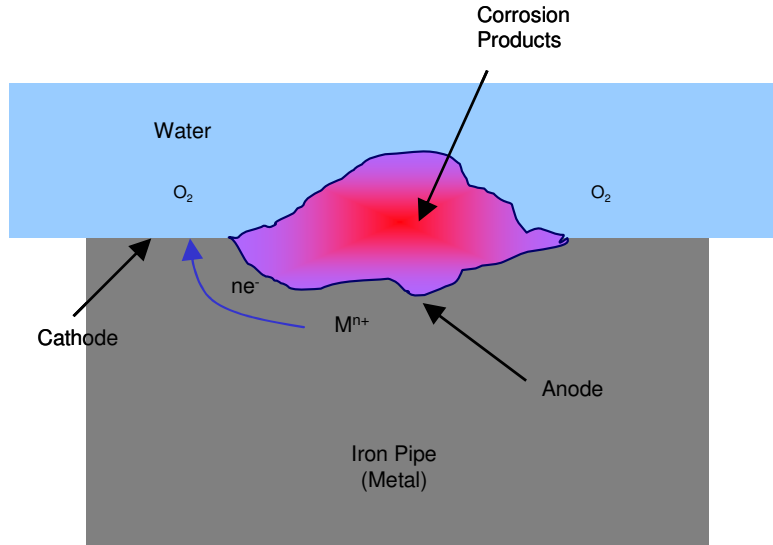
Figure 2-8: Under Deposit Corrosion Process Stage 3: The corrosion products combine with bacteria to create tubercles, further limiting oxygen movement into the area of metal loss. (Under deposit corrosion is an *Autocatalytic* process)

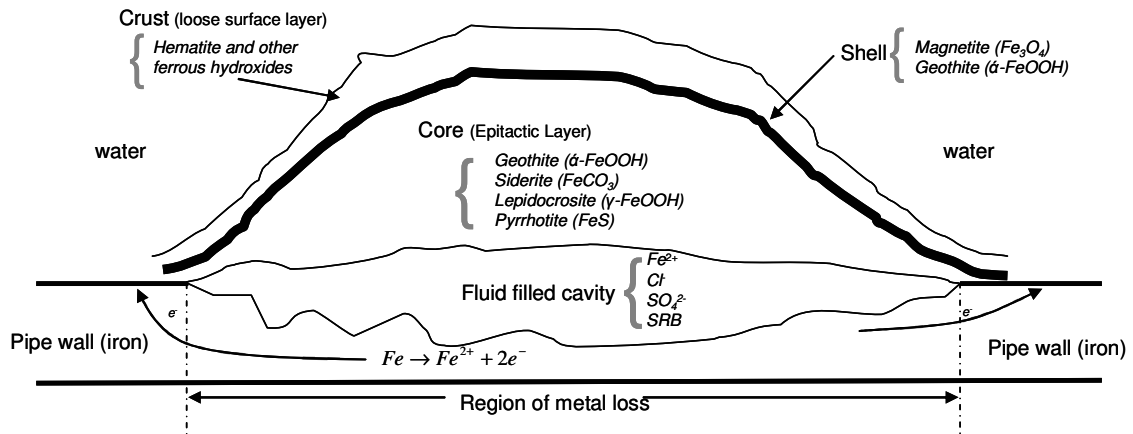
Figure 2-9: Tubercle composition. (Adapted from Knight and Amyot, 2006 and Jones, 1996).

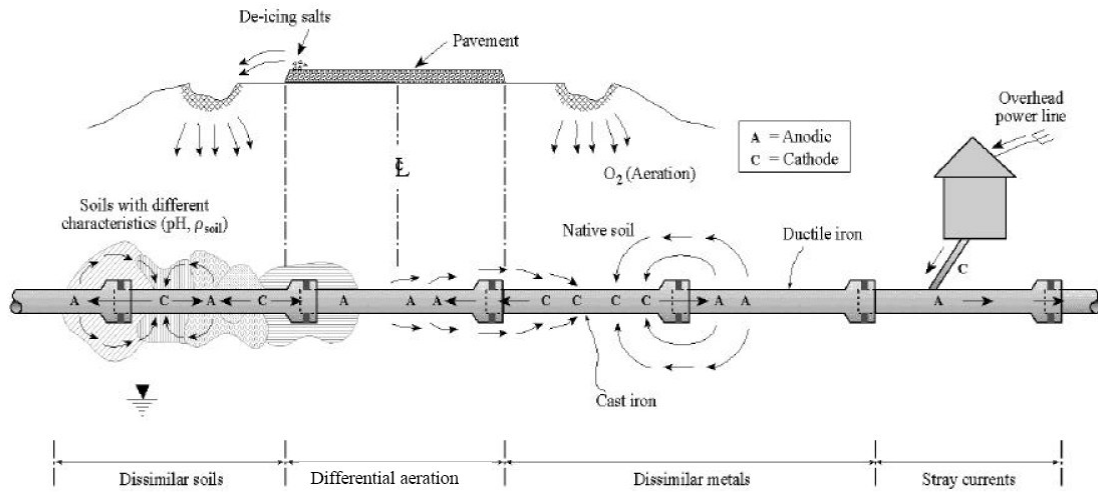
Figure 2-10: Conditions leading to external iron pipe corrosion (Rajani and Kleiner, 2001).

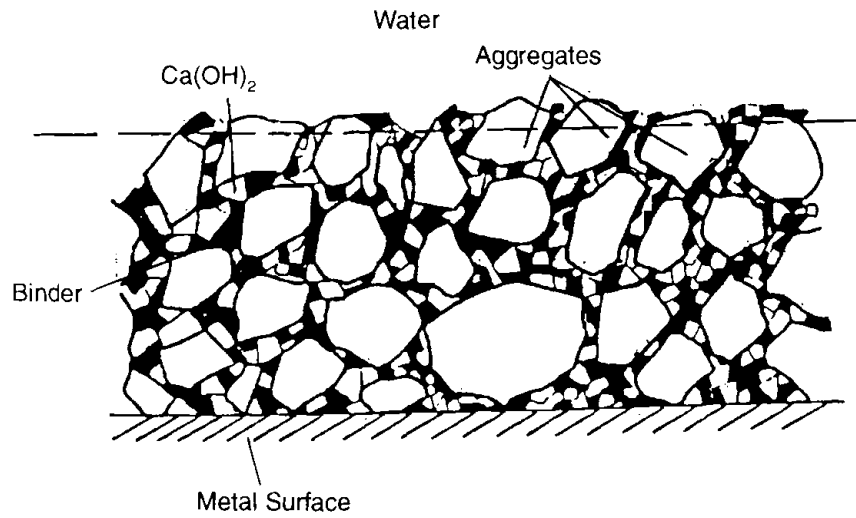
Figure 2-11: Structure of cement based material.

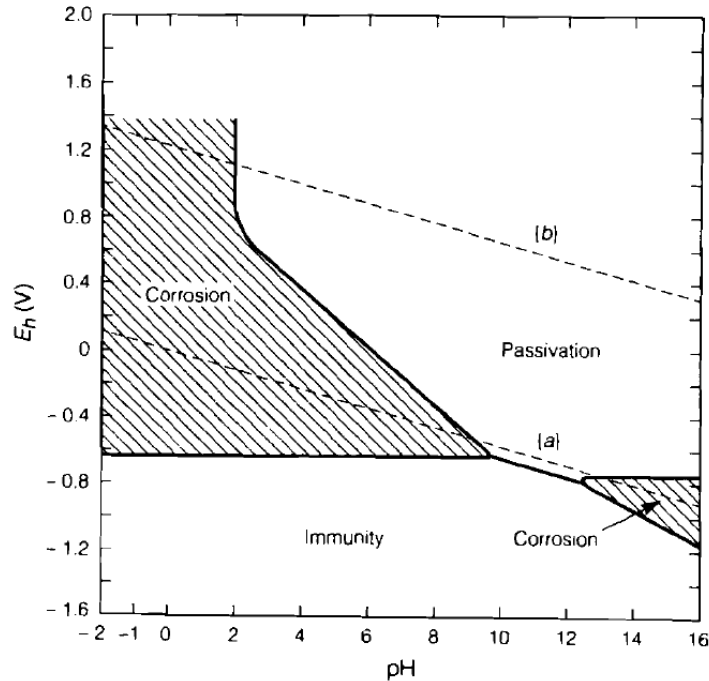
Figure 2-13: Simplified Pourbaix diagram for Fe/H₂O system.

Pourbaix claims that the iron is passivated in the high pH ranges due to the formation of insoluble iron oxide or hydroxide, predominantly Fe₂O₃ and or Fe₃O₄, which adhere sufficiently to the iron and are impermeable such that they “stifle” the corrosion of the underlying metal (1973).

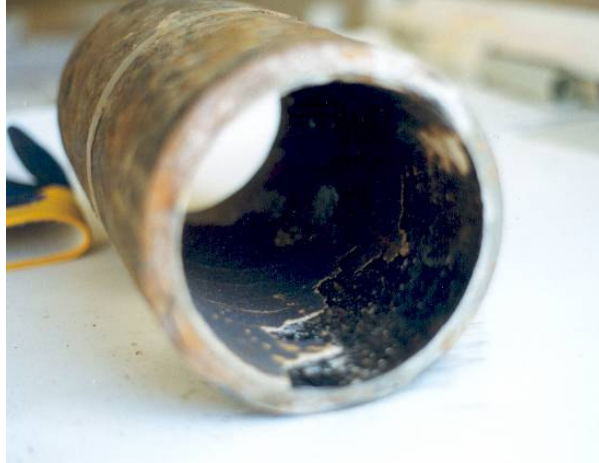
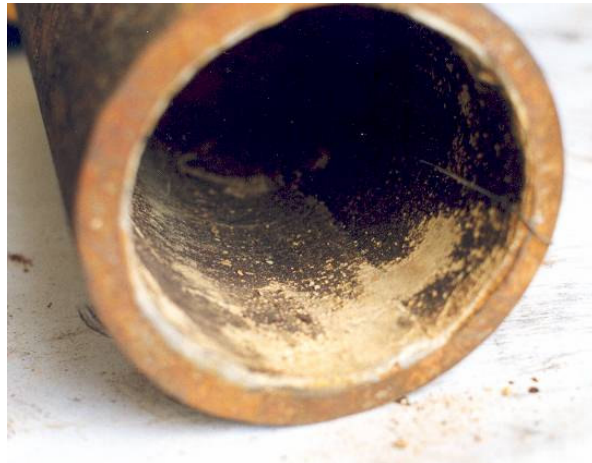
Figure 3-4: Cement mortar lined pipes from the City of Toronto. The pipes were lined in 1969 (top) and 1979. The pictures were taken in 1998. They show excellent long-term performance of the cement mortar lining (pictures courtesy of Kamran Sarami).

The City of Toronto has performed investigations regarding the long-term performance of cement mortar lining. These investigations, a sample of which is presented in Figure 3-4, show that cement mortar lining withstands the build up of internal corrosion products over a significant time period.

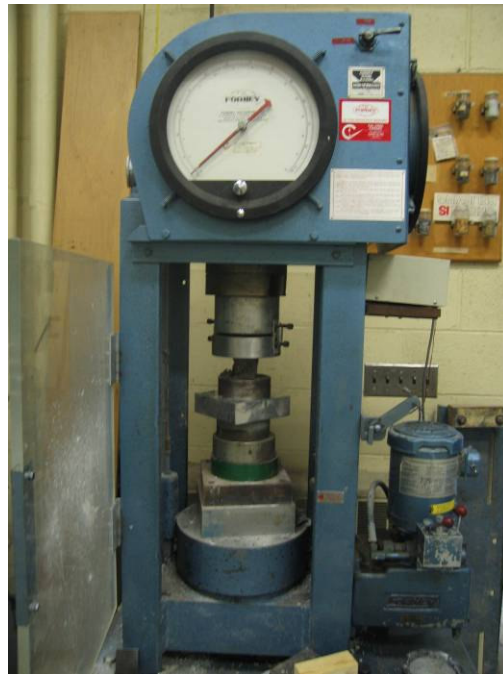
Figure 4-2: Forney QC-50-DR compressive strength testing machine.

Compressive strength testing was carried out in accordance to ASTM C109, Standard Test Method for Compressive Strength of Hydraulic Cement Mortars on field and laboratory specimens which were cured longer than 28 days (ASTM, 2002). The compressive strength testing was performed at the University of Waterloo using a Forney QC-50-DR compressive strength testing machine which is shown in Figure 4-2. The strength characteristics of

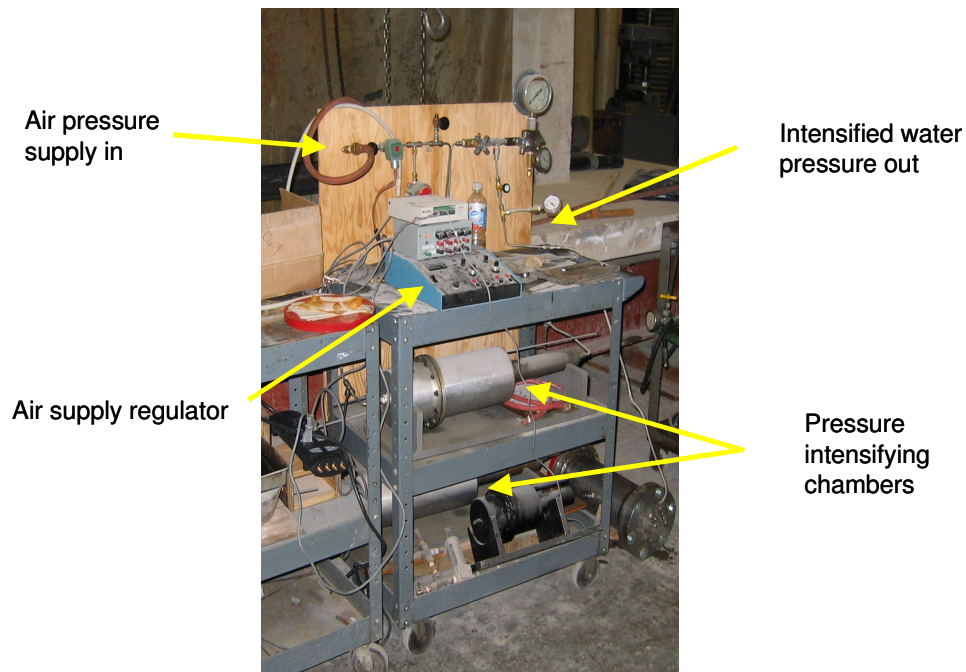
Figure 4-3: Air to water pressure intensifier.

The air supply regulation was performed using a two solenoid valves; an input regulator valve and a bleed valve. The solenoid valves were controlled by a voltage regulator built by the University of Waterloo. The solenoid valves limited the maximum pressure that could be applied to the pressure vessel. The rate at which water pressure was increased within the pressure vessel was dependant on a manual input by the test operator. As a result of this manual operator input the rate of pressure increase could not be easily maintained in all tests and loading rate variation was introduced to the testing scheme.

The pressure intensifier also had a fixed volume of water that it could pressurize. If water-loss through the cement mortar lining or through improperly tightened gaskets exceeded the volume of the intensifier then the test had to be stopped so that the pressure intensifier could be re-filled.

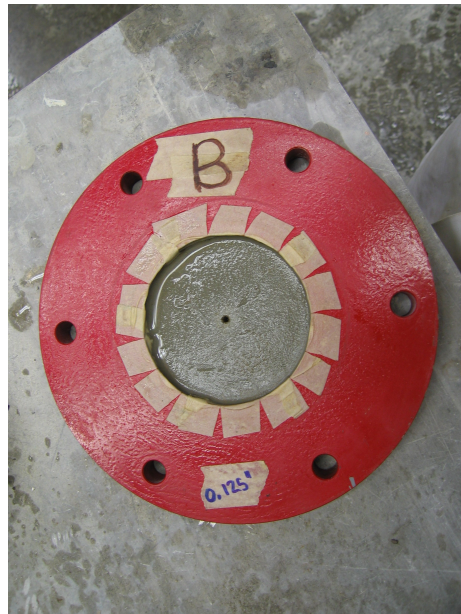
Figure 4-5: Lined post test bottom plate where blow-out has occurred.

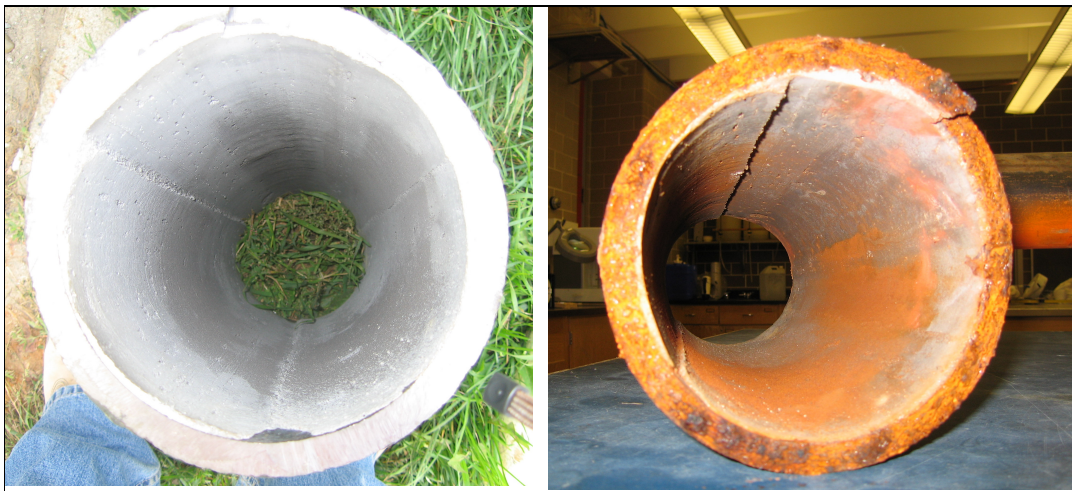
Figure 4-7: Pipe section #1 at collection (left) and prior to testing.

Figure 4-7 shows pipe section #1 before and after pipe section #1 was placed in the humidity room. The variations in lining diameter as well as the effects of corrosion can be seen in Figure 4-7.

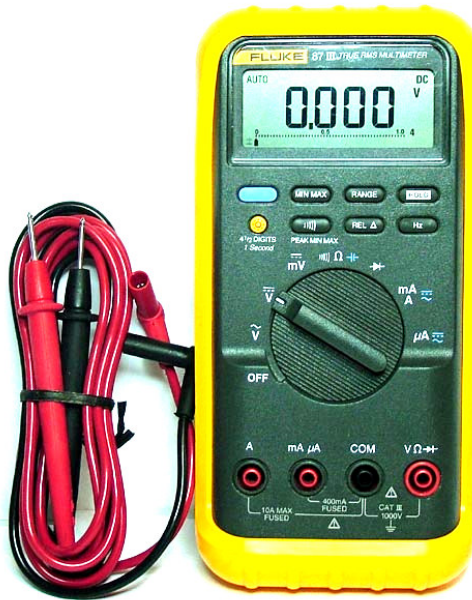
Figure 4-9: Fluke 87 III voltmeter.

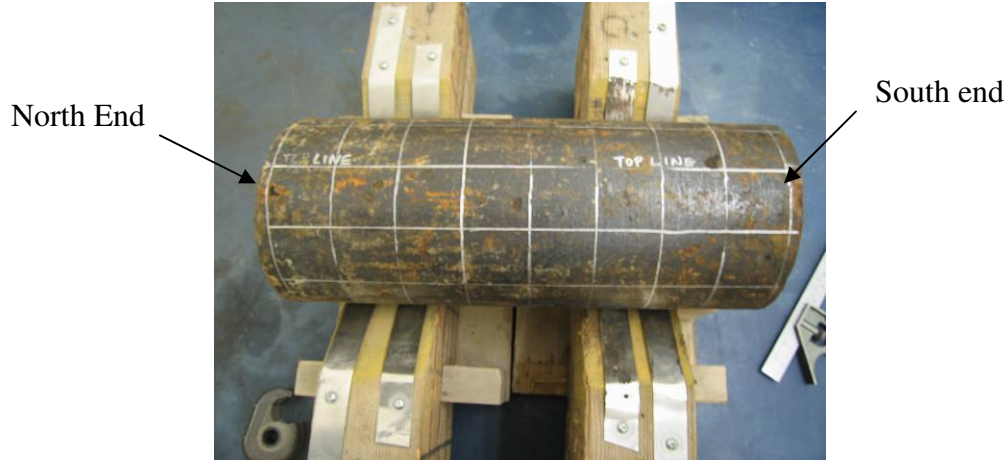
Figure 4-10: Pipe section #1 showing grid pattern for corrosion potential measurements.

Pipe section #1 was used for the corrosion potential testing due to the difficulties inherent in consistently measuring the corrosion potential in the same location in a longer pipe with accessibility issues. The exterior of the pipe was cleaned of corrosion products and a 5cm square grid pattern was drawn on the pipe as shown in Figure 4-10. The corrosion potential measurement locations correspond to the locations directly beneath the grid intersections on the interior of the pipe. The grid was aligned so that measurements would be taken at locations where lining thickness variations occurred.

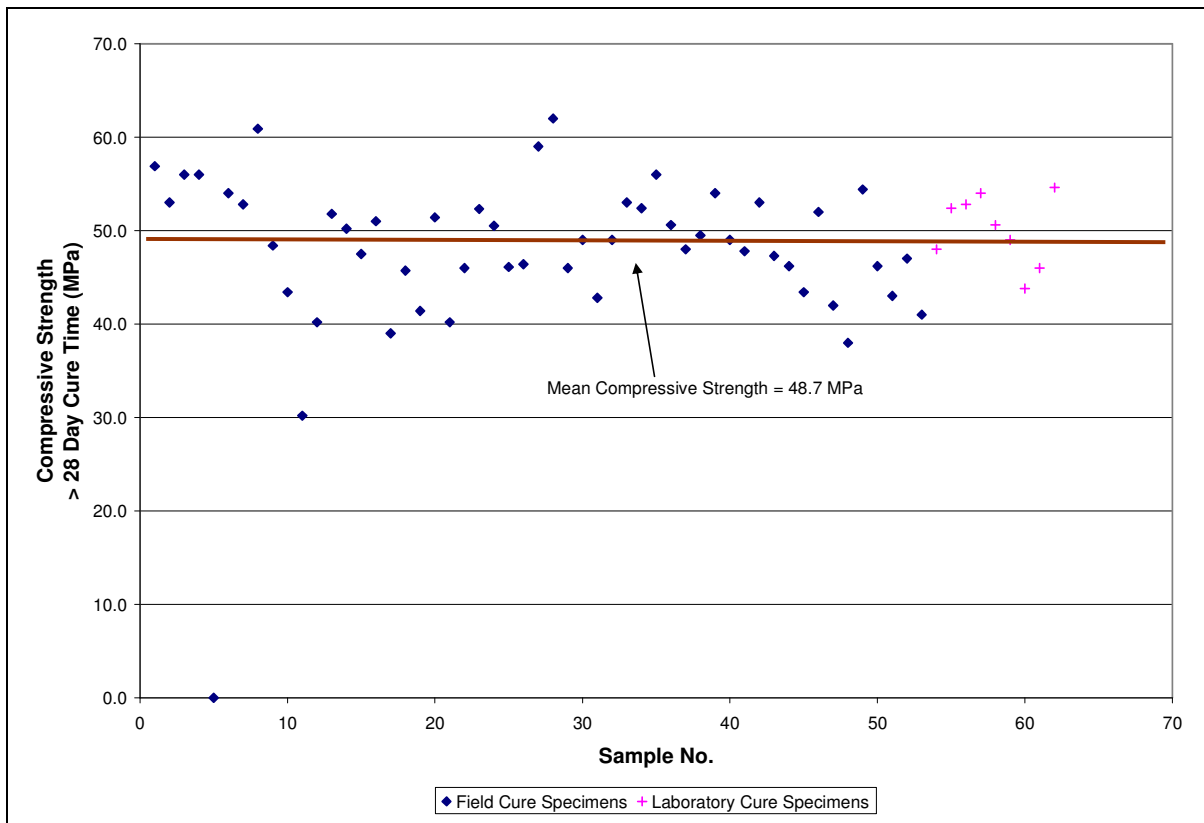
Figure 5-1: Compressive strength of field and laboratory cast mortar cube specimens.

The results of compressive strength testing on individual samples are presented in Appendix B and are summarized in Figure 5-1. The mean long-term (>28 day) maximum compressive strength of the field cast mortar cube specimens was 48.7 MPa with a standard deviation of 6.14 MPa. The mean maximum compressive strength of the laboratory cast mortar cube specimens was 50.1 MPa with a standard deviation of 3.71 MPa.

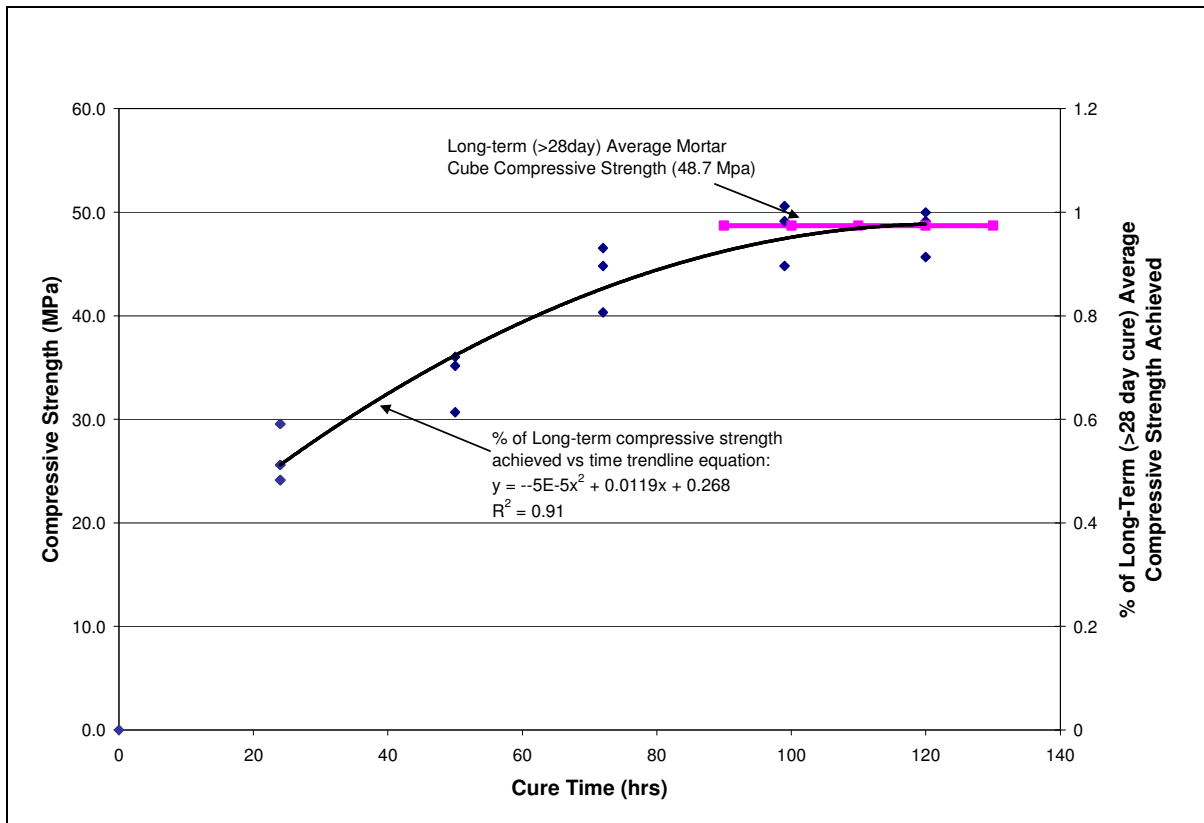
Figure 5-2: Compressive strength versus time for field cast mortar cube specimens.

compressive strength testing, a newly cement mortar lined pipe should not be returned to service until the cement mortar has cured for a time period of at least four days if it is to have maximum strength. As outlined in Section 2.3.2, pressure can be returned to the watermain during the disinfection process as soon as 24 hours after lining has been completed. The compressive strength testing results indicate that the time period between lining and disinfection should be extended from a minimum period of 24 hours to a period of at least 96 hours if the lining is expected to bridge pin-holes in the watermain.

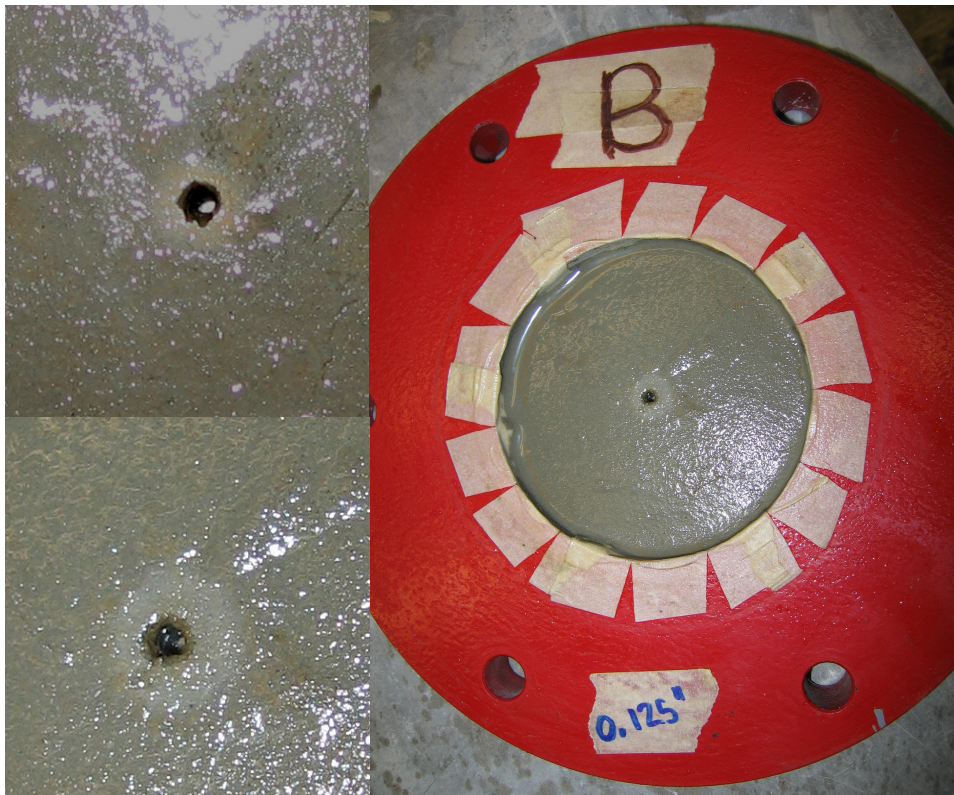
Figure 5-3: Cement mortar lined bottom plate after failure occurred.

For the remainder of this Section failure will be defined as loss of pressure due to catastrophic blow-out of the cement mortar lining covering the corrosion pin-hole. Figure 5-3 contains an example of the cement mortar lined bottom plate after failure had occurred. In all tests where failure occurred all of the mortar covering the pin-hole was removed in a circular pattern after a catastrophic failure of the cement mortar lining.

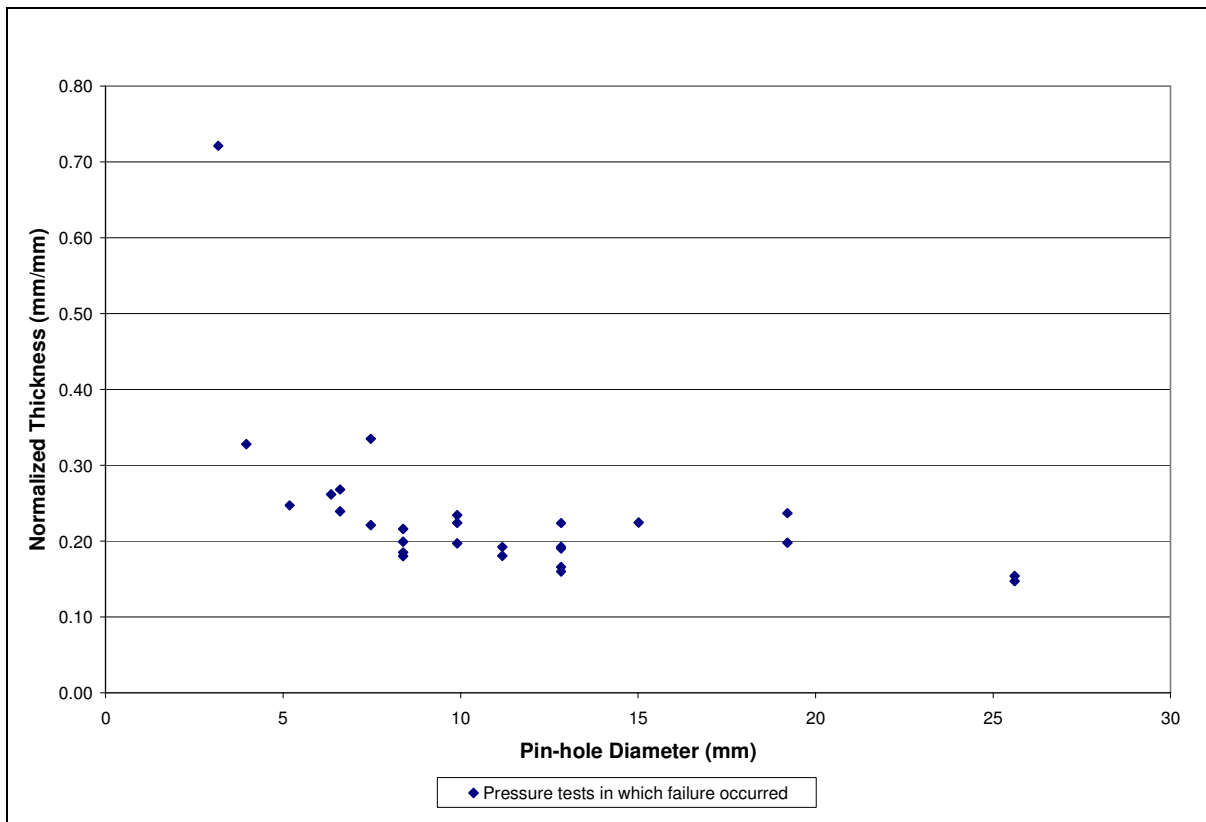
Figure 5-4: Water loss prevention failure data; normalized thickness at failure vs. pin-hole diameter.

by cure time. From Figure 5-4 it can be seen that as pin-hole diameter was increased the normalized thickness at failure decreased. The normalized thickness at failure sample mean was 0.234 with a standard deviation of 0.108. In Figure 5-4 the data point which has a normalized thickness of 0.72 corresponds to the 24.5 hour cure time test with a 3.18 mm diameter and lining thickness of 2.29 mm. Failure occurred in this test at a normalized thickness 218% greater than any other failure. Table 5-4 represents the test parameter combinations that were similar to the failed test with a normalized thickness of 0.72. From Table 5-4 it can be seen that failure did not occur in any test parameter combinations that were similar to the failed test. This indicates that the failure at a normalized thickness of 0.72 was an outlier.

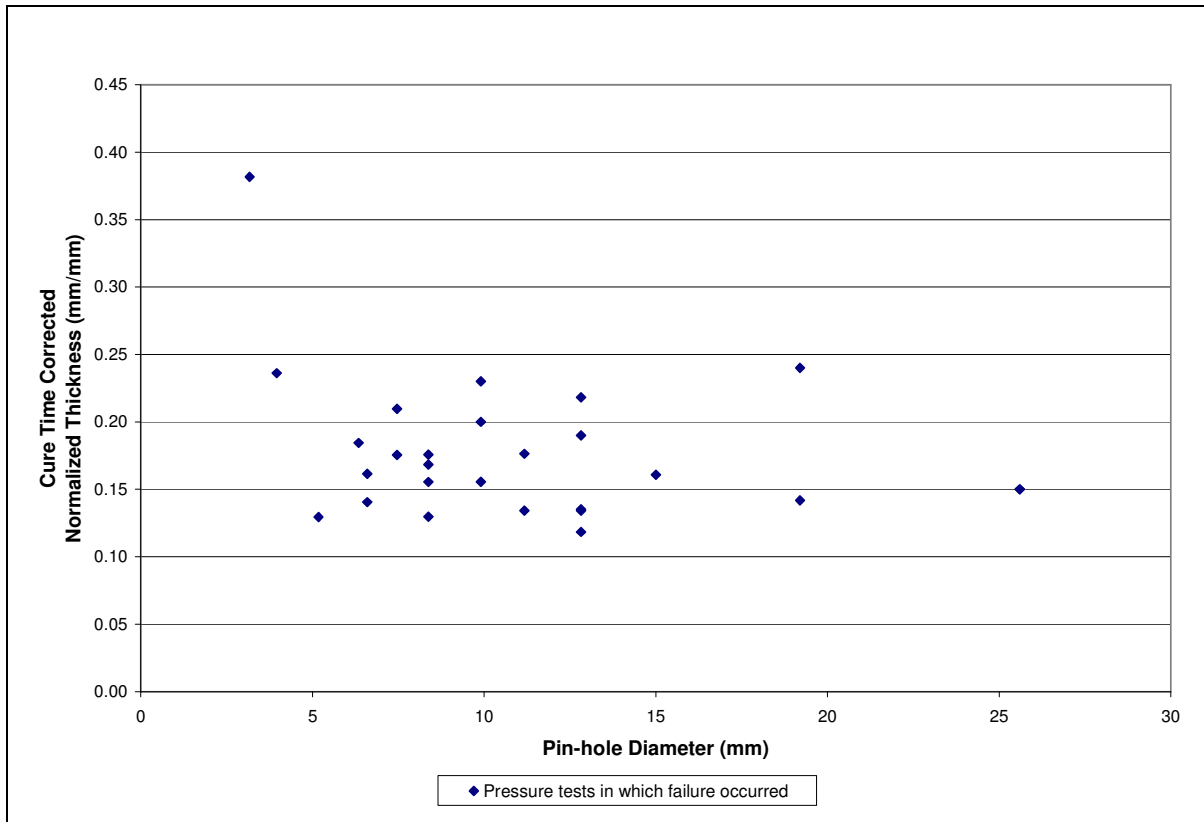
Figure 5-5: Water loss prevention failure data; cure time corrected normalized thickness at failure vs. pin-hole diameter.

Figure 5-5 represents the cure time corrected normalized thickness. The cure time corrected normalized thickness at failure sample mean was 0.177 with a standard deviation of 0.054. From Figure 5-5 it can be seen that once the failure data has been corrected to account for strength variations due to differing cure times, the cure time corrected normalized thickness no longer increases as the pin-hole diameter decreases.

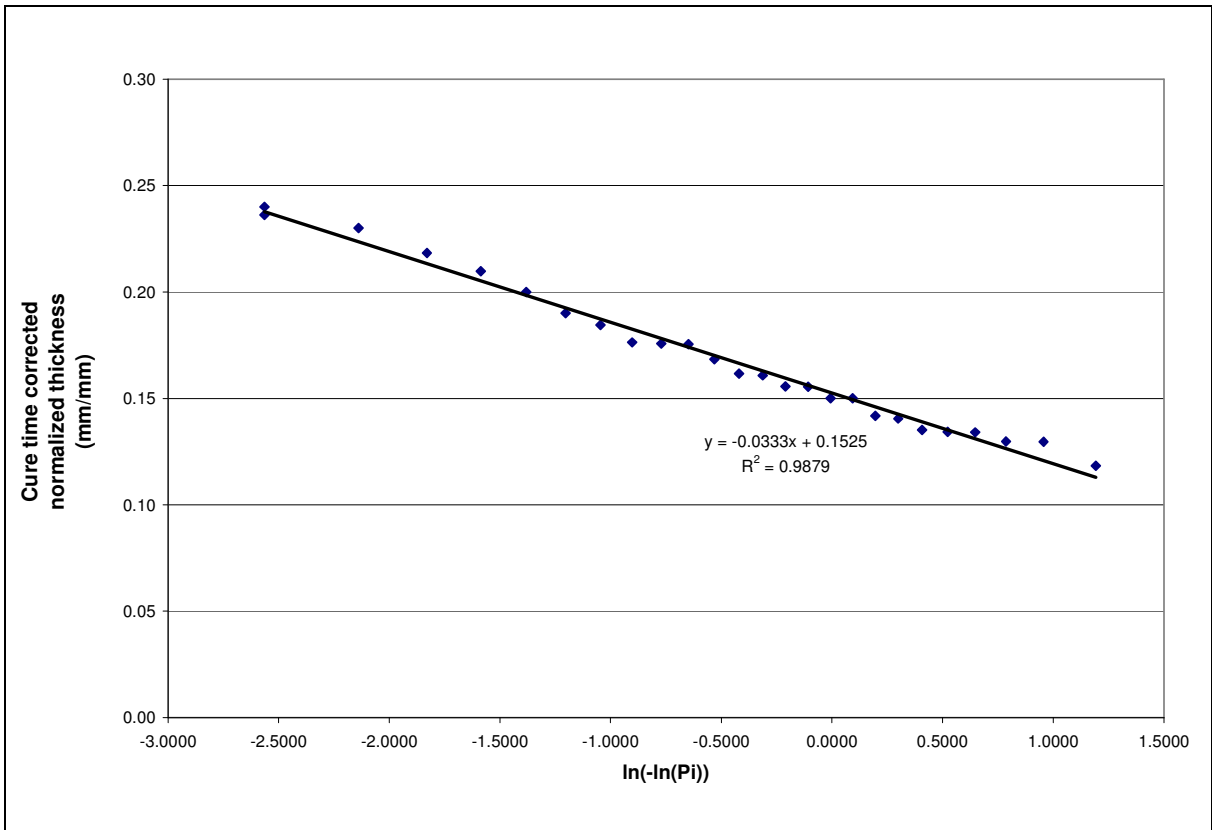
Figure 5-6: Gumbel distribution probability paper plot.

- the location parameter (α) is 0.1525
- the scale parameter (β) is 0.0333

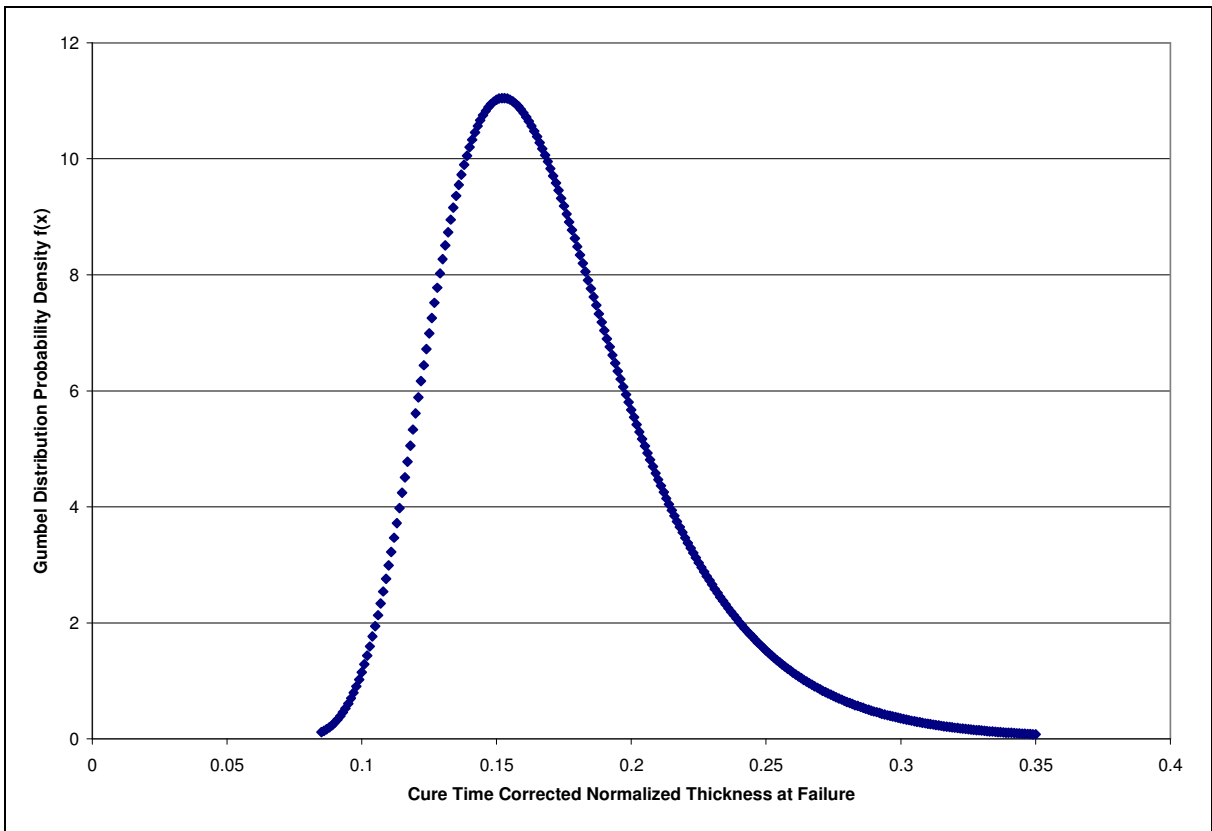
Figure 5-7: Gumbel probability density function of cure time corrected normalized thickness at failure.

By solving this integral for b a value of $b = 0.251$ was obtained. This value corresponds to the cure time corrected normalized thickness at which there is a 95% chance that failure will not occur. Solving for the 99% probability that failure will not occur provides a value of $b = 0.304$

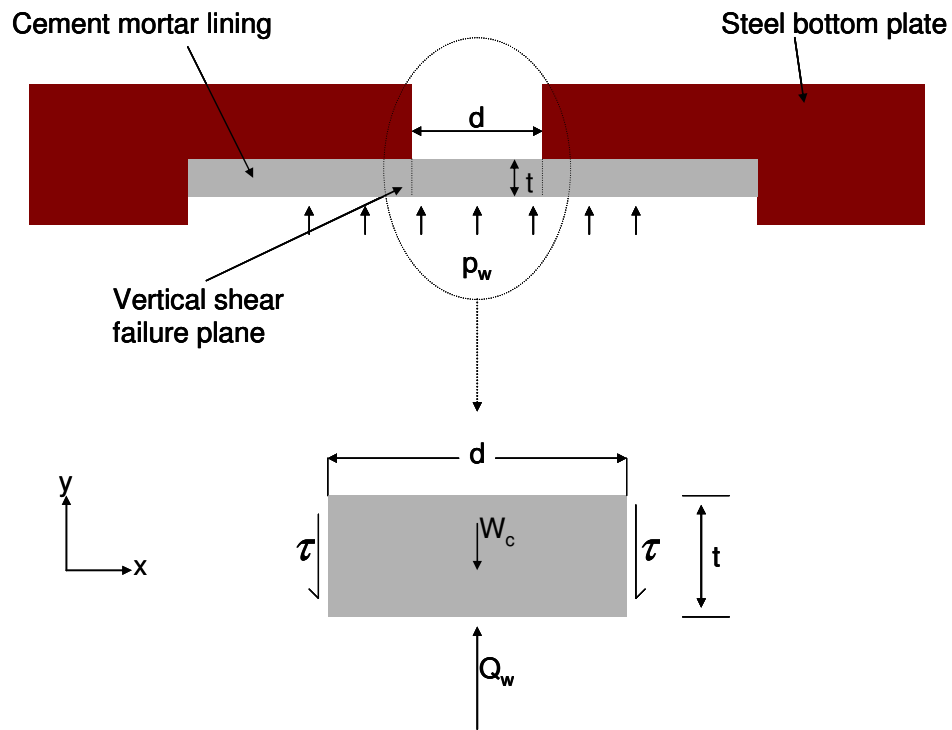
Figure 5-8: System used for force balance analysis of cement mortar lining shear strength.

Figure 5-8 outlines the system used to perform the force balance analysis. The force balance method for determining the shear strength of the cement mortar lining at failure was based upon the assumption that the summation of forces acting in the vertical (y) direction was equal to zero at equilibrium.

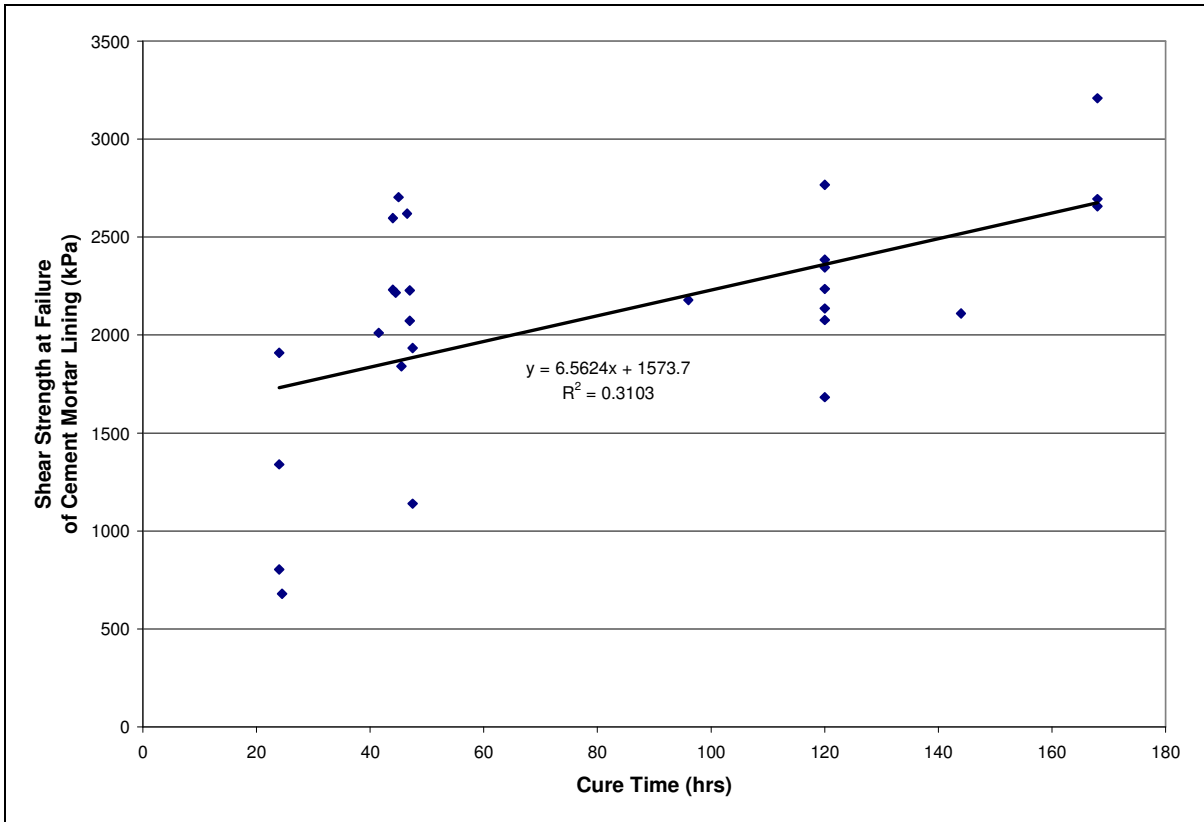
Figure 5-9: Shear strength at failure of cement mortar lining versus cure time.

Figure 5-9 presents the cement mortar shear strength at failure plotted against the cure time of the specimen. Figure 5-9 shows that the shear strength of the cement mortar increased as the cure time increased. This agrees with the trend of increased compressive strength with increased cure time shown in Section 4.2.1. The average shear strength at failure calculated using the force balance method was 2.10 MPa with a standard deviation of 0.59 MPa.

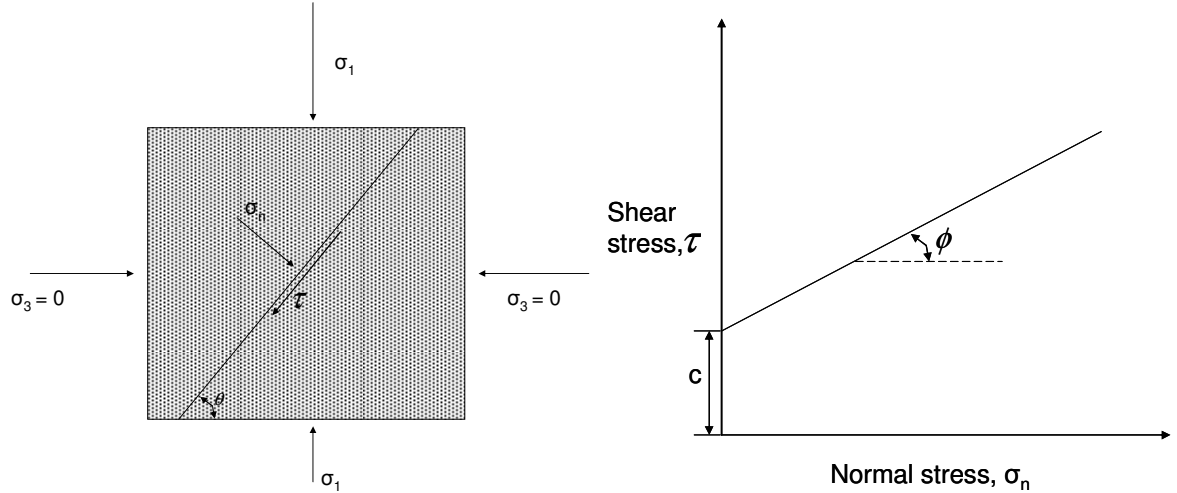
Figure 5-10: Mohr-Coulomb failure criterion.

ϕ = angle of internal friction

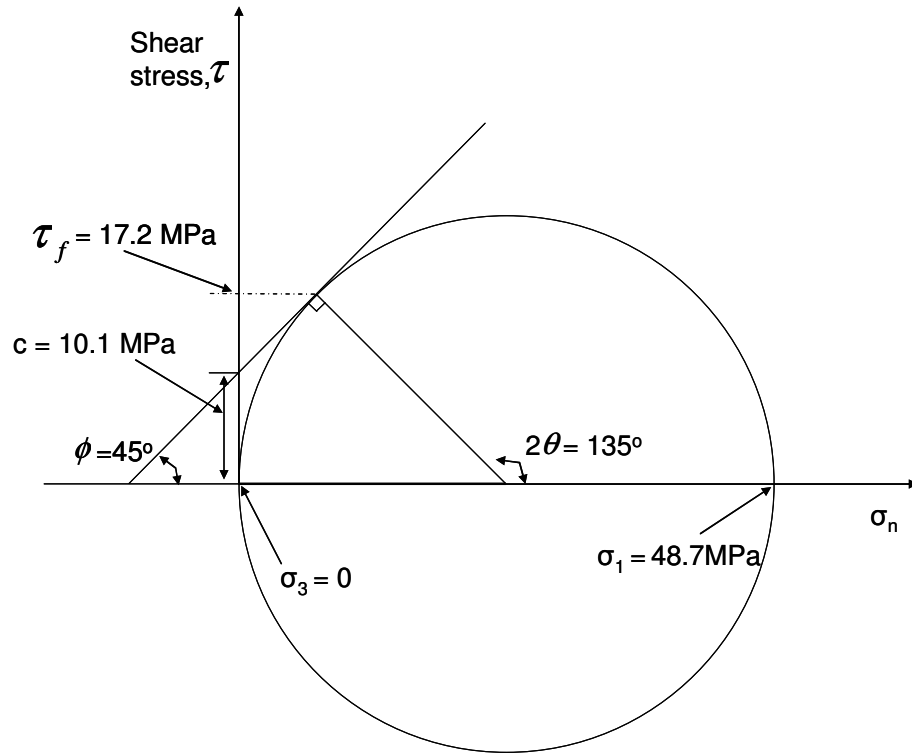
Figure 5-11: Mohr-Coulomb failure criterion analysis for field cast cement mortar cubes.

mortar for pin-hole blow-out applications. The discrepancy between these two results is likely due to the application of the Mohr-Coulomb failure criterion to this application.

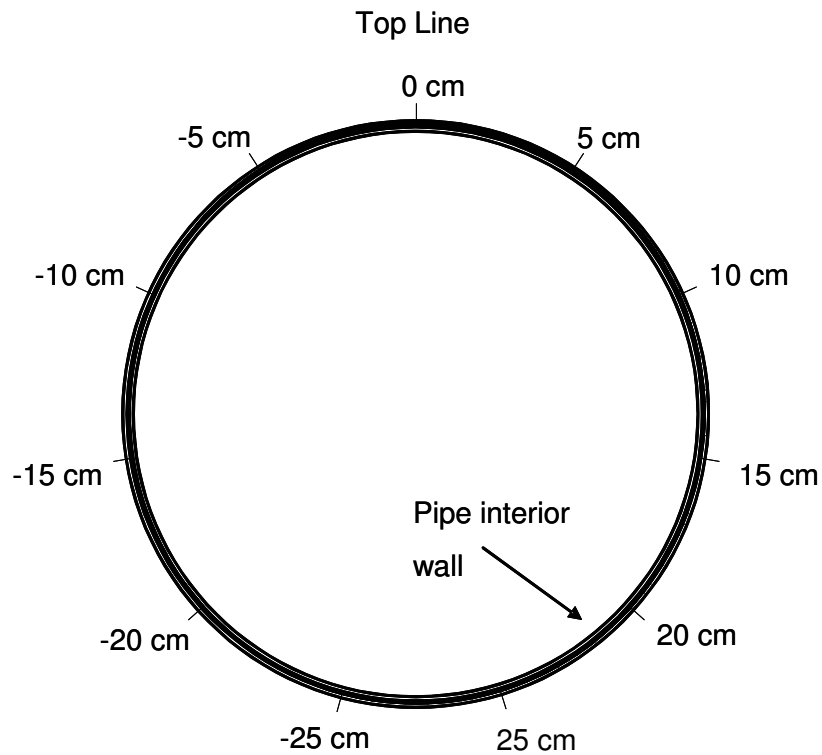
Figure 5-12: Pipe section #1 measurement reading convention. View from north end of pipe.

Measurements were recorded at 5 centimetre intervals around the circumference of the pipe.

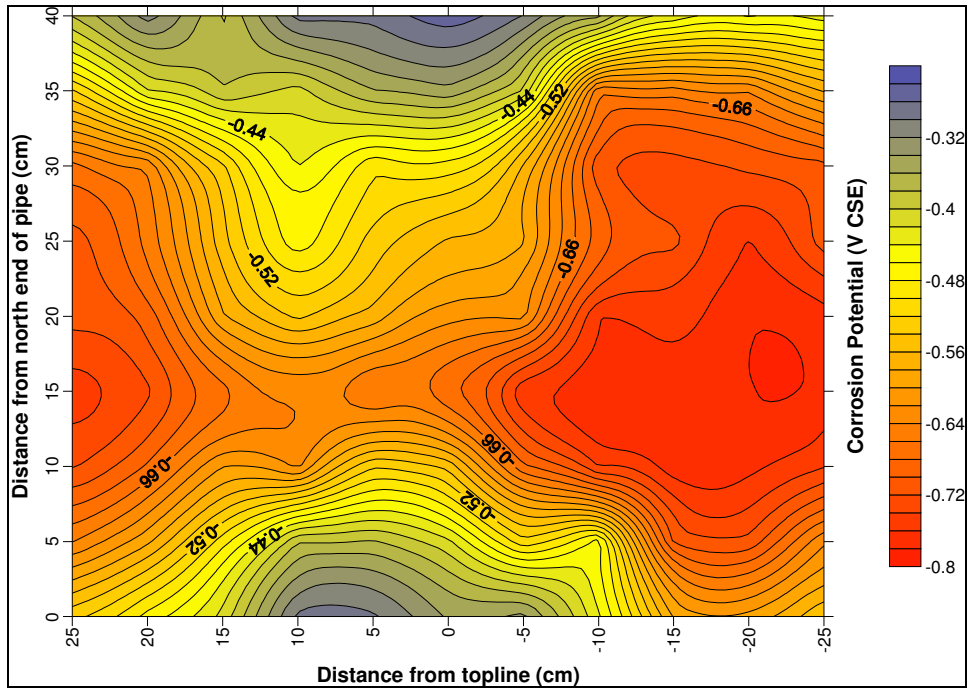
Figure 5-14: Corrosion potential contour map pipe section #1, Aug 15, 2006.

The three corrosion potential contour maps show similar corrosion potential patterns. Pipe section #1 showed the most negative potential measurements at the bottom of the pipe near the midpoint of the length of the pipe during the three testing periods. In all three tests the most negative potential recorded was between -0.86 V CSE and -0.76 V CSE. According to ASTM C876-91 potentials more negative than -0.35 V CSE indicate that there is greater than a 90% chance that corrosion is occurring. In all three tests the least negative potentials recorded were located near the topline of the pipe at both the north and south end. The potentials recorded at these points ranged from -0.27 V CSE to -0.17 V CSE. According to ASTM C876-91 potentials less negative than -0.20 V CSE indicate that there is a greater than

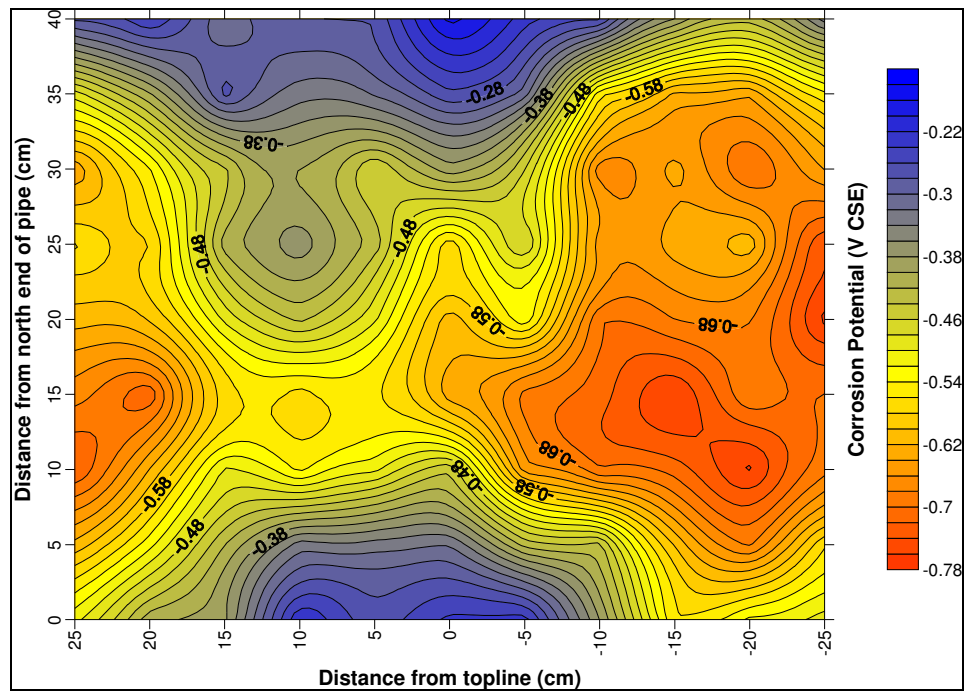
Figure 5-15: Corrosion potential contour map pipe section #1, Aug 16, 2006.
