**Renewal of Potable Water Systems Using Cement
Mortar Lining; an Investigation into Corrosion
Reduction and Water-loss Prevention**

A thesis

presented to the University of Waterloo

Civil Engineering

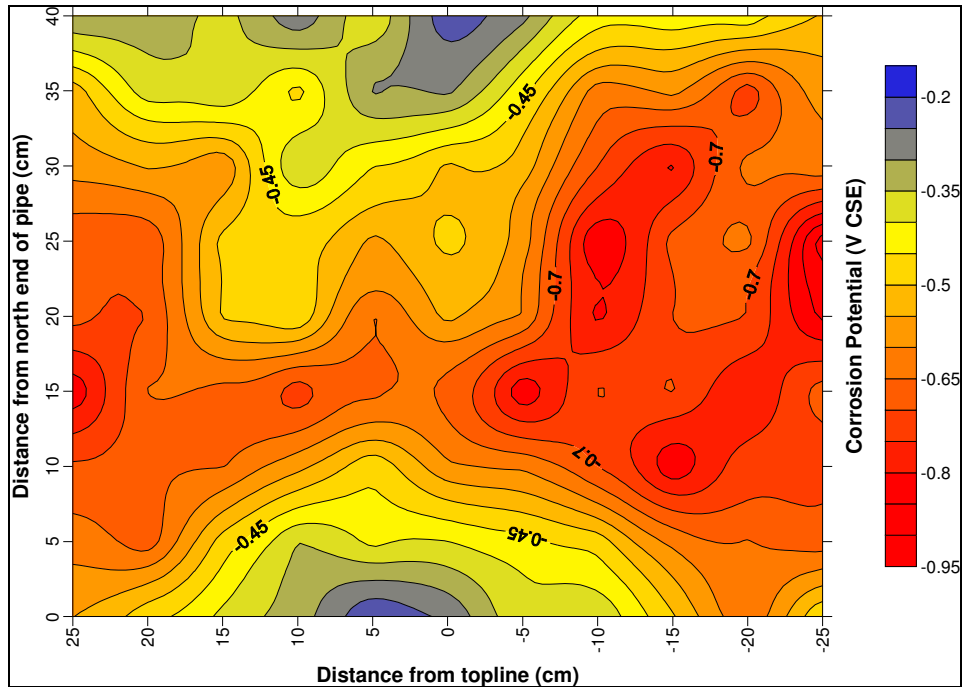
Figure 5-16: Corrosion potential contour map pipe section #1, Aug 17, 2006.

The three corrosion potential contour maps show similar corrosion potential patterns. Pipe section #1 showed the most negative potential measurements at the bottom of the pipe near the midpoint of the length of the pipe during the three testing periods. In all three tests the most negative potential recorded was between -0.86 V CSE and -0.76 V CSE. According to ASTM C876-91 potentials more negative than -0.35 V CSE indicate that there is greater than a 90% chance that corrosion is occurring. In all three tests the least negative potentials recorded were located near the topline of the pipe at both the north and south end. The potentials recorded at these points ranged from -0.27 V CSE to -0.17 V CSE. According to ASTM C876-91 potentials less negative than -0.20 V CSE indicate that there is a greater than

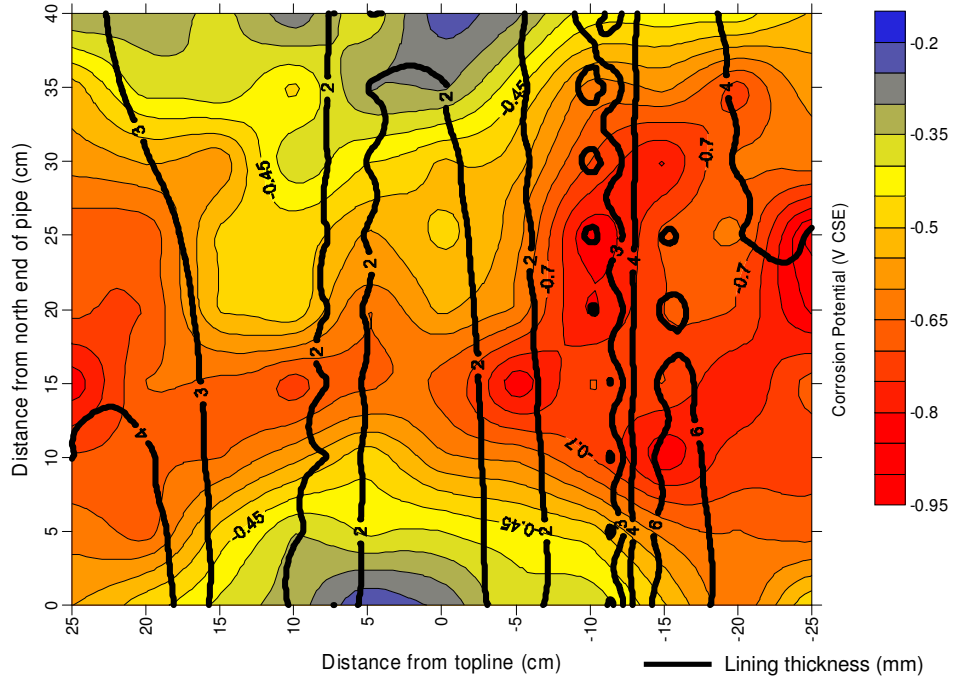
Figure 5-17: Corrosion potential contour map pipe section #1, Aug 17 2006, overlaid by pipe section #1 interpolated lining thickness contours.

effects of cement mortar lining thickness on the ability of the cement mortar lining to prevent corrosion.
