Hygrothermal Behavior of Interior Basement Insulation

A thesis
presented to the University of Waterloo
in fulfillment of the
thesis requirement for the degree of
Master of Applied Science
in
Civil Engineering

Abstract: Hygrothermal Behavior of Interior Basement Insulation

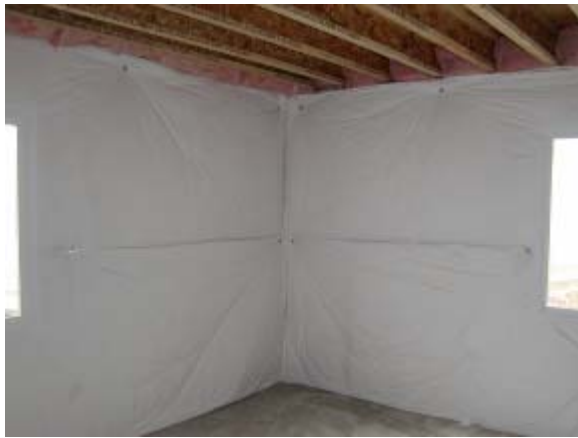
Another common basement insulation system that is currently used is known as a “roll blanket”: it is a 1.2 m (4 foot) wide roll of fiberglass insulation with an interior facer (polyethylene, polypropylene, or reinforced foil), and is attached either directly to the concrete or to wooden furring strips. It can be installed either full height (Figure 2.8) or half-height (Figure 2.9). Moisture accumulation problems have occurred with this material; manufacturers have responded by producing a roll blanket with a permeable perforated facer.

Figure 2.8: Roll blanket insulation, full-height

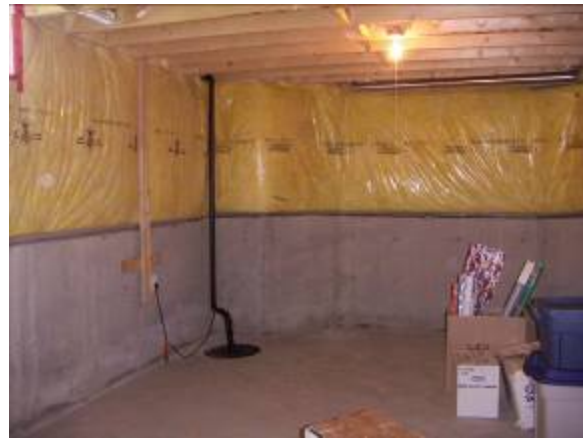
Figure 2.9: Roll blanket insulation, half-height

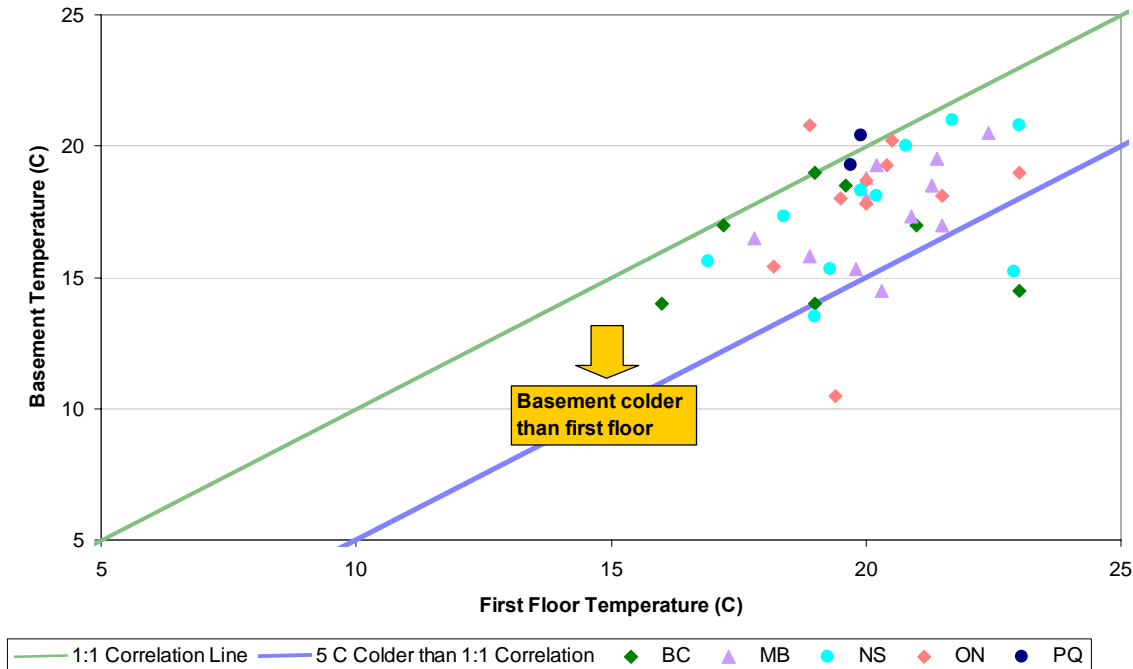
In addition to the BSC data, a 50-house cross-Canada study completed by Ruest (1993) examined the relationship of basement and above-grade interior conditions. Temperature and humidity were measured in the basement and the above grade space, at a single visit in the winter, in houses across five provinces (British Columbia, Manitoba, Nova Scotia, Ontario, and Quebec). The temperatures of the two spaces are plotted against each other in Figure 3.9.

Figure 3.9: Interior above-grade and basement temperature conditions (Ruest 1993)

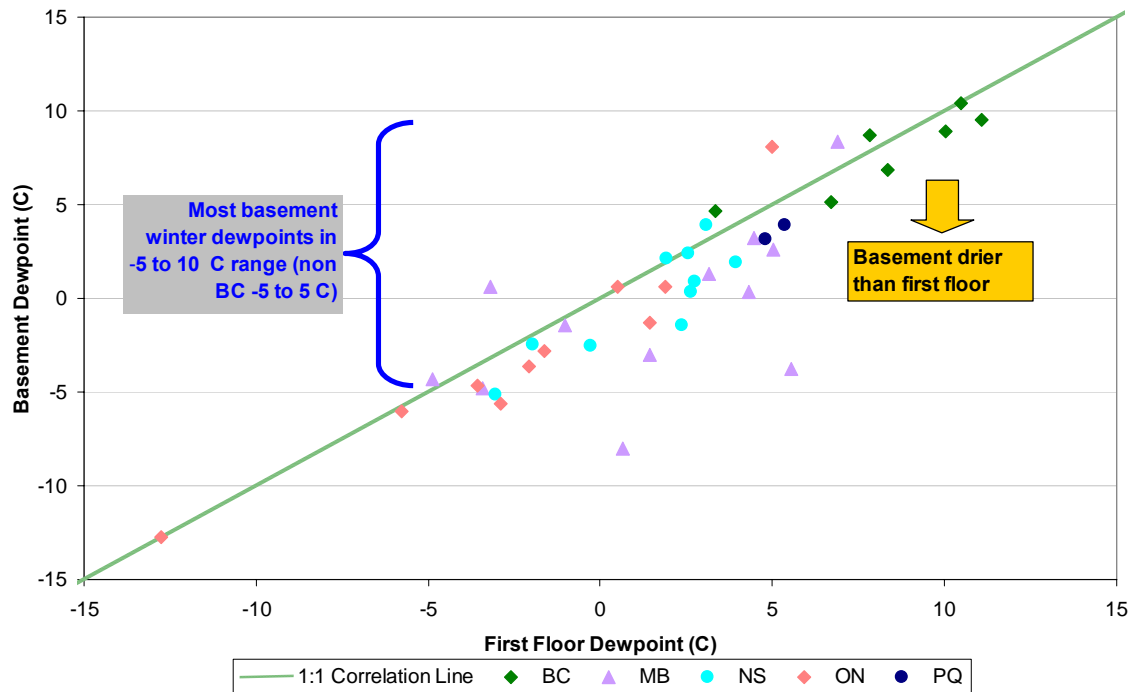
The dewpoint temperatures were plotted against each other in a similar manner, in Figure 3.10; a 1:1 correspondence line is plotted on that graph. The figure is set up so that basements drier than the first floor are below this correspondence line.

Figure 3.10: Interior above-grade and basement dewpoint conditions (Ruest 1993)

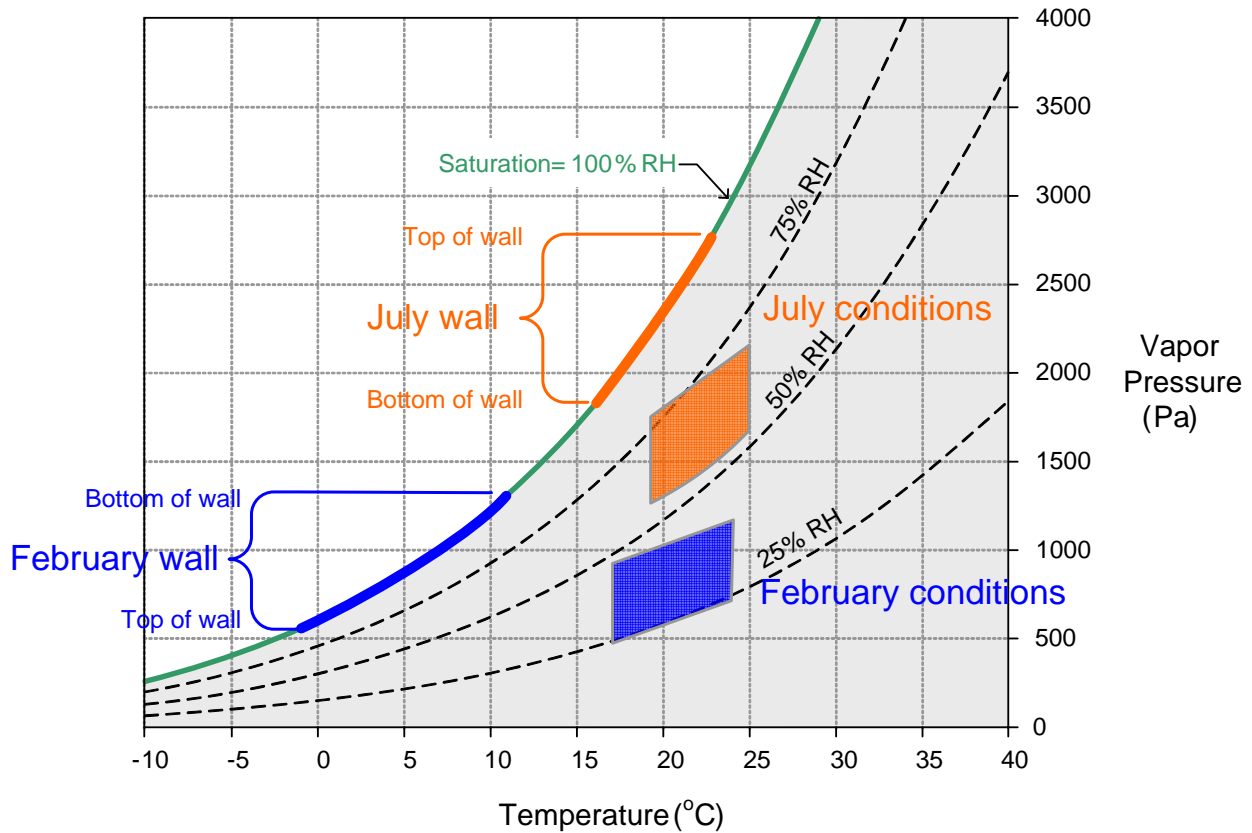
Given the interior and exterior temperature and humidity boundary conditions described above, their relationship can be summarized on a psychrometric chart (see Figure 3.11).

Figure 3.11: Psychrometric relationships of basement wall boundary conditions

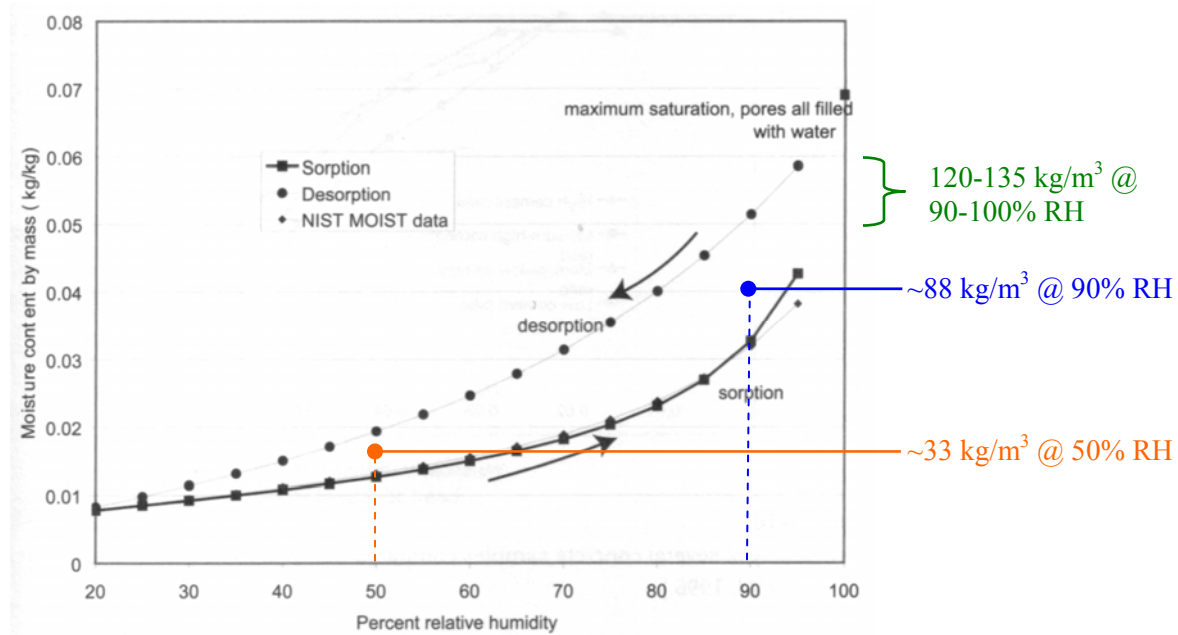
The sorption isotherm for concrete is shown in Figure 3.21; it also shows the strong effect of sorption/desorption hysteresis in this material.

Figure 3.21: IEA Annex 24 Data: sorption and desorption isotherm for concrete (Rose 2005)

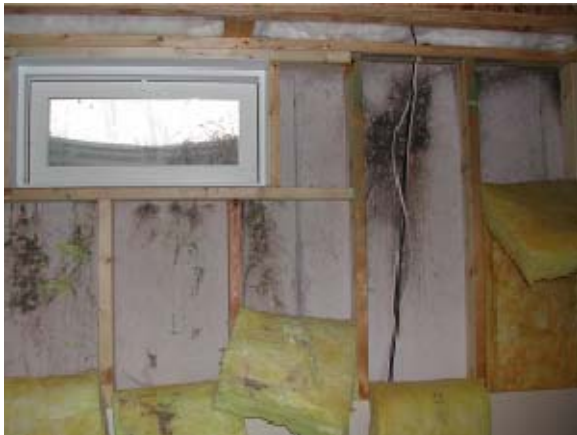
An example of this failure is shown in Figure 3.22, taken in a basement in Iowa (photos courtesy of Building Science Corporation, 2004).

Figure 3.22: Mold growth on upper portion of basement wall

The wall system is (from interior to exterior) concrete wall, fiberglass batt in wood framing, polyethylene vapor barrier, and gypsum drywall. It is important to note that the mold damage is concentrated on the upper portion of the wall and at the window well. The large plume of mold is located

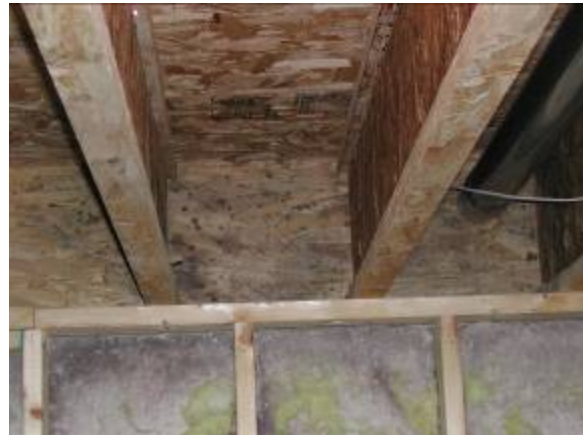
Figure 3.23: Mold growth at insulated rim joist of basement

Figure 3.23 shows further mold damage from the same basement, at the insulated rim joist. In this case, the cold condensing surface is the rim closure board; it appears that the rim joist was insulated without either a vapor retarder or an air barrier; either transport mechanism could explain the mold growth. This problem can be effectively solved by cutting, fitting, and air sealing XPS foam blocking into the rim joist space, or by insulating with XPS on the exterior of the rim joist.

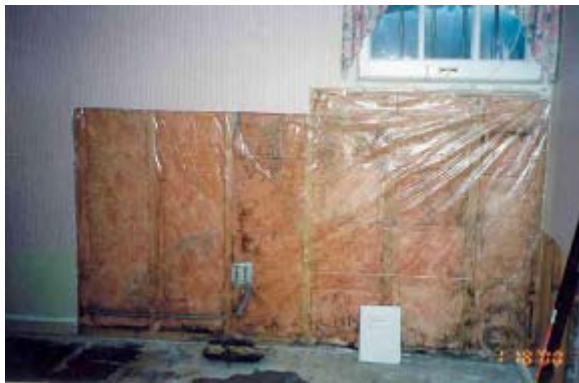
The interior insulation assemblies of interest here include the roll blanket and stud wall with polyethylene; they both have an impermeable layer on the interior side. This material is specified ostensibly as an air and vapor barrier, to (for instance) protect the wall from condensation of interior moisture on the concrete surface during the winter. However, as demonstrated in section 3.4, the drying direction of the basement wall assembly is primarily to the interior: an impermeable layer on the interior removes the ability to dry in this direction almost entirely.

There can be many actual causes of failure in this assembly, including stored construction moisture, trapped condensation, or bulk water leakage. As a caveat, it would be unreasonable to claim that all of these assemblies would have been able to dry with the omission of the polyethylene, especially in the case of bulk water leakage. However, a sufficiently low deposition or moisture emission rate can be safely dried to the inside through a permeable interior finish, without damaging that material. Possible consequences of the removal of the vapor retarding layer from the bottom portion of the insulated wall are discussed in section 3.7.3.

Figure 3.24: Moisture accumulation and mold growth in single polyethylene wall

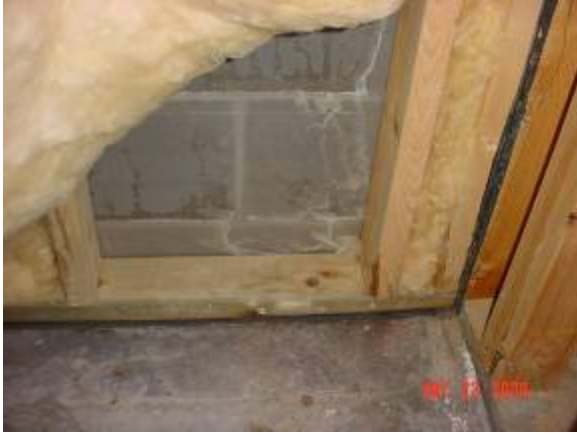
Photos provided by Paul Ellringer of Tamarack Technologies Incorporated show the types of failures seen in this assembly. Figure 3.25 shows accumulation of moisture behind the concrete side “moisture barrier;” in addition, there are high moisture contents and mold growth in the framing. Figure 3.26 shows surface mold at the interface between the fiberglass batt and the interior vapor barrier.

Figure 3.25: Moisture accumulation behind polyethylene; high MCs in framing

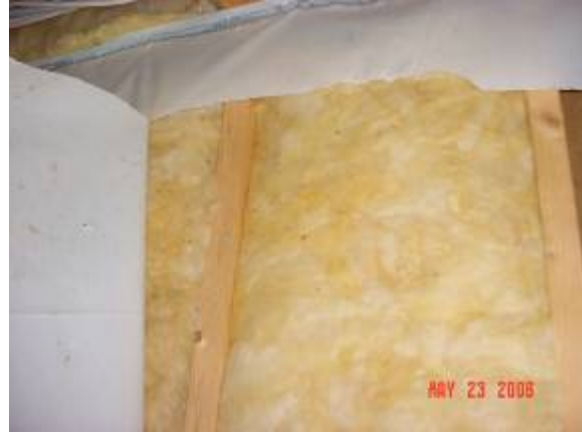
Figure 3.26: Surface mold at interface of fiberglass batt and polyethylene

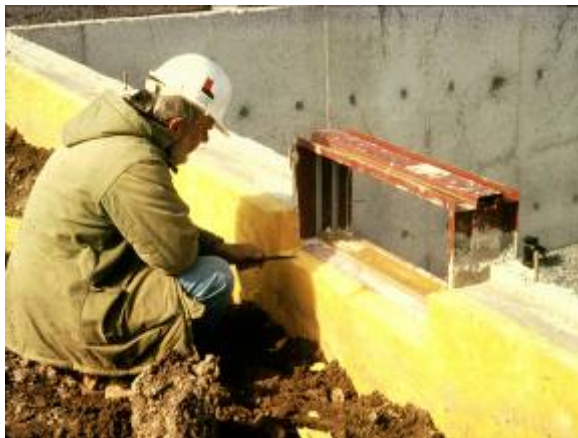
Figure 3.29: Exterior foundation insulation using draining rigid fiberglass board

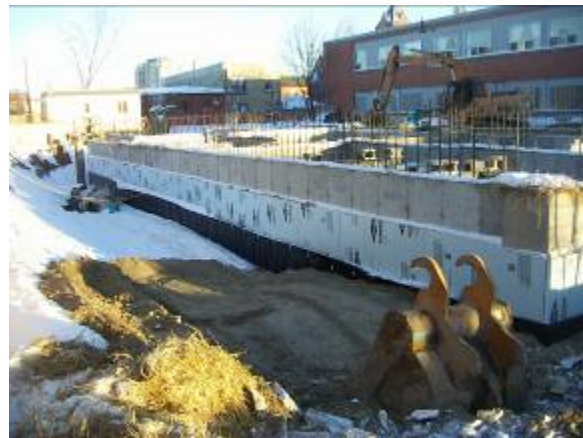
Figure 3.30: Exterior foundation insulation using extruded polystyrene and drainage mat

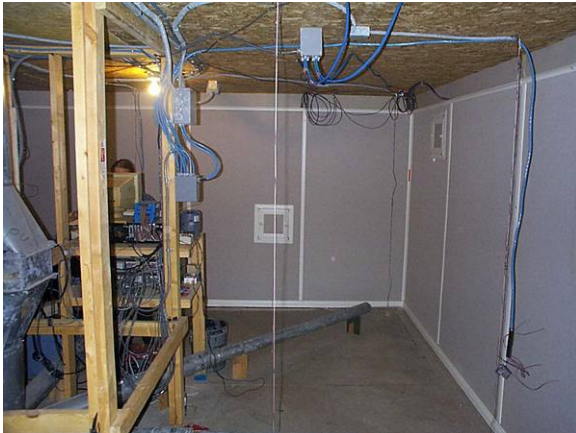
Goldberg evaluated an Owens Corning proprietary interior basement insulation and finishing system at the same basement facility, against concrete block walls. This system uses 64 mm (2.5”) rigid fiberglass insulation panels with a vapor permeable polyolefin air barrier material on the interior surface. The panels are attached to the wall by PVC tee channels nailed to the concrete (see Figure 4.6). Several variants were tested:

Figure 4.6: Owens Corning basement test (Goldberg and Aloï 2002)

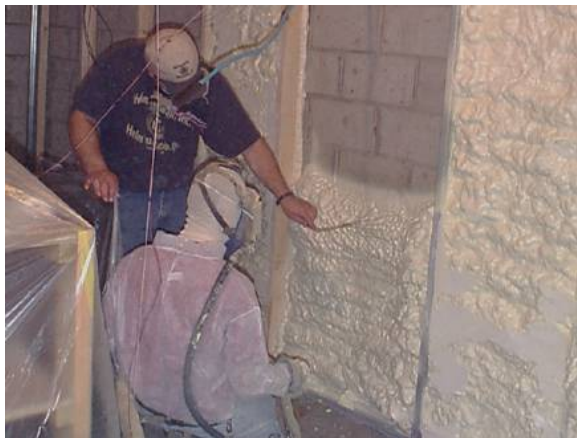
In this project, Goldberg and Farkas compared a variety of vapor control strategies using open cell spray polyisocyanate foam (Icynene) in wood and steel stud framed walls inboard of a concrete block foundation (Figure 4.10). Inspection ports were cut in the foam insulation, to allow observations of interstitial conditions and weighing of the sample, as shown in Figure 4.11. The vapor barrier combinations are shown in Table 4.2 a given “quadrant” or corner of the test basement has test panels on both orthogonal orientations.

Figure 4.10: Installation of Icynene insulation (Goldberg and Farkas 2004)

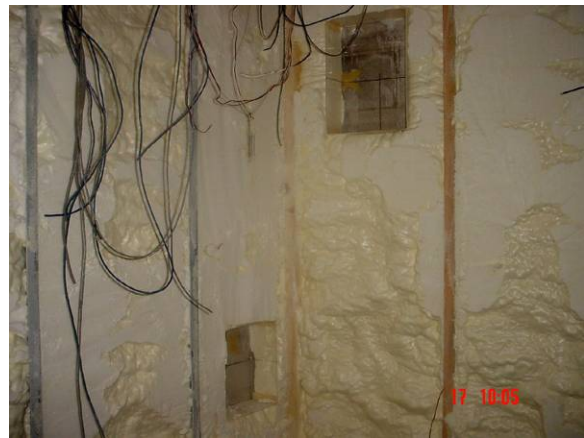
Figure 4.11: Removable test panels (Goldberg and Farkas 2004)

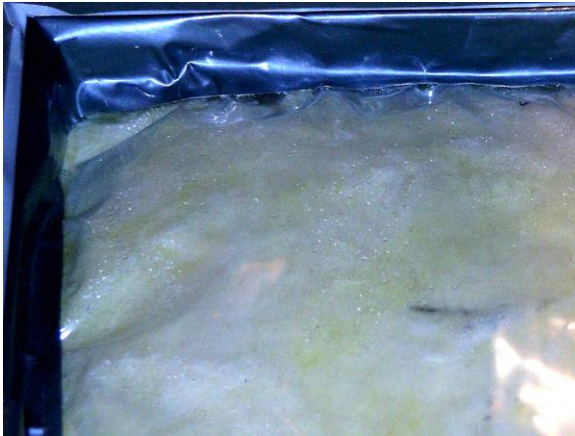
During the examination and monitoring of the walls during the experiment, interesting behavior was noted in walls experiencing summertime inward vapor drive. Although the PA-6 walls showed high relative humidity conditions on the interior side of the stud bay (i.e., where condensation was expected to happen; levels at or near 100%), little condensation actually occurred. An example of worst-case condensation is shown in Figure 4.14. Polyethylene walls being run concurrently showed substantial condensation on the equivalent surface. The incidental condensation noted in the PA-6 walls was able to dry; by wintertime, it was at dewpoint levels lower than the interior. Goldberg concludes from the data that a system using a PA-6 vapor retarder on the interior side (with no exterior moisture barrier/“water separation plane” has acceptable performance, with no net accumulation of moisture and no noted mold activity.

Figure 4.14: Example of worst condensation seen on PA-6 vapor retarder (Goldberg and Gatland 2006)

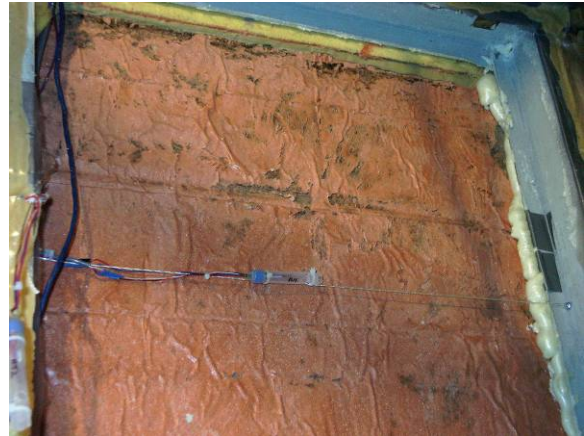
The liquid-applied dampproofing showed some delamination or bubbling on the above-grade portion on the north-side test wall, as shown in Figure 4.15. This may be damage due to extended condensate exposure, or perhaps damage due to frost exposure. As a latex-based coating, it would be vulnerable to re-emulsification in a wet (liquid water) alkaline environment, as would be caused by extended condensation. It is unlikely that the delamination is due to inward vapor gradients, given that the north wall least likely to experience this problem, and it was not seen on the east exposure.

Figure 4.15: Deterioration of wall-side waterproofing coating (Goldberg and Gatland 2006)

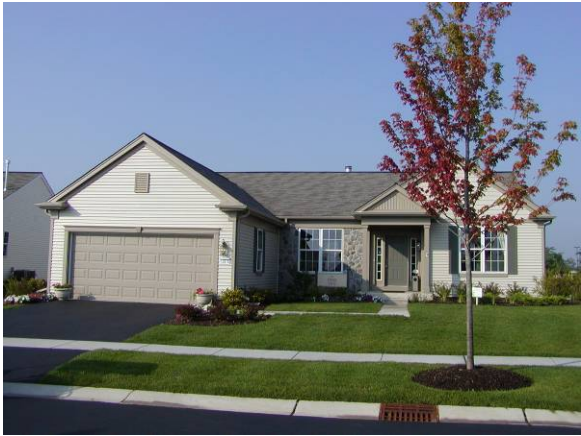
The test house is a model house built by a production builder; it is a single-story, three bedroom, 2256 square foot house with a full basement (see Figure 5.1). The basement walls are nine-foot tall 254 mm (10") cast concrete with spray-applied dampproofing (may be either a solvent-based or an emulsified water-based asphalt coating) on the exterior to grade. Downspouts are directed away from the house with splash blocks, and grading is sloped away from the house on all sides; bulk water is directed away from the foundation. The house was unoccupied for the duration of this experiment. The house had been completed and space conditioned for approximately two years before the installation of the test walls (November 2001 casting; September 2003 installation); therefore, construction moisture was not a significant loading of the experimental assemblies.

Figure 5.1: Front elevation of Huntley test house

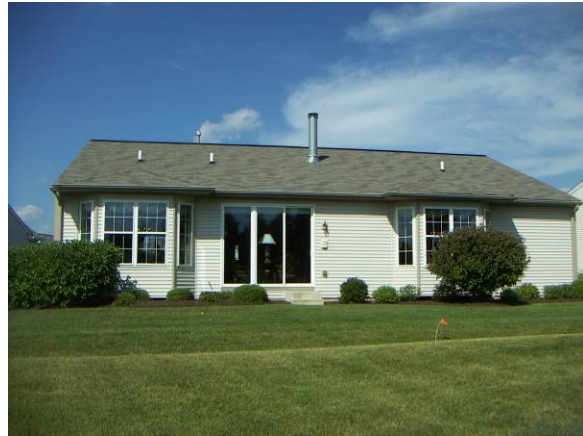
Figure 5.2: Rear elevation of Huntley test house

The interior insulation test walls are placed on the rear orientation of the house (see Figure 5.2): it is a long, straight wall, and faces southwest (see Figure 5.3). The ground changes elevation, sloping downwards from the house, on the right-hand side rear corner (see Figure 5.4).

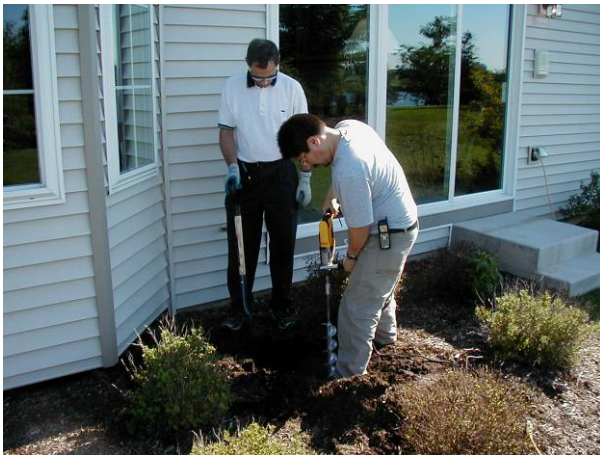
Soil conditions were measured, to obtain boundary conditions for the below-grade portions of the walls. Temperatures and water matric potentials (relative wetness) were measured at three lateral locations approximately two feet away from the test wall: installation is shown in Figure 5.16, and positions relative to the test walls are shown in Figure 5.38. Water potentials were measured using Delmhorst gypsum soil blocks (see Appendix A), which provide soil water potential as a function of electric resistance. These sensor packages were installed at three depths (6"/150 mm, 12"/300 mm, and 36"/900 mm), for a total of nine locations.

Figure 5.16: Boring for soil sensor installation, Huntley site

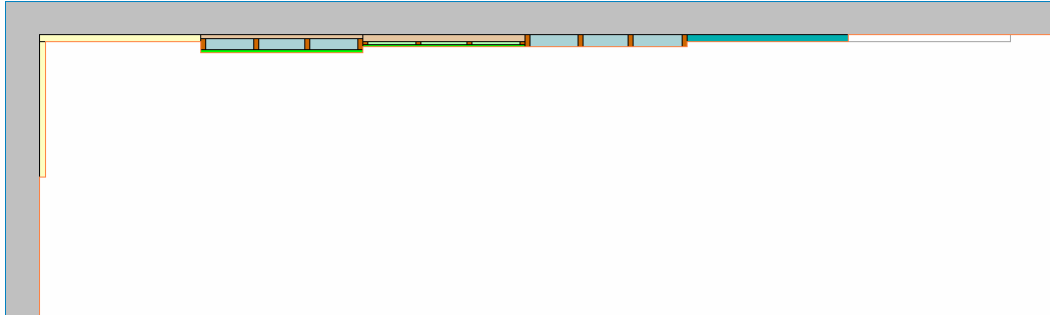
One concern was the thermal effect of the mixture of buffer and test panels: to understand these effects, a two-dimensional static thermal model (THERM) was run on the distinct basement panels, assuming an outdoor (soil) temperature of 10° C (50° F), and an indoor setpoint of 20° C (68° F). The modeled assembly and test results are shown in Figure 5.18 and Figure 5.19, respectively.

Figure 5.18: THERM model, showing assembly components

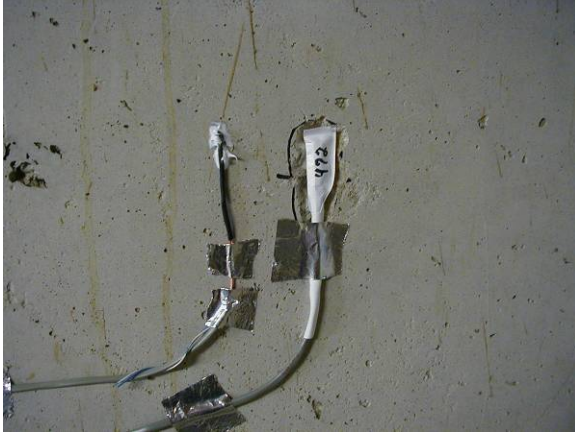
Figure 5.20: T and T/RH sensor at concrete

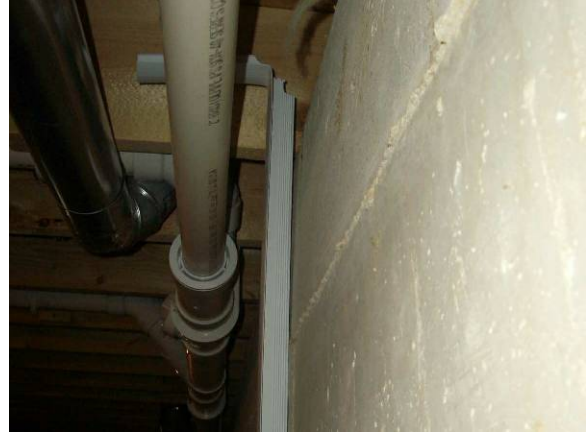
The nine-foot tall basement walls required the use of a one-foot tall extension form at the top of the walls. This extension was not maintained in plane during casting: it typically bends to the exterior by

12-25 mm (1/2" to 1"), as shown in Figure 5.21. This provided some difficulties in finishing the top detail of the interior insulation assemblies, and air sealing; these types of problems are not uncommon in practice.

Figure 5.21: Concrete wall upper form extension out of plane

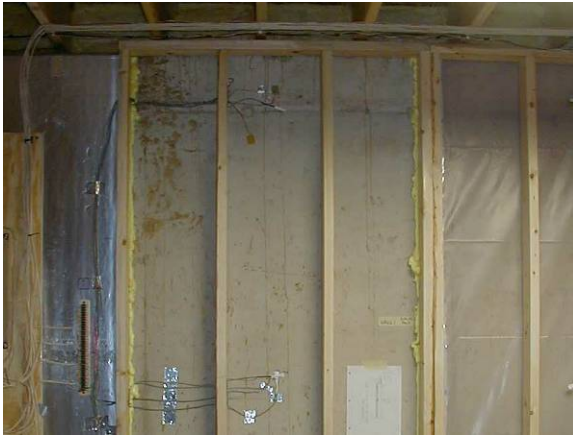
At walls 1 and 2 (stud frame with polyethylene) the walls were laterally air sealed with expanding foam (as shown in Figure 5.22), to simulate the effect of a long unbroken section of wall. However, the joint between the top plate and concrete was not sealed at the beginning of the experiment. This was done to mimic typical practice seen in the field: although an air seal is recommended at this top plate-concrete intersection, it is seldom implemented. Later in the experiment, however, this interface was sealed with expanding foam. The framing has a capillary break (polyethylene foam sill seal) below the bottom plate and is pushed tight to the concrete wall. The instrumentation installed in these walls is shown in Figure 5.23, Figure 5.24, and Figure 5.25, for lower, middle, and upper locations, respectively.

Figure 5.22: Lateral air sealing at Walls 1 and 2 (stud frame walls)

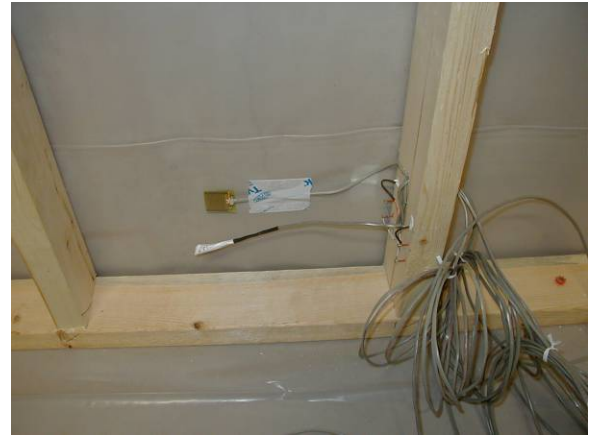
Figure 5.23: Instrumentation package at lower location of stud frame walls (Wall 2)

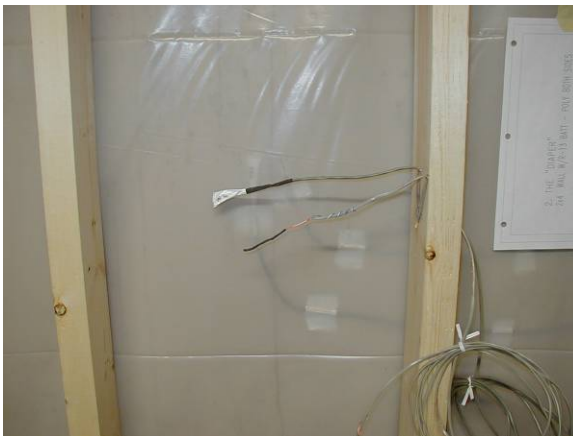
Figure 5.24: Instrumentation package at middle location of stud frame walls (Wall 2)

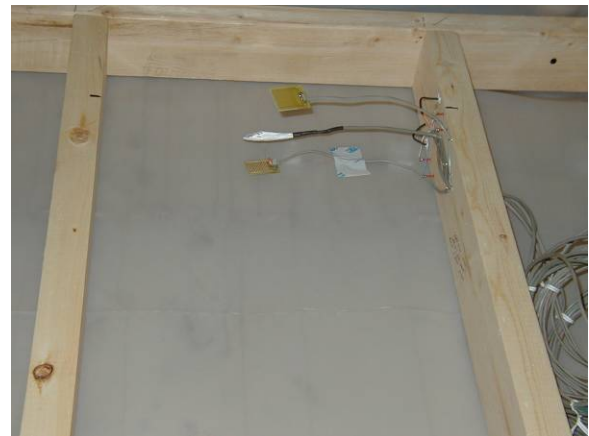
Figure 5.25: Instrumentation package at upper location of stud frame walls (Wall 2)

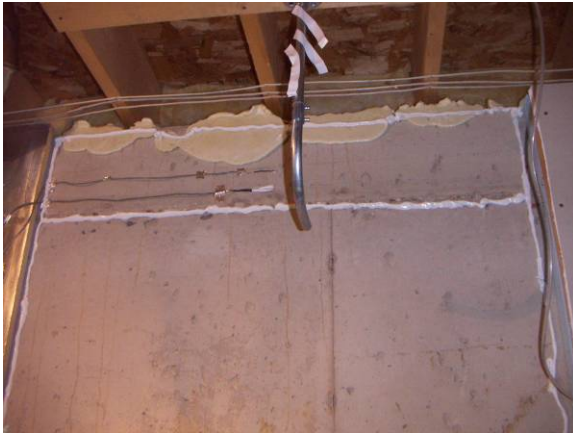
Figure 5.26: Caulk sealing and expanding foam at Wall 3 concrete

In wall 3 (foil-faced polyisocyanurate), the plastic attachment track system creates a small air gap between the insulation and the concrete, between 1/8 and 1/4" (3-6 mm) wide, even when the plastic tee cap is installed tightly. Partway into the experiment, the junction between the top of the foam insulation board and the concrete was sealed with expanding foam. However, later disassembly showed that this air seal was incomplete. During the last portion of this research, the plastic tracks were removed, and the foam insulation was directly applied to the concrete using caulk and concrete fasteners. Caulk was applied around the perimeter and at the junction to the top form extension to ensure a good air seal (see Figure 5.26).

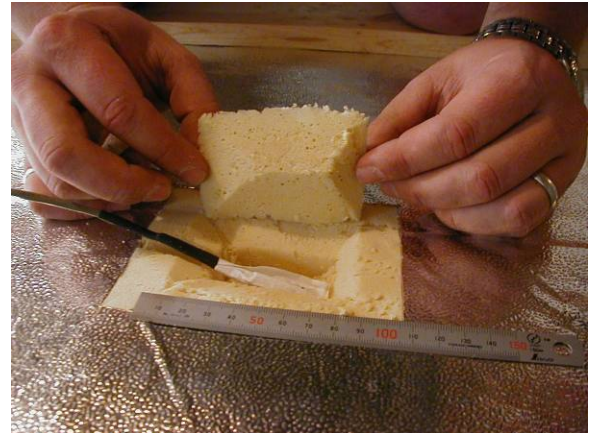
Figure 5.27: Installation of temperature/RH sensor in foam board (Wall 3)

A temperature/relative humidity sensor was installed mid-thickness in the insulation board by cutting a pocket out of the board from the exterior face, as shown in Figure 5.27. The sensor was installed, and sealed with foil tape.

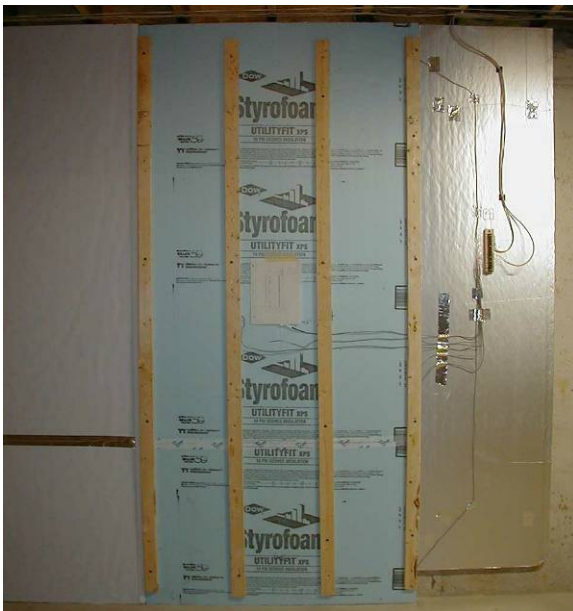
Figure 5.28: Installation of furring strips and foam at wall 4

At wall 4 (2" XPS), the furring strips were attached at 410 mm (16") o.c., using concrete screws (see Figure 5.28). This attachment method resulted in the foam being held tightly against the concrete wall, with little chance of air leakage, despite the lack of other air sealing measures. Unpainted gypsum drywall was attached to the furring strips at the interior; the vented cavity space was well connected to the interior. Due to the 9-foot tall walls, two pieces of foam board were required; the joint was placed between the "lower" and "middle" sensor locations, to minimize the effects of this seam. The joint was sealed with builders' tape on the interior face.

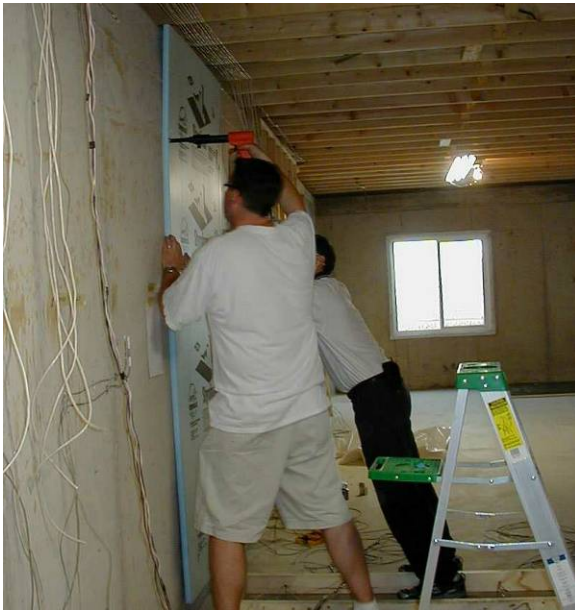
Figure 5.30: Installation of XPS board at wall 6 with powder actuated fasteners

Walls 5 & 6 (XPS with stud frame/insulation) were the most involved in construction, due to the combination of stud framing and foam board. In wall 6 (XPS + cellulose), the foam was attached to the concrete with powder-actuated fasteners (see Figure 5.30), and the stud frame erected inboard. No air sealing measures were taken laterally or at the top between the frame and the foam, due to scheduling constraints of cellulose damp-spray installation. The cellulose installation is shown in Figure 5.31 and Figure 5.32.

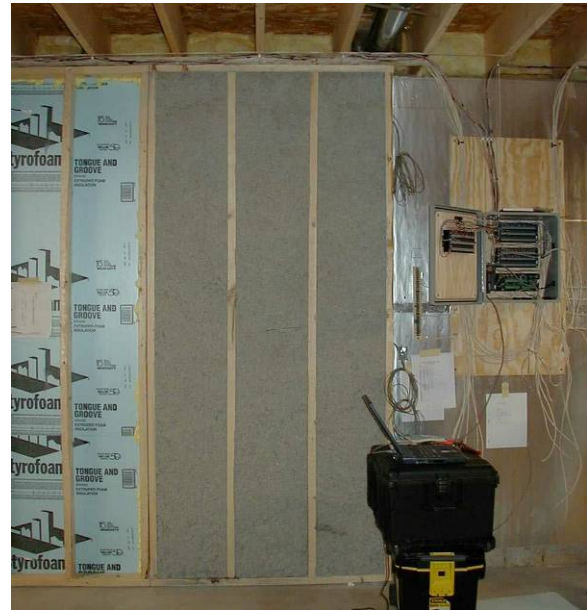
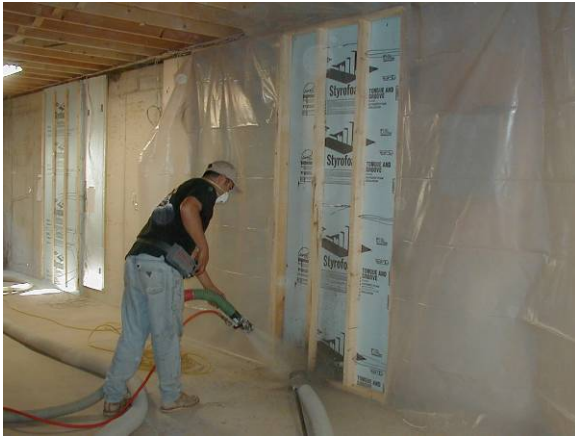
Figure 5.31: Installed cellulose insulation in wall 6

Figure 5.32: Installation of cellulose insulation in wall 6

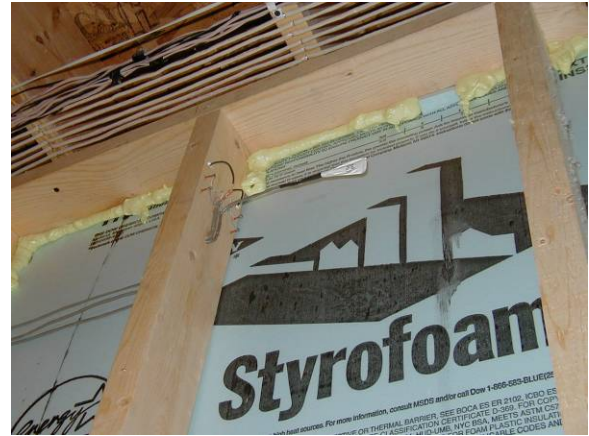
Figure 5.33: Top air sealing detail and foam wedge at wall 5

In contrast, in wall 5 (XPS + fiberglass), the foam was installed and then wedged tightly against the concrete, to conform to the uneven wall profile (see Figure 5.33). The joint between the foam and stud bay cavity was then sealed using expanding foam, both at the sides and the top. The difference in the installation method is a likely explanation for some of the differences in behavior seen in these walls.

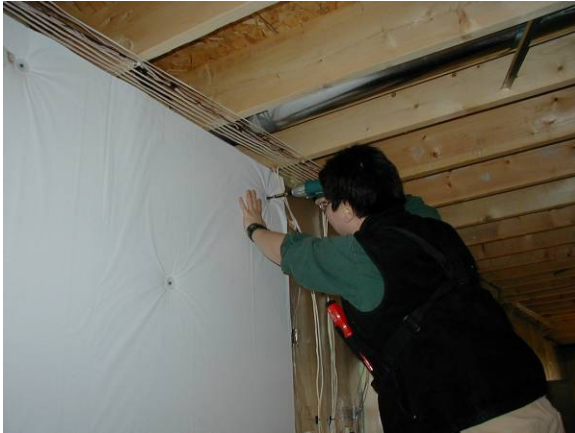
Figure 5.34: Installation of PA-6/rigid fiberglass material (wall 7)

The material for wall 7 (PA-6 facer and perforated scrim attached to rigid fiberglass) was shipped after the initial installation; this wall was commissioned in January of 2004. The material was attached tightly to the concrete wall with concrete screws and nylon washers. The horizontal joint between panels and the vertical side joints were sealed with foil tape; the lateral joints were sealed to the adjacent buffer panels. Although no special effort was made to air seal the system at top and bottom, semi-rigid fiberglass is of a high enough density that airflow through the insulation would be minimal.

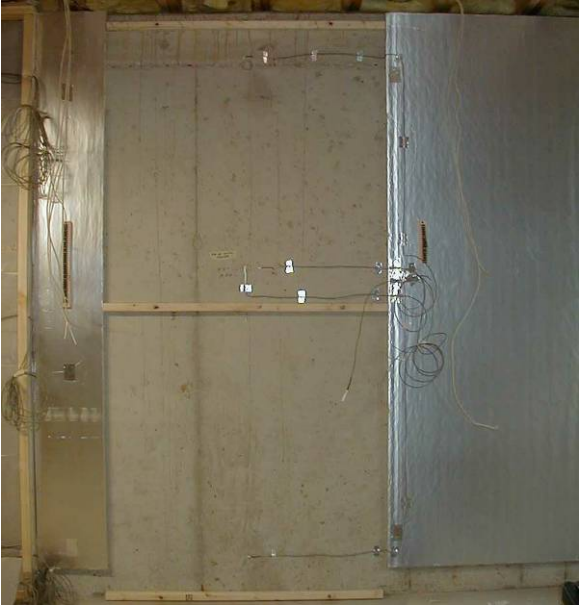
Figure 5.36: Installation of 2x2s at wall 8

Wall 8 it is attached to the concrete wall by installing 2x2 at the bottom, middle, and top of the wall, attached with powder actuated tool pins to the concrete. The vinyl flanges of the rolls were then stapled to the 2x2s. The lateral joints were sealed to the buffer panels with builders' tape; the horizontal joints were left untaped. However, the vertical joints failed routinely, and air leakage is likely. It was upgraded over time, using foil tape and staples; the latter sealing methods were more successful.

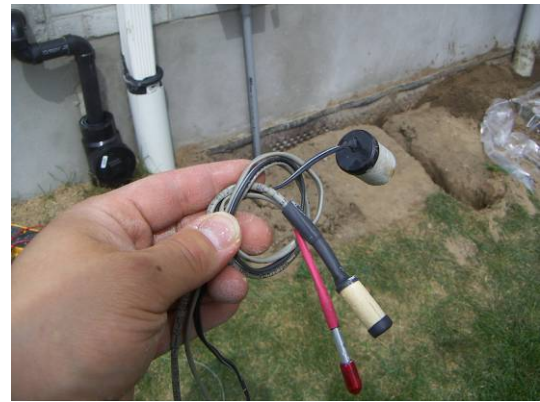
Figure 5.49: Gypsum soil block, wood plug sensor, and temperature sensor in soil installation

As with the Huntley site, interior and exterior temperature and relative humidity were recorded; interior conditions were measured at two locations. Soil conditions were measured as well, to obtain boundary conditions for the below-grade portions of the walls. Soil sensors recorded temperatures, water matric potentials (with soil gypsum blocks), and moisture content using wood “plug” sensors (similar to “wafer” sensors; see Appendix B). Measurements were taken at two lateral locations approximately two feet away from the test wall: positions relative to the test walls are shown in Figure 5.48; installation is shown in Figure 5.49 and Figure 5.50. These sensor packages were installed at three depths (6"/150 mm, 12"/300 mm, and 36"/900 mm), for a total of six locations.

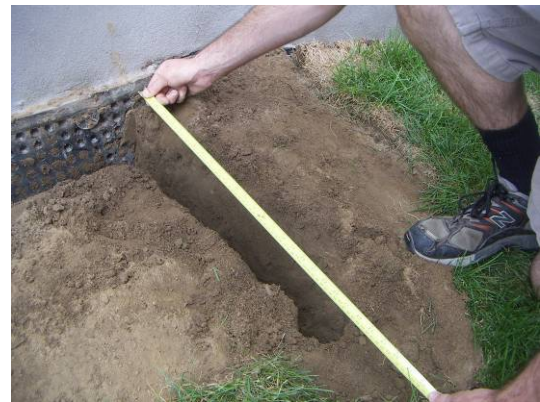
Figure 5.50: Location of soil sensor hole

On the exterior, the basement walls are treated with spray-applied dampproofing to grade, which is then covered with an HDPE (high density polyethylene) plastic “dimple mat” drainage and protection board; the top termination of this board can be seen in Figure 5.50.

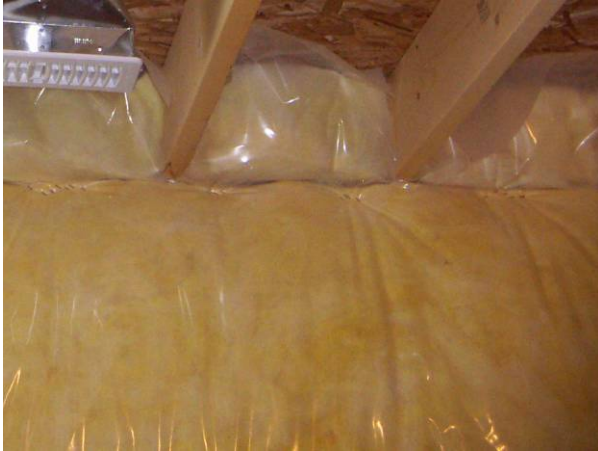
Figure 5.51: Existing rim joist condition at Kitchener site

During the initial disassembly of the existing walls, some evidence of moisture accumulation was noted at the rim joist, as shown in Figure 5.52; note that in Figure 5.51, the polyethylene facer of the roll blanket is continued from the foundation wall up to the rim joist. This moisture damage could be bulk leakage, or it could be redistribution of moisture accumulated from inward vapor drives. There was some discoloration of the fiberglass roll blanket, suggesting the occurrence of this inward drive.

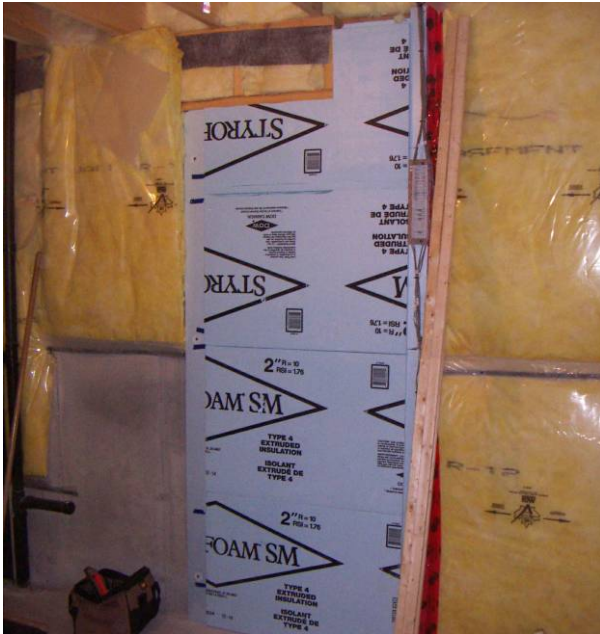
Figure 5.54: Installation of XPS wall at foundation step down

The installation of the XPS wall (Wall 1) is shown in Figure 5.54. Two-foot wide pieces were installed horizontally, and held in place with furring strips attached with concrete screws. The roll blanket wall (Wall 2) was installed with materials used in the original installation; the panel was air sealed to the panel separators using builders' tape, to mimic the effect of a long continuous wall.

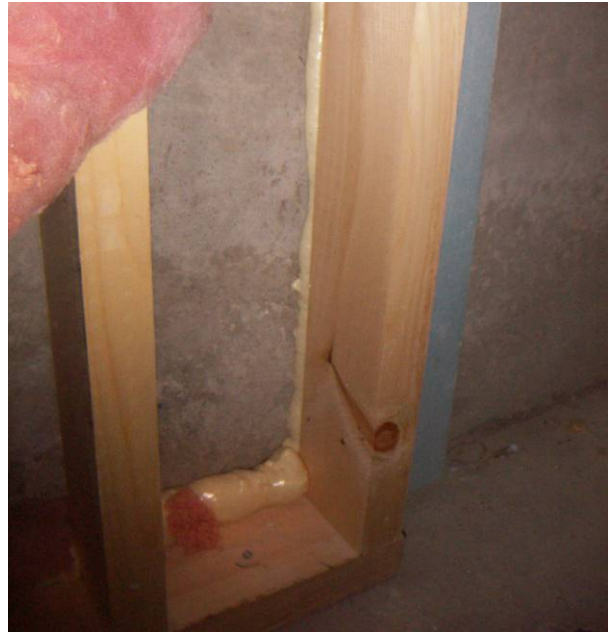
Figure 5.55: Air sealing at perimeter of stud frame walls

The frame walls were installed with a polyethylene foam sill seal below the bottom plate. The frame was installed directly plumb but against the concrete wall; contact between the two occurred at some points. The gap between the frame and concrete was sealed with expanding foam at top, side, and bottom, as shown in Figure 5.55 and Figure 5.56.

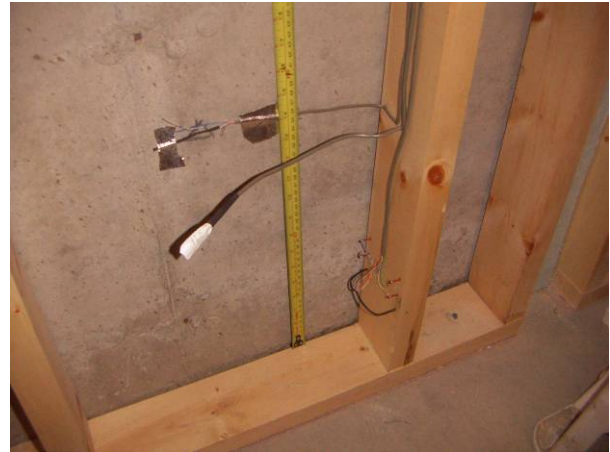
Figure 5.59: Sensors at lower location of stud frame wall

The sensor installation for the frame walls is illustrated in several photos: at the upper location (Figure 5.57: stud MC/T, upper concrete T, mid-batt T/RH, upper wafer), middle location (Figure 5.58: middle wafer, concrete-side T/RH, mid-batt T/RH, GWB T), and lower (Figure 5.59: stud MC/T, lower concrete T, mid-batt T/RH).

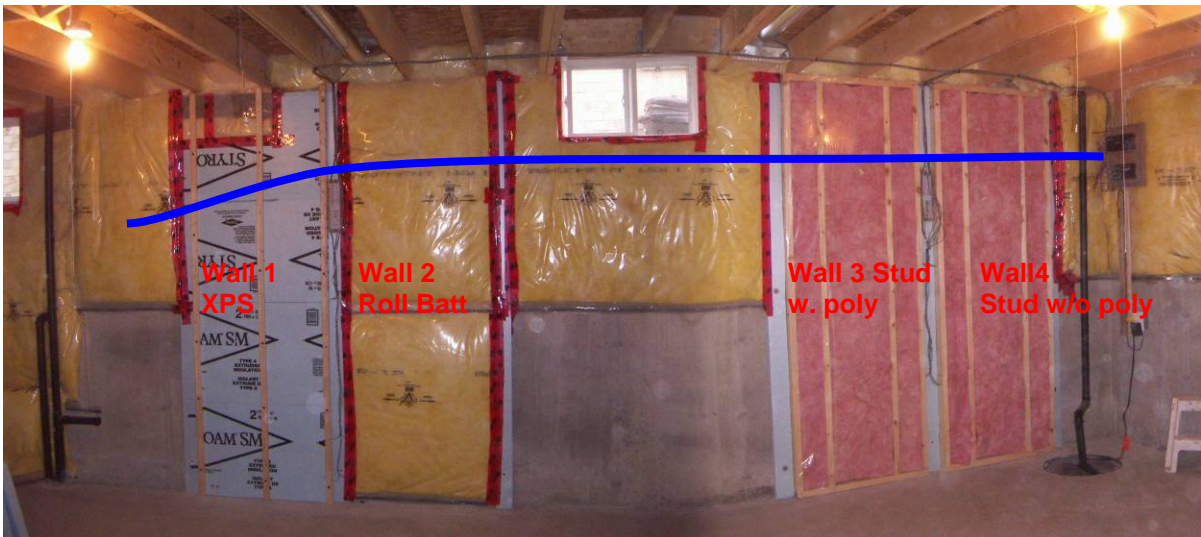
Figure 5.60: Test panels at Kitchener site (pre-drywall); approximate grade level shown

The completed installation, pre-drywall, is shown in Figure 5.60; approximate grade level is shown.

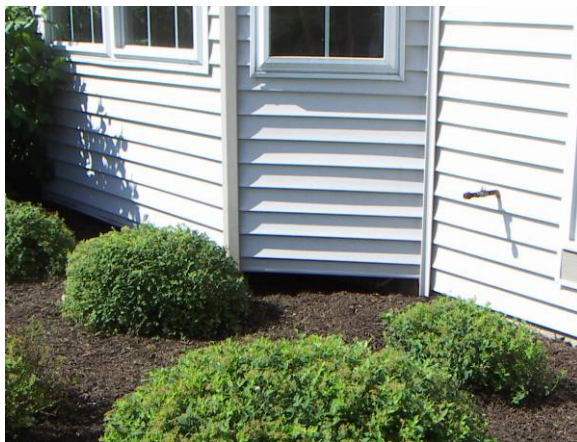
Figure 6.15: Bay near Wall 8, showing shading on above-grade portion of concrete

Further measurements were taken around the non-experimental sides of the house, to gauge the effects of solar exposure on above-grade temperatures. The east (left) side of the house, which was in the shade by the afternoon, was at 25-26° C, except at the garage (26-27° C). The west (right) side was at 28-30°, except behind the shrubbery at the corner.

It was therefore concluded that solar exposure creates a noticeable temperature difference at the above-grade wall portions of the wall in summertime. This is demonstrated in the plot of the temperature at the concrete-insulation interface at the upper location (Figure 6.16). The solar exposed walls (1 and 6) show markedly higher temperatures, and sharper daily peaks than the shaded walls (7 and 8). The peak differences are roughly 4° C. Note that these selected walls are the extreme cases: walls 7 and 8 are noticeably cooler than the remaining walls; the remaining six walls are clustered near the warmer walls.

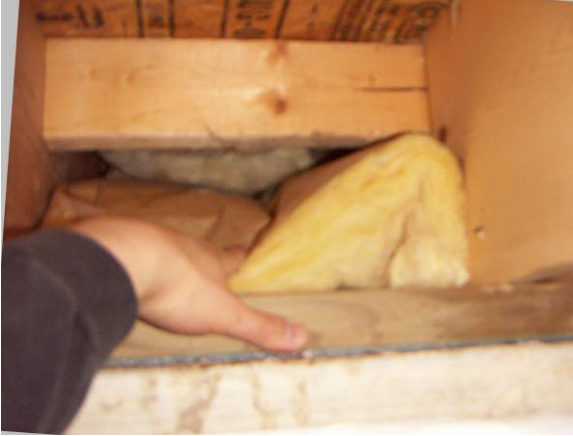
Figure 6.17: Bay interior near Wall 8, showing incomplete blocking/air leakage location

A similar examination was conducted for winter; it also showed temperature differences between the walls. During field visits, a second reason for this temperature difference was observed. At the cantilever bays, there was no air barrier in the joist bay between the interior and the cantilever space (Figure 6.17), and the air barrier at the cantilever (to exterior) is very poor, due to access/detailing difficulties. As a result, there is a substantial cold air leak at the cantilever bays; this was noticeable

while standing several feet away from the wall. Stack effect will tend to draw exterior air into the house at this location (bottom). This air infiltration tends to cool the upper portion of the concrete wall, as reflected in the data (Figure 6.18). Maximum temperature differences were roughly 4° C.

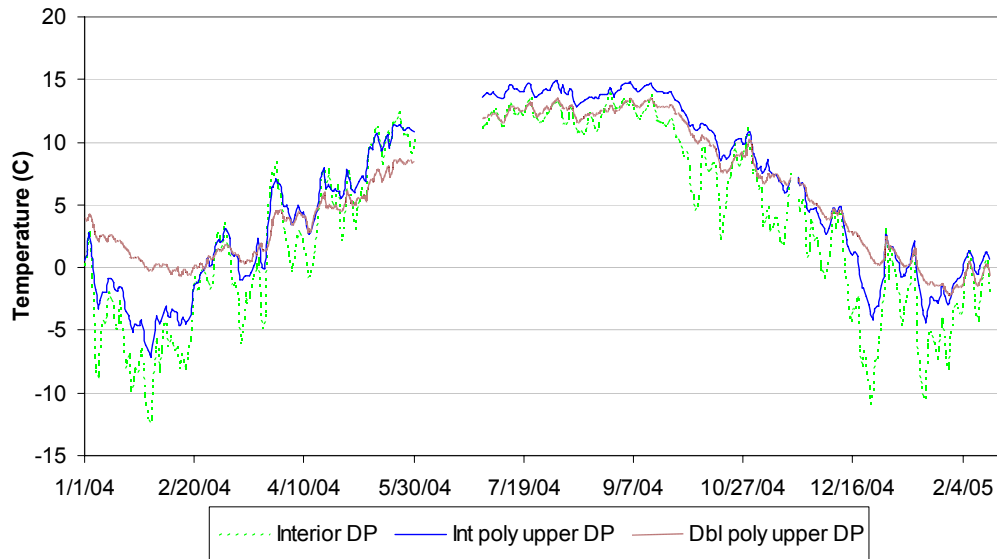
Figure 6.24: Single and double poly dewpoint (upper location), with interior DP

The walls were compared using dewpoint temperatures within the assembly, first at the upper location (Figure 6.24). Although the profiles are similar, the single poly wall is drier (lower dewpoint) than the double poly wall in both winters, but is wetter in the summer. This can be explained with the moisture physics of these assemblies mentioned earlier. During the winter, the double poly assembly eliminates any drying to the exterior due to its low permeability (roughly 3 ng/Pa·s·m², or 0.06 Imperial perms for poly, vs. 19 ng/Pa·s·m², or 0.3 Imperial perms for concrete). The exterior polyethylene “moisture barrier” also removes the moisture storage capacity of the concrete.

But in the summer, there is some inwards vapor drive: the double poly wall is isolated from this source, while in the single poly wall, this moisture can enter the stud bay cavity. However, it should be noted that this was not a very strong inwards vapor drive: summertime humidity in the stud bay

peaks at roughly 70% in mid-batt; no condensation would have occurred on the interior polyethylene. As noted earlier, this wall had been drying for two years before the installation of these assemblies.

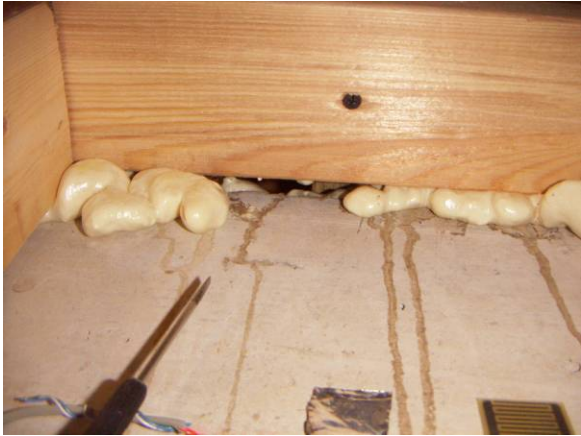
Figure 6.27: Gap in air seal at the top of panel 1

In the single polyethylene wall (panel 1), the air seal between the top of the framing and the concrete wall went through several stages. It was originally constructed unsealed, as per typical builder practice. Expanding foam was used to seal this joint in September 2005 (see Figure 6.27), and when the walls were opened in July 2006, this seal was refined with builders' tape (see Figure 6.28).

Unfortunately, the effect of the first air sealing could not be discerned, because the wetting system was run on the same trip that this repair was completed. The data at the time of the second air sealing (using builders' tape) showed no effect.
