Hygrothermal Behavior of Interior Basement Insulation

A thesis
presented to the University of Waterloo
in fulfillment of the
thesis requirement for the degree of
Master of Applied Science
in
Civil Engineering

Abstract: Hygrothermal Behavior of Interior Basement Insulation

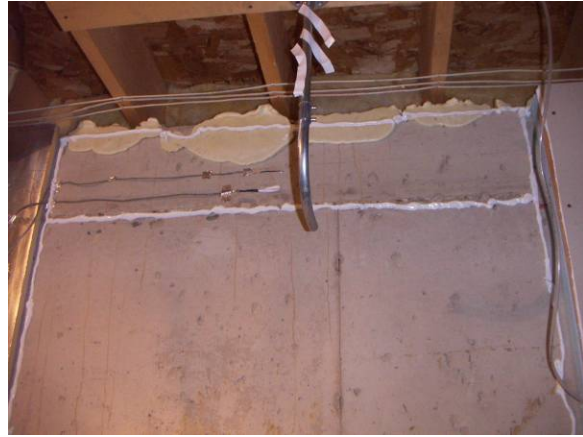
Figure 6.31: Caulk air seal around the perimeter and at form board extension intersection

Subsequent field visits demonstrated that the plastic channels used to install the insulation panel result in a gap of 3 to 9 mm (1/8" to 3/8") between the panel and the concrete; it is apparent that interior air can communicate freely with this space. This was true even after the installation of expanding foam at the top interface of the insulation and the concrete in late 2005 (see Figure 6.30). In addition, the sensor installed mid-thickness in the panel has an inadequate air seal, despite the lack of visible installation deficiencies: it could communicate with the air gap space. The hygric mass of the concrete and the polyisocyanurate results in the damping seen in the sensor response (relative to interior dewpoint).

bows outwards (creating an additional gap), as shown in Figure 6.31. The board was attached directly to the foundation wall with concrete screws and washers.

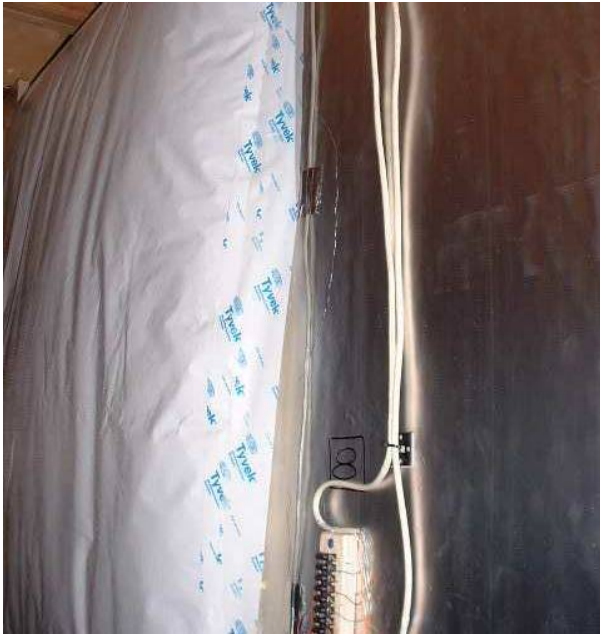
Figure 6.39: Roll blanket lateral seal failure in October 2003

In contrast, the roll blanket wall (panel 8) shows dewpoint levels that are practically identical to interior dewpoint. There is some damping, likely due to the hygric storage of the concrete. As mentioned in Chapter 5 (Section 5.1.4.2) the vertical seals at the edges of the panels were problematic, failing over time as shown in Figure 6.39. However, later repairs using mechanical fasteners to reinforce the tape (as shown in Figure 6.40) proved to be more durable.

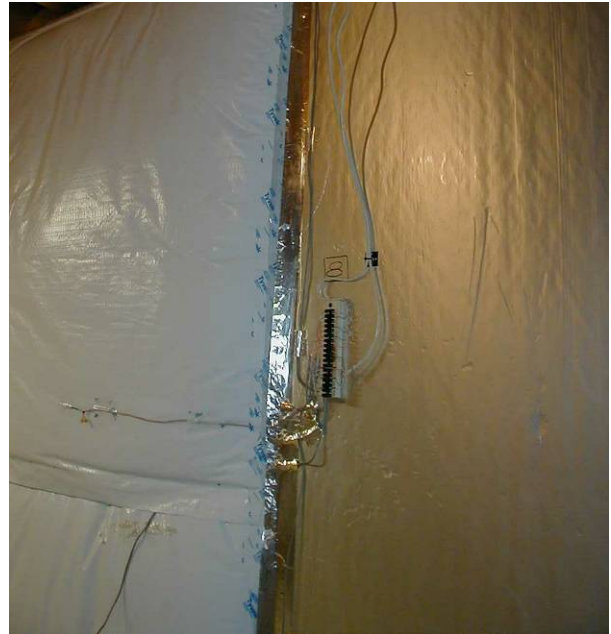
Figure 6.40: Roll blanket lateral seal condition in June 2004

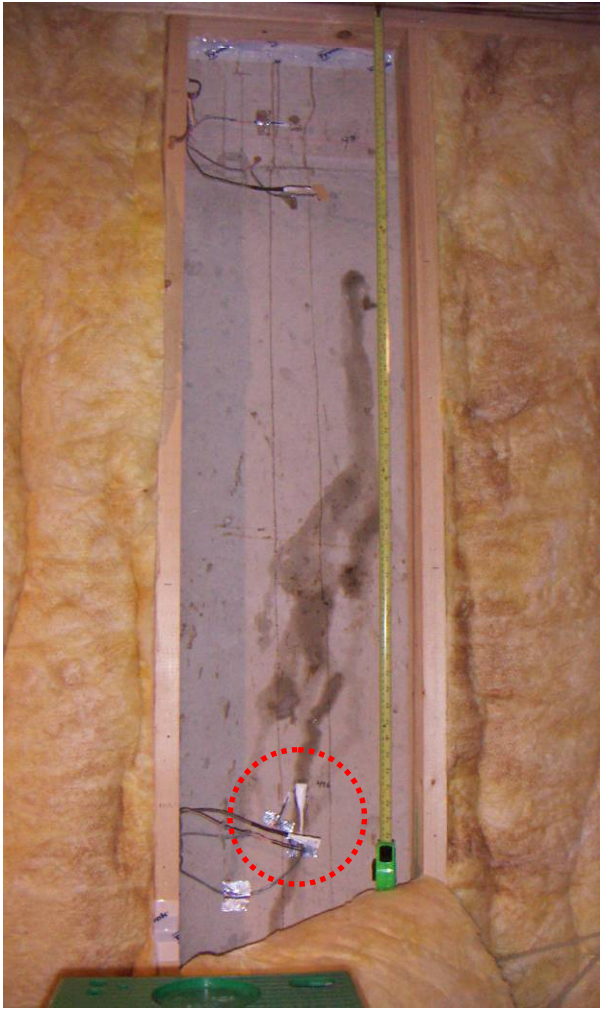
Figure 6.62: Upper portion of wetting plume in single polyethylene wall (panel 1)

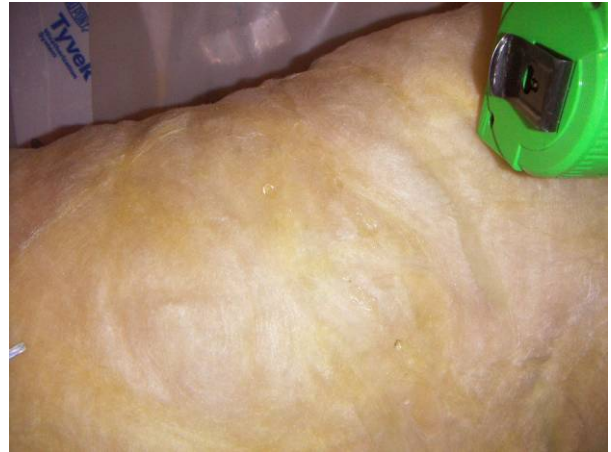
In contrast, in the double polyethylene wall, the wetting system introduced water at the interface between the outer “moisture barrier” polyethylene and the fiberglass batt; it was not in contact with the concrete. The water quickly ran down this interface, along the hydrophobic polyethylene, with negligible accumulation, as seen in Figure 6.64. There was water retained in the fiberglass batt, as seen in Figure 6.65.

Figure 6.65: Water beading at fiberglass batt in double polyethylene wall (panel 2)

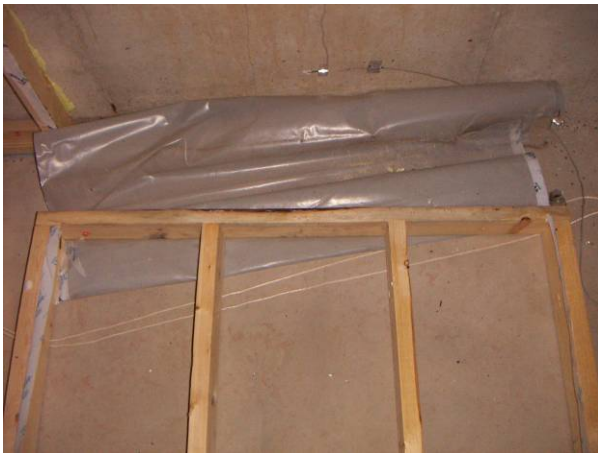
Figure 6.66: Sill plate of double polyethylene wall (panel 2)

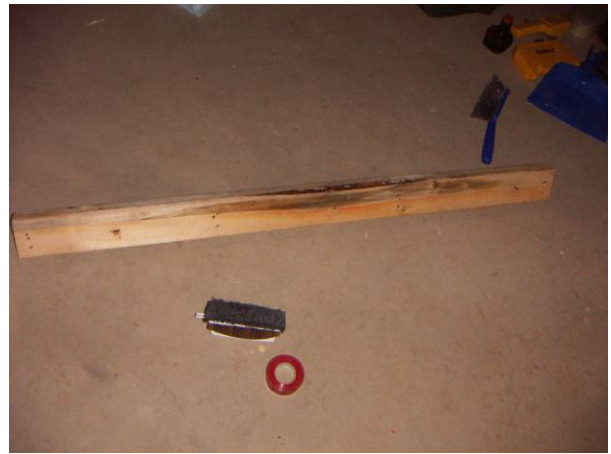
Figure 6.67: Close up of double polyethylene sill plate

The conditions behind the polyethylene in panel 2 were close to 100% RH for most of the experiment; however, no mold growth was seen at this interface. Dirt/dust and insect bodies had collected at this cavity, but no odors or problems were noted.

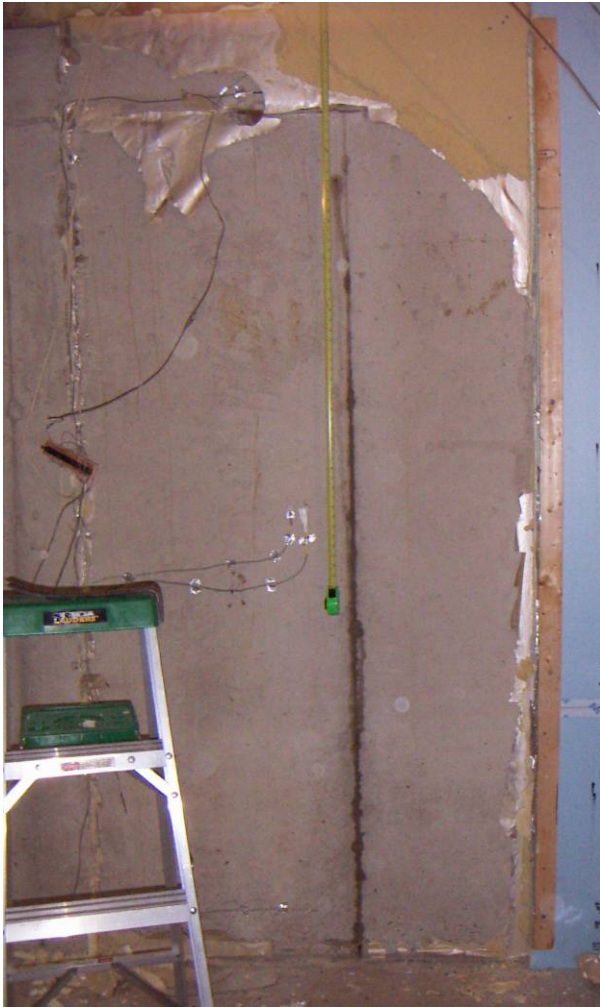
Figure 6.68: Wetting plume in foil-faced polyisocyanurate wall

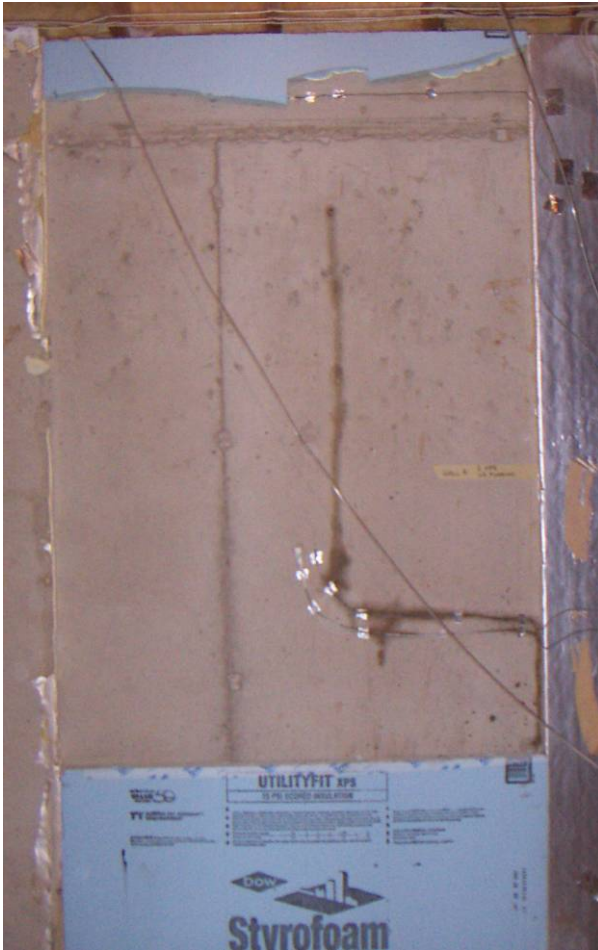
Figure 6.69: Wetting plume in 2" XPS wall

This wall showed extended periods at high relative humidity, especially after the wintertime wetting event. The panel was installed “tight” against the concrete, with concrete screws at a regular fastening schedule. Therefore, it was believed that water was “sandwiched” at this interface, instead of draining out of the system.

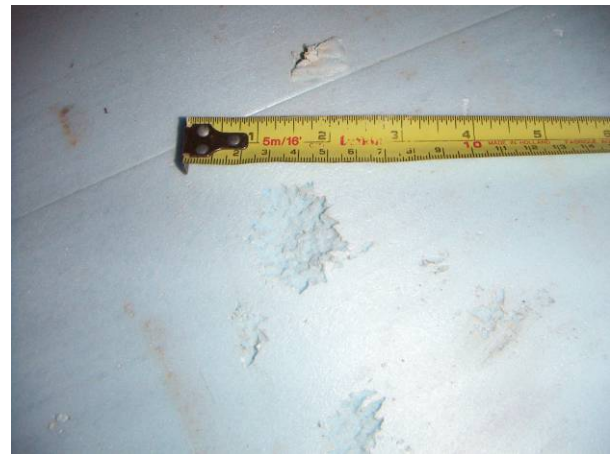
Figure 6.71: Craters or burrows on exterior

insulation, showing wire tracks

The exterior side of the insulation also revealed craters that appeared to be burrowed or chewed by insects or other pests (Figure 6.71). They were only seen on the upper panel. A large number of dead “pill bugs” (*Armadillidium vulgare*) were seen in most of the assemblies. These creatures are limited to damp environments: the observed damage corresponds to the wetting pattern (only seen in upper panel; wetting plume leaves the wall before hitting the lower panel).

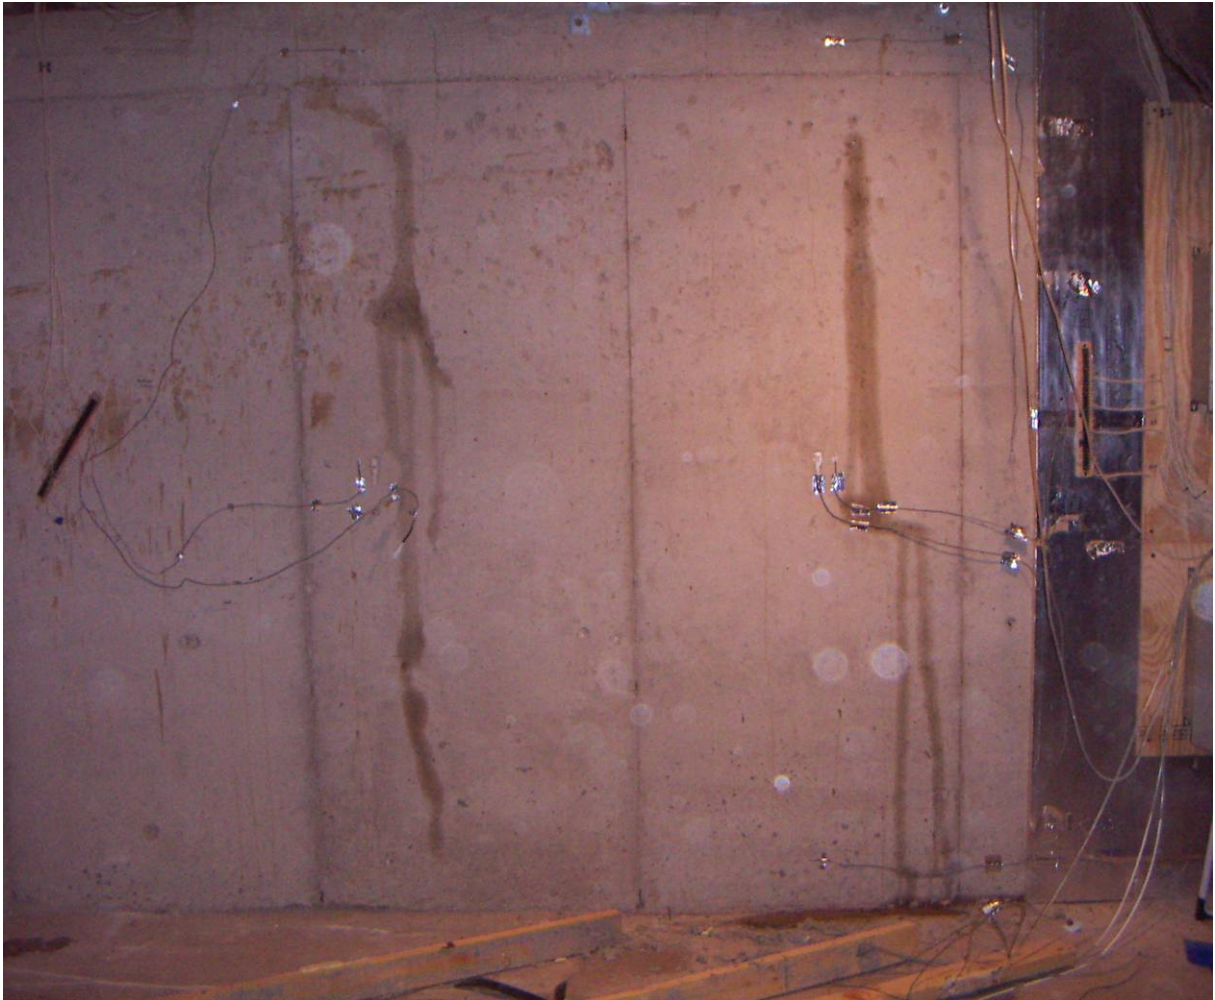
Figure 6.72: Wetting plume in 1" XPS + fiberglass (left) and XPS + cellulose (right) walls

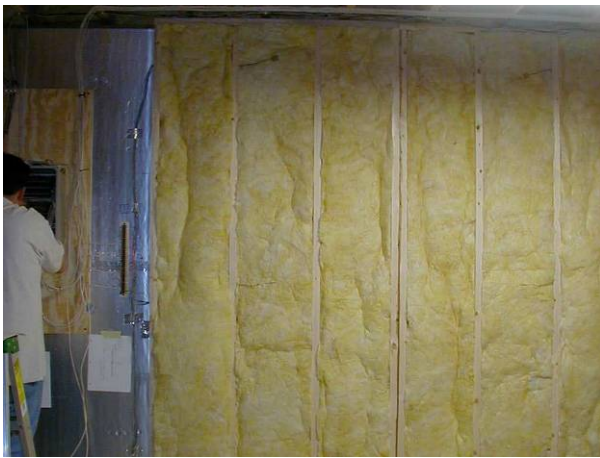
Figure 6.75: Initial condition of interior of fiberglass (panels 1 and 2), September 2003

The progress of the brown staining of the fiberglass batt walls was photographed over time; the initial installation condition is seen in Figure 6.75, and some small stains were noted in June 2004, prior to the installation of the wetting system (Figure 6.76).

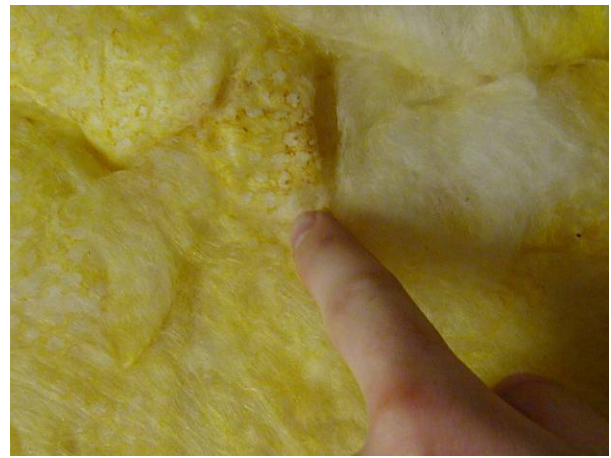
Figure 6.76: Small brown stains in June 2004; double polyethylene wall (panel 2)

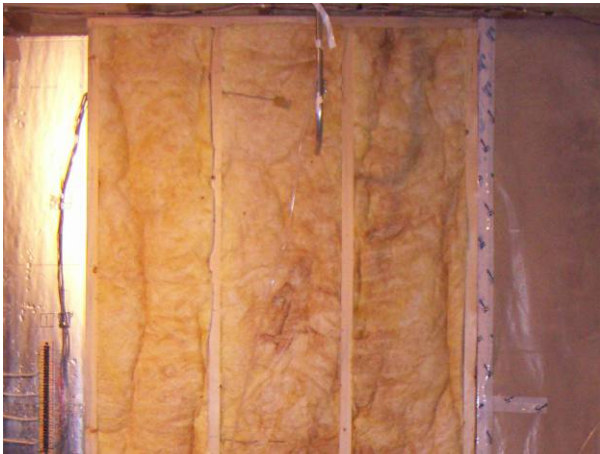
Figure 6.77: Brown stains on interior of fiberglass (panel 1), July 2006

By the time of wall disassembly in July 2006, brown staining on the interior side of the fiberglass was pronounced, as seen in Figure 6.77 (single polyethylene), Figure 6.78 (double polyethylene), and Figure 6.79 (XPS and fiberglass). This staining was mostly seen on the interior face; a similar stain was seen on the exterior face in one bay of the XPS-fiberglass wall.

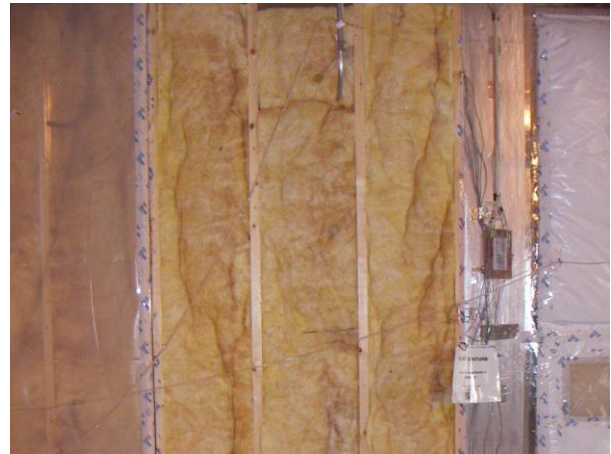
Figure 6.78: Brown stains on interior of fiberglass (panel 2), July 2006

The pattern is arguably the worst in the double polyethylene wall, with visible staining in all stud bays. However, if this is a moisture-related phenomenon, it is surprising that it was seen in the XPS-fiberglass wall, given the low stud bay dewpoints and lack of condensing conditions. On the other hand, the correspondence between the brown staining and the wetting system location in panel 5 suggests a relationship. The possibility of some air-transport phenomenon has not been conclusively dismissed. The chemistry of this staining is unknown; it is likely a water-based reaction with the organic binders used in the fiberglass batts.

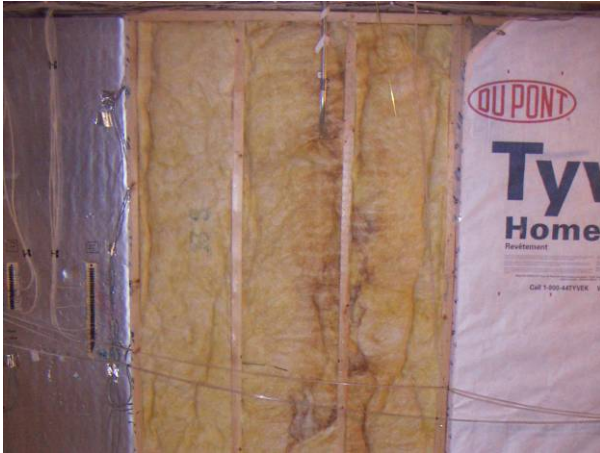
Figure 6.79: Brown stains in XPS/FG (panel 5), July 2006

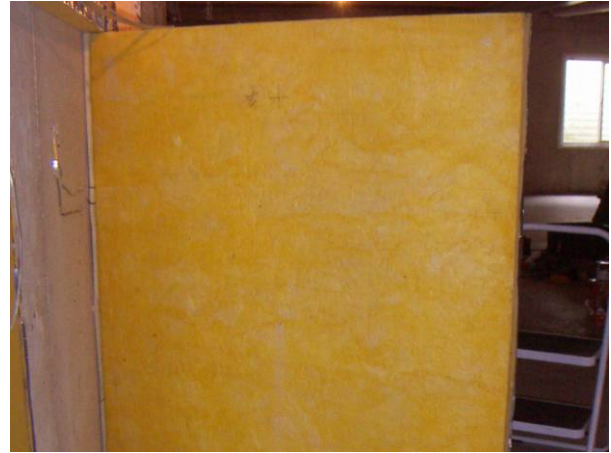
In the PA-6/rigid fiberglass wall, no similar brown staining was noted at the fiberglass surface in contact with the concrete (Figure 6.80). No brown staining was observed in the white roll blanket fiberglass. This could be a function of either moisture exposure, or different binder chemistry between the materials.

Figure 6.80: Concrete interface of rigid fiberglass in PA-6 wall (panel 7)

There was minimal staining of the exterior side of the rigid fiberglass, as seen in Figure 6.80; no mold growth was observed, despite sustained high humidity levels.

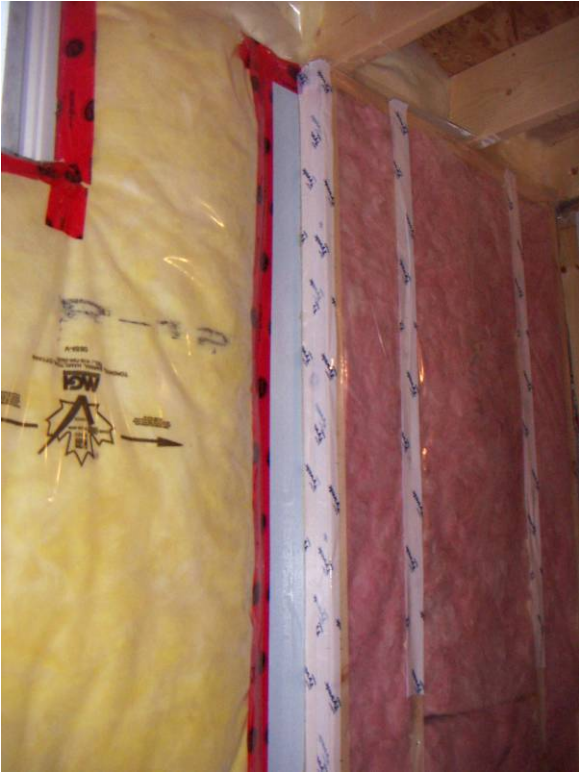
The first and third items were addressed during a field visit in January 2007; the exposed portions of the perimeter studs were covered with builders' tape (see Figure 7.15). Unfortunately, the buffer panels prevented complete taping of the edge studs (see Figure 7.16). The top was not taped, as per normal practice. A second layer of tape was installed to link the vertical edges of the polyethylene with the tape on the side of the stud, completing the air seal at the lateral joints.

Figure 7.15: Taping of perimeter studs, and faces of inner studs (at staple holes)

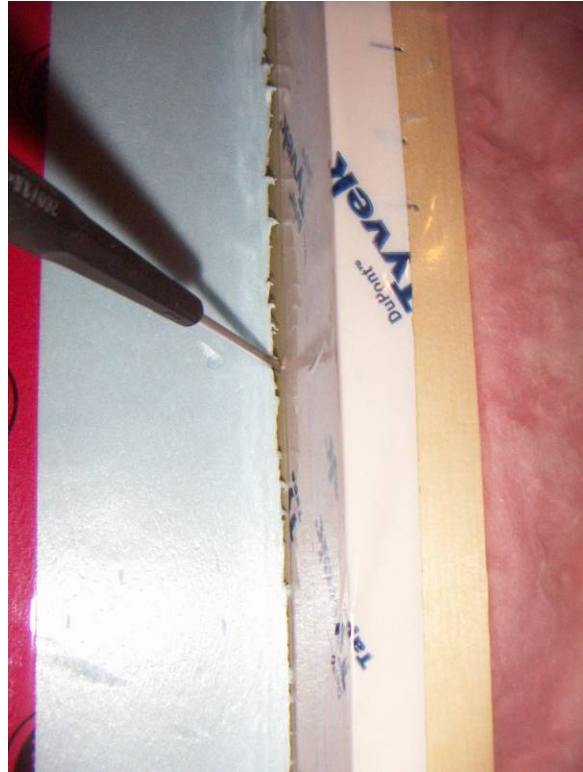
Figure 7.16: Tape only covers exposed portion of edge studs; could not apply at buffer panels

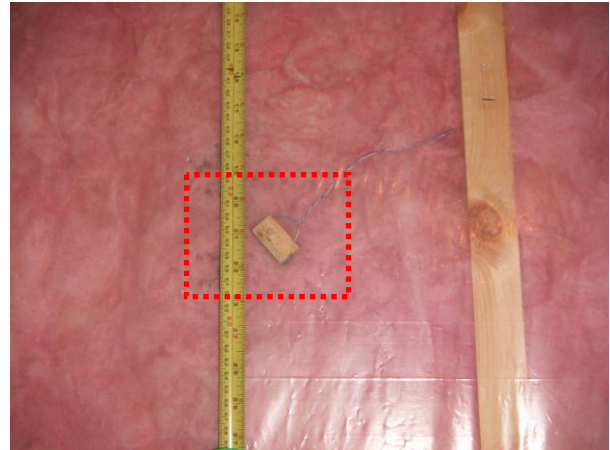
Initial inspection after removing the drywall showed no moisture damage on the drywall or the fiberglass insulation; no condensation was seen on the polyethylene vapor barrier. The only notable observation was the mold growth on the upper moisture content wafer, on the interior side (Figure 7.24 and Figure 7.25).

Figure 7.24: Upper moisture content wafer

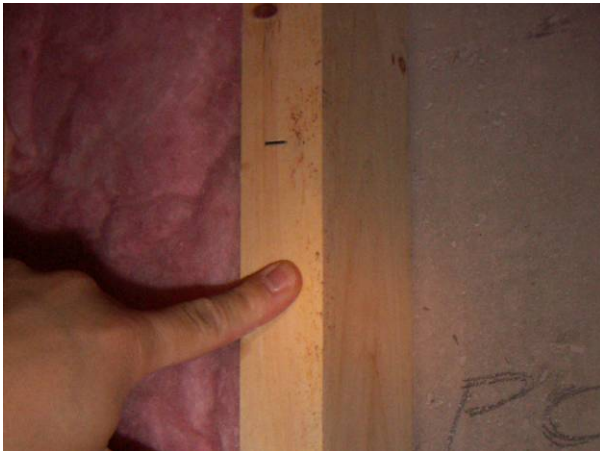
After removing the polyethylene, a small amount of brown spotted staining was found on the upper (above-grade) portions of the studs, on the inboard side (Figure 7.26 and Figure 7.27). This staining or growth was superficial/surface in nature.

Figure 7.26: Brown staining at inboard side of upper portion of left-hand test bay stud

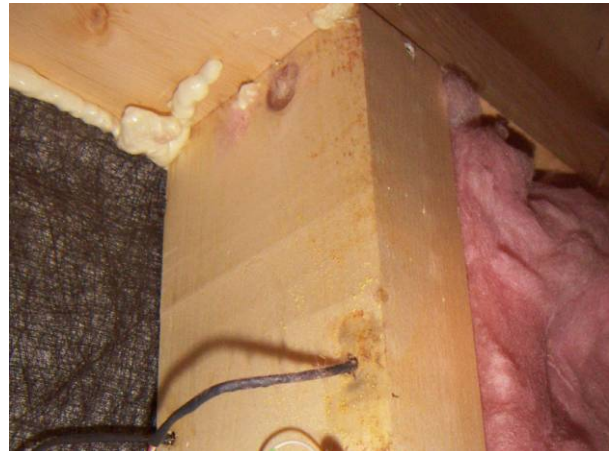
Figure 7.27: Brown staining at inboard side of upper portion of right-hand test bay stud

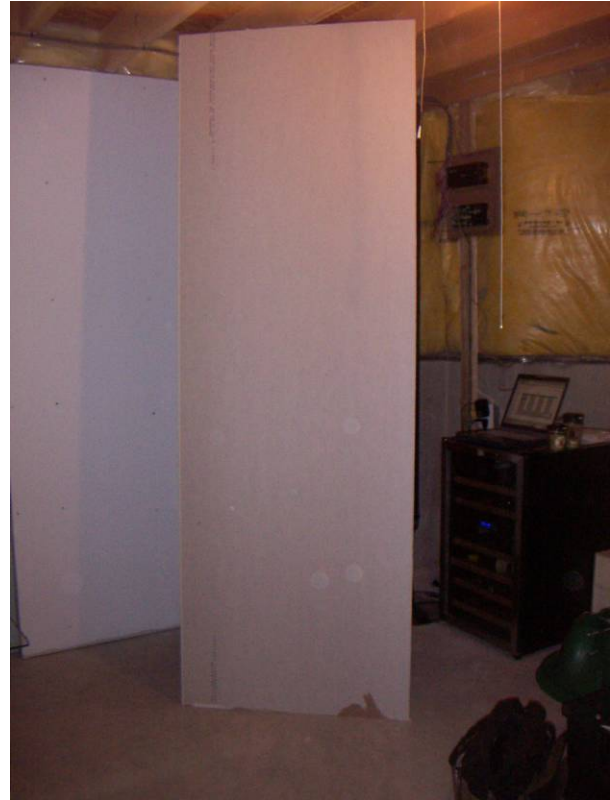
in Figure 7.31 and Figure 7.32 indicate that moisture passes through without causing harm. The circles visible in Figure 7.31 are dust/flash photographic artifacts.

Figure 7.31: Exterior face of drywall in frame-latex paint wall

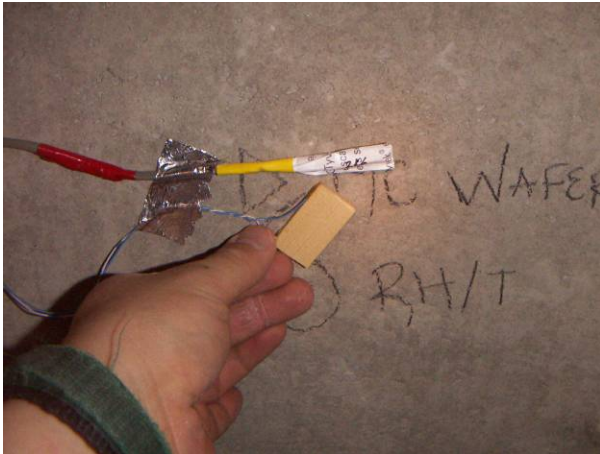
The middle-height concrete-insulation interface wafer showed no mold evidence on the interior side; there was a slight amount of brown spotted staining on the exterior face.

Figure 7.36: Mid-height concrete-insulation interface wafer, interior side

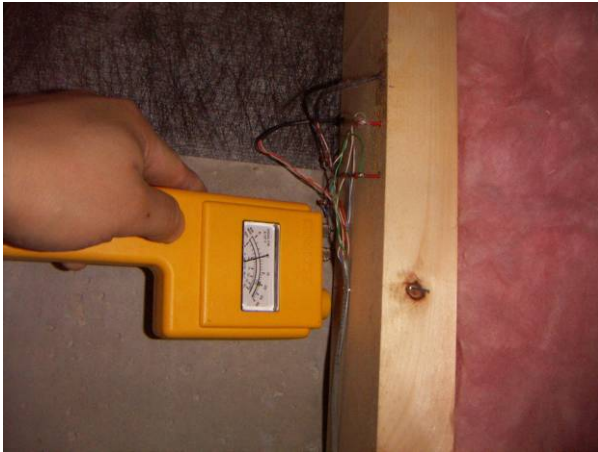
A handheld moisture meter was used to examine the spatial variation of moisture content (MC) measurements of the wood frames (Figure 7.38 & Figure 7.40); results are shown in Table 7.1 below.

Figure 7.38: Moisture meter measurements of the test bay stud, parallel to MC pins

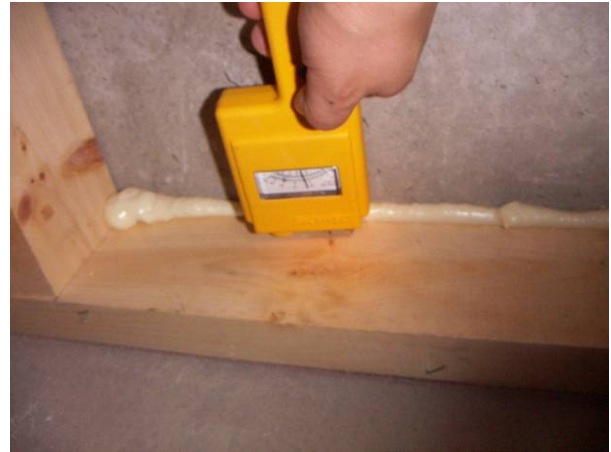
Figure 7.39: Measurement of bottom plate

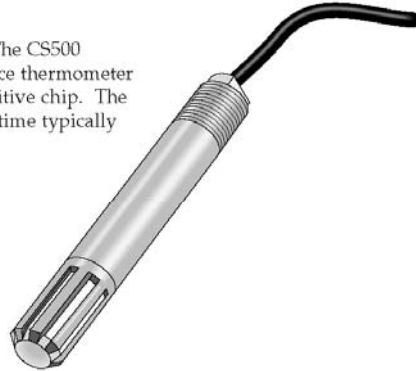
When exposed to sunlight, the CS500 must be housed in a radiation shield. If the CS500 is mounted to a CM6/CM10 tripod or a UT10 tower, a model 41303 6-plate radiation shield is used. If the CS500 is mounted on a UT20 or UT30 tower, a UT018 Crossarm and Mounting Bracket and a UT6P 6-plate radiation shield are used.

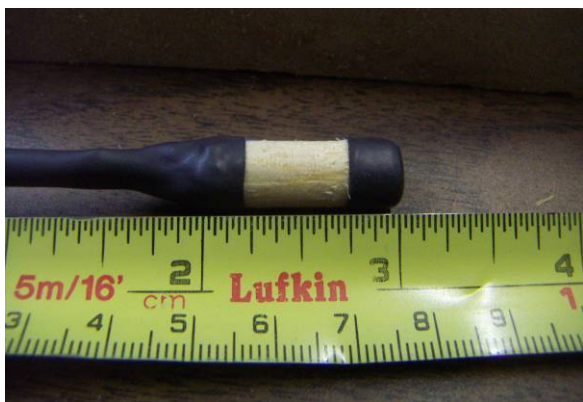
The sensors were fabricated from Eastern White Pine cylinders 9.5 mm diameter x 29 mm ($3/8'' \times 1-1/8''$), as shown in the figures below.

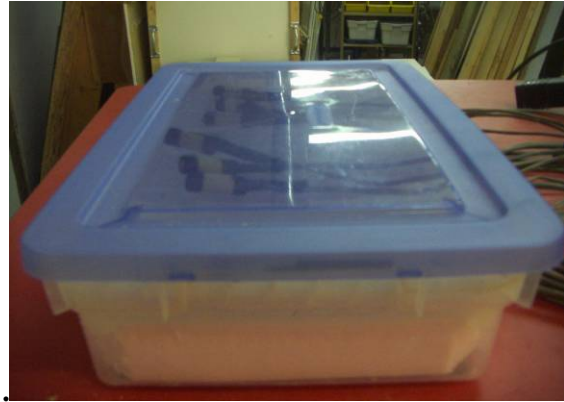
Several sensors were acclimated in the test lab, and then moved to a 100% relative humidity enclosure for calibration. The intent of this work was to record the response to a step change of 50% RH to 100% RH, as well as to gauge sensor variability. One sensor was coated with damp clay, as per its use as a capillary filler, to note any effect on sensor response.

Figure 4: Sensors in 100% humidity calibration enclosure

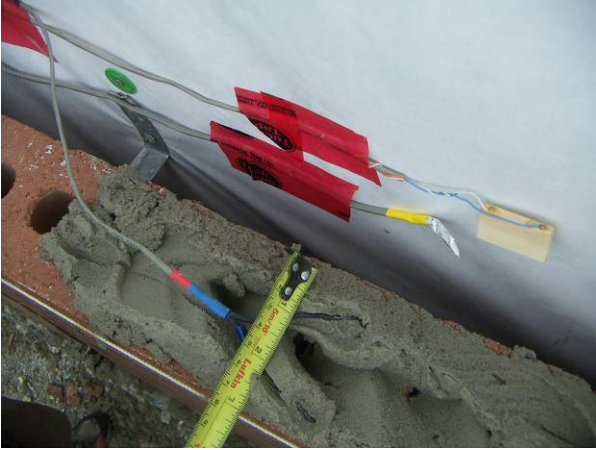
At the BEGHut, wafer sensors were placed in parallel with relative humidity sensors in the brick space ventilation/drainage cavity in six walls (three north, three south), as shown in Figure 24 and Figure 25. This was done to provide redundancy, given the challenging high humidity conditions in the ventilation space.

Figure 24: RH sensor and MC wafer in brick space cavity at UW test facility

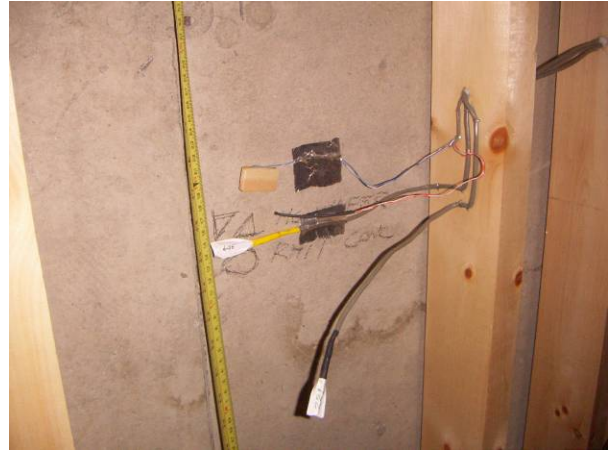
At the Kitchener basement site, RH and wafer sensors were installed in parallel at the concrete-insulation interface, at mid-height, as shown in Figure 29. The results were plotted against each other in Figure 30; one of the four walls had a failed RH sensor, so only three channels are shown.

Figure 29: Mid-height sensors in Kitchener basement

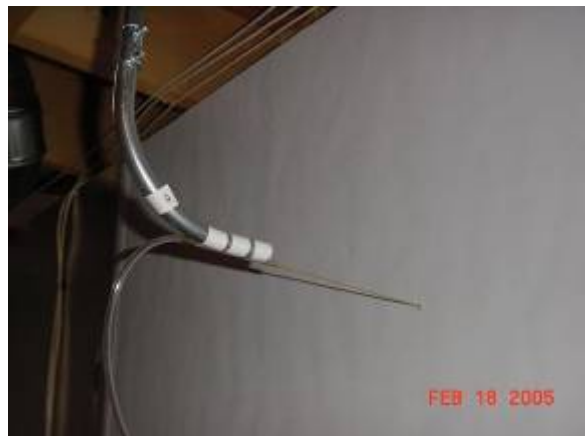
Figure 32: Injector, for size reference and as installed

Figure 32 shows the injector alone and as installed. The injector is made of a 12" piece of 1/16" brass tubing fixed to a short section of 3/16" brass tubing (in order to connect to the 1/4" vinyl tubing). The installation is accomplished by drilling a 5/23" hole through the insulation assembly and approximately 1/4" into the concrete basement wall. The injector is then inserted into the hole so that the end of the injector is in the hole in the concrete.

the stud space. For all walls, the injector is fixed in place using ½” metal conduit attached to the joists (as shown in Figure 32). A laser level was used in order to ensure that all the injectors were installed at the same elevation (Figure 33).

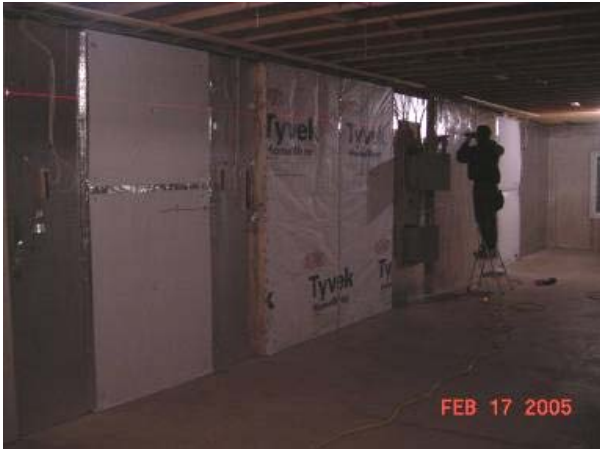
Figure 33: Holes were drilled at the same elevation in each wall

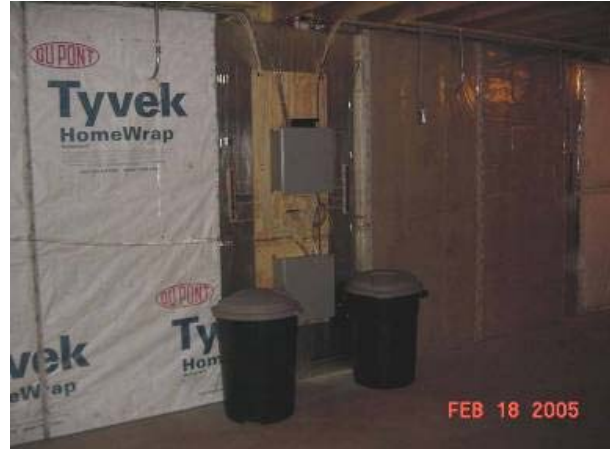
Figure 34: Reservoirs and pump and manifold housing

Figure 34 shows the wetting equipment as installed in the test basement. The lower gray box contains the pump and manifold, and two 32-gallon trash containers serve as the reservoir. ¼” vinyl tubing leaves the manifold and carries water to each injector.

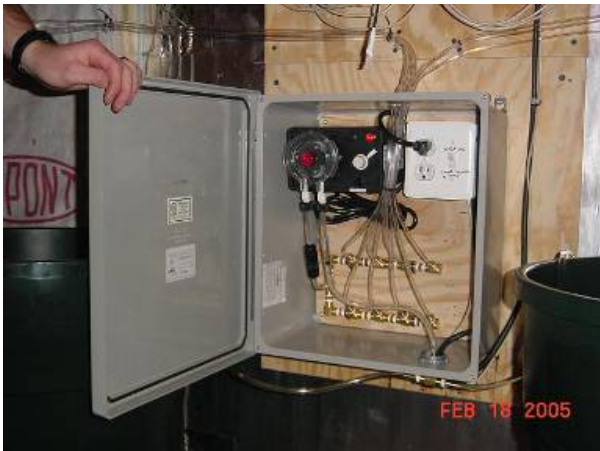
Figure 35: Pump housing

The pump is controlled by the data logger program, through a relay. Figure 35 shows the interior of the pump housing, with the pump (upper left corner), the manifold (lower half), and relay housing (upper right, white electrical outlet). The relay (and therefore the pump) is controlled by the data logger program, which can be changed remotely.

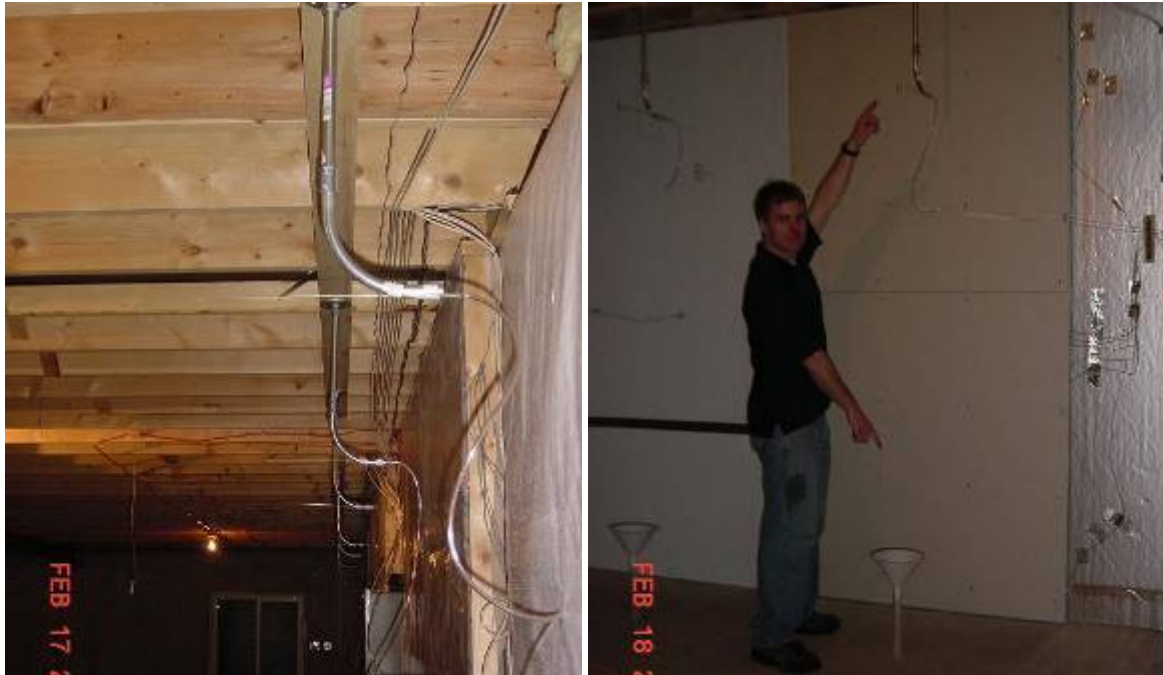
After installation, the system was commissioned. First, the injectors were turned around backwards on their supports, to allow measurement of the flow from each one (see Figure 36). The pump was run until all the air was purged from the tubing and a steady flow was obtained from the injectors.

Figure 36: Commissioning

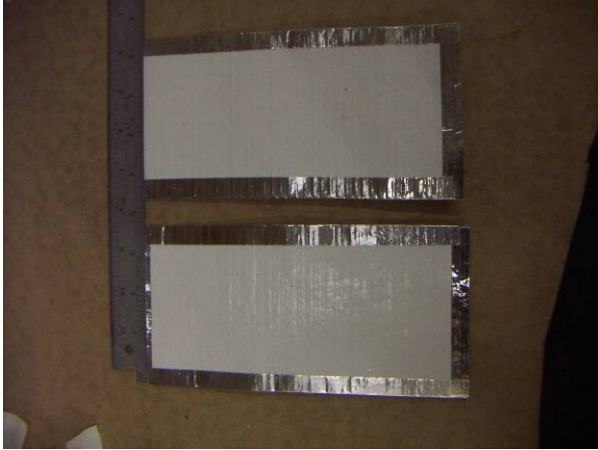
Figure 37: Sample edges wrapped with foil tape

Since both of these samples were sheet goods, the edges were first wrapped with foil tape to provide a defined test area. The samples were then taped to the lids of the test containers; the lid was sealed to the container body with foil tape. The samples were tested with the "finish" (interior) face of the material on the outside of the container, facing the variable humidity environments.

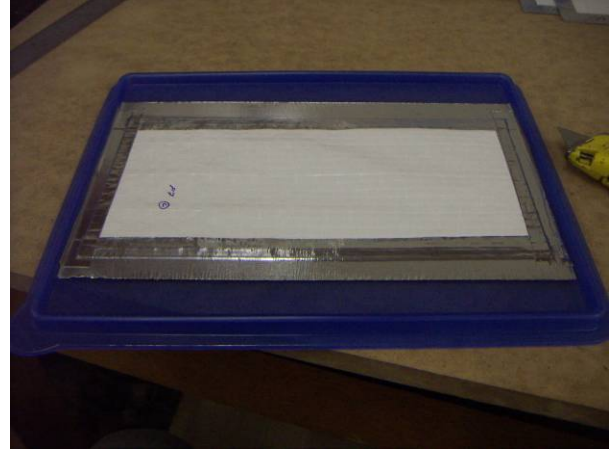
Figure 38: Sample sealed to container lid with foil tape

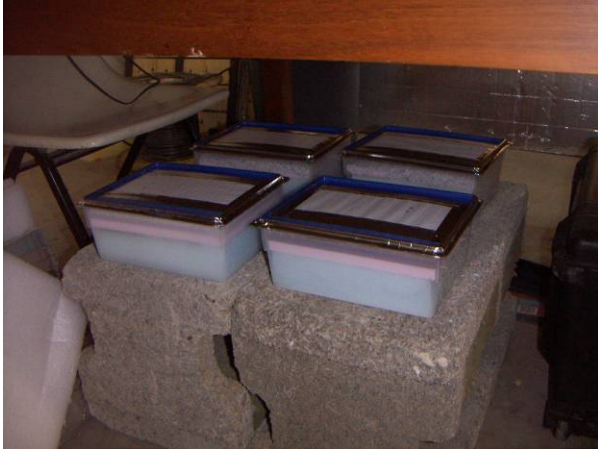
Figure 39: Testing at 20° C/50% RH in climate-controlled test laboratory

The samples were run at multiple humidity levels to obtain several points on the permeance vs. relative humidity curve; these included the conditions of approximately 50%, 72%, 87% RH. The samples were held at these conditions for various lengths of time, from 48 hours to 12 days. The 50% RH data was obtained in the 20° C/50% RH climate-controlled test laboratory; elevated humidity levels were run in an environmental chamber.

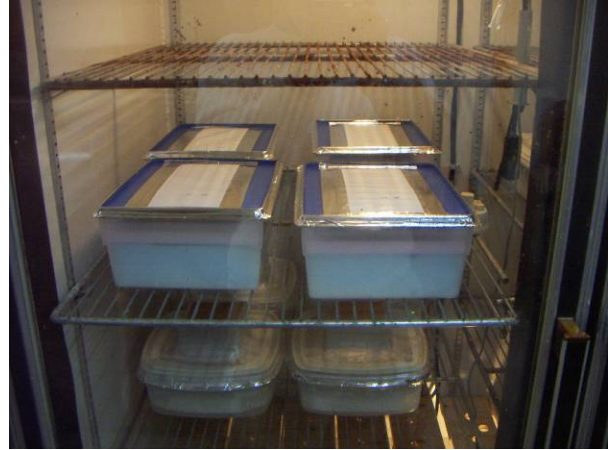
Figure 40: Testing at elevated humidity levels in environmental chamber

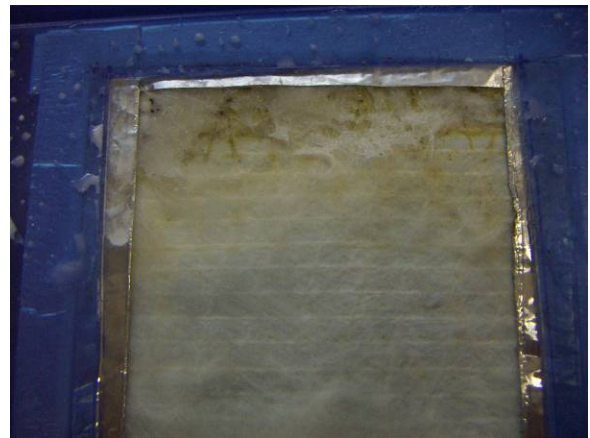
Figure 43: Detail of mold growth, showing water "matting" at one end

However, the perforated vinyl facer from wall P8 showed apparent mold growth on one side of the sample. Based on the presence of liquid water in the adhered fiberglass insulation, it appears that this damage is the result of liquid water contact with the underside of the sample. The fact that this pattern is limited to one end of the sample (i.e., the container was tipped to one side), as opposed to uniform over the area, suggests that the damage is not solely due to high relative humidity exposure.

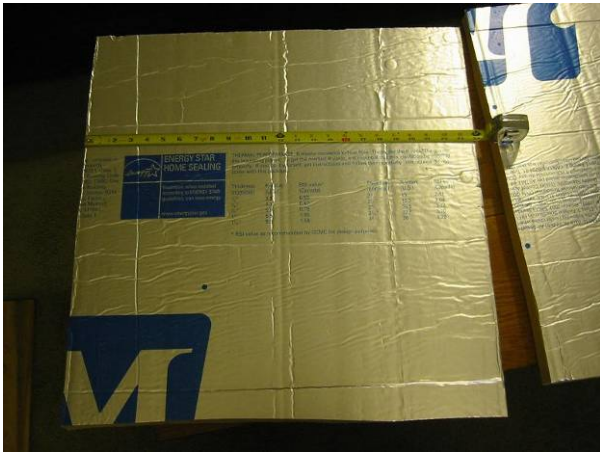
Figure 44: View of the 2' square polyisocyanurate specimens

I purchased the polyisocyanurate used in this experiment from my local Home Depot. I cut a sheet of 38 mm (1.5") thick polyisocyanurate insulation made by Johns Manville into two 0.61 m (2') squares. On both specimens, I cut an access port at the center of the square, inserted a BS sensor, replaced the removed polyisocyanurate, and resealed the foil facing using foil tape. On the first specimen, I used foil tape to seal all four sides of the square. On the second specimen, I made a recess in the polyisocyanurate on one side of the square, inserted a CS sensor, and sealed three sides of the square with foil tape, leaving the side opposite the CS sensor open. Figure 44 shows one of the two test specimens before cutting the access port; Figure 45 shows one of the access ports cut into the center of each specimen; and Figure 46 shows a diagram of the sensor locations in the two test specimens.

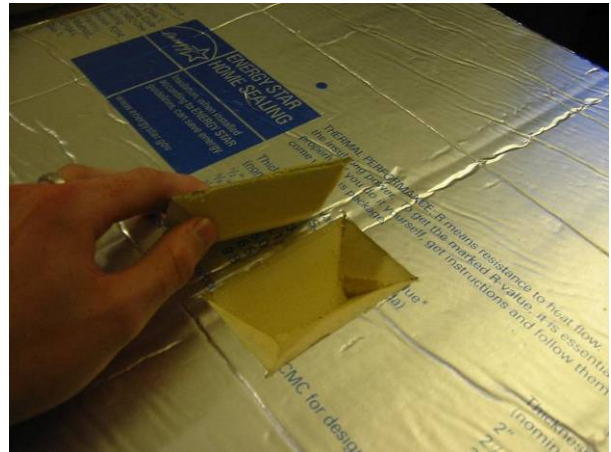
Figure 45: View of access port cut into center of each specimen

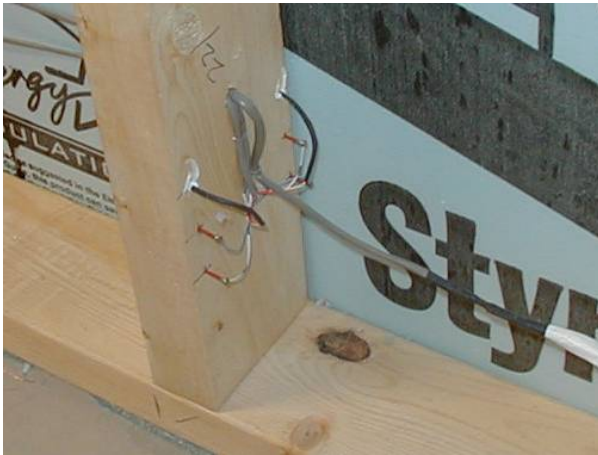
Figure 51: Original installation of MC pins (unpainted)

The likelihood of electrical shorting through the pins was high, given the lack of insulating material at the heads of the pins, as shown in Figure 51. Therefore, during a field visit in October of 2004, the pins were excavated and painted with a non-conductive coating, as shown in Figure 52.

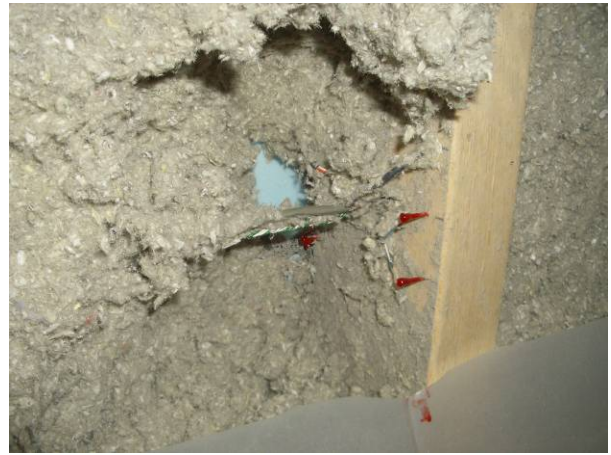
Figure 52: MC pin painting with non-conductive coating, 10/04

This measure immediately brought the apparent moisture content of the upper stud measurements down to levels similar to the XPS-fiberglass wall (under 10%). However, the lower moisture content measurements did not demonstrate a similar drop. Therefore, during a later trip (September 2005), these pins were insulated a second time, using electrical tape (see Figure 53).

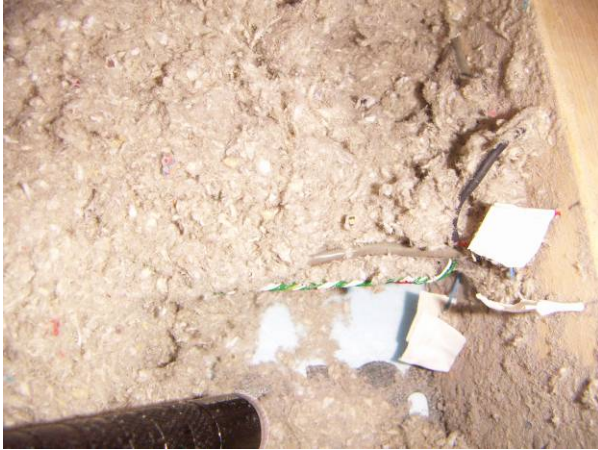
Figure 53: Wrapping pins with electrical tape, 9/05

However, it appears that this second repair attempt had little impact; the effect of these two repairs on apparent moisture content is shown in Figure 54.

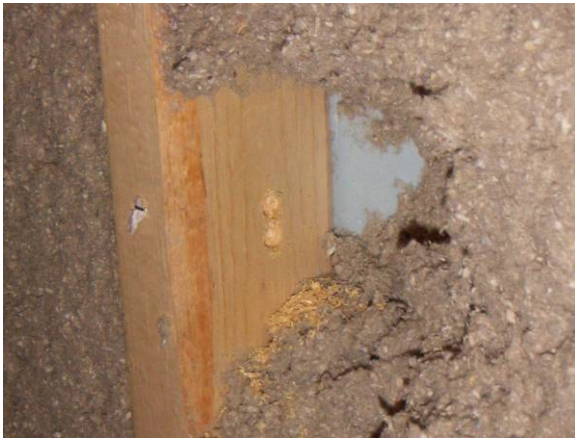
Figure 55: Holes drilled into test stud for sub-surface MC measurements

Holes were drilled that cleared the Delmhorst pins, past the surface of the stud (see Figure 55); measurements taken here were noticeably lower than the surface measurement (15% vs. 20%). This suggests that increased conduction at the surface is caused by salt migration from the cellulose insulation into the wood. This would explain why the use of electrical insulation at the pins did not result in a drop in apparent moisture content. However, it is also possible that the interior of the wood is drier than the surface, and has not reached equilibrium.

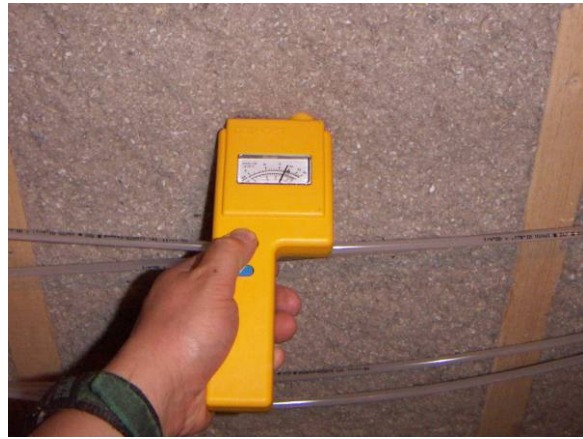
Figure 56: Handheld moisture meter measurement of cellulose insulation

As an additional test, the cellulose itself was measured with the Delmhorst meter. Although the insulation felt dry to the touch, the meter read ~20% MC.
