# The Influence of Loading on the Corrosion of Steel in Cracked Ordinary Portland Cement and High Performance Concretes

A thesis  
presented to the University of Waterloo  
in fulfilment of the  
thesis requirement for the degree of  
Doctor of Philosophy  
in  
Mechanical Engineering

Waterloo, Ontario, Canada, 2007

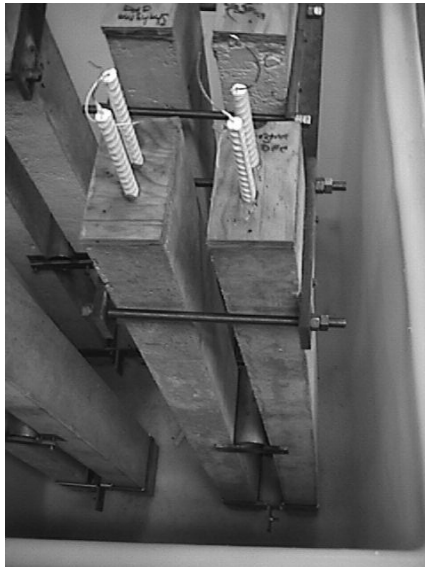
Figure 9: Beams under static loading.

The beams in the statically loaded conditions were subjected to three-point bending by coupling in pairs and using the bracket and fulcrum set-up shown in Figure 8. Static loading was applied to each pair of beams by tightening the nuts on the threaded rod indicated in Figure 8. Figure 9 shows beams under static loading.

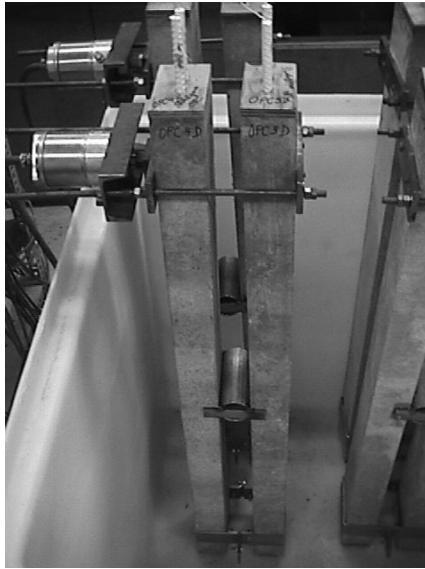
Figure 10: Beams under dynamic loading.

Dynamically loaded beams were coupled in a similar manner to the statically loaded beams but an air cylinder and a piston were mounted at the top bracket and connected to a square wave generator to control the frequency of the pulsed load. Applying compressed air to the cylinder, load was applied at a 0.5 Hz frequency. Figure 10 shows beams subjected to dynamic loading.

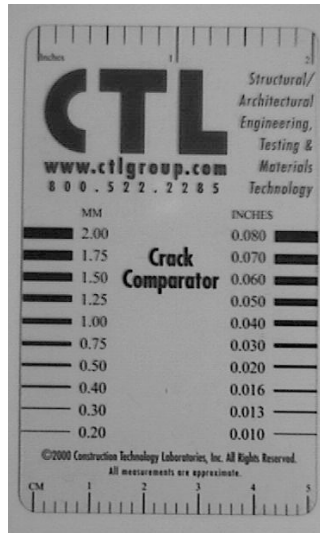
Figure 12: A crack comparator.

Initial widths of the macrocracks in the beams were measured using a crack comparator (Figure 12) and their morphology was noted after subjecting the beams to the load change at 70 hours of exposure to salt solution. Crack-widths prior to exposure were not noted, as most cracks were difficult to observe. After exposure to chloride solution, the cracks became easier to detect because salt crystallized in the cracks. Examples of the cracks are shown Figure 13. The actual crack-widths were determined by comparing an actual line width on the comparator to the crack-width and a comparator line width in the photographs.

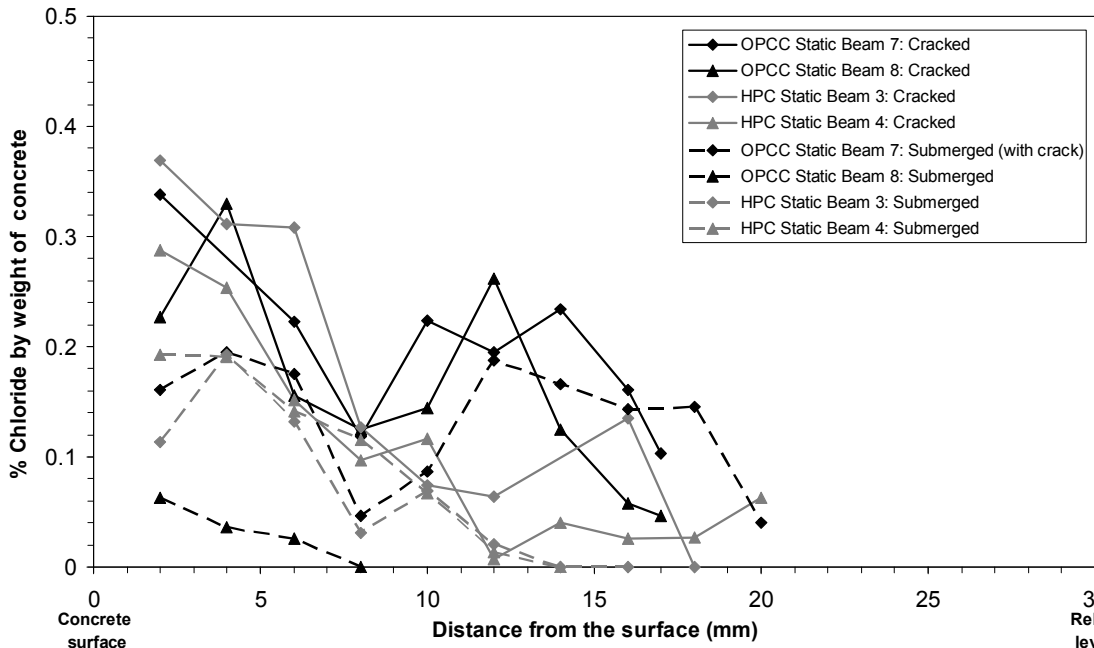
Figure 24: Chloride profiles in the cracked and submerged regions of OPCC and HPC beams that were statically loaded.

The chloride concentration profiles from the cracked and submerged regions of two each of OPCC and HPC beams subjected to static and dynamic loading are presented in Figure 24 and Figure 25. It should be noted that the profiles are not smooth curves because the amount of paste and aggregate varied at the crack, and influenced chloride penetration from the crack into the concrete.

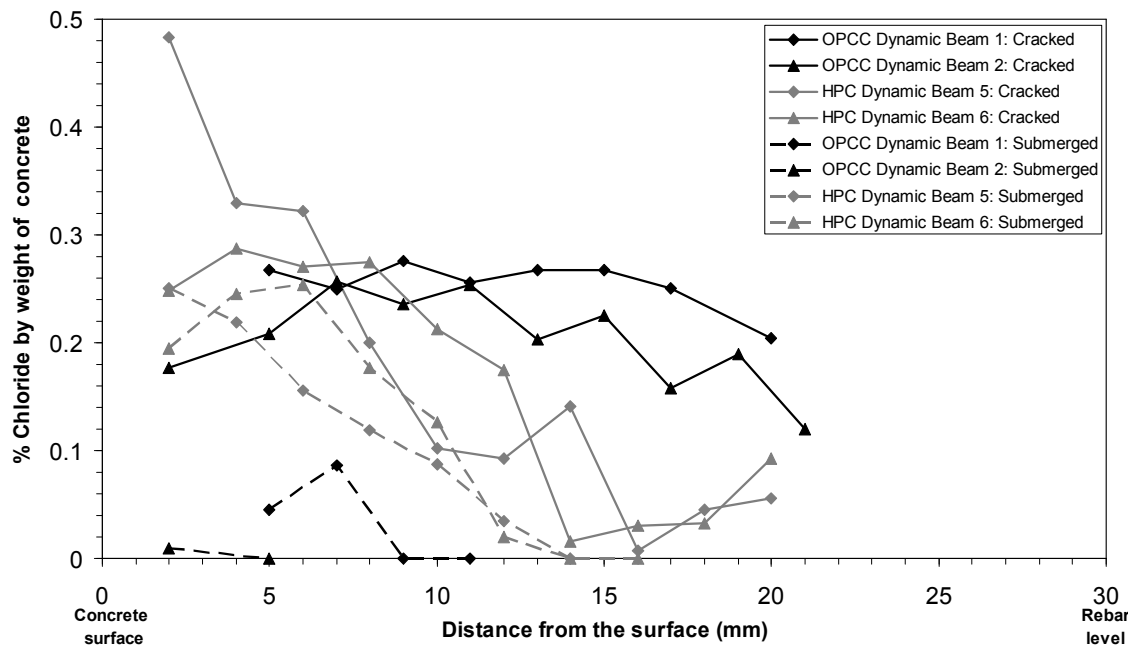
Figure 25: Chloride profiles in the cracked and submerged regions of OPCC and HPC beams that were dynamically loaded.

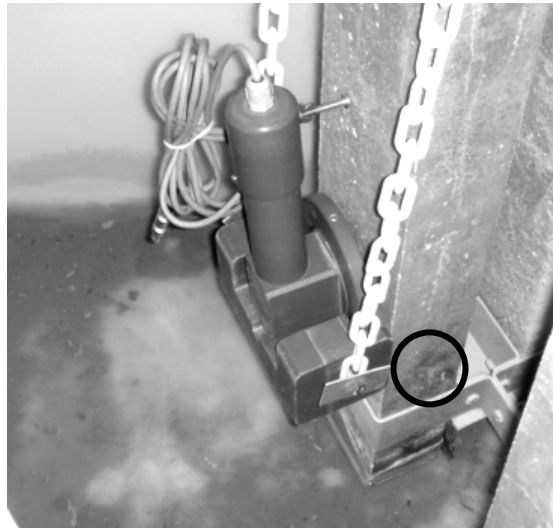
Figure 54: Encircled area shows corrosion products coming out of the casting defect in the submerged region of the dynamically loaded HPC beam 3.

Higher ECN currents were also observed in the dynamically loaded HPC in the wet cycle than in the dry. However, the overall difference in currents was much lower than in the OPCC because of its higher resistance. Also peaks were not observed in the ECN current measurements in the HPC because, in the areas away from the crack, the concrete had low porosity and was resistant to the ingress of chlorides. Hence, it was highly protective towards the steel. The dynamically loaded HPC beam D-3 illustrated higher currents than the other beams because it had a casting defect in the submerged region which allowed the salt solution to penetrate into the concrete. This is shown in Figure 54.

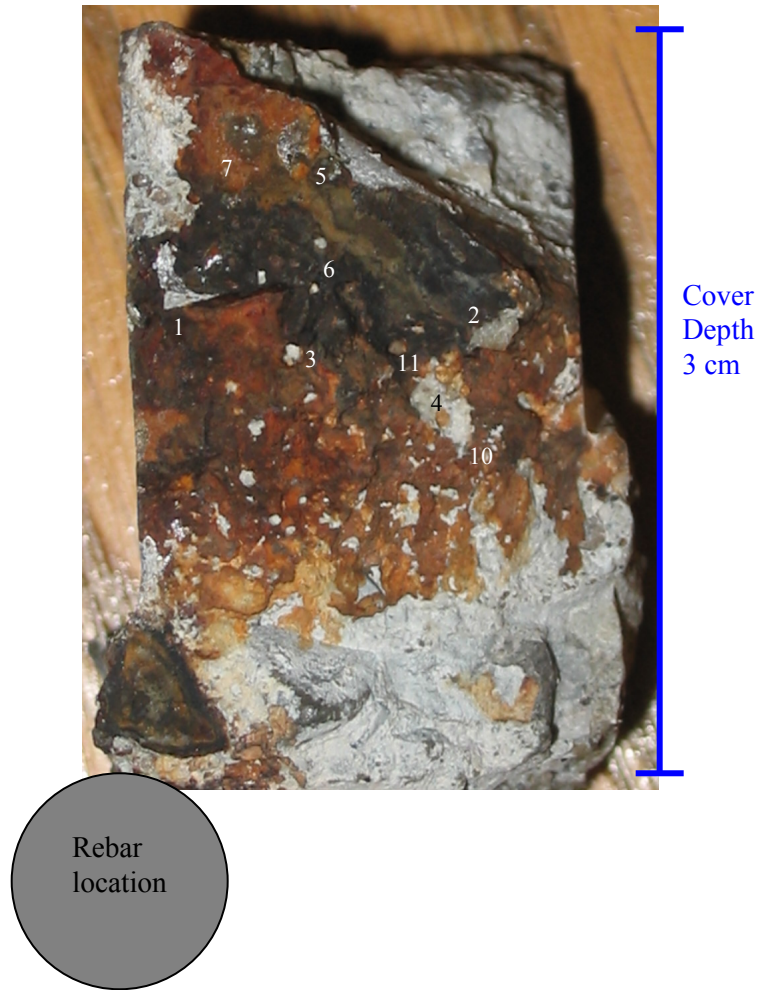
Figure 73: A photograph showing the distribution of corrosion products at a crack in the dynamically loaded OPCC beam. The Raman spectra from the locations indicated by numbers in this photograph are presented in Figure 74.

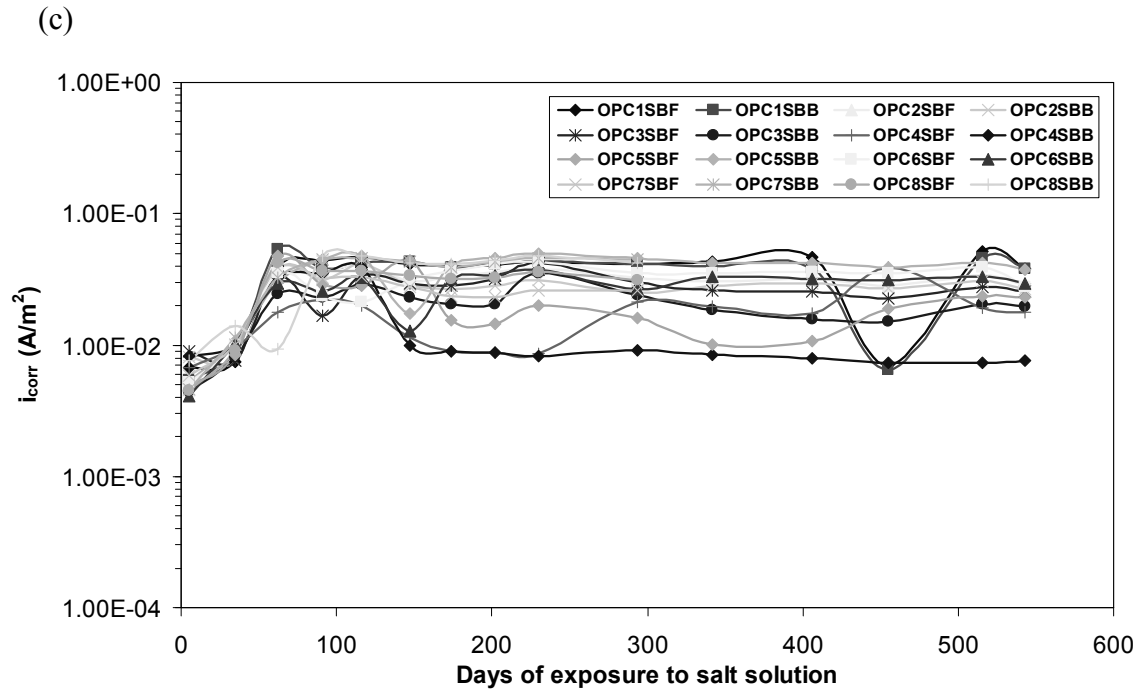
Figure C2: Corrosion current density obtained in the (a) non-submerged, (b) submerged and (c) cracked regions of the statically loaded OPCC beams using LPR technique.

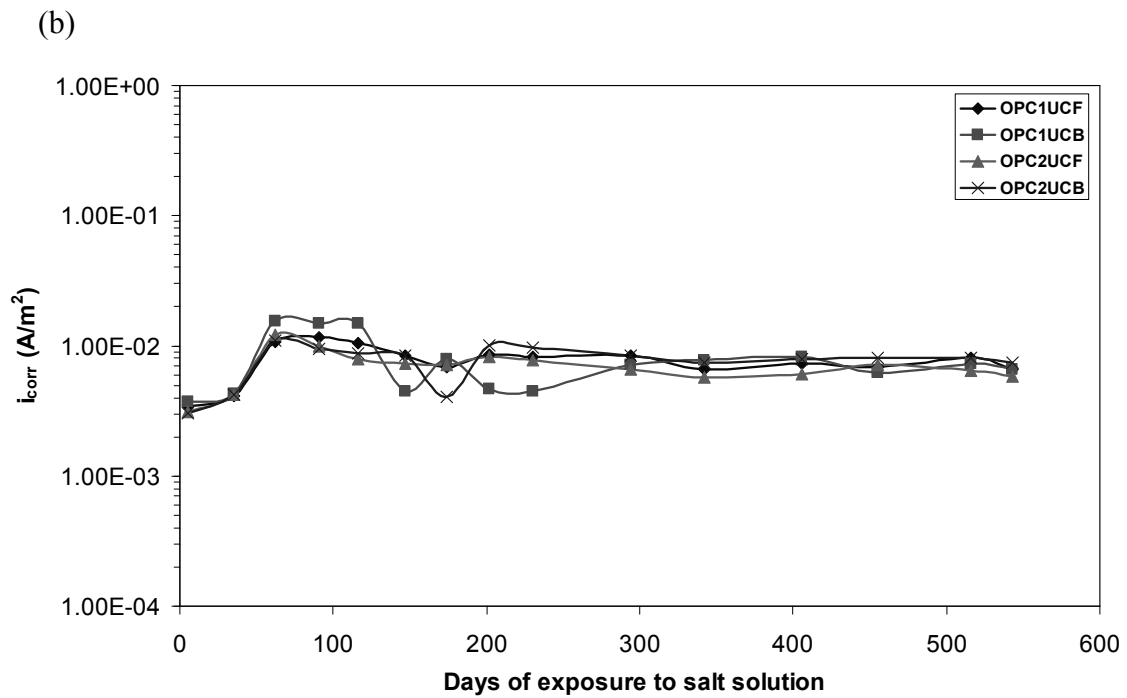
Figure C3: Corrosion current density obtained in the (a) non-submerged, (b) submerged and (c) cracked regions of the unloaded OPCC beams using LPR technique.

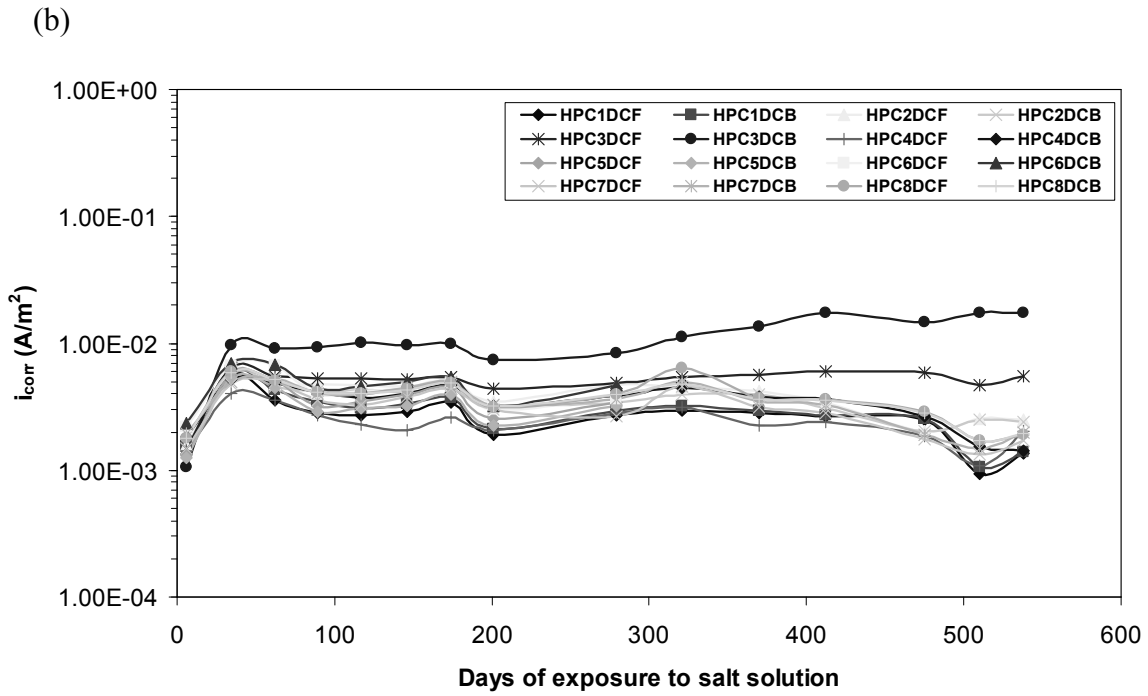
Figure C4: Corrosion current density obtained in the (a) non-submerged, (b) submerged and (c) cracked regions of the dynamically loaded HPC beams using LPR technique.
