The Effect of Galvanized Steel Corrosion on the Integrity of Concrete

A thesis
presented to the University of Waterloo
in fulfillment of the
thesis requirement for the degree of
Master of Applied Science
in
Civil Engineering

Waterloo, Ontario, Canada, 2007

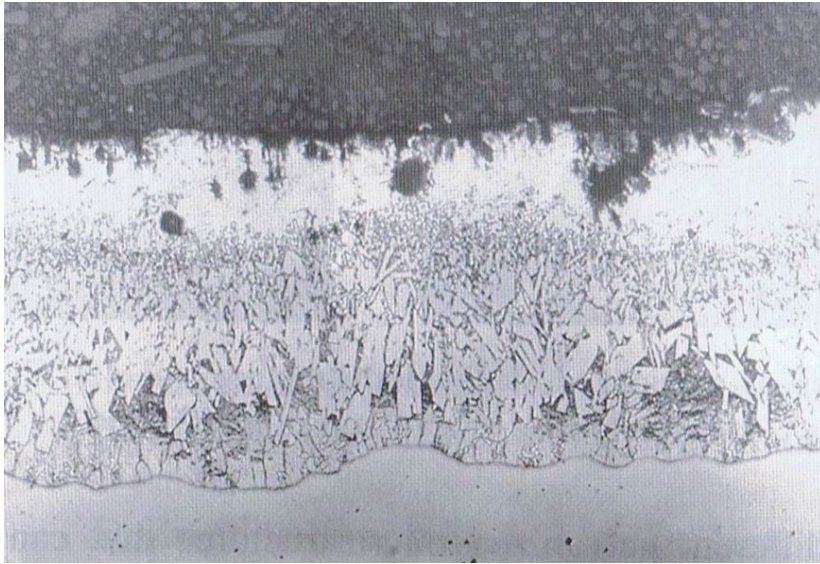
Figure 2-10. Dissolution of pure zinc surface layer during passivation [7]

The corrosion of the galvanized coating is influenced by its surface condition. A galvanized coating which contains a subsurface of Fe-Zn intermetallic layers and a pure zinc surface layer has been claimed to provide the most effective passivation due to the high availability of zinc on the surface [7]. Figure 2-10 illustrates the nature of dissolution of the pure zinc layer during passivation.

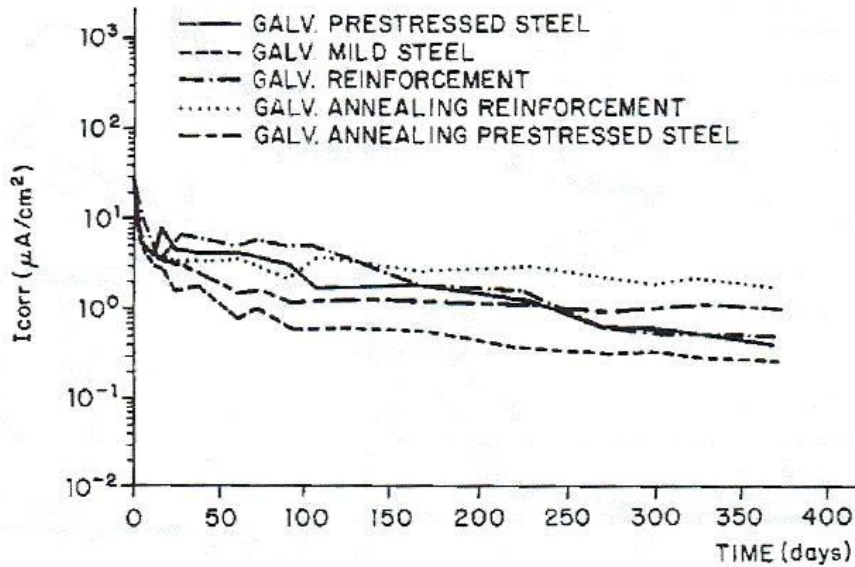
Figure 2-12. i_{corr} of galvanized and galvannealed steel [7]

Despite observations of this type, it remains unclear whether or not the degree of corrosion protection is compromised. While on one hand it has been reported that annealed bars exhibit higher corrosion rates than non-annealed bars in OPC mortar, Figure 2-12, on the other, similar type of bars were shown to exhibit significantly lower corrosion rates as shown in Figure 2-13.

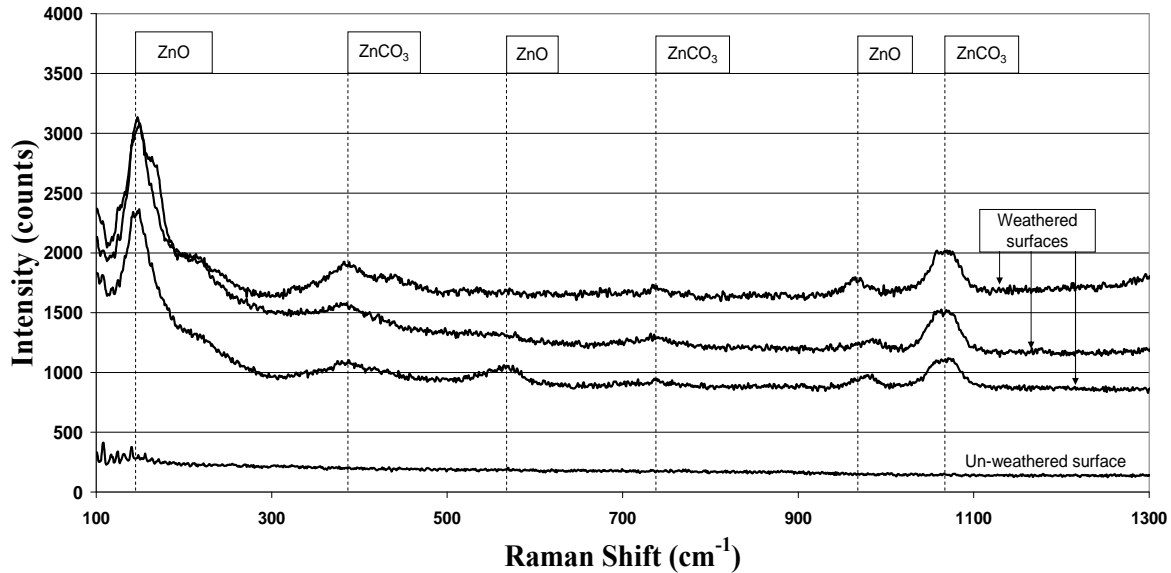
Figure 4-2. Raman spectra of weathered surfaces

confirmed by Raman spectroscopy (RS) to consist of zinc oxide and carbonate, as indicated in Figure 4-2.

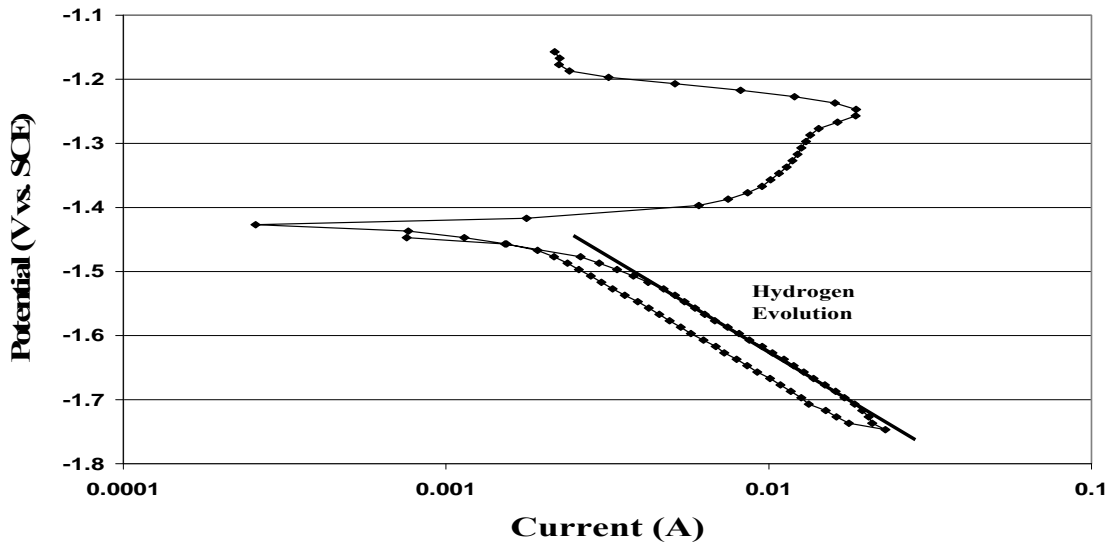
Figure 4-3. Cyclic polarization plot for active corrosion

Based on Equation 2.9, the B values for active and passive zinc corrosion were determined to be 39mV and 20mV, respectively.

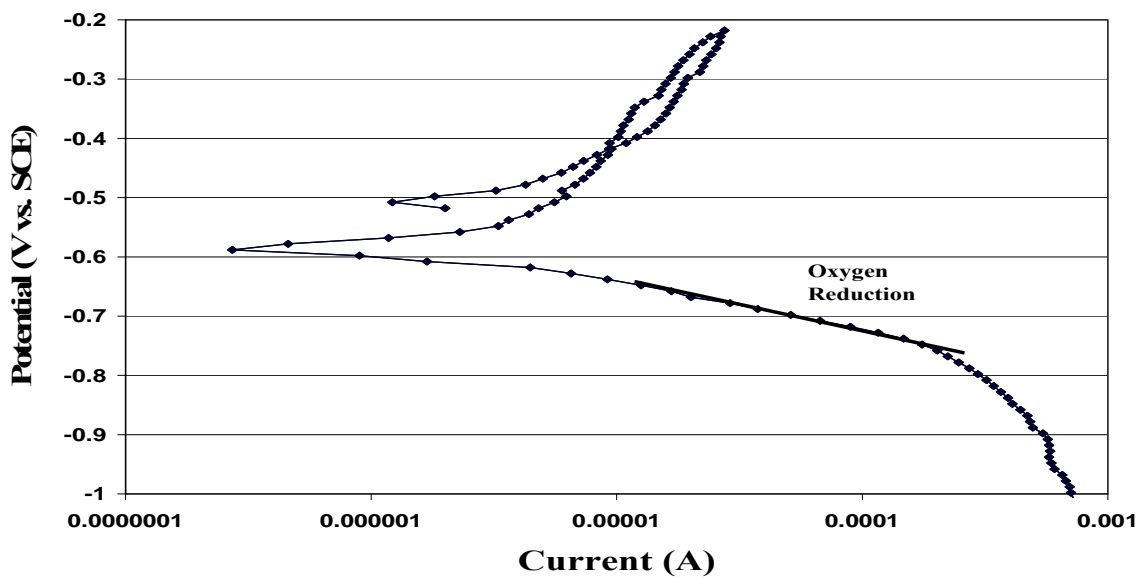
Figure 4-4. Cyclic polarization plot of passive corrosion

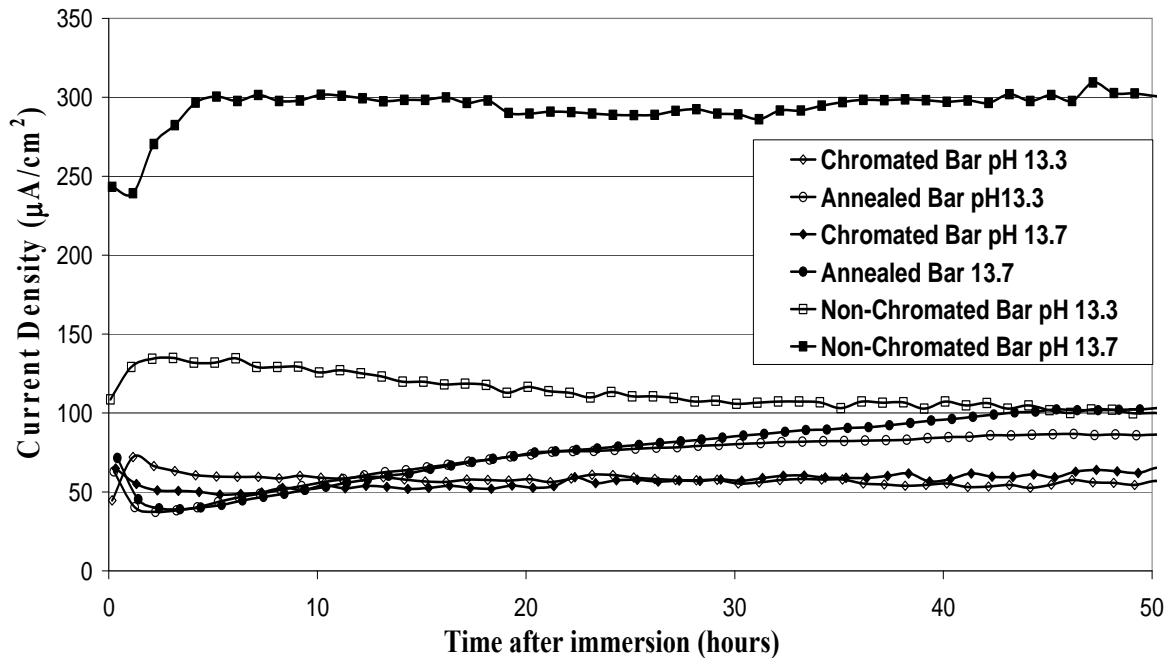
Figure 4-5. Corrosion of HDG bars when exposed to pH 13.3 and 13.7

The corrosion of HDG bars in solution is summarized in Figure 4-5 and Figure 4-6. It is confirmed that bars exposed to pH 13.3±0.1 and 13.7±0.1 did not passivate. However, it is evident that the chromate film increases the corrosion resistance under high pH. The annealed specimens also showed lower corrosion rates than the non-chromated, which is attributed to the lower zinc content on the surface.

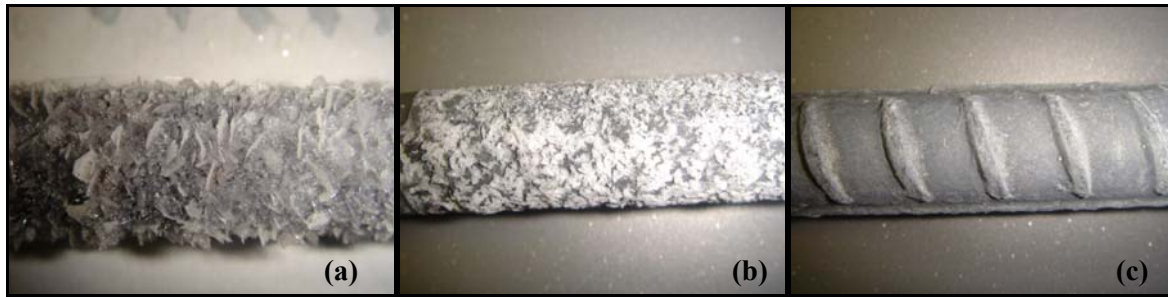
Figure 4-8. CHZ formed on bars with different coatings in pH 13.7 (a) non-chromated, (b) annealed, and (c) chromated

It can be seen from Figure 4-7 that CHZ crystal size increases with increasing pH, in agreement with the work of Andrade et al. [5]. Comparing the different HDG bars at pH 13.7±0.1, it is apparent from Figure 4-8, that the amount of CHZ is a function of the availability of zinc on the surface. The CHZ volume is the highest on the non-chromated bar and lowest on the chromated bar. Although the CHZ was not visible on the chromated bar, it was detected by Raman spectroscopy.

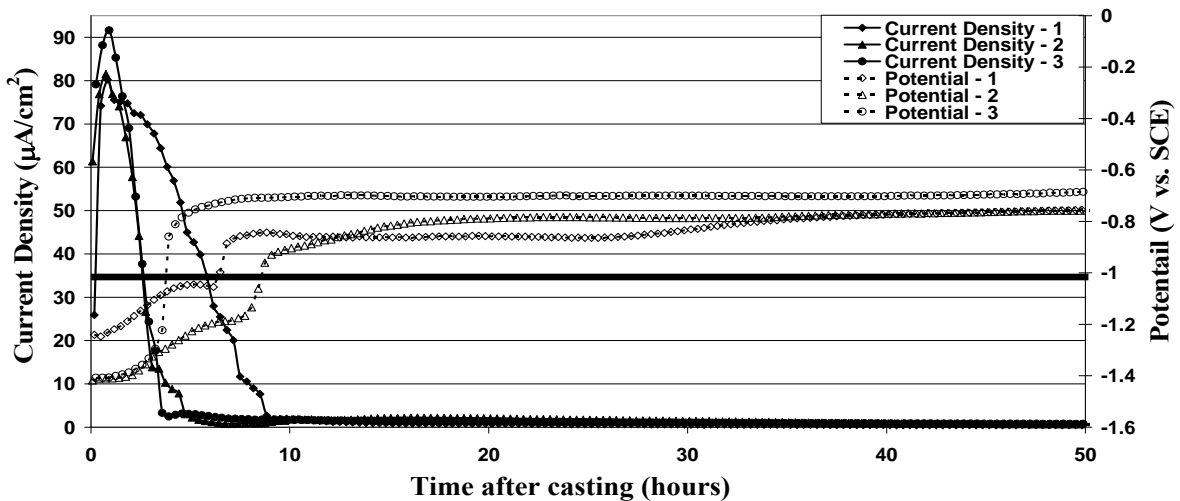
Figure 4-11. Corrosion current and corresponding half cell potential for three non-chromated bars

The corrosion current and potential plots for the various HDG bars in the cylinders shown in Figure 3-1 are shown in Figure 4-11 through Figure 4-14 . The thick horizontal line represents the potential above which hydrogen evolution ceases and oxygen reduction occurs as the cathodic half cell reaction. From these results, it is clear that hydrogen evolution ceases when the bar becomes passivated. The characteristic of these plots will be further discussed in conjunction with the corrosion results presented below.

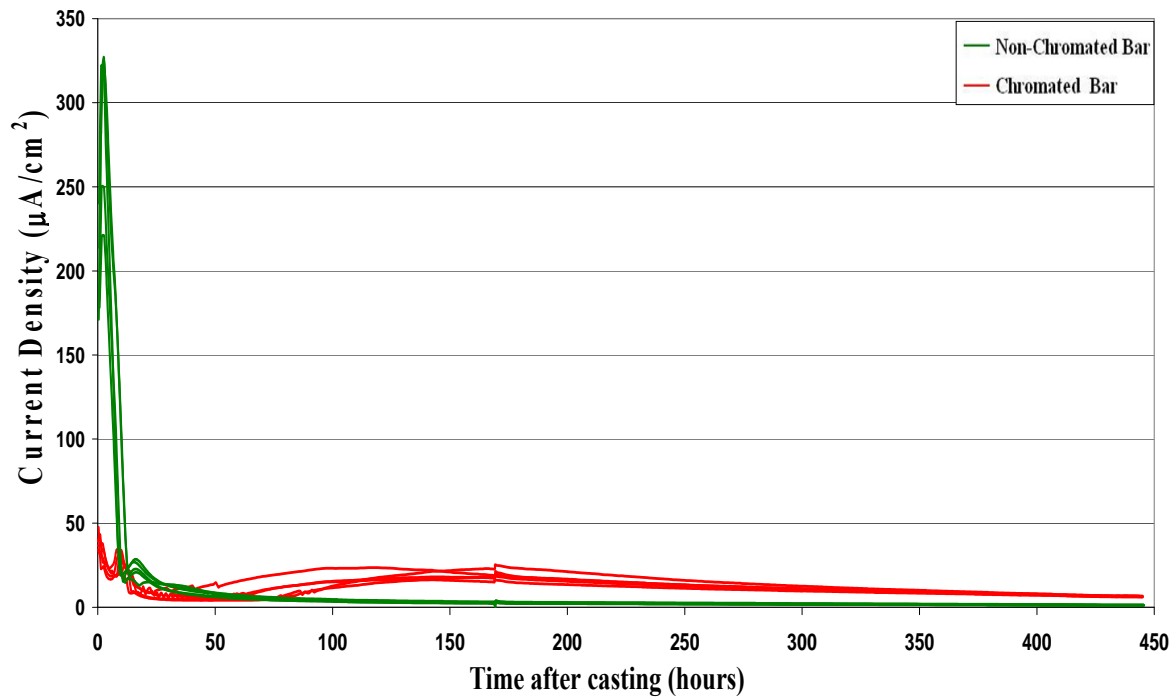
Figure 4-23. Extended corrosion monitoring in slag concrete

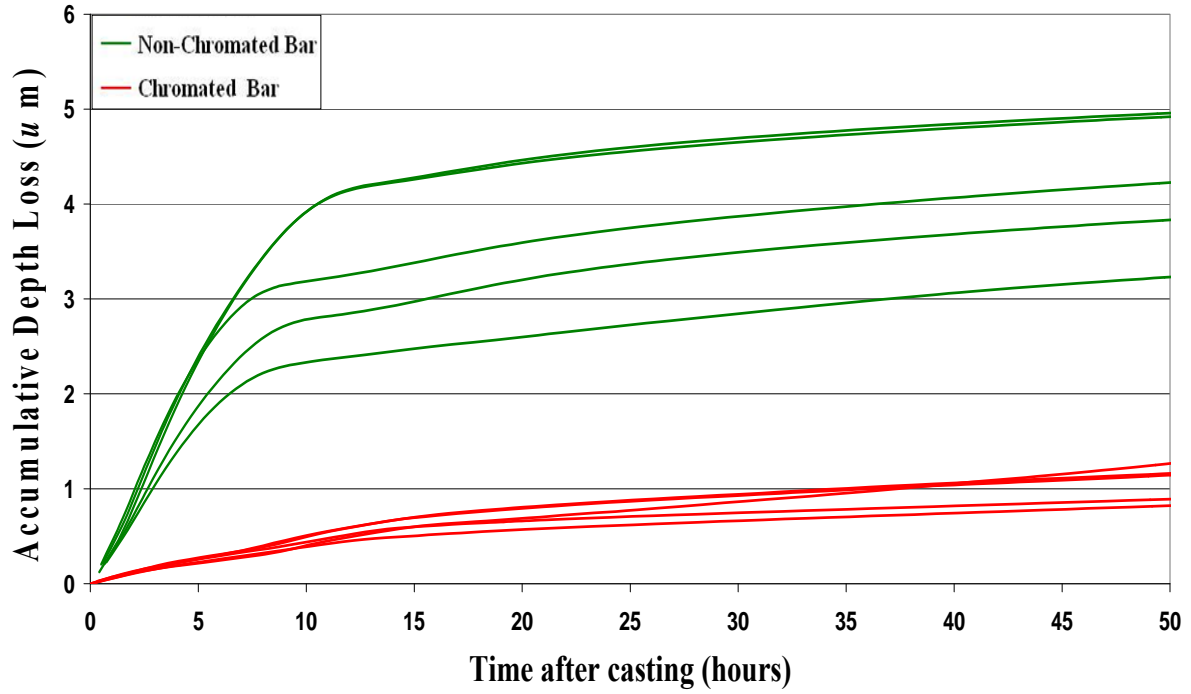
Figure 4-27. Coating depth loss over the initial two days in slag concrete

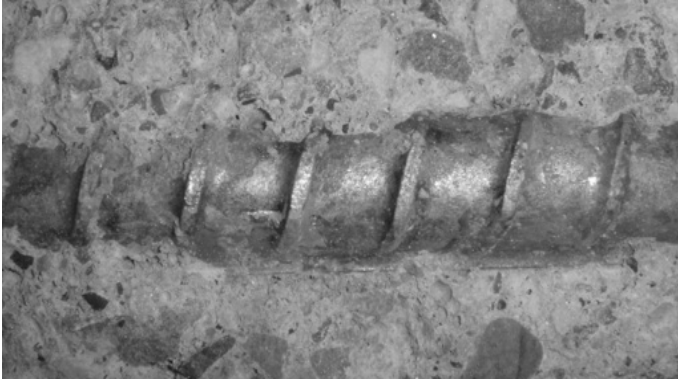
Figure 4-30. Photograph of corroded bar exposed to OPC concrete

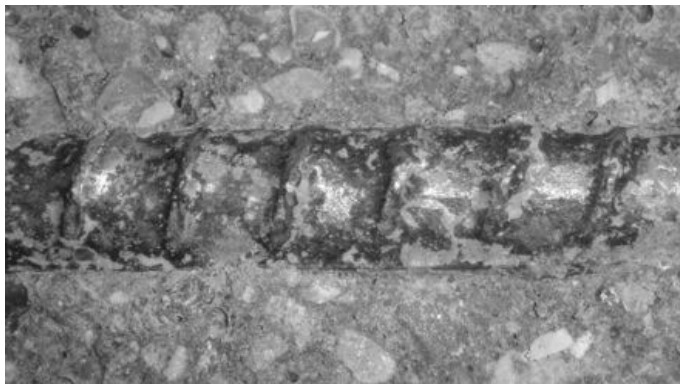
Figure 4-31. Photograph of corroded bar exposed silica fume concrete

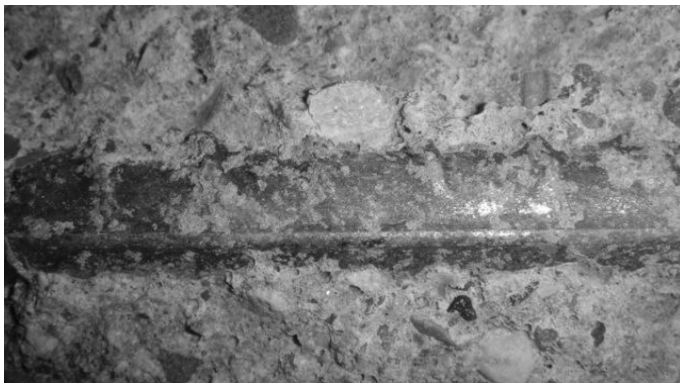
Figure 4-32. Photograph of corroded bar exposed to slag concrete

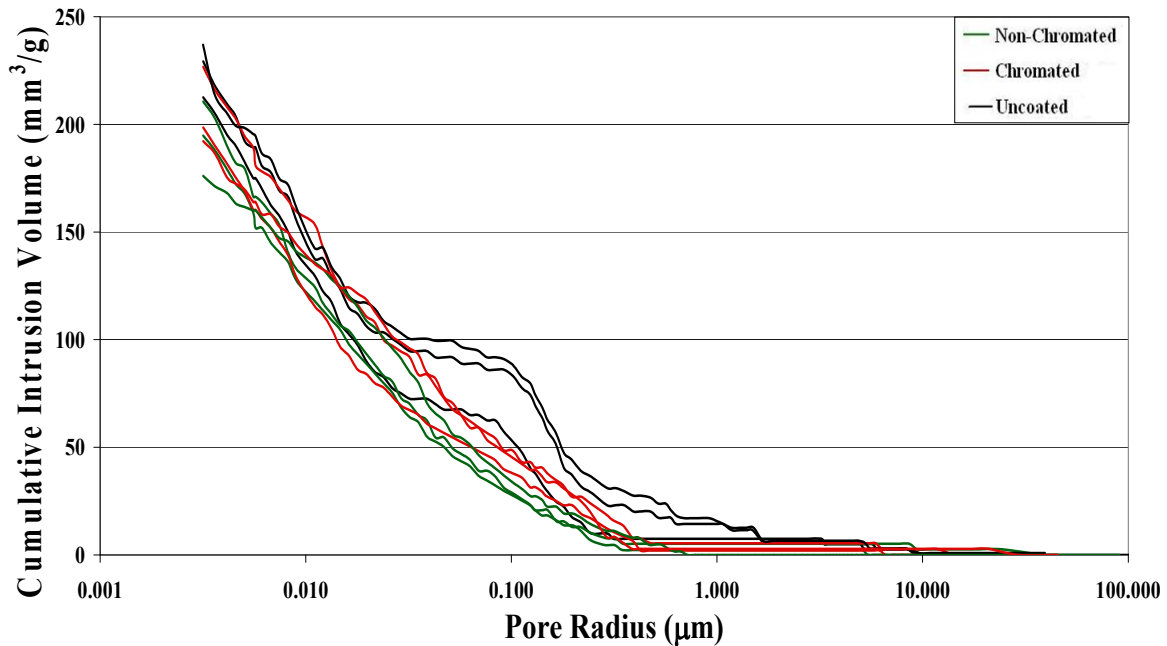
Figure 4-38. Pore size distribution of OPC cement adjacent to HDG and uncoated bars

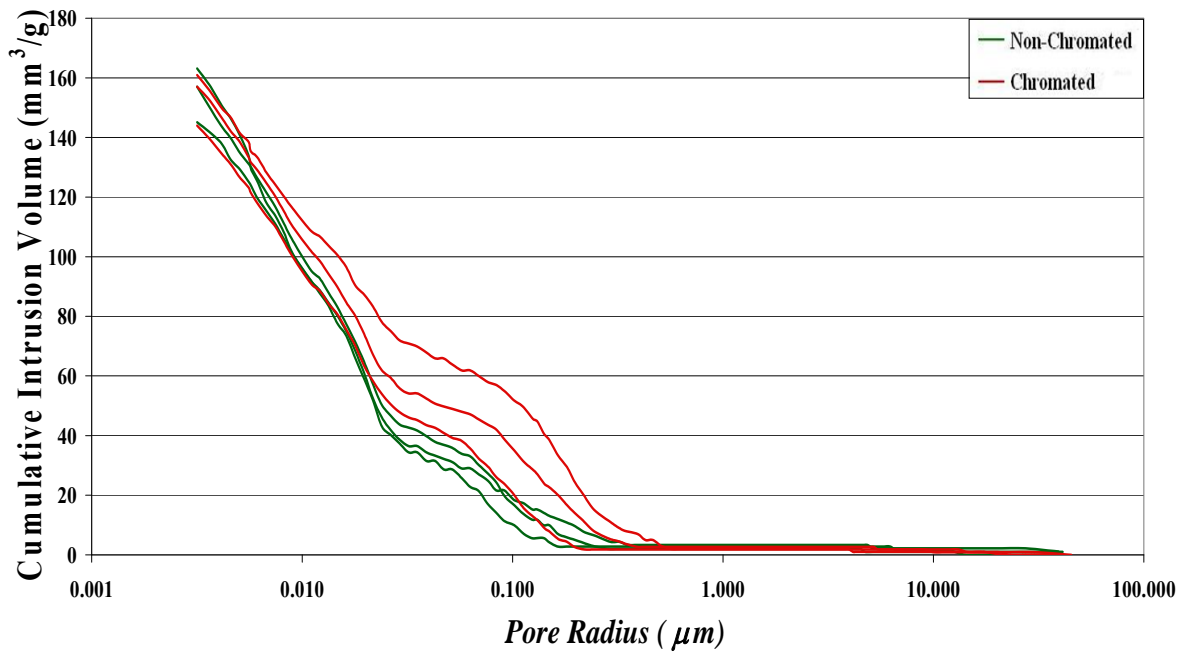
Figure 4-40. Pore size distribution of slag cement adjacent to HDG bars
