The Effect of Surface and Loading Conditions on the Corrosion Performance of Stainless Steel Rebar

A thesis
presented to the University of Waterloo
in fulfillment of the
thesis requirement for the degree of
Master of Applied Science
in
Mechanical Engineering

Waterloo, Ontario, Canada, 2009

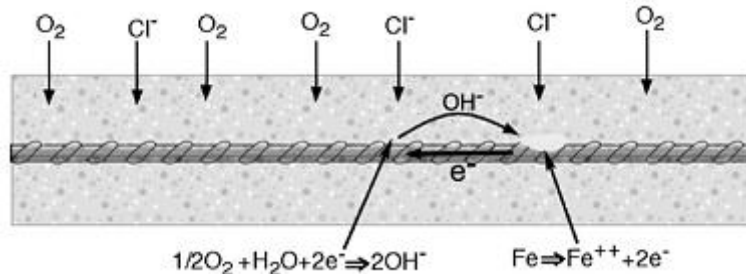
Figure 3: Schematic illustration of microcell corrosion (Hansson, Poursaei et al., 2006)

The process of corrosion requires a complete circuit between the anodic and cathodic sites to allow the transfer of electrons and ions as shown in Figure 3. The electron is moving from the anodic site, where metal is dissolving, to an adjacent cathodic site where oxygen is reduced, and this electrochemical exchange occurring closely together on a single rebar is called microcell corrosion.

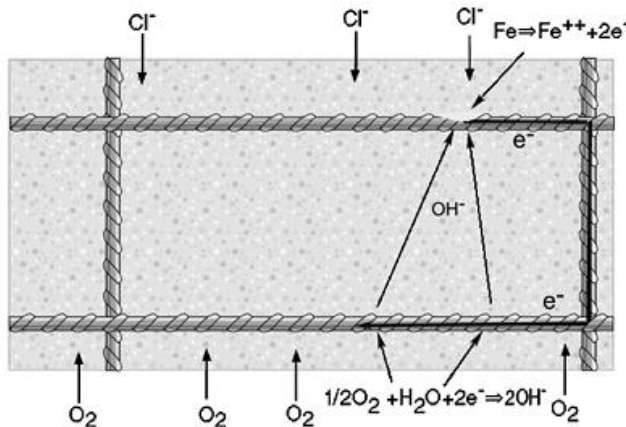
Figure 4: Schematic illustration of macrocell corrosion (Hansson, Poursaei et al., 2006)

A significant limiting factor of the corrosion current in concrete is its ionic resistance. This is important not only in microcell corrosion where ions diffuse through concrete pore solution between adjacent sites on a single rebar, but also in macrocell corrosion, where electrochemical interactions occur between anodic and cathodic sites which are well separated and may be on separate rebars, as shown in Figure 4. An uneven distribution of chloride ions typically occurs in bridge decks, with larger concentrations of chlorides present near the upper rebar mat as they diffuse down from the road. This can promote a galvanic effect where the top rebar layer behaves anodically with respect to the bottom and, thus, an additional macrocell current is applied to the top rebar in addition to the microcell corrosion taking place.

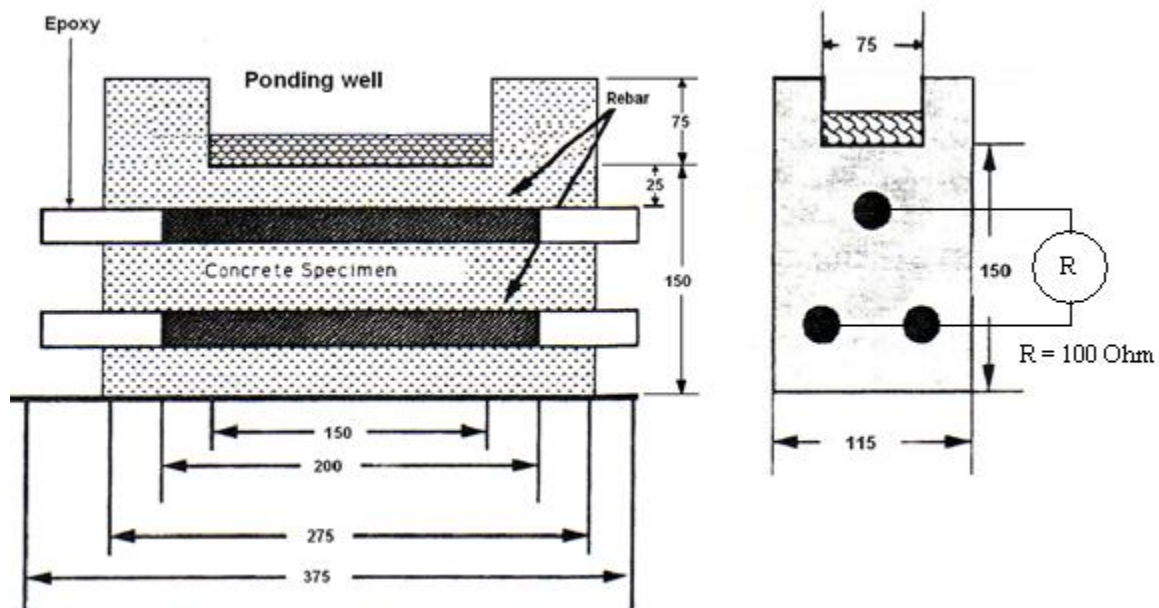
Figure 13: Schematic illustration of G109 specimen design, all dimensions in mm (ASTM-G109-99a, 2005)

The specimen design used to evaluate the effects of surface conditions is a modified version of the ASTM G109 concrete prism design shown in Figure 13. Three bars were cast in a concrete prism: one at the top, two on the bottom, and a ponding well inserted above the top rebar. The two bottom bars were connected electrically, and a 100Ω electrical connection was placed between the top and bottom bars.

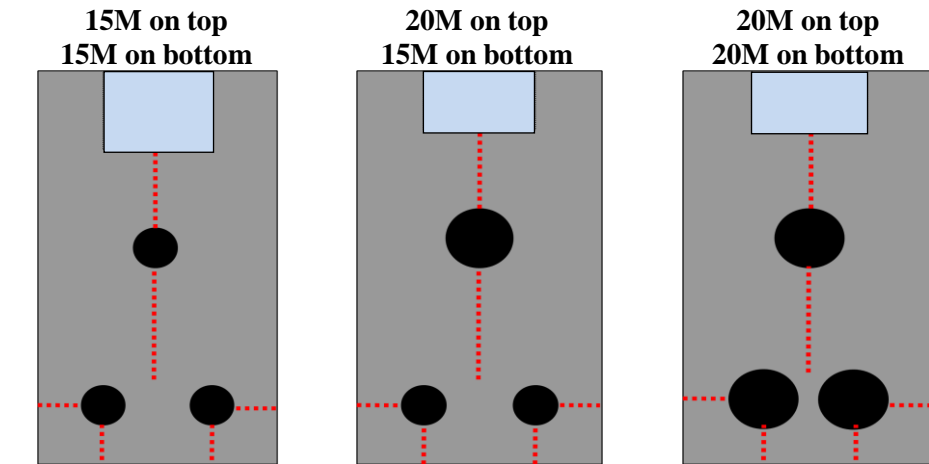
*Distances kept the same for all specimens denoted by

The reinforcements were all 38 cm in length; however two different diameters were supplied: 15M and 20M, whose nominal diameters are 16.0 and 19.5 mm, respectively. In an attempt to minimize discrepancies in the results attributed to this, a consistent concrete cover depth of 25 mm on each side of the bottom bars was established in order to keep constant the distance required for external oxidative species (i.e. oxygen, water, chlorides) to diffuse to the rebar surface. Since all prisms had equal widths however, this resulted in less concrete between the larger bottom bars than the smaller bottom bars, though this likely had negligible influence on results given that two bars in the same environment would have negligible electrochemical interaction with one another. The cover depth between the ponding well and the top bar was decreased from 25 mm in the G109 standard to 19 mm in order to intensify corrosive conditions at the top bar by providing a shorter diffusion path for oxidative species (i.e. oxygen, water, chlorides) to the bar's surface. Distances between top and bottom rebars were also kept equal by changing the ponding well depth. Schematic diagrams of the various configurations for different bar sizes and the dimensions that were kept equal are shown in Figure 14.

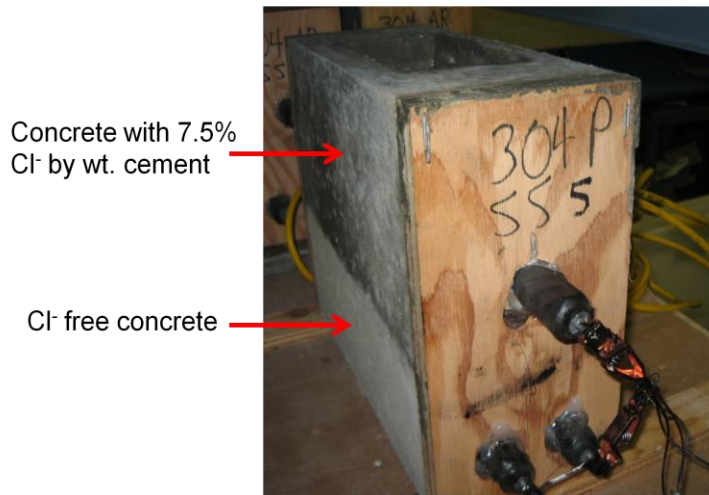
Figure 15: Modified G109 prism with a chloride contaminated upper and chloride-free lower concrete layer

To further enhance the corrosive conditions of the G109 design, which was originally intended for testing much less corrosion resistant plain carbon-steel rebar, the prisms were modified by casting them as two separate layers of concrete: a chloride contaminated upper layer, and a chloride free lower layer, as shown by the two different shades of concrete in Figure 15.

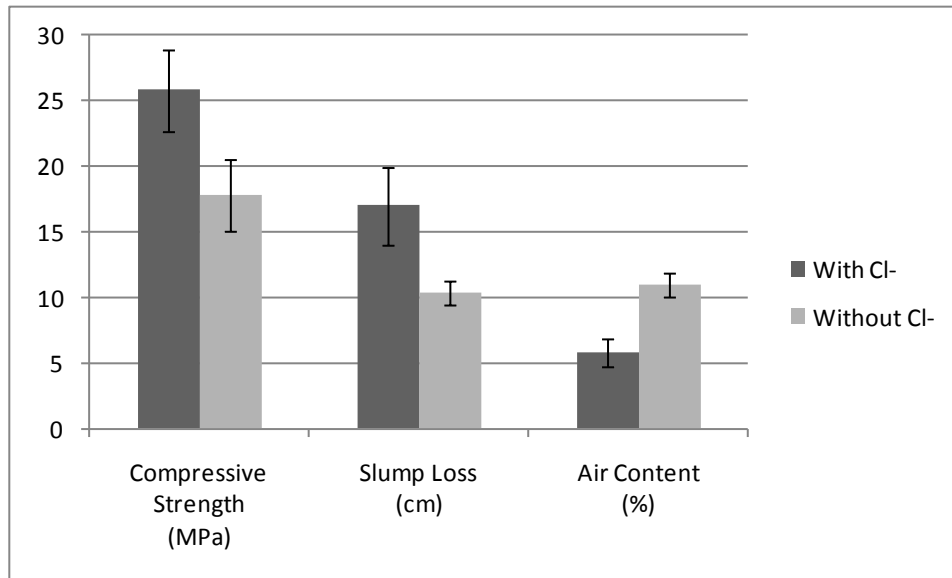
Figure 19: As-cast concrete properties for G109 specimens

days after casting for three of the 100 by 200 mm replicate cylinders from each batch in accordance with standards (ASTM-C39, 2003) using a Forney Testing Machine Model QC50DR. An exception to the ASTM standard was that the Forney machine applied compressive stress at a constant rate of displacement rather than a constant rate of loading. The as-cast concrete properties are shown in Figure 19, with more detailed data shown in Appendix C.

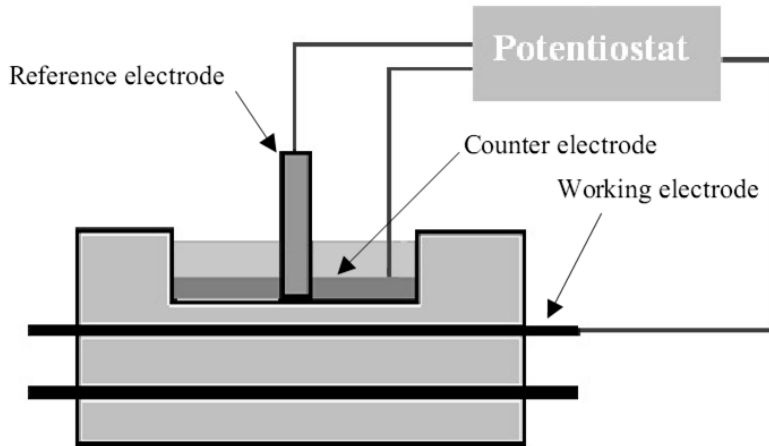
Figure 22: Experimental setup for microcell corrosion current density measurements (Tran, 2007)

immersed in the ponding well solution, and connected as shown in Figure 22 to a potentiostat (model: PARSTAT 2263 from Princeton Applied Research).

Cyclic polarization (CP) is an electrochemical corrosion evaluation technique using the same experimental setup as for LPR shown in Figure 22, but in which the potential is shifted dynamically over a much larger range, and the resulting current is recorded. The potential and current density values are typically used to plot a CP curve presented as potential (V) versus log of current density ($\log A/m^2$), as shown in Figure 25. By forcing the material from its steady-state potential and monitoring the current response, this curve provides valuable information not only on the corrosion current, but also on the behaviour of a metal's passive film, its susceptibility to pitting attack, and any diffusion limitations.

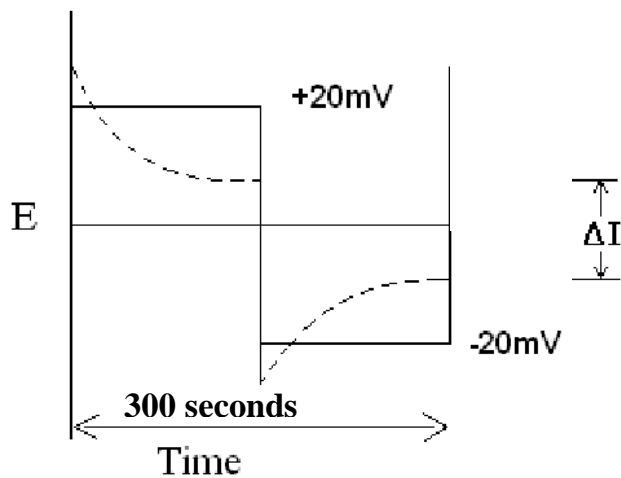
Figure 23: Applied potential and resulting current plot for potentiostatic LPR

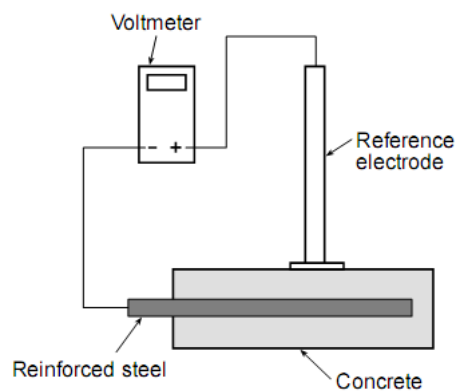
Figure 24: Schematic of corrosion potential measurement technique (Gu and Beaudoin, 1998)

First employed to evaluate bridge corrosion in California in the 1950's (Stratfull, 1957), corrosion potential measurements are commonly used, due to their speed, simplicity, and lack of external power source requirements, to determine if reinforced concrete structures are actively corroding or are passive. All that is needed is a high impedance voltmeter of at least 10 M Ω (ASTM-C876-91, 1991) with the working lead attached to the reinforcement and the ground lead attached to a reference electrode which is in electrolytic contact with the reinforcement through the concrete pore solution, as shown in Figure 24.

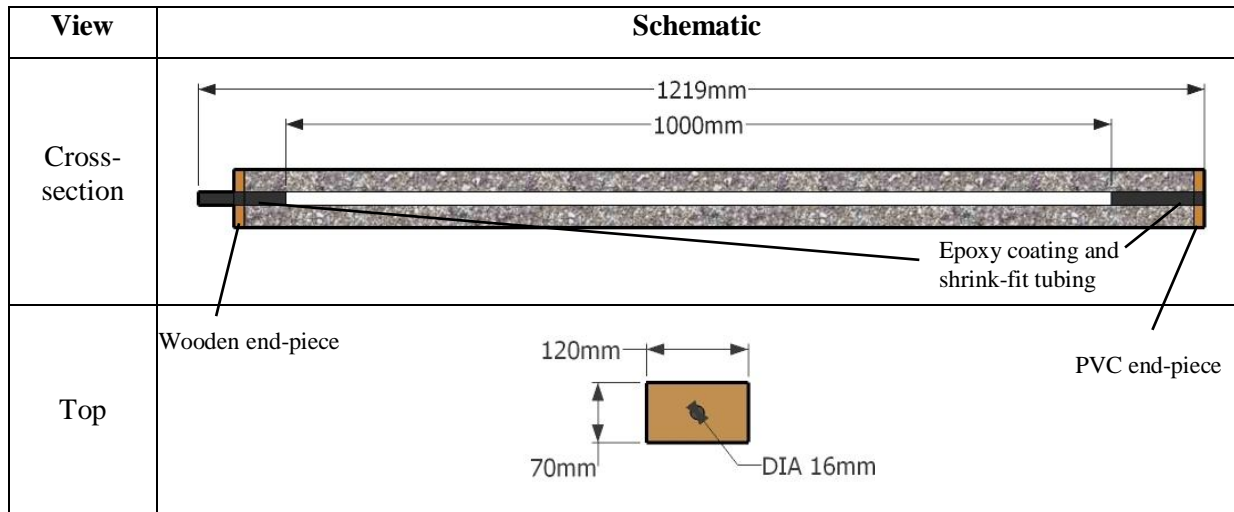
Figure 27: Dimensional overview of loaded beam

Beam dimensions of the specimens used to investigate the effect of loading conditions on the corrosion performance of pickled stainless steel rebar are illustrated in Figure 27, noting that the rebar ends shown in black were sealed with epoxy and rubber heat-shrink tubing to expose 1 m of the bar length to the concrete, and an electrical contact was screwed into the end of the bar protruding from the concrete, as described in Section 3.1.3 for the G109 prisms. This setup provided a concrete cover depth of 27 mm.

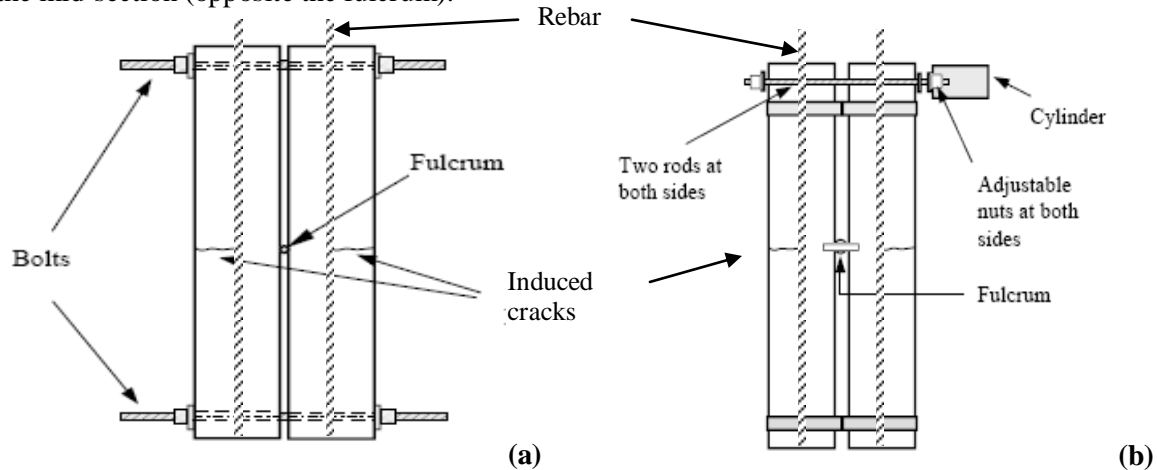
Figure 28: Schematic of setup for (a) statically loaded beam and (b) dynamically loaded beam

Pairs of the singularly reinforced concrete beams were connected together under 3-point bending, with the bottom ends fixed together in place, a fulcrum placed at the pair's mid-section and loading applied to the top ends. The static load was applied by tightening a bolted joint configuration, and the dynamic load was applied using a compressed air actuated cylinder that was cyclically pulsed, as illustrated in Figure 28 (a) and (b), respectively. The loading induces cracks on the outside edge at the mid-section (opposite the fulcrum).

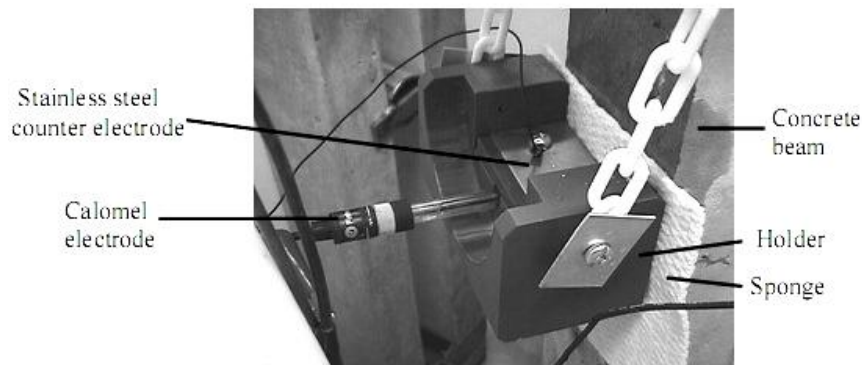
Figure 32: Electrode holder for loaded beam LPR measurements (Jaffer, 2007)

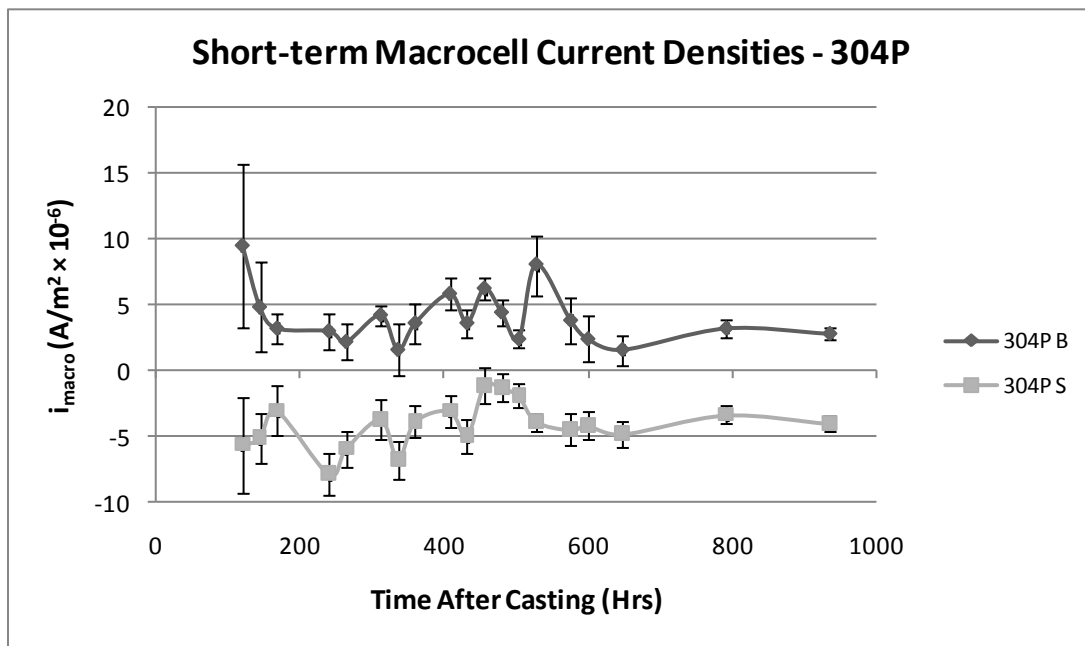
Figure 33: Short-term macrocell measurements for 304 pickled specimens with bottom black (B) and stainless steel (S) bars

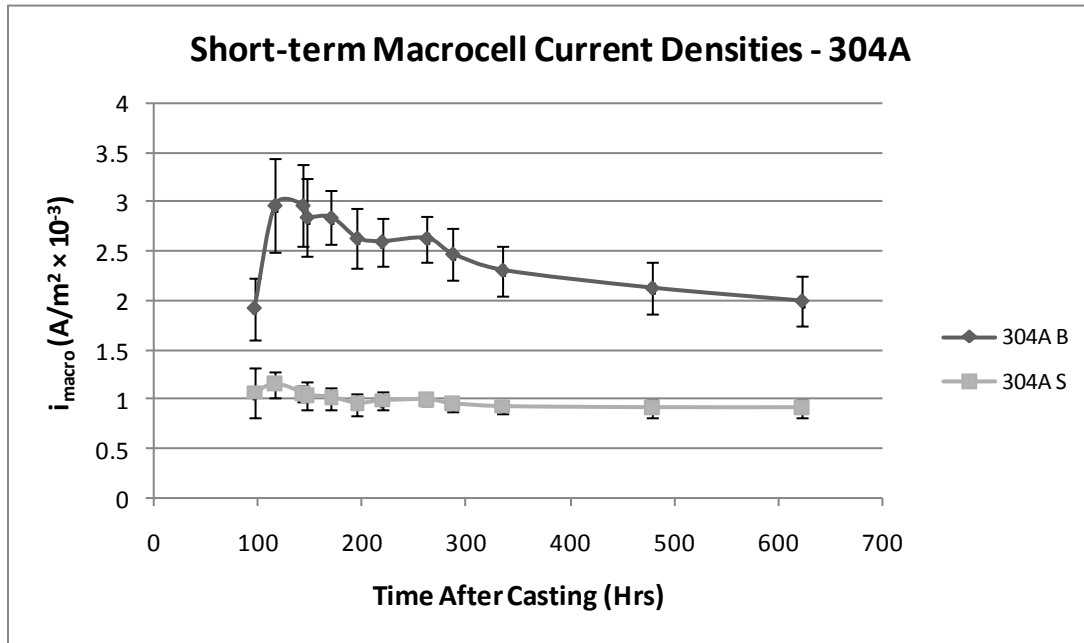
Figure 34: Short-term macrocell measurements for 304 as rolled specimens

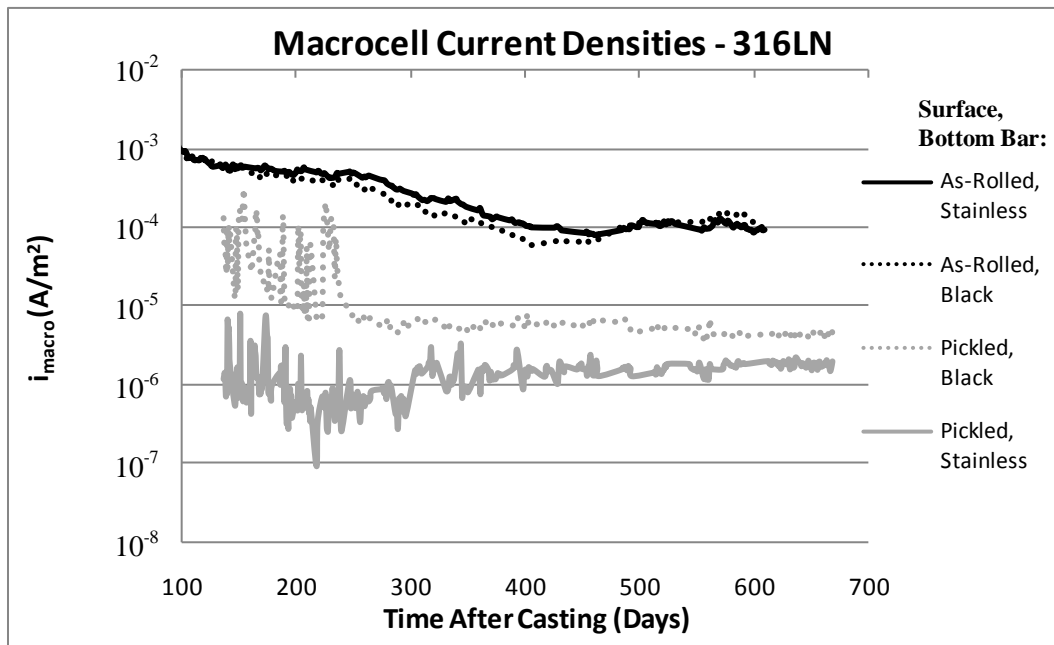
Figure 35: Average macrocell current densities over the long-term for 316LN steel type specimens

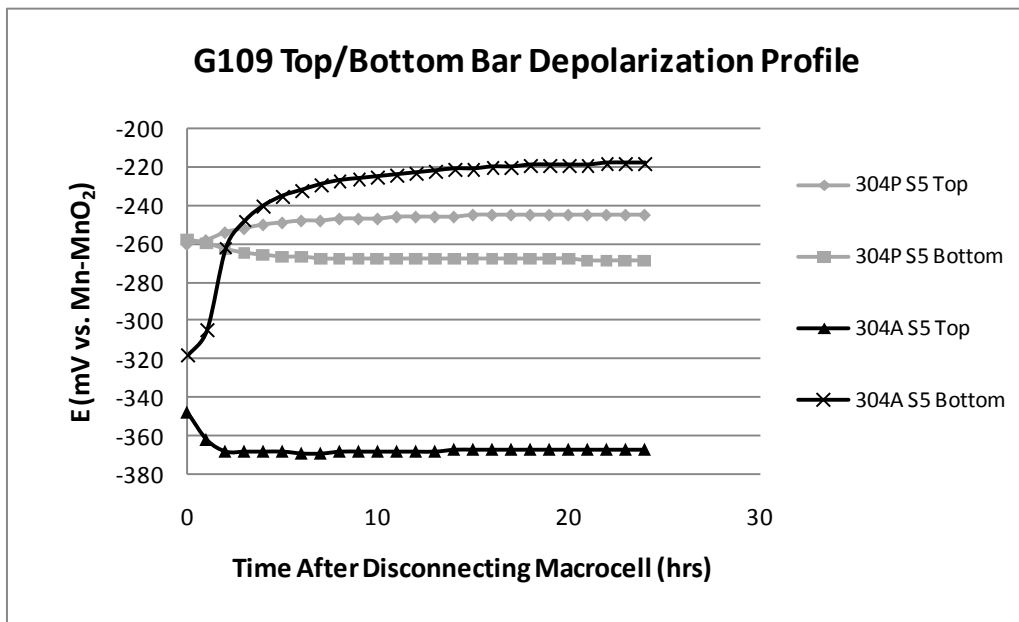
Figure 38: Depolarization profile of top and bottom 304P and 304A bars with time

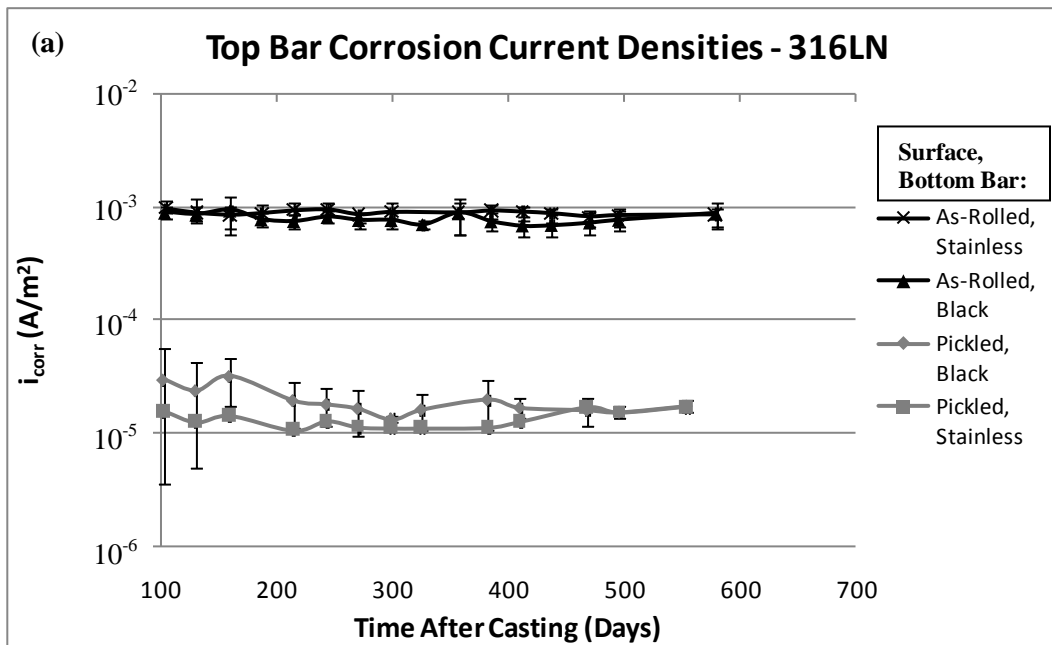
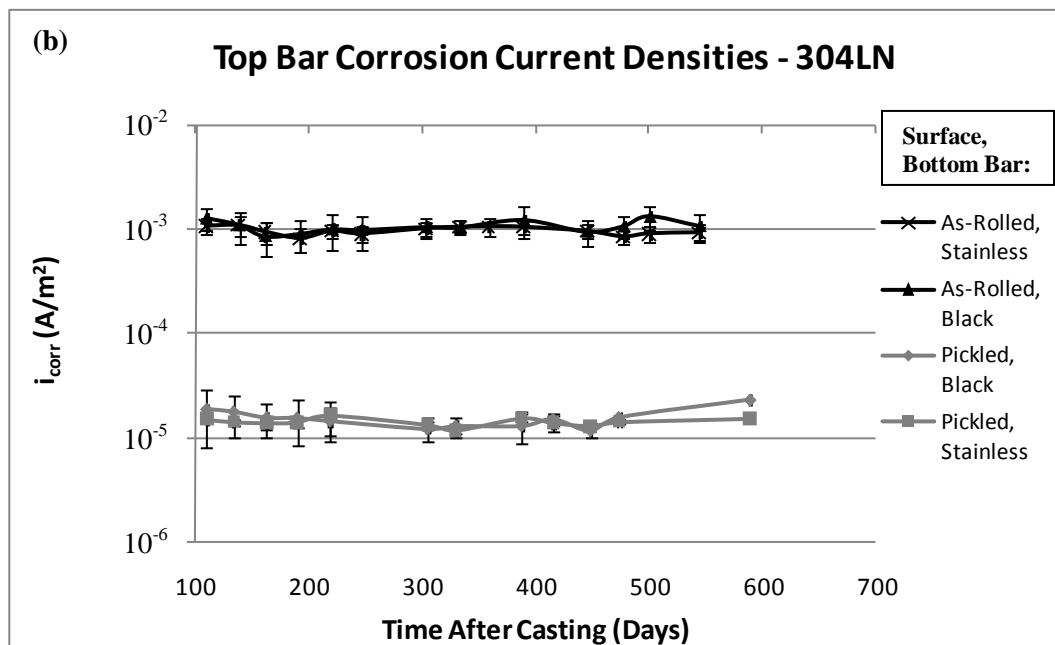
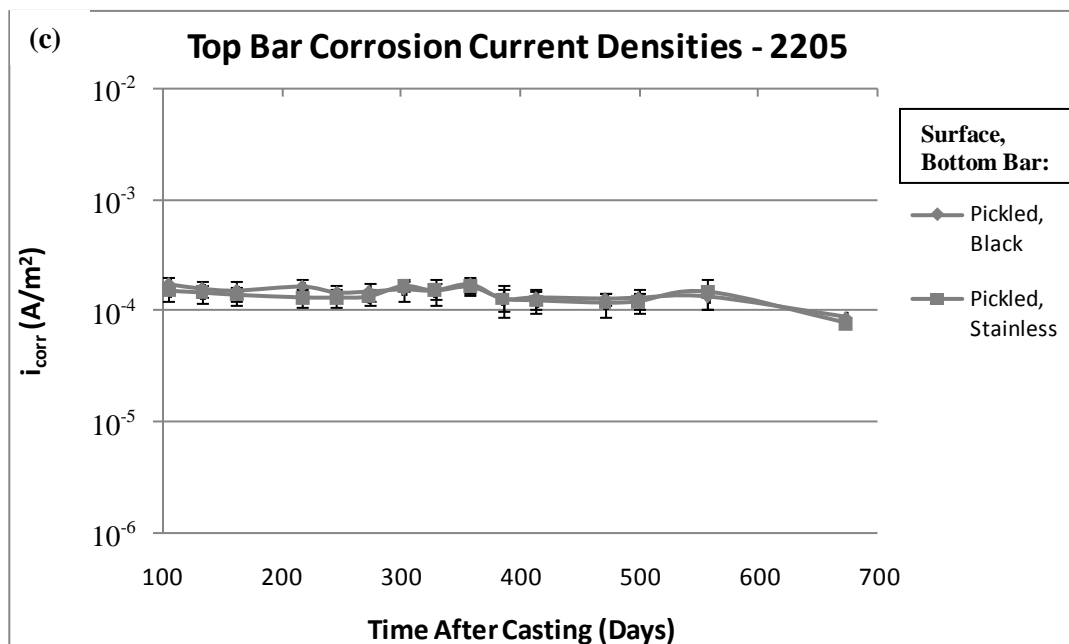
Figure 39: Average microcell corrosion current densities for (a) 316, (b) 304 and (c) 2205 steel type specimens

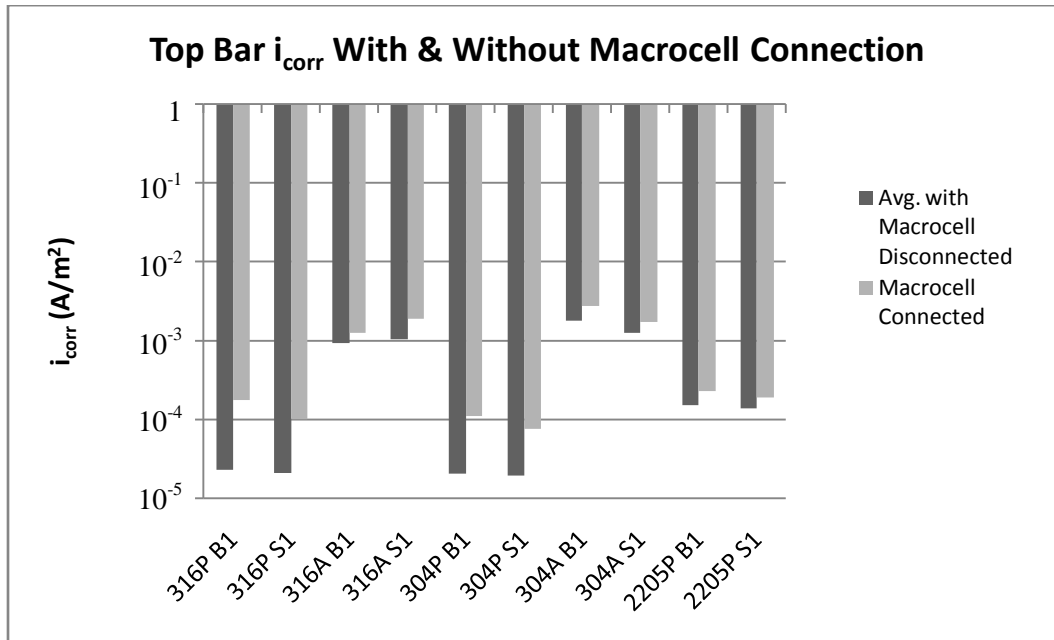
Figure 40: Microcell corrosion current densities of select top bars when polarized (macrocell connected for ≥ 24 hrs) compared with average values for top bar when depolarized (macrocell disconnected ≥ 24 hrs)

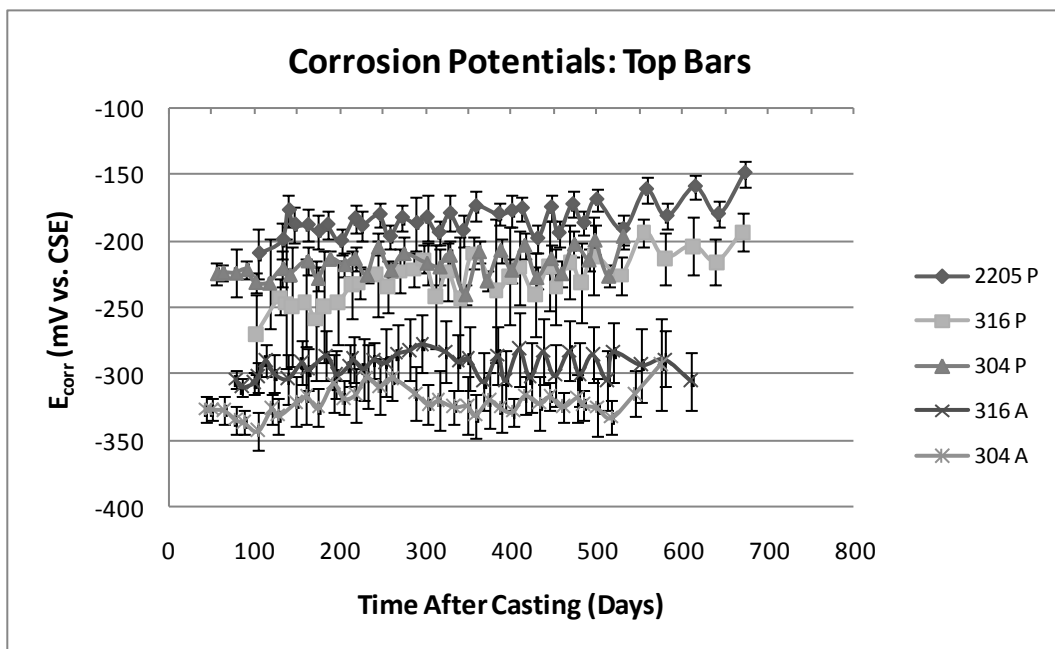
Figure 41: Average corrosion potentials of top bars in G109 specimens

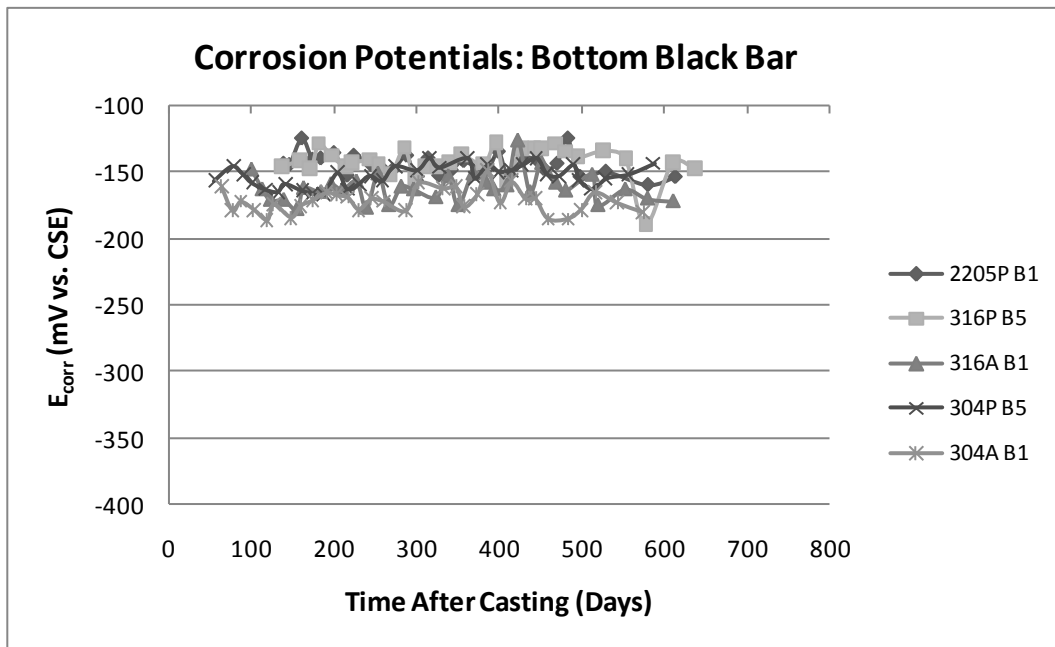
Figure 42: Corrosion potentials for certain bottom black steel bars

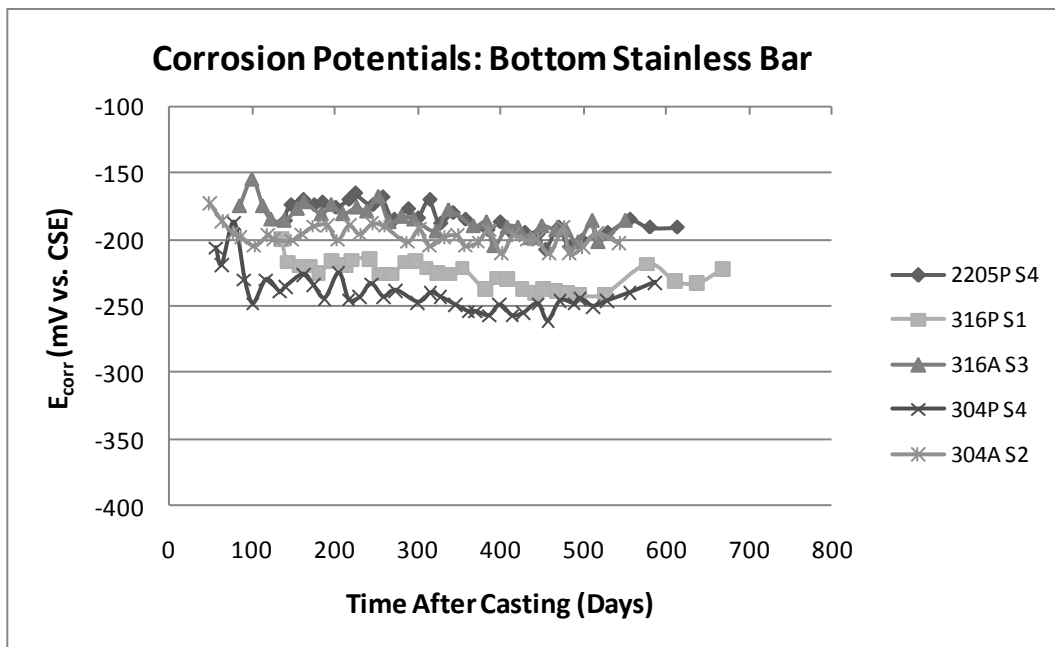
Figure 43: Corrosion potentials for certain bottom stainless steel bars

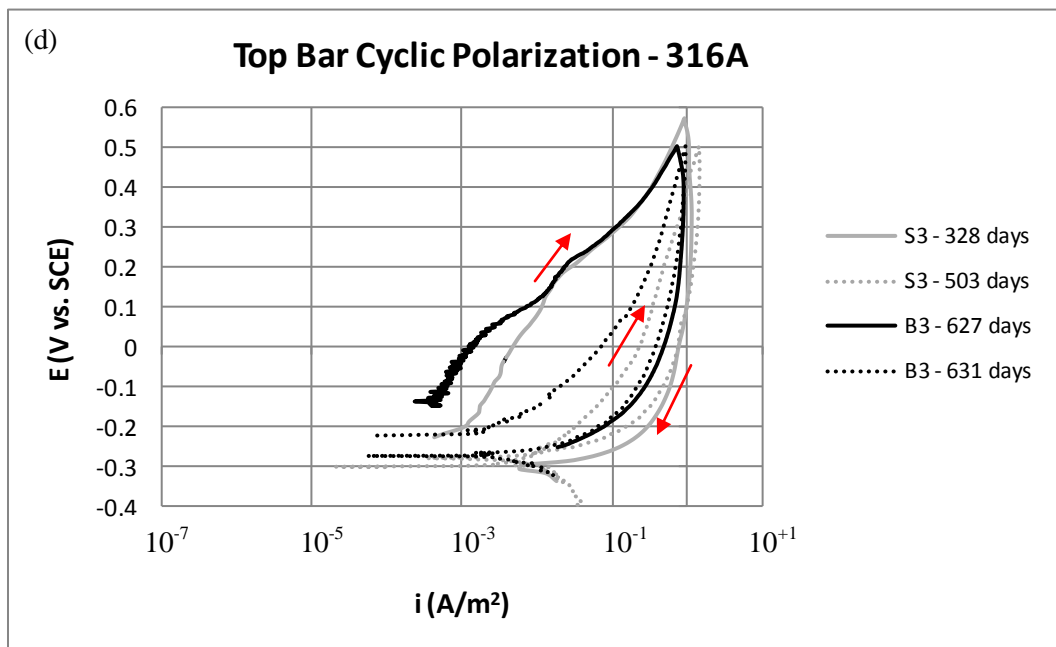
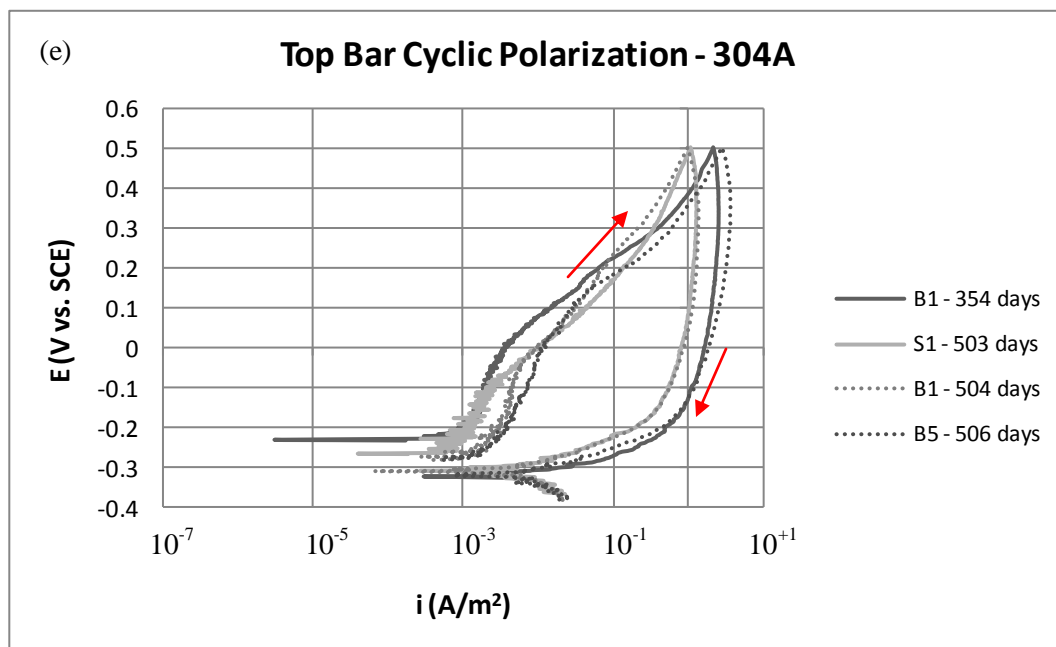
Figure 44: Potentiodynamic cyclic polarization curves for the top bars of (a) 316P, (b) 304P, (c) 2205P, (d) 316A and (e) 304A

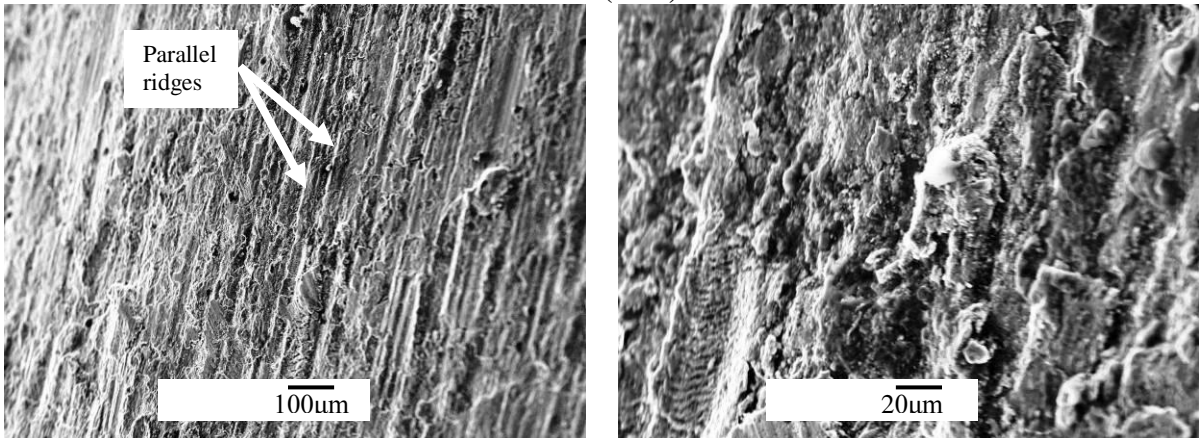
Figure 49: Surface images of the different steel types and surface conditions using scanning electron microscopy

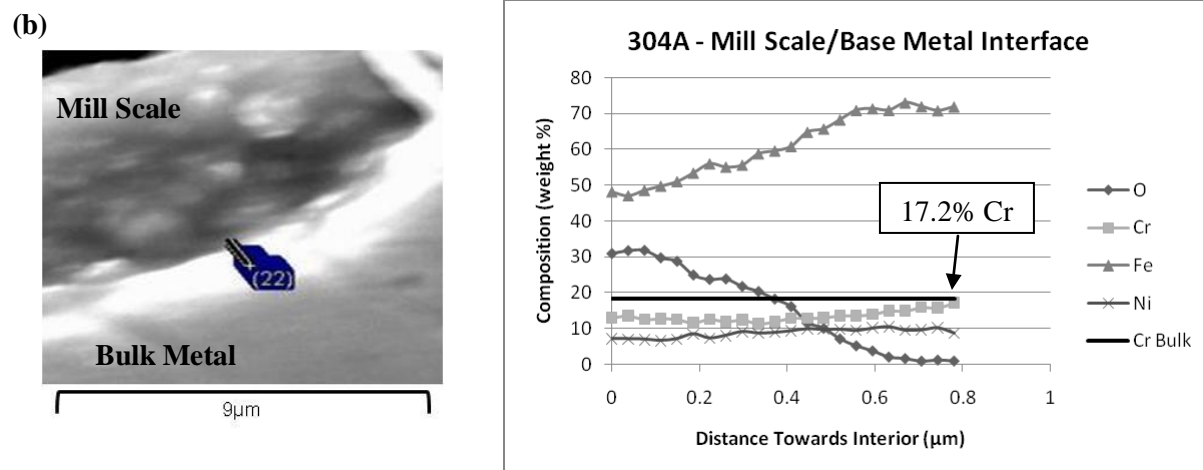
Figure 51: EDS analysis of the mill scale – base metal interface of 304A rebar

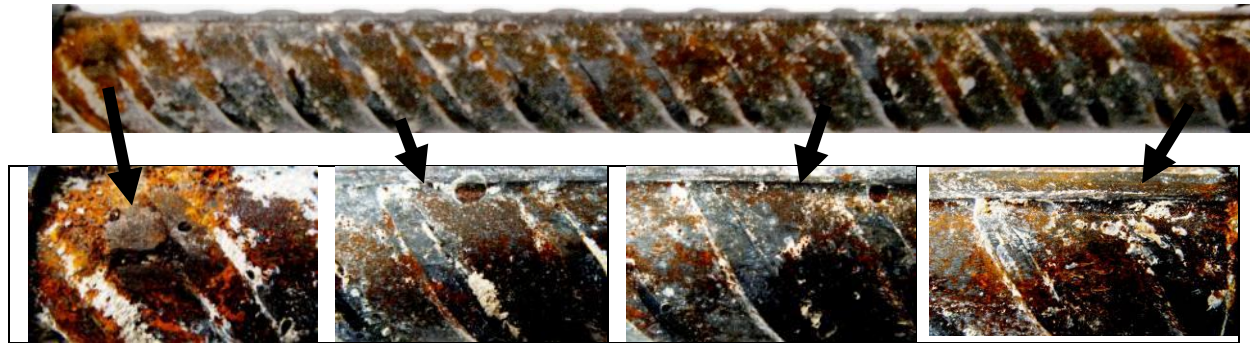
Figure 61: Top surface of 304A B4 top bar upon removal from concrete.

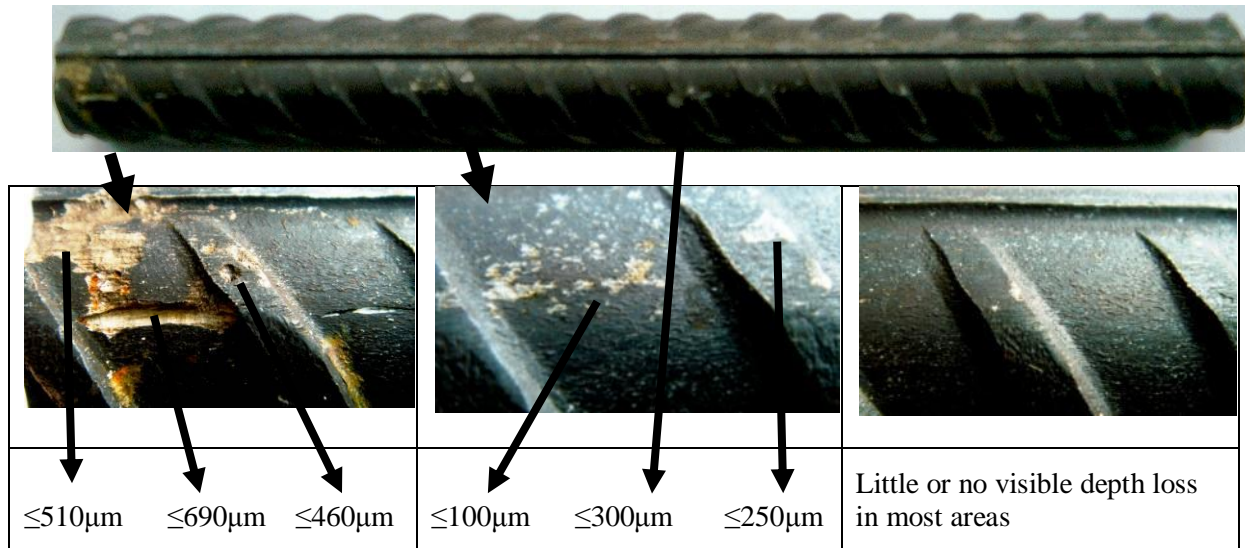
Figure 63: Appearance and depth loss analysis of 304A B4 specimen after removing corrosion products

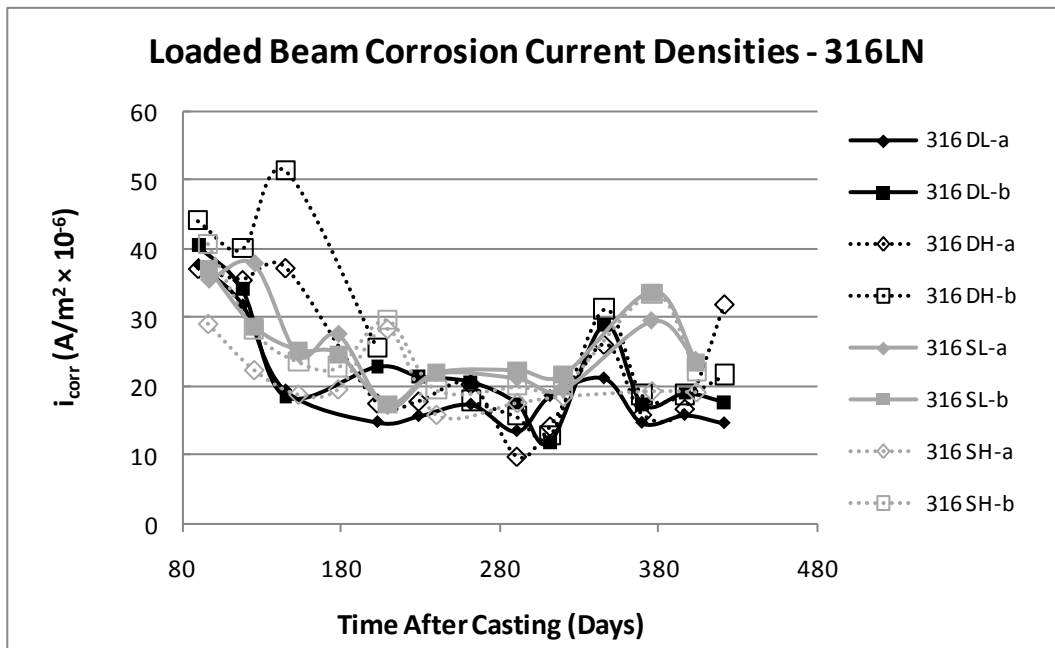
Figure 65: Corrosion current densities of 316 steel type loaded beams obtained by LPR

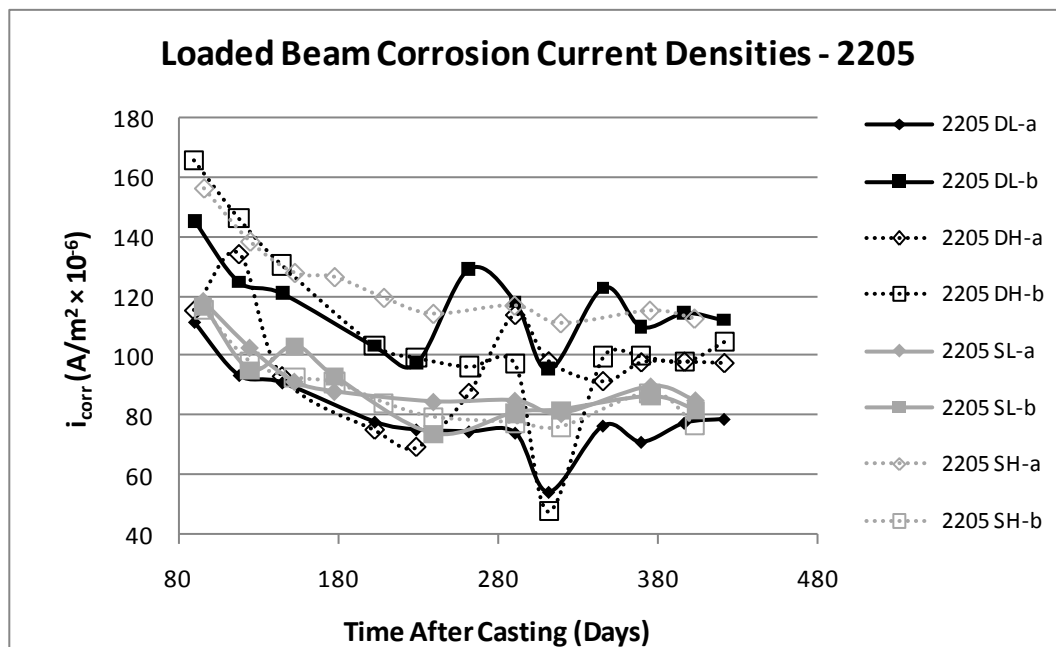
Figure 66: Corrosion current densities of 2205 steel type loaded beams obtained by LPR

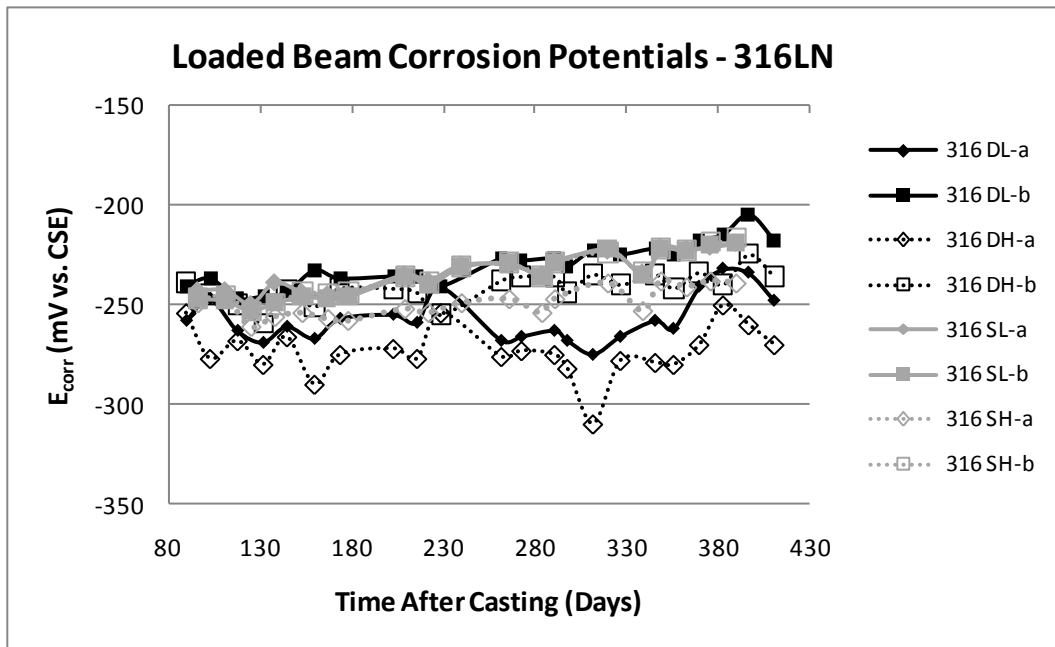
Figure 67: Corrosion potentials of the 316 steel type loaded beams

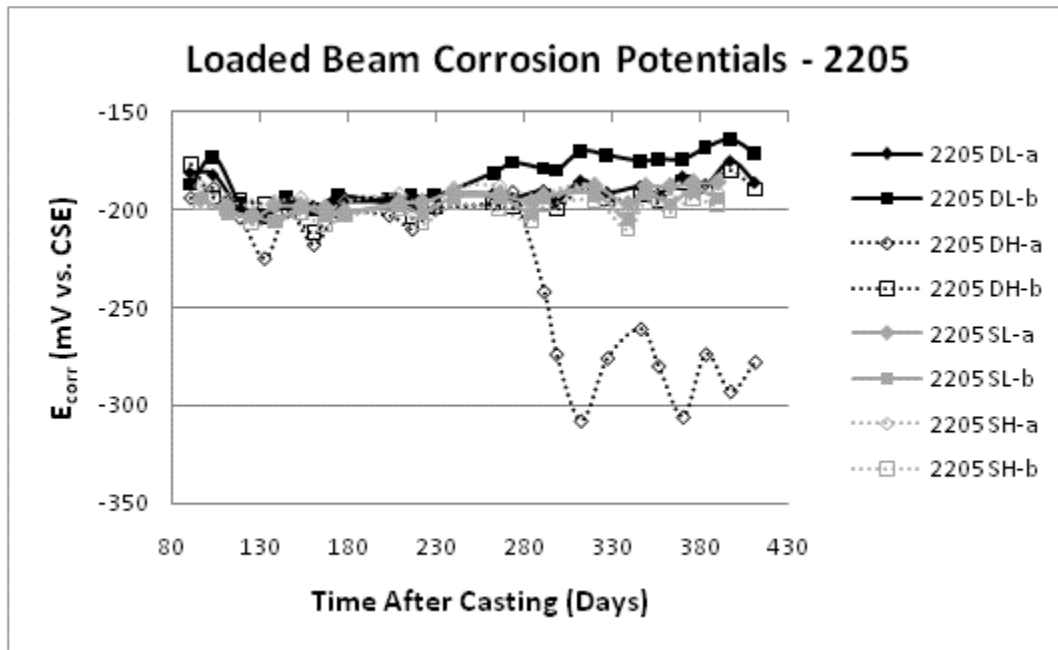
Figure 68: Corrosion potentials of the 2205 steel type loaded beams

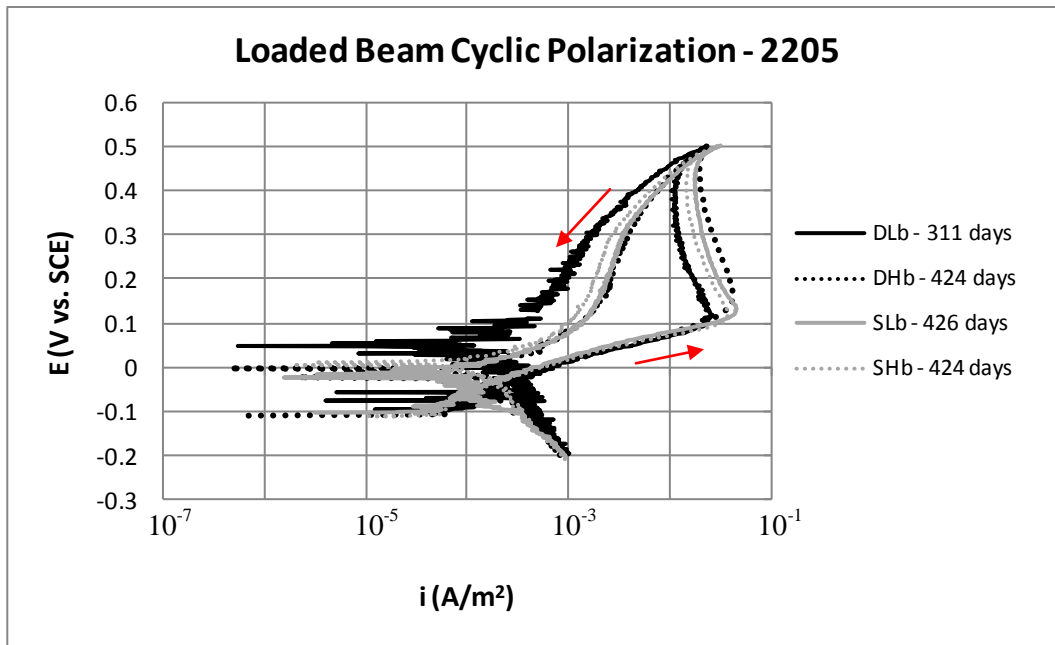
Figure 70: Cyclic polarization curves for 2205 steel type loaded beams

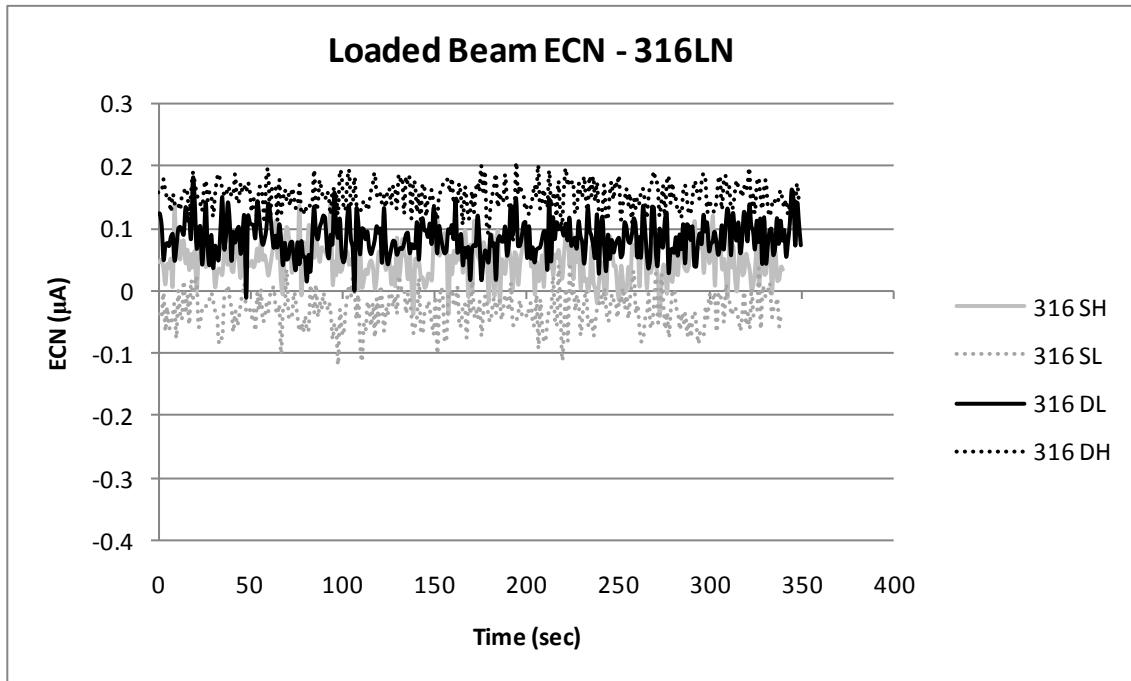
Figure 71: ECN measurements for 316 steel type loaded beams at 150 days after casting
