The Effect of Surface and Loading Conditions on the Corrosion Performance of Stainless Steel Rebar

A thesis
presented to the University of Waterloo
in fulfillment of the
thesis requirement for the degree of
Master of Applied Science
in
Mechanical Engineering

Waterloo, Ontario, Canada, 2009

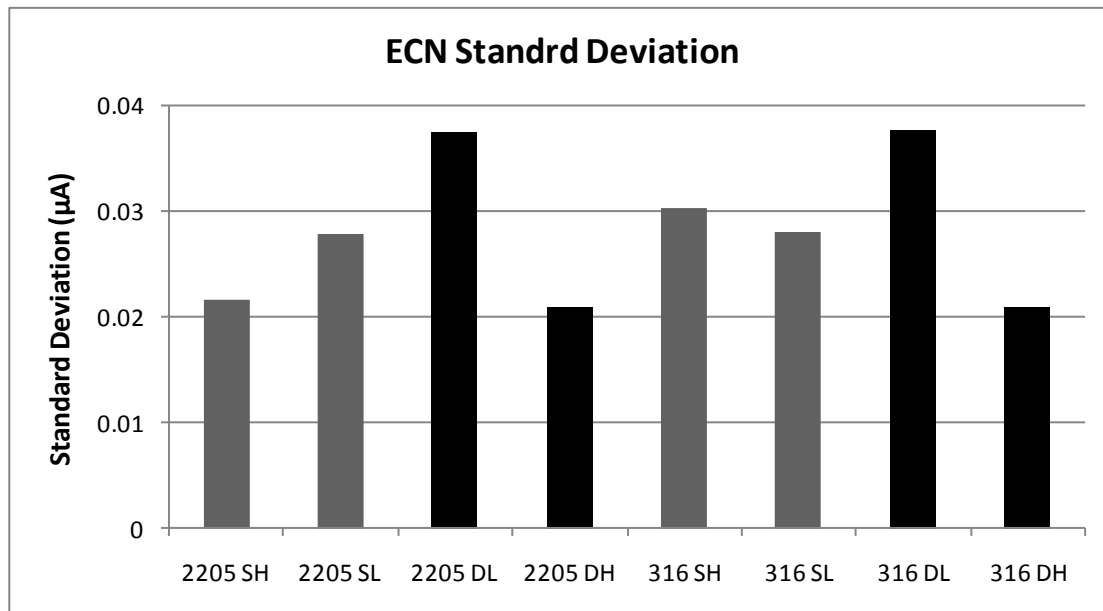
Figure 73: Standard deviation of ECN noise measurements at 150 days after casting

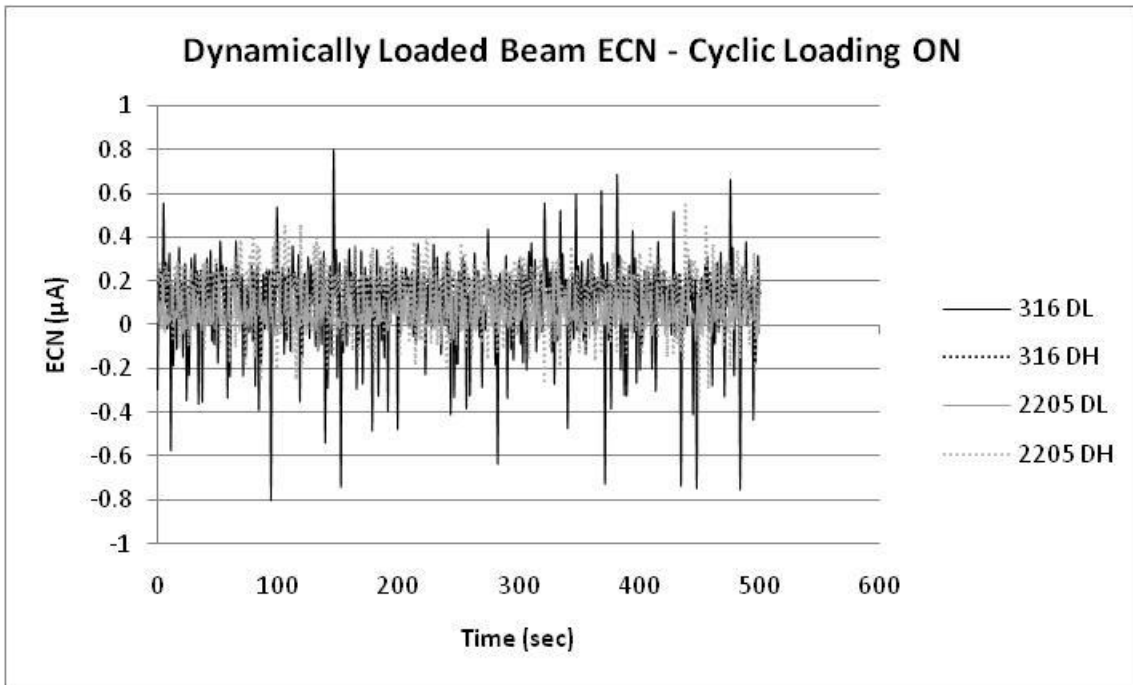
Figure 74: ECN measurements of dynamically loaded beams with cyclic loading applied at 200 days after casting

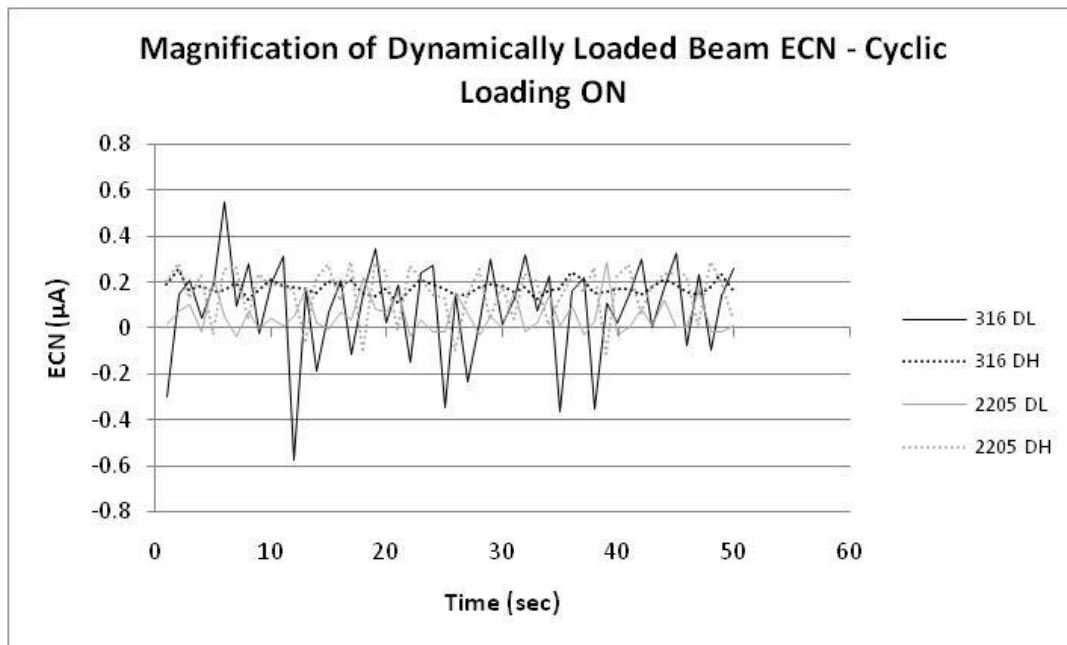
Figure 76: Magnification of ECN measurements of dynamically loaded beams with cyclic loading applied at 200 days after casting
