Performance Comparison of Large Diameter Residential Drinking Water Wells

A thesis
presented to the University of Waterloo
in fulfillment of the
thesis requirement for the degree of
Master of Applied Science
in
Civil Engineering

Waterloo, Ontario, Canada, 2010

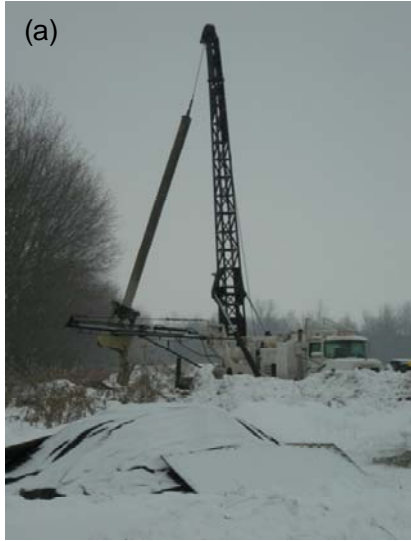
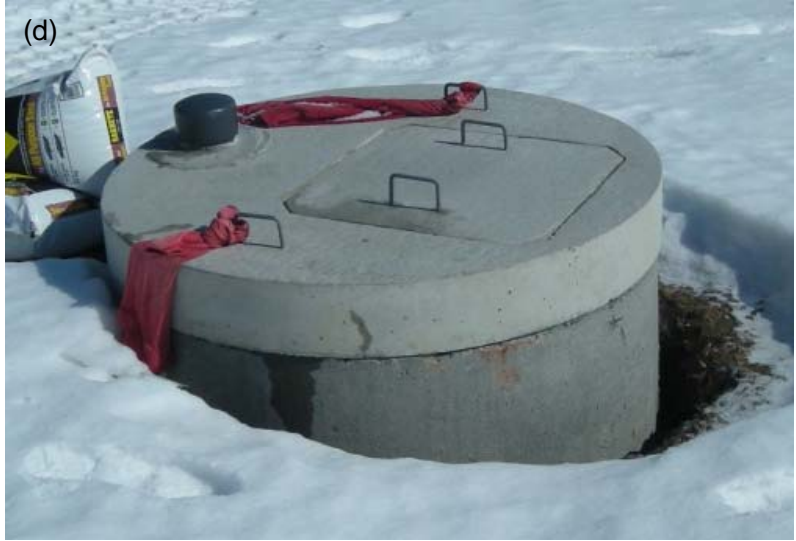
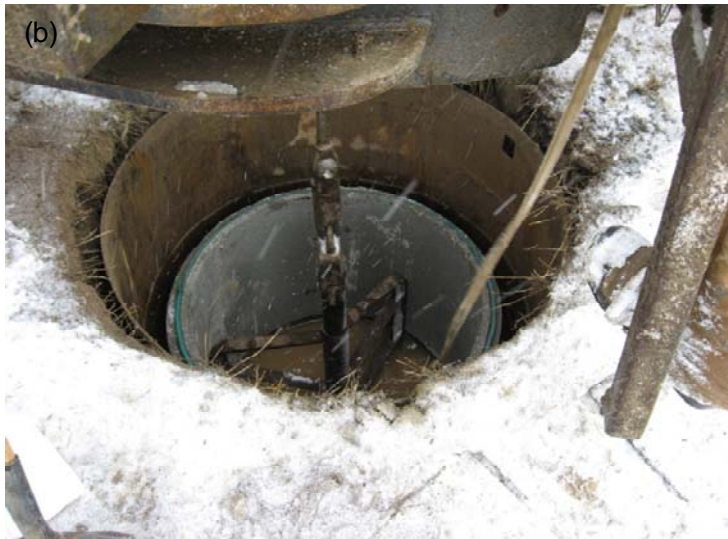
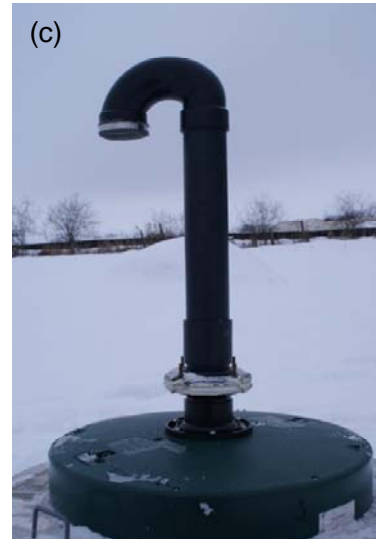
Figure 2.4. Large diameter test well installation photos showing (a) bucket auger rig, (b) hinged tile setter, (c) Poly – Lok lid with air filter, and (d) concrete cover and lid at CTH1.

ETH3 is an advanced design corrugated galvanized steel cased test well constructed using advanced methods. A single continuous riveted piece of 0.79 m (31") diameter corrugated galvanized steel casing was vertically placed to avoid damage to the casing or to the hole wall. A working casing (temporarily installed steel casing with a diameter larger than the test hole casing) was used to form an annular space with a diameter difference of 0.508 m (20"). The annular sealant consists of a mixture (1:1 by volume) bentonite granules (Baroid, Benseal, 85 % >2.36 mm and permeability $<1 \times 10^{-8}$ cm/s) and pea stone (1/2" prewashed), and was placed as a uniform mixture in the annular space. The uppermost rim of the corrugated galvanized steel casing was bonded to the concrete cover with mastic sealant. The cover consists of an airtight PVC Poly-Lok lid cast into the concrete cover. An air vent was permanently affixed to the Poly-Lok lid, which incorporates a filter for the purpose of removing airborne bacteria.

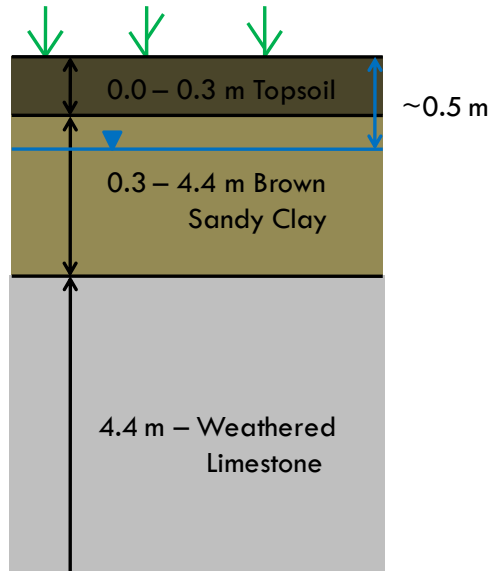
Figure 2.5. Typical soil profile.

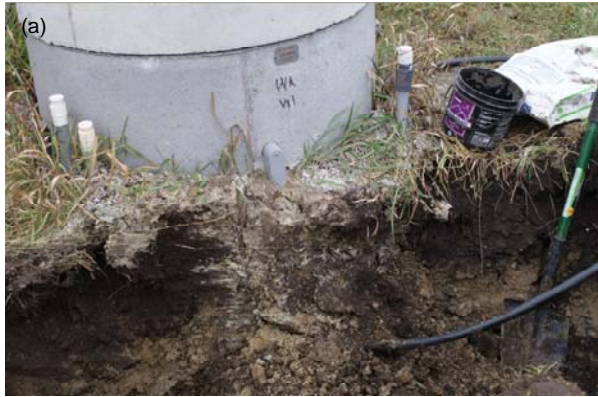
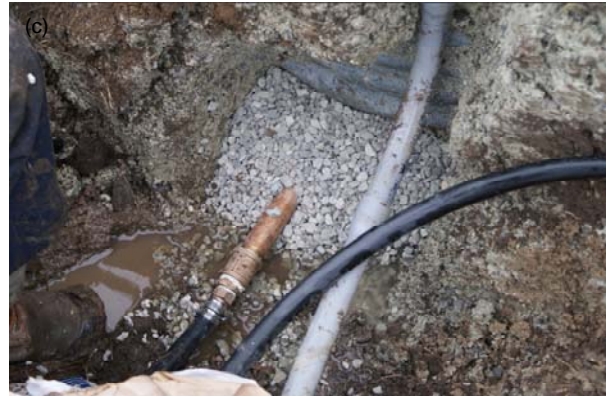
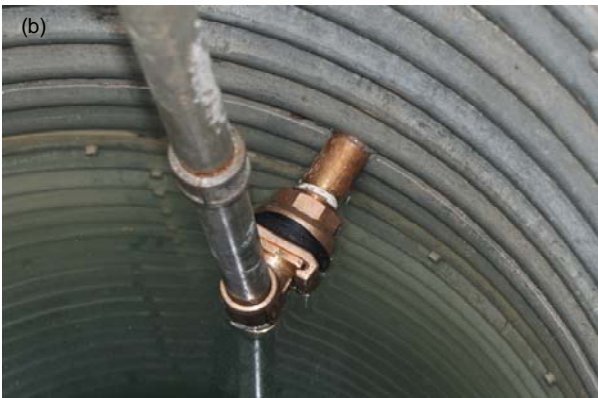
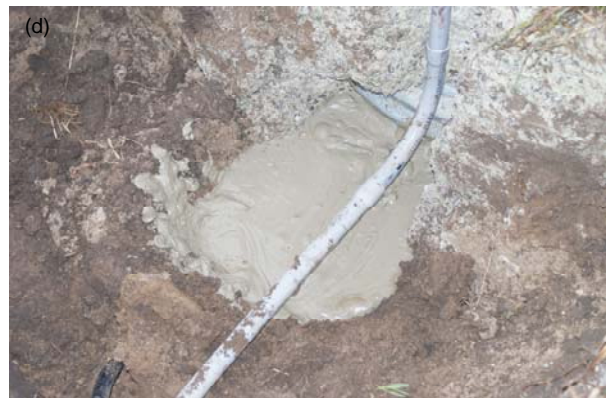
Figure 2.7. Pitless adaptor installation photos showing (a) placement of existing hydrated bentonite granules at ETH2, (b) pitless adaptor inside casing at ETH3, (c) pitless adaptor outside ETH3 covered with non-hydrated bentonite granules, and (d) pitless adaptor and non-hydrated bentonite granules covered with concrete to counterbalance the mass of the pump.

The holes for the pitless adapters in the concrete cased test wells, ETH1 and ETH2, were bored with a 51 mm (2") hammer core drill bit. These were drilled with a hammer drill above the static water level in the test wells at the time of installation. Some uncontrolled chipping was caused by the hammer core bit breaking through the inside of the casing. The pitless adapters were then installed in the hole and tightened on the outside of the casing. Once the pitless adapters were installed the annular sealant was replaced. A bentonite granule (Envirocore – Medium) was placed in the space around the ETH1 pitless adaptor and backfilled. Existing hydrated bentonite granules were placed around the ETH2 pitless adaptor and backfilled (Figure 2.7 (a)).

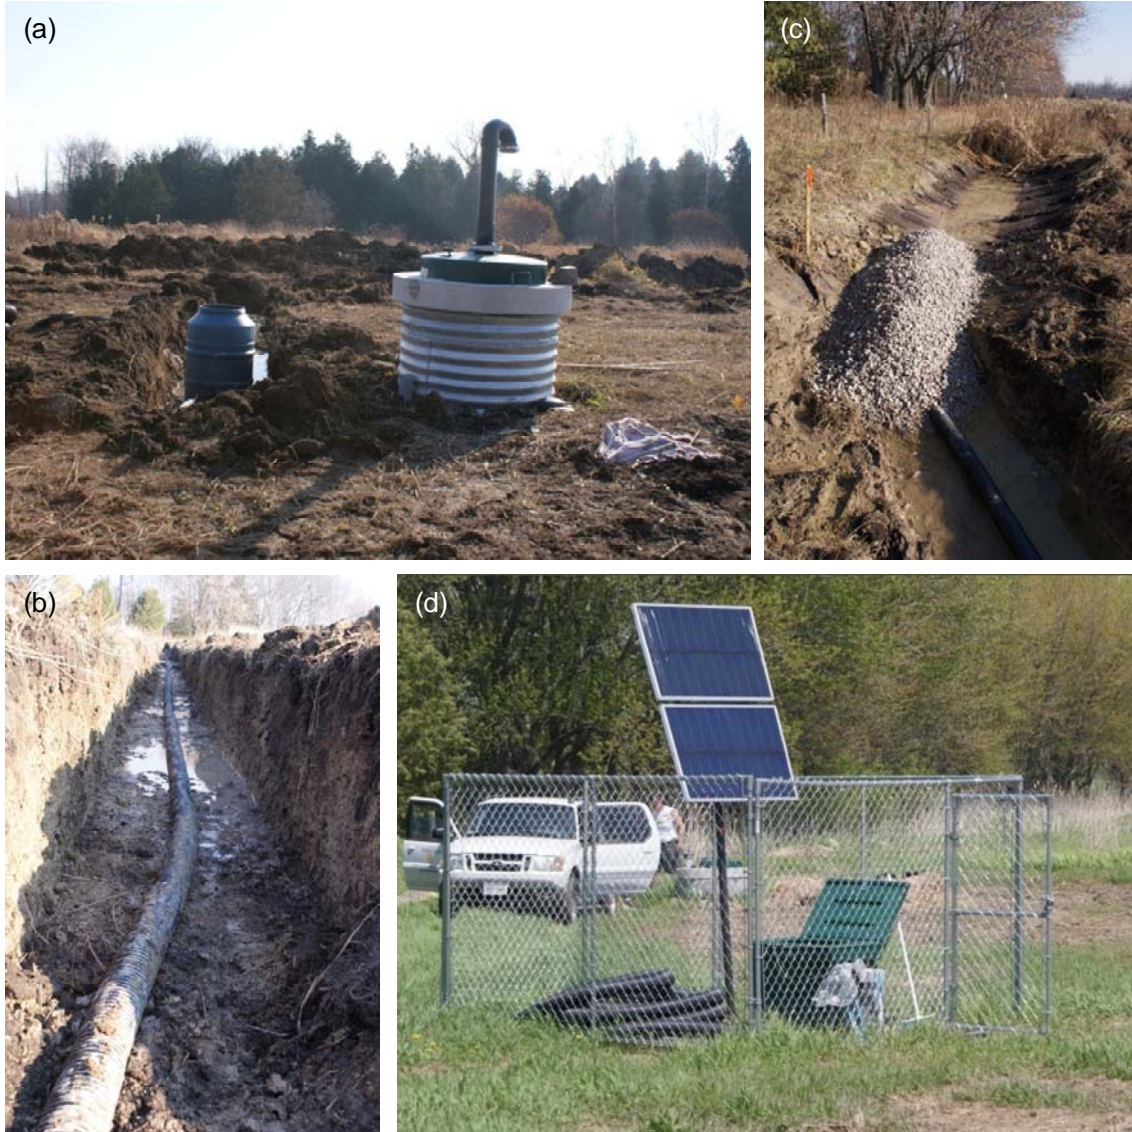
Figure 2.8. Drainage system photos showing (a) sample collection facility for ETH3, (b) drainage line from sample collection facility, (c) drainage line and stone cover at drainage ditch, and (d) solar panel and electrical enclosure.

The power for these pumps is provided by 2-12 V deep cycle batteries in series providing 24 V of power. The batteries are charged by two 1.22 m x 0.61 m (48" x 24"), 24 Watt solar panels in series. The solar panels are set on the top of a steel pole in a central location relative to the test wells (Figure 2.8 (d)). The wires from each pump are buried 45 cm below ground in conduit and meet at the solar panel. The solar panel and all controls are contained in a fenced enclosure. The electrical equipment is secured in a large plastic box with desiccant packs to absorb any moisture. Due to the high amperage of the pumps only one pump can run at a time. An Allen-Bradley Pico programmable controller (model 1760-L12DWD) operates 30 Amp relays that turn the pumps on and off for set periods of time based on the flow rates and the desired amount of water to be removed.

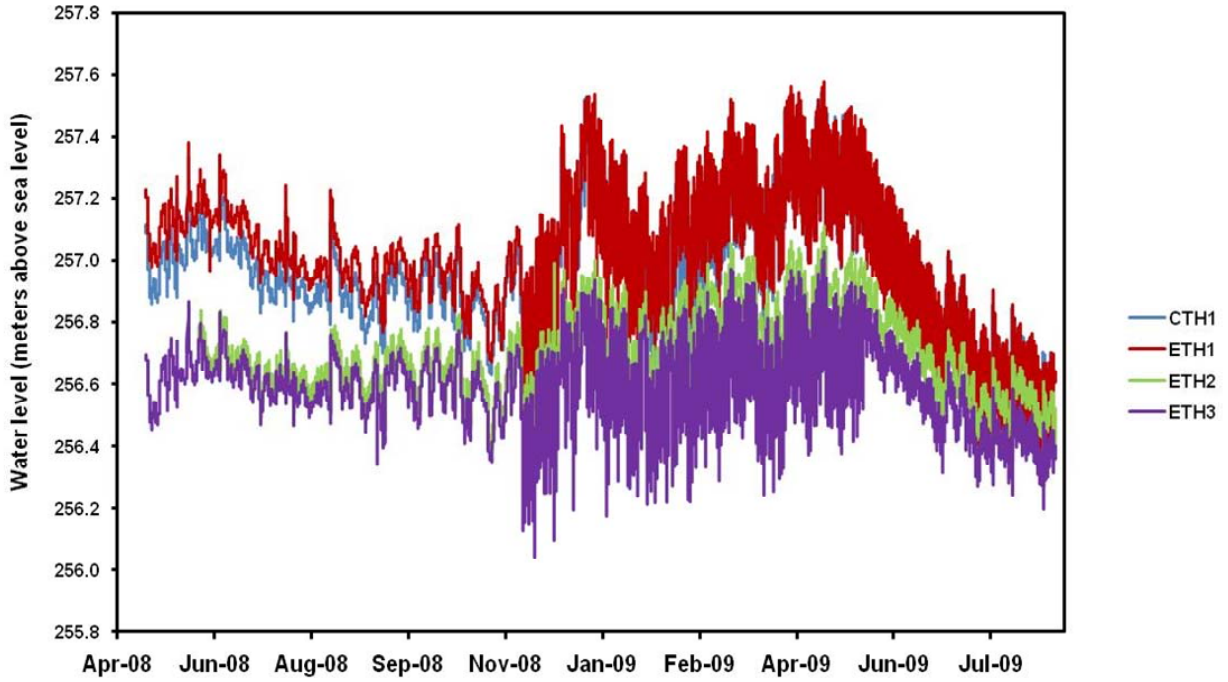
Figure 3.1. Test well water level measurements from pressure transducers.

Water level measurements collected from the test wells indicate that groundwater flows southeast toward the Scugog River, which is consistent with the hydraulic data collected from the monitoring wells. Since monitoring of water levels has begun, water table elevation fluctuations of as much as 0.8 m have been observed (Figures 3.1 and 3.2, data from pressure transducers). These fluctuations can be attributed to seasonal changes or periods of wet and dry weather. Since November 2008, much more variability in the water levels is observed. This is due to the daily pumping, to simulate regular usage of the wells, which causes daily drawdown and recharge. The water table is close to the ground surface (~0.5 m bgs), consistent with other observations. The water recharging the wells is supposed to enter the wells through the open bottom where much higher conductivity weathered limestone is located.

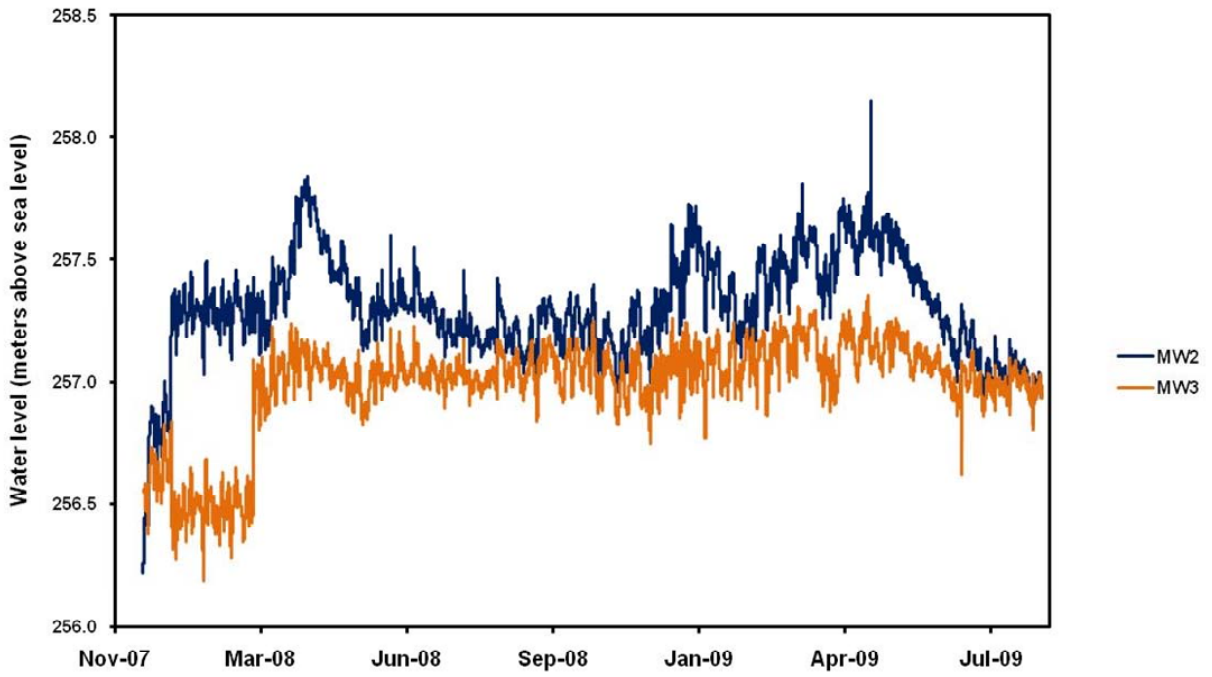
Figure 3.2. Monitoring well water level measurements from pressure transducers.

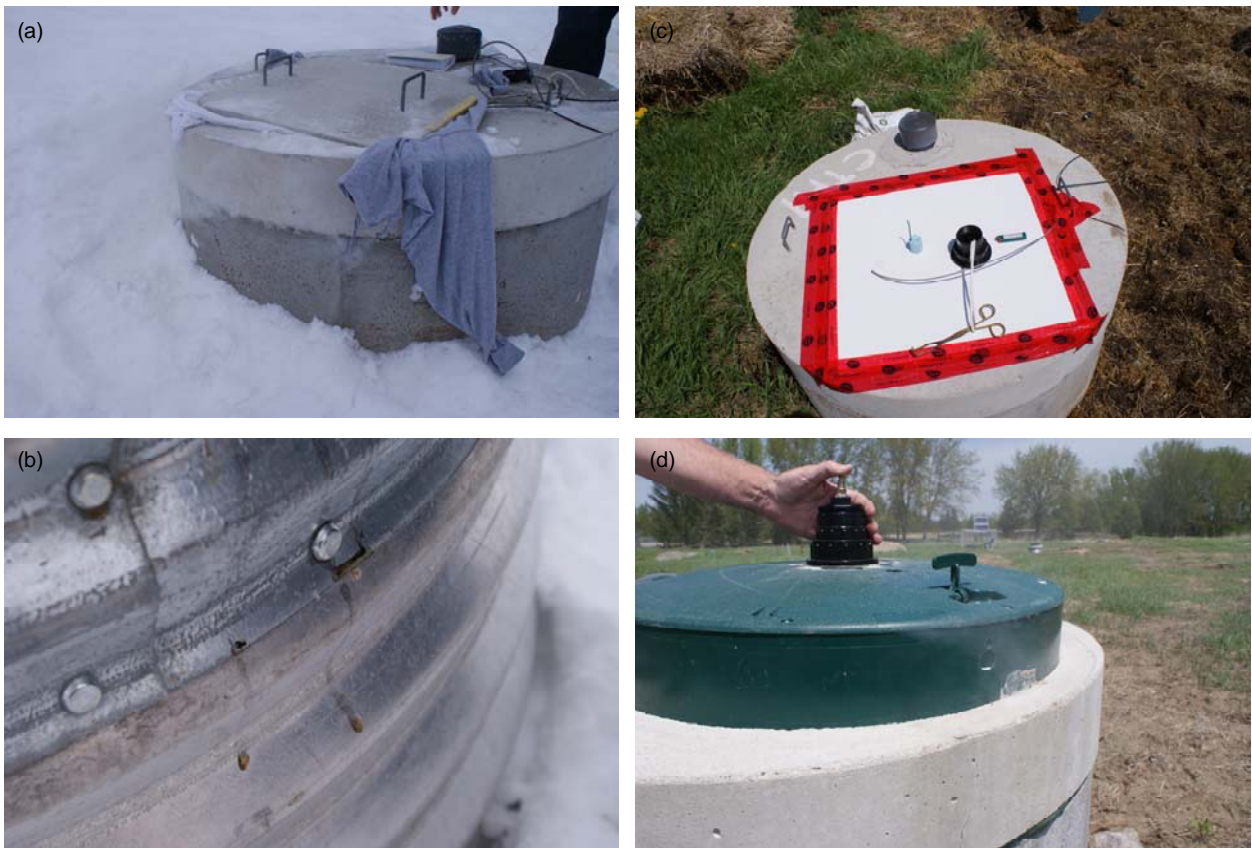
Figure 3.8. Photos of smoke tracer tests showing (a) rags used to seal CTH1 during test #1, (b) dark coloured water leaking from seams of ETH3 casing during test #1, (c) apparatus properly sealing CTH1 during test #2, and (d) smoke escaping from Poly – Lok lid of ETH1 during test #2 caused by damage during test #1.

At all concrete cased test wells smoke was observed escaping from around the interior geophysical access tubes and other joints in the casing. Since there is no mastic sealant between the casing sections in CTH1 it had much more visible smoke emitting from these locations. ETH3 (galvanized casing) had smoke emitting from around the joint between the concrete cover and the galvanized casing. When pressure was applied to ETH3 black air bubbles and dark coloured liquid appeared along the seams of the galvanized casing (Figure 3.8 (b)). The black air bubbles and dark coloured liquid may have been caused by machine oil left between the riveted

At all enhanced test wells smoke was observed at the electrical conduit box, interior geophysical access tube, and along the seam of the Poly-Lok lid. The access lid in the cover of CTH1 was properly sealed during this test (Figure 3.8 (c)) and smoke was observed emitting from all joints in the casing construction. The smoke observed emitting from the seam of the Poly-Lok lid was caused by damage to the foam seal which occurred during smoke tracer test #1 (Figure 3.8 (d)). During smoke tracer test #1 smoke was visibly emitting from all the seams in the casing where mastic sealant was used, but during the test #2 no visible smoke emitted from these locations. During the test #1 the mastic sealant that was visible outside the casing was very firm to the touch; however, during test #2 the mastic sealant was soft and very malleable and could have created a better seal. The mastic sealant losing plasticity in the cold may have caused the seal to contract and create voids, which may be the cause of observed smoke pathways between the joints of the concrete cased. During test #2 smoke emitted from the seams in the galvanized casing where it was riveted together. This was not observed during test #1 and may have been a result of condensation freezing in the seam. Table 3.2 provides a summary of the observations from smoke tracer test #2.

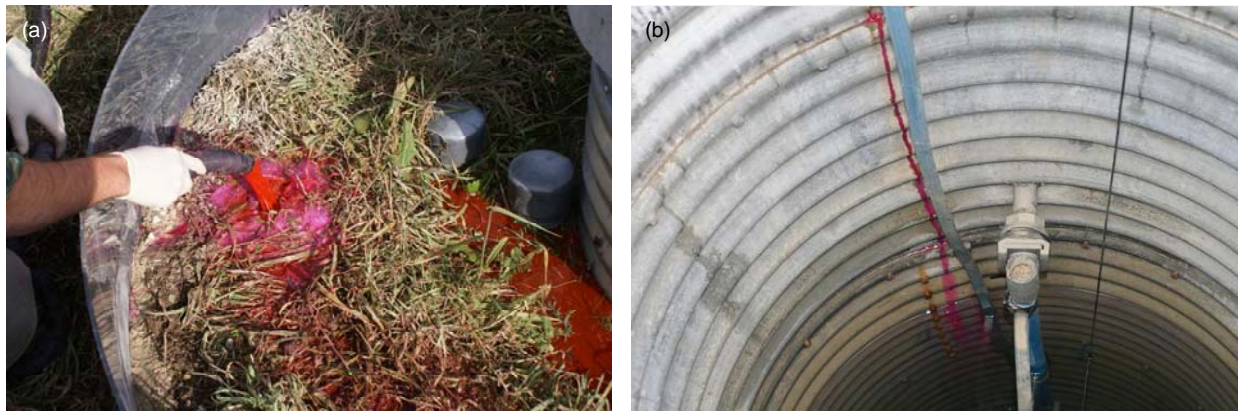
Figure 3.14. Photos of tracer solution at ETH3 (a) being placed on thick grass cover, and (b) leaking through the riveted seam in corrugated galvanized casing.

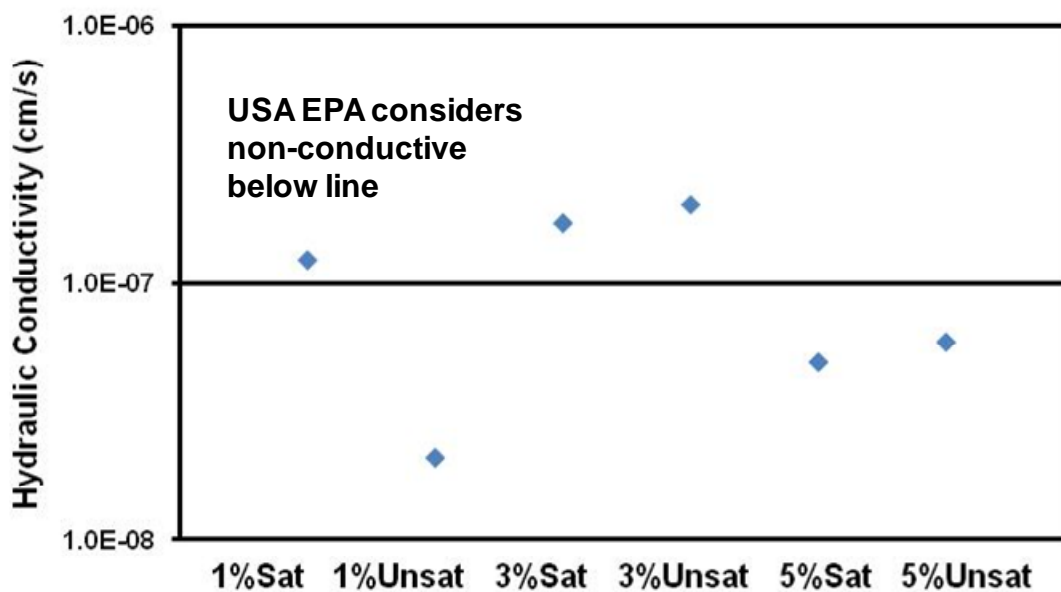
Figure 3.20. Average hydraulic conductivity of cement-bentonite grouts.

Cement-bentonite grout with 5% bentonite cured in both saturated and unsaturated conditions would make a suitable annular sealant provided that a reduction in the diametric volume does not create a vertical pathway on the geologic formation. The 5% bentonite grout investigated here was non-conductive and provided a suitable barrier against infiltrating water coming in contact with the well casing both above and below the water table. Based on the vertical load bearing capacity, each of the grouts analyzed would resist cracking or failure when the load of a man or truck is applied. The 5% bentonite content mixture also had the least vertical shrinkage and least overall volume change. Excess vertical shrinkage may cause a low spot around the ground surface which would allow water to pond in the vicinity of the well casing.

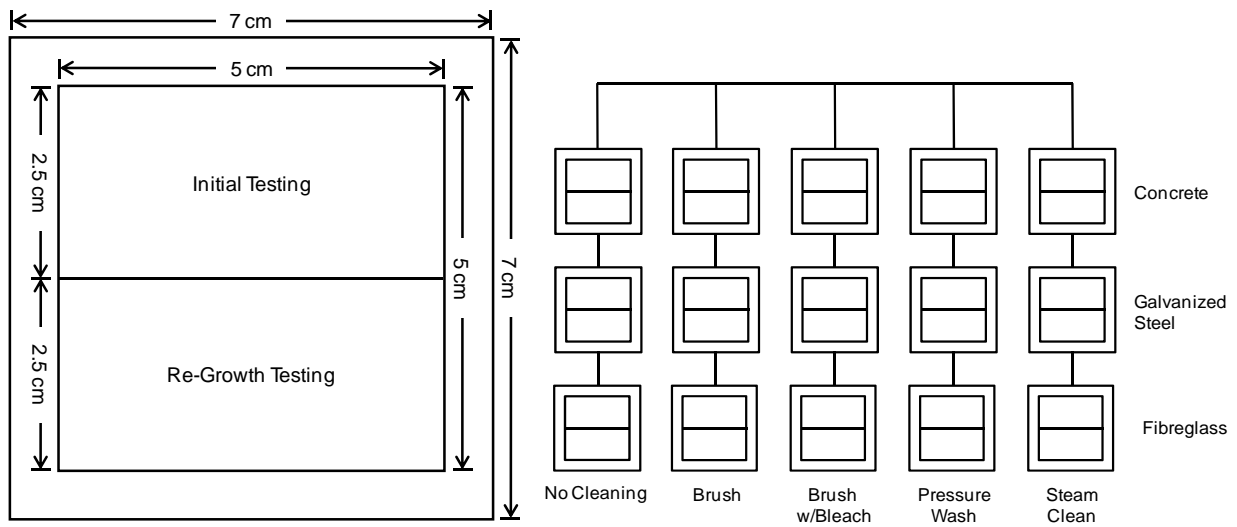
Figure 1: Individual coupon and coupon array.
