**Bond Behaviour of Beams Reinforced with Near  
Surface Mounted Carbon Fibre Reinforced Polymer  
Rods under Fatigue Loading**

A thesis

presented to the University of Waterloo

Civil Engineering

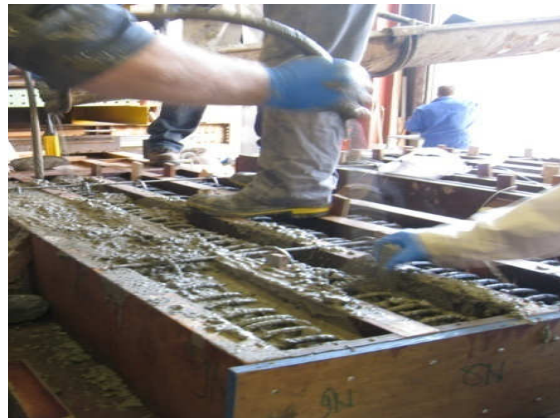
b- Concrete pouring

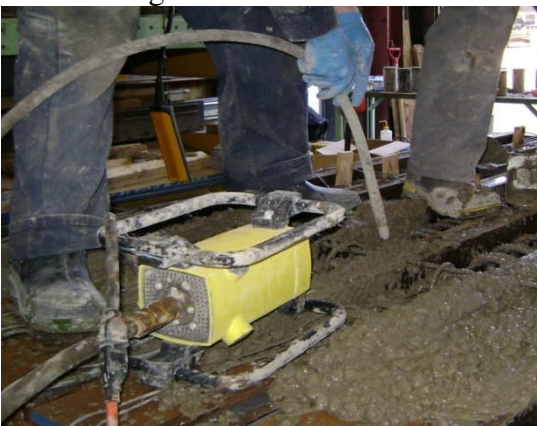
c- Concrete vibration

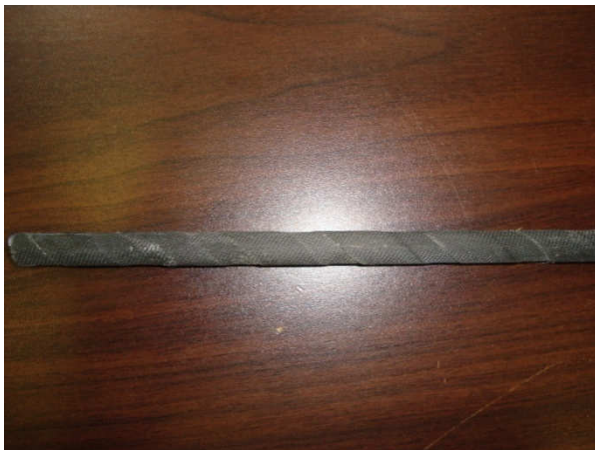
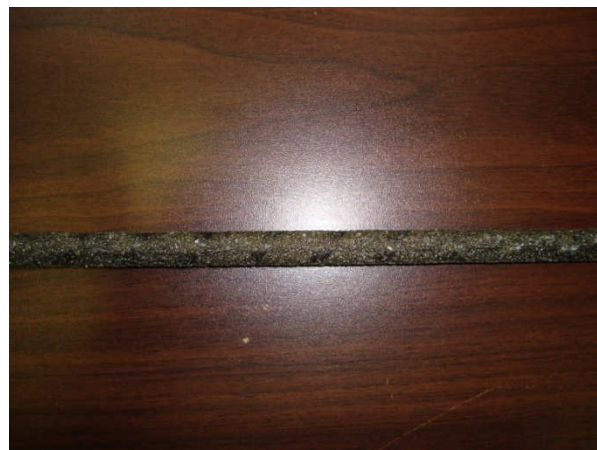
Figure 2.4: Different CFRP rod types

a- Spirally wound (SW) CFRP rod

b- Sand coated (SC) CFRP rod

The mechanical properties for the carbon fibre reinforced polymer (CFRP) rods were provided by the manufacturer. The rods were supplied by Hughes Brothers. Two different types of CFRP rods were used: sand coated rods and spirally wound rods as shown in Figure 2.4. The spirally wound and the sand coated rods had a nominal diameter of 9 mm and 9.5 mm, respectively. The mechanical properties of the CFRP rods as provided by the manufacturer were: tensile strength of 1970 MPa (spirally wound) or 2166 MPa (sand coated), modulus of elasticity of 136 GPa (spirally wound) or 130 GPa (sand coated) and average ultimate strain of 1.45% strain (spirally wound) or 1.67% (sand coated). Table 2.4 shows the properties for the used CFRP rods.

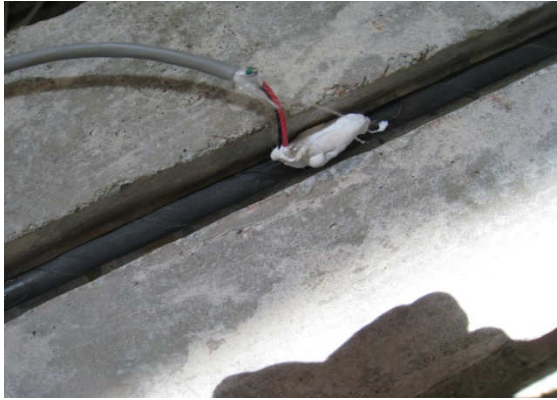
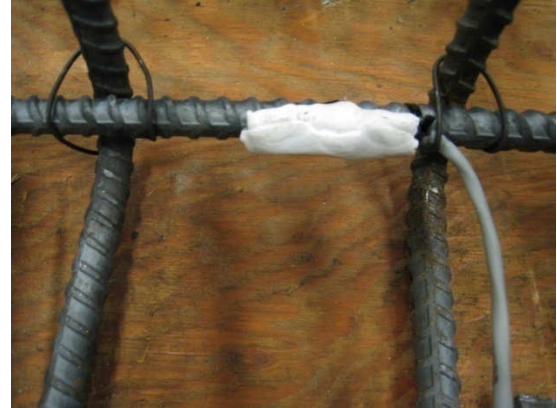
Figure 2.5: Strain gauges and their location on CFRP rod and steel rebar

a- Strain gauge on CFRP rod

b- Strain gauge on steel rebar

Seven strain gauges were mounted on the tension steel; 3 gauges at each beam end at 125mm, 250mm and 375mm measured from centerline of the support and one gauge at midspan. The ribs were first ground flat, then the surface was cleaned before placing the strain gauge. Four strain gauges were mounted on the CFRP rod at each end at 125mm, 250mm, 375mm and 500mm measured from the centerline of the support in addition to one gauge at midspan as shown in Figure 2.5. For the sand coated rods, the coating was removed over a small distance just enough to glue the strain gauge. After placing the strain gauge on either the steel rebar or the CFRP rod, the strain gauge was waxed and coated with V-M tape (3mm thick). This local protection was used to minimize the disturbance to the bond (between the reinforcement and the concrete or the epoxy) by the strain gauges as much as possible. Five strain gauges were mounted on the concrete; 2 gauges on each side at 125mm and 375mm measured from centerline of the support and one gauge at midspan.

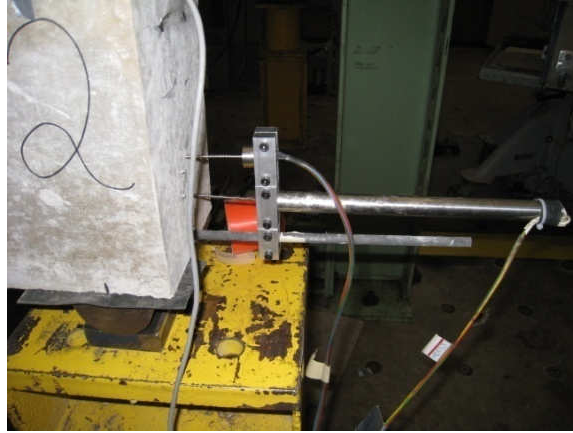
Figure 2.6: LVDTs attached to the CFRP rod to measure end slip

Two linear variable differential transformers (LVDTs) were attached to the CFRP rod at each end of the beam to measure the slip between the rod and the concrete as shown in Figure 2.6. The vertical deflection of the beam was measured using an internal LVDT on the loading ram and an external LVDT at midspan.

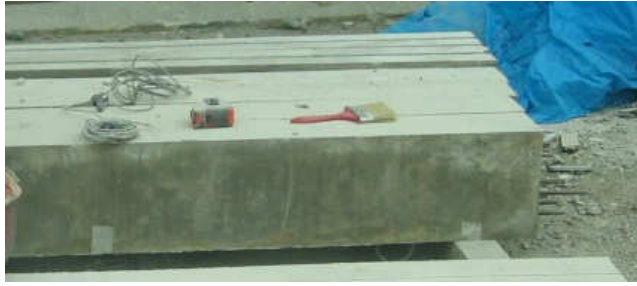
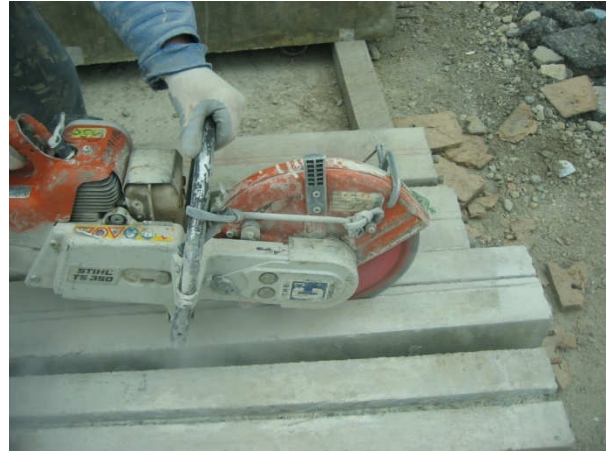
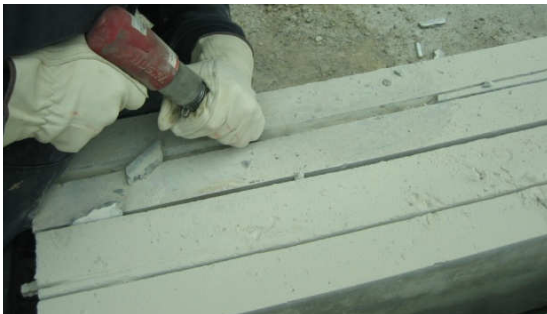
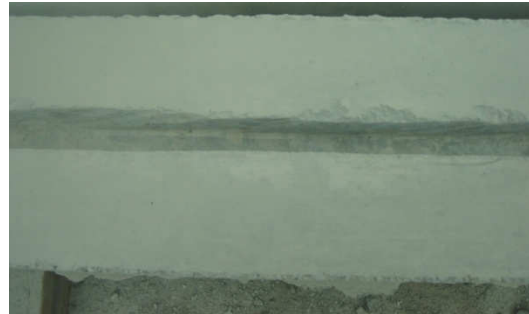
Figure 2.7: Cutting the grooves in the beams

a- Beams before cutting the groove

b-Grooves being cut in the concrete

c-Chipping concrete pieces from the groove

d-The final Groove

For this stage, the beams were turned upside down such that the tension steel was at the top. Grooves were cut along the centerline of the beam in the longitudinal direction. The tension side of the beams was centered and chalk marked with 2 lines 15mm apart. Then, using a diamond concrete saw, the 2 marked lines were cut into the concrete and the remaining pieces were chipped as shown in Figure 2.7. The grooves were 15 mm wide  $\times$  25 mm deep  $\times$  2200 mm long as recommended by ACI 440.2R-08.

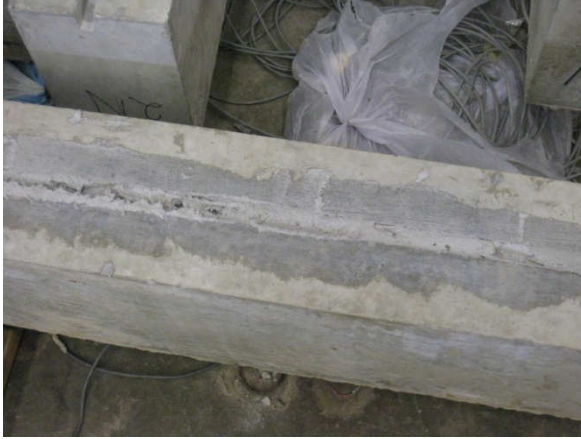
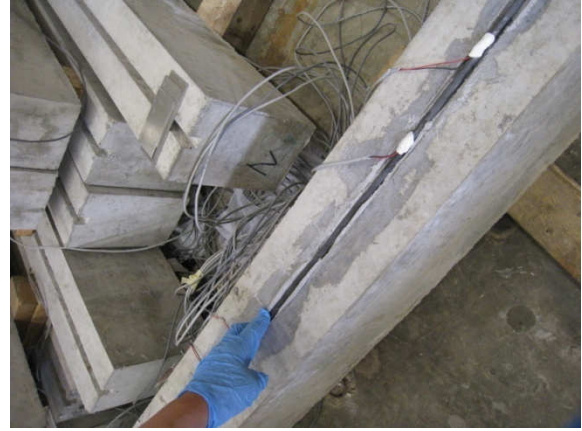
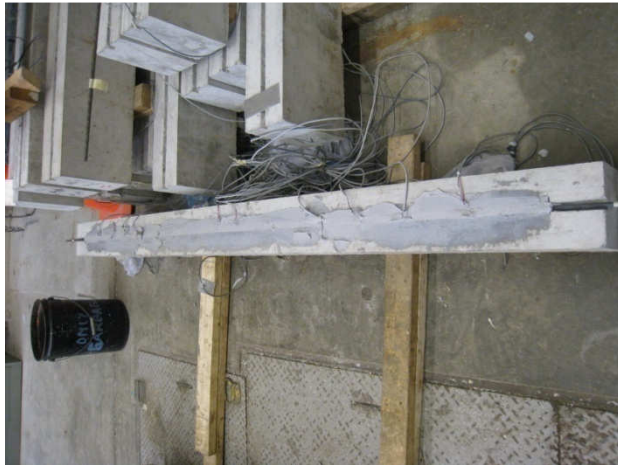
Figure 2.8: Beams strengthened with non-prestressed CFRP rods

a- Groove half filled with epoxy

b- Rod placed and pressed into the epoxy

c- Groove completely filled with epoxy

The beams strengthened with non-prestressed CFRP rods were prepared as follows. The grooves were cleaned with compressed air. Then, the grooves were half filled with epoxy, and the CFRP rod was placed in the groove and pressed into the epoxy. Then, the remainder of the groove was filled with epoxy as shown in Figure 2.8. The epoxy was left to cure for 7 days.

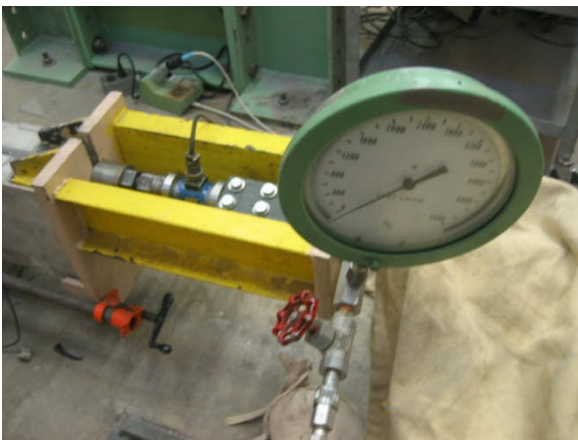
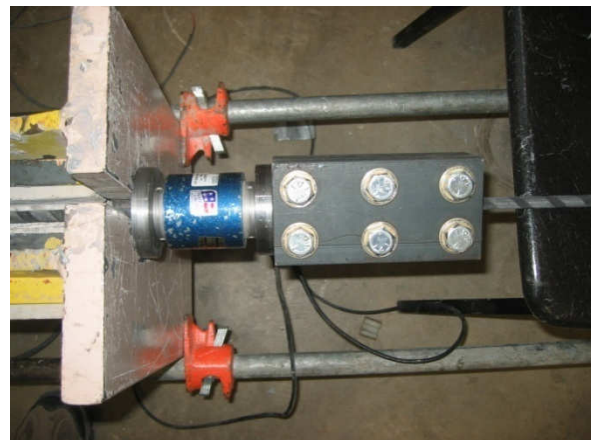
Figure 2.9: Strengthening the beam with a prestressed CFRP rod

c-Set up at live end

d-Set up at dead end

the monotonic capacity of the spirally wounded rods and to 40% of the monotonic capacity of the sand coated rods. The prestressing set up is shown in Figure 2.9. It consists of 2 prestressing chairs, 3 clamps, 2 load cells, a hydraulic jack and spacers. The clamp was used to grip the CFRP rod during the prestressing operation. The clamp consists of two steel blocks with a half circular groove along each block to form a circular hole with the same diameter as the outer diameter of the sleeve. An annealed aluminium sleeve was used to encase the rod and avoid the crushing of the fibres under high confinement pressure. The two blocks were fastened to each other by six prestressed bolts, three bolts on each side of the rod.

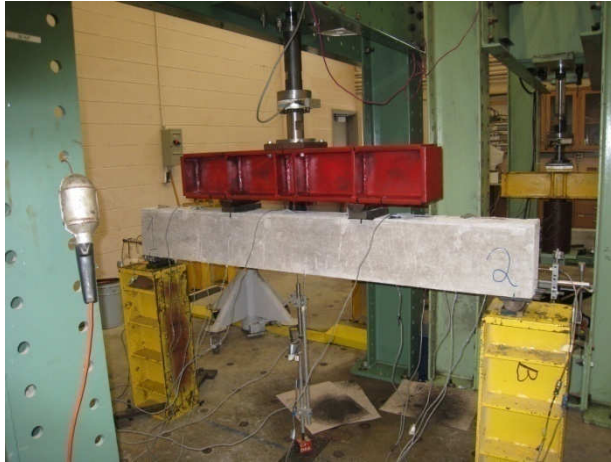
Figure 2.11: Test set up

The beams were tested in four-point bending with a shear span of 600mm using a servo-hydraulic actuator controlled by a MTS 407 controller. The test set up is shown in Figure 2.11. The beam had a hinge support at one end and a roller support at the other. The hinge support was a half cylinder resting on a curved plate. The roller support was a steel cylinder between two curved plates. Two steel plates, each 42mm wide x 112 mm long, were used at each side underneath the beam. The plates were centered in the cross section. At each end, the beam was resting on 2 plates that were resting on the support as shown in Figure 2.12. The reactions at the supports would produce compressive forces at the bottom face of the beam. When the beam rests directly on a bearing plate, these compressive forces increase the frictional force on the CFRP rod and increase the shear stress between the rod and the epoxy. Thus, the support shown in Figure 2.12 was aimed at minimizing the compressive forces transmitted from the supports to the CFRP rod.

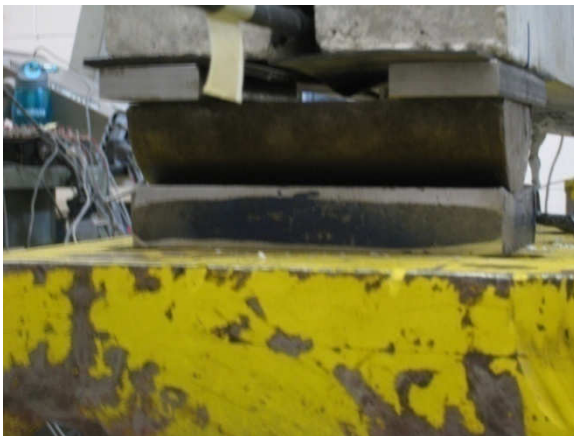
a- Hinge support

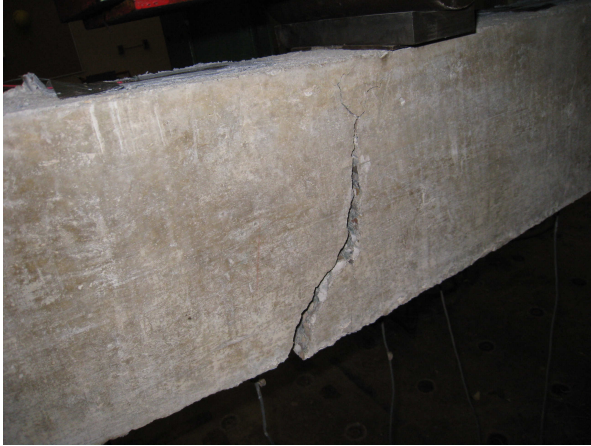
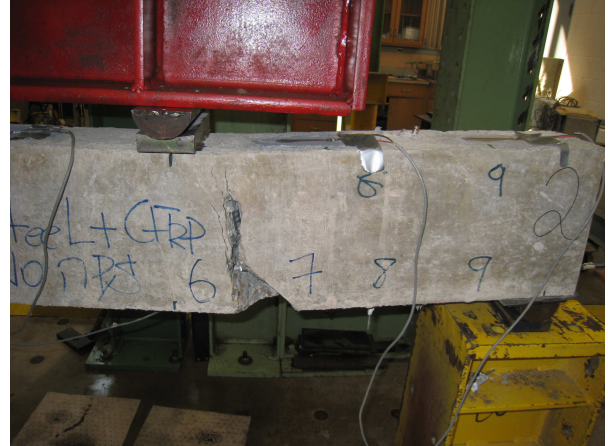
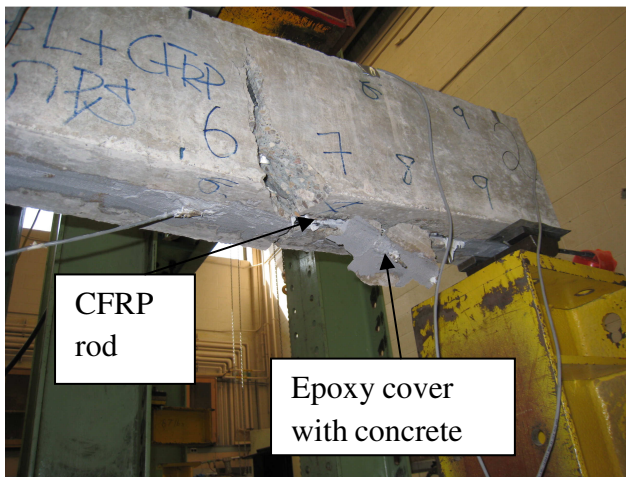
Figure 3.3: Beam after failure for beam NS-SW-0%-M

a-Crack in the shear span

b-The same crack after complete failure with chunk of concrete separated

CFRP rod

Epoxy cover with concrete

c-Bottom view of the beam after failure

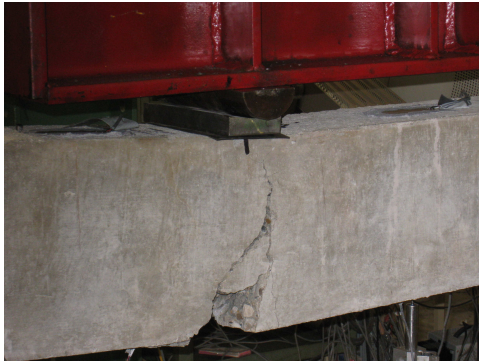
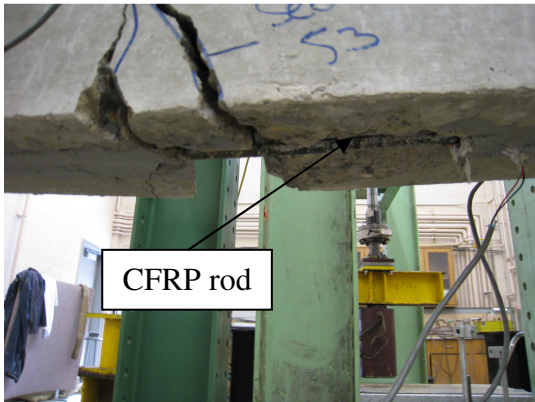
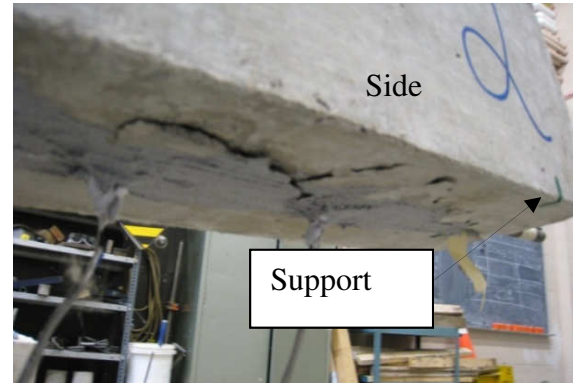
Figure 3.6: Beam NS-SC-0%-M at failure

a-Beam just after failure

b-Bottom view of the beam

c- Longitudinal cracks in the epoxy and the

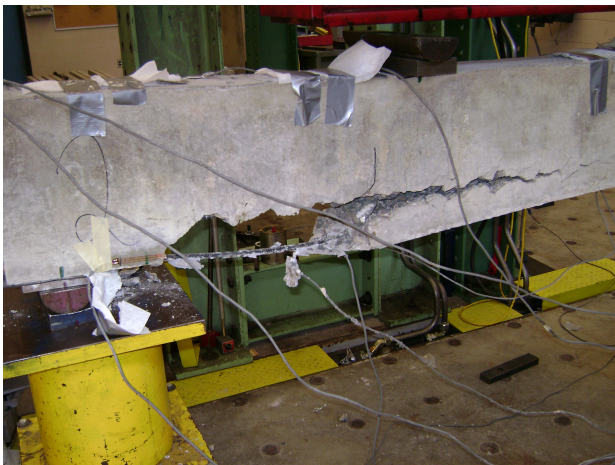
Figure 3.14: Beam S-SC-0%-M after failure

up to the loading point, the crack that propagated horizontally caused the rod to separate from the beam. The separated rod had chunks of epoxy covered with concrete adhering to it (Figure 3.14).

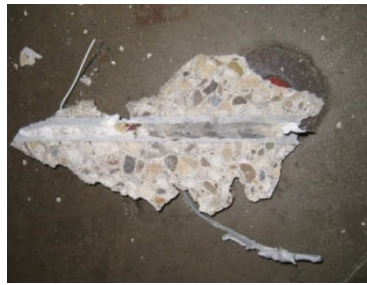
Figure 3.21: Beam after failure NS-SW-0%-44%

c-Epoxy with concrete separated from the  
bottom of the beam

As the beam was loaded monotonically in the first cycle, the first crack occurred at midspan. As the load increased, cracks occurred underneath the loading points. As the load was increased to the peak load a major (flexural-shear) crack occurred in the shear span. This major crack location ranged from 400 to 570 mm and it was deeper than other cracks. As the load was cycled, the major crack in the shear span grew deeper. It was clear that the CFRP rod at the major crack location is separated from the epoxy and that the debonding between the CFRP rod and the epoxy is spreading towards the supports as the beam was cycled further. At failure, concrete prisms separated from the sides of the beam at the major crack location and the CFRP rod separated from the surrounding epoxy. These concrete prisms were with or without epoxy attached to it. Also, the epoxy cover with concrete attached to it separated from the soffit of the beam at the major crack location as shown in Figure 3.21.

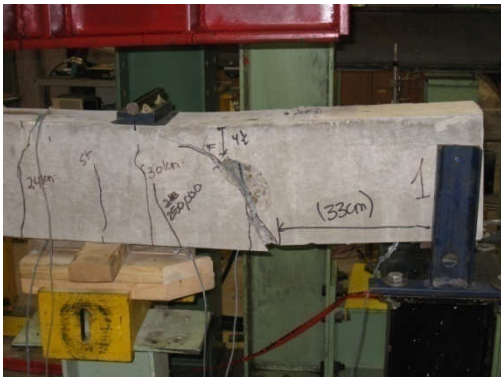
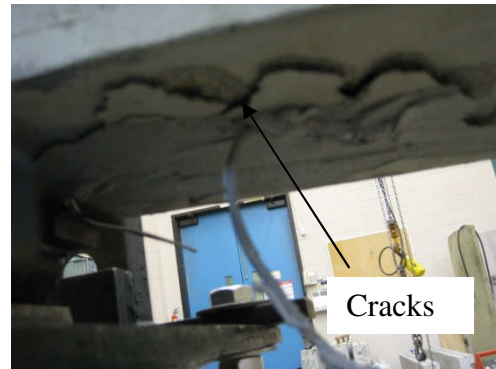
a-Major crack in shear span after failure

b-Cracks in concrete surrounding the epoxy

underneath the loading points followed by a major crack in the shear span. The major crack location ranged from 300 to 515 mm from the support. As the load was cycled, the major crack in the shear span grew deeper. At failure, the cracks occurred in the concrete surrounding the epoxy at the soffit of the beam as shown in Figure 3.24. Epoxy cover with concrete attached to it separated from either the bottom or side of the beam at the major crack location and the CFRP rod separated from the surrounding epoxy. In some cases, the epoxy cover together with concrete separated from the bottom of the beam in the shear span, starting from 50mm from the support until the location of the major crack. Also, in the cross section of the beam, at the support (free end) the epoxy around the CFRP rod was cracked as shown in Figure 3.24. It is noteworthy that the beams that failed in shear cracked in a similar way as the beams that failed in bond, yet the final failure was shear failure.

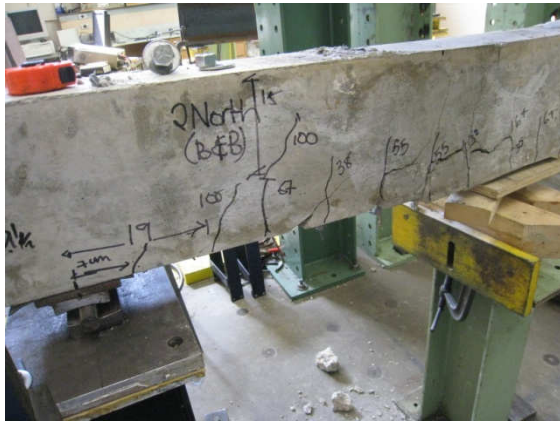
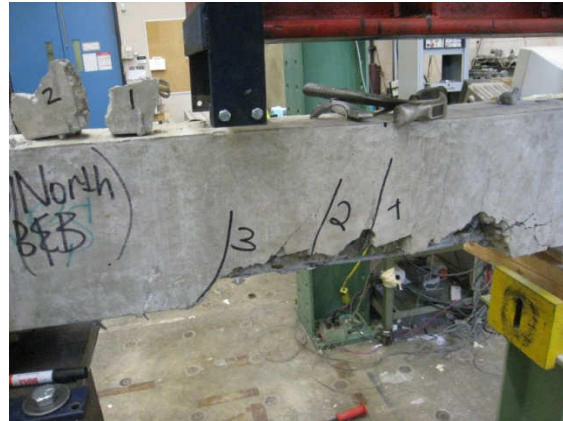
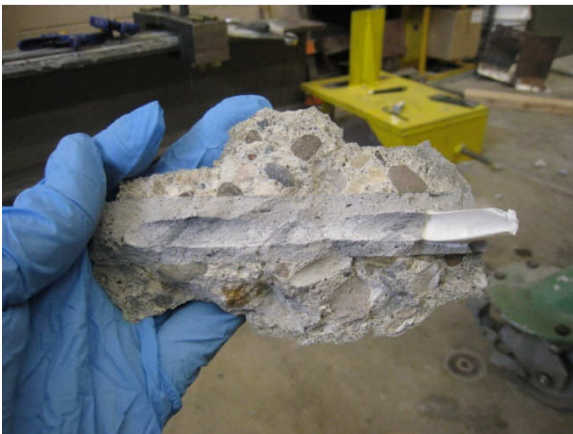
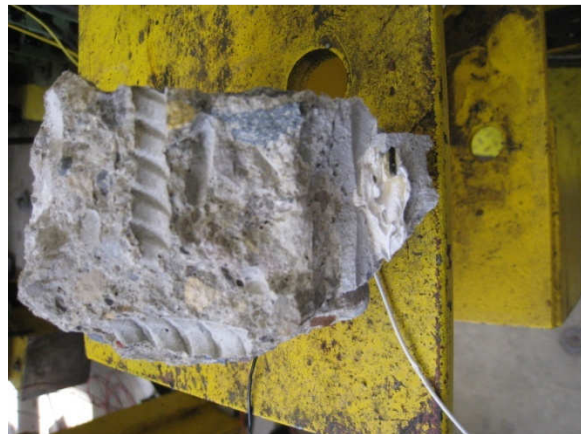
Figure 3.29: Beams after failure

a-Cracking in shear span before chunk separation

b-Beam after complete failure

c-Samples of separated blocks from the beam

In the second region; from the closest crack to the support to the loading point, the vertical cracks that formed during cycling and loading propagated horizontally and joined one another at the steel- concrete interface. Chunks of concrete and epoxy separated from the beam leaving the CFRP rod. Figure 3.28 illustrates the possible chunks that could separate from the cross section. As shown in the figure, the chunks of concrete and epoxy separate as either the bottom cover of the CFRP rod ( chunk 3) or at the steel interface ( chunk 1 or 2). Figure 3.29 shows a beam after failure.

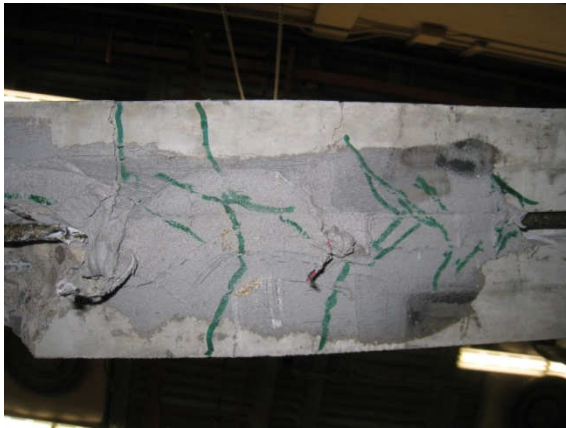
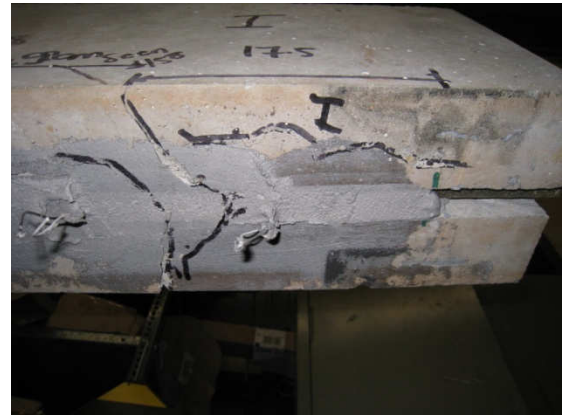
a-Cracks fanning from the CFRP rod

b-Cracks parallel to the CFRP rod

Region 2 is bounded by the closest crack to the support and the loading point. At the beginning of this zone (from the support side), the cracks that occurred at both sides of the beam connected together through cracks at the soffit of the beam. Some of the side cracks might have interconnected with one another or propagated horizontally at the steel to concrete interface. Yet, in all cases the chunks of concrete and epoxy would still be intact with the beam and the CFRP rod and if any separation happened it would be the bottom cover of the epoxy and concrete (chunk 3 in Figure 3.28). Close to the loading point, chunks of epoxy and concrete separated from the side of the beam as shown in Figure 3.33 leaving the CFRP rod and the beam.

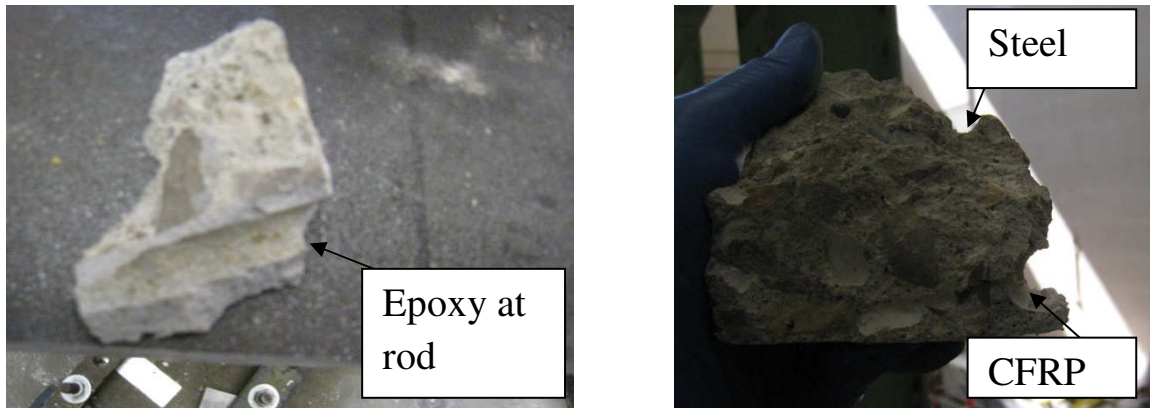
Figure 3.33: Beams after failure (zone 2)

b-Separated chunks from the CFRP rod

Past the loading point, the horizontal crack would propagate at the steel concrete interface separating the CFRP rod with the epoxy and the concrete as one unit from the rest of the beam as shown in Figure 3.33.

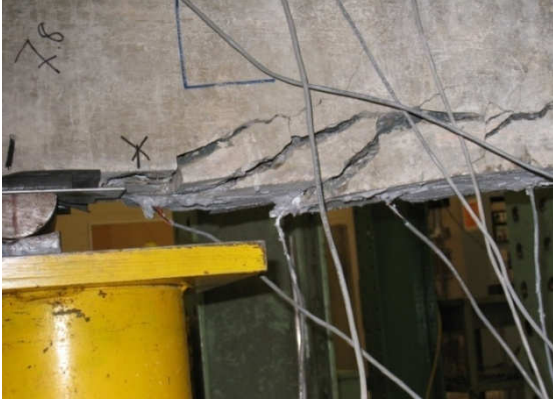
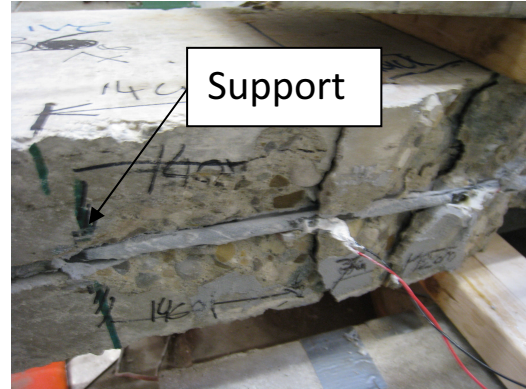
Figure 4.9: Beam S-SW-45%-M after failure

a-Beam after failure

b-Soffit of the beam after failure

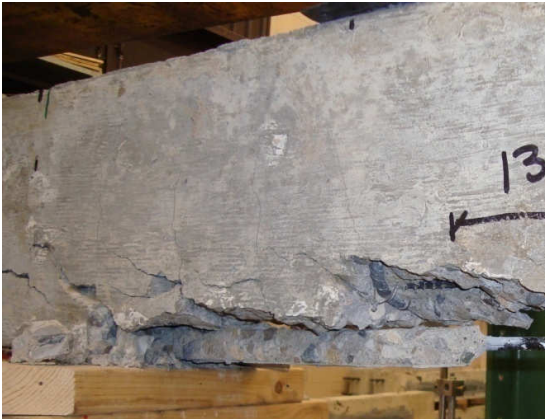
Figure 4.21: Beams after failure for Group F

d-Region 3 with concrete chunks separated from the beam

In region 2, which extends from 150mm to 500 mm from the support, cracks that occurred on both sides of the cross section after the CFRP rod slipped, connected through the bottom of the beam and connected horizontally with one another through a horizontal crack at the steel concrete interface as shown in Figure 4.21-b. At the beginning of this region (at 150mm), separated chunks of concrete remain intact with the rod and the beam. In the middle and end of this region, chunks of concrete separated from the beam and the rod as shown in Figure 4.21-c. In region 3, which extends from 500 mm from the support to midspan, chunks of concrete separated from the

beam at the steel interface and from the rod at the epoxy interface as shown in Figure 4.21-d. At the same time, the CFRP rod together with epoxy separated from the beam. The separated concrete and epoxy chunks had various forms as shown schematically in Figure 4.22.

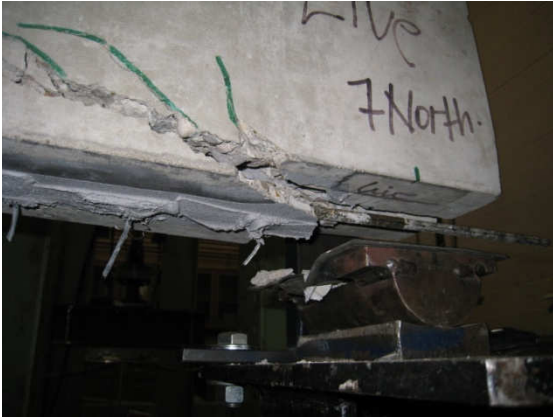
Figure 4.26: Beams after failure

a-Bottom view showing the CFRP separation from the beam in region 1

In region 1, epoxy cover together with concrete separated from the soffit of the beam and the CFRP rod separated from the beam as shown in Figure 4.26-a. Horizontal cracking propagated from the support to the midspan (Figure 4.26-b). In region 2, the CFRP rod together with chunks of concrete and epoxy separated from the beam as shown in Figure 4.26.
