# CFRP Strengthening of RC Beams with Corroded Lap Spliced Steel bars

A thesis  
presented to the University of Waterloo  
in fulfillment of the  
thesis requirement for the degree of  
Master of Applied Science  
in  
Civil Engineering

Waterloo, Ontario, Canada, 2011

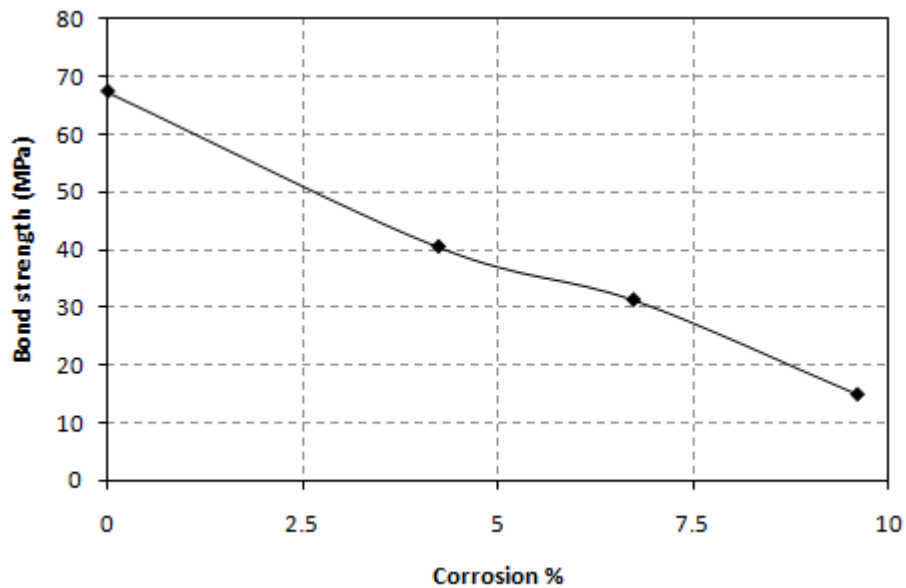
Figure 2-14 Bond strength vs. Degree of corrosion % (Craig and Soudki (2002))

As the level of the corrosion increased the bond strength of the steel reinforcement decreased. The bond strength reduced by 40%, 53%, and 77% for (5.0%, 10%, and 15% corrosion level), respectively in comparison to specimen with 0% corrosion.

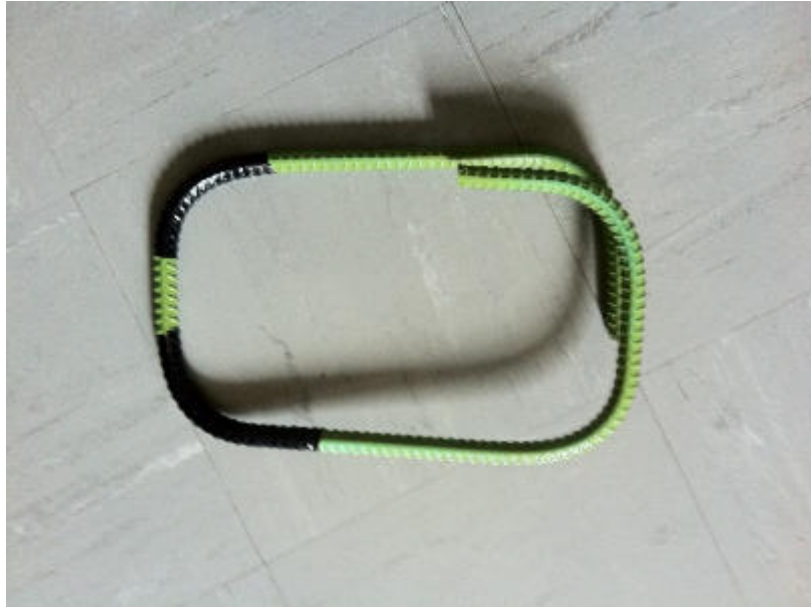
Figure 3-6 Epoxy coated stirrups with electrical tape at the corner

and the stirrups. Figure 3.6 shows the epoxy coated stirrups isolated and coated with electric tape at the corner. The reinforcement steel cages were placed inside the form work as shown in Figure 3.7.

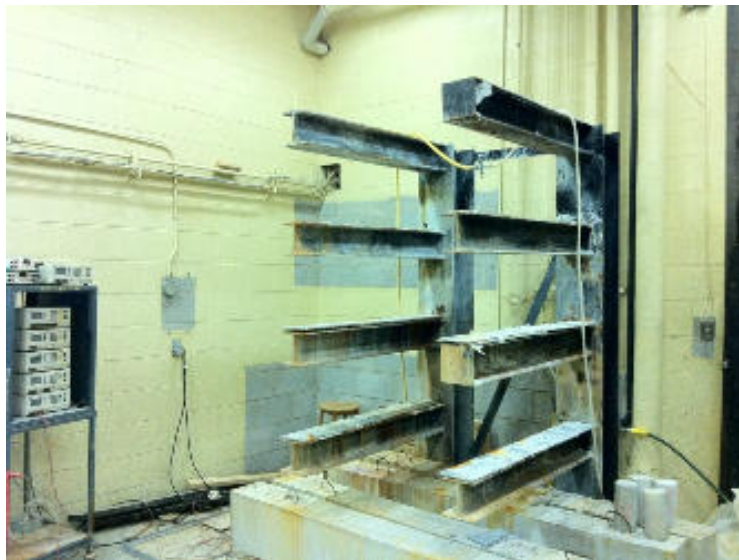
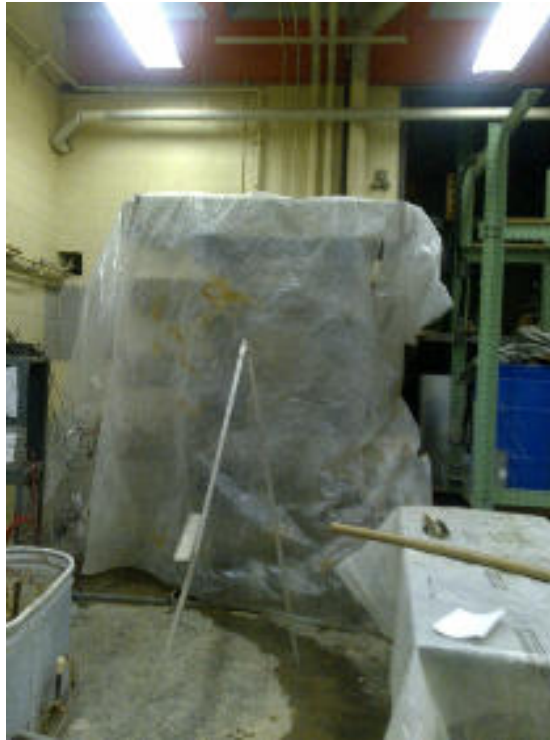
Figure 3-9 Corrosion chamber

An accelerated corrosion technique was adopted to corrode the reinforcing lap-splice in a reasonable time frame. The corroded beams were placed on steel racks inside the corrosion chamber. A 3 mm of polyvinyl chloride (PVC) plates was placed underneath each beam to isolate the beam from the steel racks and to prevent any current leakage to the ground. A galvanostatic technique was used by impressing an electric current through the main reinforcement. In this system, the current remains constant and the voltage changes depending on the resistance of the beams. The mass loss was predicted based on Faraday's law. Figure 3.9 shows an overview of the corrosion chamber and the power supplies used in the corrosion process

a) Corrosion chamber-racks

b) Corrosion chamber with beams

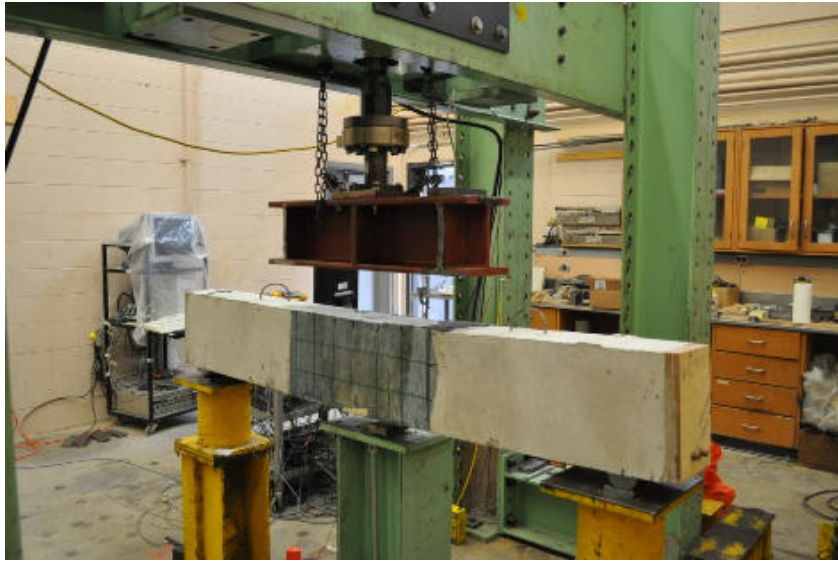
Figure 3-13 CFRP repair scheme

The viability of CFRP repair for corroded lap-spliced concrete beams is investigated in this study. The CFRP repair scheme was kept the same for all the repaired beams. It consisted of a 605 mm wide continuous U-wrap placed around the cross section along the constant moment region. Figure 3.12 and 3.13 shows the CFRP repair scheme. This U-wrap will confine the dilation due to bond/splitting stress and increase the bond strength between the reinforcement steel and concrete.

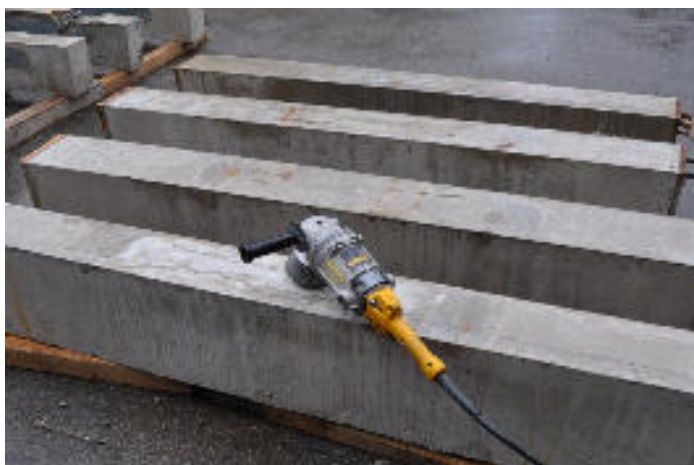
Figure 3-14 The specimen surface before and after cleaning

Prior to application of the CFRP laminate, a grinder was used to clean the concrete surface from corrosion staining and other foreign particles. The grinder was also used to expose the aggregates to get a sufficiently rough surface to ensure that there will be good bond between the CFRP laminate and the concrete substrate. The corners of the beam's cross section were rounded as per ACI 440.2R-08 to avoid localized stress concentration in the CFRP laminates. Figure 3.14 shows the specimen surface before and after surface preparation.

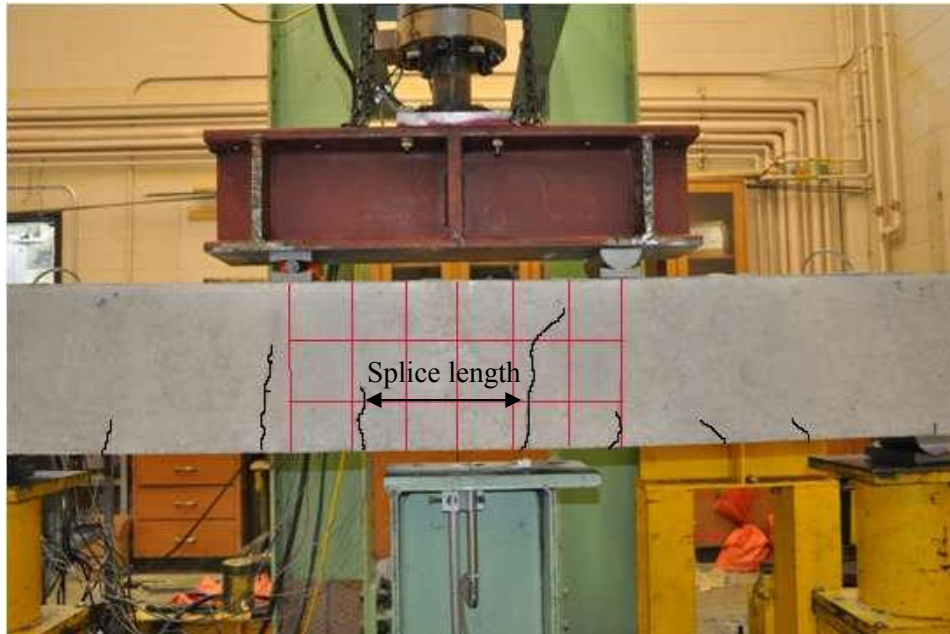
Figure 4-5 The failure mode for the control beam (0% corrosion)

The first cracks that appeared during load testing were flexural cracks and were located randomly within the constant moment region. As the loading continued, shear, flexural, and splitting cracks developed. Shear cracks were observed only in the shear spans between the loading point and the support. At higher load levels, the crack pattern became complicated around internal discontinuities. Flexural cracks were observed at mid span and at one or both ends of the lap-splice region. Additional flexural and shear cracks formed and the initial cracks at the end of the splice region extended to the compression zone. Splitting cracks were initially observed at the end of splice region on the tension face of the specimen. These splitting cracks originated from flexural cracks and propagated along the spliced bars as loading continued. As the load increased, the crack at the end of the lap-splice propagated to the compression zone and the width of the splitting crack increased until failure. The failure mode of the beams was by splitting of the concrete cover from the side and soffit of the beam in the tension zone. Figures 4.5a and 4.5b show an elevation and bottom view of the control beam (0% corrosion level) at failure. Figures 4.6a and 4.6b show an elevation and bottom view of the corroded beam (2.5% corrosion level) at failure. Figures 4.7a and 4.7b show an elevation and bottom view of the corroded beam (5.0% corrosion level) at failure.

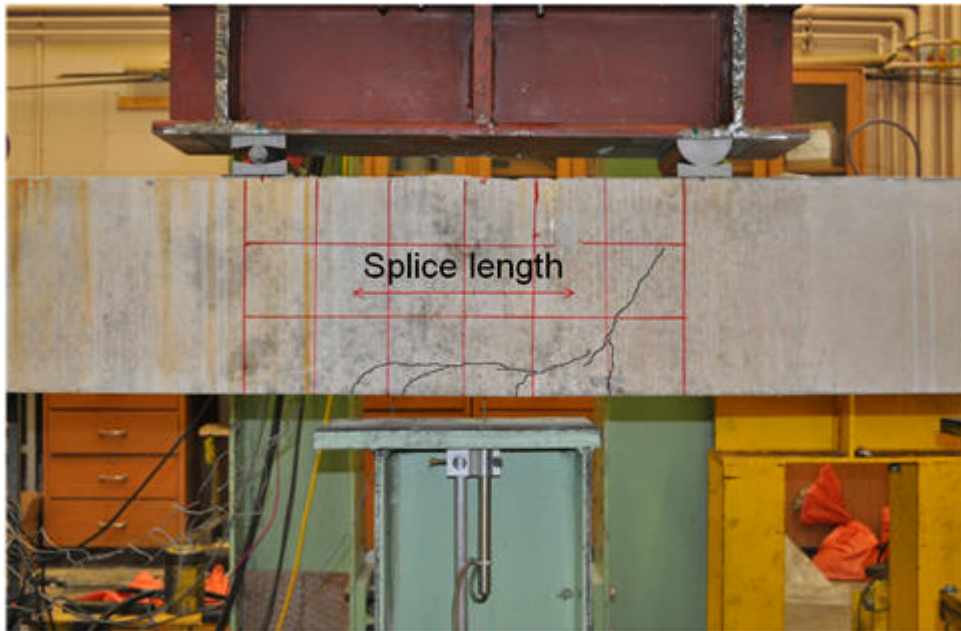
Figure 4-6 The failure mode for the corroded beam (2.5% corrosion)

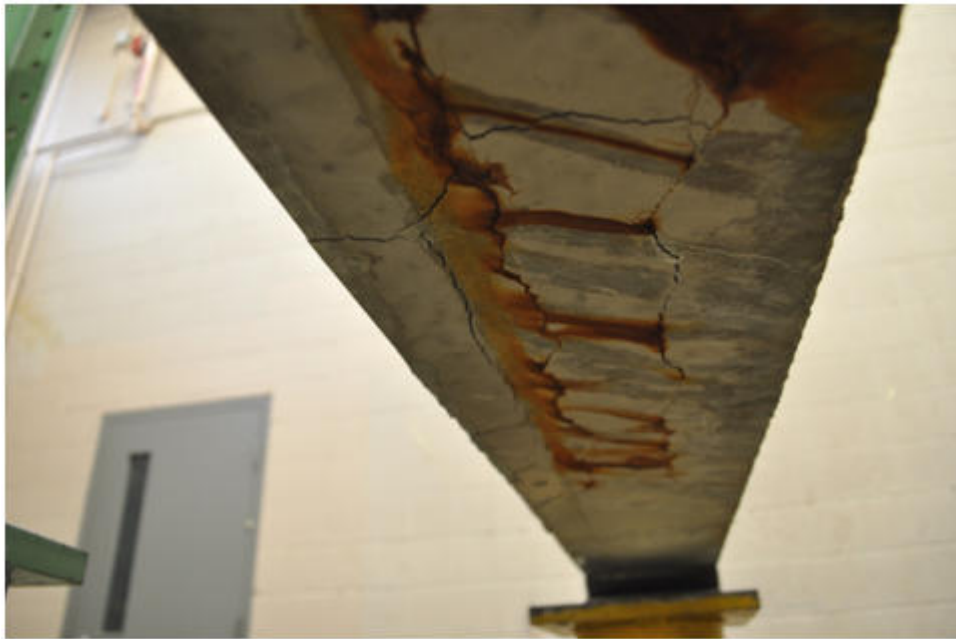
Figure 4-7 The failure mode for the corroded beam (5.0% corrosion)

b) Bottom view

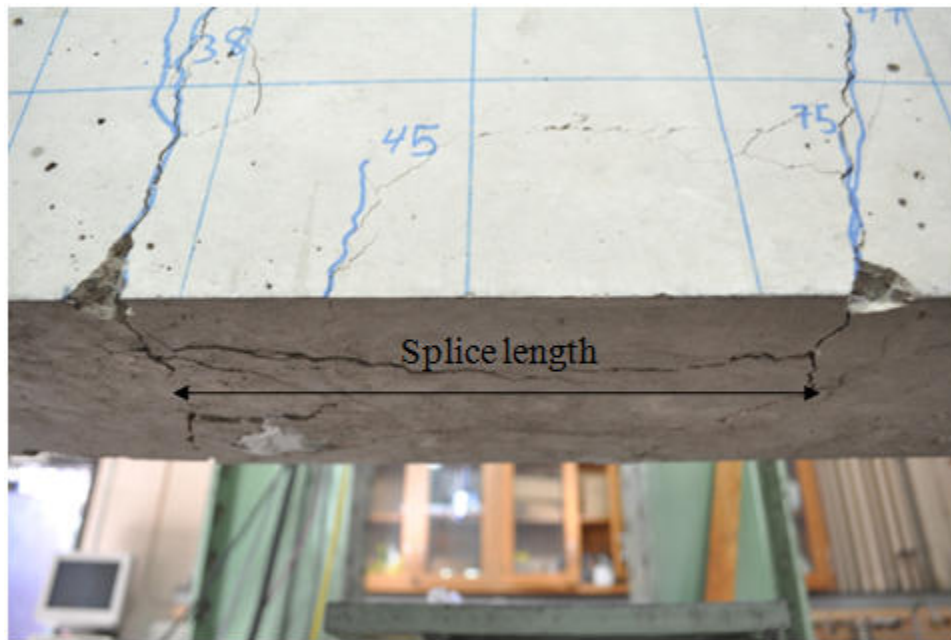
Figure 4-11 The splitting crack of the control beam (0%) at failure

The cracking behavior of the beams with  $c/d = 2.0$  was similar to that of beams with  $c/d = 1.5$ . The first cracks that appeared during load testing were flexural cracks within the constant moment region. Shear, flexural, and splitting cracks developed as the loading was increased. Shear cracks were observed in the shear spans between the loading point and the supports. The crack pattern became complicated around internal discontinuities. Flexural cracks were observed at mid span and at one or both ends of the lap-splice region. Additional flexural and shear cracks formed and the initial cracks at the end of the splice region extended to the compression zone as loading continued. Splitting cracks were initially observed at the end of splice region on the tension face of the specimen. These splitting cracks originated from flexural cracks and propagated along the spliced bars. As the load increased, the crack at the end of the lap-splice propagated to the compression zone and the width of the splitting crack increased until failure. The failure mode of beams was by splitting of the concrete cover from the side and soffit of the beam in the tension zone. Figures 4.11a and 4.11b show an elevation and bottom view of the control beam (0% corrosion level) at failure. Figures 4.12a and 4.12b show an elevation and bottom view of the corroded beam (2.5% corrosion level) at failure. Figures 4.13a and 4.13b show an elevation and bottom view of the corroded beam (5.0% corrosion level) at failure.

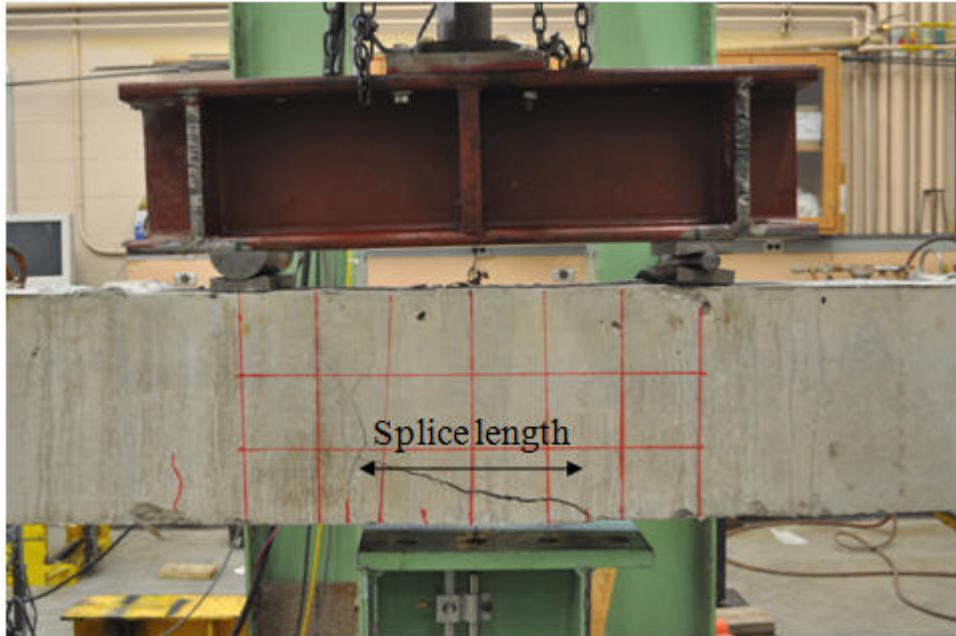
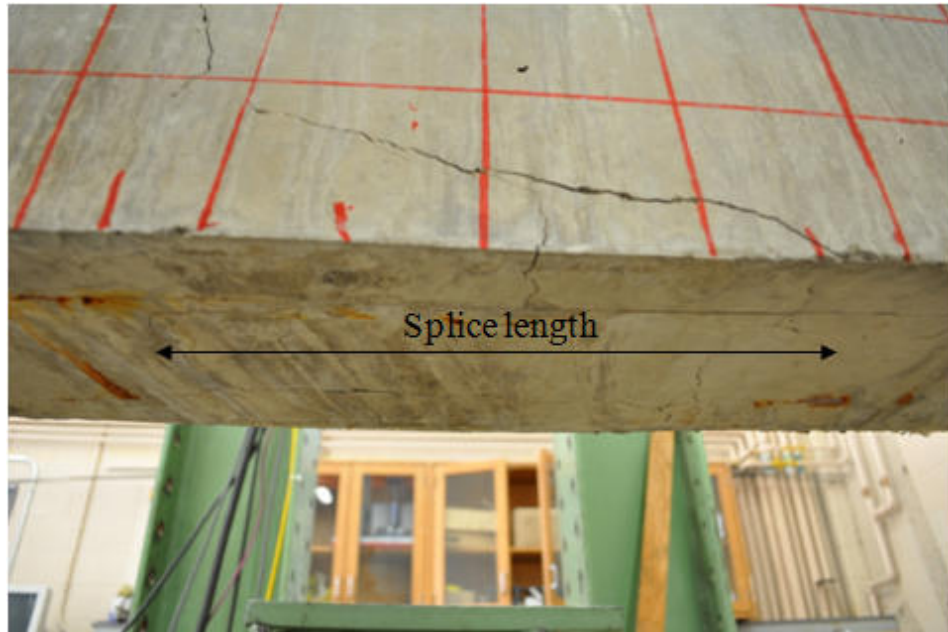
Figure 4-12 The splitting crack of the corroded beam (2.5%) at failure

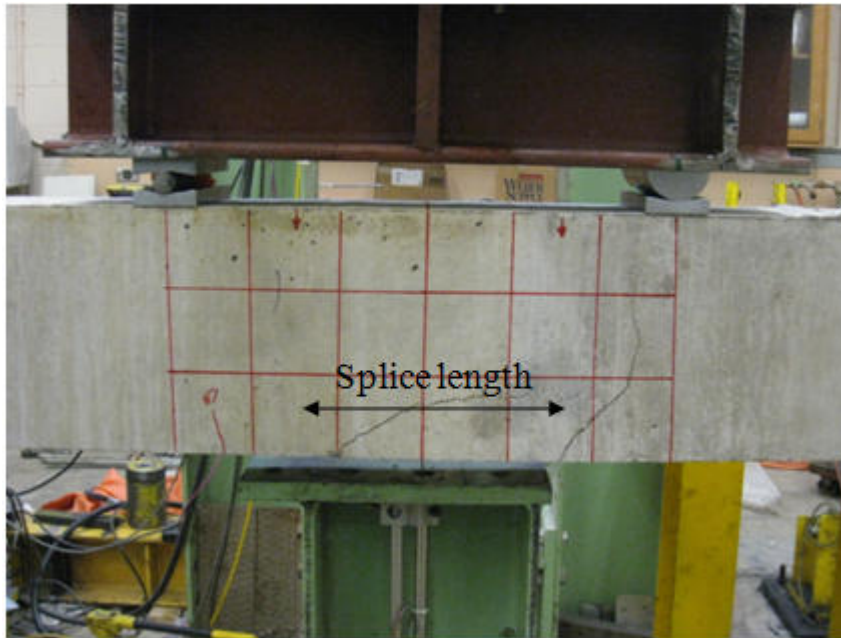
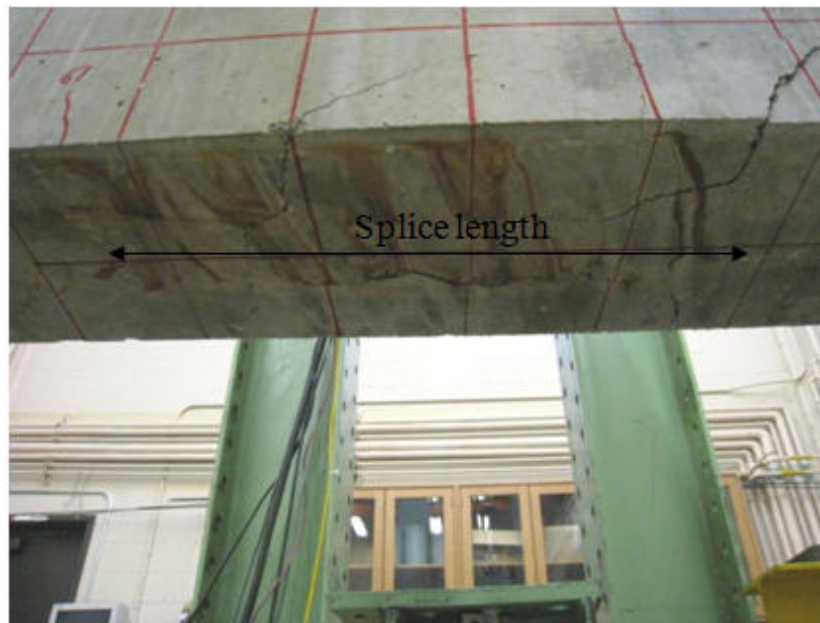
Figure 4-16 The splitting crack of the corroded beam (2.5%) at failure

The cracking behavior of the beams with  $c/d = 2.67$  was similar to that of beams with  $c/d = 1.5$  and  $2.0$ . The first cracks that appeared during load testing were flexural cracks within the constant moment region. As the loading continued, shear, flexural, and splitting cracks developed. Shear cracks were observed only in the shear spans between the loading point and the support. The crack pattern became complicated around internal discontinuities. Flexural cracks were observed at mid span and at one or both ends of the lap-splice region. Additional flexural and shear cracks formed and the initial cracks at the end of the splice region extended to the compression zone as loading continued. Splitting cracks were initially observed at the end of splice region on the tension face of the specimen. These splitting cracks originated from flexural cracks and propagated along the spliced bar. As the load increased, the crack at the end of the lap-splice propagated to the compression zone and the width of the splitting crack increased until failure. The failure mode of beams was by was splitting of the concrete cover from the side and soffit of the beam in the tension zone. Figures 4.15a and 4.15b show an elevation and bottom view of the control beam (0% corrosion level) at failure. Figures 4.16a and 4.16b show an elevation and bottom view of the corroded beam (2.5% corrosion level) at failure. Figures 4.17a and 4.17b show an elevation and bottom view of the corroded beam (5.0% corrosion level) at failure.

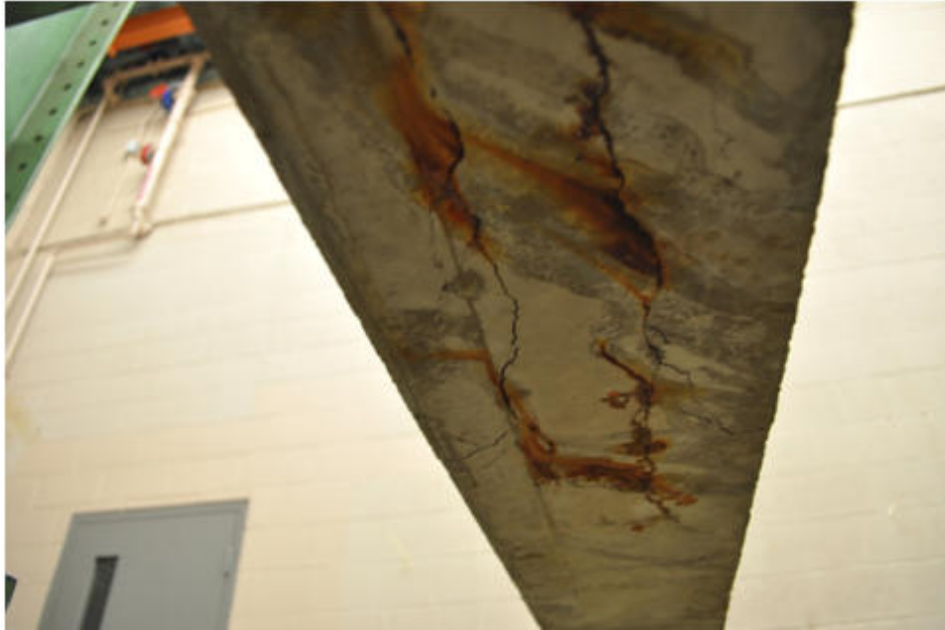
Figure 4-17 The splitting crack of the corroded beam (5.0%) at failure

b) Bottom view

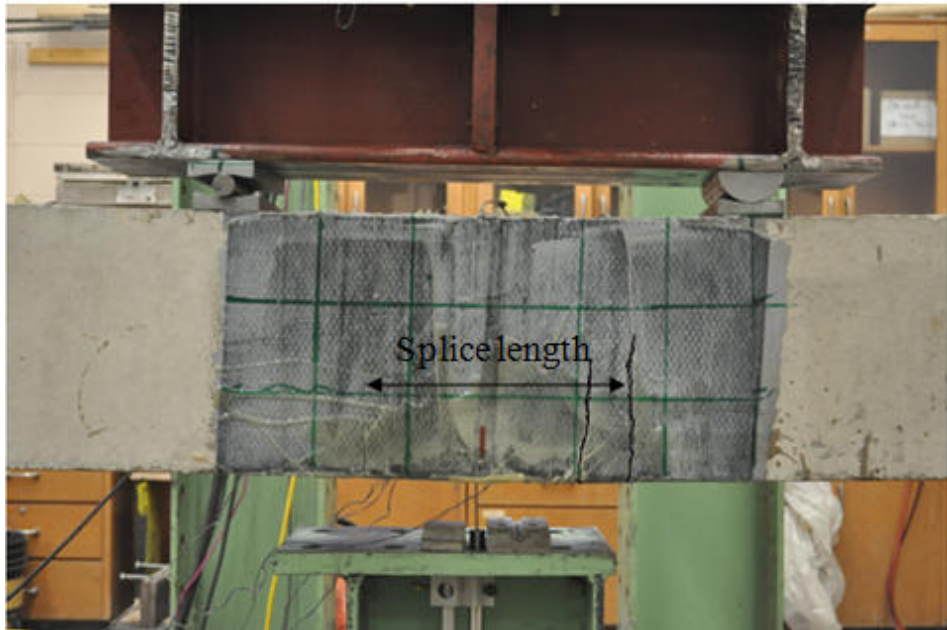
The first cracks that appeared during testing were the flexural cracks located within the constant moment region. With further loading, shear, flexural, and splitting crack developed. Shear cracks were observed only in the shear spans between the loading point and the support. Flexural cracks were observed in the mid span and at one or both ends of the lap-splice region. As loading continued, some additional flexural and shear cracks formed and the initial cracks at the end of the splice region extended to the compression zone. The crack width at the end of the lap splice increased and propagated towards the compression zone until failure occurred. There were no horizontal cracks along the lap spliced region. Figures 4.21a and 4.21b show an elevation view of the control beam (0% corrosion level) at failure. Figures 4.22a and 4.22b show an elevation view of the corroded beam (2.5% corrosion level) at failure. Figures 4.23a and 4.23b show an elevation view of the corroded beam (5.0% corrosion level) at failure.

a) Elevation view

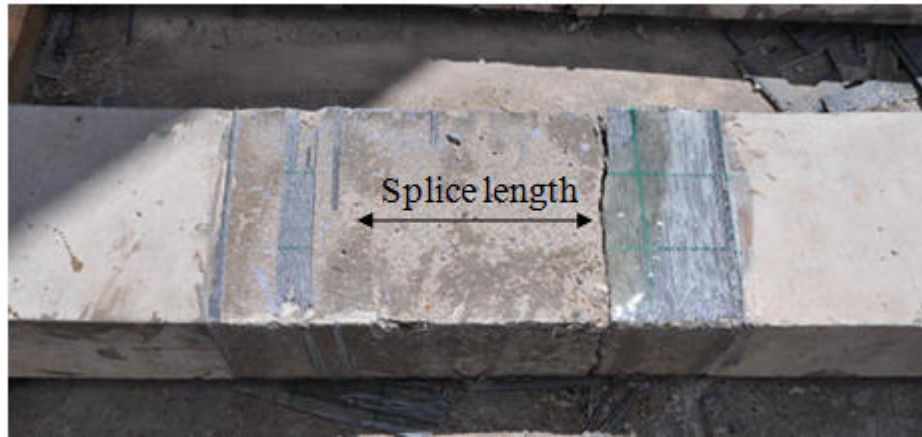
Figure 4-29 The failure mode for the corroded repaired beam (5.0%)

b) Elevation view after removing the CFRP wrap

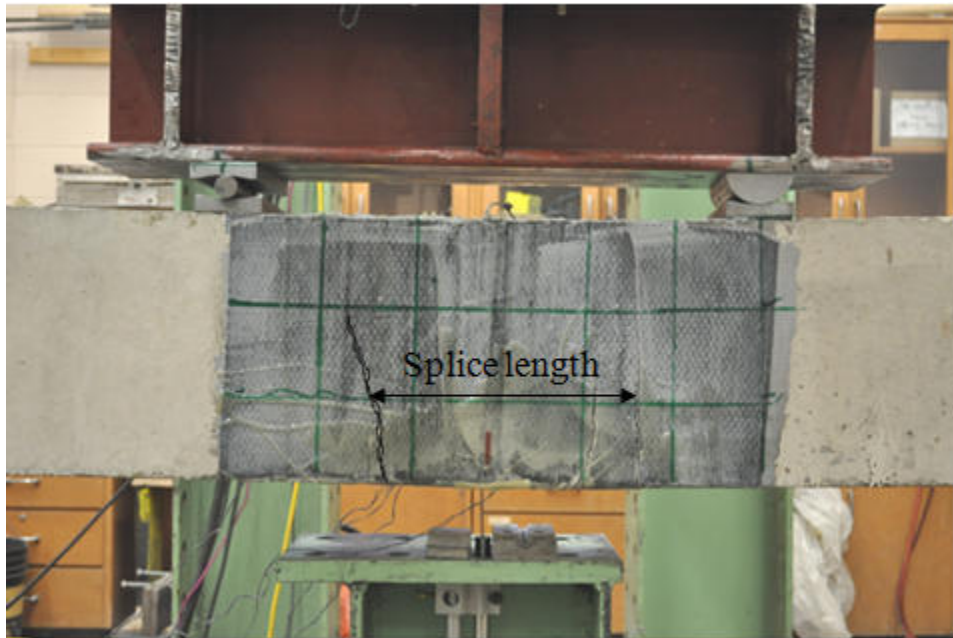
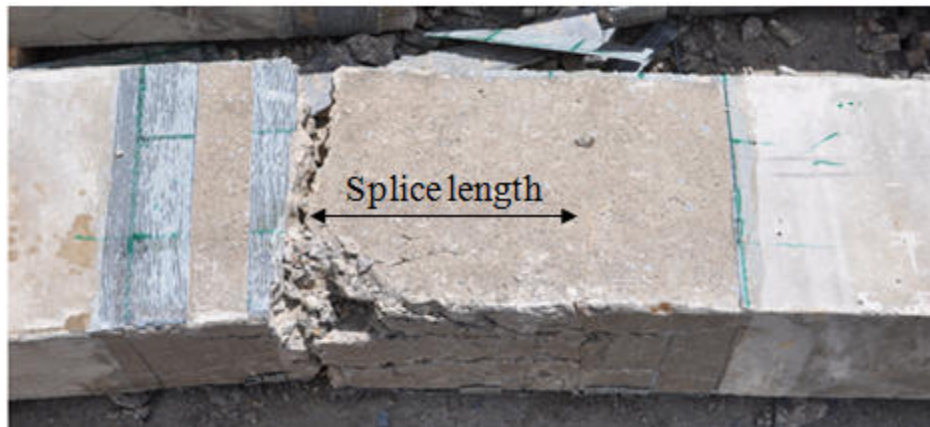
Figure 4-33 The failure mode for the corroded repaired beam (5.0%)

a) Elevation view

b) Elevation view after removing the CFRP wrap
