# **Effects of Curing Agents and Drilling Methods on CAF Formation in Halogen-Free Laminates**

A thesis  
presented to the University of Waterloo  
in fulfillment of the  
thesis requirement for the degree of  
Master of Applied Science  
in  
Mechanical Engineering

Waterloo, Ontario, Canada, 2011

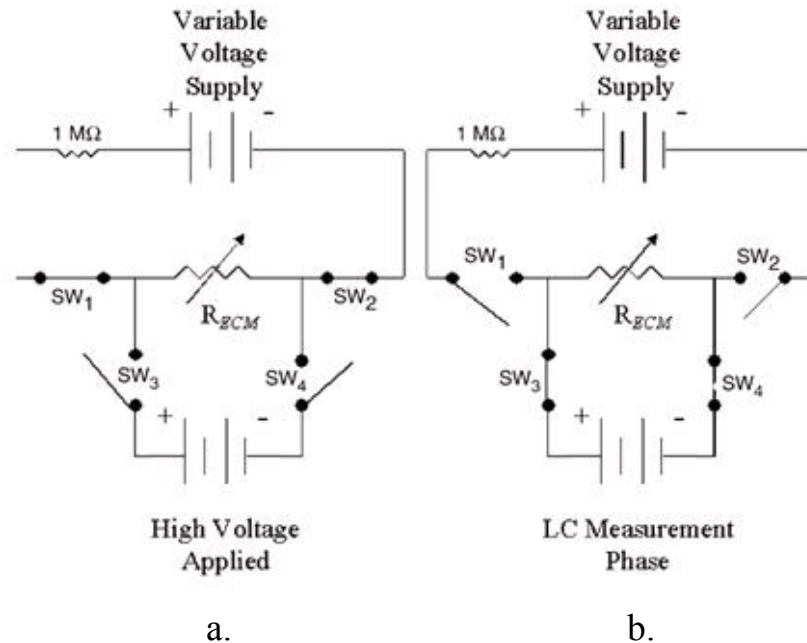
Using this technique, Ready and Turbini *et al.* were able to detect CAF electrically and identify CAF dissolution phenomenon that was believed to be responsible for the increased in resistance during the measurement phase (low power supply) when the high power supply was temporarily disconnected. [47]

Figure 2-8: Switching system for the LC. (a). At high bias supply state, (b). At low voltage measurement stage [47]

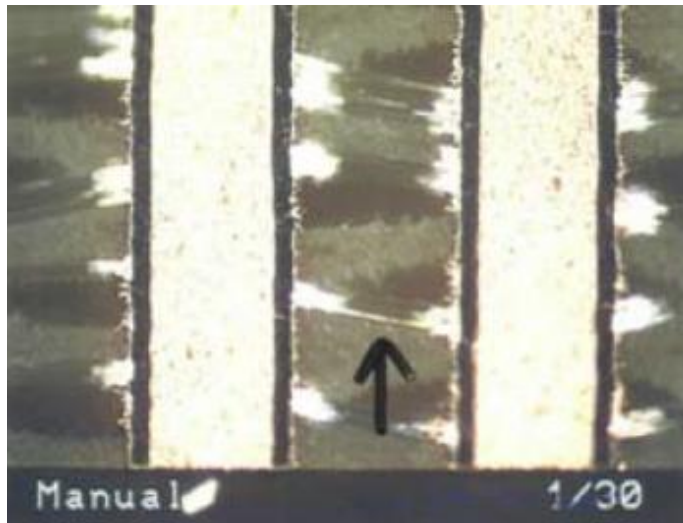
The researchers concluded that mechanical drilling exerted more stress on the epoxy/glass fibers compared to laser drilling; therefore, making it easier for CAF formation. [29] For example, copper wicking could occur during the copper plating process after mechanical drilling as shown in Figure 2-10. Once wicking occurs, copper will migrate along glass fibers during copper deposition, and hence, creates a shorter distance between anode and cathode. [11] In order to reduce CAF formation, drilled holes should be smooth and straight, and there should not be any glass fibers protruding from the hole. [63]

**Figure 2-10: Copper wicking due to mechanical drilling [27 and 29]**

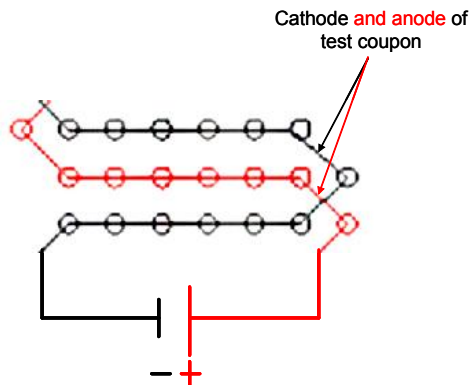
The anode of the test coupon was connected to the positive side of the power supply; the cathode of the test coupon was connected to the negative side of the power supply as shown in Figure 3-3.

**Figure 3-3: Electrical layout of SLDM**

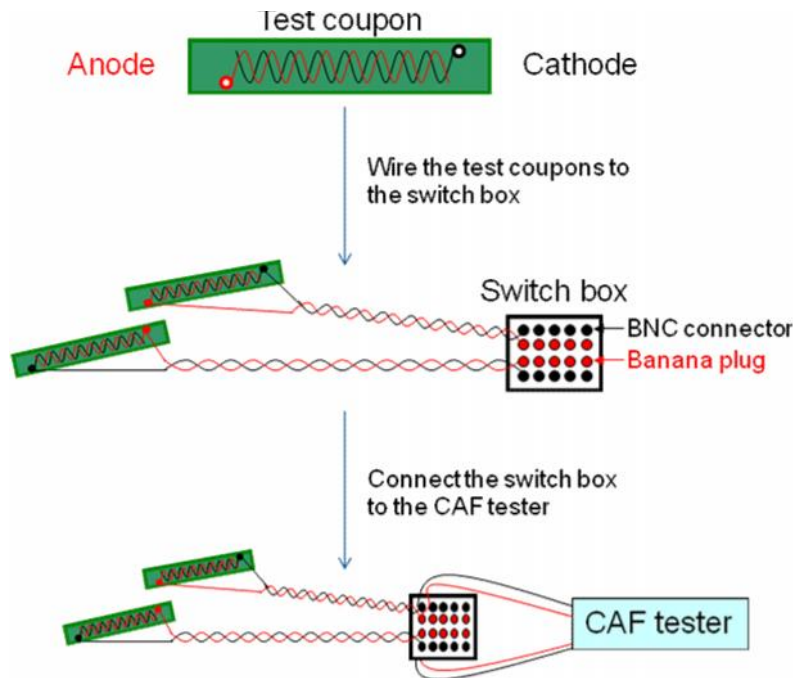
One twisted wire (colored red) was electrically connecting the anode of the test coupon to the banana plug (positive charge) of the switch. Another twisted wire (colored black) was connecting the cathode of the test coupon to the BNC connector (negative charge) of the same switch. The banana plug was the positive electrode of the power supply, and the BNC connector was the negative charge of the power supply as explained in Section 3.1. The twisted wires used for connections were single-strand ALPHA WIRE (22 AWG SOLID). Moreover, each switch box was wired with a 1 mega-ohm resistor to limit the maximum current of the circuit.

**Figure 3-9: Simplified sample preparation procedures.**

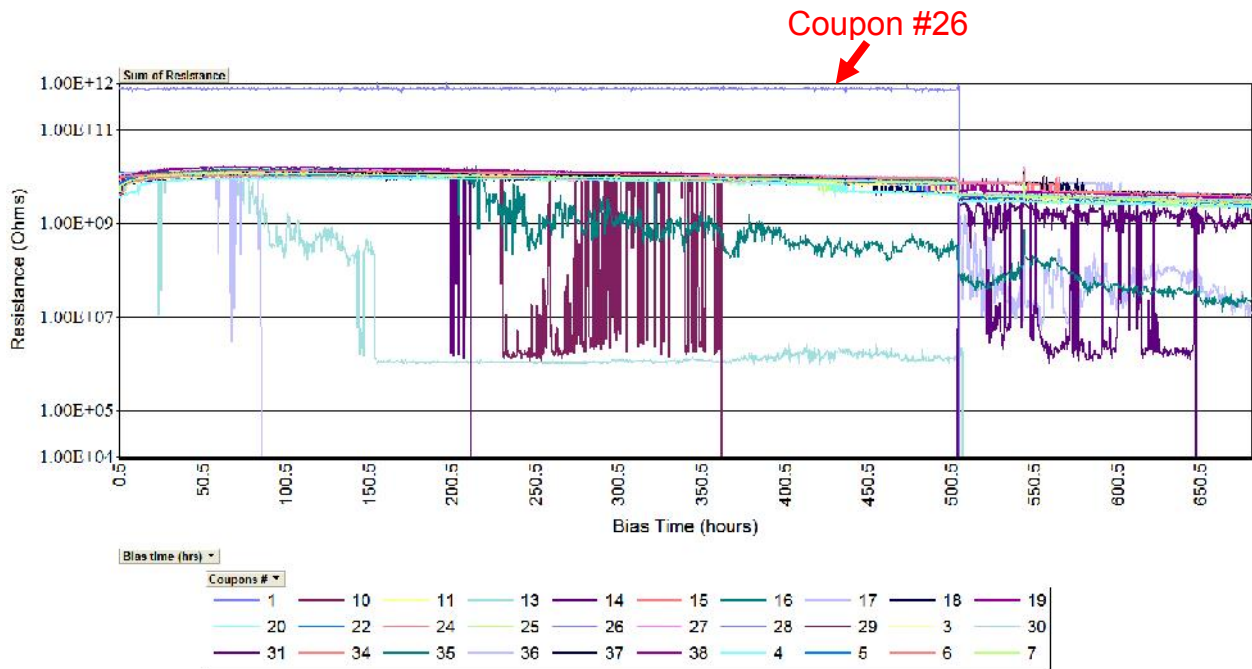
Figure 4-1: Resistance readings for the thirty DICY-cured test coupons with SLDM.

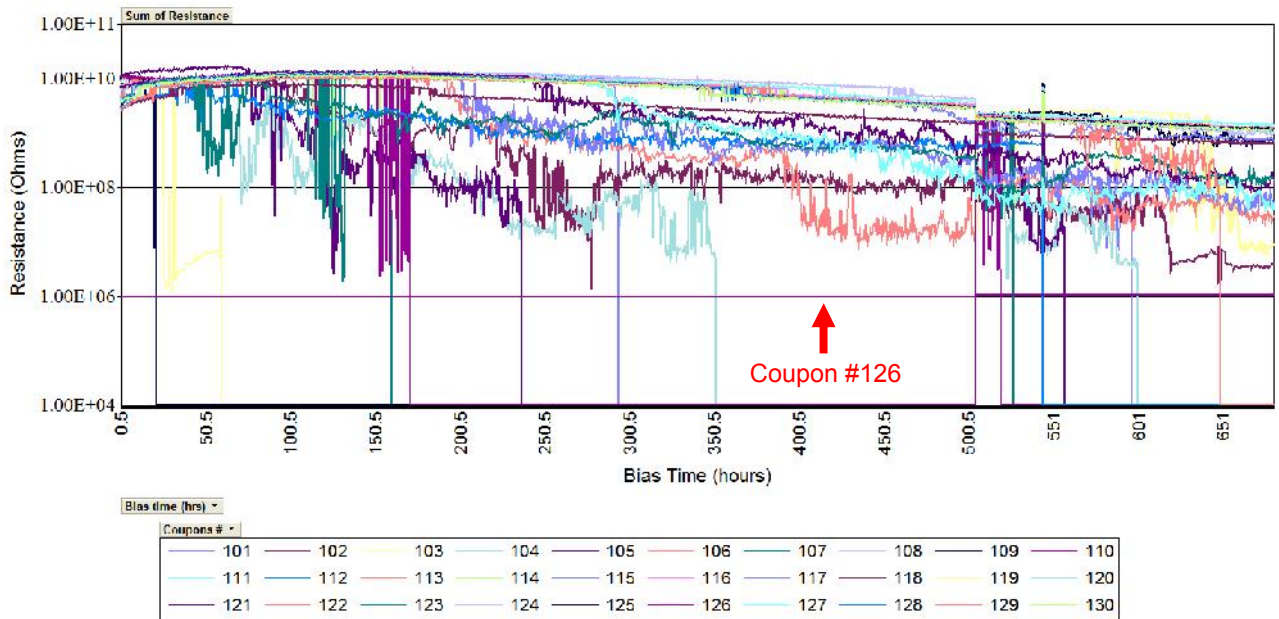
Figure 4-2: Resistance readings for the thirty phenolic-cured test coupons with SLDM

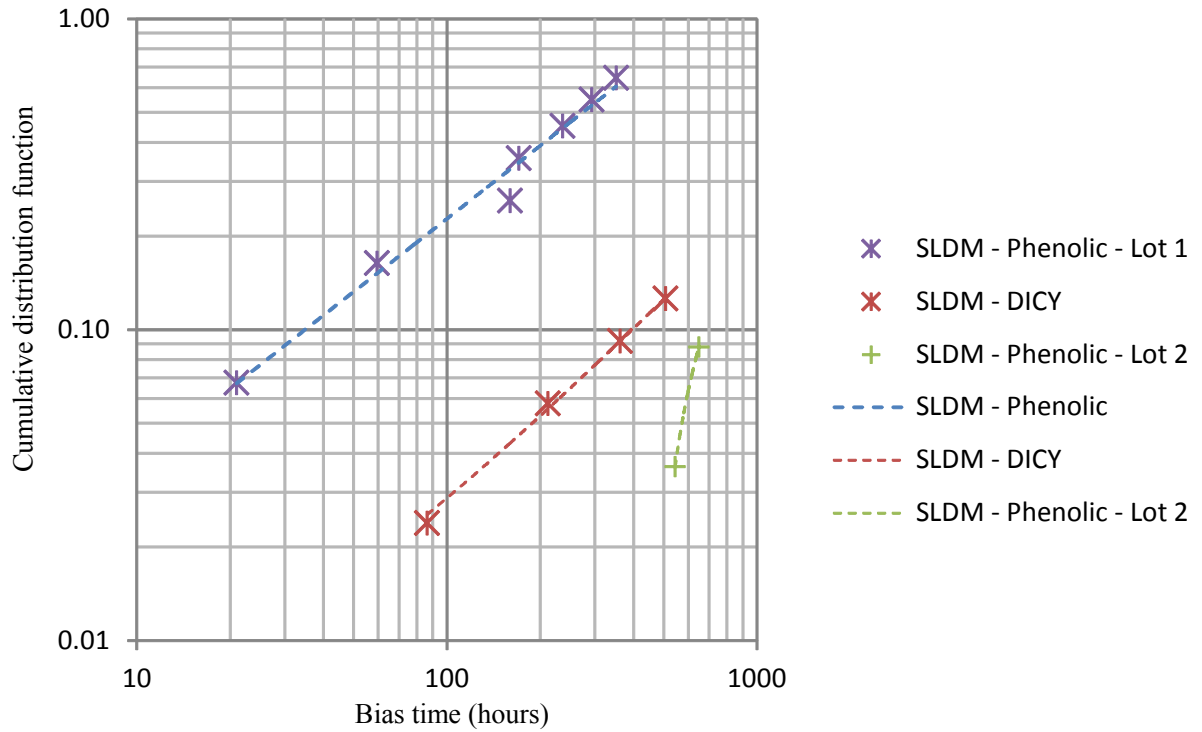
**Figure 4-7: Weibull plot for DICY-cured (red) vs. phenolic cured (blue and green) test coupons with SLDM**

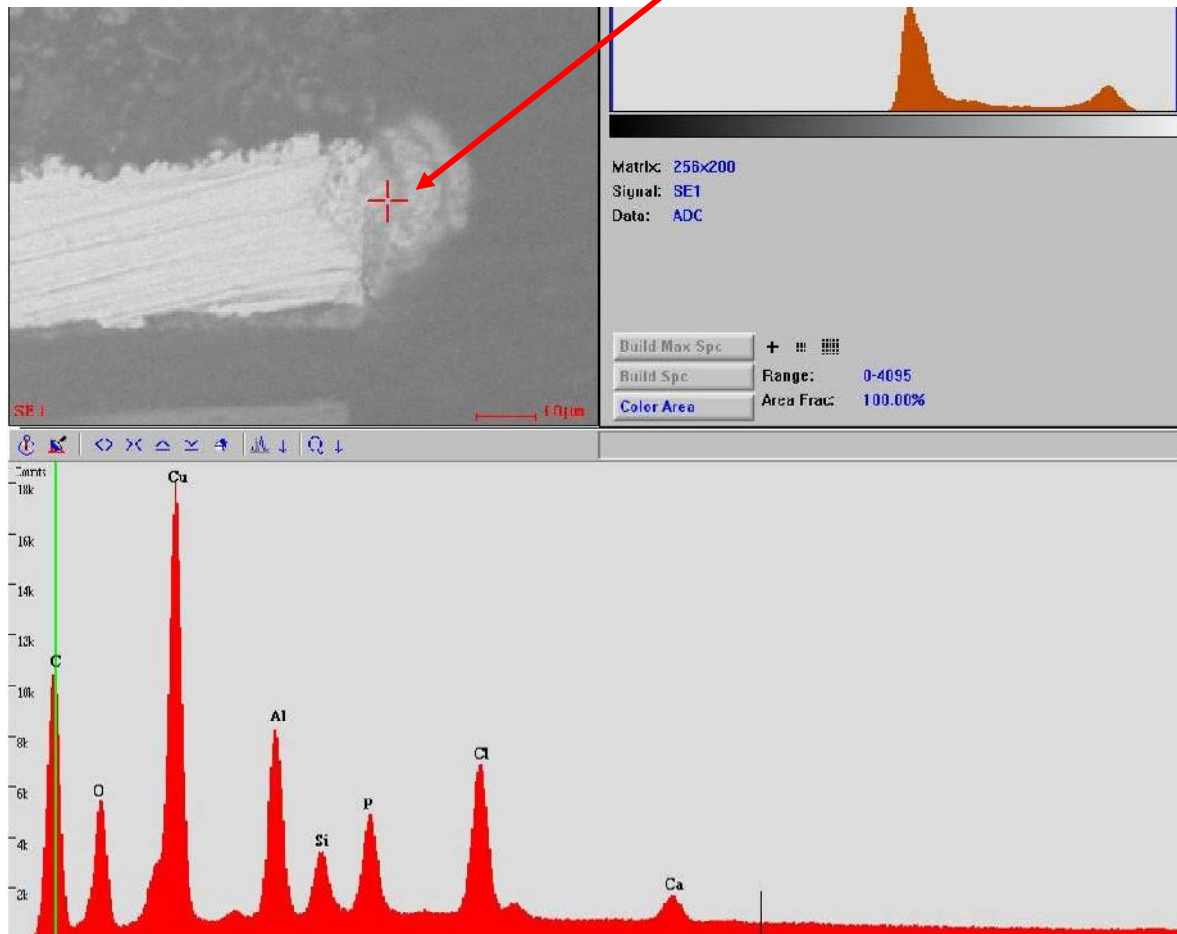
Figure 4-24: SEM-EDX image of test coupon: B24 (open circuit) at t = 607.5 hrs

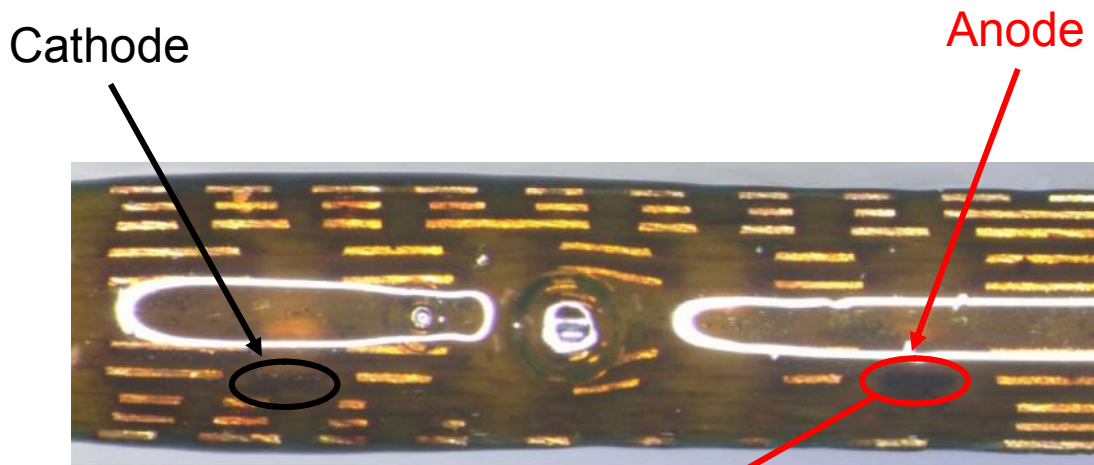
Figure 4-29: Optical image of test coupon B118 (open circuit) at  $t_B = 69.5$  hrs

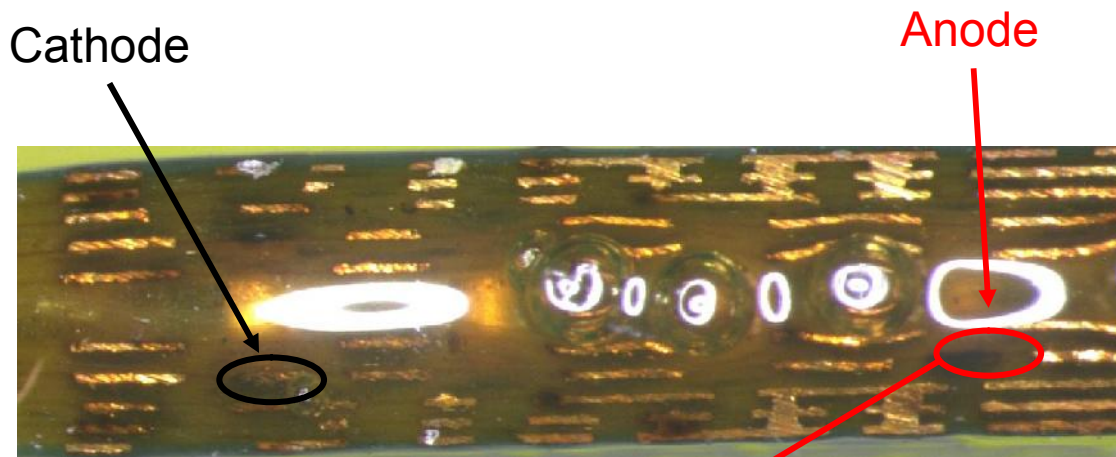
Figure 4-31: Optical image of test coupon B116 shorted at  $t_B = 180$  hrs
