**Characterization of Chloride-Induced  
Corrosion Products that form in  
Steel-Reinforced Cementitious  
Materials**

A thesis  
presented to the University of Waterloo  
in fulfilment of the  
thesis requirement for the degree of  
Doctor of Philosophy  
in  
Mechanical Engineering

# ABSTRACT

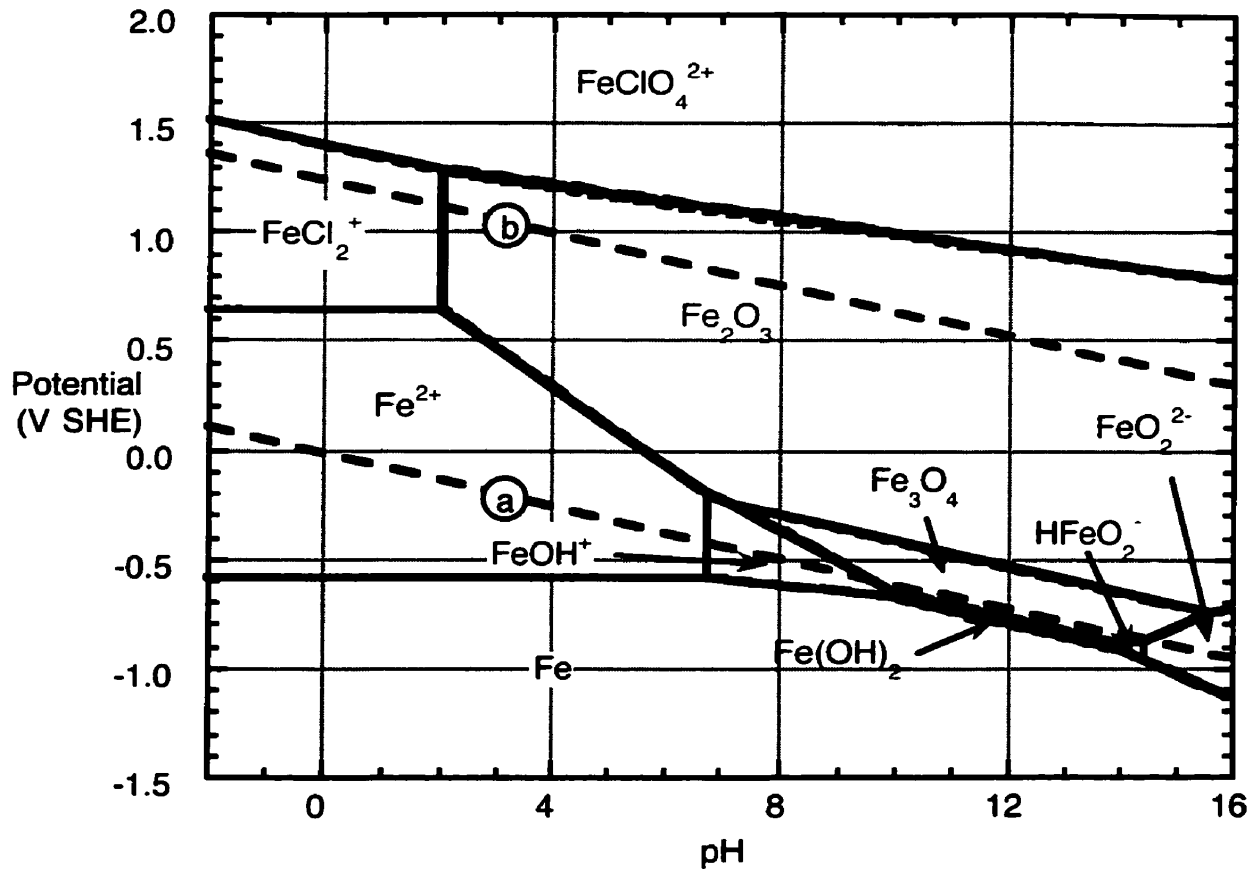
**Figure 2.3** Calculated Fe-H<sub>2</sub>O redox potential-pH diagram (25°C and 101.3 kPa) that assumes the molality of iron is 10<sup>-6</sup> (Bale, Pelton et al. 1995).

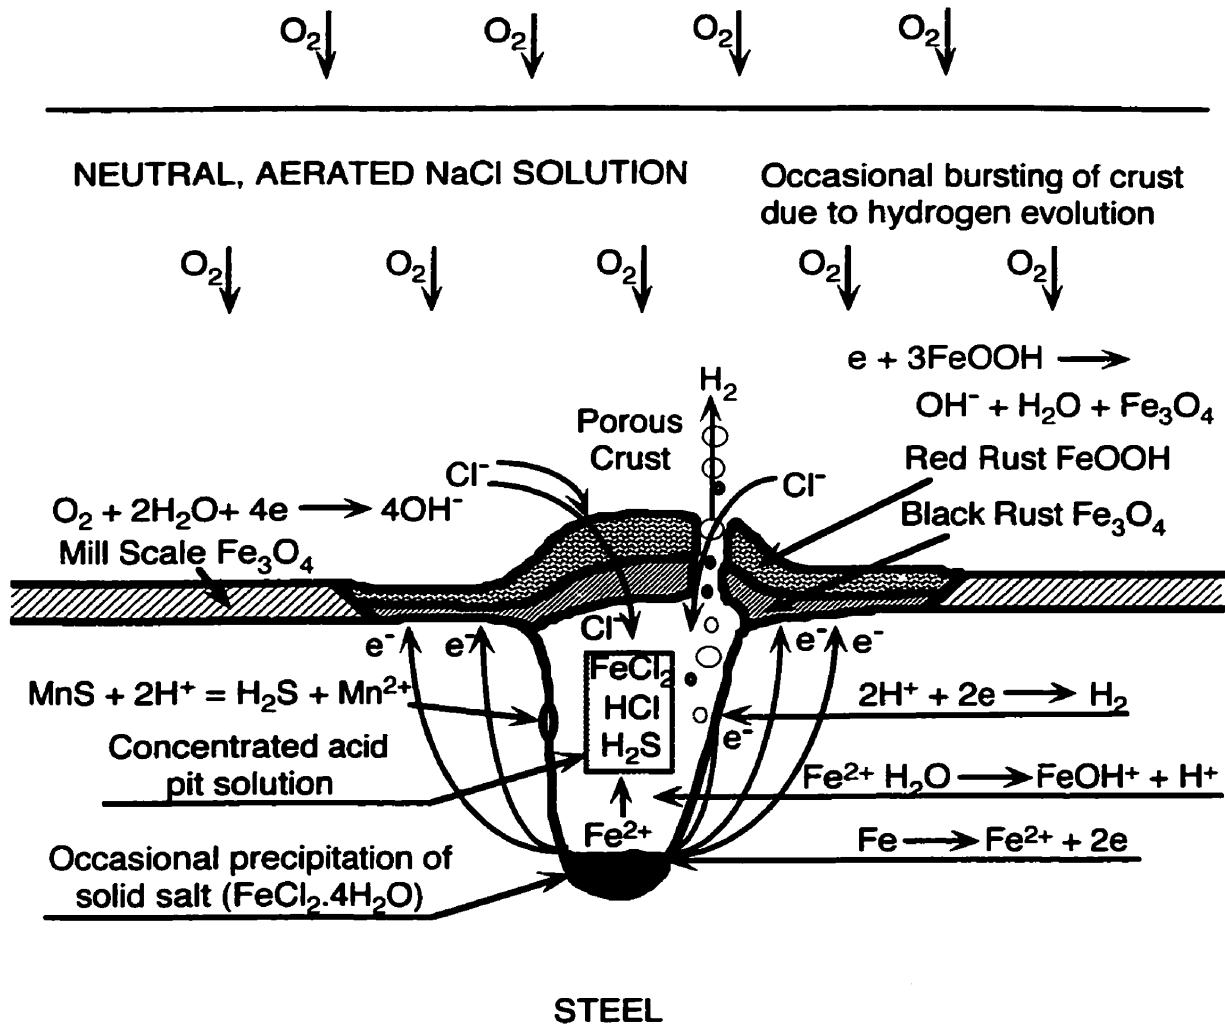
**Figure 2.4** Schematic illustration of the chloride-induced corrosion of steel in a neutral, aerated solution (Wranglén 1985).

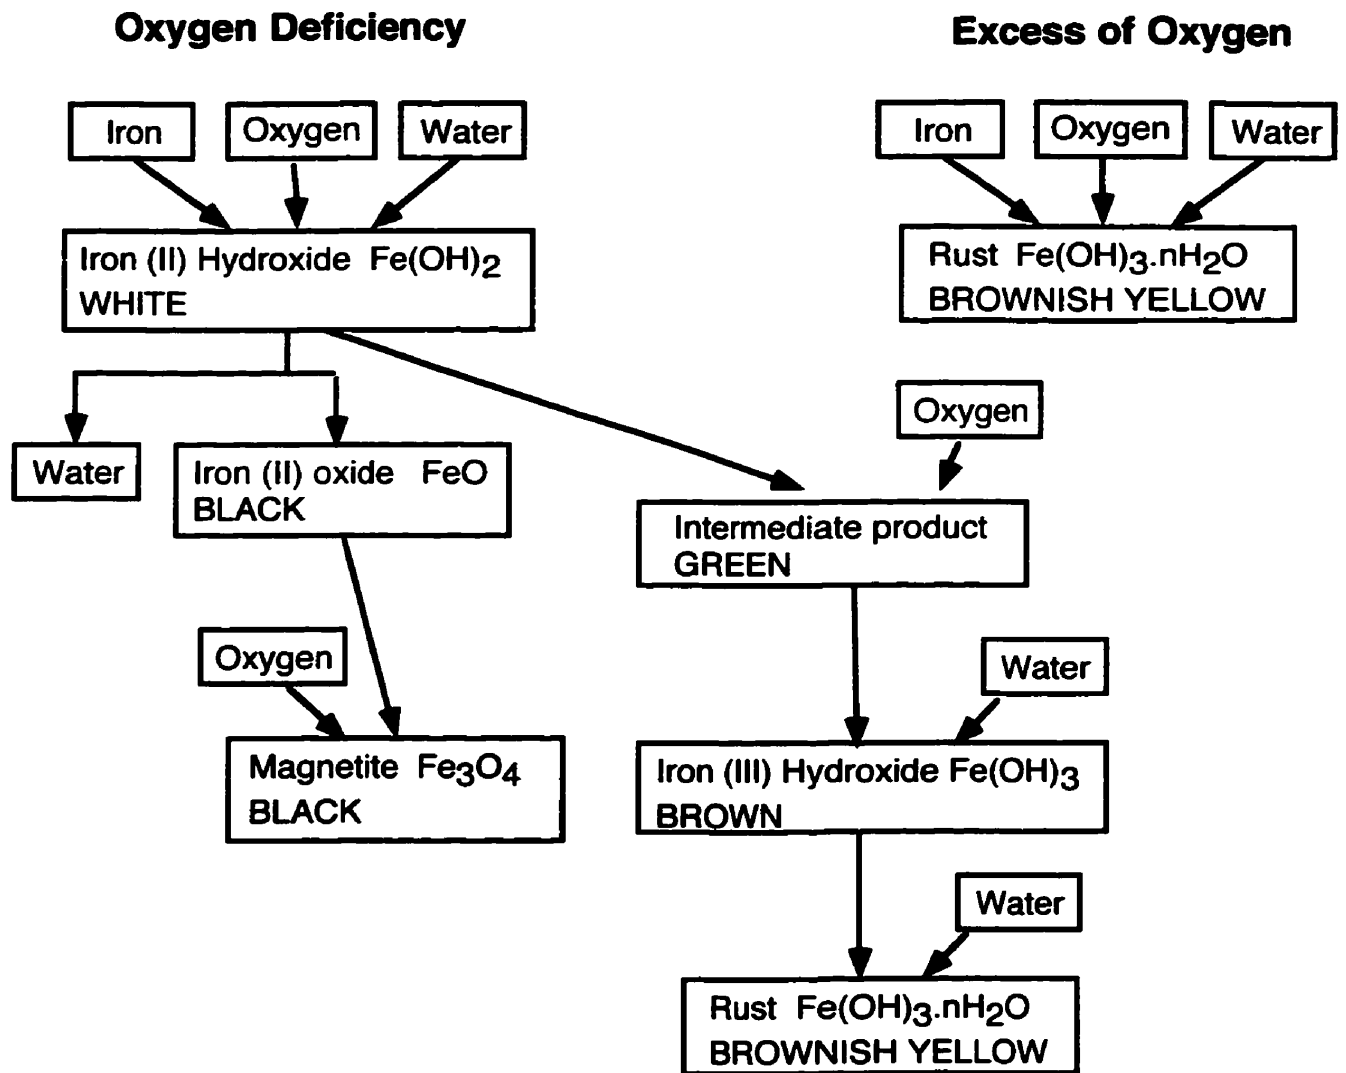
**Figure 2.5** Flowchart of Product formed during the Corrosion Process depending upon the Availability of Water and Oxygen (Herholdt, Justesen et al. 1985).

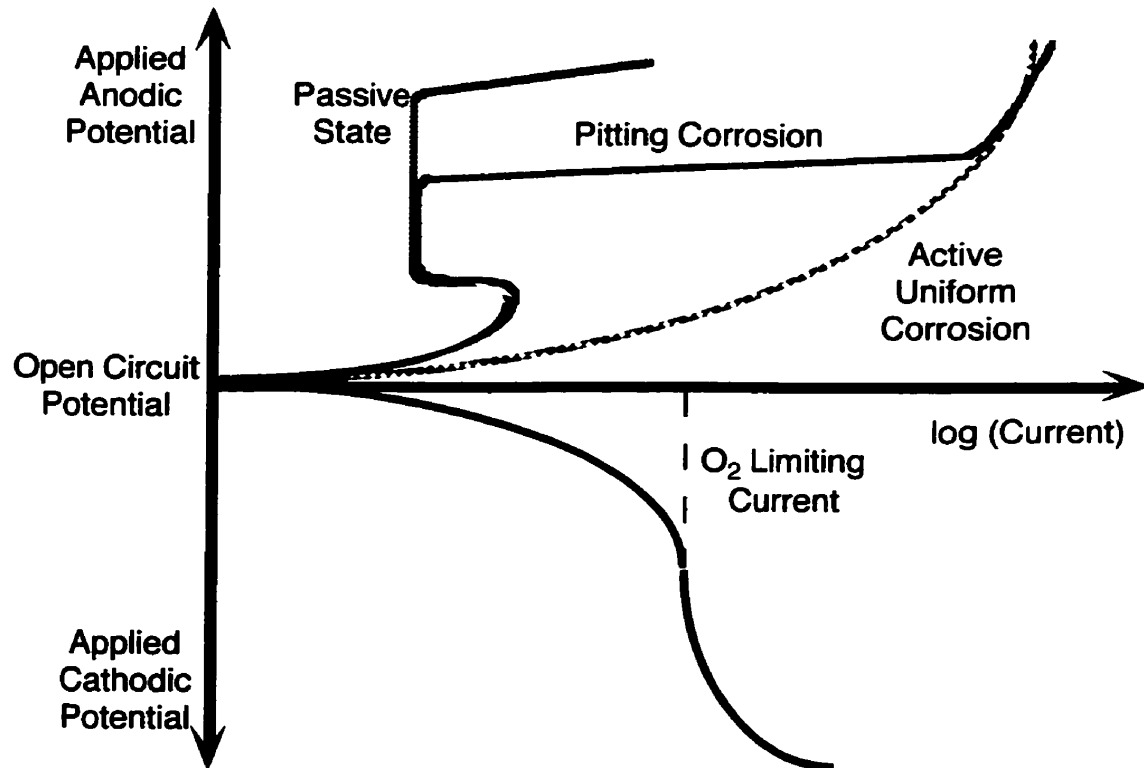
**Figure 2.11** Graphical representation of the information provided by the anodic and cathodic portions of the full potentiodynamic polarization curves (modified from Enevoldsen (1993)).

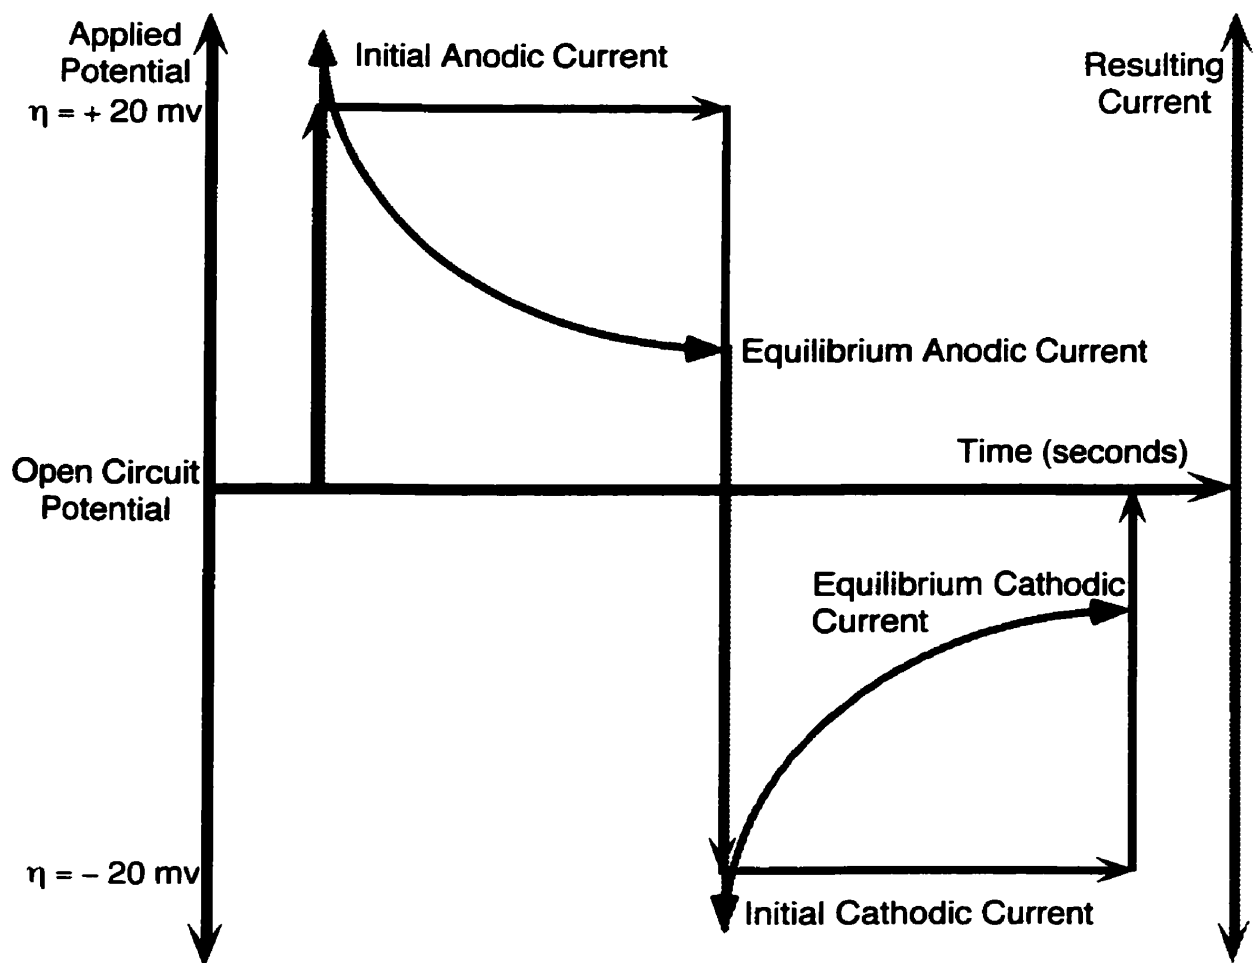
**Figure 2.13** Graphical illustration of the potentials applied over time and resulting current during linear polarization resistance measurements where  $h$  represents overpotential.

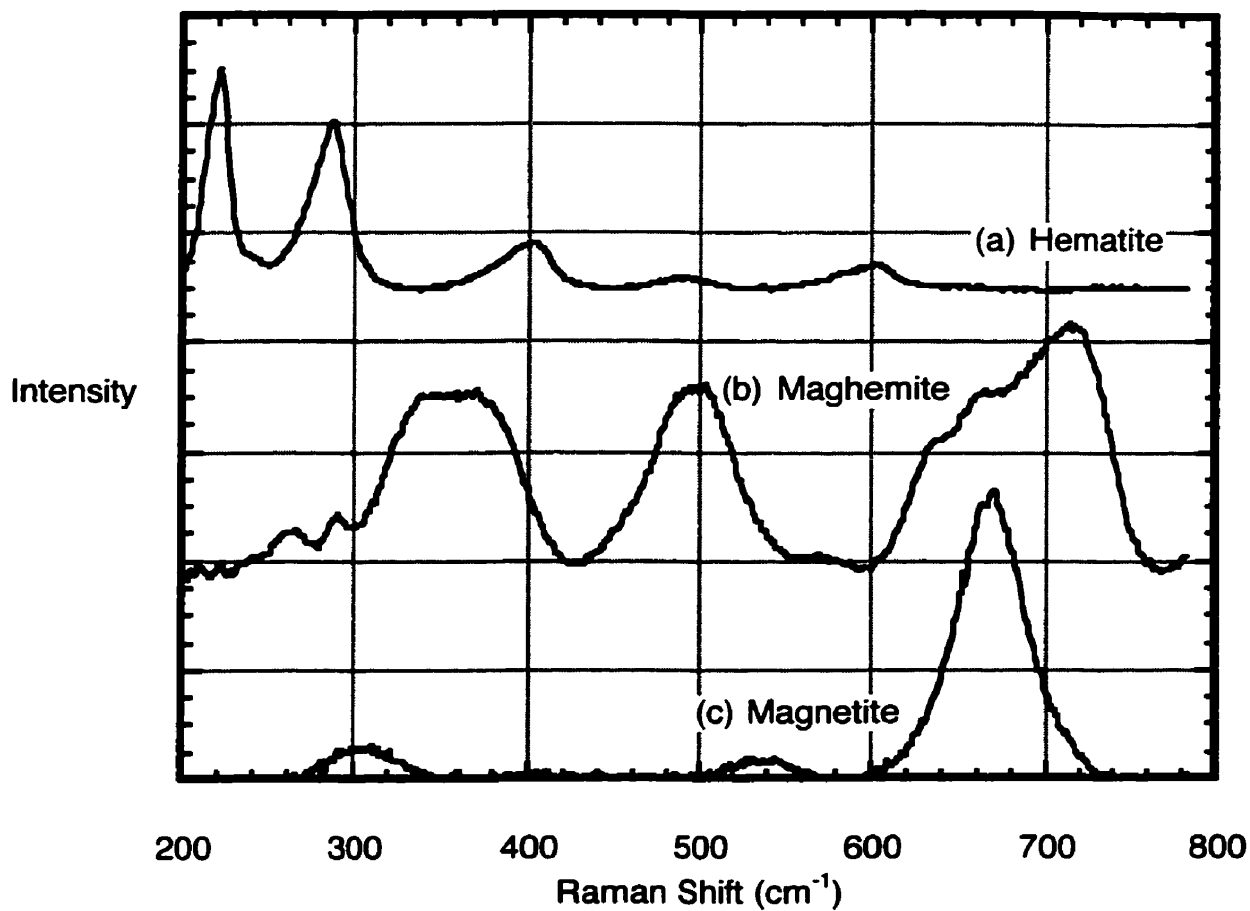
**Figures 3.2(a), (b), and (c)** Representative spectra of (a) hæmatite ( $\alpha\text{-Fe}_2\text{O}_3$ ), (b) maghemite ( $\gamma\text{-Fe}_2\text{O}_3$ ), and (c) magnetite ( $\text{Fe}_3\text{O}_4$ ). Spectra courtesy of Prof. D.E. Irish and his research group in the Chemistry Department, University of Waterloo.

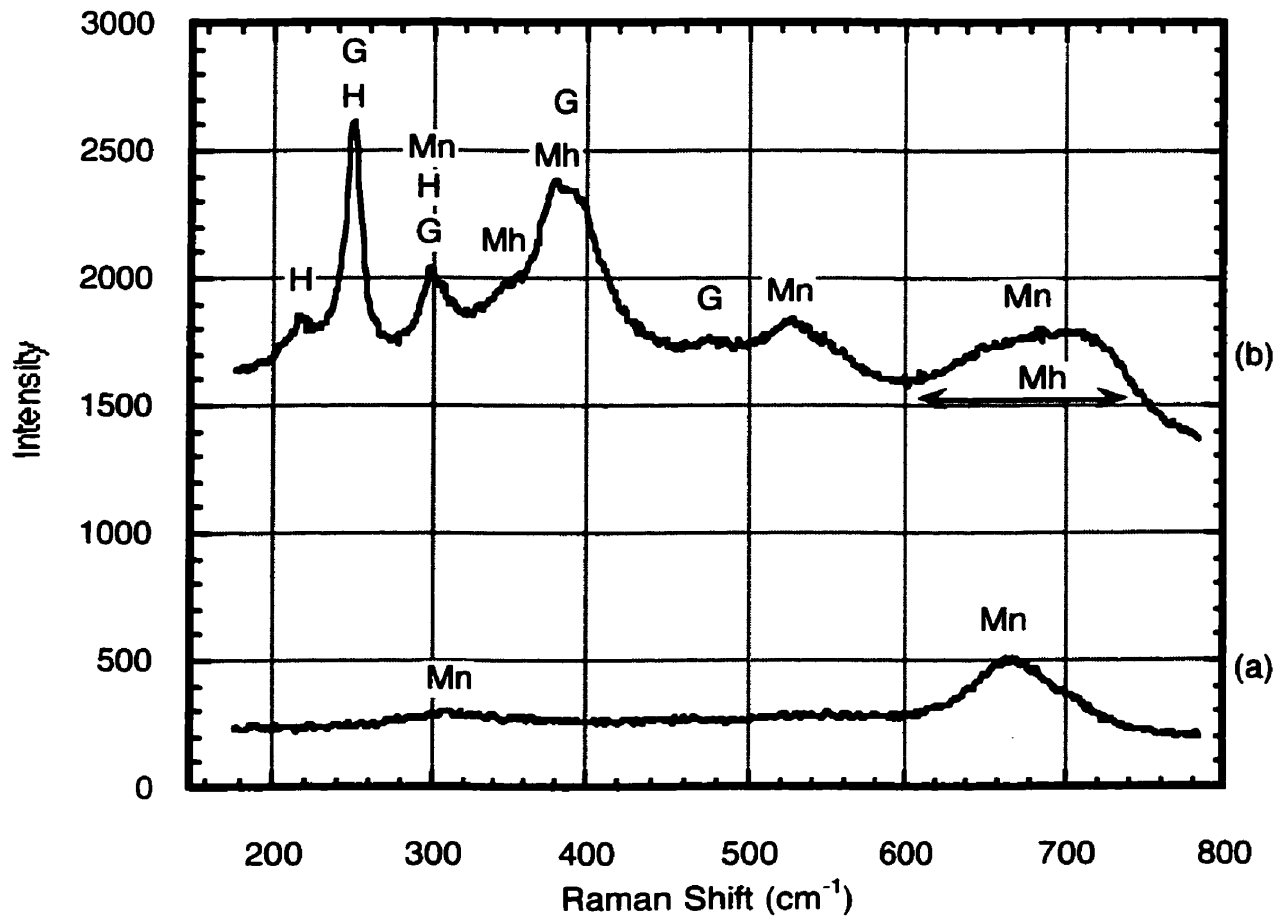
**Figures 3.4(a) and (b)** Raman spectra of regions indicated in Figure 3.2 showing (a) predominantly magnetite and (b) a combination of goethite, hæmatite, maghemite, and magnetite. G ≡ Goethite ( $\alpha$  - FeOOH), H ≡ Hæmatite ( $\alpha$  - Fe<sub>2</sub>O<sub>3</sub>), Mh ≡ Maghemite ( $\gamma$  - Fe<sub>2</sub>O<sub>3</sub>), Mn ≡ Magnetite (Fe<sub>3</sub>O<sub>4</sub>)

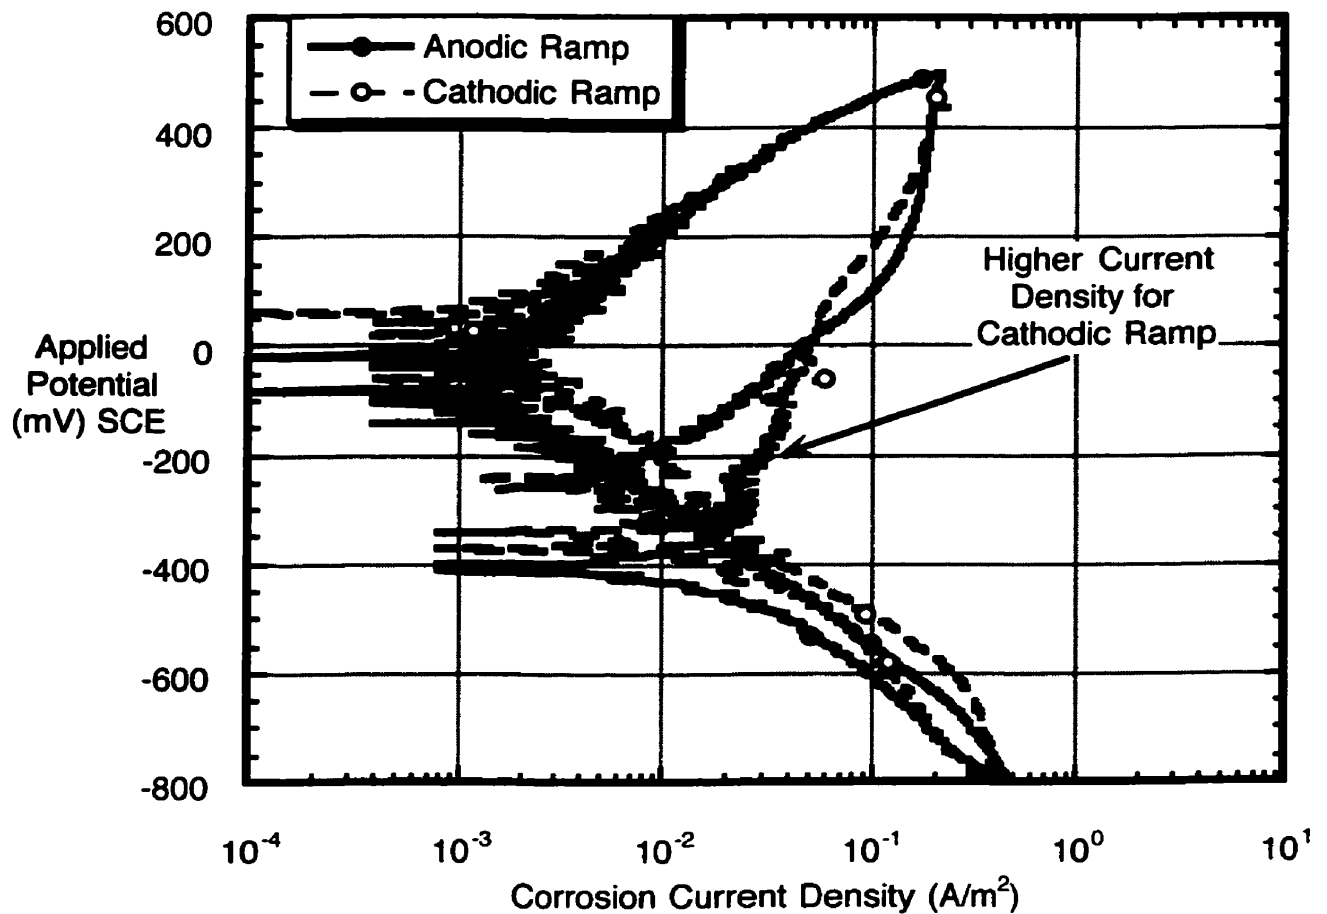
**Figure 4.3.1.1** Comparison of applied potential-corrosion current density curves for ground steel samples exposed to a chloride-free Type 10 simulated pore solution.

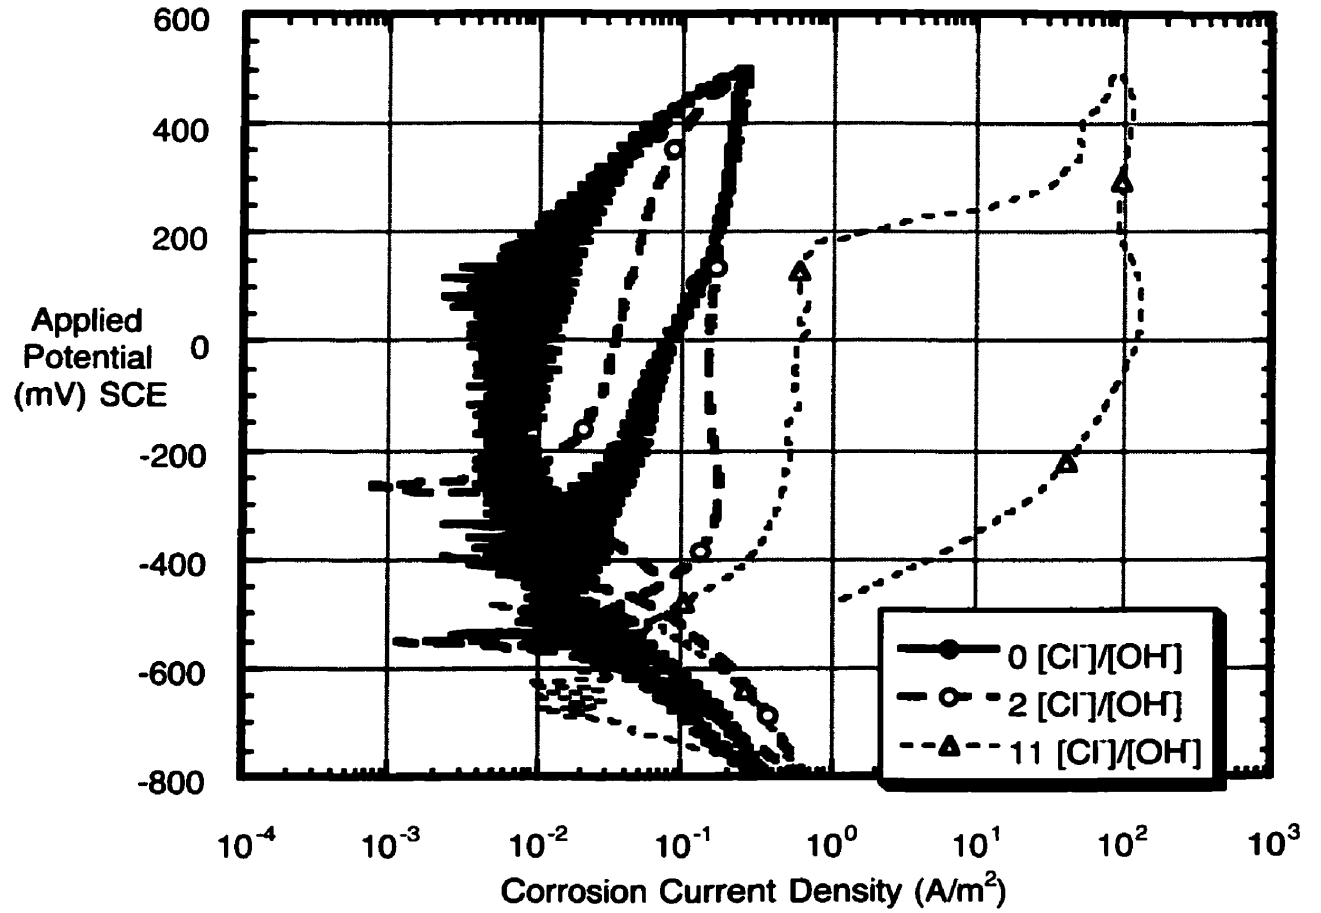
**Figure 4.3.1.2(a)** Comparison of applied potential-current density curves for ground steel in a white simulated pore solution with chloride/hydroxide ratios of 0, 2, and 11.

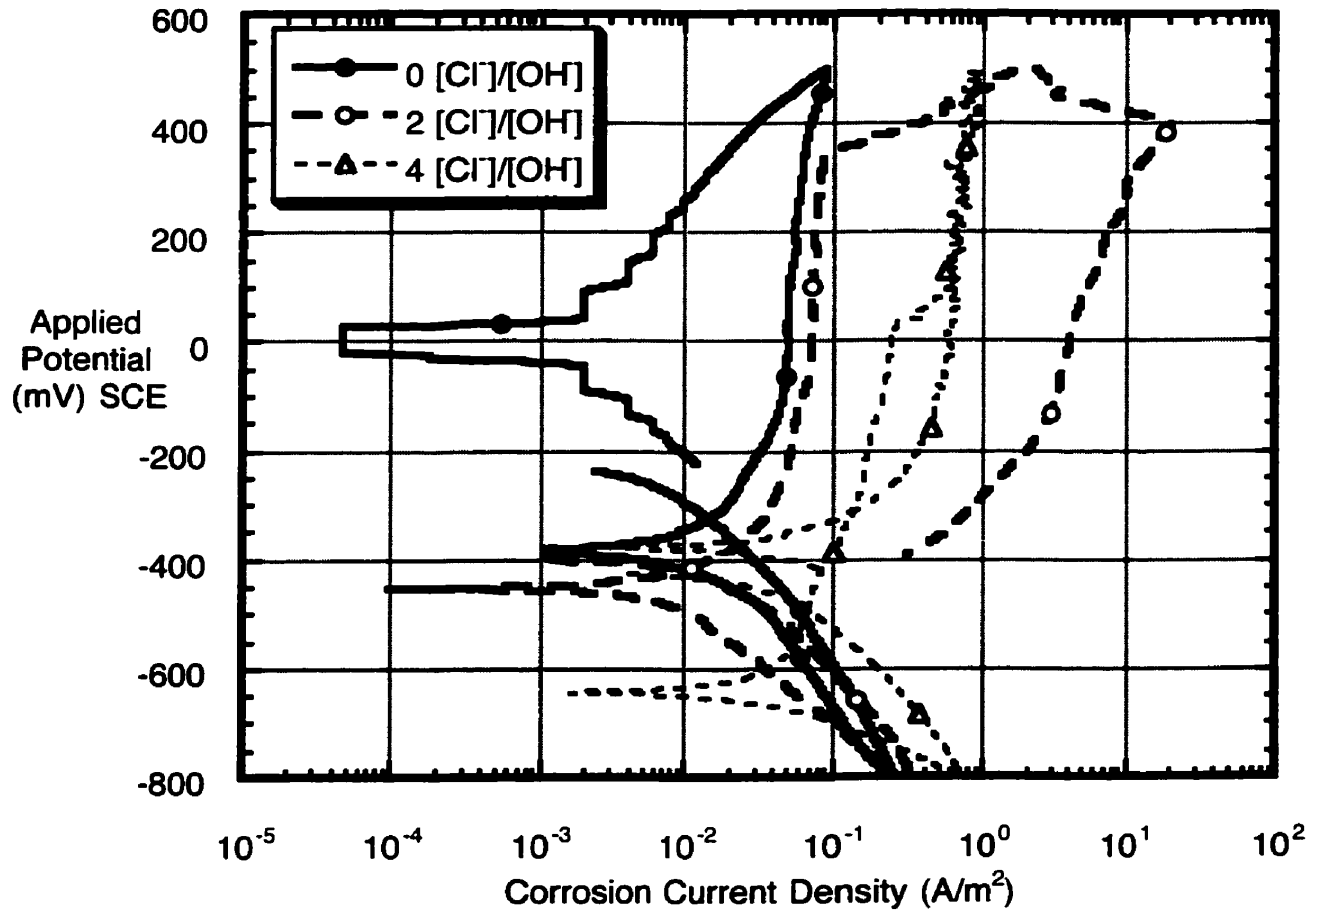
**Figure 4.3.1.2(d)** Comparison of applied potential-current density curves for as-received steel in a Type 10 simulated pore solution with chloride/hydroxide ratios of 0, 2, and 4.

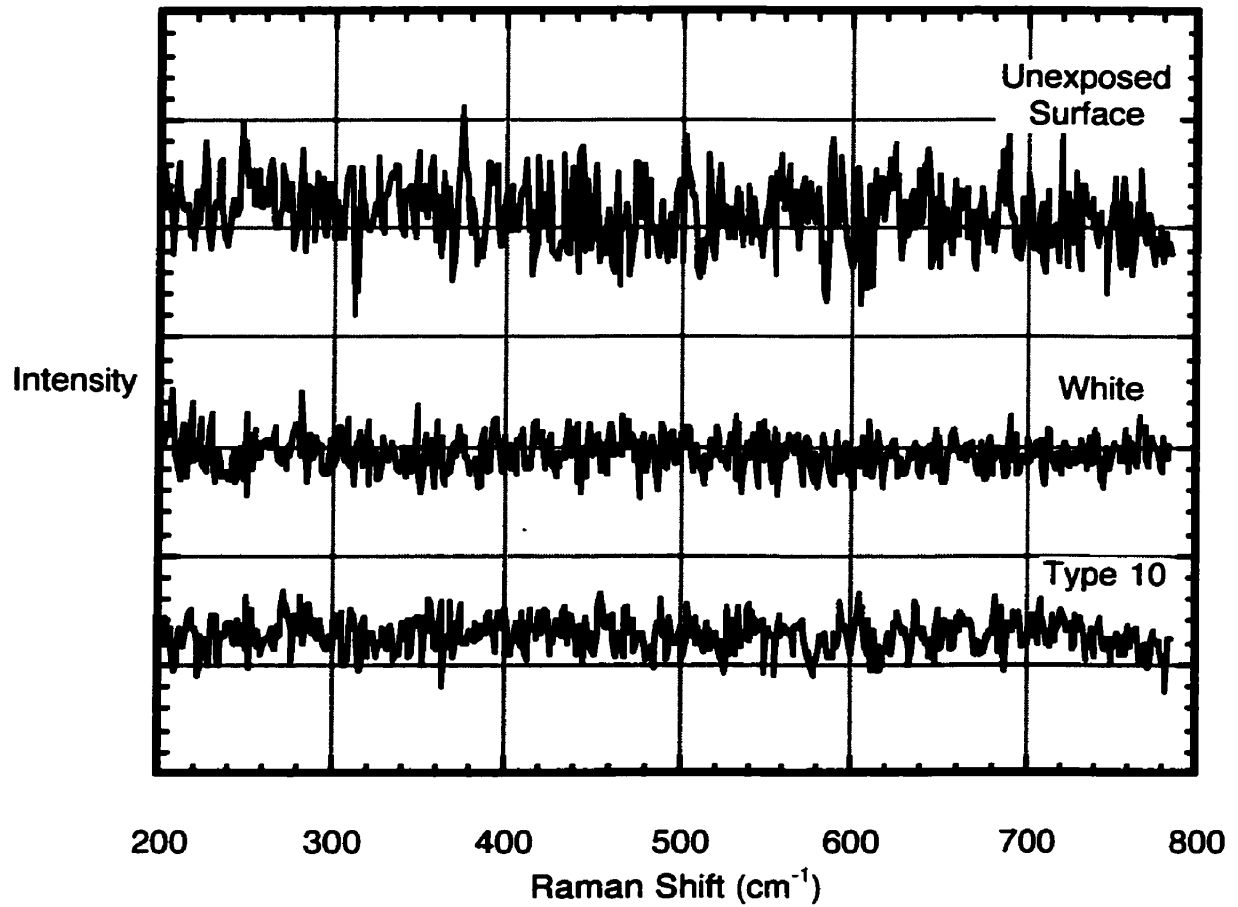
**Figure 4.3.2.1(a)** Comparison of ground steel surfaces before exposure, and after exposure to both white and Type 10 simulated pore solutions.

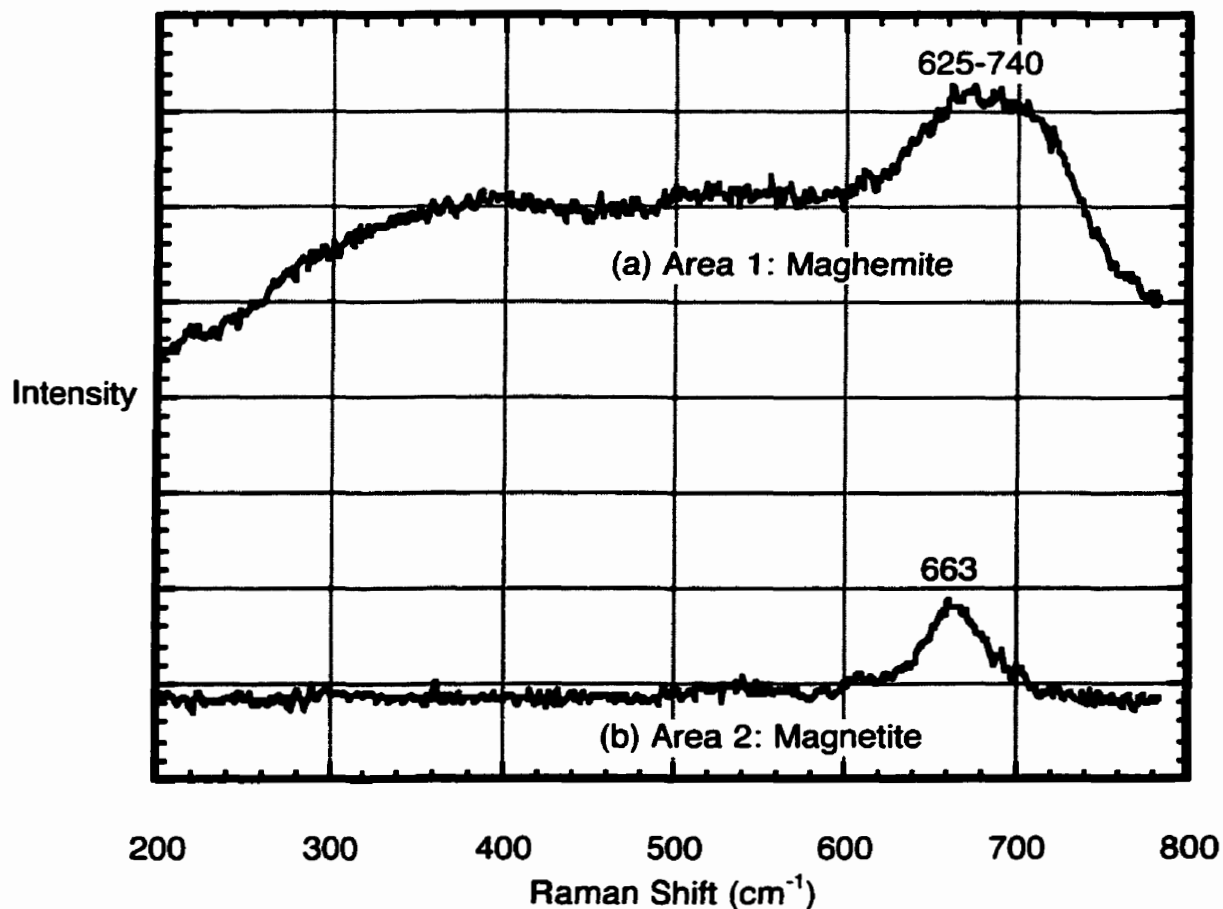
**Figures 4.3.2.2(a) and (b)** Raman spectra of the corrosion products observed on the surface of the as-received steel immersed in a Type 10 cement simulated pore solution while under potentiodynamic control at -400 mV SCE, (a) area 1, and (b) area 2.

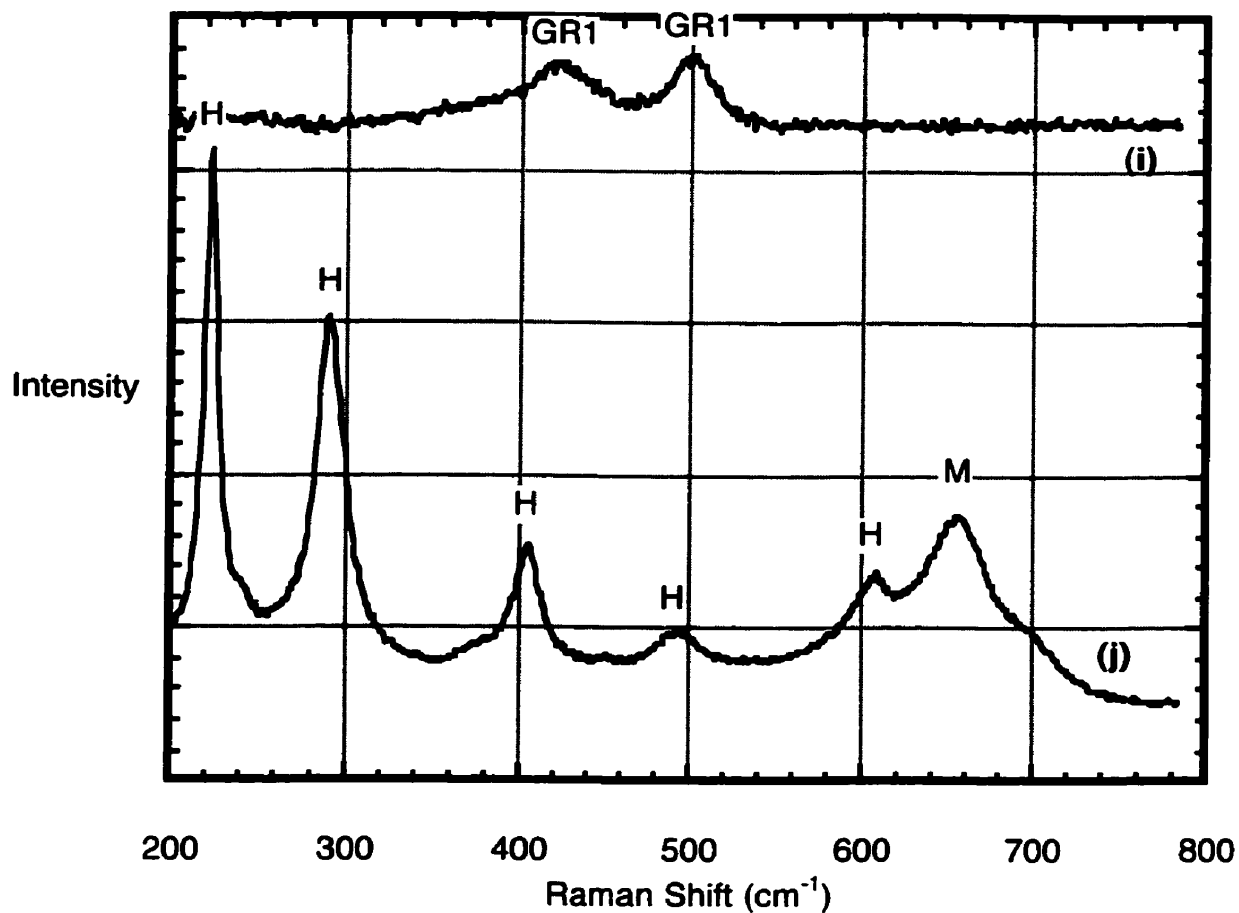
**Figures 4.3.2.2(i) and (j)** Raman spectra of (i) Green Rust I (GR1), and (j) magnetite (M) and hematite (H) which formed on the surface of ground steel in a Type 10 simulated pore solution containing sufficient chlorides to make a chloride/hydroxide ratio of 4.

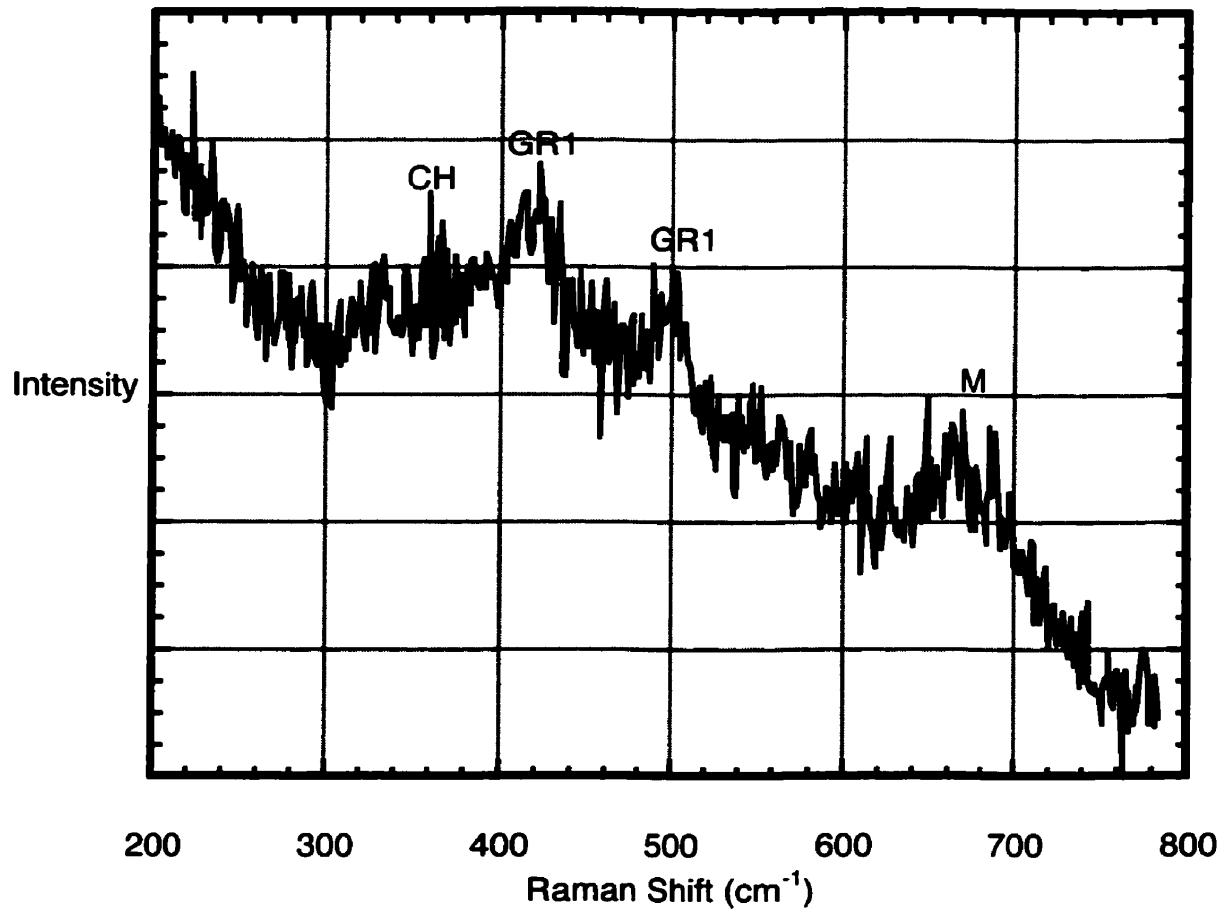
**Figure 4.3.2.2(I)** Raman spectrum indicating Green Rust I and magnetite which formed on the surface of ground steel in a white simulated pore solution containing sufficient chlorides to make a chloride/hydroxide ratio of 11. The calcium hydroxide peak resulted from the excess present in the simulated pore solution.

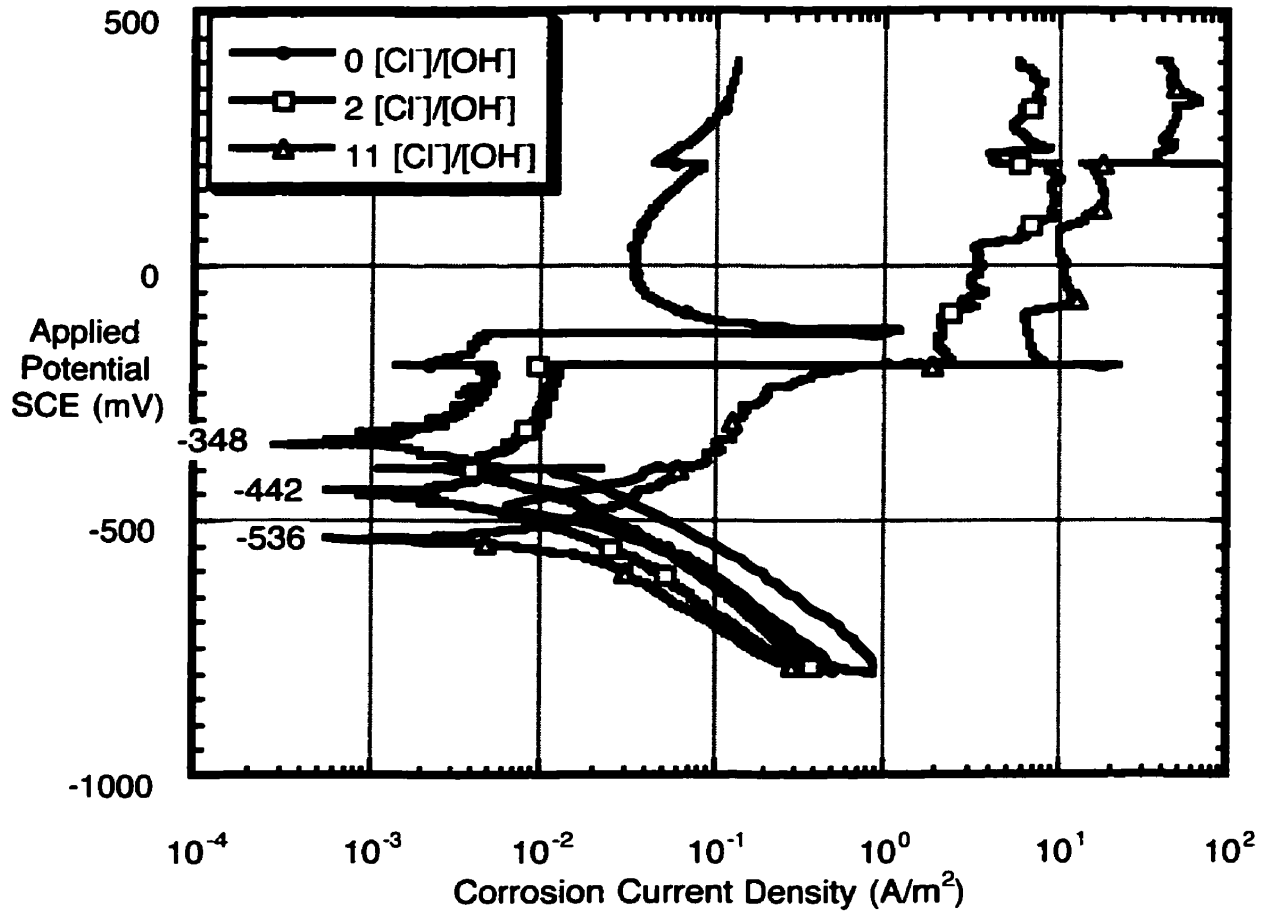
**Figure 4.3.3(a)** A comparison of the applied potential/corrosion current density curves obtained from ground steel samples in white simulated pore solution during *in situ* Raman experiments.

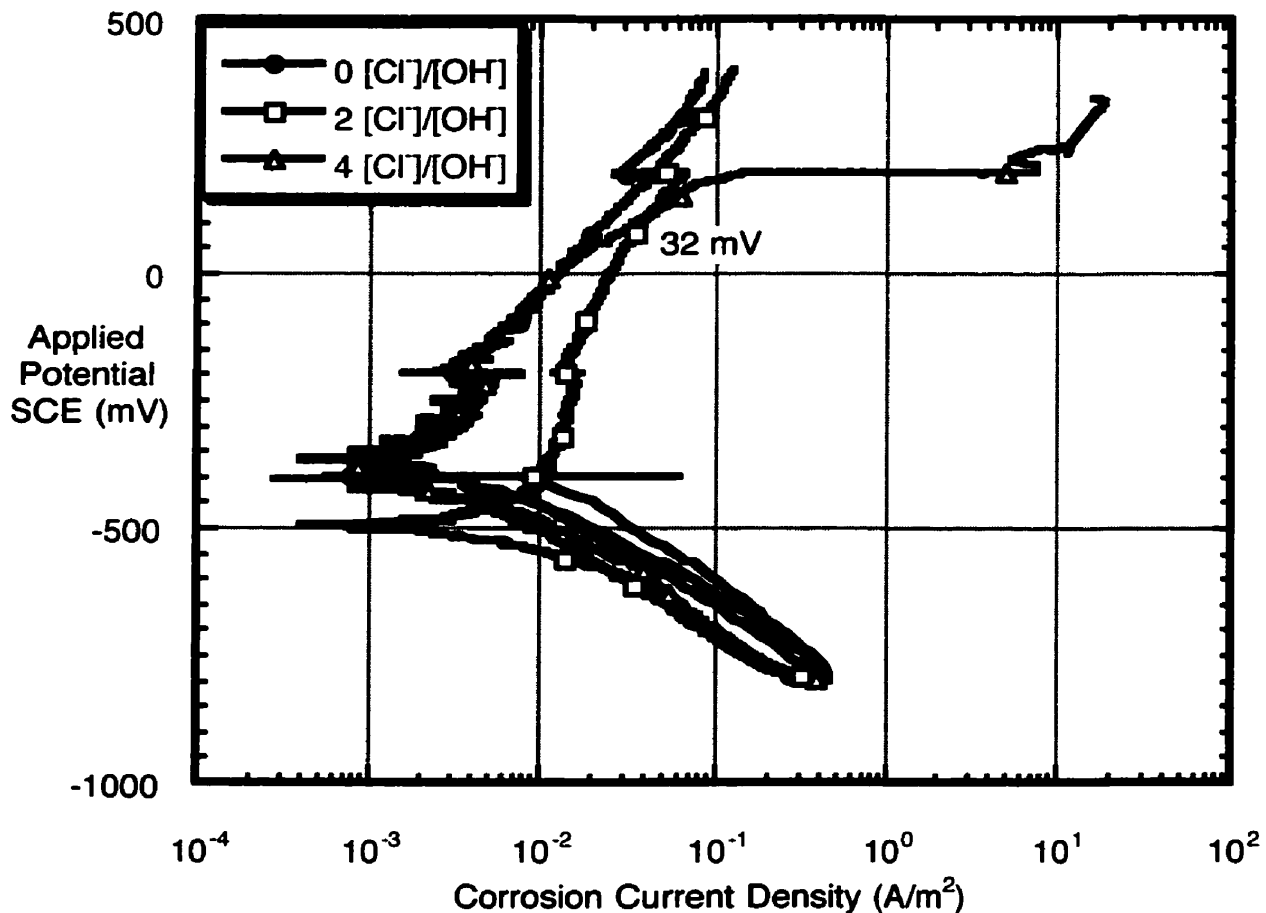
**Figure 4.3.3(b)** A comparison of the applied potential/corrosion current density curves obtained from ground steel samples in Type 10 simulated pore solution during *in situ* Raman experiments.

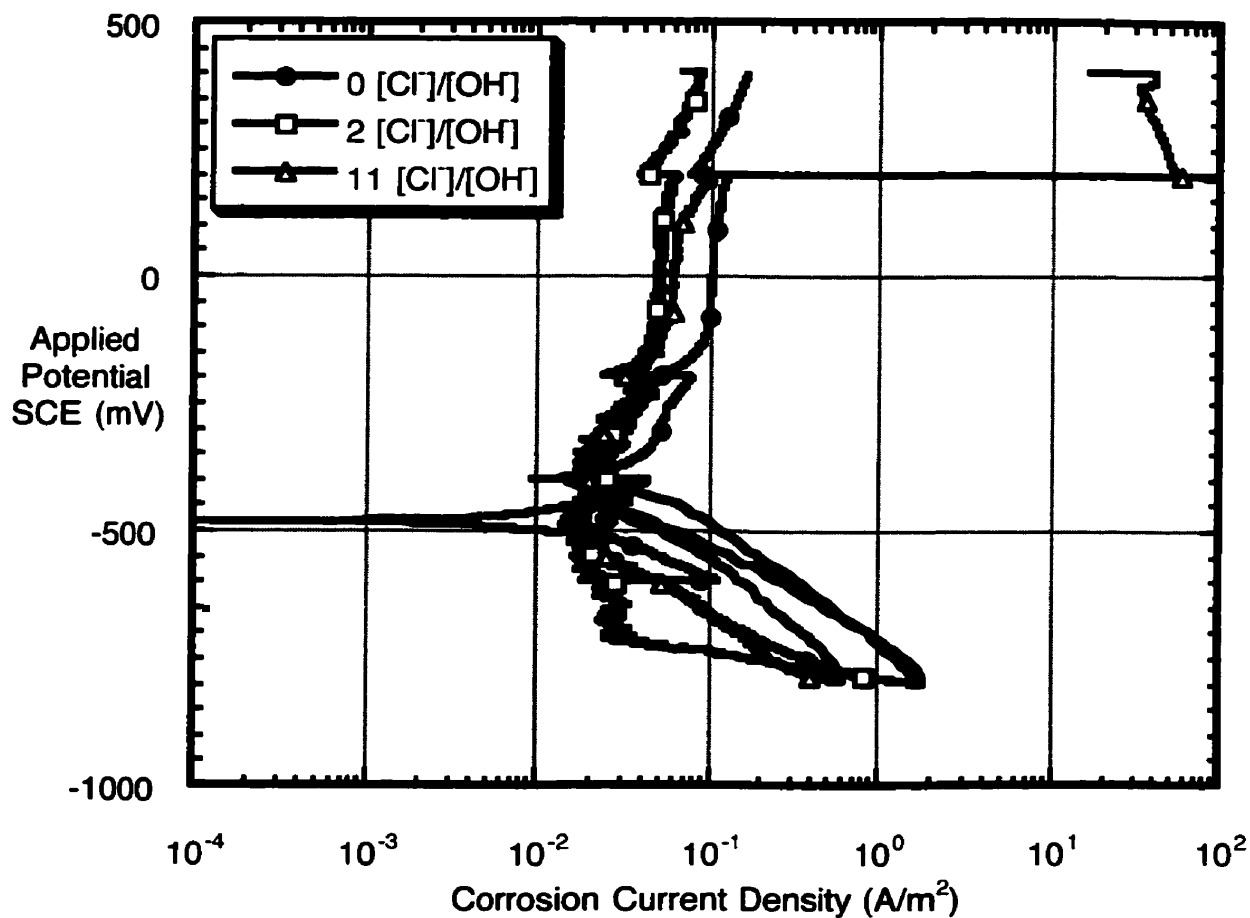
**Figure 4.3.3(c)** A comparison of the applied potential/corrosion current density curves obtained from as-received steel samples in white simulated pore solution during *in situ* Raman experiments.

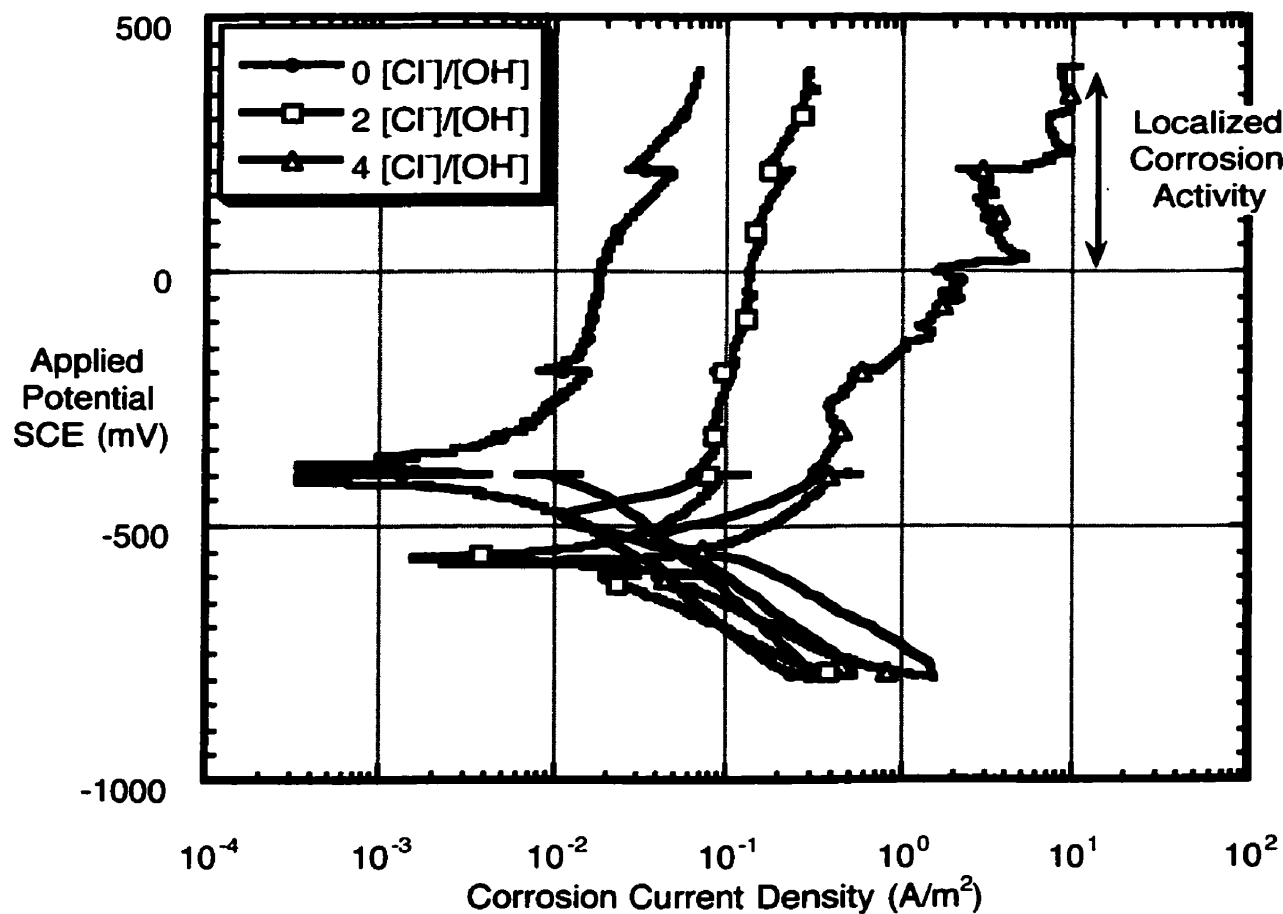
**Figure 4.3.3(d)** A comparison of the applied potential/corrosion current density curves obtained from as-received steel samples in Type 10 simulated pore solution during *in situ* Raman experiments.

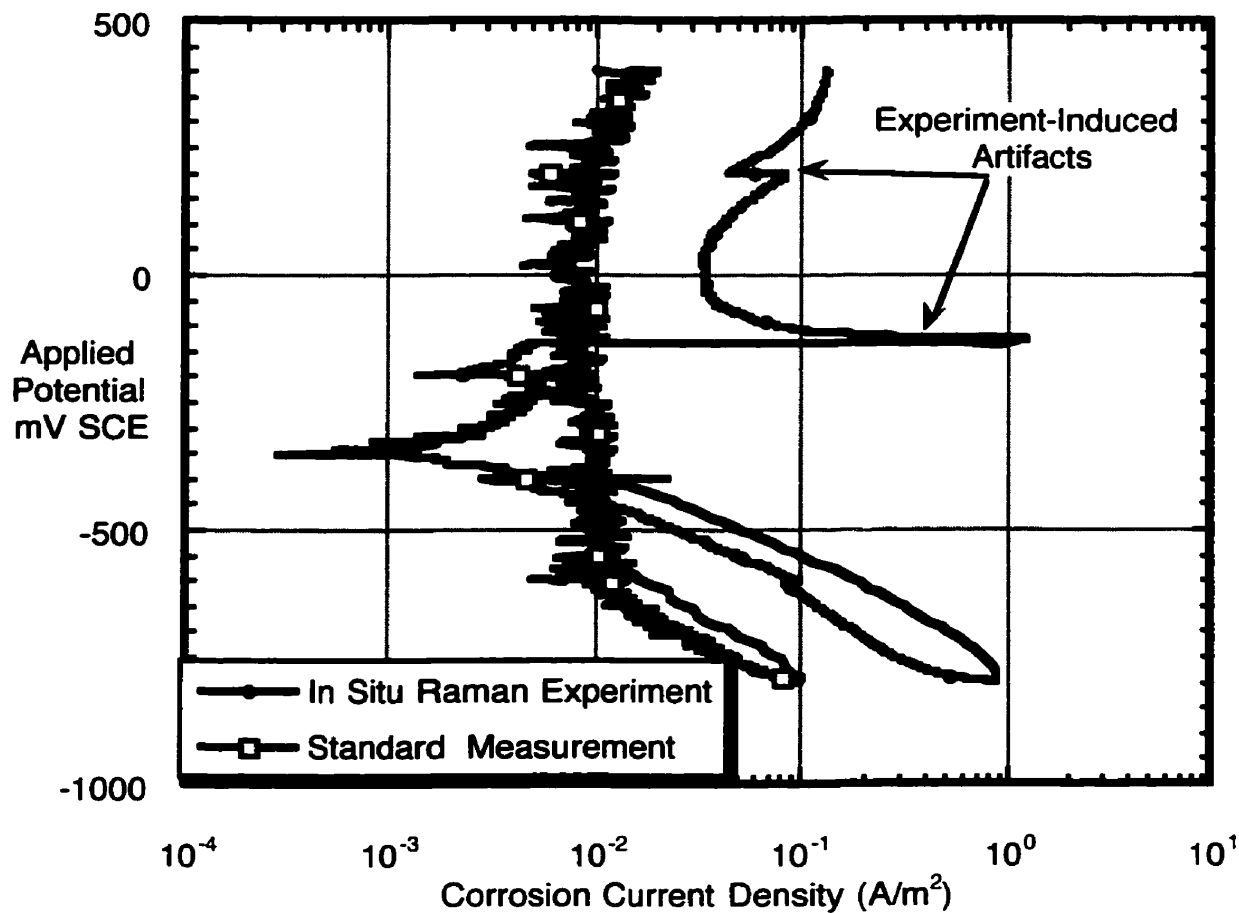
**Figure 4.3.3(e)** A comparison between applied potential/current density curves demonstrating the effect of pore solution height over the steel during *in situ* Raman experiments.
