**Characterization of Chloride-Induced  
Corrosion Products that form in  
Steel-Reinforced Cementitious  
Materials**

A thesis  
presented to the University of Waterloo  
in fulfilment of the  
thesis requirement for the degree of  
Doctor of Philosophy  
in  
Mechanical Engineering

# ABSTRACT

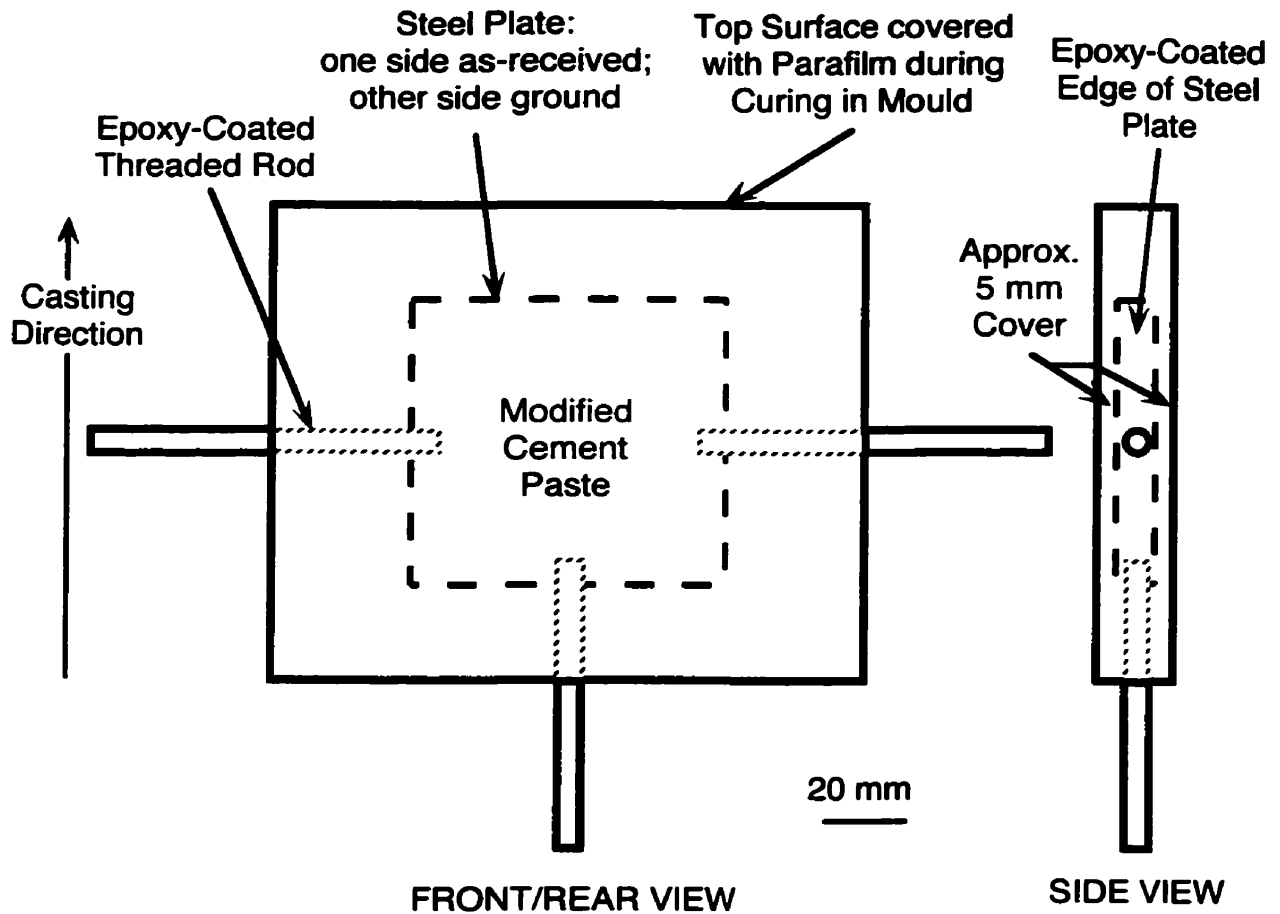
**Figure 5.2.2** Detailed diagram of the modified cement paste specimens (approx. 150 by 125 by 20 mm).

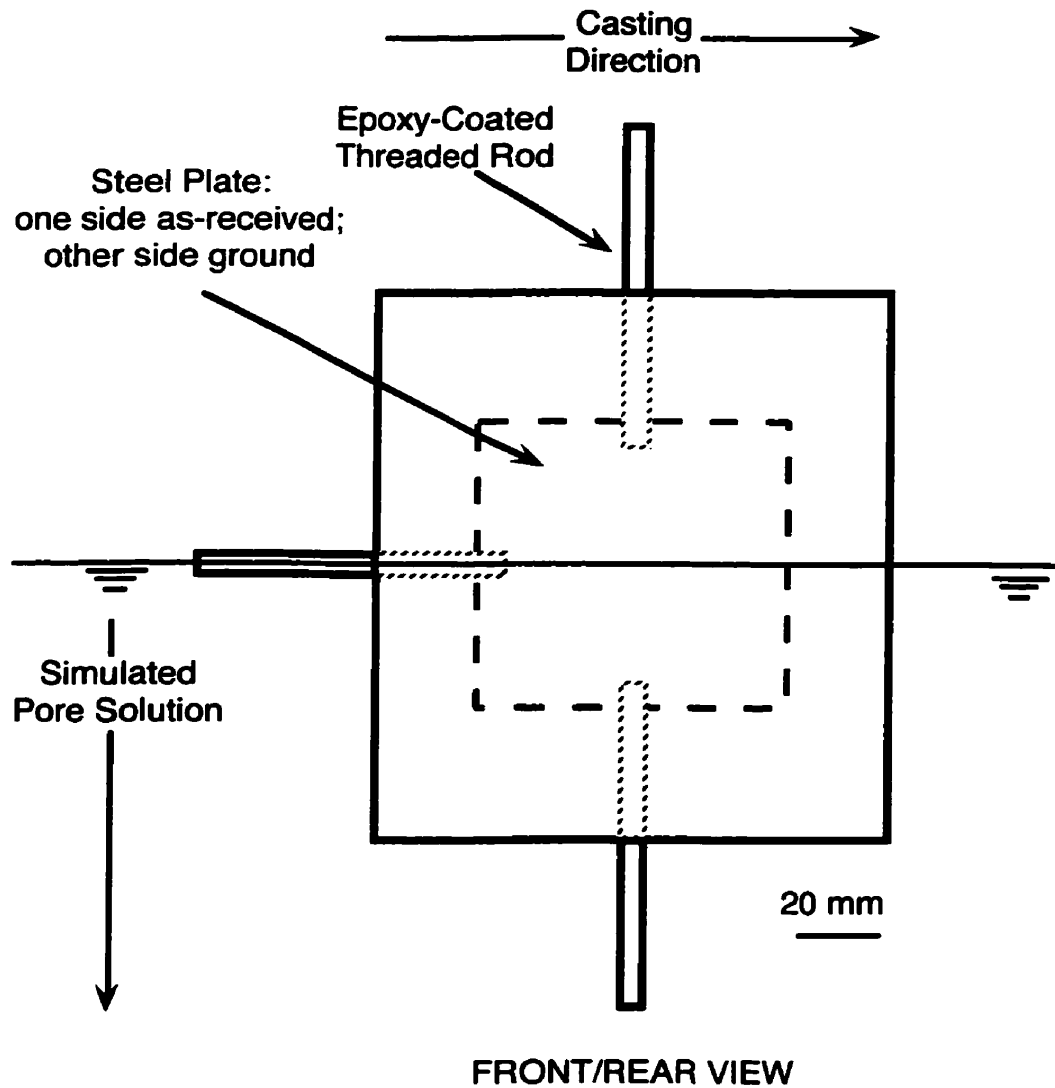
**Figure 5.2.4** Orientation of steel plate/modified cement paste specimens during exposure to 1 M NaCl simulated pore solution.

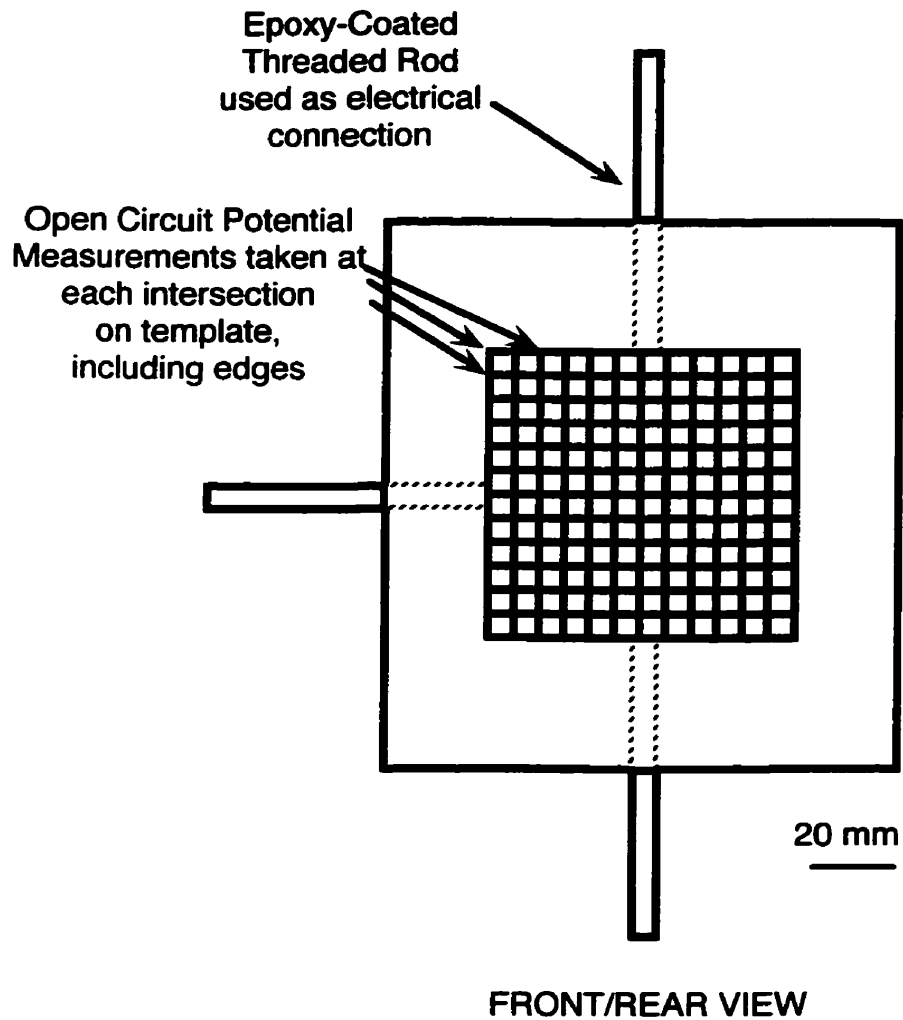
**Figure 5.2.5** Detailed diagram illustrating open circuit potential measurement locations, similar to the method described in ASTM C 876.

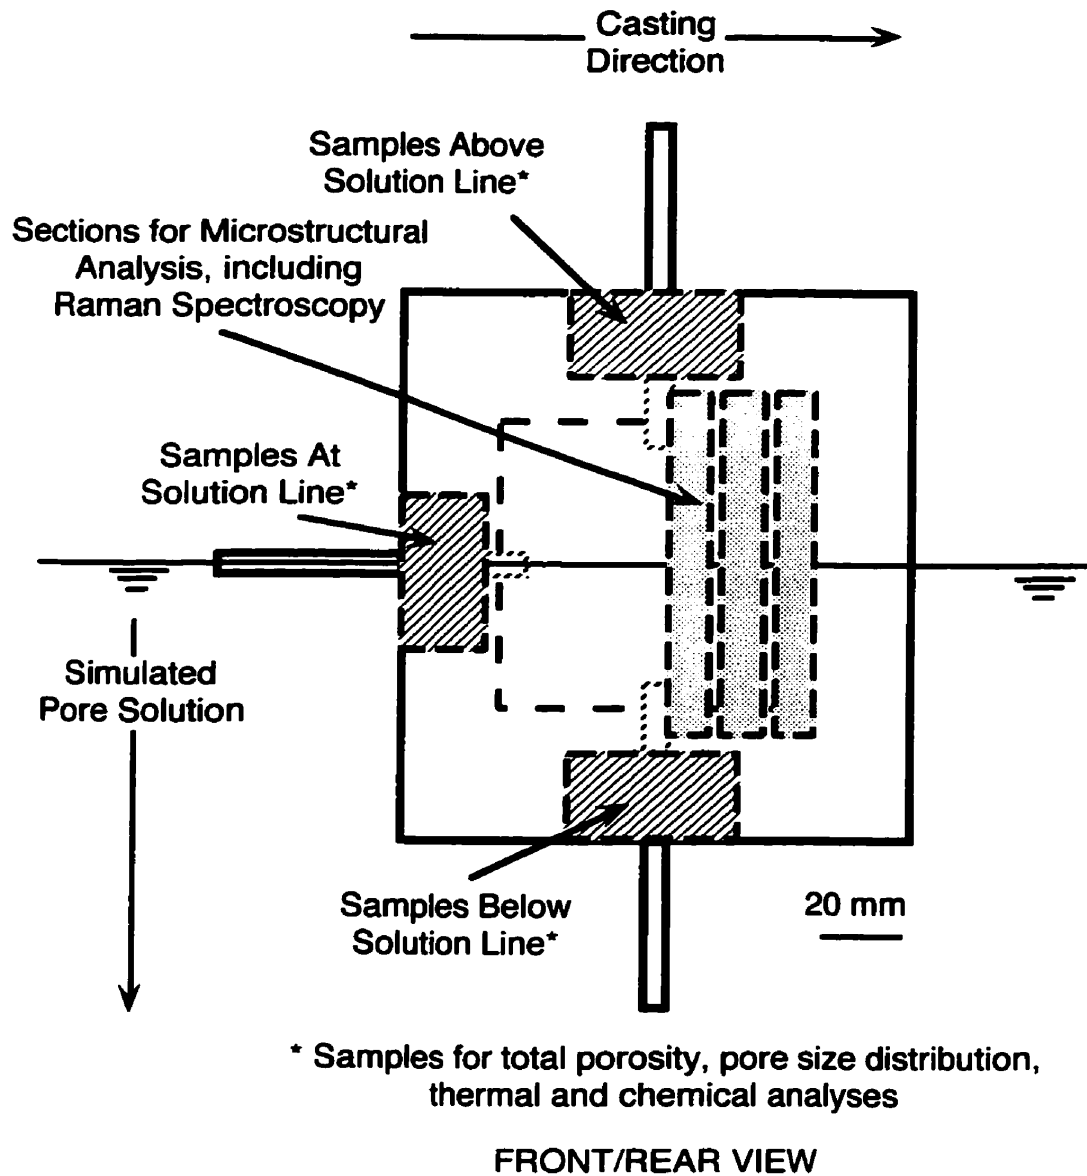
**Figure 5.2.6** Detailed diagram of the specimen areas from which samples and sections were taken for microstructural, thermal, and chemical analyses.

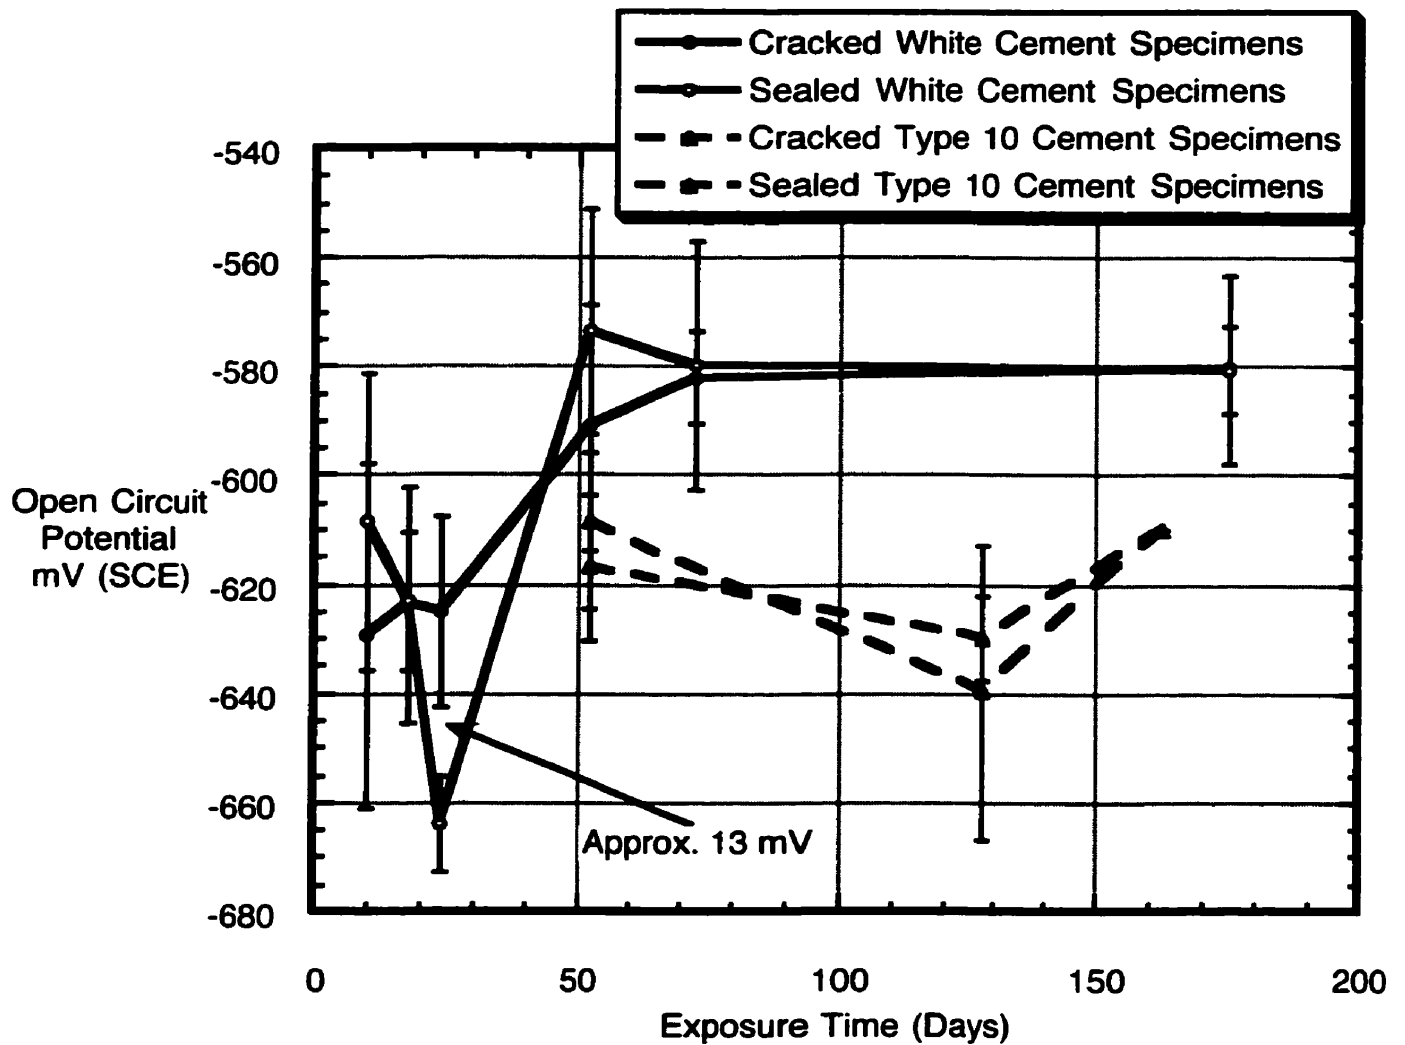
**Figure 5.3.1(a)** Comparison of the open circuit potential measurements from the cracked and sealed, white and Type 10 modified cement paste specimens.

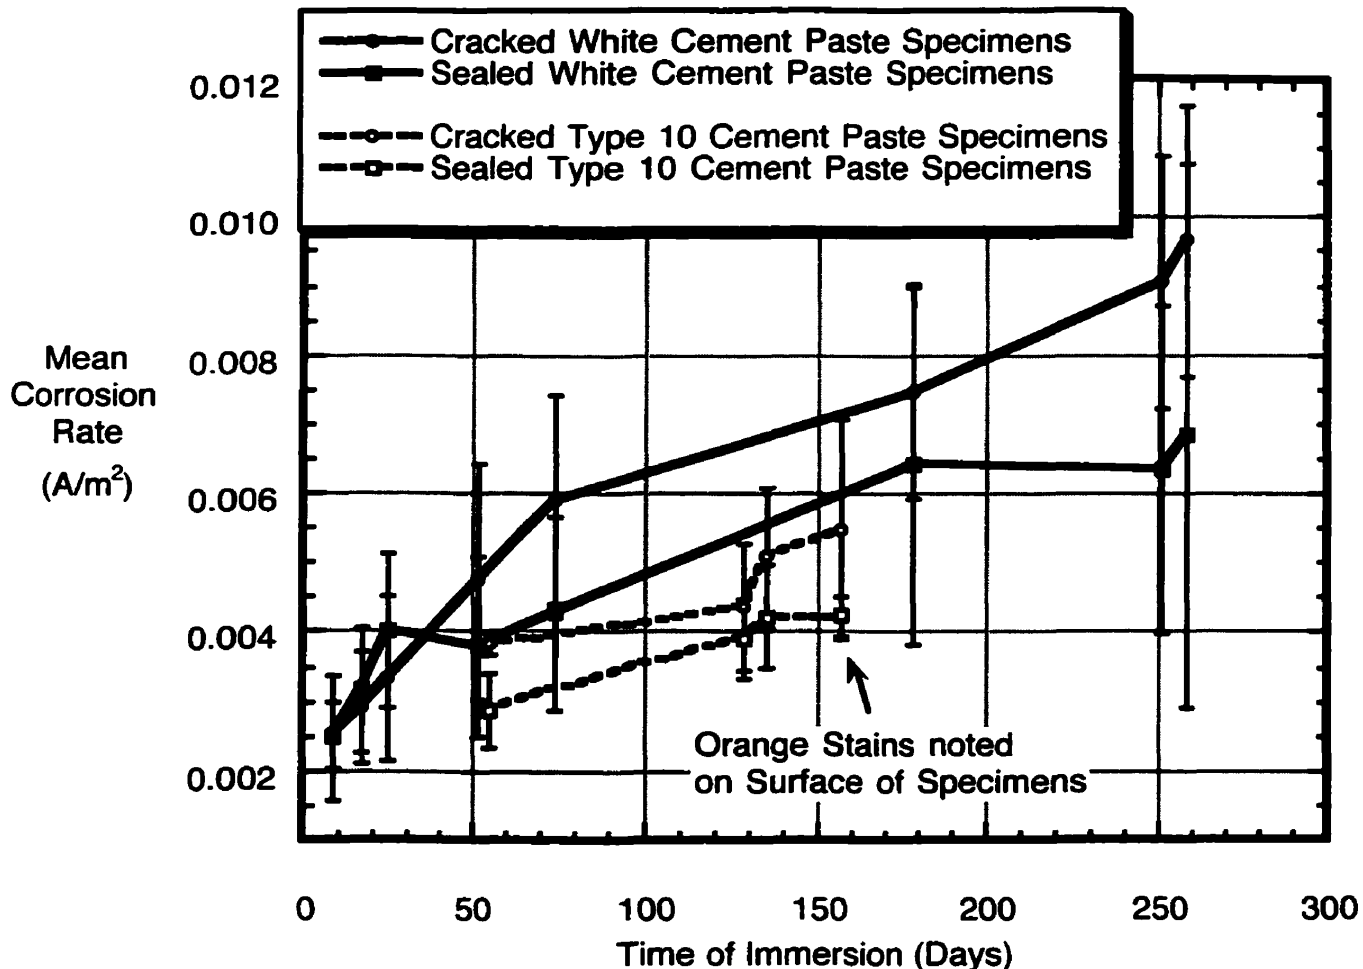
**Figure 5.3.2** Comparison of the mean corrosion rates for both the cracked and sealed specimens. The error bars represent a 67% confidence interval.

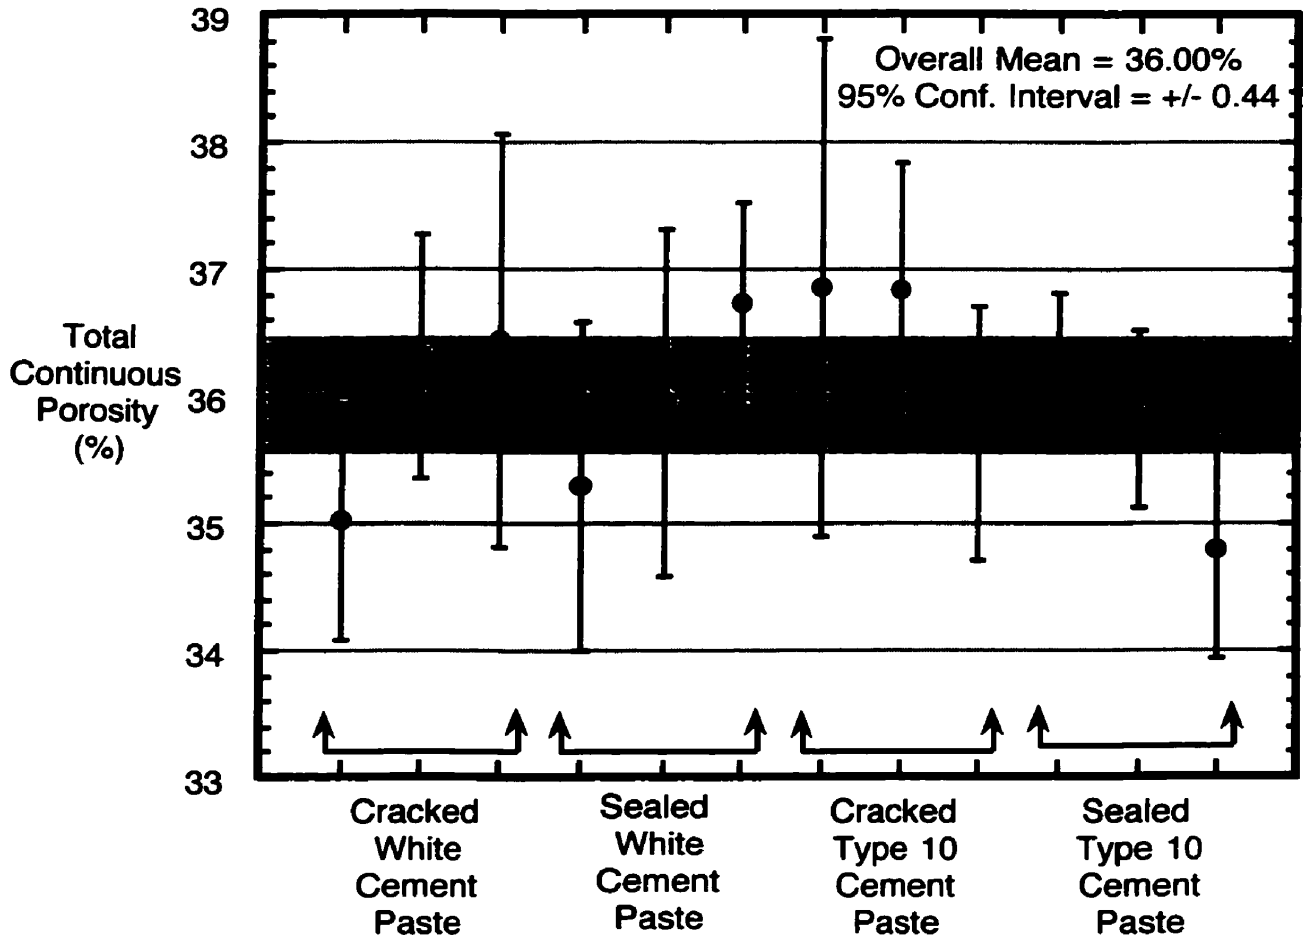
**Figure 5.3.3(a)** Comparison of the total continuous porosity 95% confidence intervals for all specimen types: cracked, sealed, white and Type 10 modified cement paste.

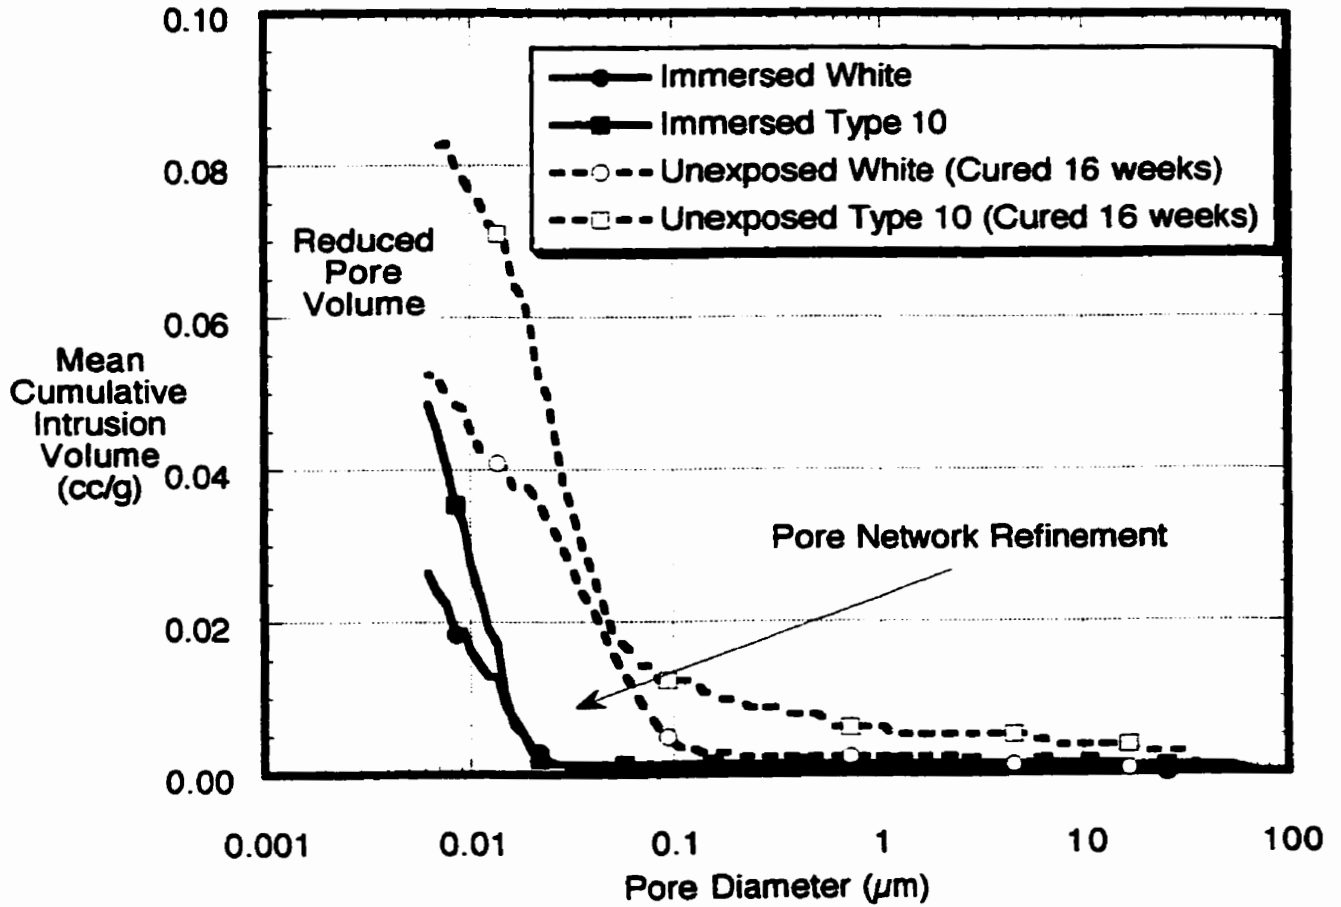
**Figure 5.3.3(b)** Comparison of the mean cumulative intrusion volumes for white and Type 10 modified cement paste samples after 16 weeks of curing versus up to nine months of immersion in a chloride-contaminated simulated pore solution. Each curve is the mean of either three samples (16 weeks curing) or twelve samples (up to nine months of immersion).

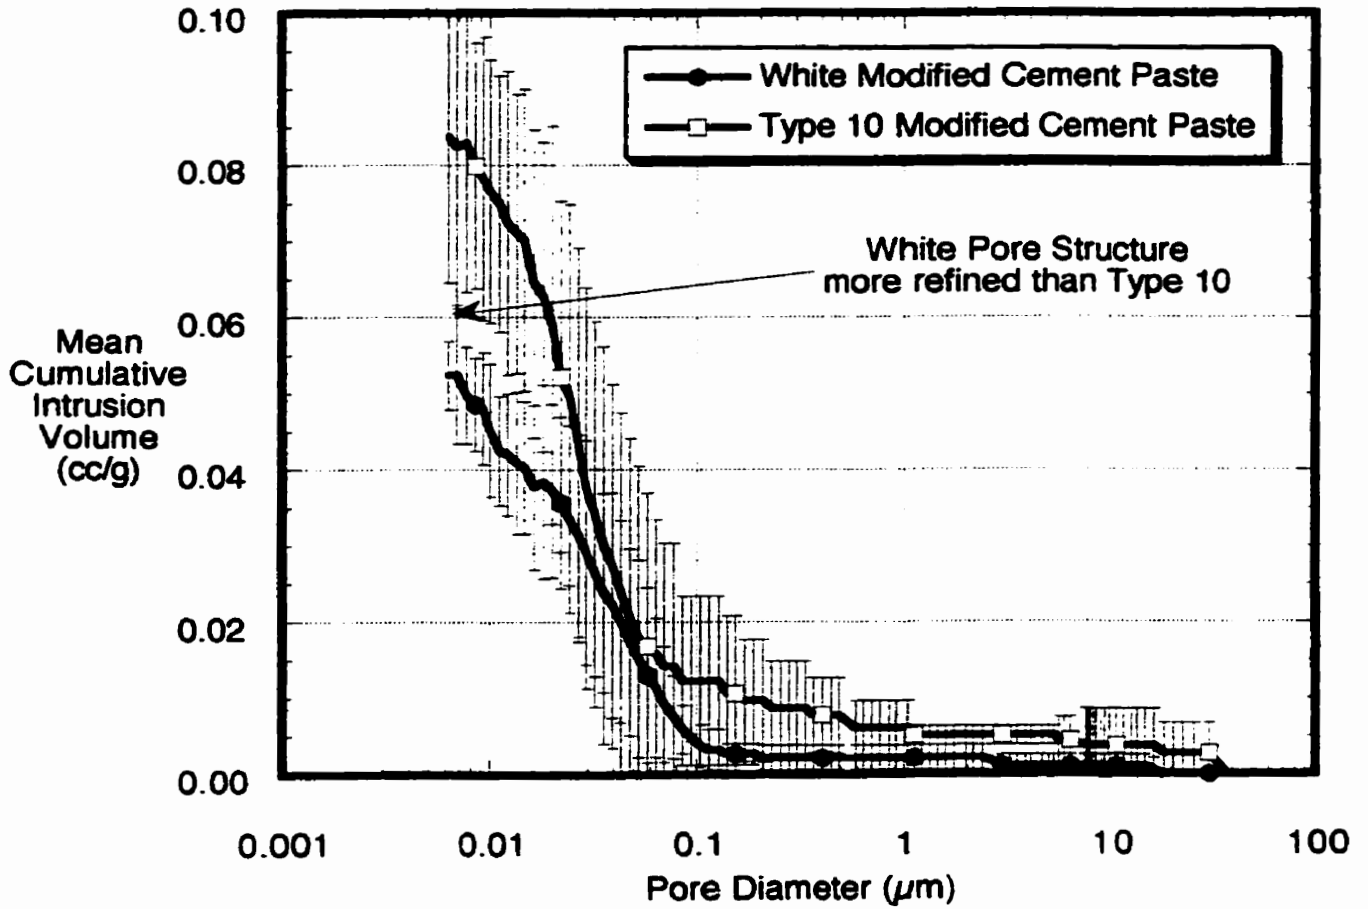
**Figure 5.3.3(c)** Comparison of the mean cumulative intrusion volumes after moist curing for 16 weeks in their moulds. Each curve is an average of three samples and a 80% confidence interval was applied.

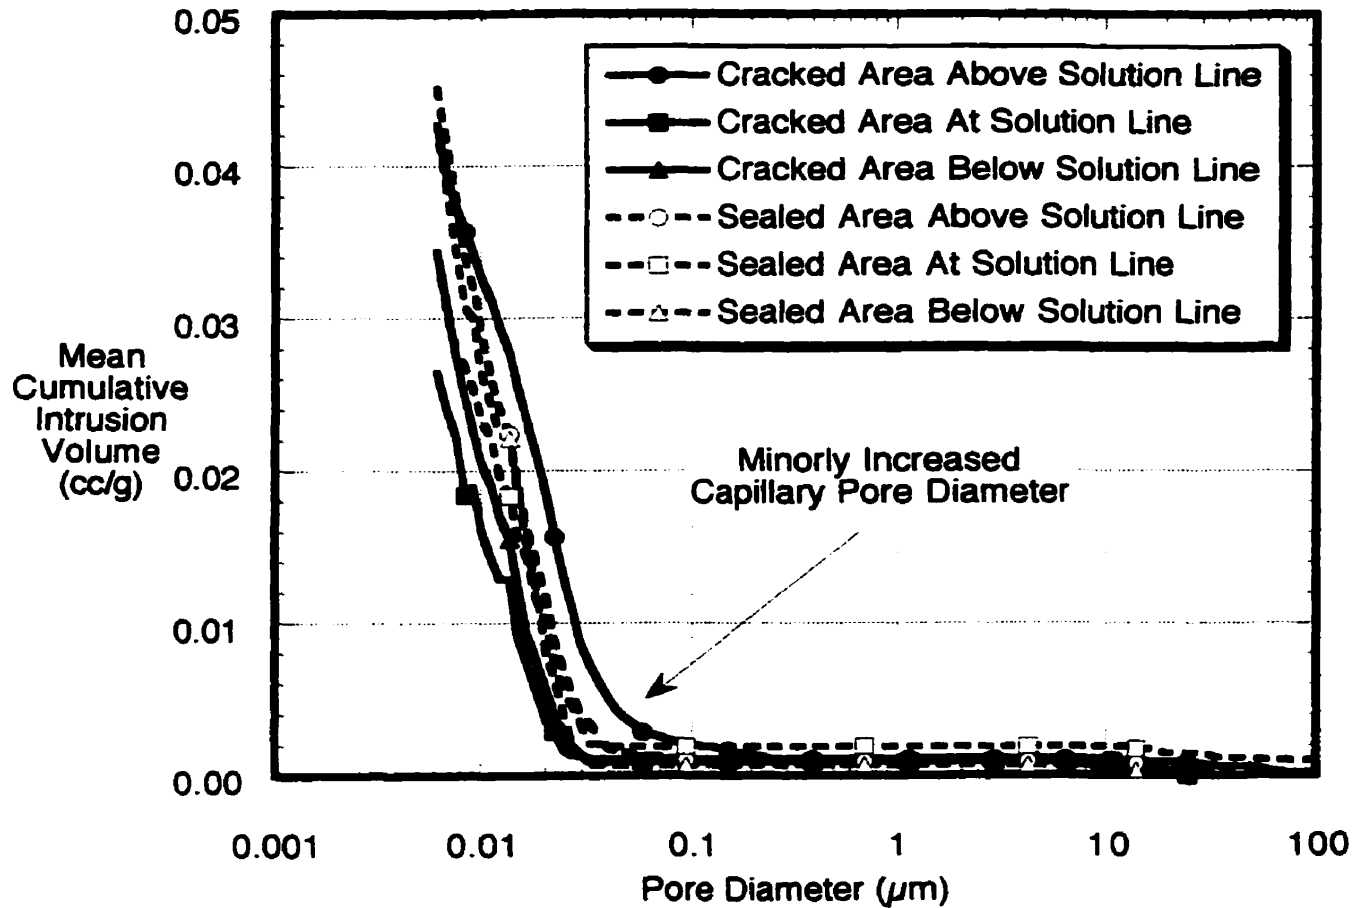
**Figure 5.3.3(d)** A comparison of the mean cumulative intrusion volume for white modified cement samples from above, at, and below the solution line. Each curve is the mean of three samples, one sample from three different specimens.

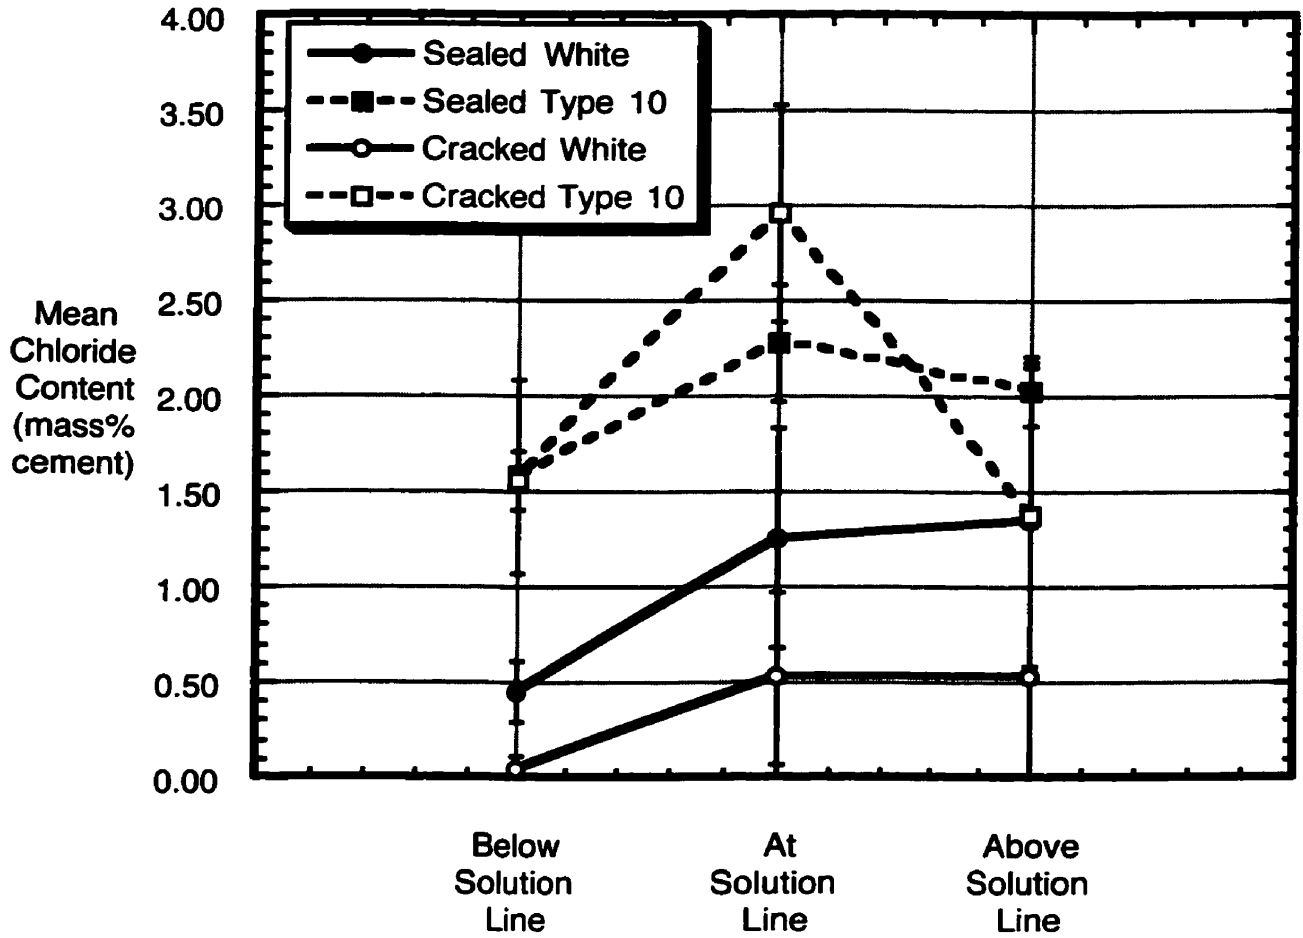
**Figure 5.3.4** Comparison of the mean chloride contents for the white and Type 10 modified cement paste samples. The error bars represent a 67% confidence interval.

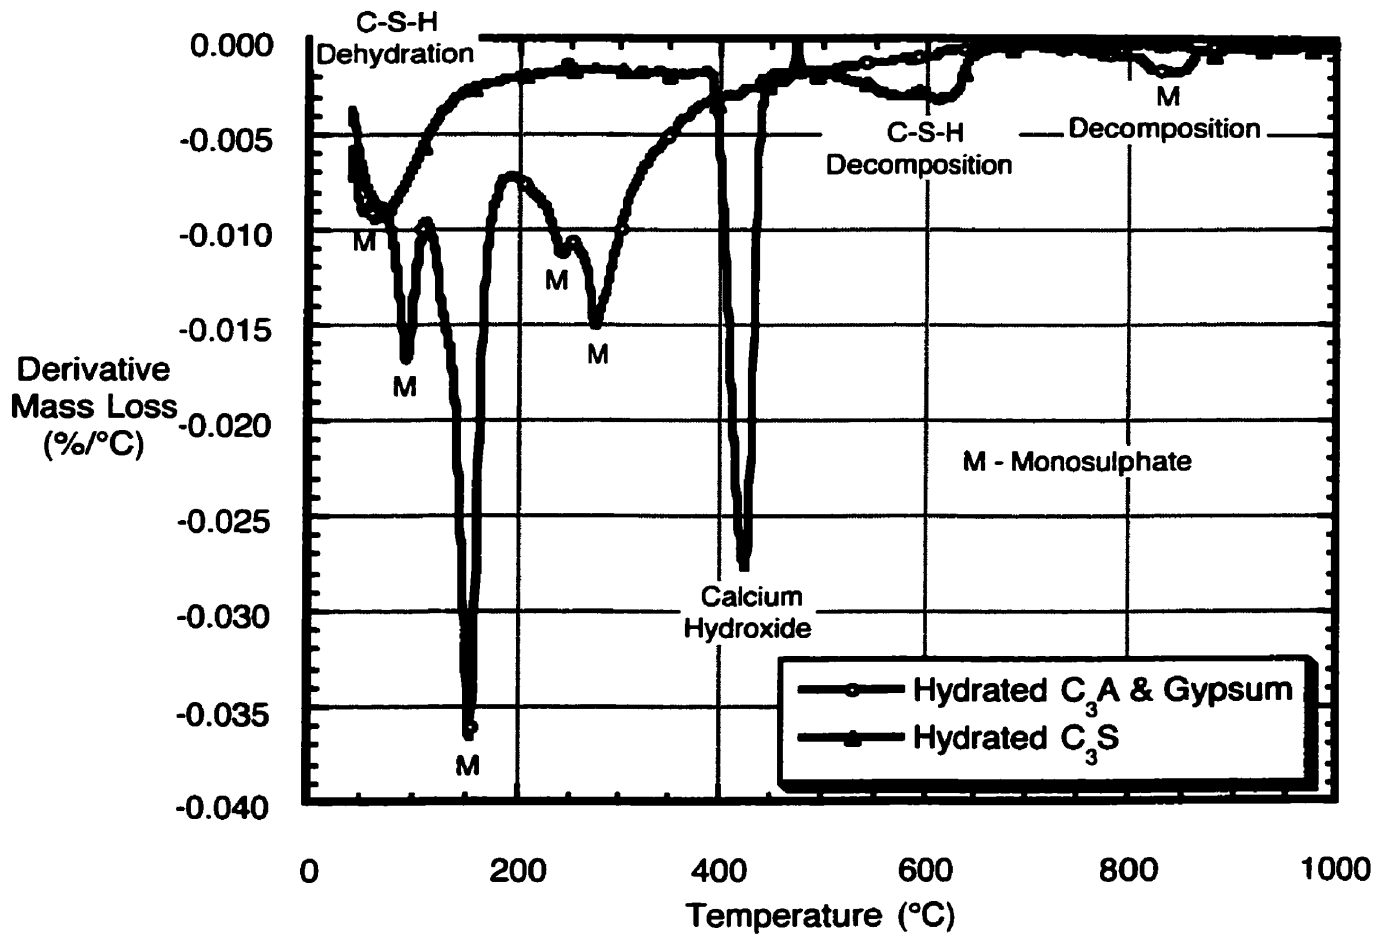
**Figure 5.3.5(a)** The differential thermogravimetric curve for mineral reference standards of C<sub>3</sub>S and C<sub>3</sub>A intermixed with an appropriate quantity of gypsum (CaSO<sub>4</sub>·2H<sub>2</sub>O).

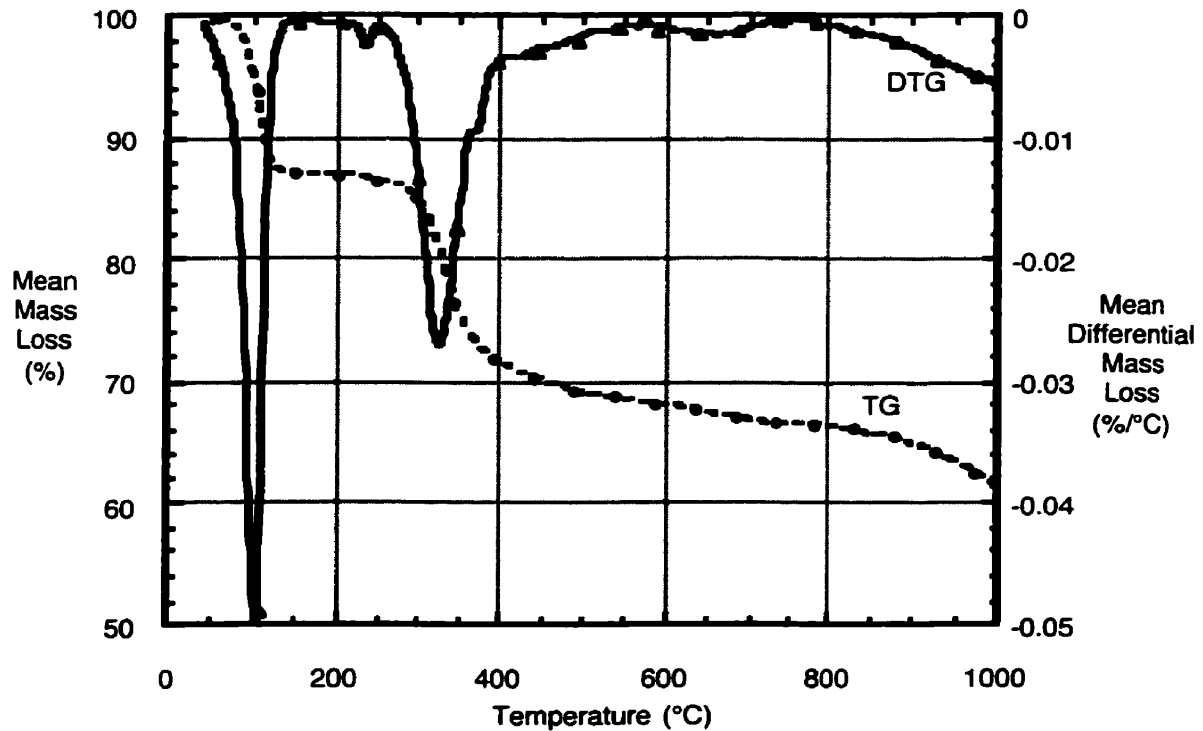
**Figure 5.3.5(b)** The mass loss and differential thermogravimetric curves for mineral reference standard of synthetic calcium monochloroaluminate (Friedel's salt -  $C_3A \cdot CaCl_2 \cdot 10H_2O$ ).

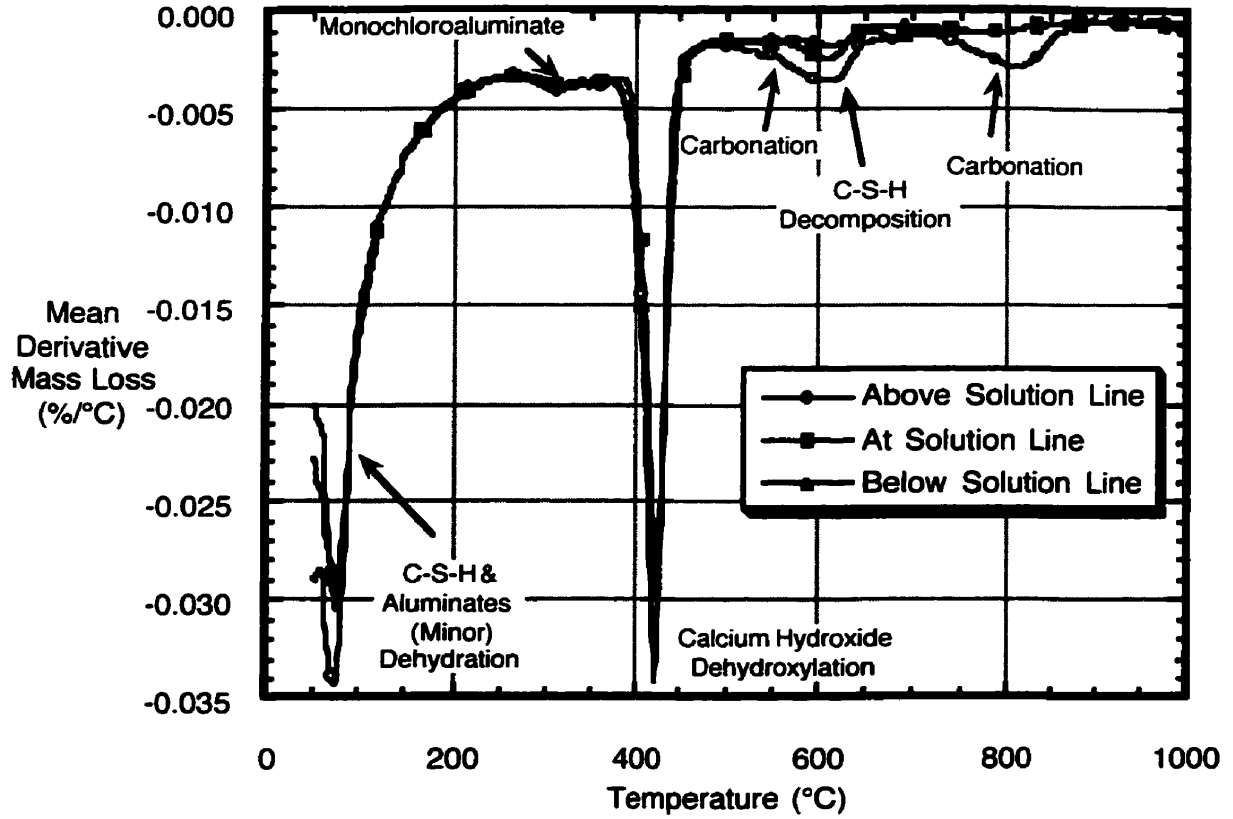
Figure 5.3.5(c) The differential thermogravimetric curve for white modified cement paste samples taken from above, at, and below the solution line.

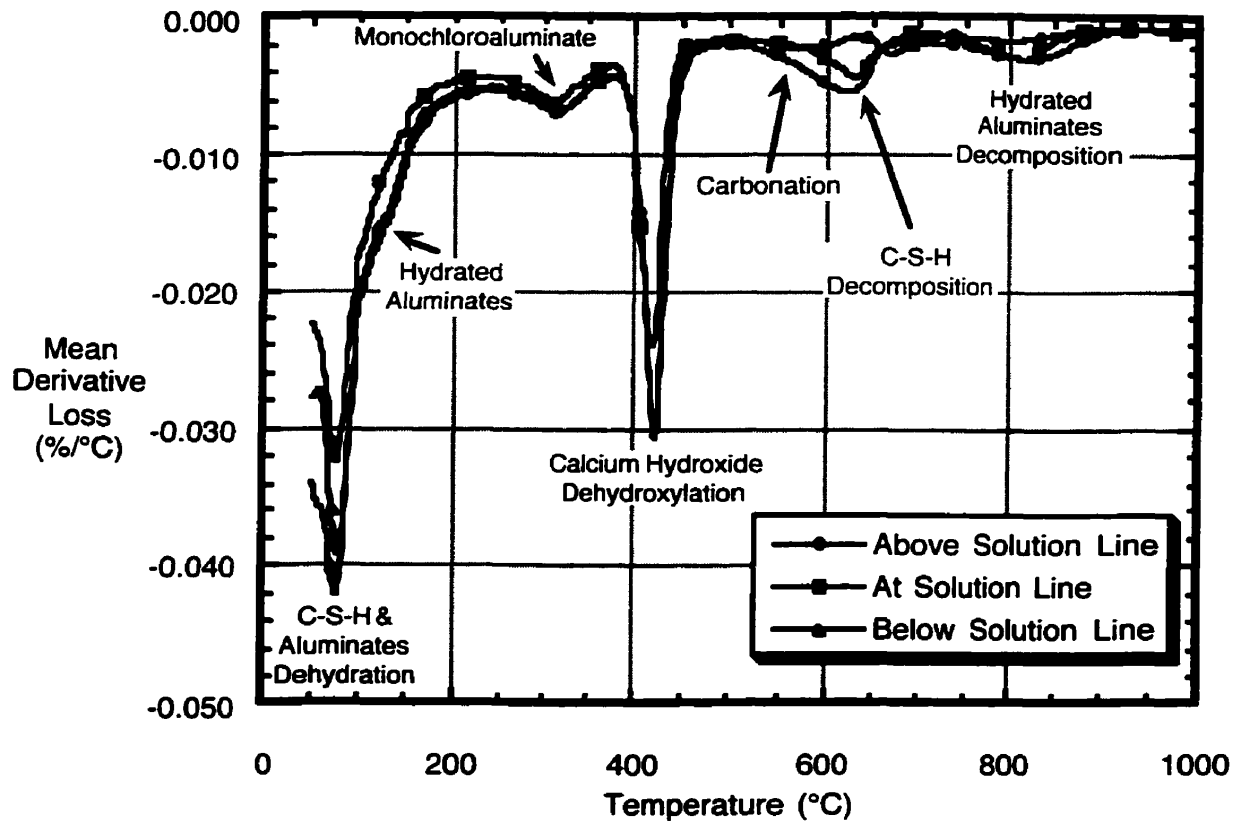
**Figure 5.3.5(d)** The differential thermogravimetric curve for Type 10 modified cement paste samples taken from above, at, and below the solution line.

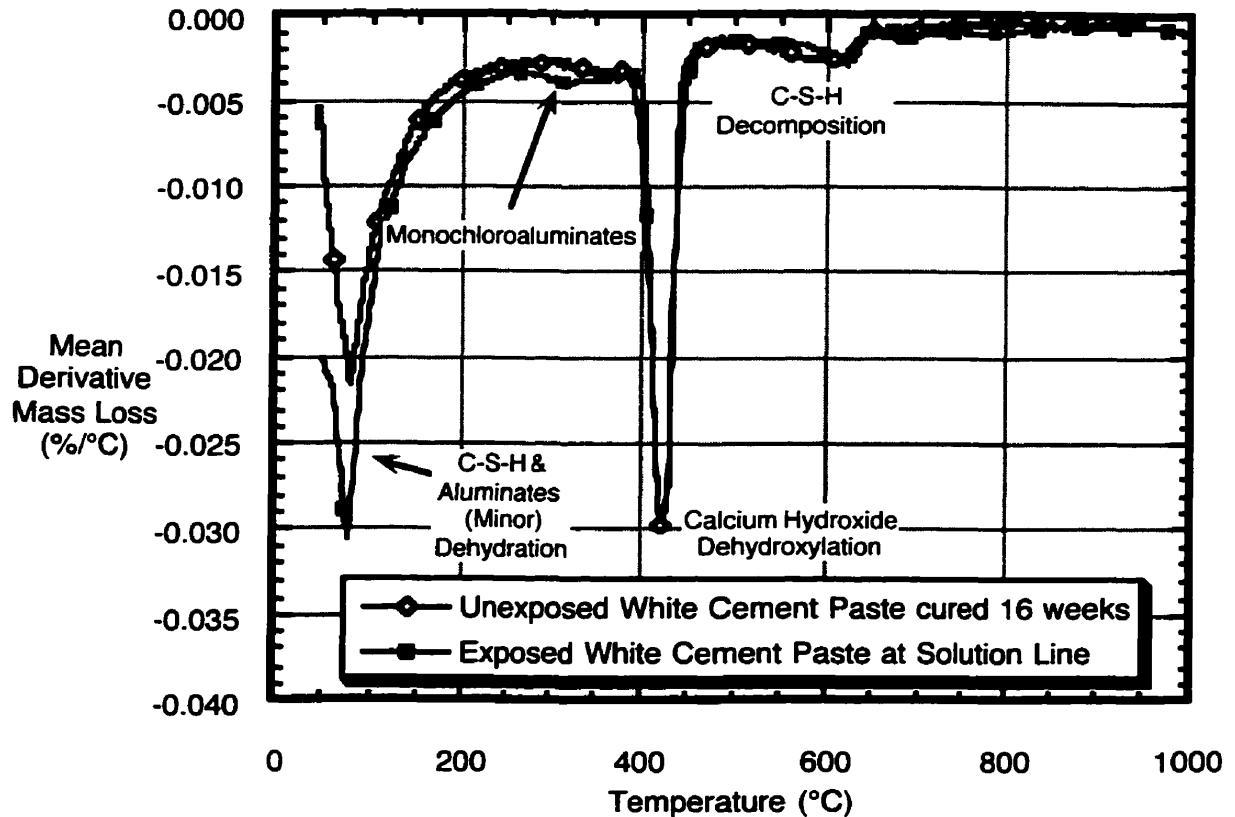
**Figure 5.3.5(e)** A comparison of the mean differential thermogravimetric curves for samples of white modified cement paste that were not exposed to the chloride-contaminated simulated pore solution (only moist-cured for 16 weeks) with those that had for almost one year. Each curve is the mean of six samples.

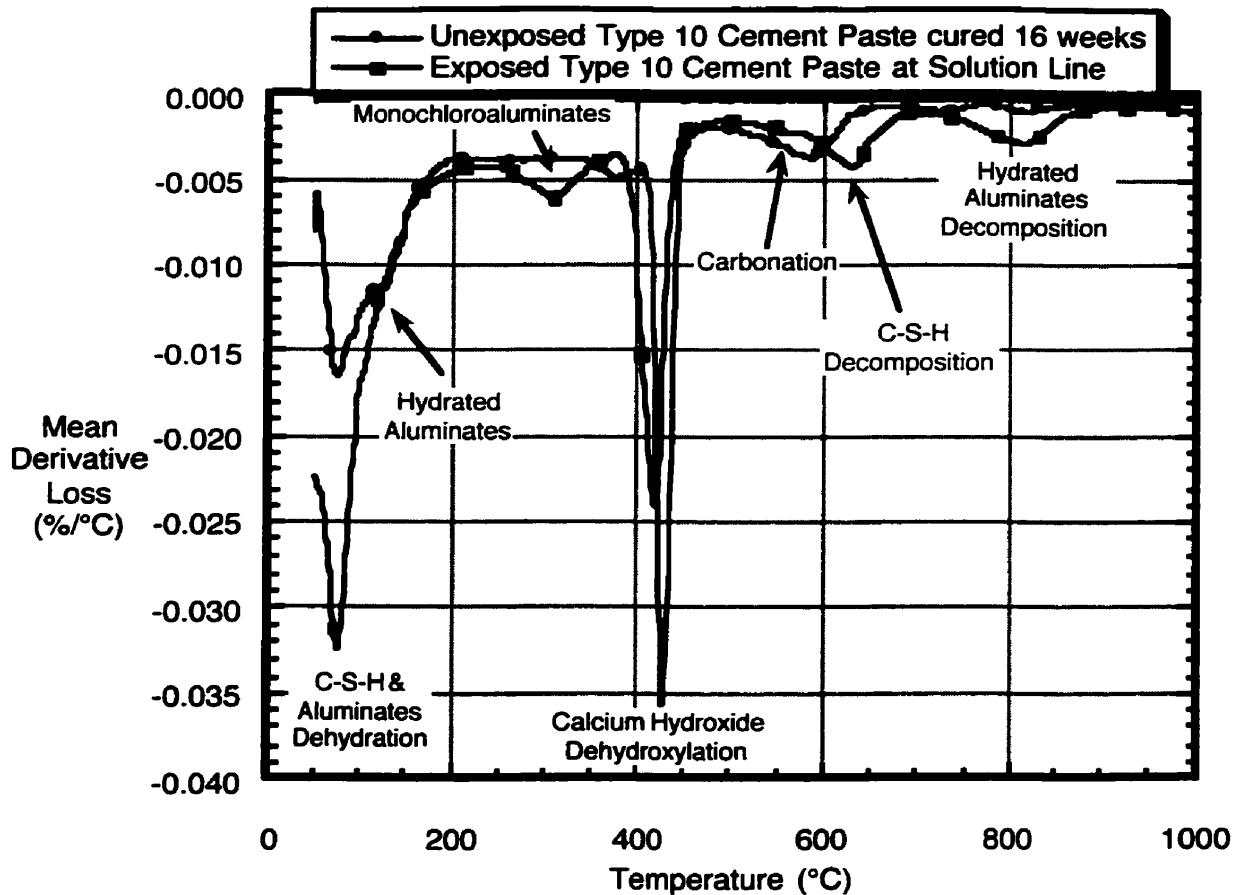
**Figure 5.3.5(f)** A comparison of the mean differential thermogravimetric curves for samples of Type 10 modified cement paste that were not exposed to the chloride-contaminated simulated pore solution (only moist-cured for 16 weeks) with those that had for almost one year. Each curve is the mean of six samples.

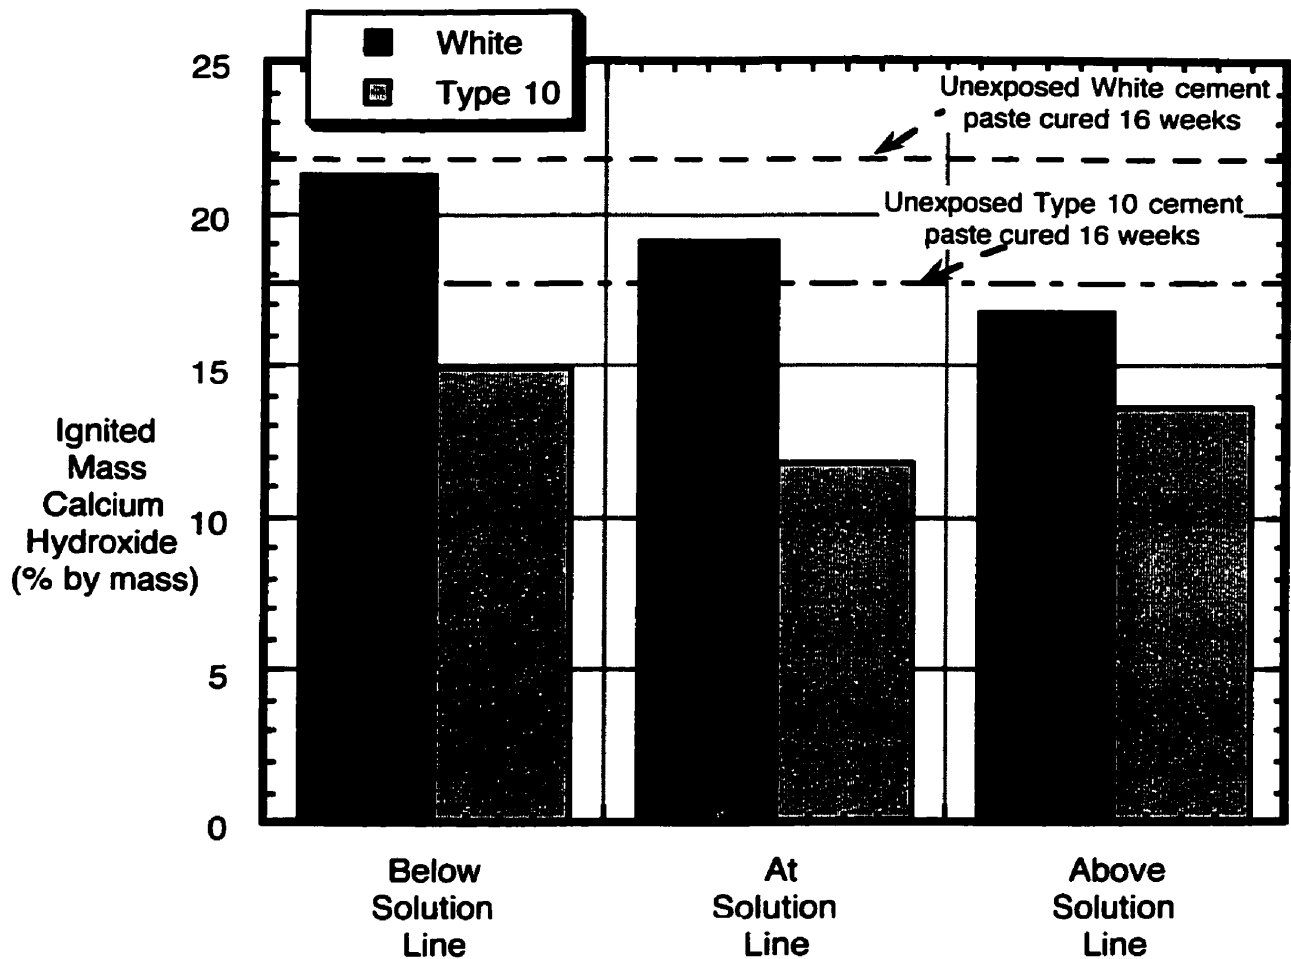
**Figure 5.3.5(g)** A comparison of the mean ignited mass of calcium hydroxide measured in samples taken from above, at, or below the solution line. Each measurement is the mean of six samples and contained an error of  $\pm 0.5\%$  for a 95% confidence interval.

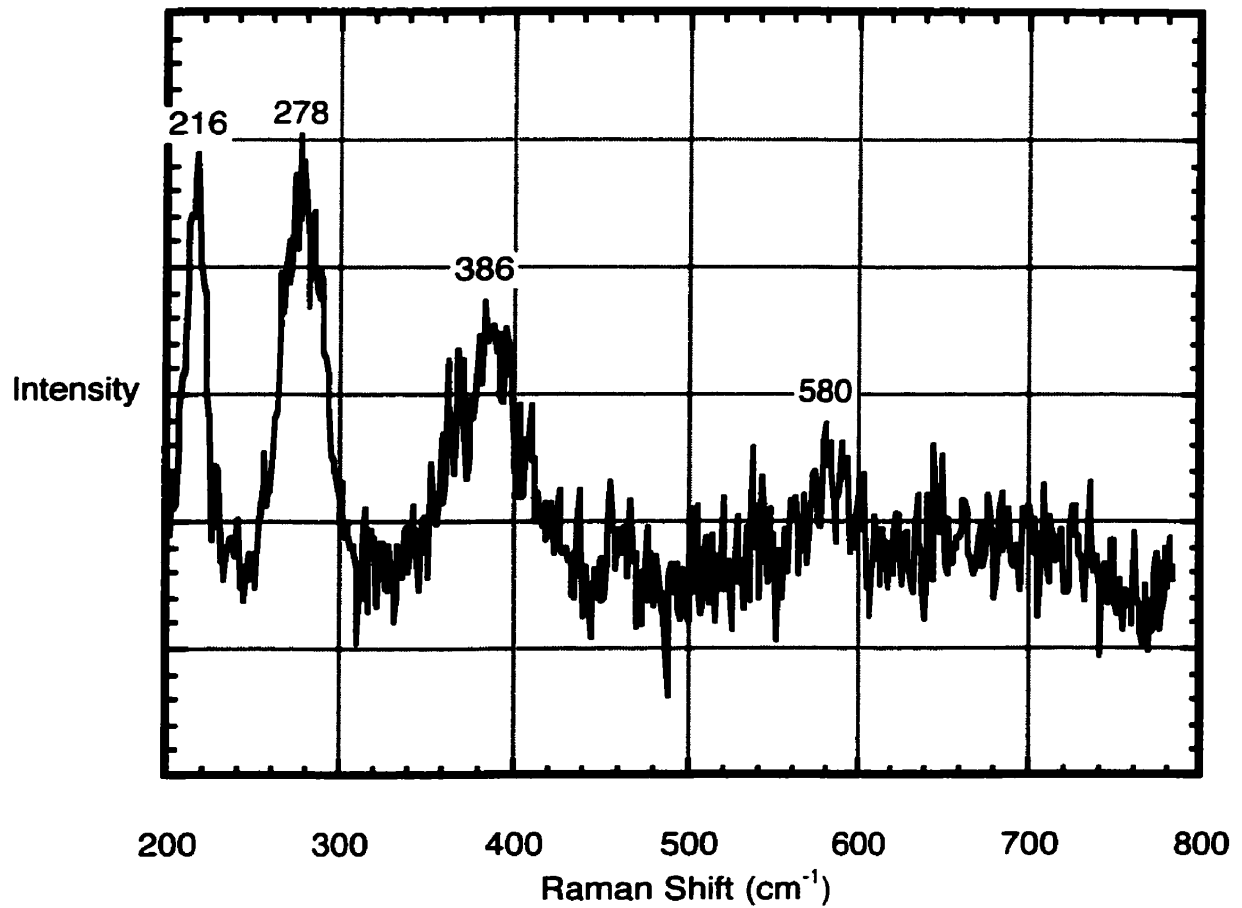
**Figure 5.3.6(b)** Representative spectrum from an area of a white cement paste section containing a green coloured corrosion product--spectra identified as hæmatite.
