**Characterization of Chloride-Induced  
Corrosion Products that form in  
Steel-Reinforced Cementitious  
Materials**

A thesis  
presented to the University of Waterloo  
in fulfilment of the  
thesis requirement for the degree of  
Doctor of Philosophy  
in  
Mechanical Engineering

# ABSTRACT

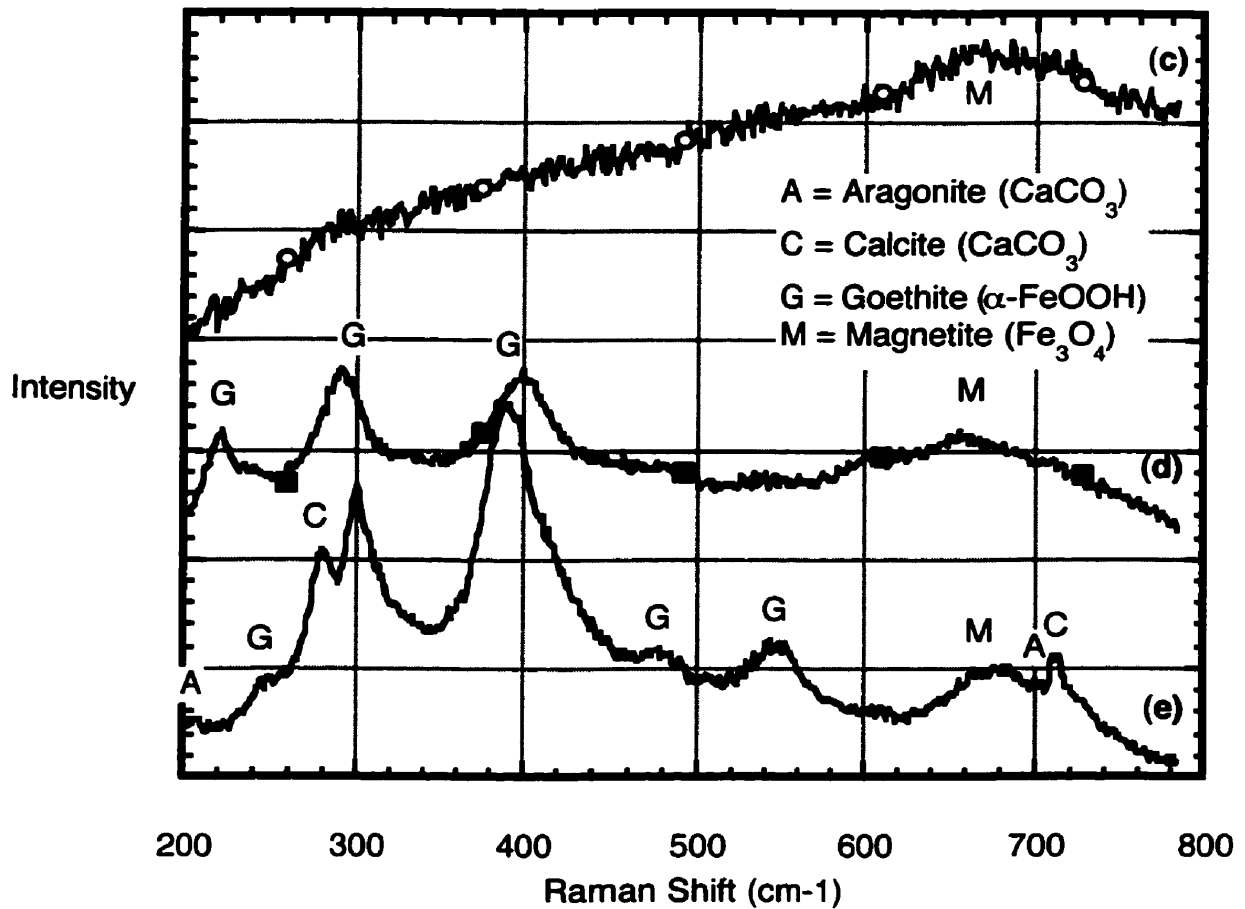
Figures 5.3.6(c), (d), and (e) Representative spectra of corrosion products within a crack located below the solution line.

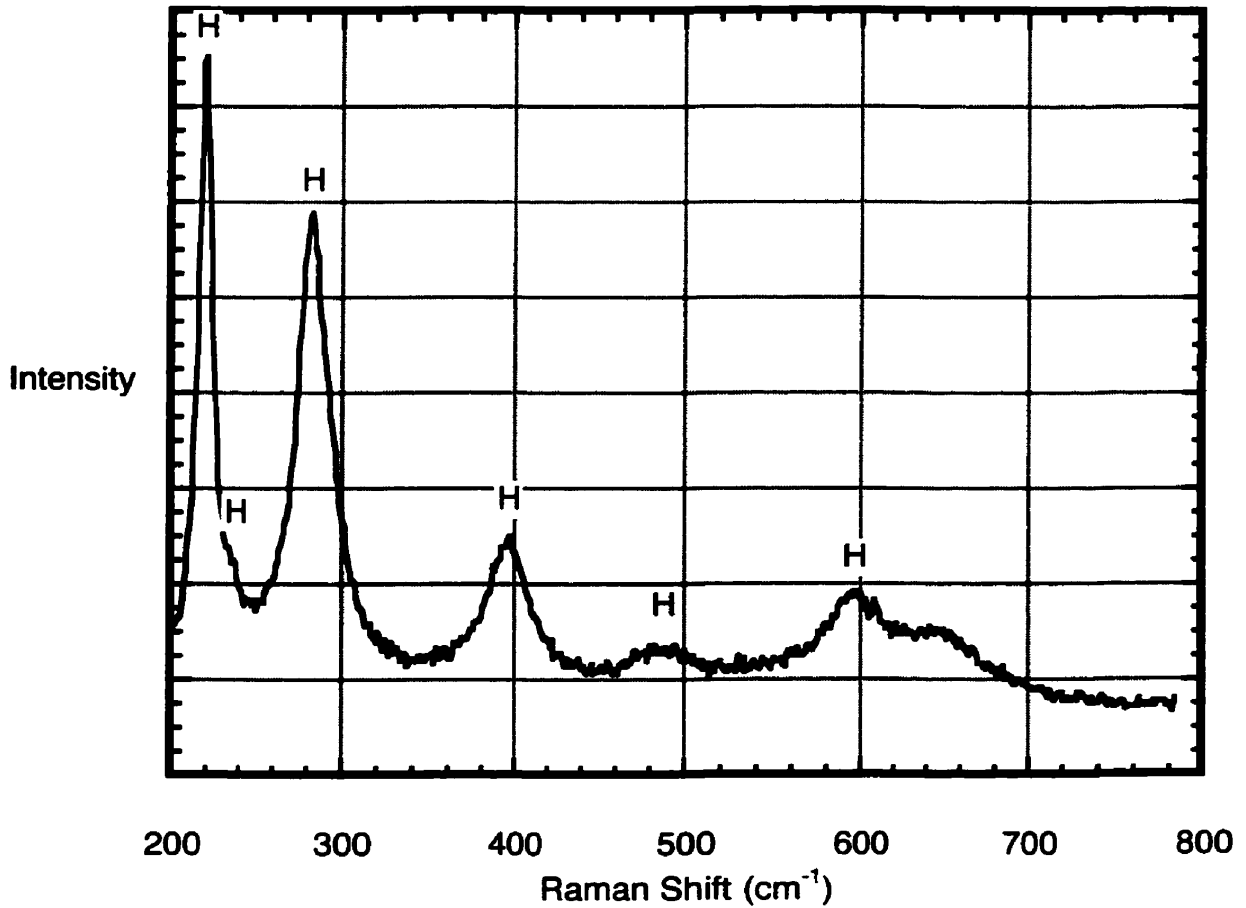
**Figures 5.3.6(f)** Representative spectrum of hæmatite (H) within a crack located above the solution line.

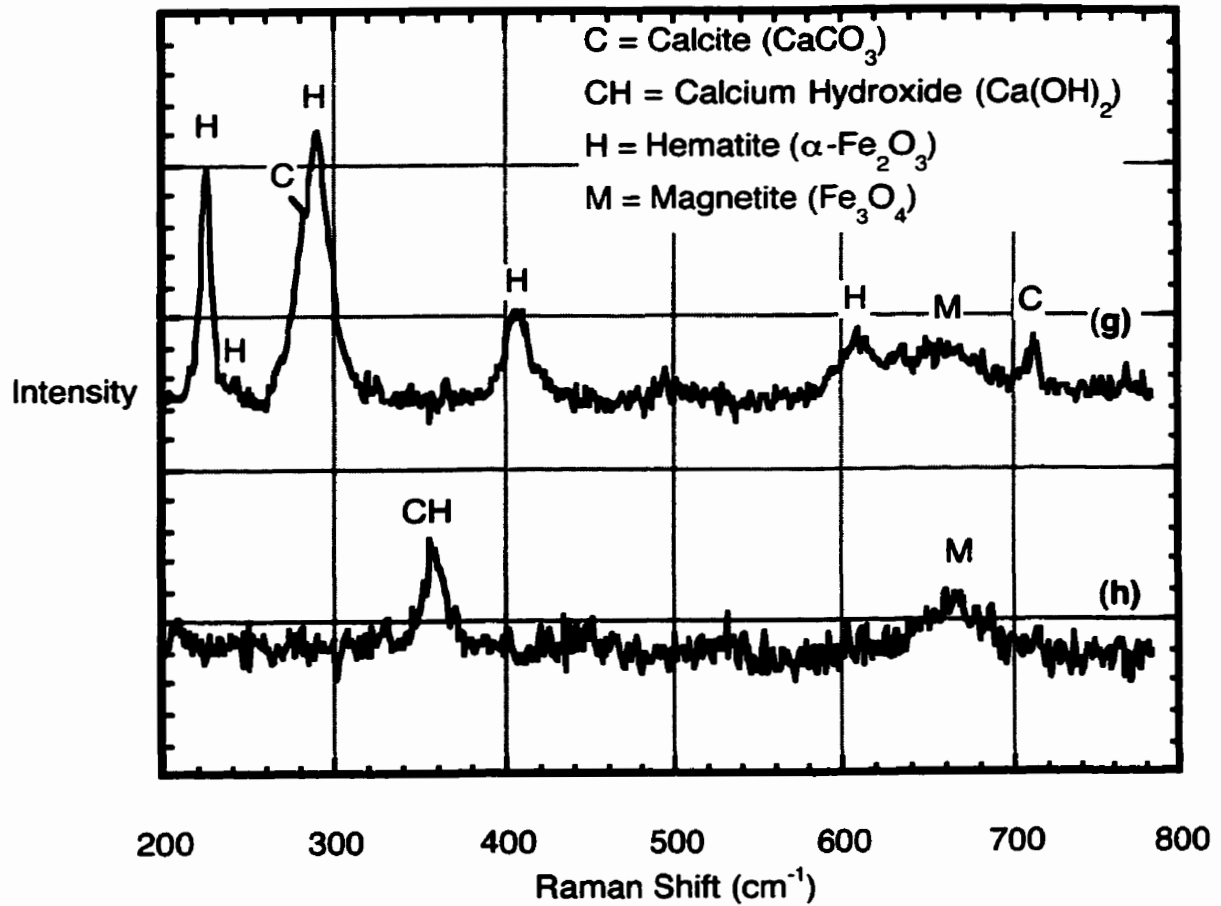
**Figures 5.3.6(g) and (h)** Comparison of Raman spectra from (g) an area of Type 10 modified cement paste with a concentrated orange stain and (h) an area of unstained cement paste.

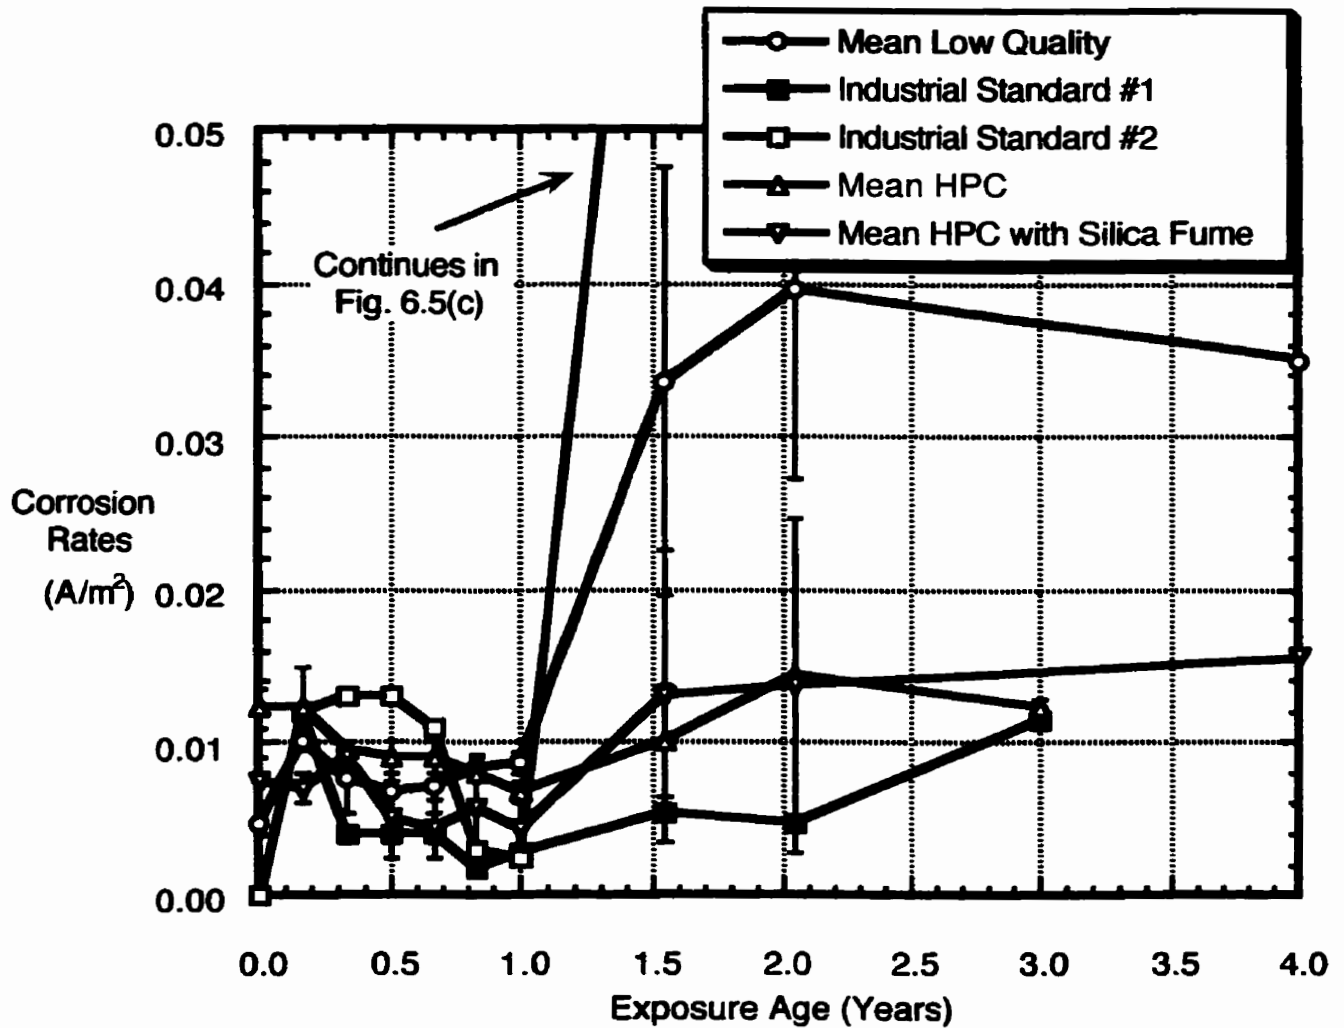
**Figure 6.5(a)** Comparison of the mean corrosion rates of the steel probes intersected by the crack. Note: Bars representing the range of measurements are shown for all concretes except for the industrial standard concrete. For this concrete, both curves are shown instead.

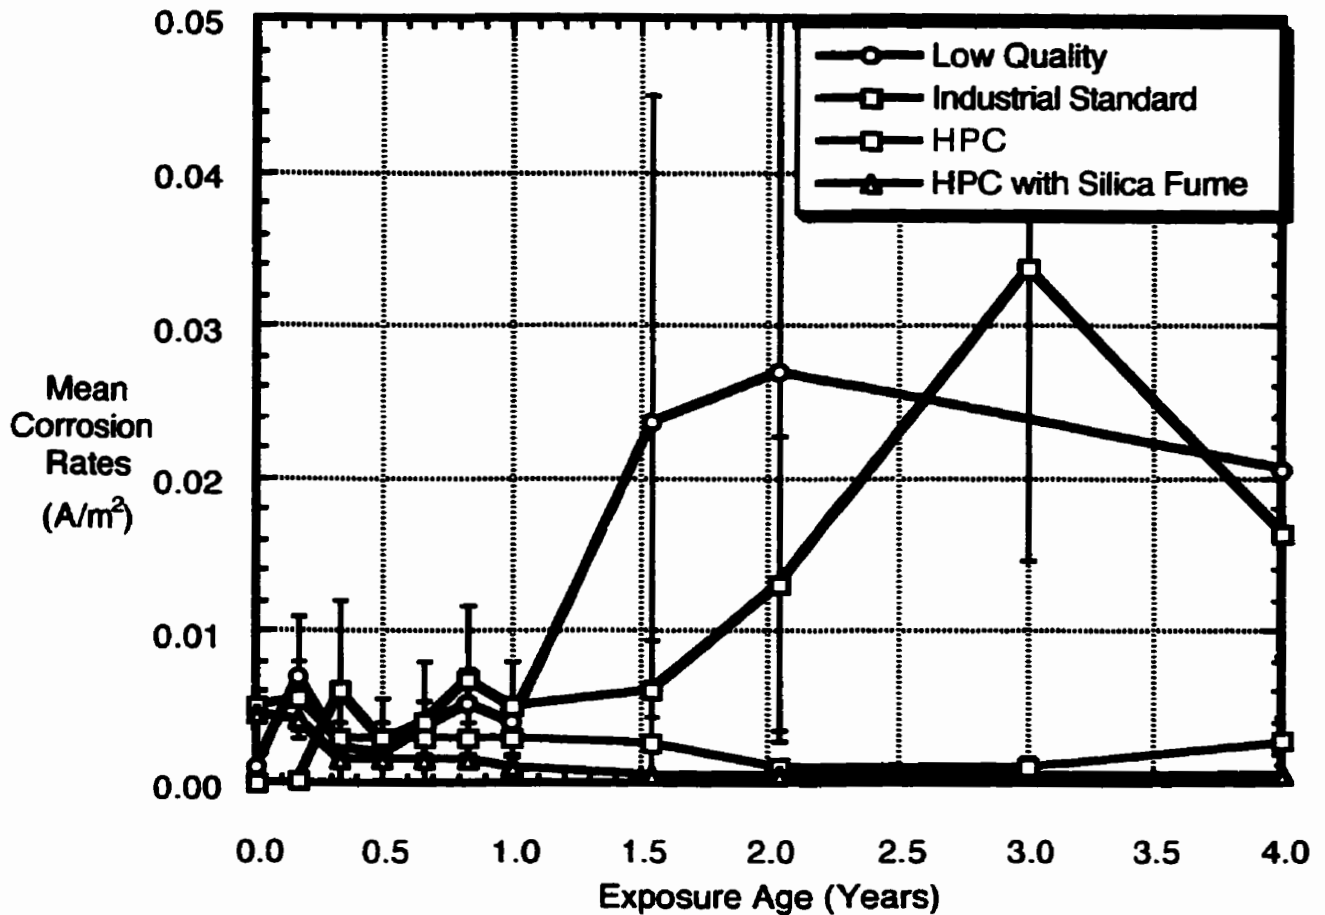
**Figure 6.5(b)** Comparison of the mean corrosion rates of the steel probes embedded within uncracked prisms. Note: Bars representing the range of measurements are shown for all concretes.

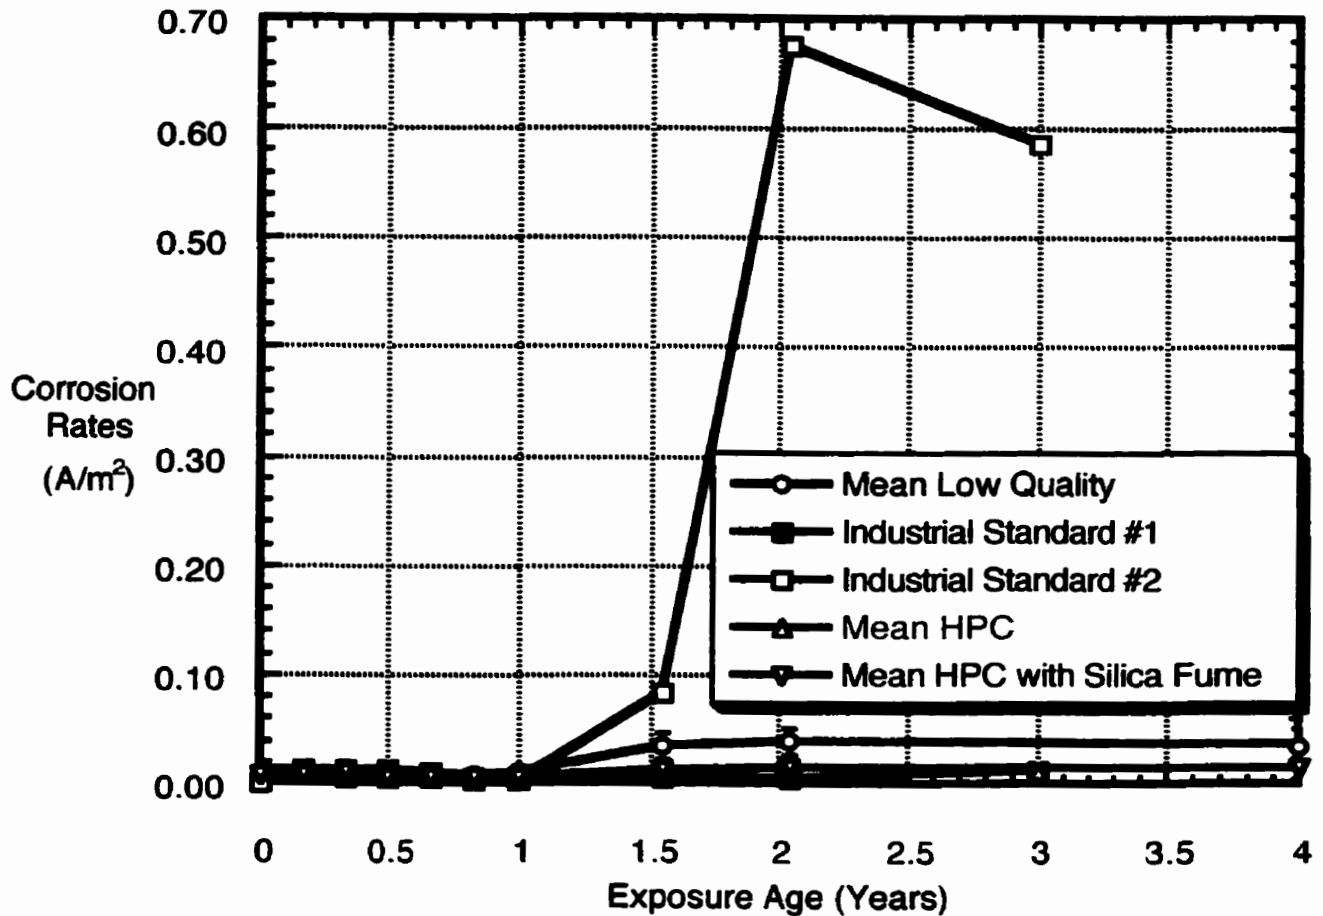
**Figure 6.5(c)** Comparison of the mean corrosion rates of the steel probes intersected by the crack (full scale version of Figure 6.5(a)). Note: Bars representing the range of measurements are shown for all concretes except for the industrial standard concrete. For this concrete, both curves are shown instead.

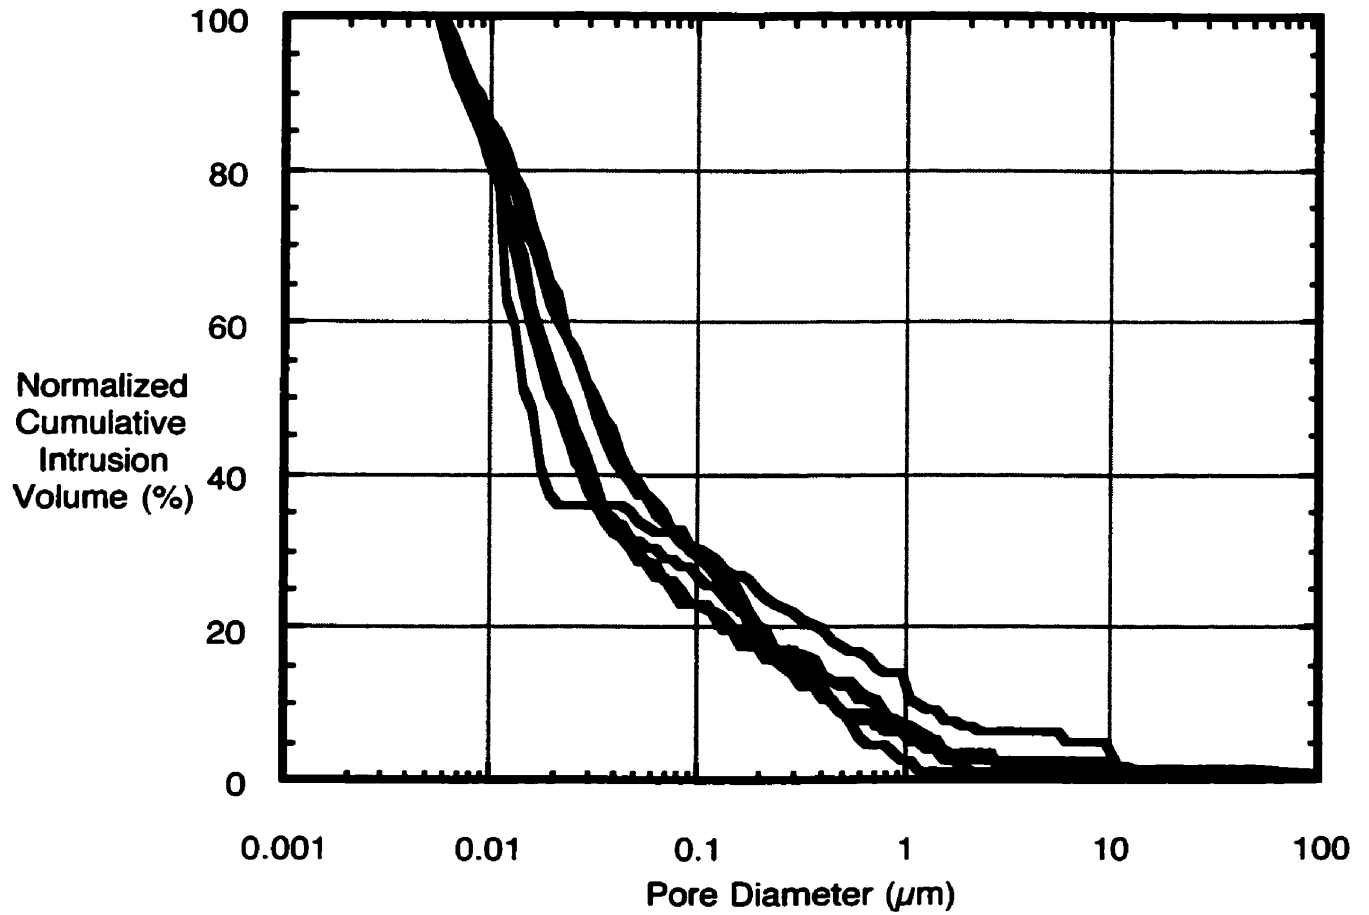
**Figure 6.6(a)** Comparison of the normalized cumulative intrusion volumes for concrete samples taken from the unstressed region of the low quality concrete.

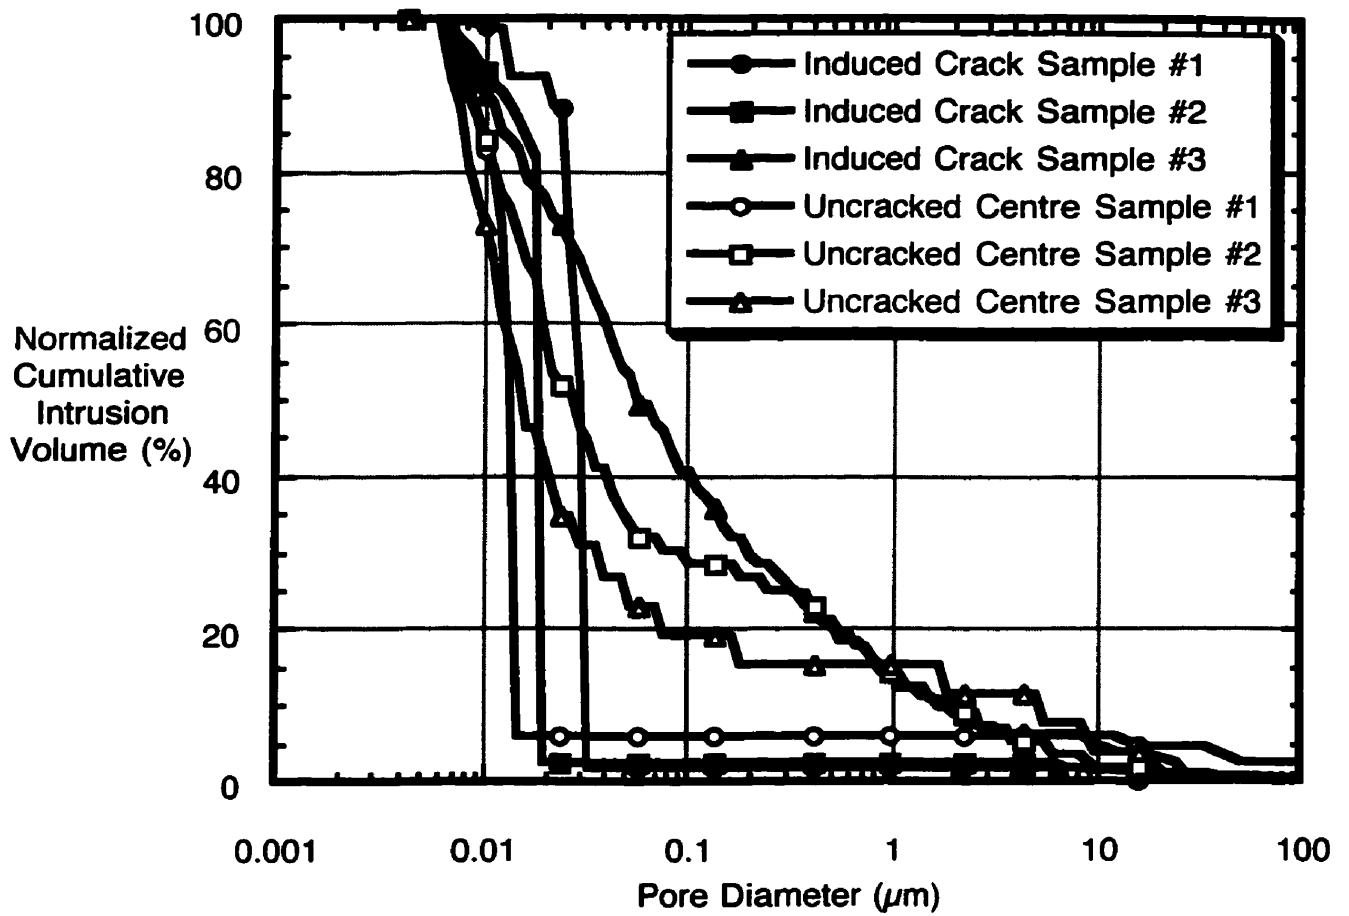
**Figure 6.6(b)** Comparison of the normalized cumulative intrusion volume for cracked and uncracked concrete samples taken from the low quality concrete.

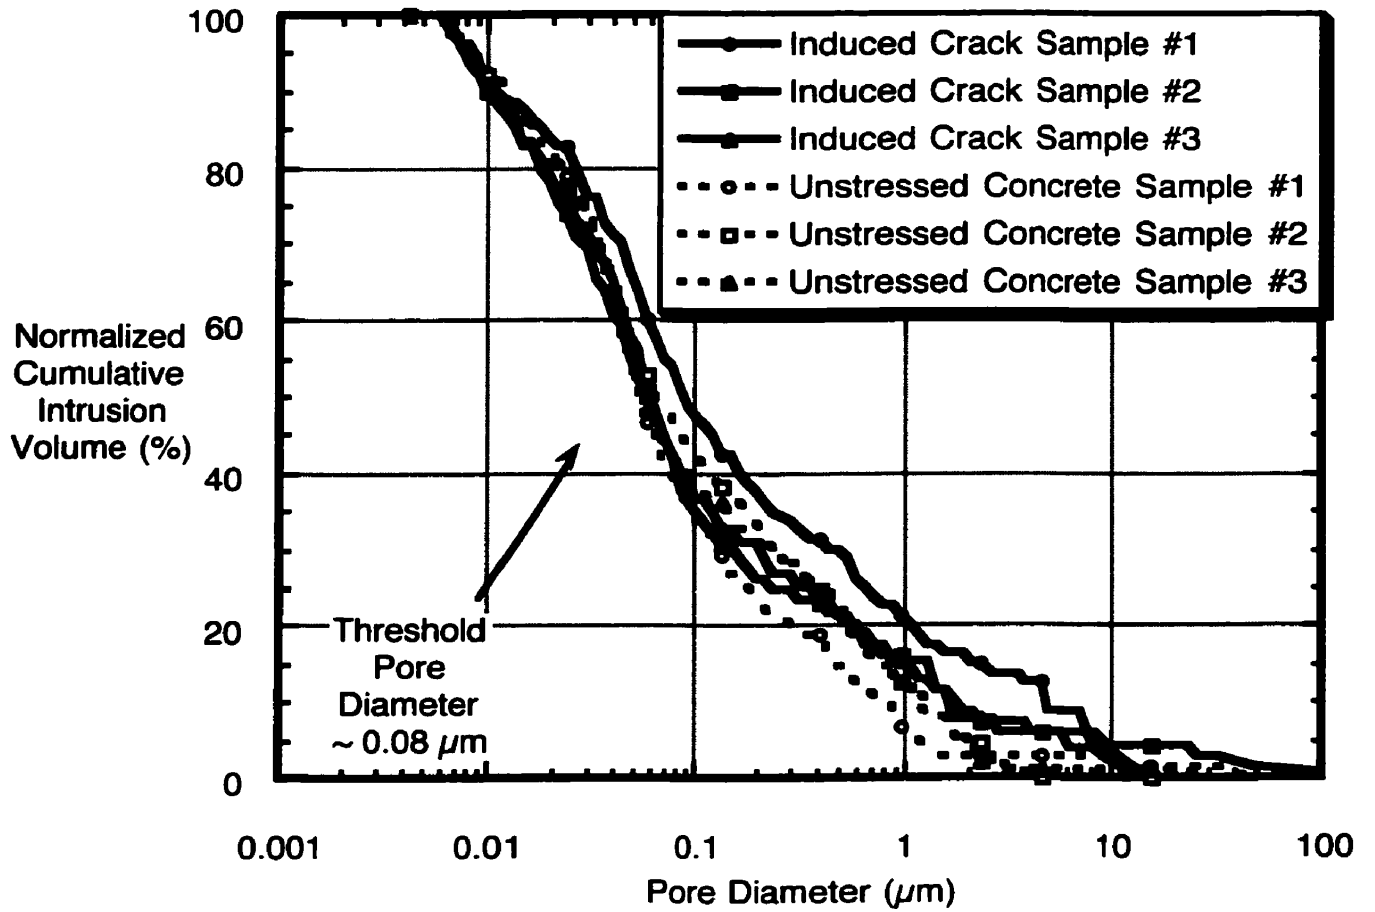
**Figure 6.6(c)** Comparison of the normalized cumulative intrusion volumes for concrete samples taken from the induced crack and unstressed regions of the industrial standard concrete.

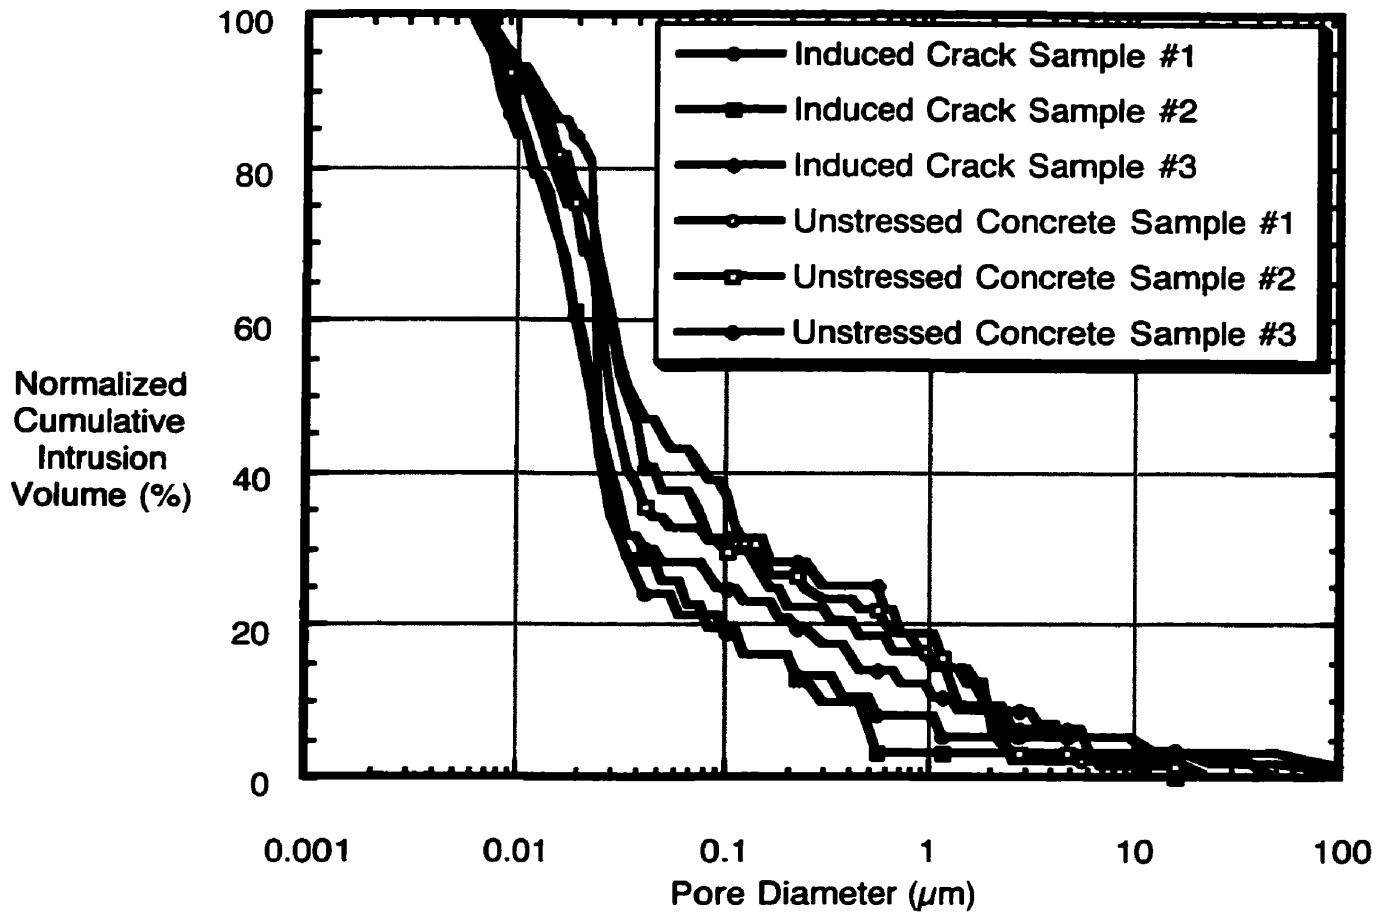
**Figure 6.6(d)** Comparison of the normalized cumulative intrusion volumes for concrete samples taken from the induced crack and unstressed regions of the high performance concrete (HPC).

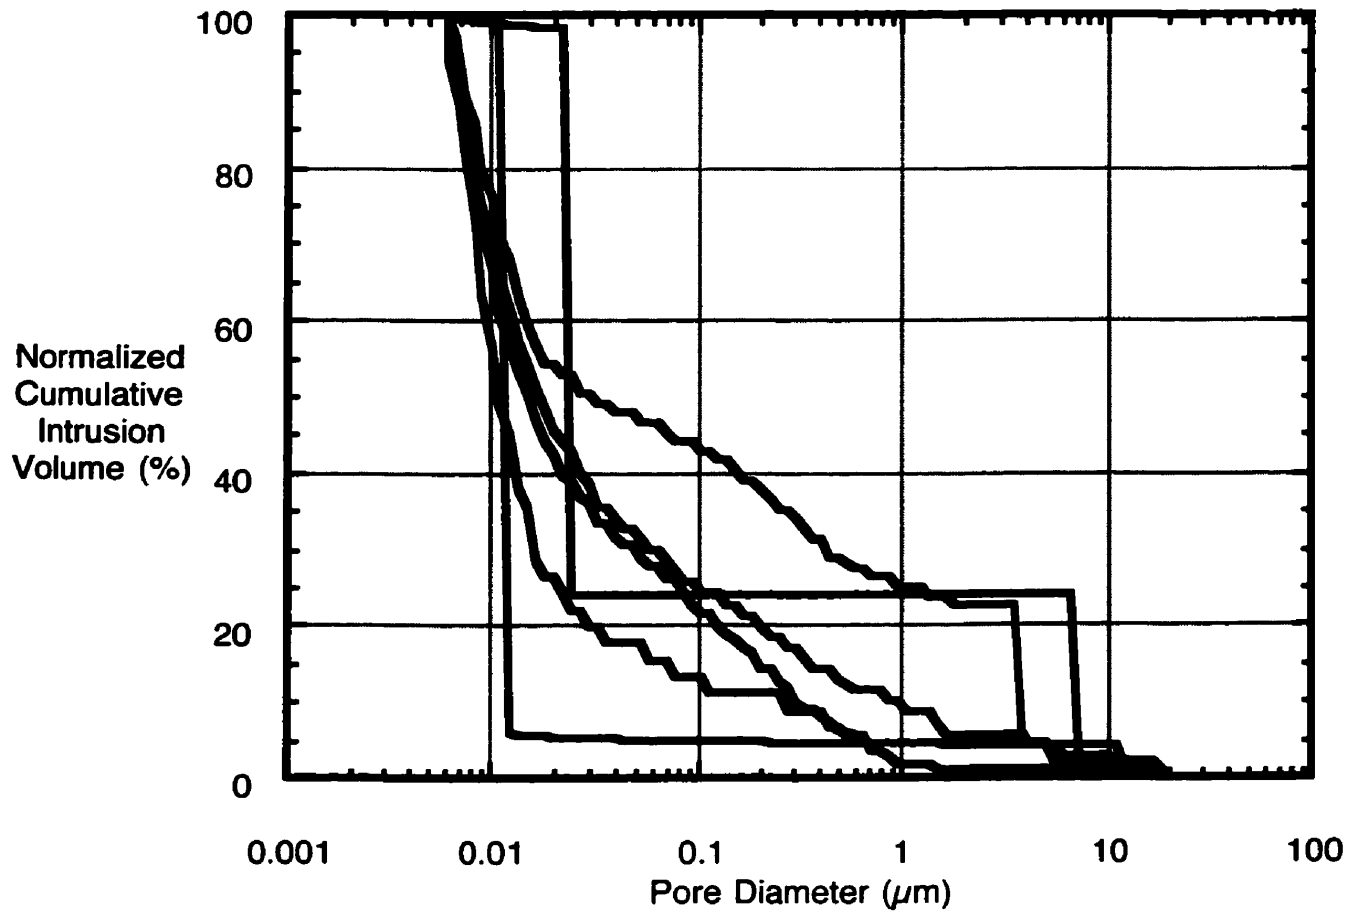
**Figure 6.6(e)** Comparison of the normalized cumulative intrusion volumes for concrete samples taken from the unstressed region of the high performance concrete with silica fume (HPC/SF).

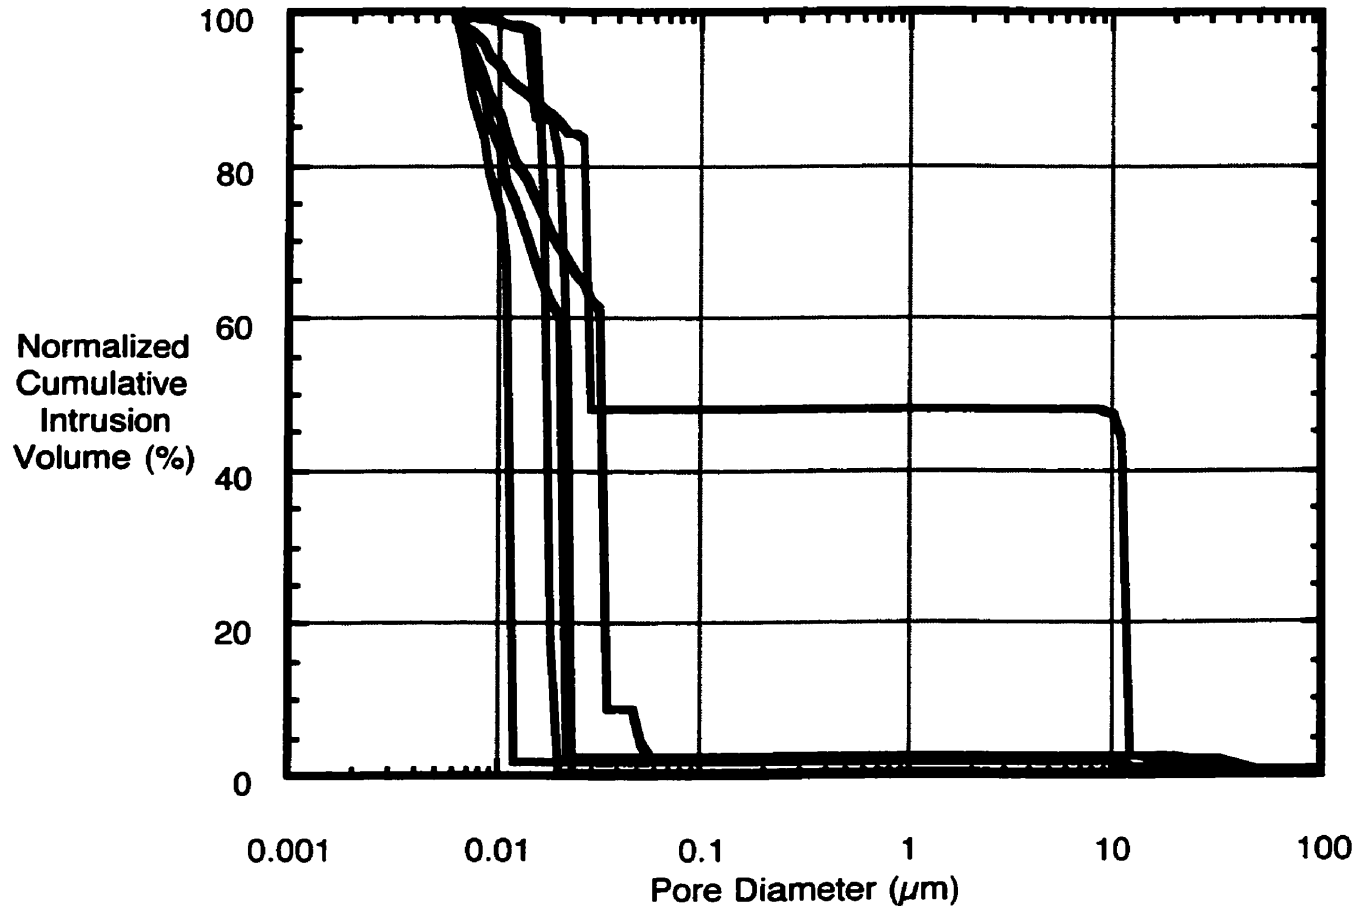
**Figure 6.6(f)** Comparison of the normalized cumulative intrusion volume for samples taken from the induced crack region of the high performance concrete with silica fume.

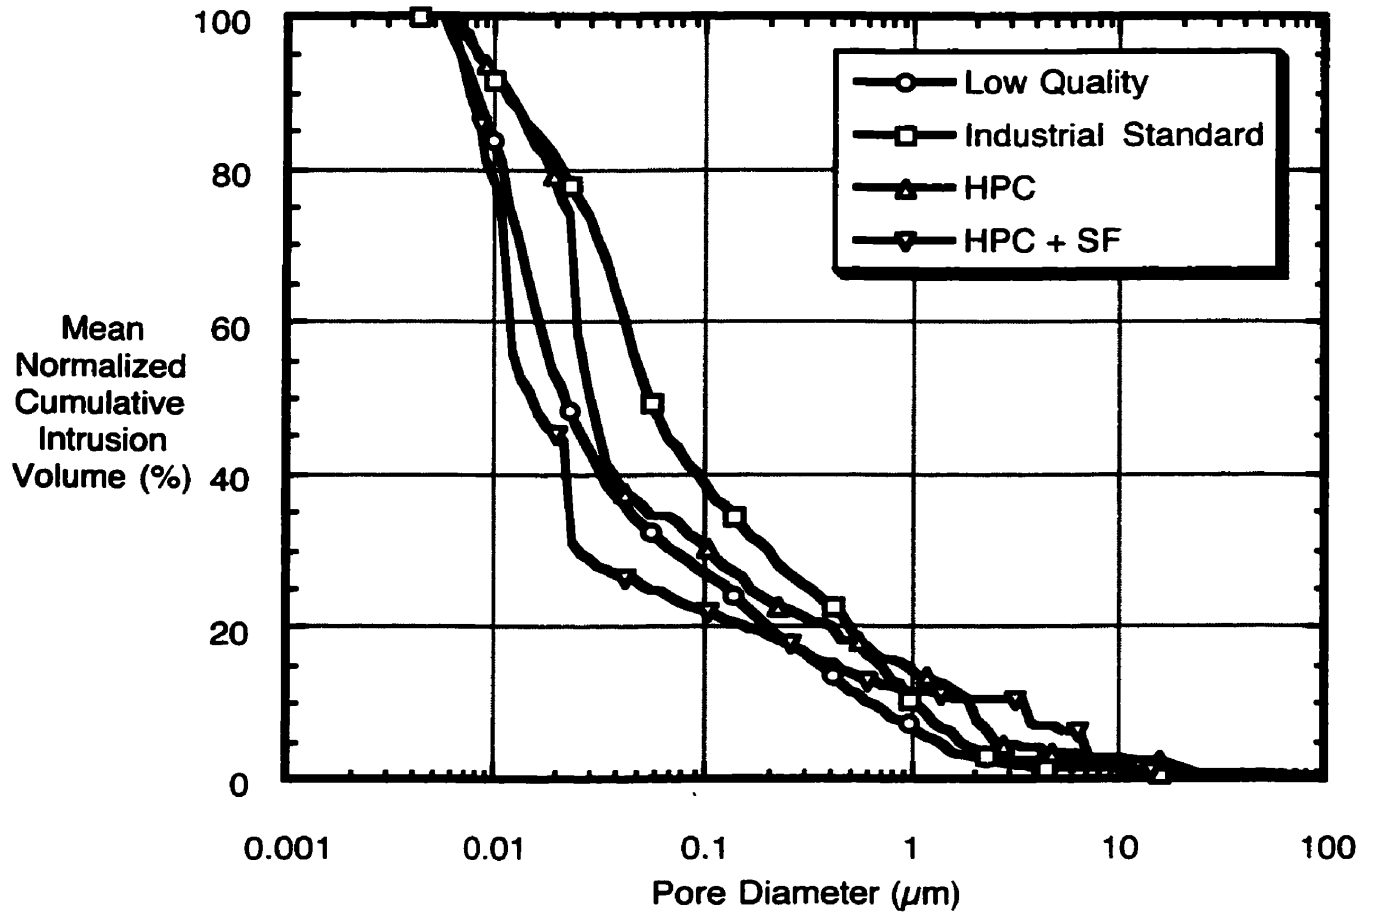
**Figure 6.6(g)** Comparison of the mean normalized intrusion volumes for concrete from the unstressed region of the concrete prisms.

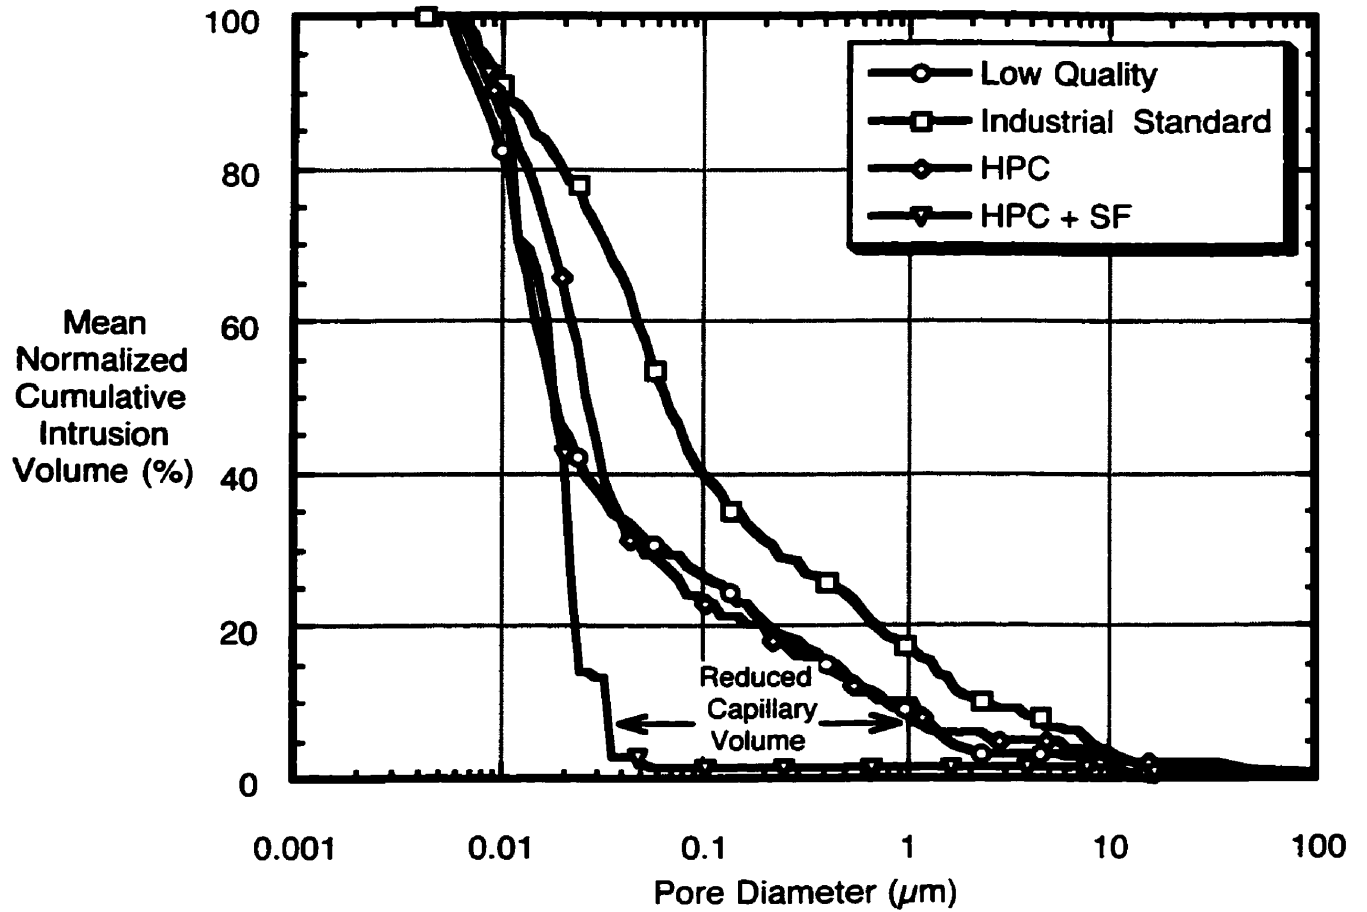
Figure 6.6(h) Comparison of the mean normalized intrusion volumes for the cracked region of the concrete prisms.

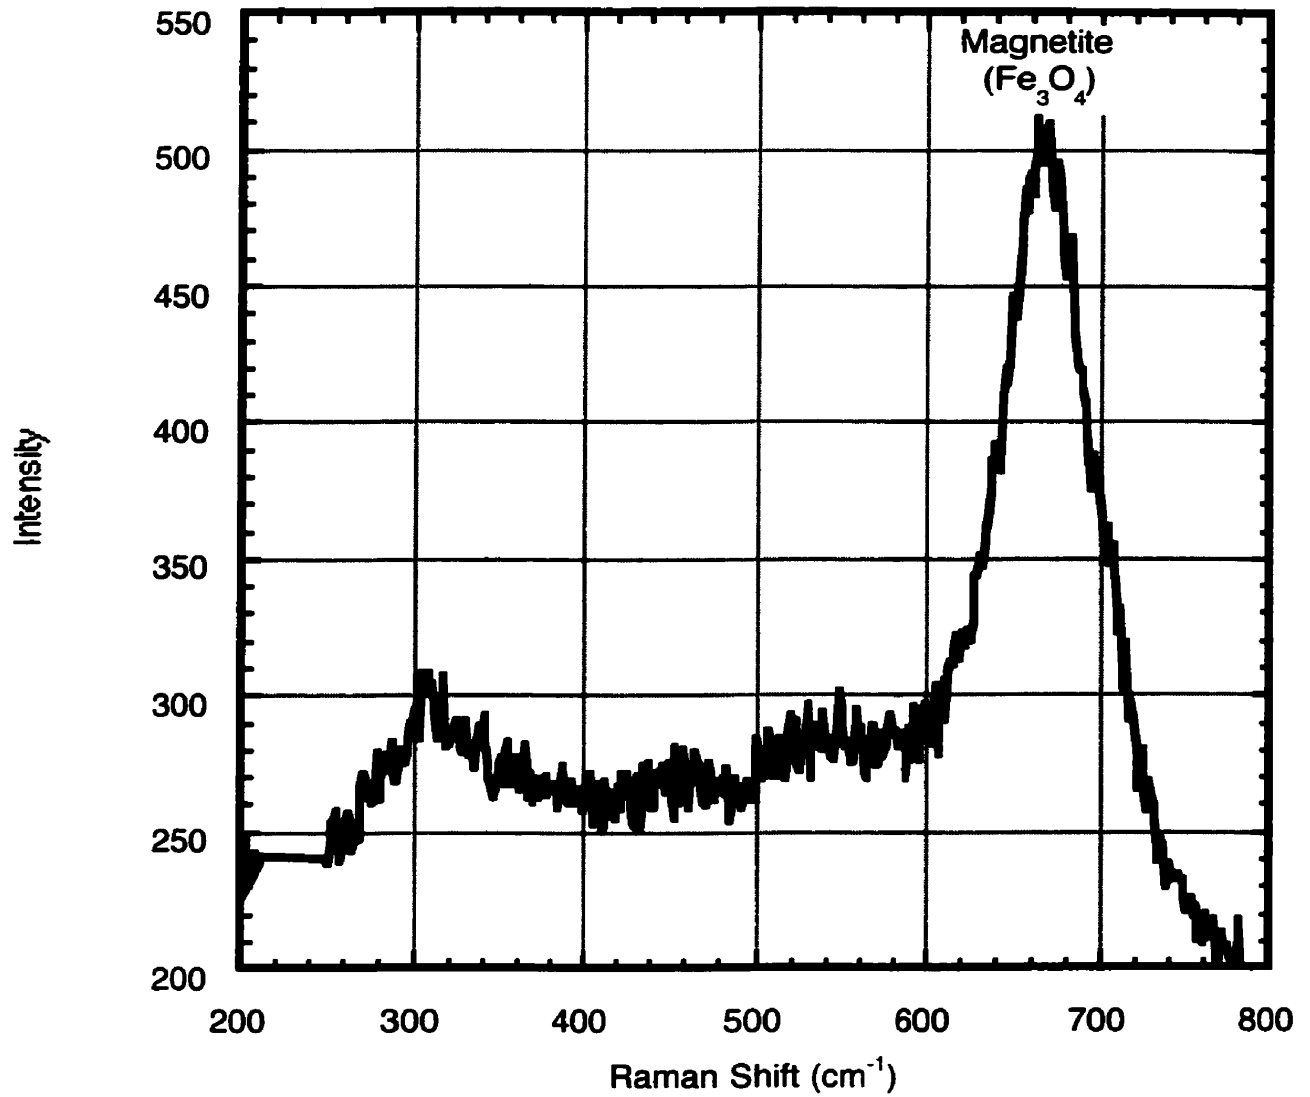
**Figure 6.7(f)** Raman spectra of the dense, dark brown/black corrosion product observed at the steel/concrete interface which also filled the induced crack of the HPC/SF. This product was predominantly composed of magnetite ( $\text{Fe}_3\text{O}_4$ ).

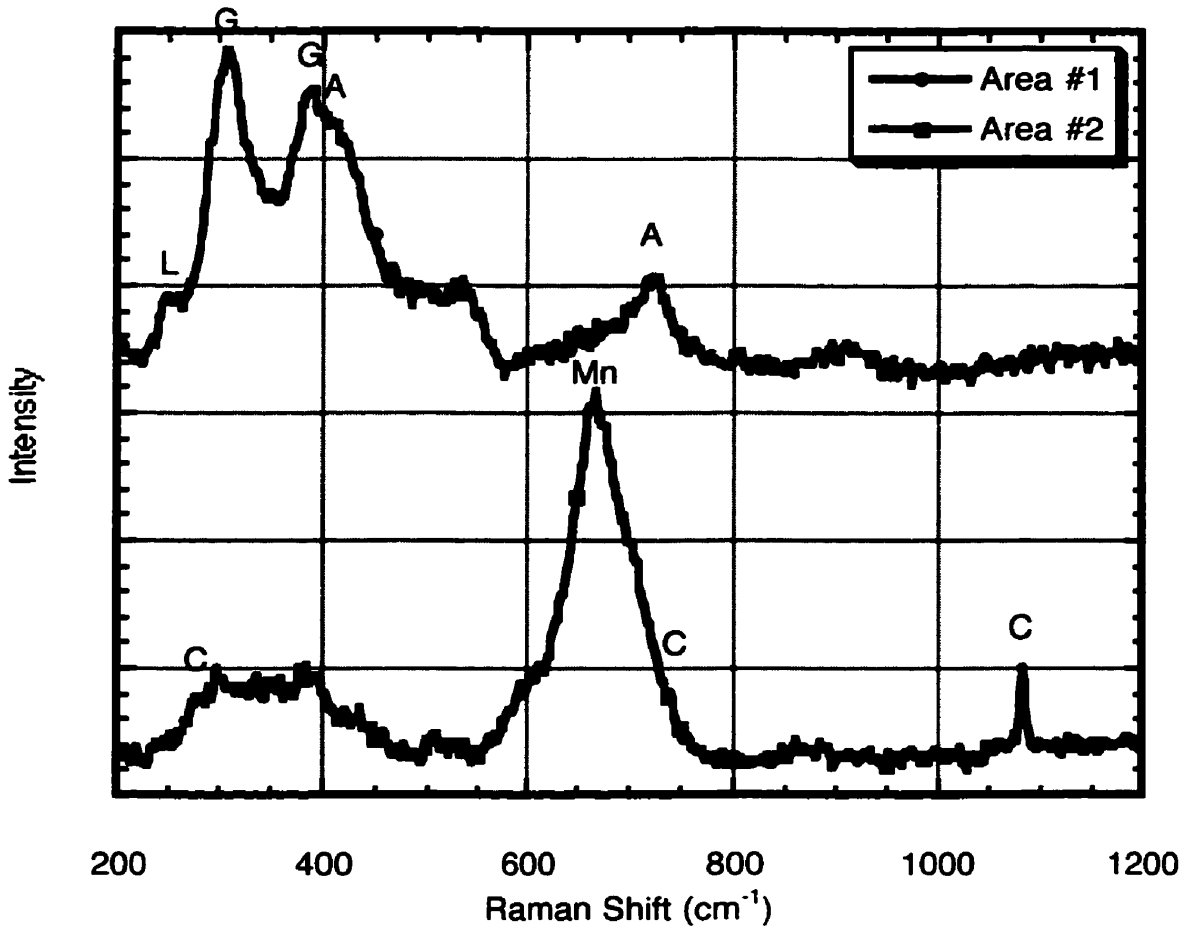
**Figure 6.7(h)** Raman spectra of the brown/red coloured corrosion products within the low quality concrete cover near the induced crack. Calcite was also detected near the induced crack of this concrete. Mn ≡ Magnetite (Fe<sub>3</sub>O<sub>4</sub>); A ≡ Akaganeite (β - FeOOH); Mn ≡ Goethite (α - FeOOH); L ≡ Lepidocrocite (γ - FeOOH); C ≡ Calcite (CaCO<sub>3</sub>)

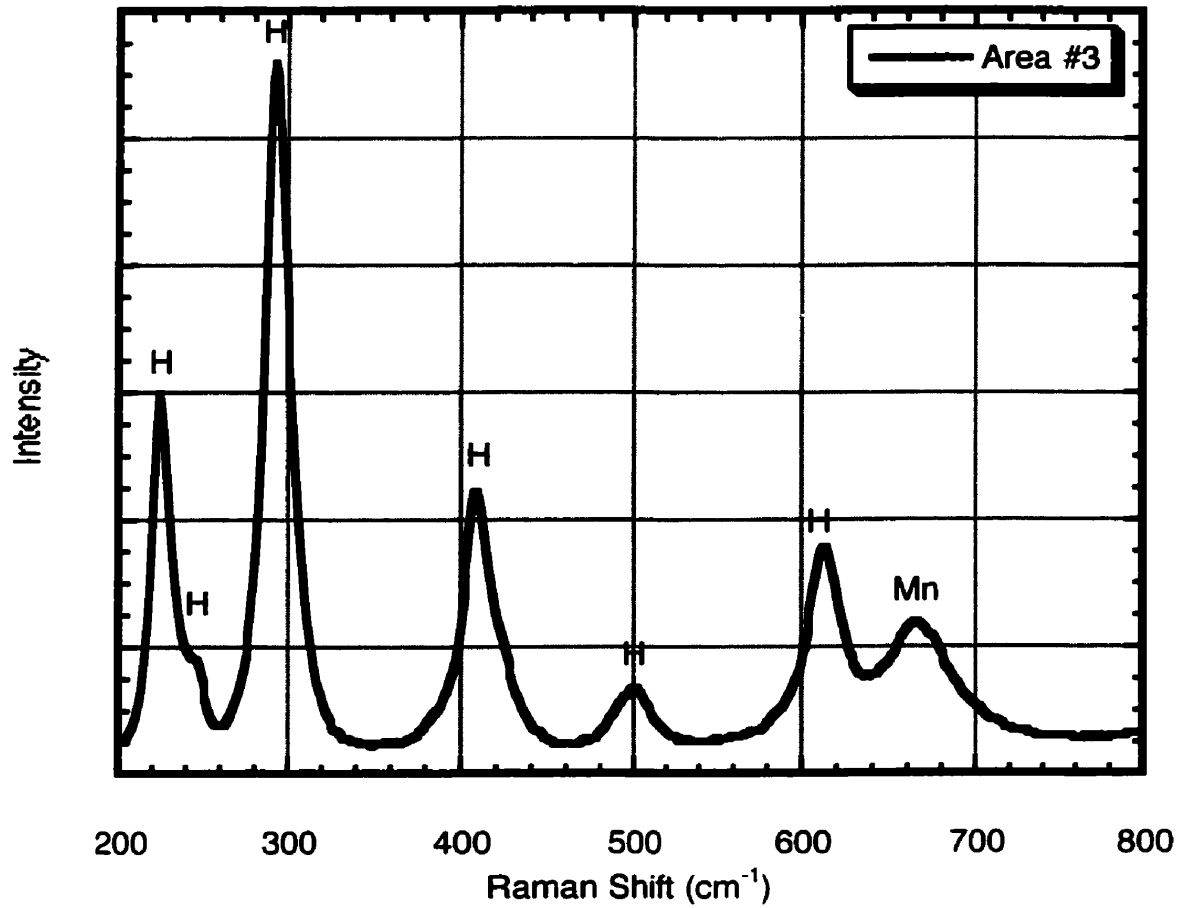
**Figure 6.7(i)** Raman spectra of the dark brown/red coloured corrosion products within the low quality concrete cover near the induced crack. Mn  $\equiv$  Magnetite ( $\text{Fe}_3\text{O}_4$ ); H  $\equiv$  Hæmatite ( $\alpha - \text{Fe}_2\text{O}_3$ )

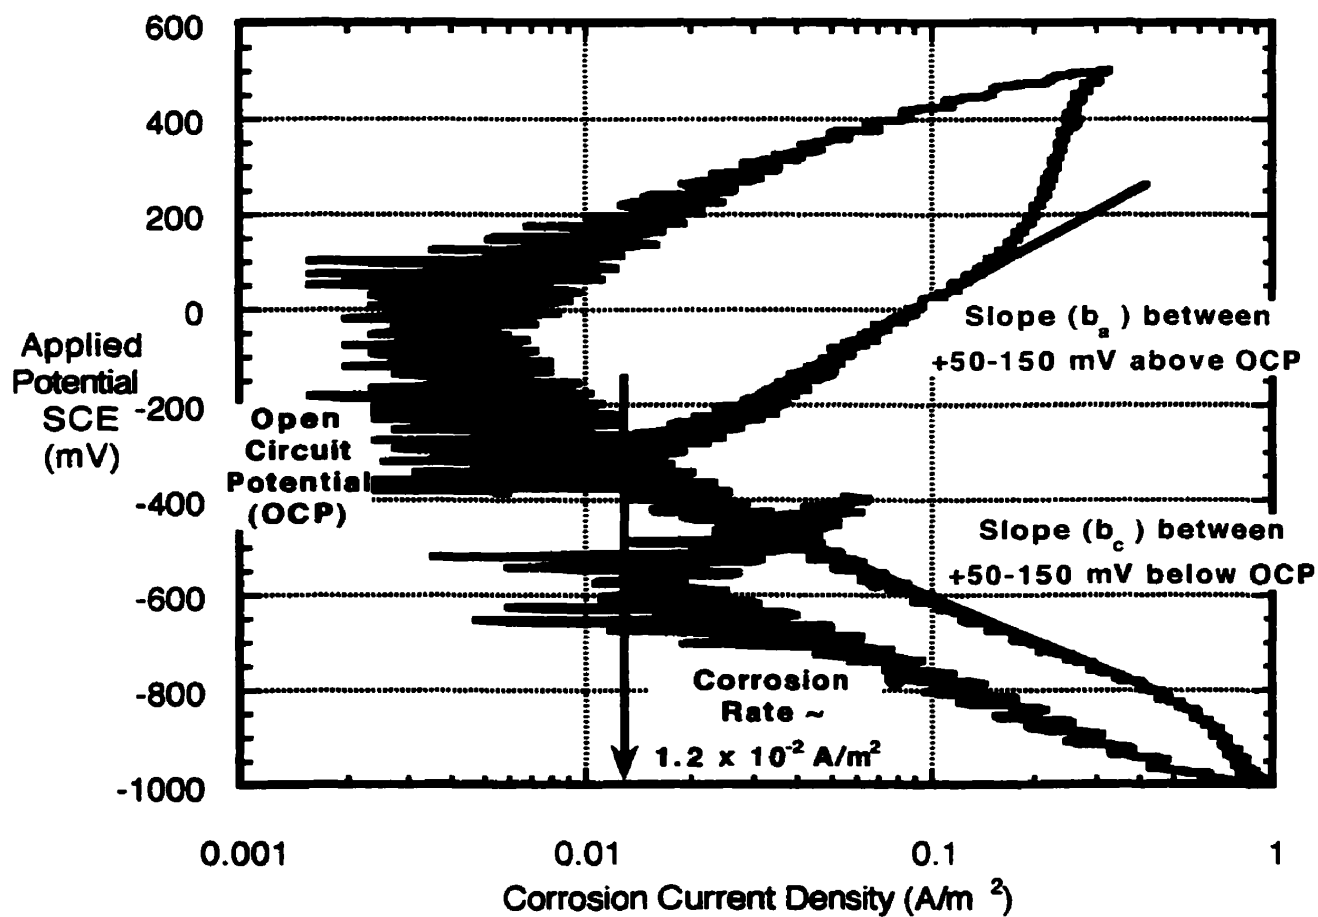
**Figure A** The estimation of corrosion rates from full polarization curves.
