Bond Behaviour of Corroded and CFRP Repaired RC Beams Subjected to Monotonic and Repeated Loading

A thesis

presented to the University of Waterloo

Doctor of Philosophy

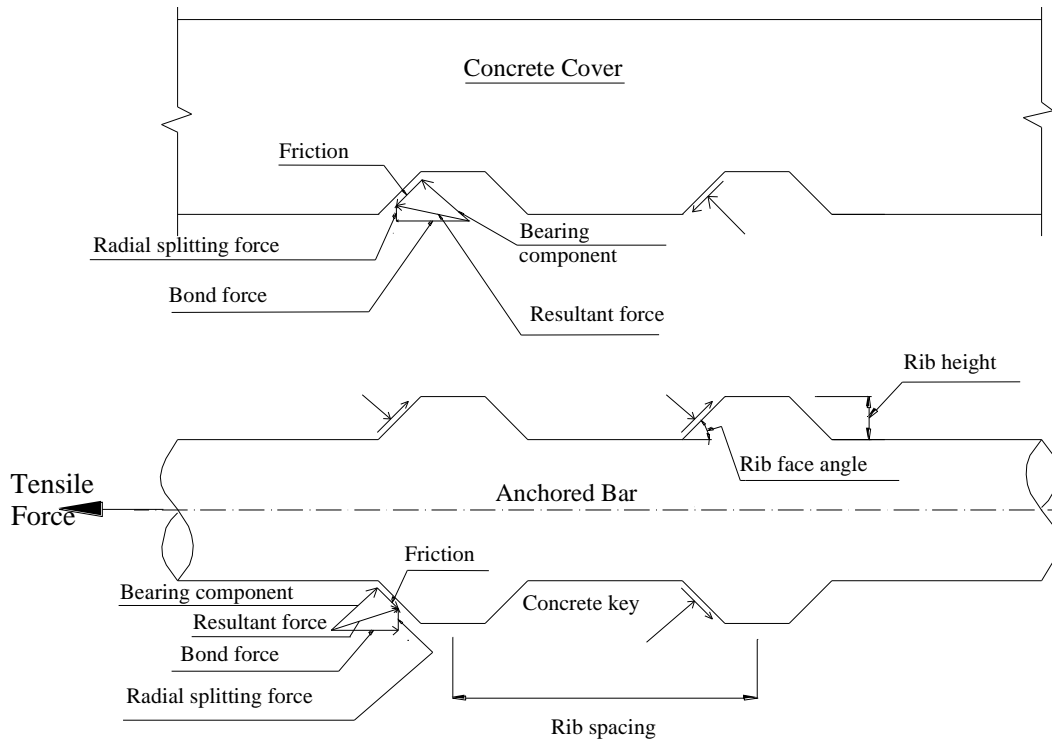
Figure 2.2 Bond mechanism of deformed reinforcement in concrete due to (a) adhesion, (b) bearing and (c) friction.

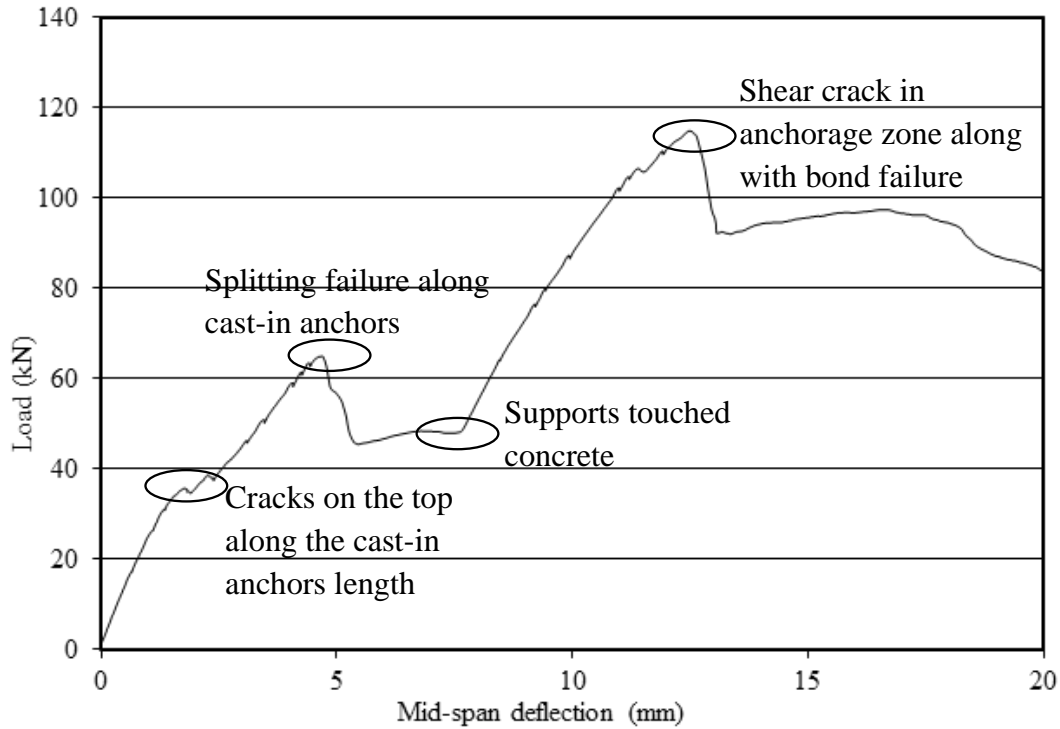
Figure 4.1 Load versus mid-span deflection curve for Beam M-A-100-0-1.

The beams differed in only one variable which was the support condition. In beam M-A-100-0-1, the supports were not in contact with the bottom of the beam at the start of the test, they were only fixed to the beam from the end through the cast-in anchors, hence providing no confinement to affect the bond. The ultimate load reached by this beam was 114.9 kN. The observed beam behaviour was as follows: cracks along the length of the cast-in anchors were observed at about 34kN, however the beam continued to carry load until splitting failure occurred along the cast-in anchors at 65kN causing the supports to fail. The load dropped to 47 kN and remained at this level until the mid-span displacement reached about 7.4mm and the supports touched the beam. Then the load increased again. The beam reached a maximum load of 114.9 kN and a mid-span displacement of 12.5mm with respect to the initial end level before the supports touched the beam. The slip at maximum load was about 2 mm. After the load dropped, the beam continued to carry load with increasing slip. Figure 4.1 shows the load versus mid-span displacement curve of beam M-A-100-0-1.

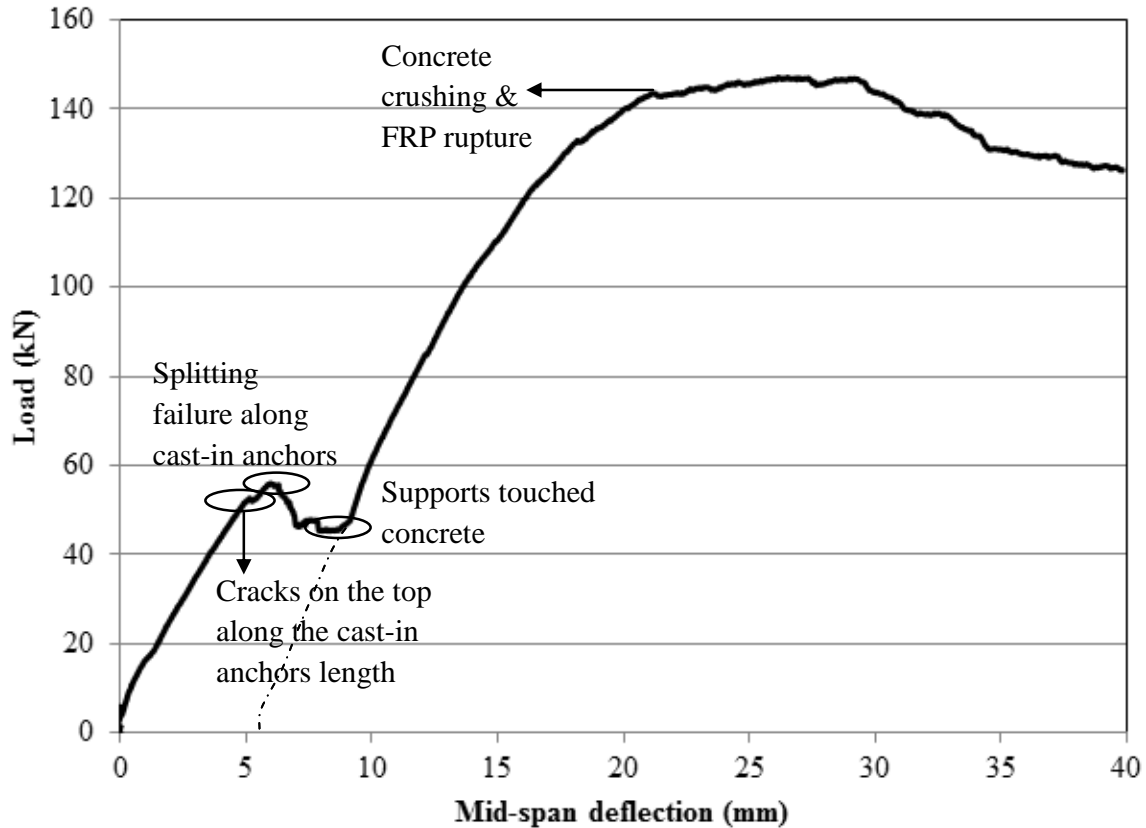
Figure 4.10 Load versus mid-span deflection for Beam M-B-100-0-1.

Beam M-B-100-0-1 was similar to Beam M-A-100-0-1 except for the stirrup spacing which was 75 mm (stirrup configuration B) instead of 150 mm. Beam M-B-100-0-1 was tested monotonically to failure to determine its bond static capacity. The supports were initially not in contact with the bottom of the beam; they were only fixed to the beam from the end through the cast-in anchors. Figure 4.10 shows the load versus mid-span deflection for Beam M-B-100-0-1. The observed beam behaviour was similar to Beam M-A-100-0-1 where cracks along the length of the cast-in anchors were observed at about 51 kN, however the beam continued to carry load until splitting failure occurred along the cast-in anchors at 55kN causing the supports to fail. The load dropped to 46 kN and then continued at this level until the supports contacted the beam soffit and the load increased again (Figure 4.10). The beam failed at a maximum load of 147 kN by concrete crushing in the compression zone (flexural failure). Although the final failure of the beam was by concrete crushing, there was a high slip at maximum load (about 2.0 mm) suggesting that bond failure has also occurred. Figure 4.11 shows the variation of the strain with load along the length of the bar. Two vertical cracks appeared in the anchorage zone at about 130 mm and 230 mm from the support, accompanied by an increase in the strain readings at strain location 2 at about 120 kN load. This is explained as follows: before cracking occurred in the concrete both the steel and the concrete worked together as one section in taking the tension force. After cracking the steel resisted the tension force in the beam and the stiffness of the beam at the crack location decreased. This increased the value of the strain in the bar at the location of the crack compared to the uncracked section. As the load continued to increase, a horizontal crack propagated from the support towards the closest vertical crack and the two strain gauge readings within this section became almost equal suggesting that debonding had happened in this region. In addition, at the maximum load the strain values at strain gauge locations 3 and 4 were equal suggesting that the bar was completely debonded in this section. This is explained further in Section 4.4.

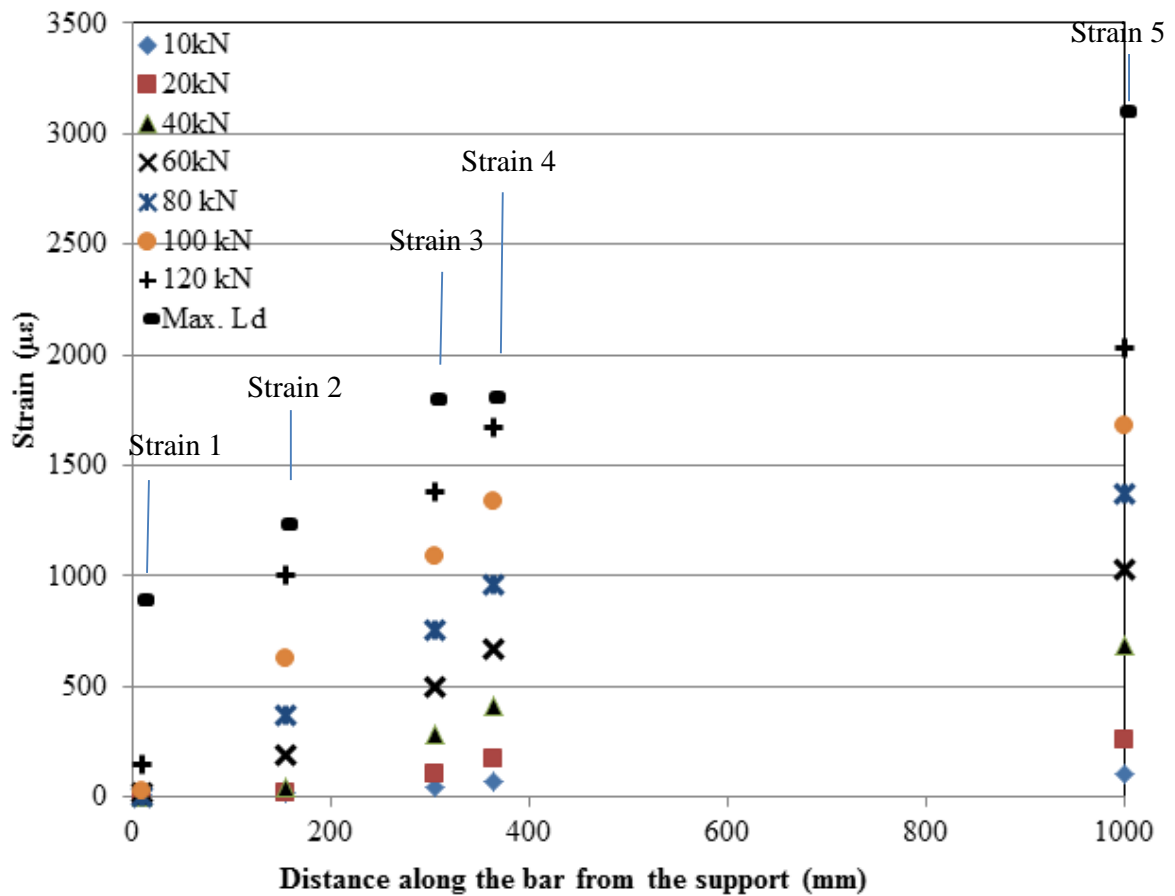
Figure 4.11 Strain profile for Beam M-B-100-0-1.

by resisting the vertical component of the force of the lugs on the concrete. Since the stirrups were very close (75mm spacing), there was little bending of the bar in between the stirrups. Accordingly for the bar to slip, the concrete keys had to be crushed. Decreasing the stirrup spacing from 150 mm to 75 mm, that is doubling the amount of stirrups, increased the static bond capacity on average by 30%. The stirrups held the reinforcement in place, so that the lugs on the bar crushed all the concrete keys in the anchorage zone region between the support and the pocket.

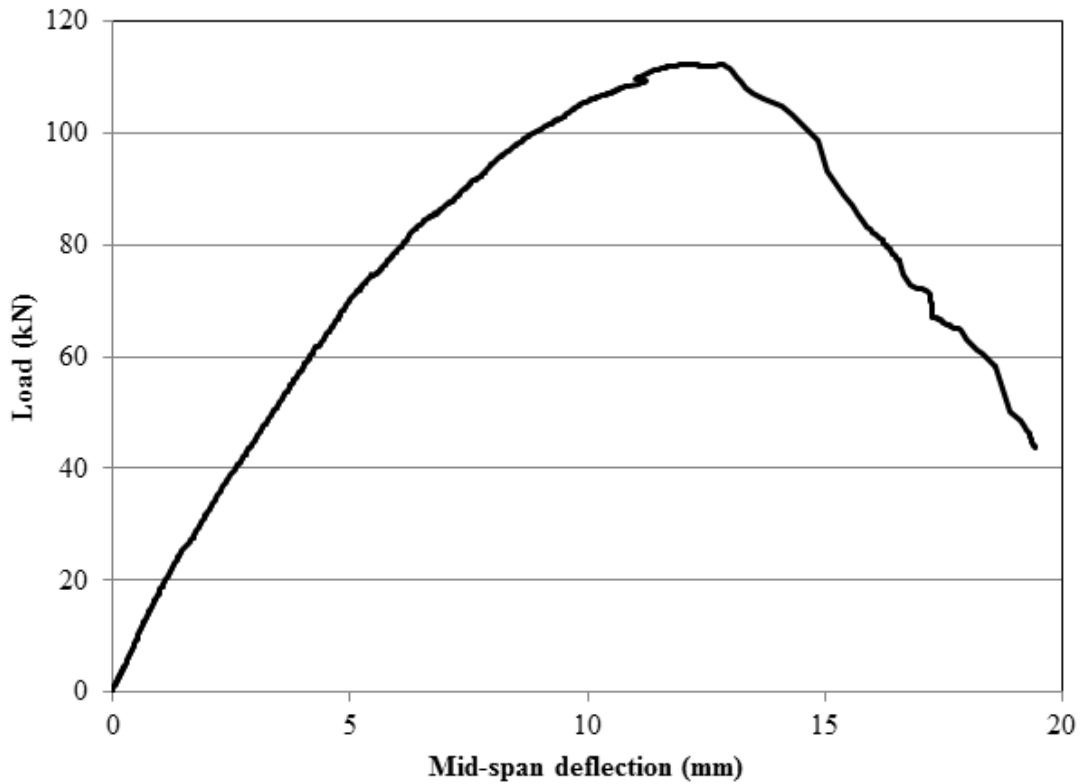
Figure 4.16 Load versus mid-span deflection for Beam M-A-100-5.

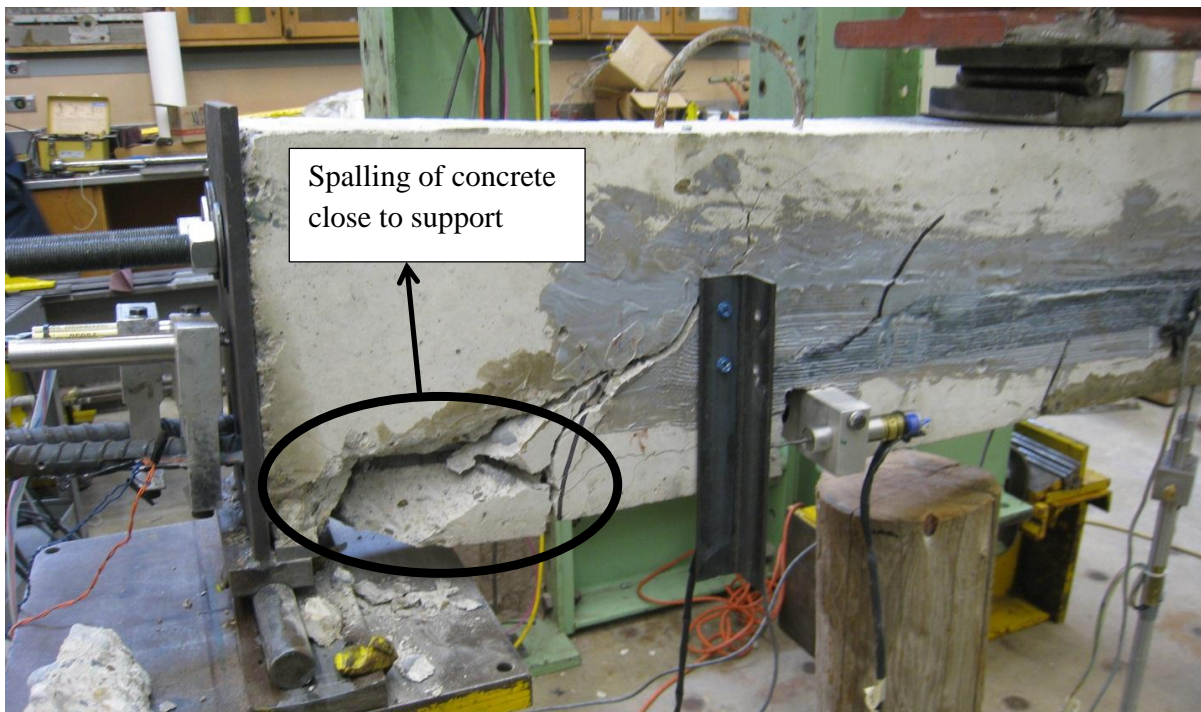
Figure 4.34 Beam F-A-64-0 close to failure in the testing frame showing the concrete close to the support spalling.

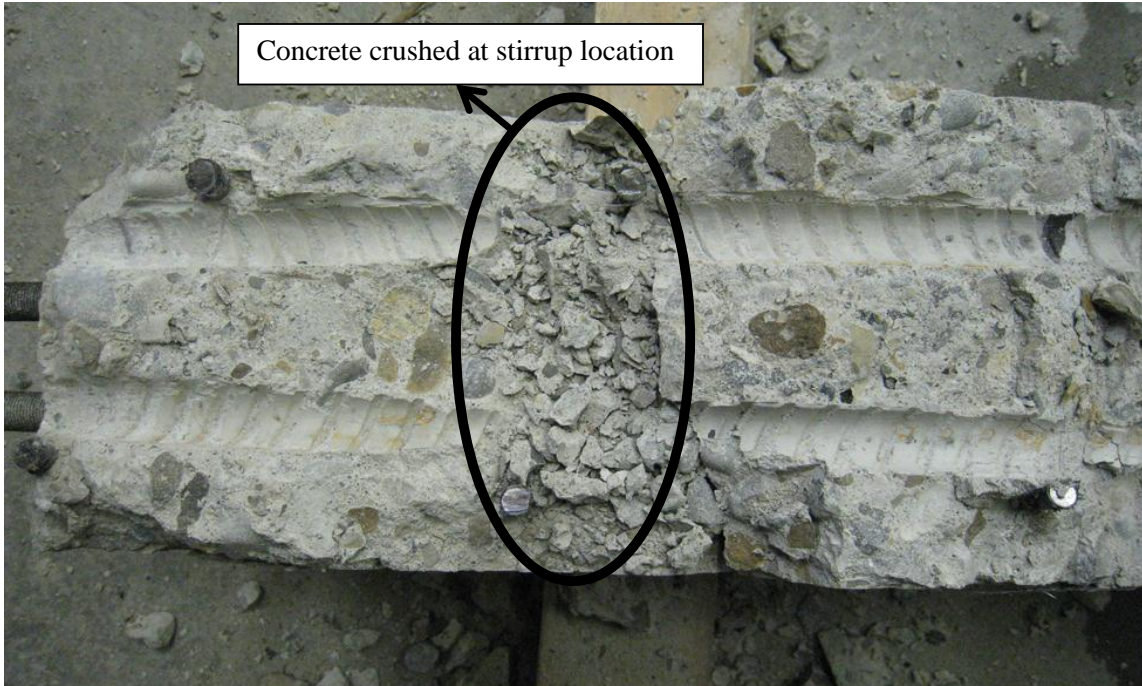
Figure 4.35 Beam F-A-64-0 after failure and removing the reinforcing bars. The beam was turned upside-down.

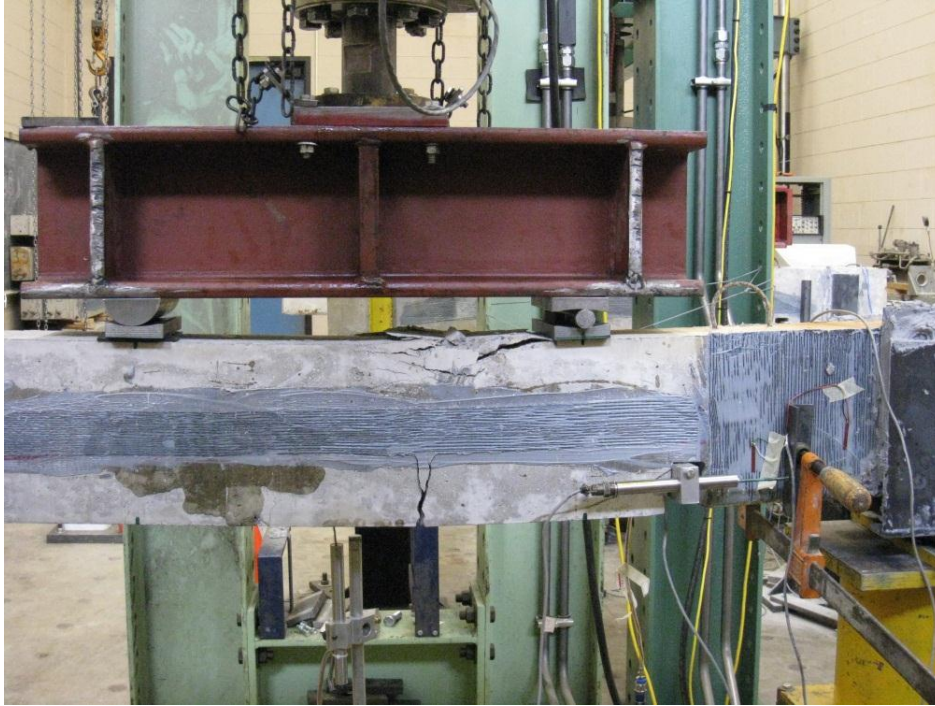
Figure 5.30 Flexural failure of Beam M-350-R-m.

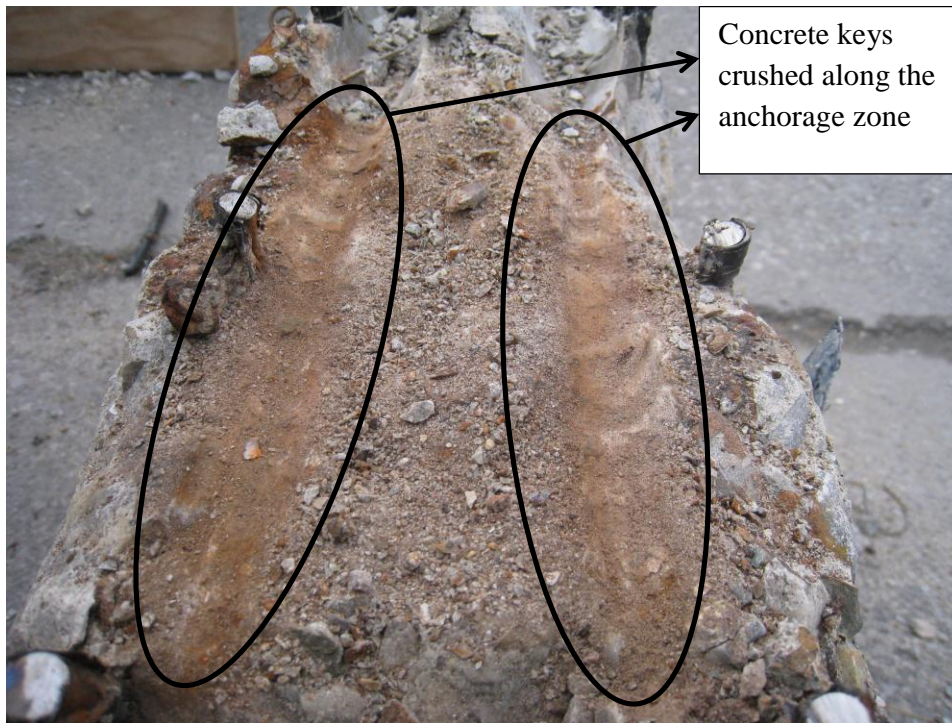
Figure 5.50 Concrete Keys crushed along the anchorage zone for Beam F-200-R-h-80. The beam was upside down and the reinforcing bars removed.

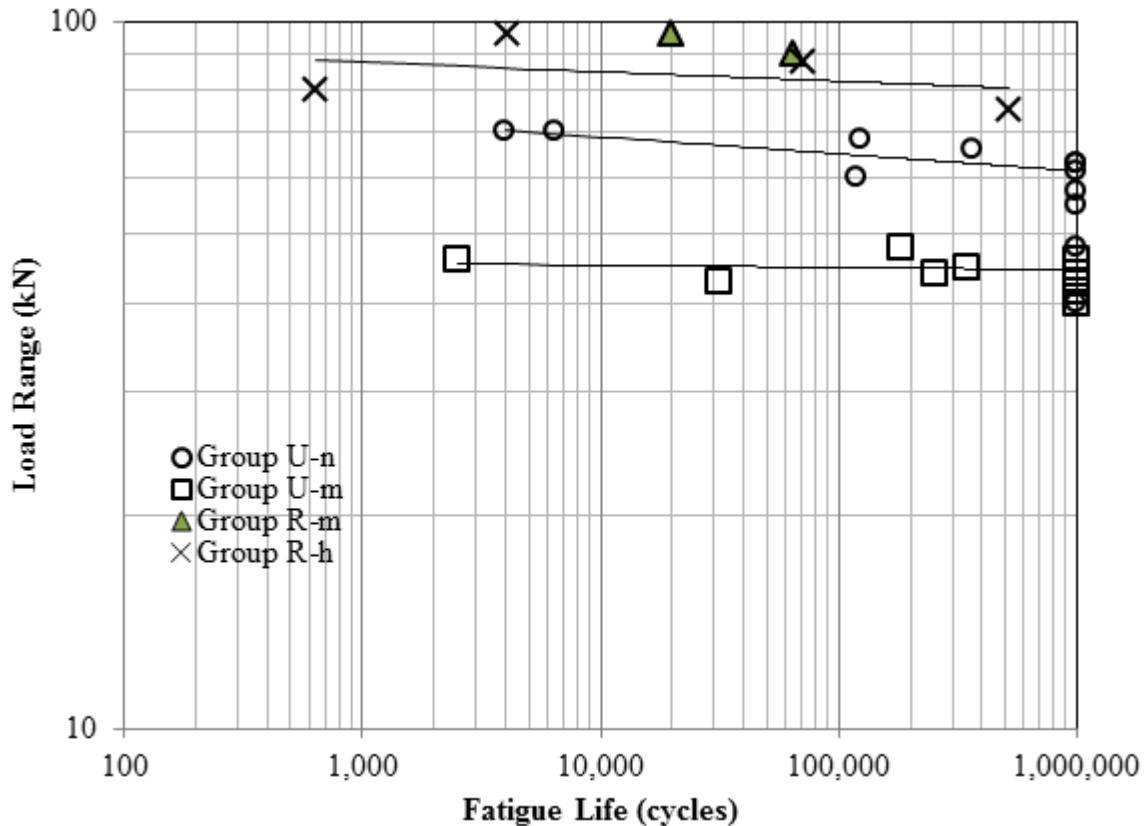
Figure 5.51: Variation in load range with life for Set 1 beams failing in fatigue of bond.
