Shear Behaviour of Slender RC Beams with Corroded Web Reinforcement

A thesis

presented to the University of Waterloo

Master of Applied Science

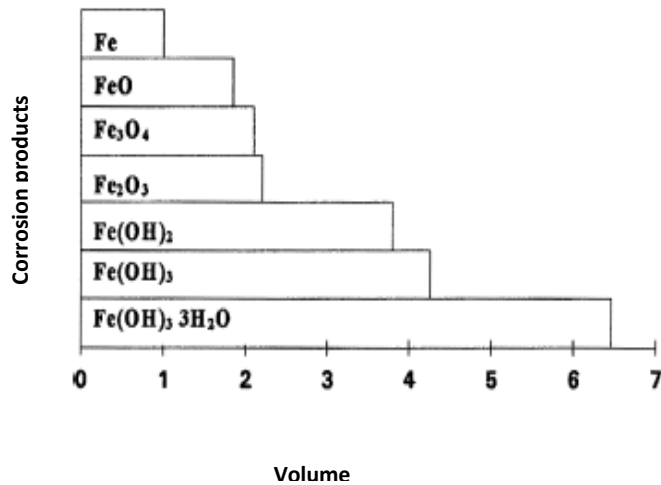
Figure 1.3 Relative volumes of iron and iron oxides and hydroxides (Liu and Weyers, 1998)

The volumes of the corrosion products including iron hydroxide and oxides are greater than the original iron (Fe). These volumes grow when the secondary reactions are continued. Figure 1.3 shows the rust densities for different forms of iron hydroxides and oxides in comparison to the original iron (Fe) (Liu and Weyers, 1998).

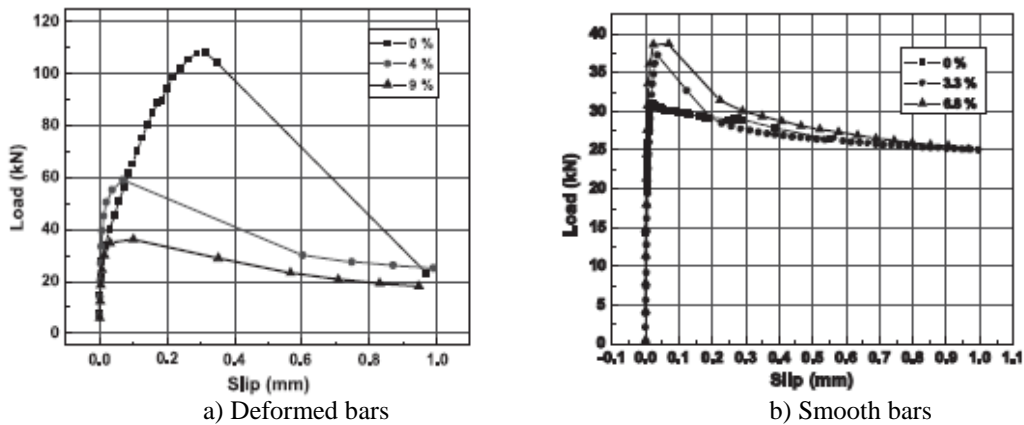
Figure 1.7 Load-slip plot for corroded and un-corroded smooth and deformed steel bars (Fang et al., 2004)

The effect of corrosion-damage on the bond strength of reinforced concrete elements are well investigated by many researchers. The previous works concluded that the bond strength increased initially with low corrosion levels prior to the initiation of concrete-surface cracking and then as corrosion progressed further the bond strength decreased significantly (Al-Sulaimani et al., 1990; Almusallam et al., 1996; Sherwood and Soudki 2003; Fang, 2004; Craig, 2005). Fang et al. (2004) also reported that the deformed steel bars had a 65% reduction in the bond strength at 9% mass loss, while in smooth steel bars, as the corrosion level reached 6.8% mass loss the bond strength increased up to 27% as shown in Figure 1.7a,b (Fang et al. 2004).

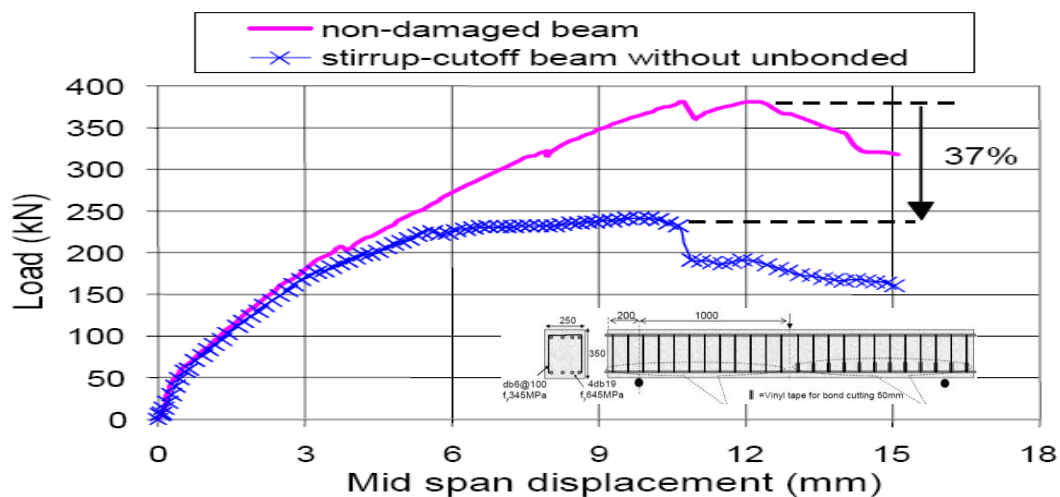
Figure 1.9 Load-displacement plot (Toongoenthong and Maekawa, 2005)

at 100 mm c/c that enclosed the top portion and were open at the bottom portion of the beam as indicated in Figure 1.9. The fracture of the shear reinforcement replicated the damage due to corrosion or alkali-aggregate reaction of concrete. The bond near the edges of the stirrup legs was removed by using a 50 mm strip of vinyl tape. The authors reported that the capacity of the damaged shear reinforcement was decreased by 37% compared to non-damaged stirrups. It was also observed that insufficient anchorage led to initiation of longitudinal cracks along the flexural reinforcement and then a diagonal crack propagated. The authors concluded that the tied or truss mechanisms could not be used to model the response because the damaged stirrups were functionally no able to carry the loads. This fact was correlated by the fact that the stirrups did not yield.

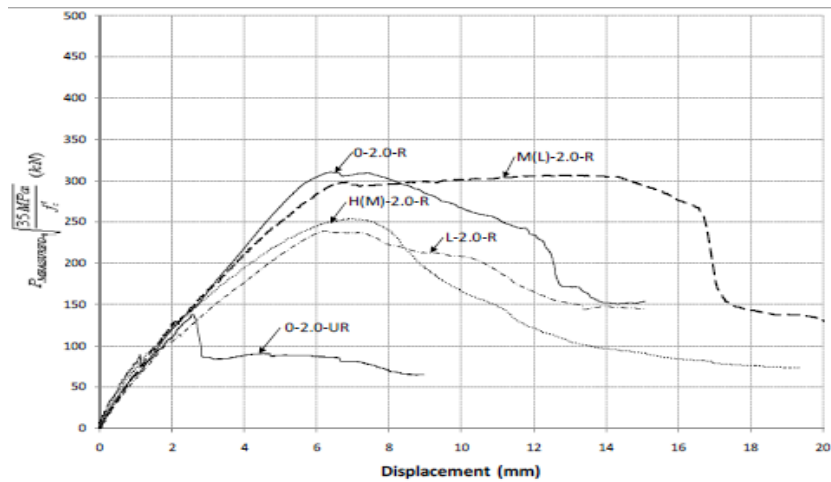
Figure 1.12 Load-displacement behaviour in rectangular beams (Suffern 2008)

Suffern (2008) carried out an experimental work that investigated the shear behaviour of reinforced concrete deep beams with corroded stirrups. A total of 15 rectangular beams were tested. The beams were 350 mm deep by 125 mm wide by 1850 mm long. These specimens were simply supported over a clear span of 1.5 m. The tension and compression reinforcement consisted of 2-25M bars and 2-10M bars, respectively. The stirrups were 10M deformed bars spaced at 150 mm. The test variables included: the shear span to depth ratio (1.0, 1.5, and 2.0), stirrups availability (without stirrups and with stirrups) and corrosion levels (control, low, medium, high). After the accelerated corrosion reached the target mass loss, the specimens were tested in three-point bending with the different shear span to depth ratios (a/d) (1.0, 1.5 and 2.0). Figure 1.12 shows the comparison of the load-deflection response for corroded specimens versus the control and corroded-repaired beam with $a/d=2$. The author concluded that there was a reduction of the shear capacity at all levels of corrosion: low corrosion level had a 26% reduction in shear capacity; for medium corrosion level, the reduction in shear was 18%-53%; for high corrosion level, the reduction was 41%. The author found that the corroded specimens with the lowest shear span-to-depth ratio experienced the highest reduction in ultimate shear strength.

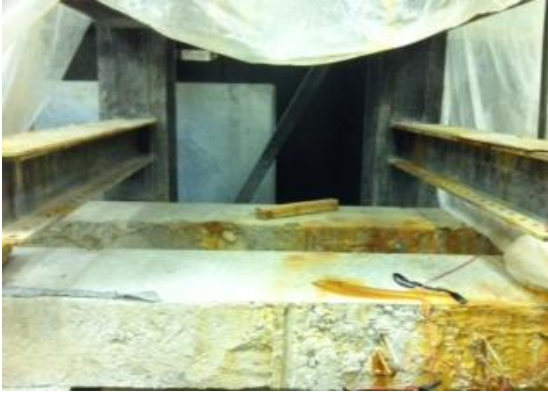
b) Typical beams layout on the rack

The corrosion damage in the stirrups was accelerated in twelve RC beams. The targeted mass losses were theoretically calculated using Faraday's law to reach two levels of corrosion (7.5% and 15%). Sample calculations to get the required time for the accelerated corrosion process are provided in Appendix A. The accelerated corrosion was conducted by impressing a constant current into the RC beams using an external direct current (DC) power supply. The positive terminal of the power supply was connected to the stirrups to act as an anode using an electrical wire. A U-shape stainless tube (6.5 mm diameter and 0.71mm wall thickness) was embedded inside the concrete in the beams acting as an internal cathode. The RC beams were placed in a corrosion chamber that provided a mist of pressurized air / water to maintain high relative humidity. The internal stirrups and stainless steel tubes in a beam were connected in series. The current density was kept constant at $250 \mu\text{A}/\text{cm}^2$ (or 250 micro-Ampares/ surface area) for all beams. This corresponds to an applied current based on the surface area of the stirrups of $43 \mu\text{A}$, $77 \mu\text{A}$ and $86 \mu\text{A}$ for D6, 10M, and D12 closed stirrups, respectively. A schematic drawing of the accelerated corrosion process is shown in Figure 2.4a. The beams were stacked on the steel rack inside the corrosion chamber as shown in Figure 2.4b, c.

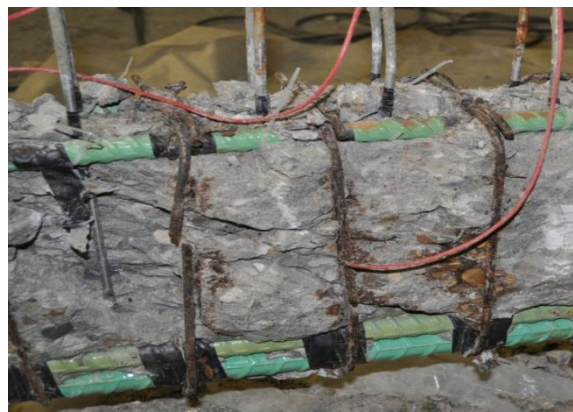
Figure 2.12 Stirrups after removing concrete cover

Figure 2.12 shows the exposed corroded stirrups after carefully removing the concrete cover with electrical jackhammer to avoid damaging the stirrups.

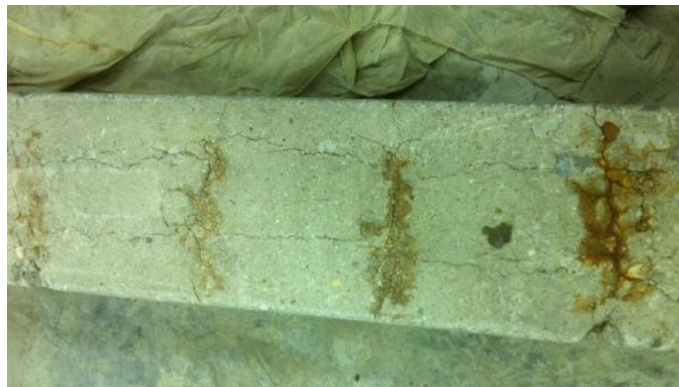
Figure 3.1 Bottom view of corroded shear span (10M-15%-R)

All the corroded beams had similar corrosion crack patterns on the concrete surface that were formed due to the expansive pressure of corrosion products from the corrosion-damaged stirrups as shown in Figure 3.1. The cracks were mainly aligned with the stirrup locations. At high corrosion level, some cracks were also aligned with the bottom face of the cross-section. Schematic drawings of typical crack patterns of the bottom and side faces in the corroded beams at low and high corrosion levels are shown in Figure 3.2, respectively. The crack patterns for the remaining beams are presented in Appendix B. Table 3.1 shows that the maximum crack widths in group A (10M @ 200 mm c/c) were 0.9 mm and 2.5 mm at 7.5% and 15% theoretical mass loss, respectively. In group B (D12@200 mm c/c), the maximum crack widths were 0.7mm and 1.5mm at 7.5% and 15% theoretical mass loss, respectively. Group C (D6 @ 200 mm c/c) and D (D6@100 mm c/c) had maximum crack widths of 0.1 and 0.3mm for 7.5% and 15% theoretical mass loss, respectively. It is evident that corrosion crack widths were significantly reduced for the smaller diameter stirrups possibly because of the lower mass losses achieved for these specimens during the corrosion phase.

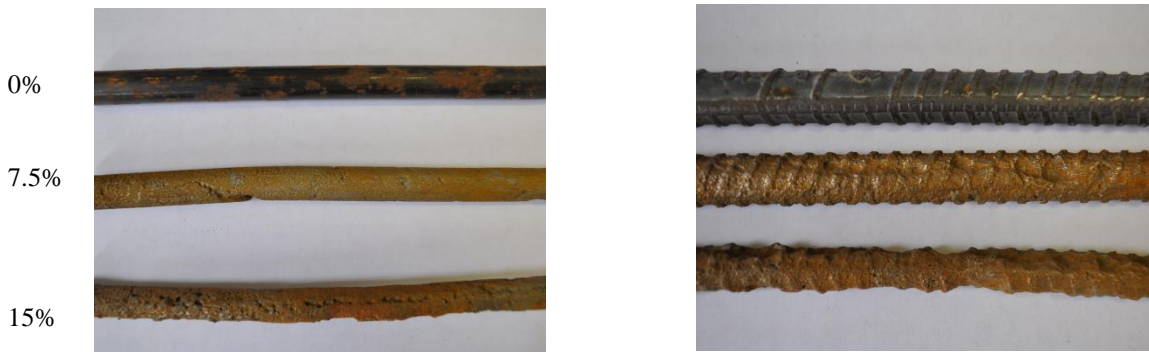
Figure 3.3 Photos of coupons of 10M and D12 ordered by corrosion level (0%, 7.5%, and 15%)

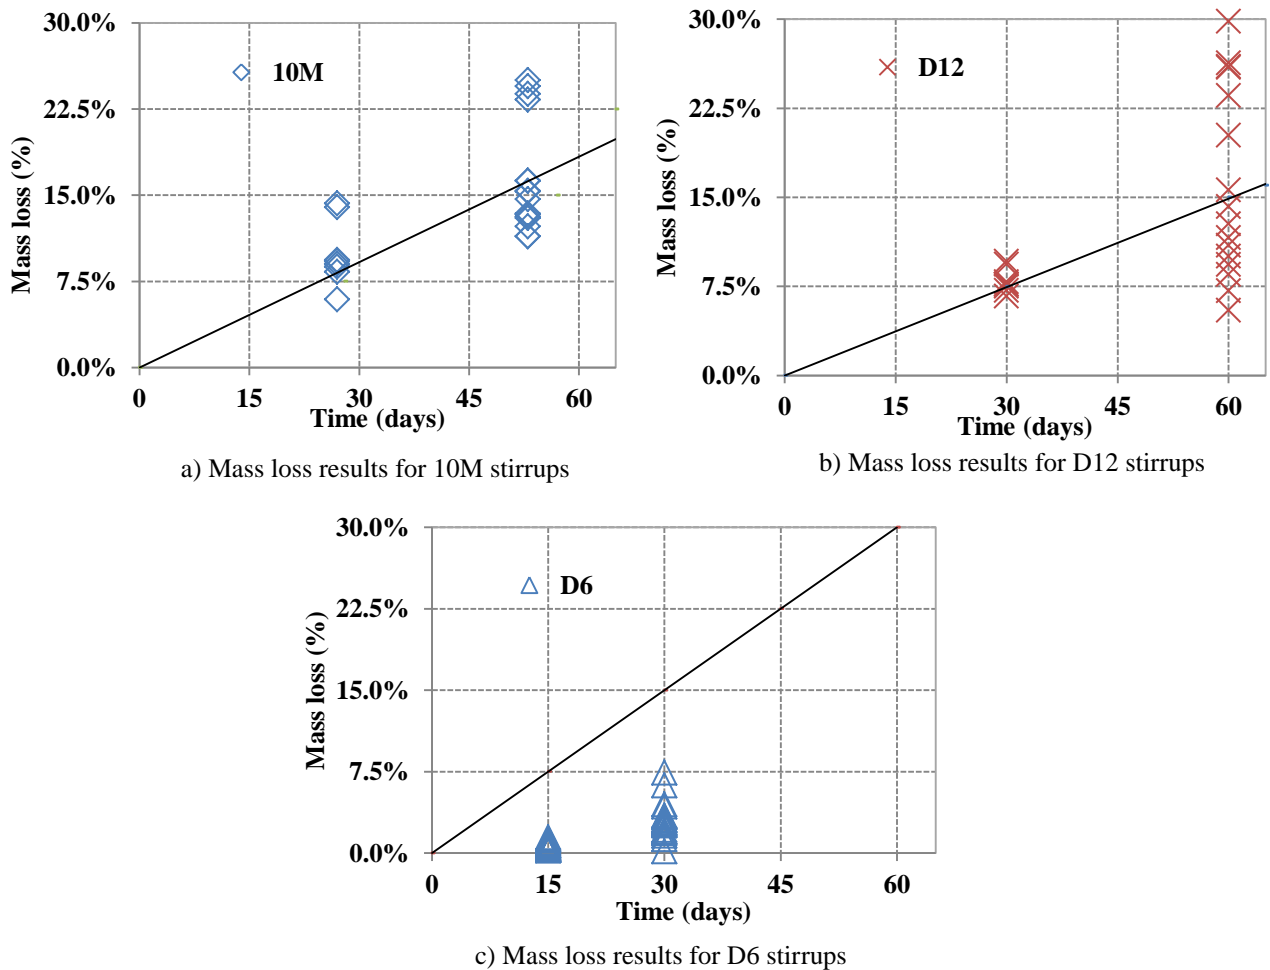
Figure 3.4 Mass loss results of coupons for 10M, D12, and D6 stirrups

Figure 3.4a,b,c show the mass loss results for all coupons of different stirrups diameters (D6, D12 and 10M) at two corrosion levels (7.5% and 15%). It can be observed from the figures that for lower mass losses, the actual mass losses were close to theoretical predictions; whereas for higher mass losses, there were large variations in measured data which were not close to the theoretical corrosion predictions. The large scatter at high corrosion level can be inferred to the increase in volume of corrosion rust and therefore reducing the diffusion of oxygen. As a result, corrosion mass losses at different locations of the stirrups will vary depending on the availability of oxygen and moistures.

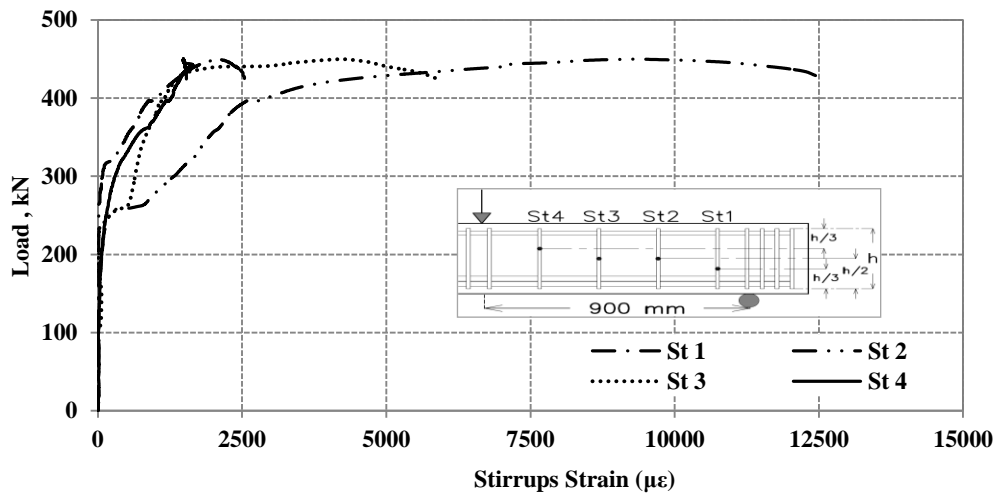
Figure 3.9 Load-transverse reinforcement strain relationship of the control beam (10M-0%-UR)

The load vs. strain responses of the longitudinal steel reinforcement in the tension zone and concrete surface in compression zone for all beams are shown in Appendix C. In all beams, the ultimate strain in the steel rebar was below the yield strain and the strain in the concrete was below the crushing strain. Figure 3.9 shows the load versus strain for the four stirrups in the critical shear span. It is evident that the second and third stirrups from the support (St2 and St3) reached the yield strain. At beam failure, the strain in St2 was 12,000 $\mu\epsilon$ as the gauge corresponded to the location of the inclined crack. No strain gauges were mounted on the corroded stirrups.

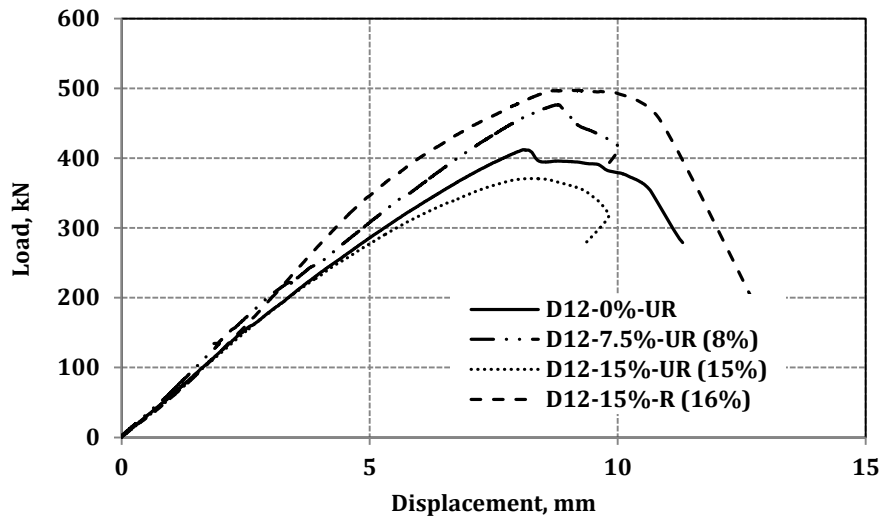
Figure 3.11 Load-displacement responses of beams in group B

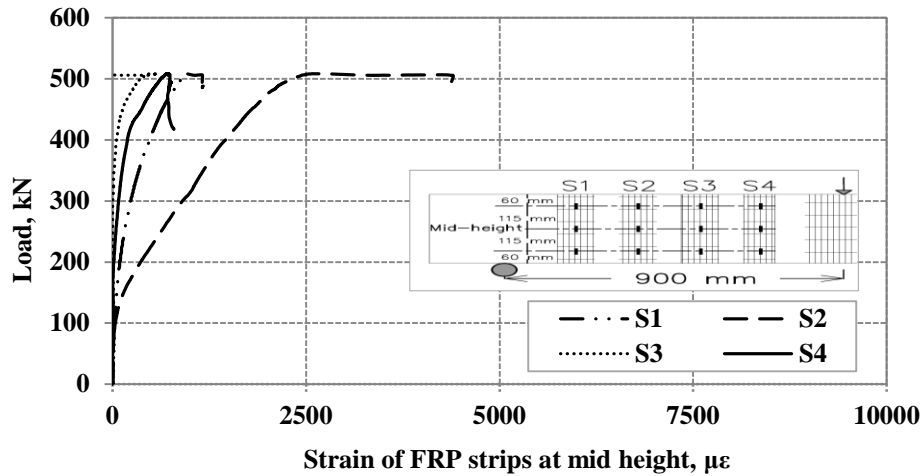
Figure 3.23 Load-strain behaviour of CFRP strips in Beam D6-15%-R-100

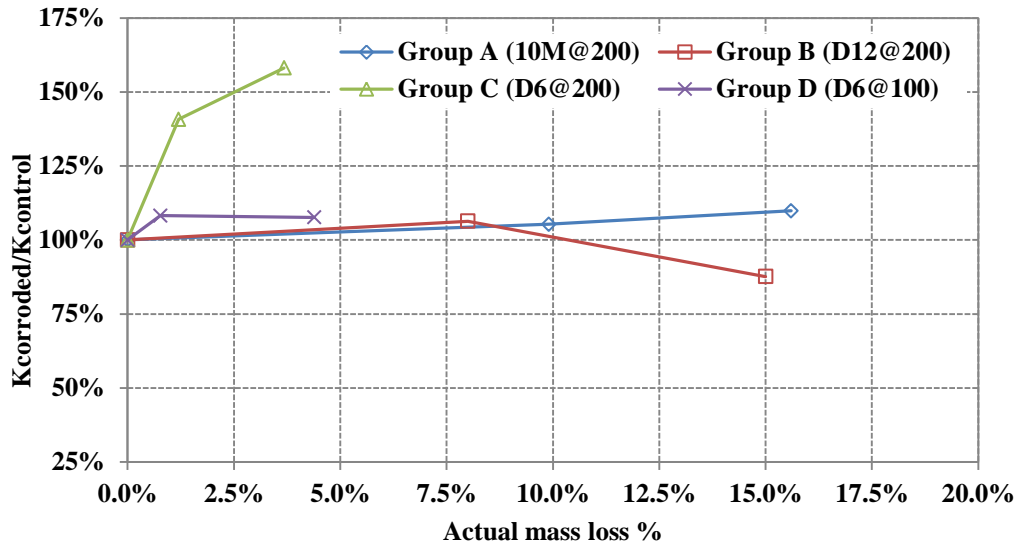
Figure 4.2 Overall stiffness of unrepaired corroded beams versus control beams

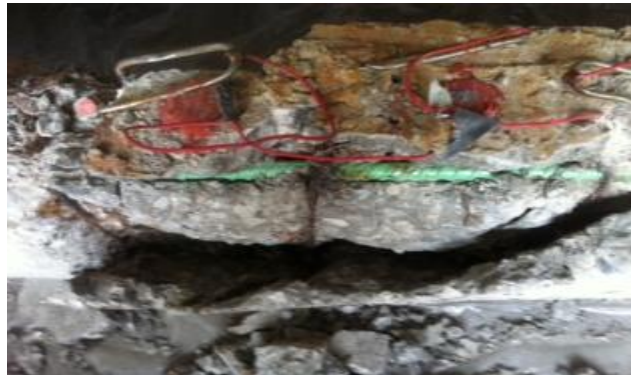
Figure 4.9 Concrete cover delamination as one layer due to corrosion damage on the stirrups (top view of corroded beam)
