# **The Case for Stainless Steel Reinforcing Bars**

Colin Bradley Van Niejenhuis

A thesis

Civil Engineering

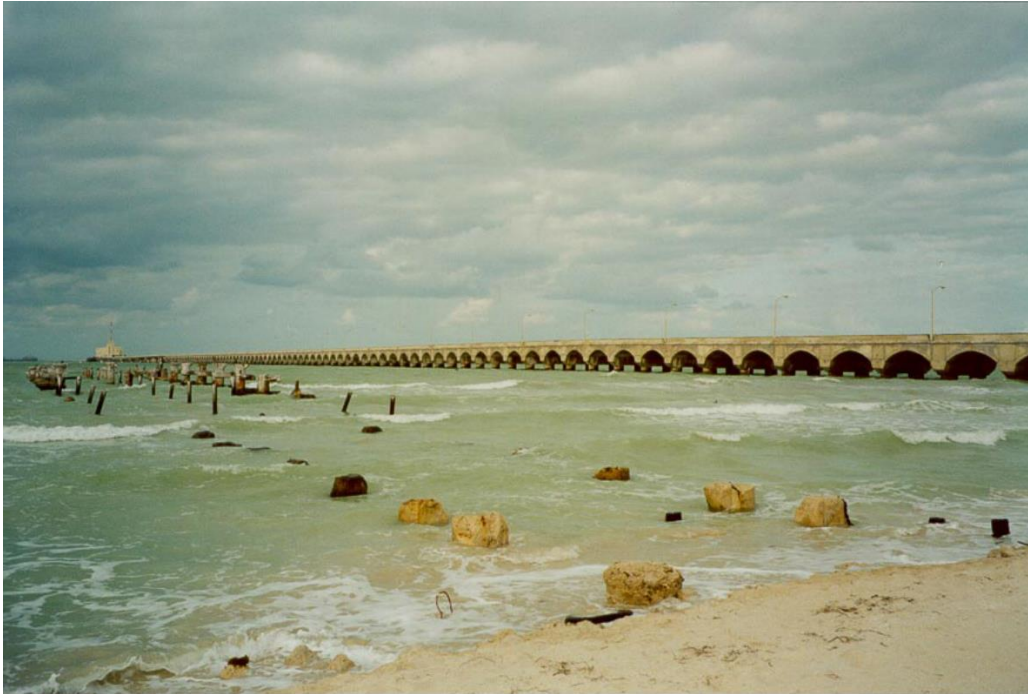
Figure 2-4: Progreso Pier, Mexico [26]

The use of stainless steel for reinforcement has often been seen as a last resort due to the high initial cost. It is thought to have first been used between 1937 and 1941 to create a 2100 meter long pier in the Port of Progreso, Mexico [25]. In 1999, Arminox Stainless [26] conducted both a physical inspection and chloride penetration analysis, and determined that the UNS32304 stainless steel in sound concrete had exhibited little corrosion over the first 60 years of its service life. In comparison, a second pier build in the early 1970's using plain carbon steel had already completely deteriorated by 1999 and was no longer useable, Figure 2-4.

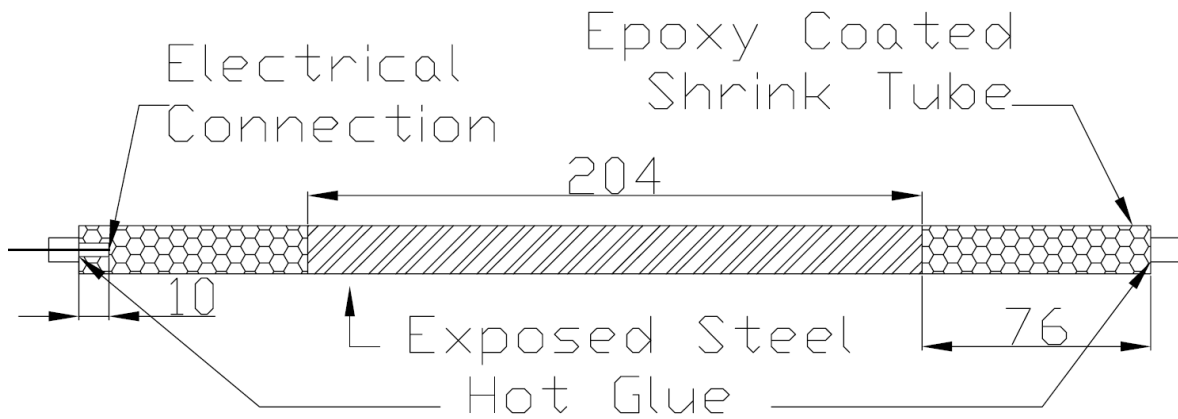
Figure 3-1: Rebar preparation

The rebar were cut into 356 mm (14 inch) lengths with a band saw and the cut edges were ground to remove burs. A 4.5mm ø hole was drilled to a depth of 10 mm, into which a 20 gauge copper wire was soldered to create an electrical connection. Each specimen type had wire with a specific colour coating, in order to easily differentiate the different steel grades while embedded in concrete. The ends were then sealed with varying lengths of epoxy lined shrink tube (25mm (1 inch) to 76 mm (3 inches)), allowing between 204 mm (8 inches) and 255 mm (10 inches) of exposed length. The ends were filled with hot glue to fully seal the end of the bar and limit end effects, Figure 3-1.

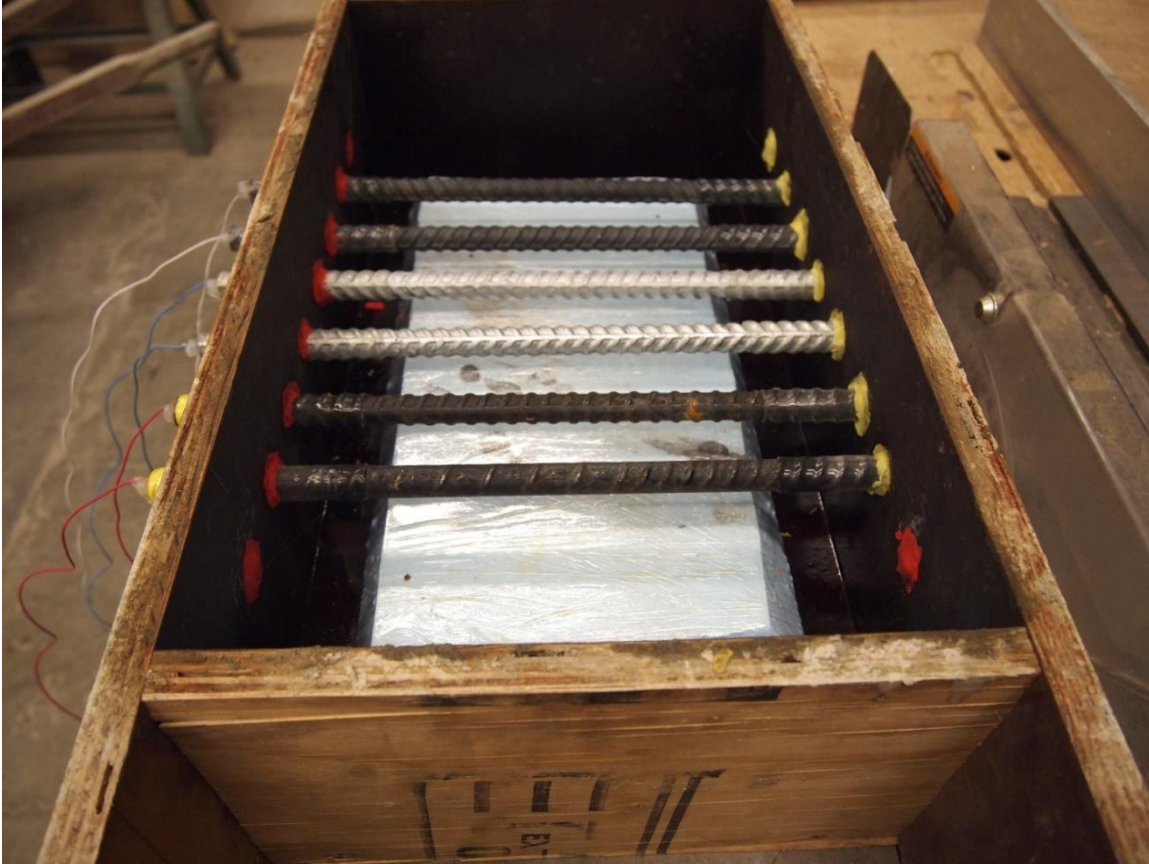
To ensure a consistent ponding well, and for ease of construction the specimens were cast upside down on top of a 38 mm (1.5 inch) extruded polystyrene insulation board, Figure 3-4. This also allowed for the 64 mm (2.5 inch) transverse rebar to be tied to the bottom side of the 204 mm (8 inch) exposed section of test specimen using UNS S31653 stainless steel tie wire.

Figure 3-4: Sound concrete formwork

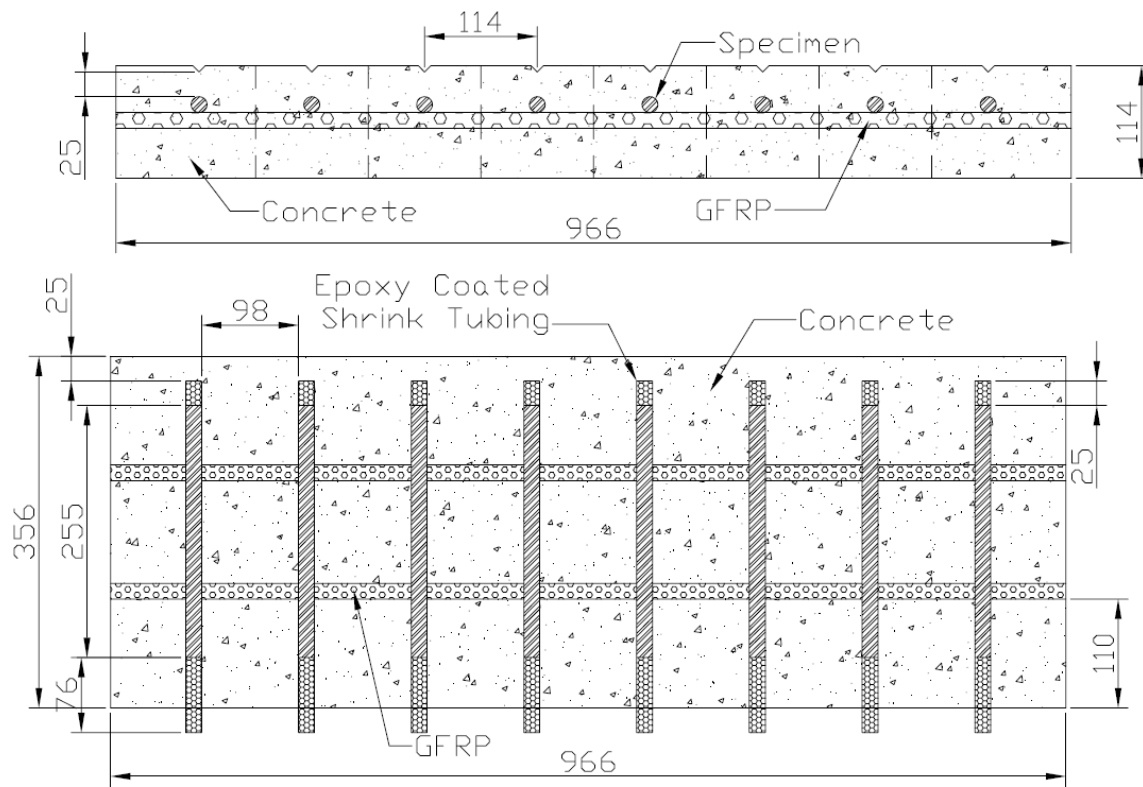
These specimens were prepared to represent the cracks which often form above, and parallel to, the lateral bars of a bridge deck. Eight bars with a 255 mm exposed length were cast into concrete beams measuring: 966 mm (~38 inches) long by 114 mm (~4.5 inches) tall by 356 mm (14 inches) wide, Figure 3-7. The specimen was cast upside down with the bars located above a 6.4 mm (1/4 inch) deep plexiglass triangular prism. This created a notch in the surface of the beam to create an area of higher stress when inducing the crack parallel to the rebar. This provided a 25 mm cover between the root of the notch and the surface of the rebar.

Figure 3-7: Longitudinal specimen beam

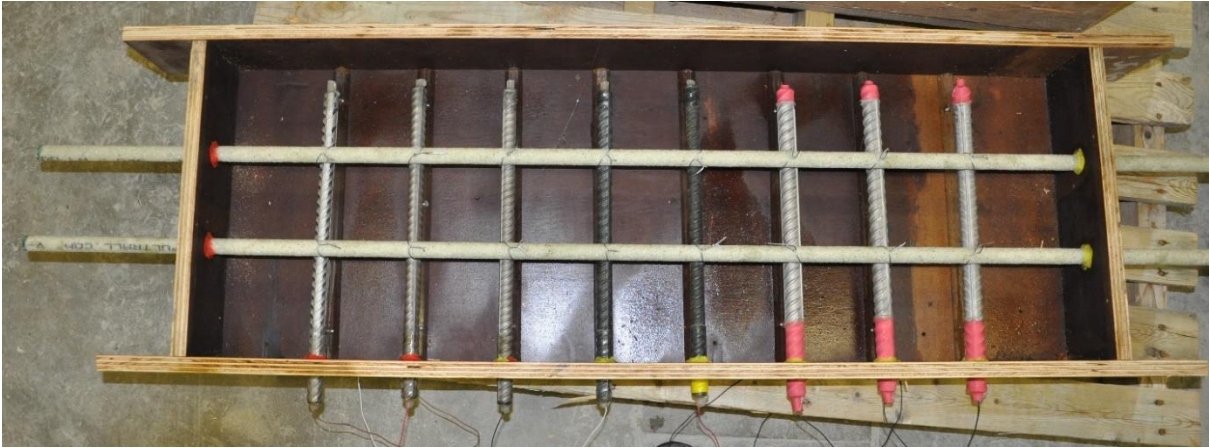
Figure 3-8: Formwork and bars for longitudinally cracked specimens

The bars were supported by two 15 mm Glass Fibre Reinforced Polymer (GFRP) bars in order to reinforce the concrete while the cracks were induced. The GFRP was used because it is an effective electrical insulator and prevented shorting between bars during subsequent electrochemical testing, Figure 3-8.

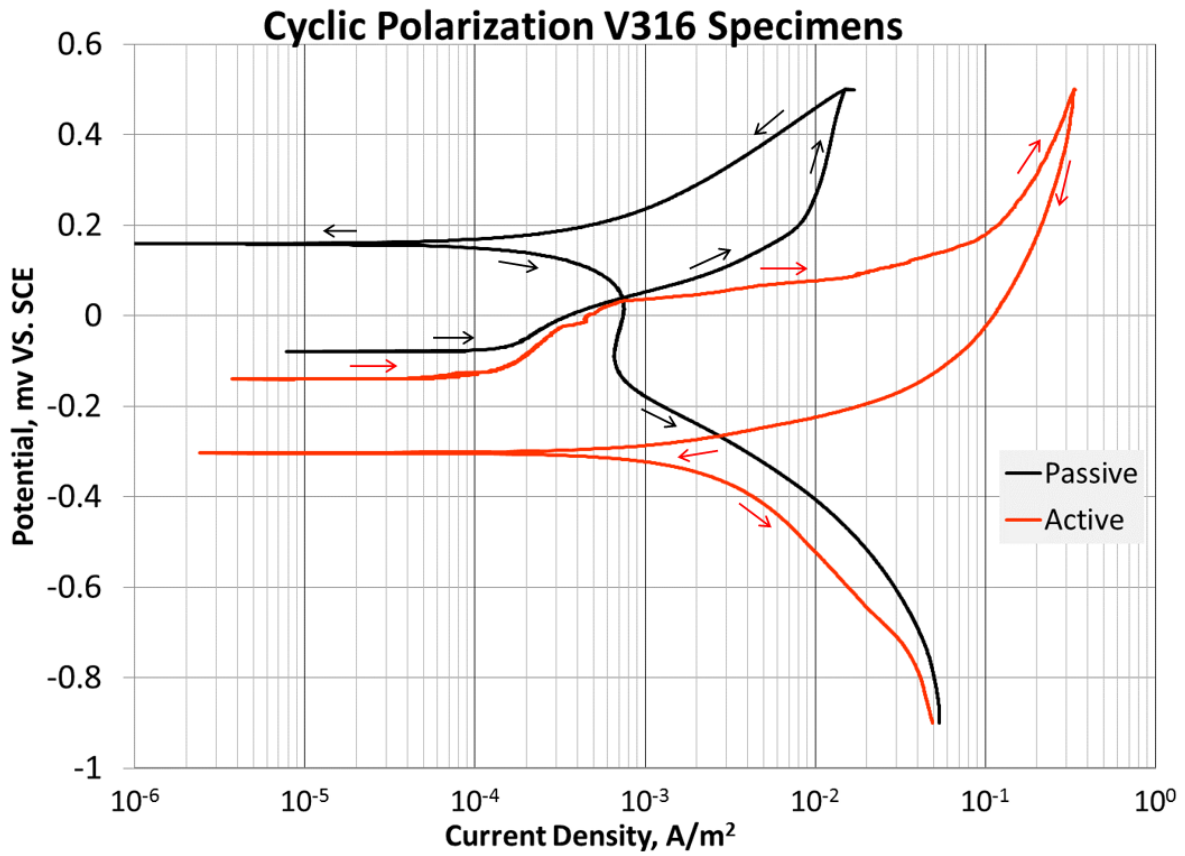
scan reverses, the bar is not stable enough to reform the passive film (resulting in a higher current density at each potential and a more cathodic open circuit potential).

Figure 3-13: Cyclic polarization curve for passively and actively corroding steel

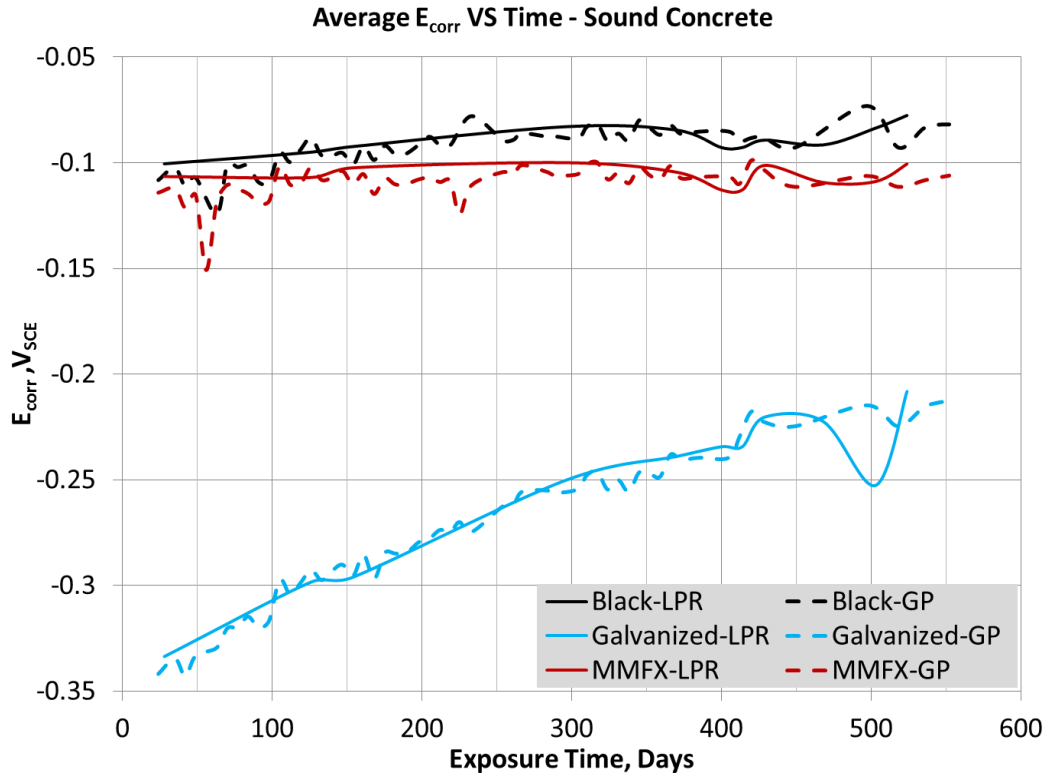
From both the  $E_{corr}$  and  $i_{corr}$  data, Figure 4-2 and Figure 4-3 respectively, the black and corrosion resistant rebar in sound concrete specimens currently do not appear to be corroding because the  $E_{corr}$  values are in the low risk of corrosion region for the black steel, and the  $i_{corr}$  values fall below  $0.001 \text{ A/m}^2$ , which equates to an average corrosion depth loss of approximately  $1\mu\text{m}$  per year. Note however, how anodic the galvanized rebar is, between  $-350\text{mV}$  and  $-225\text{mV}$ , compared with the  $-950\text{mV}$  to  $-400\text{mV}$  (Figure 4-4), and  $-1000\text{mv}$  to  $-500\text{mv}$  (Figure 4-6) for the transversely and longitudinally cracked bars respectfully. It should also be noted that the  $i_{corr}$  data from the LPR tests all fall well below the values determined by the GP technique because the concrete resistance cannot directly be removed by the polarization resistance of the system.

Figure 4-2: Average  $E_{corr}$  – Corrosion resistant rebar in sound concrete

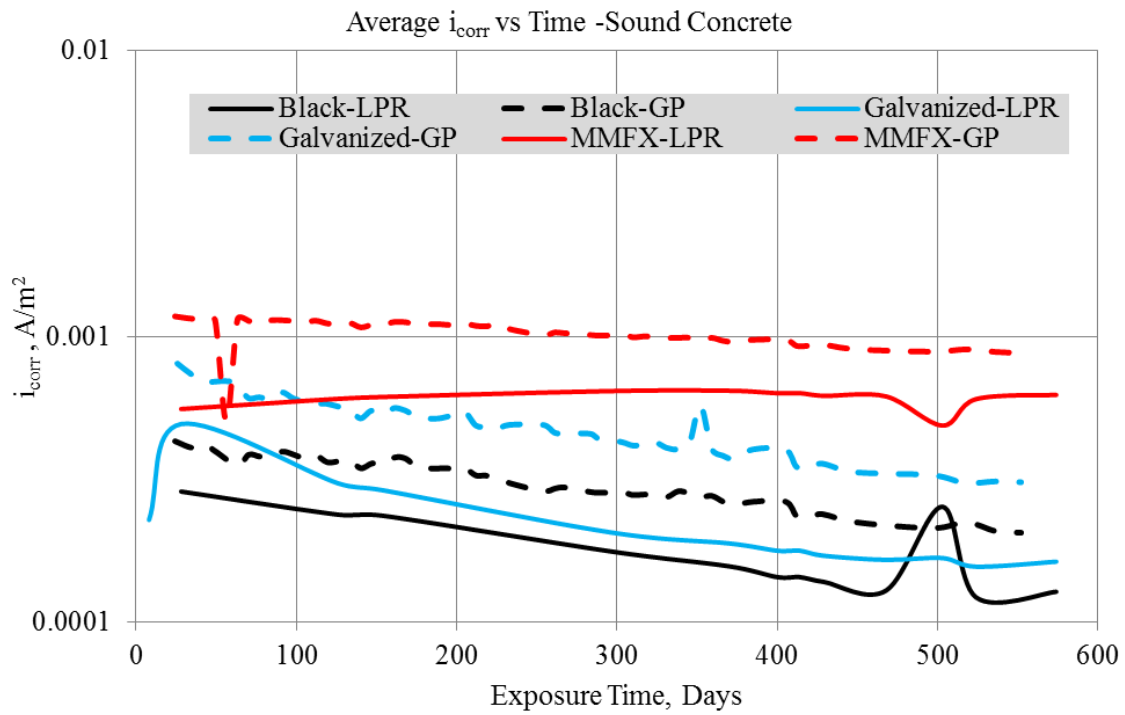
Figure 4-3: Average  $i_{corr}$  - Corrosion resistant rebar in sound concrete

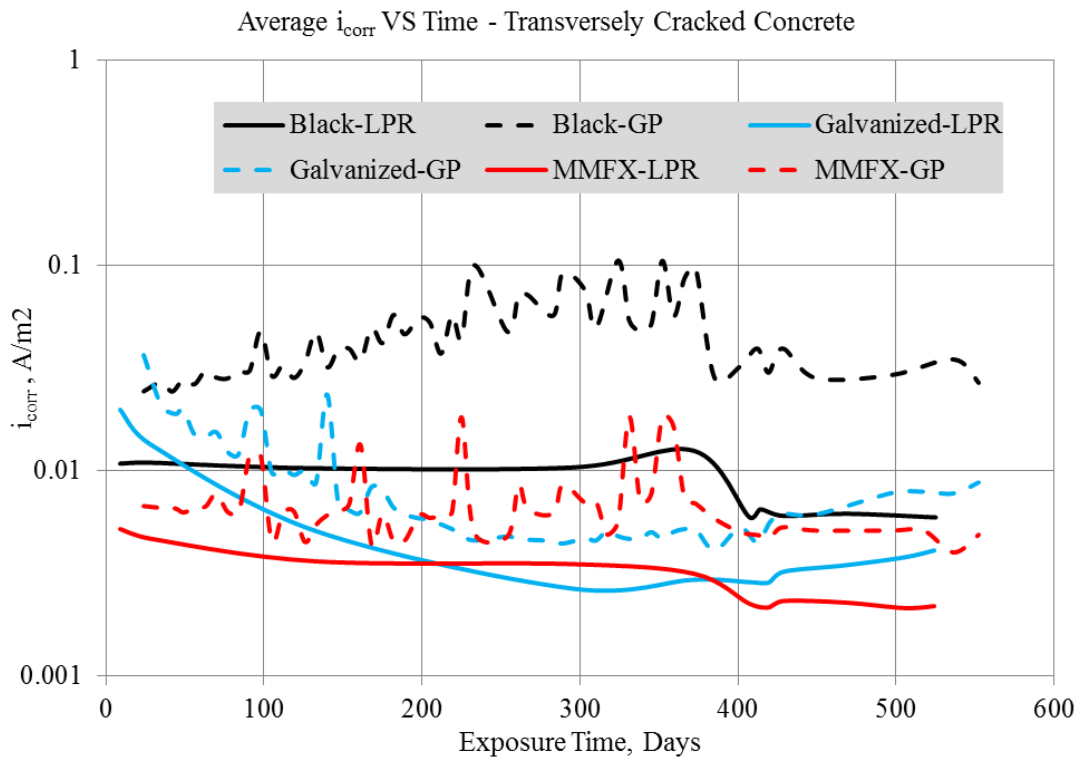
Figure 4-5: Average  $i_{corr}$  – Corrosion resistant rebar in transversely cracked concrete

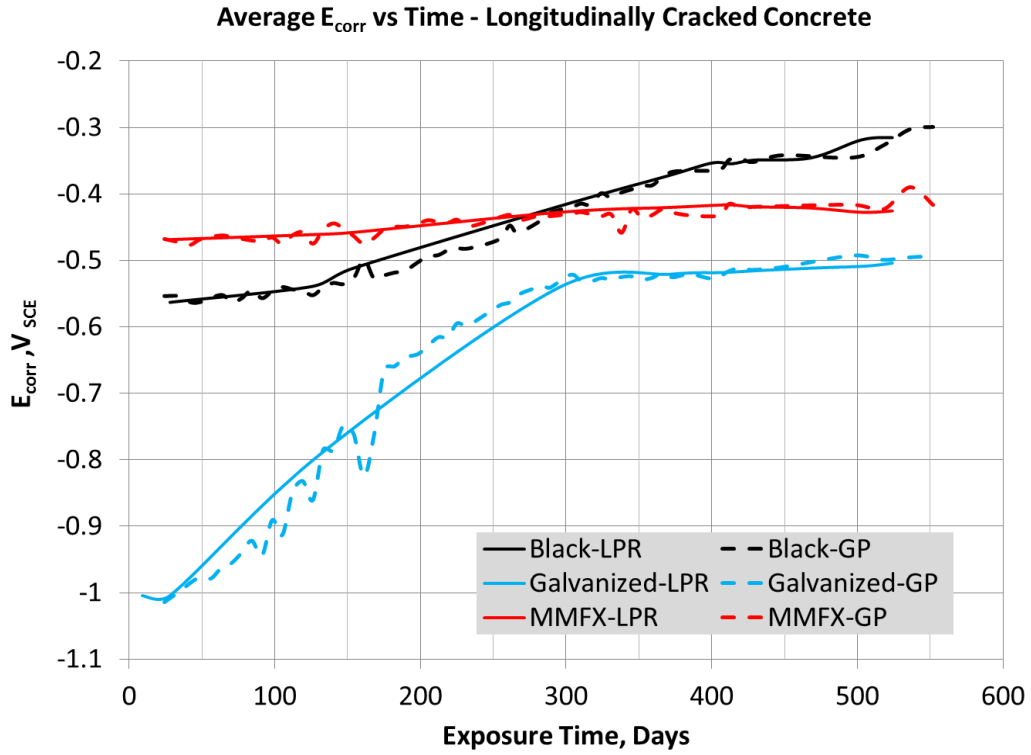
Figure 4-6: Average  $E_{corr}$  - Corrosion resistant rebar in longitudinally cracked concrete

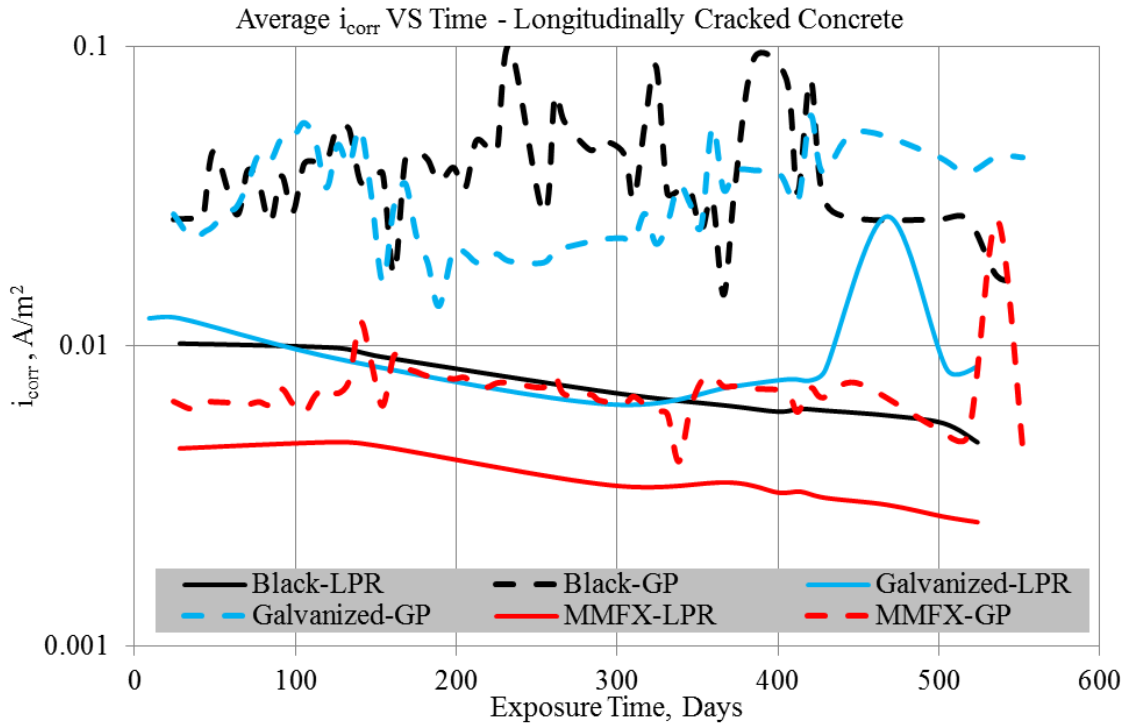
Figure 4-7: Average  $i_{corr}$  - Corrosion resistant rebar in longitudinally cracked concrete

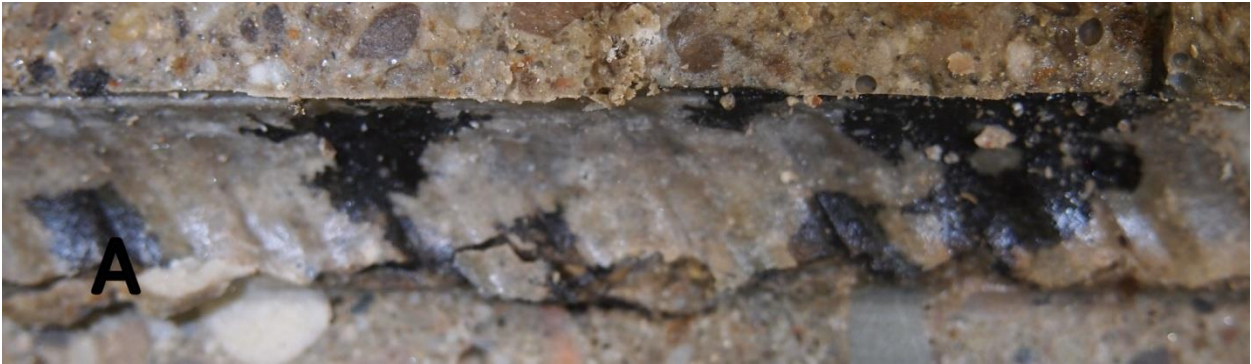
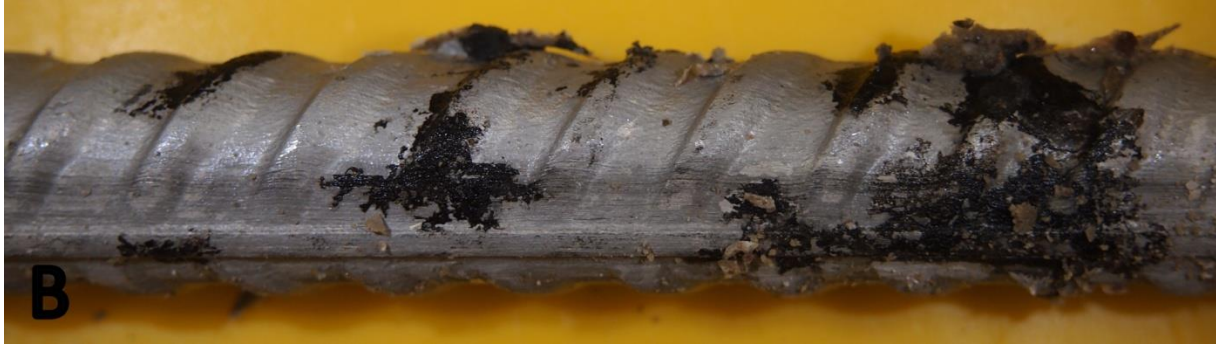
Figure 4-34: A: Corrosion products migration demonstrated on the concrete surface adjacent to the steel; B: rebar surface corrosion on Valbruna XM28

The specimens were then autopsied by cutting the concrete on both sides to a depth of approximately 3mm (1/8 inch) above the steel, as to not detrimentally effect the surface of the rebar, or wash away corrosion products. One side of the sample was then compressed in a vice and levered to crack the prism in half. This allowed the surface of the rebar to be examined for corrosion, and the adjacent concrete to be examined to determine the migration of corrosion products, Figure 4-34.

It was noted that all the stainless steels, as well as the corrosion resistant steels exhibited corrosion to varying extents beginning directly under the crack with corrosion and corrosion products often migrating horizontally along the surface of the rebar, see summary and rank in Table 4-3. This is likely because of different crack widths and crack length providing different chloride concentrations to each specimen.

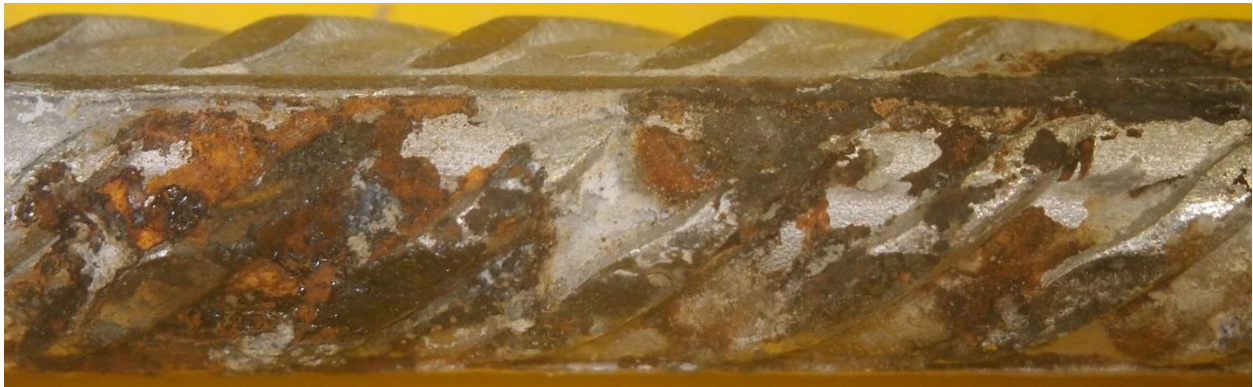
Figure 4-37: Delaminated corrosion product on 2101 stainless steel

Approximately one month after the initial bars were autopsied, the remainder of the bars were removed from the chloride solution and autopsied, the crack widths and extent of corrosion have been presented in Appendix C. Although many of the bars have exhibited corrosion products on the surface of the rebar, and staining on the concrete, both of the XM28 bars exhibited a different surface staining pattern. While most corrosion product appears to be wet, with an expansion and delamination of the corroding steel, Figure 4-37, the XM28 corrosion product appeared dry and did not appear to stain the concrete, Figure 4-38.

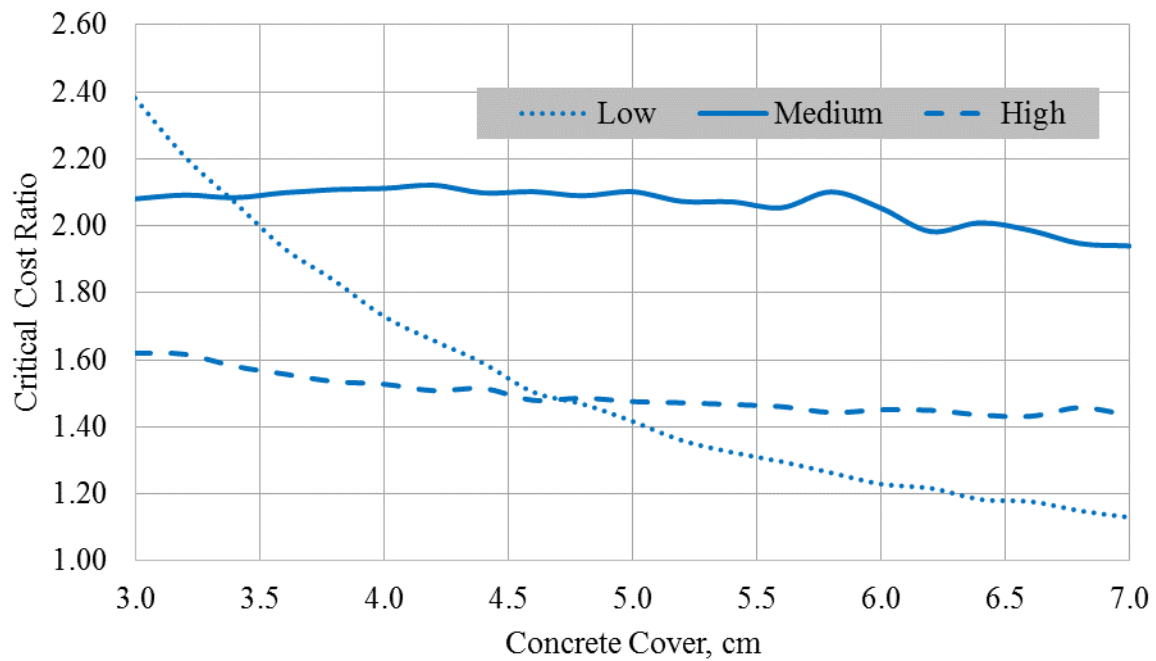
Figure 5-15: Critical cost ratio vs concrete cover for structures with 100 year service life, under three environmental conditions with a stainless steel chloride threshold of 3.0
