Flexural Fatigue Behaviour of Corroded Pretensioned Beams and Their Repair Using Carbon Fibre Reinforced Polymer Sheets

A thesis
presented to the University of Waterloo
in fulfillment of the
thesis requirement for the degree of
Doctor of Philosophy
in
Civil Engineering

Waterloo, Ontario, Canada, 2015

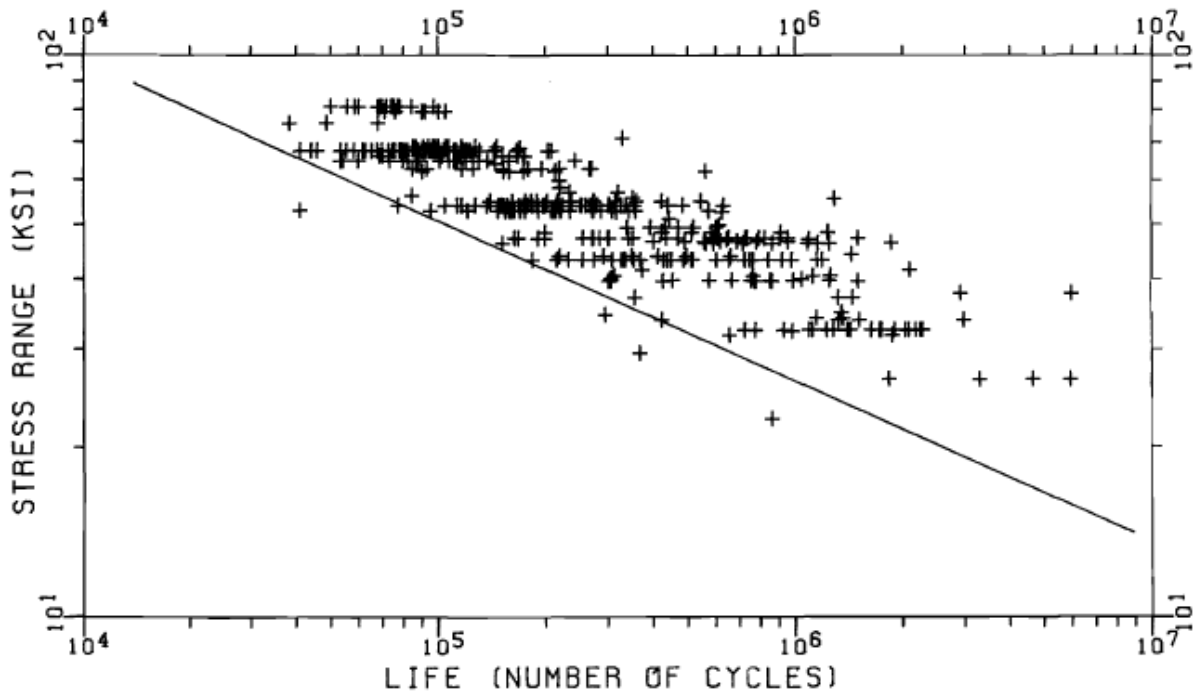
Figure 2-10 – Compiled fatigue test results for prestressing strand as an isolated element, the statistical design expression of 95% of no failure, Paulson et al. (1983)

Paulson et al. (1983) also noted that the fatigue behaviour of the prestressing strand varied from one manufacturer to another, and between strands from the same manufacturer. In addition, they observed that the fatigue resistance decreased with increased specimen length, which they attributed to the increased likelihood of flaws being present with a longer length.

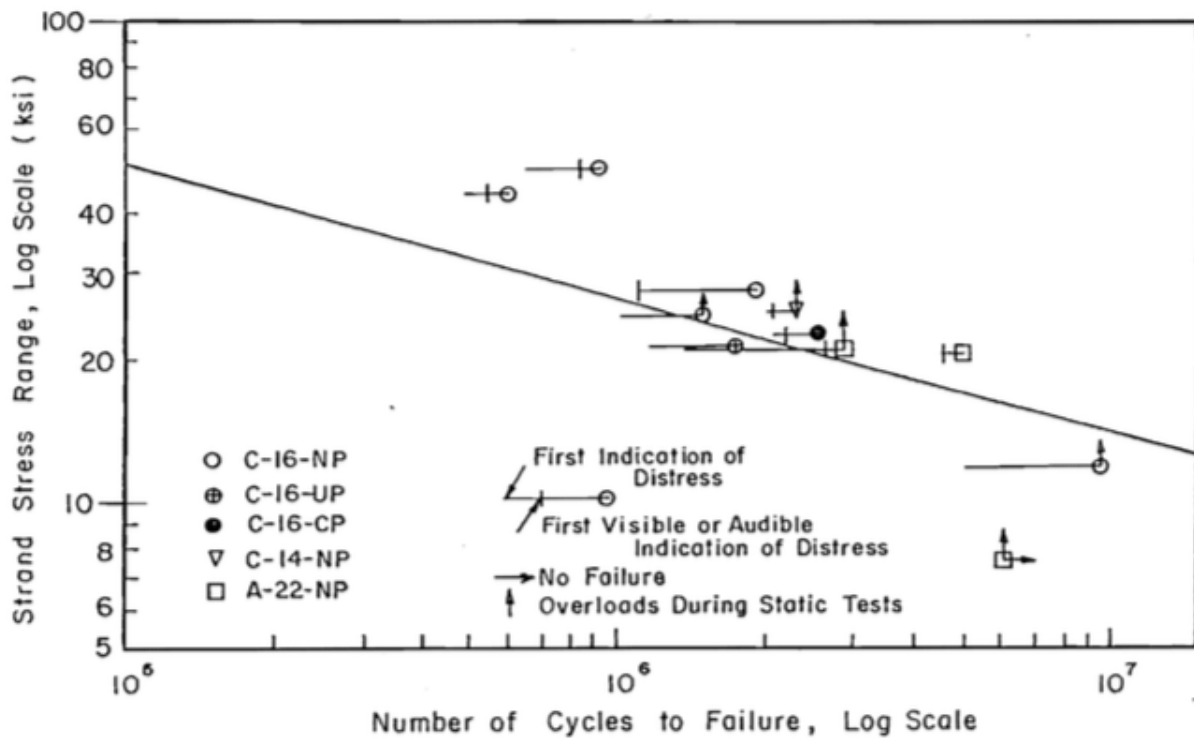
Figure 2-16 – Large-scale pretensioned beams fatigue test results in comparison to Paulson et al. (1983) lower bound strand-in-air model, Overman et al. (1984)

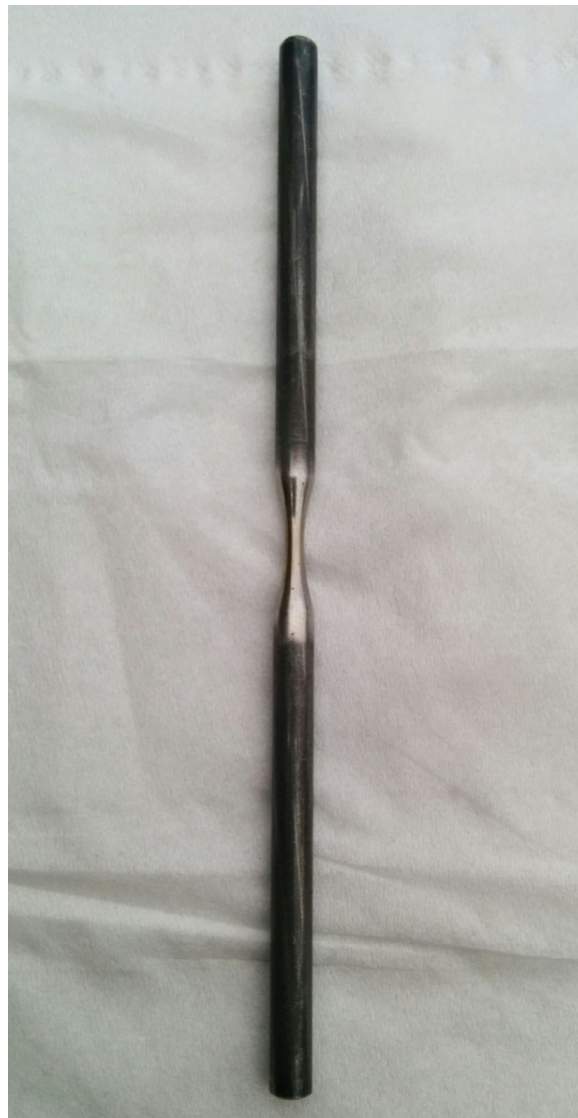
Figure 3-2 – Machined single wire specimens for fatigue testing

anchor failure by avoiding stress concentrations due to the sudden change in diameters, Figure 3-2. The samples were tested under different strain ranges. The results of the non-corroded samples are used to plot a strain versus number of cycles to failure (ϵ -N curve), which is used as the baseline data and is used to identify the material fatigue properties, and a stress versus strain curve that is used to describe the stress-strain behaviour of the wires.

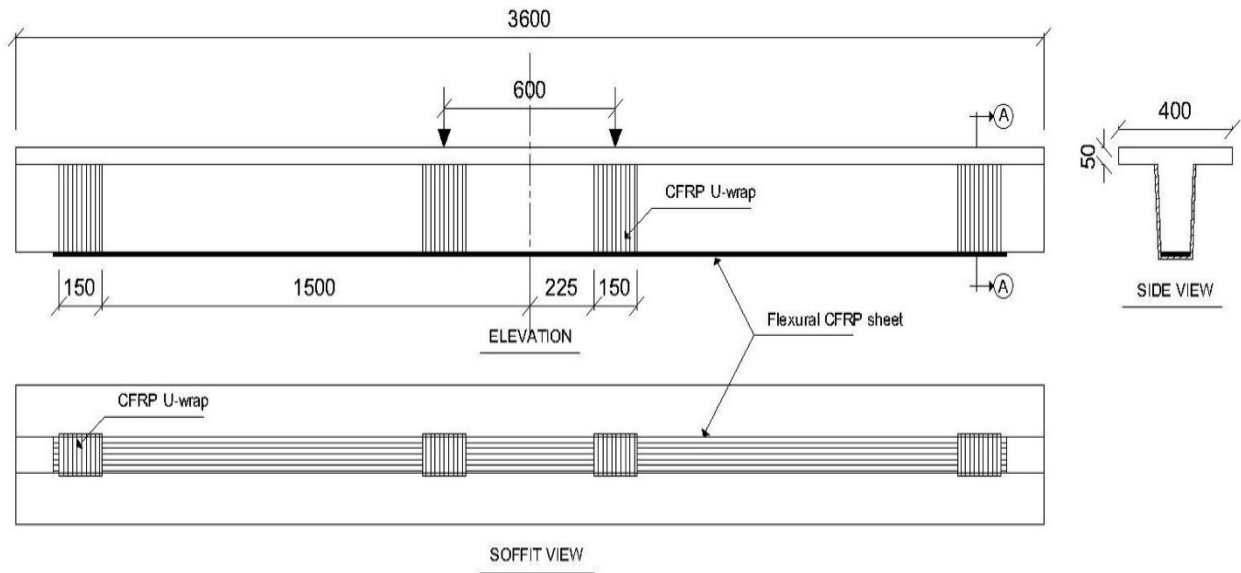
Figure 3-8 – CFRP sheets repair configuration

All 14 repaired beams had the same CFRP repair configuration. The unrepaired beams were expected to fail in flexure, and corrosion was expected to cause a reduction in load bearing capacity. The repair configuration was designed to restore the reduction in load bearing capacity. A 100mm wide×0.38mm thick flexural CFRP sheet was applied to the soffit of the beam in the longitudinal direction. In addition, two U-wraps were applied at the location of the loading points to provide confinement to the concrete in the corroded zone, and two more U-wraps were placed at the beam-ends to prevent delamination of the flexure sheet. The orientation of the fibres of the flexure sheet was in the longitudinal direction (parallel to the prestressing strand), while for the U-wraps the fibres were oriented in the direction transverse to the prestressing strand. Figure 3-8 shows a schematic of the CFRP repair configuration, while Figure 3-9 shows the beams after CFRP repair application.

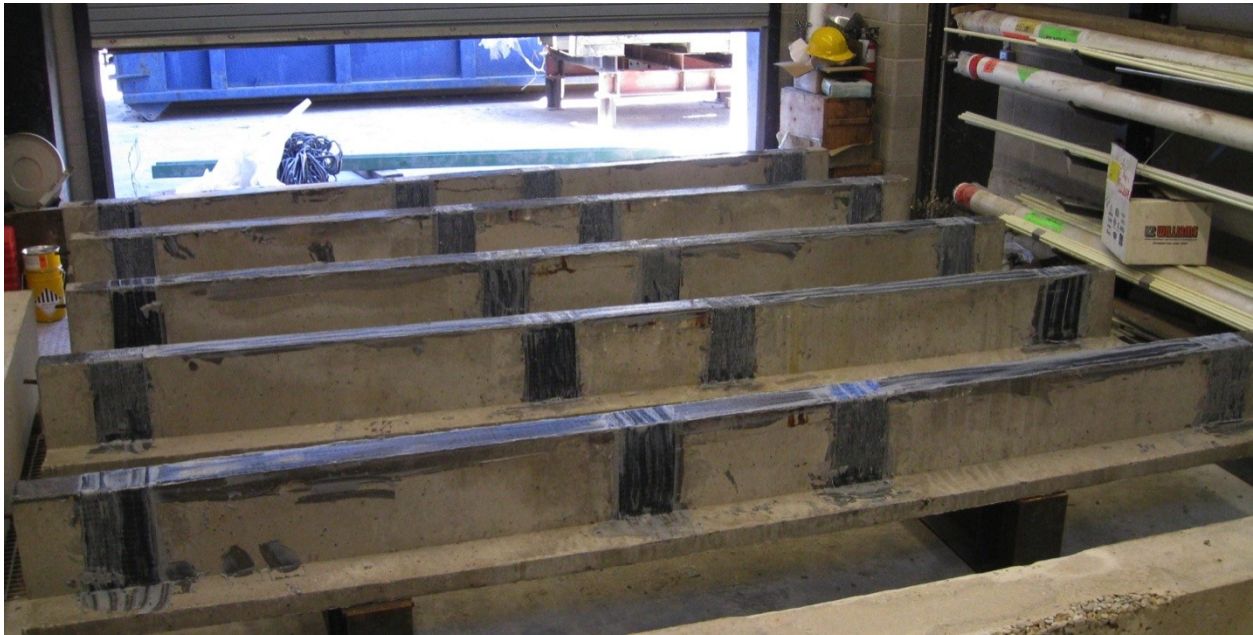
Figure 3-9 – Beams after application of CFRP sheet repair

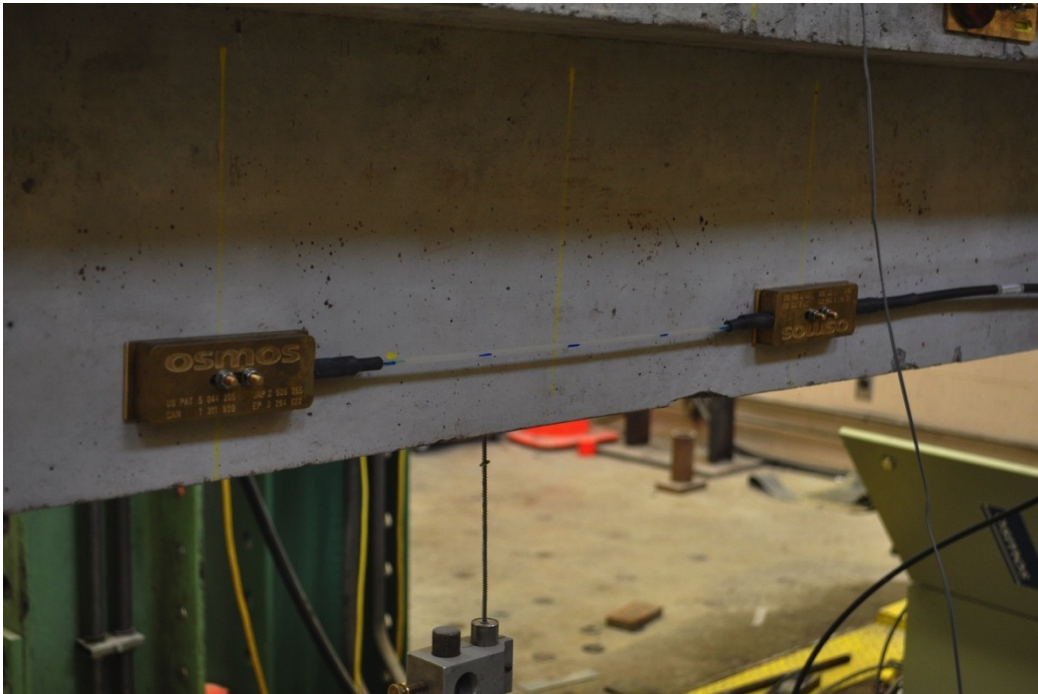
Figure 3-13 – OSMOS FOS across flexure zone for average strain readings at the level of the strand

The average tension strain at the concrete surface was also measured using a 500 mm long OSMOS fibre optic sensor (FOS) placed on the web at the location of the embedded prestressed strand, Figure 3-13. For beams wrapped with CFRP sheets, two 5 mm strain gauges were installed on the flexural CFRP sheet at midpoint in the longitudinal direction. A National instruments data acquisition system was used to acquire all measurements.

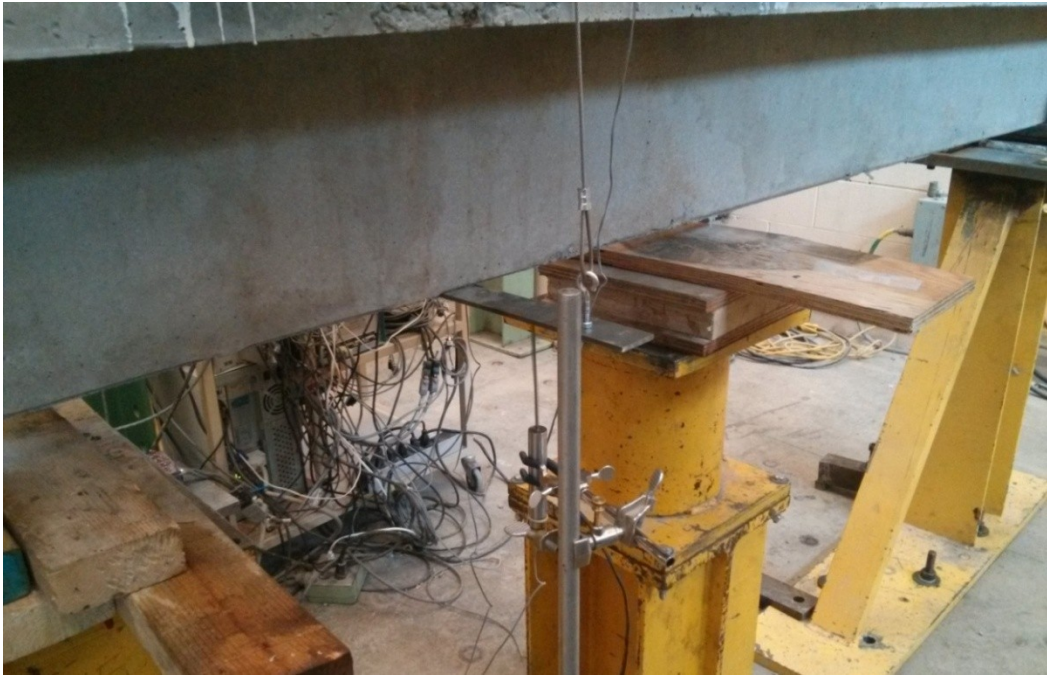
Figure 3-14 – Midspan deflection measurement by an external LVDT

Instrumentation for the fatigue beam test included: external LVDT(s) monitoring the midspan deflection (Figure 3-14) and the flexure crack opening widths (Figure 3-16), a 280 kN load cell to monitor the applied load, a 60 mm strain gauge that monitored the compressive strain at the concrete's top fibre (Figure 3-15), and two 10 mm strain gauges at mid-span to monitor the tensile strain in the CFRP sheets. A national instruments data acquisition system (DAQ) was used to record all the instruments' readings. Fatigue tests were stopped upon rupture of the prestressing strand, concrete crushing, or after recording more than one million cycles.

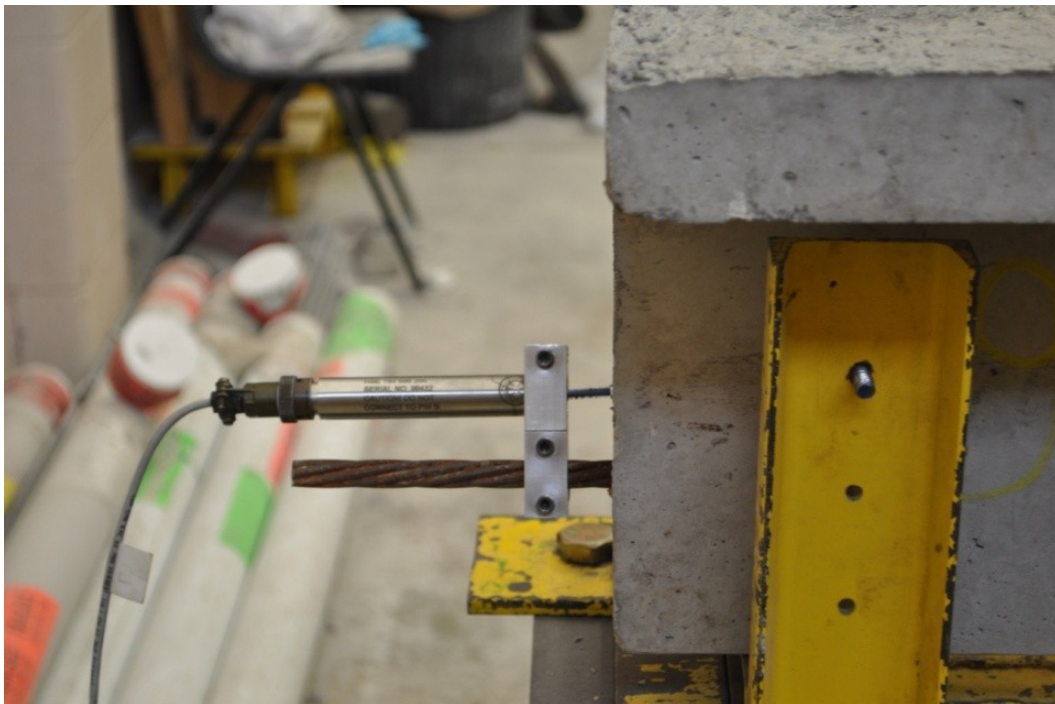
Figure 4-14 – LVDT mounted at beam end to monitor end slip of prestressing strand

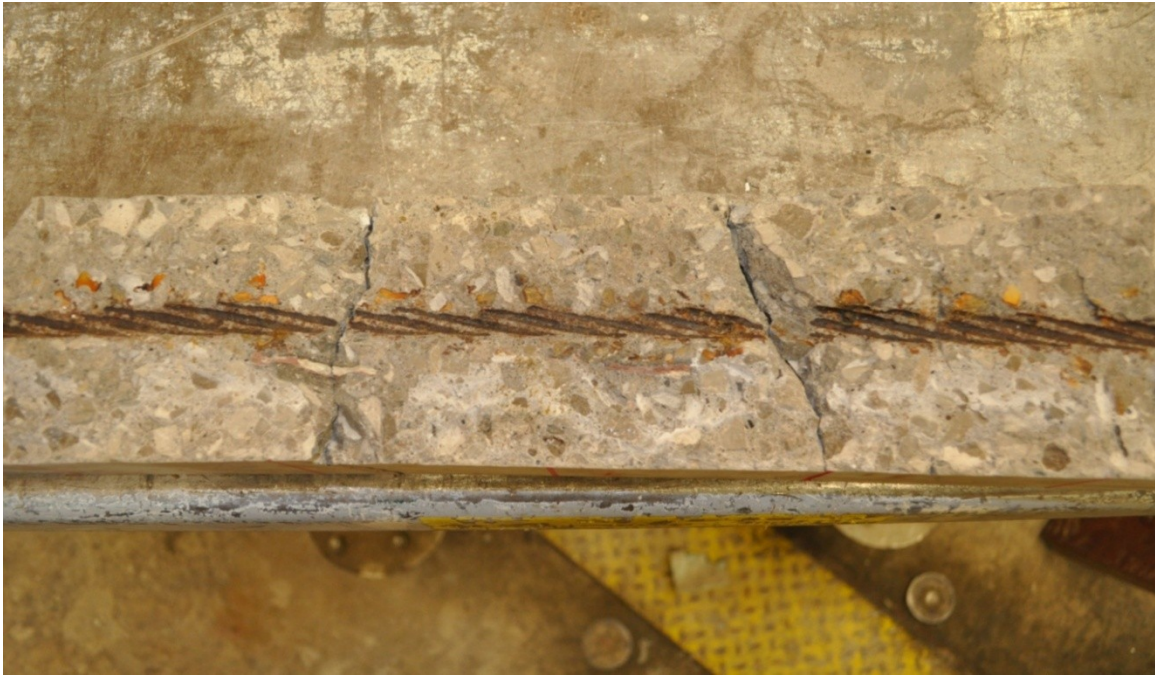
Figure 4-22 – Concrete strand interface below the strand

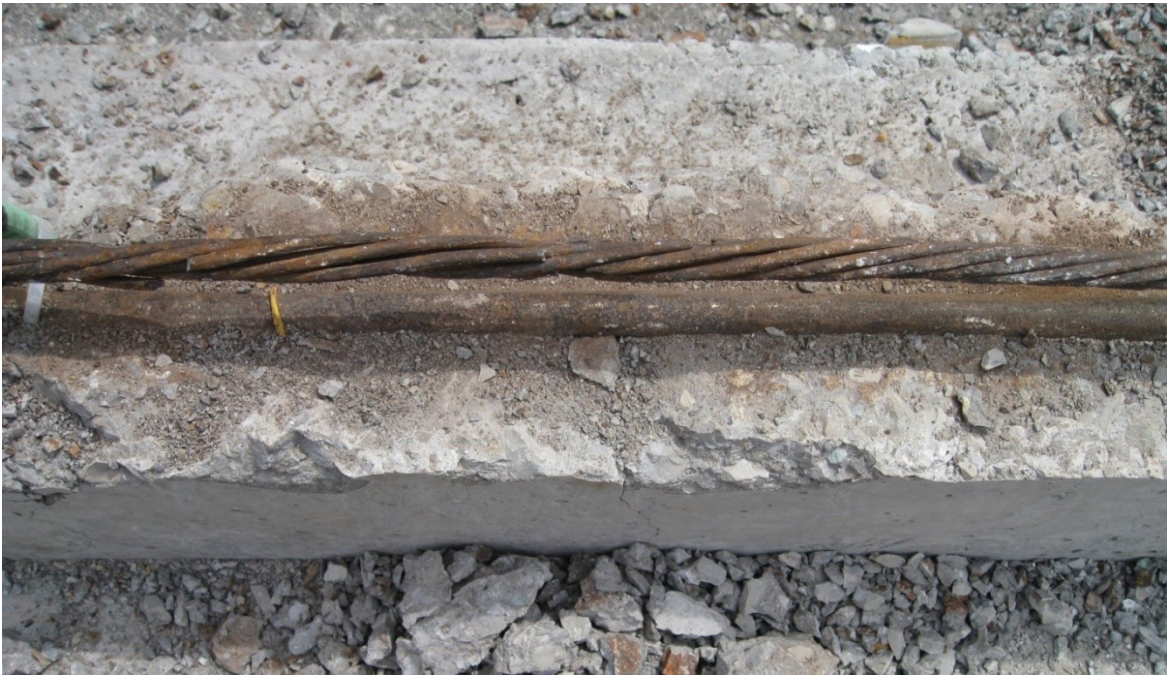
Figure 4-23 – Concrete strand interface above the strand

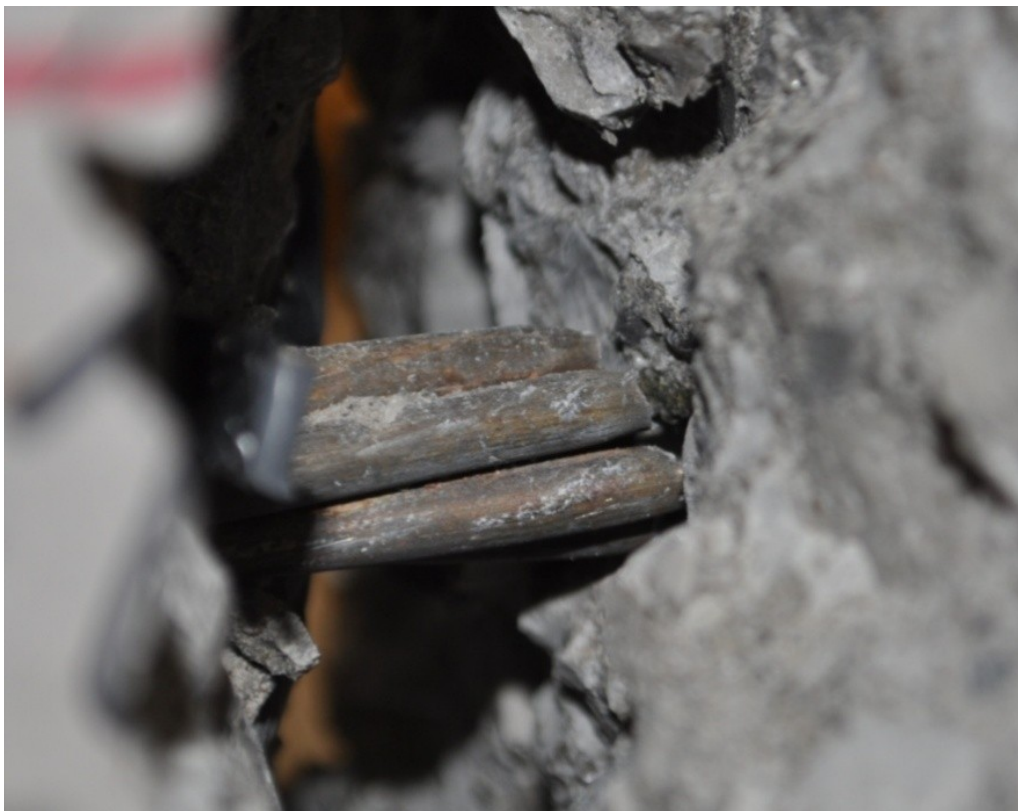
Figure 4-24 – Multi-wire rupture at the same location for the uncorroded beam

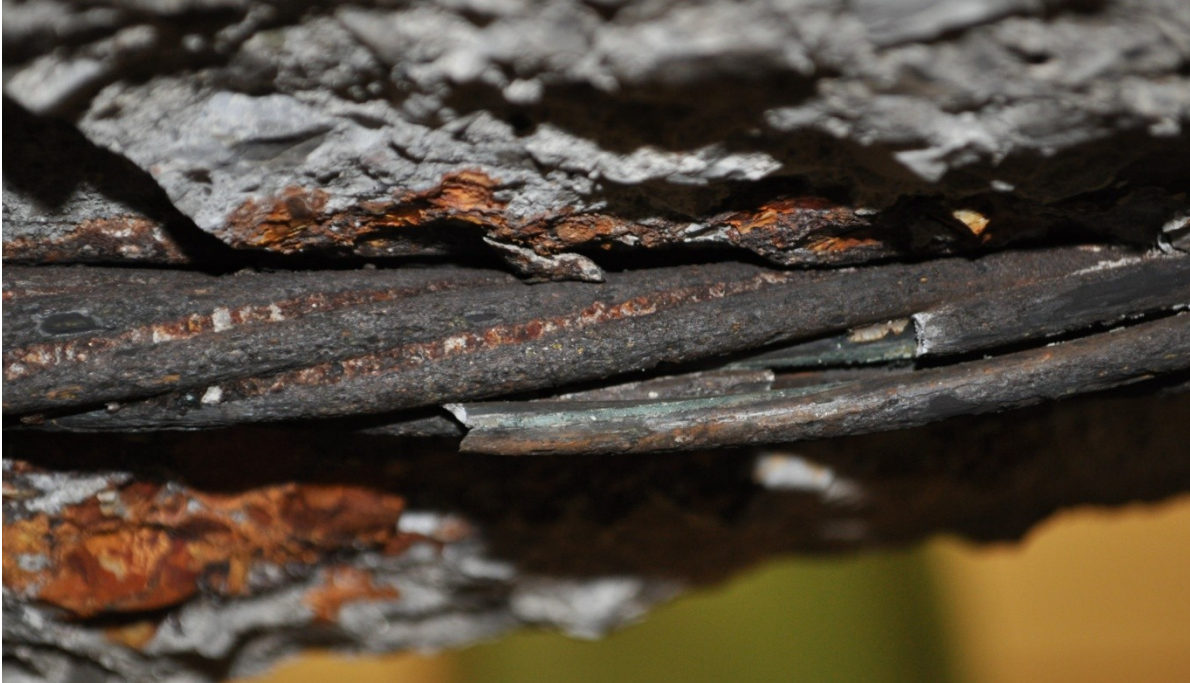
Figure 4-25 – Wires rupture at adjacent locations in a corroded beam

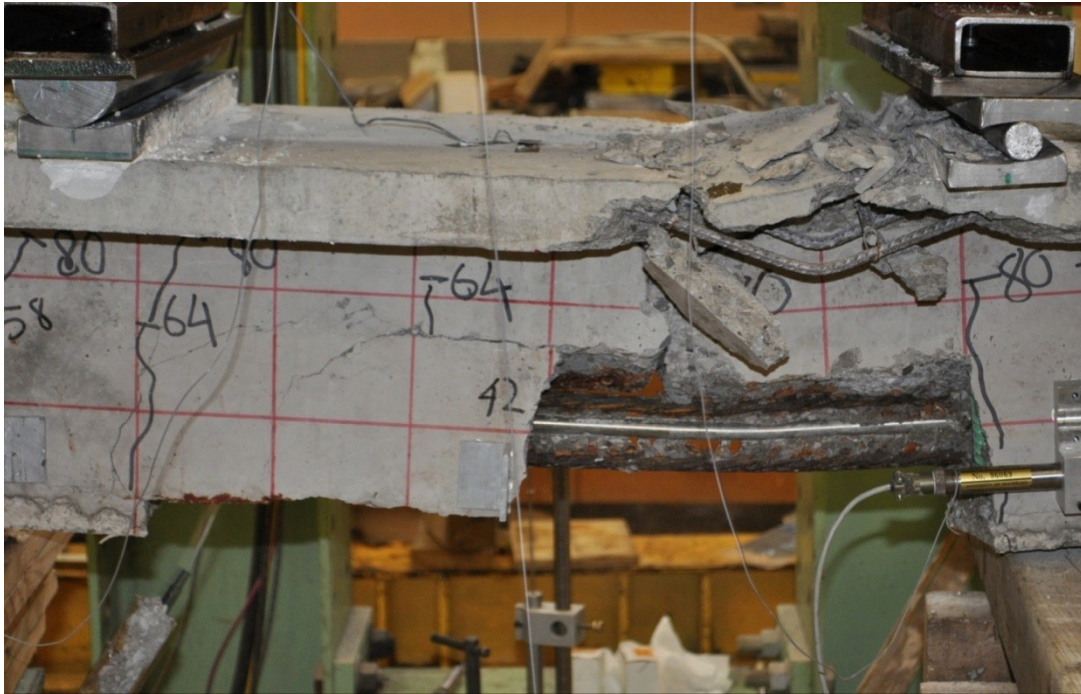
Figure 4-31 – Failure by concrete crushing of beam ST-2S-10%-NW-SC

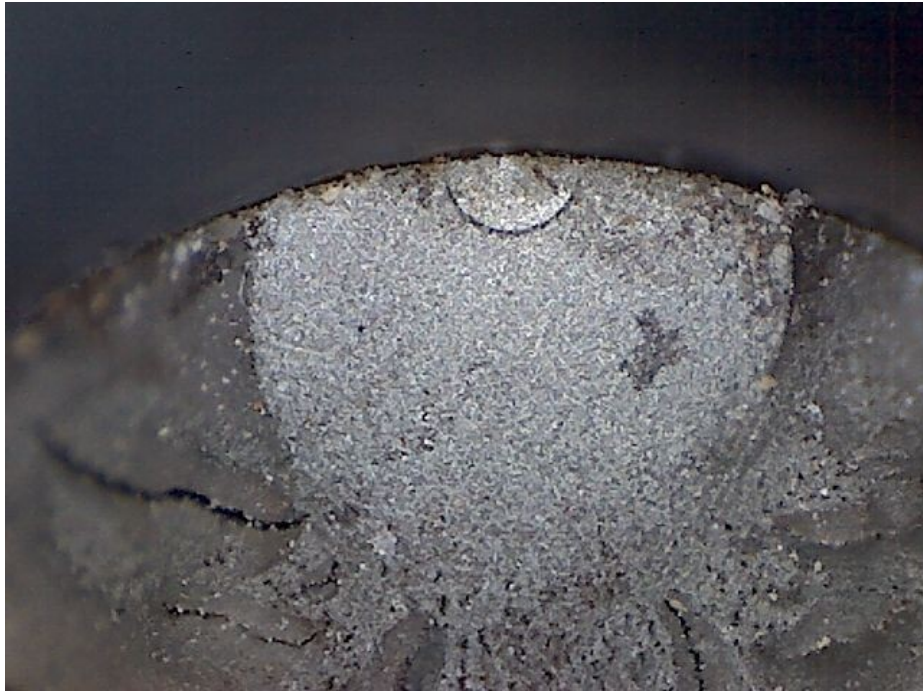
Figure 5-12 – 200× magnification of a sample the fretting damage

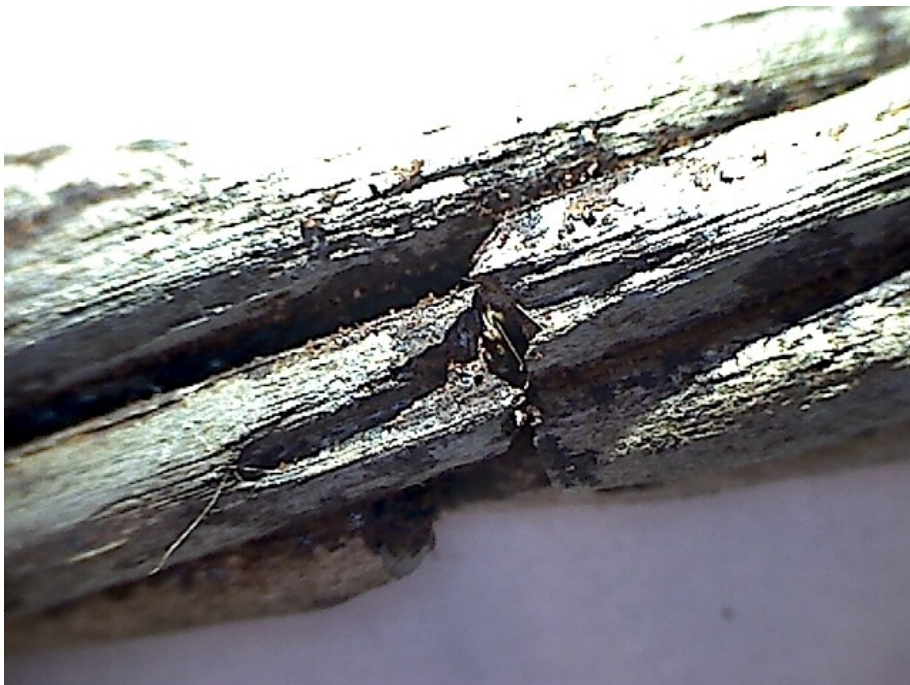
Figure 5-15 – Failure at a corrosion pit location on a strand specimen

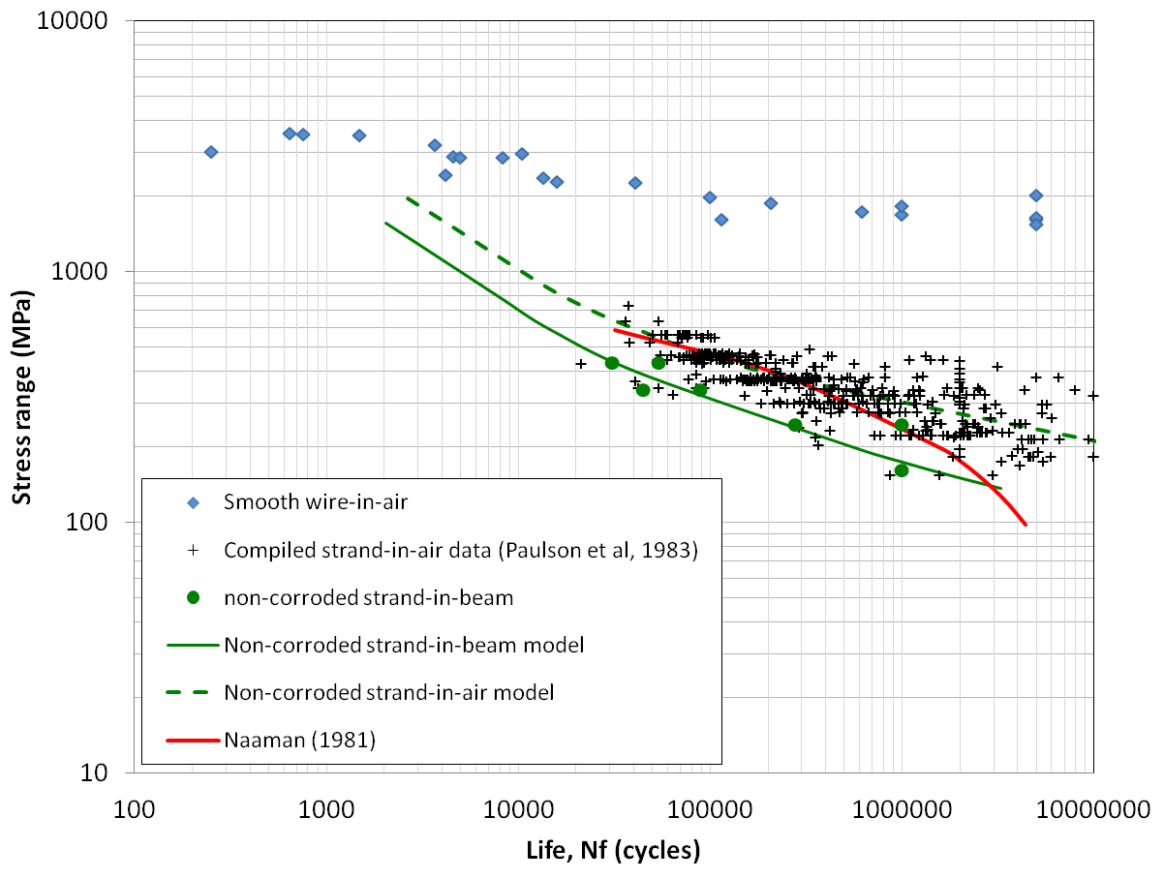
Figure 5-34 – Comparison of the modelled Strain-Fatigue life curve to Paulson et al. (1983) data using an incremental introduction of the fretting damage

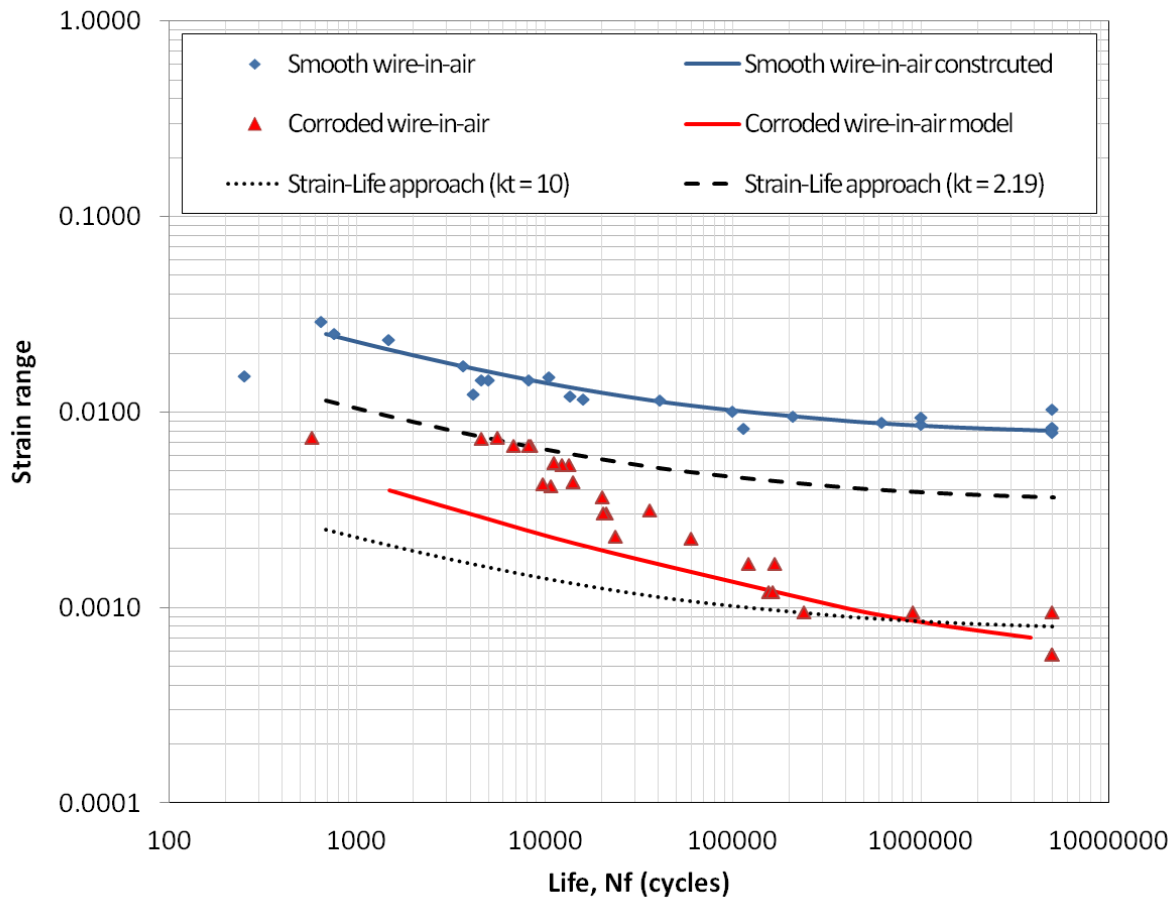
Figure 5-37 – Strain-fatigue life model of corroded-wire-in-air specimens

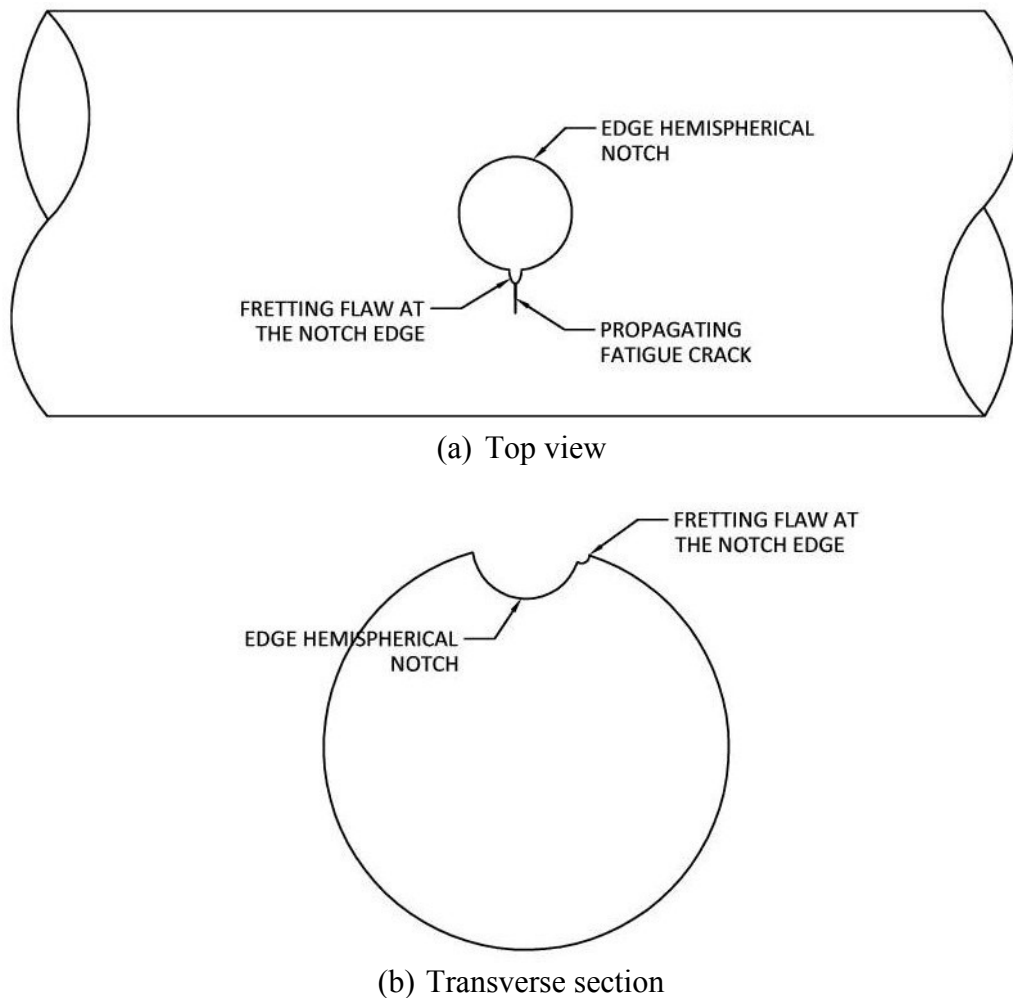
Figure 5-39 – Schematic showing a fatigue crack propagating from a fretting induced flaw intersecting the edge of a pit for a corroded strand-in-beam specimen

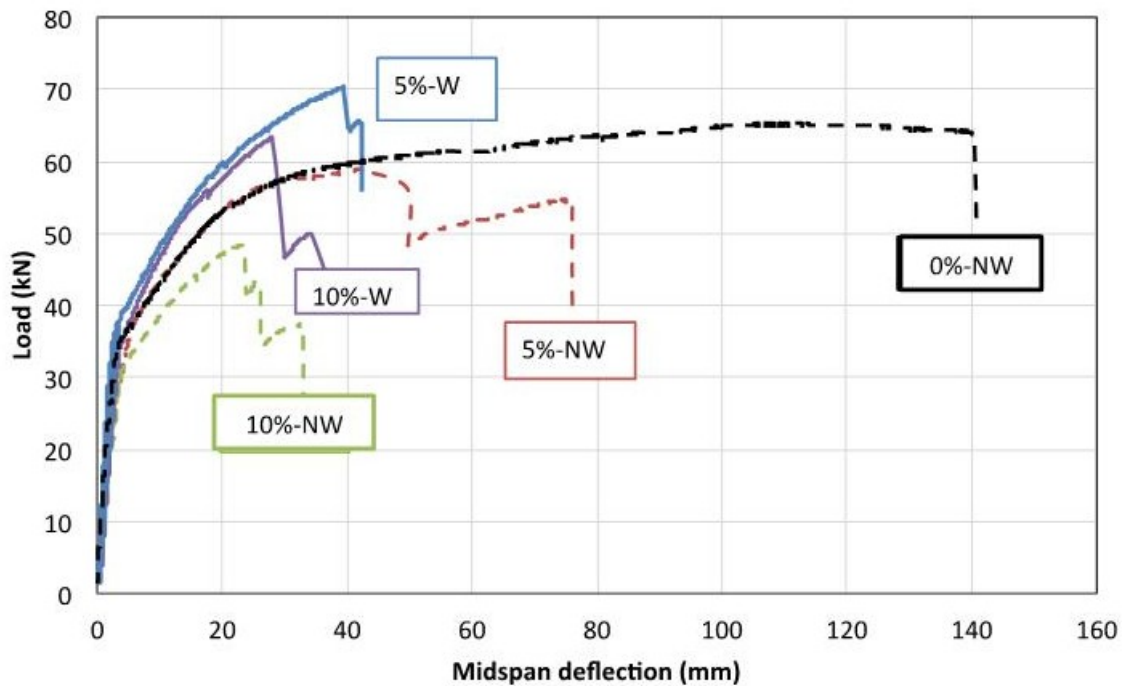
Figure 5-42 – Load vs. midspan deflection comparison of the repaired and unrepaired beams

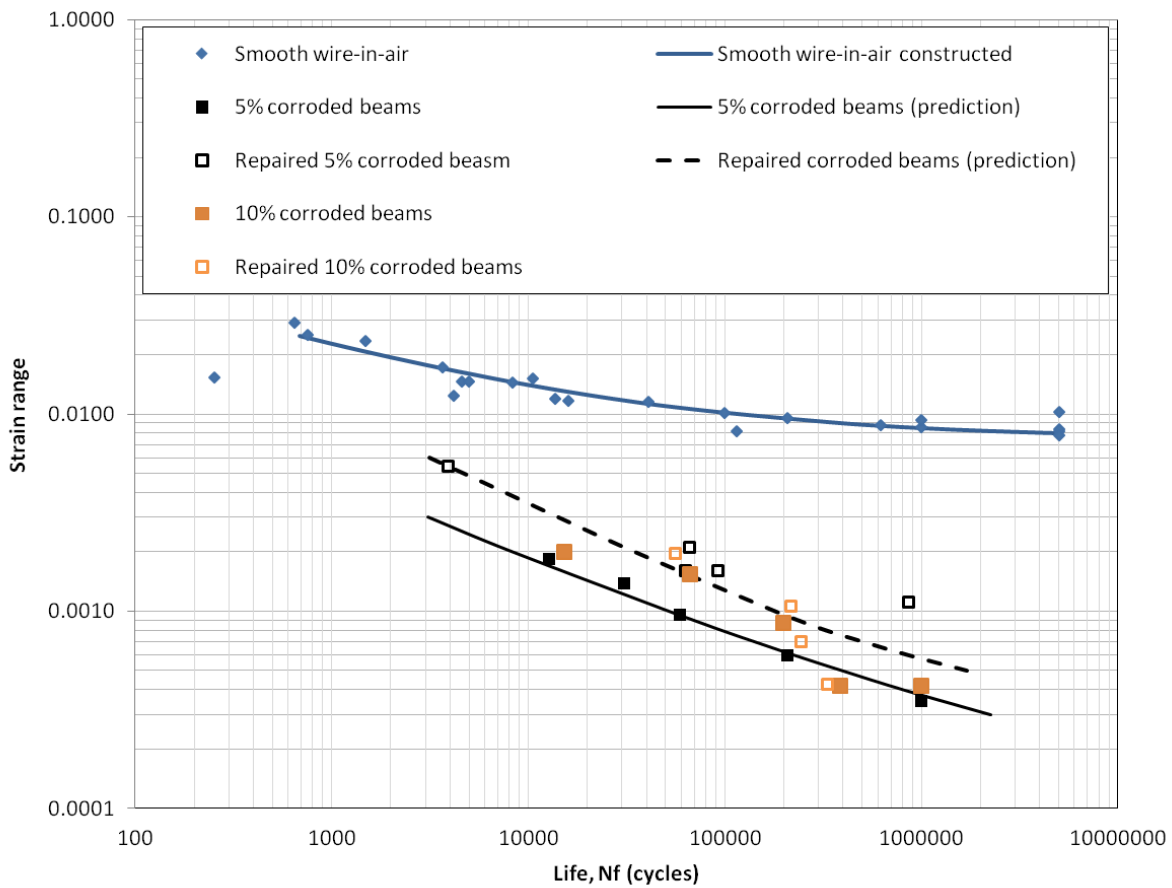
Figure 5-43 – Modelled strain range vs. fatigue life curve non-repaired and repaired corroded strand-in-beam specimens (assuming a reduced concrete fretting damage)

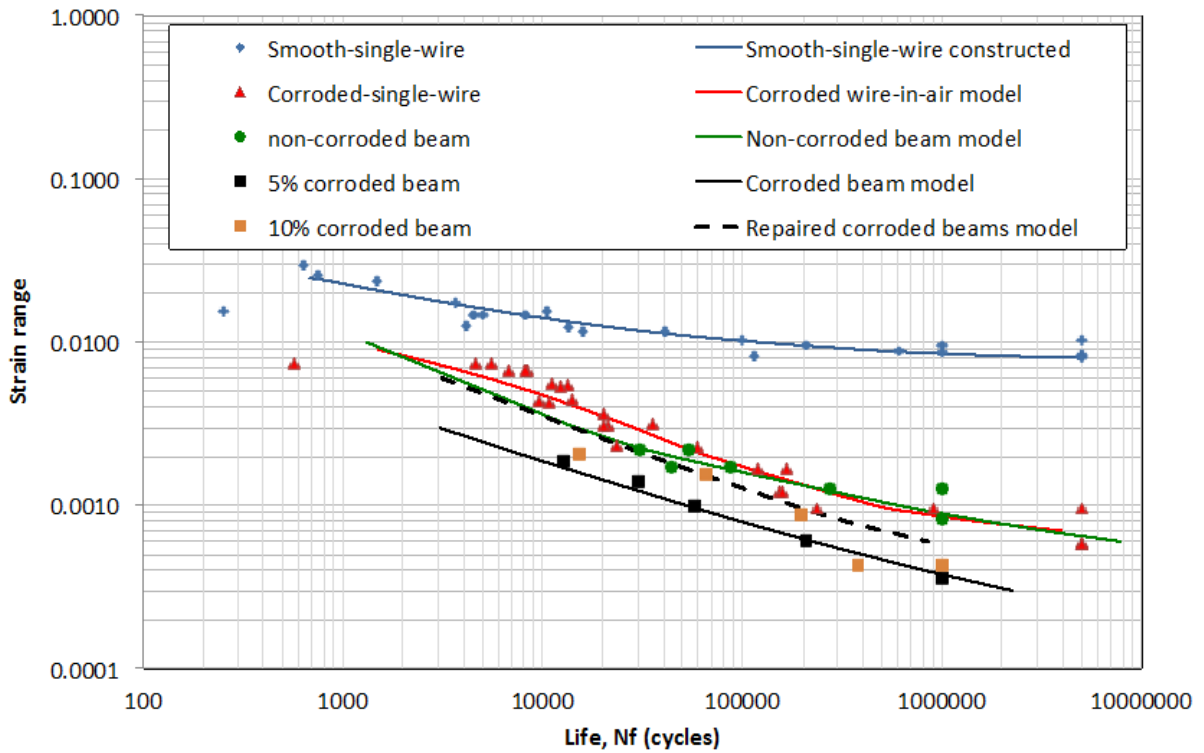
Figure 5-44 – Summary of fatigue resistance models versus experimental behaviour
