**A STUDY ON OPTIMIZING INFRARED HEATING
TECHNOLOGY FOR ASPHALT PAVEMENT
MAINTENANCE AND REHABILITATION**

A thesis
presented to the University of Waterloo
in fulfilment of the
thesis requirement for the degree of
Master of Applied Science
in
Civil Engineering

Waterloo, Ontario, Canada, 2019

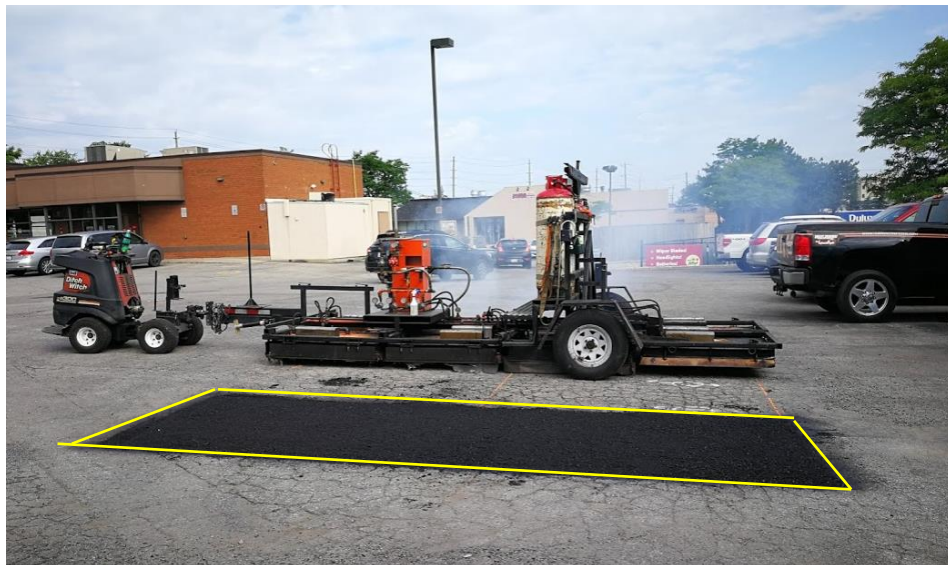
Figure 3.9: Fresh Infrared Heating Patch Repair

The first site observed was a restaurant parking lot shared with a Tim Horton's drive through located at 384 King Street North, Waterloo. This location had a working history with infrared heating repairs, and has implemented annual infrared patch repairs for the past couple of years targeted at repairing the most deteriorated areas of the parking lot causing the greatest safety hazards for users. Figure 3.9 and 3.10 below display one brand new infrared heating patch and an area surrounding a storm drain with a two year old infrared patch, marked for further repairs this year. The repaired areas are outlined in yellow.

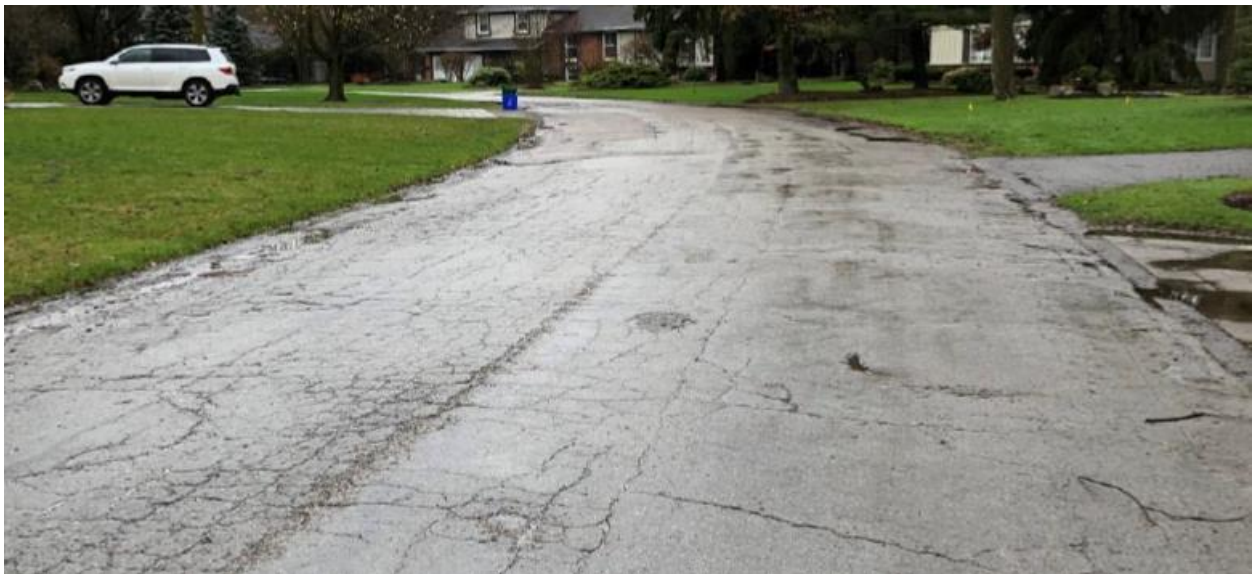
Figure 4.2: Typical layout of Sugarbush Drive, Taken May 8th, 2019

Based on the visual inspection, the pavement structure appeared to consist of a 40 mm surface course of asphalt pavement on a granular base. The thickness of the granular base and the nature of the subgrade could not be determined from visual inspection. The pavement surface is crowned at its center allowing minimal drainage; however, the edges of the roadway sit at a lower elevation than the adjacent residential lots. No drainage system was observed. Figure 4.2 below displays a typical street view of Sugarbush Drive.
