THE PERFORMANCE OF RAINSCREEN WALLS IN COASTAL BRITISH COLUMBIA

A thesis presented to the University of Waterloo in fulfillment of the thesis requirement for the degree of Master of Applied Science in Civil Engineering

Waterloo, Ontario, Canada, 2007

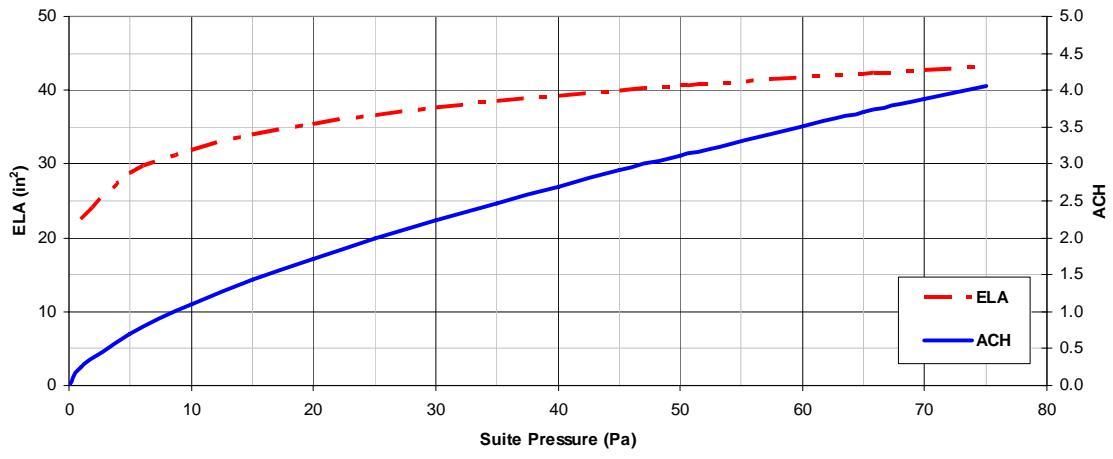
Figure 7-13: Exterior Wall ELA and ACH Relationships for Suite 608, Building 3

While the majority of air leakage occurs through the exterior building enclosure (which is beneficial for this suite as no provisions were made for makeup air), some leakage occurs between adjacent suites (22%).

The impact of taping the bathroom and kitchen exhaust fan inlets was tested by performing a series of additional tests. At 50 Pa, when the bathroom duct inlet was sealed with plastic tape, the equivalent leakage area dropped by 26 cm², when both bathroom and kitchen ducts were sealed this dropped to 32 cm² from a total of 280 cm².

The exhaust ducts were cast into the concrete floor slab and have an unknown area, however typical 2.5 cm x 250 cm $(1'' \times 10'')$ ducts would have only an area of 63 cm² and something similar was likely used here. It is also possible that the ducts were damaged or partially constricted during installation reducing the area. Sealing the bathroom/kitchen fans may also only have a minimal impact, as air may be drawn from other openings (electrical outlets) which are attached to the pressurized plenum created by the fan. The remainder of the leakage to the exterior is assumed to occur around windows, and penetrations through the building enclosure.

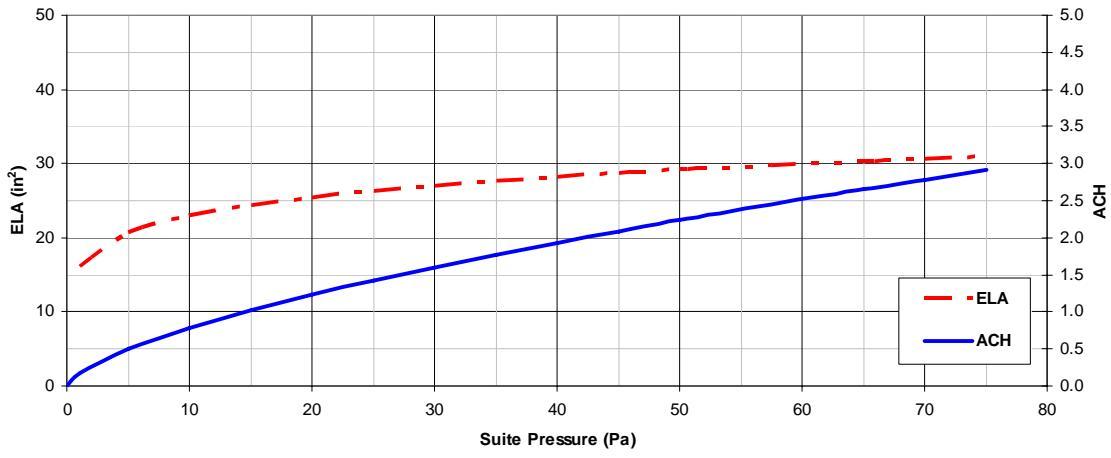
Figure 7-14: Exterior Wall ELA and ACH Relationships for Suite 611, Building 3

The majority of air leakage into this suite occurs through unintentional openings in the hallway wall (46%) and adjacent suite (16%). A negligible amount of leakage is through the floor slab (<1%) and the remainder is through the exterior walls and roof (36%).

Like suite 608 the area of in-slab ducts make up approximately 50 cm² to 100 cm² of the exterior leakage area. The remainder of the leakage to the exterior is assumed to occur around windows, and penetrations through the building enclosure.

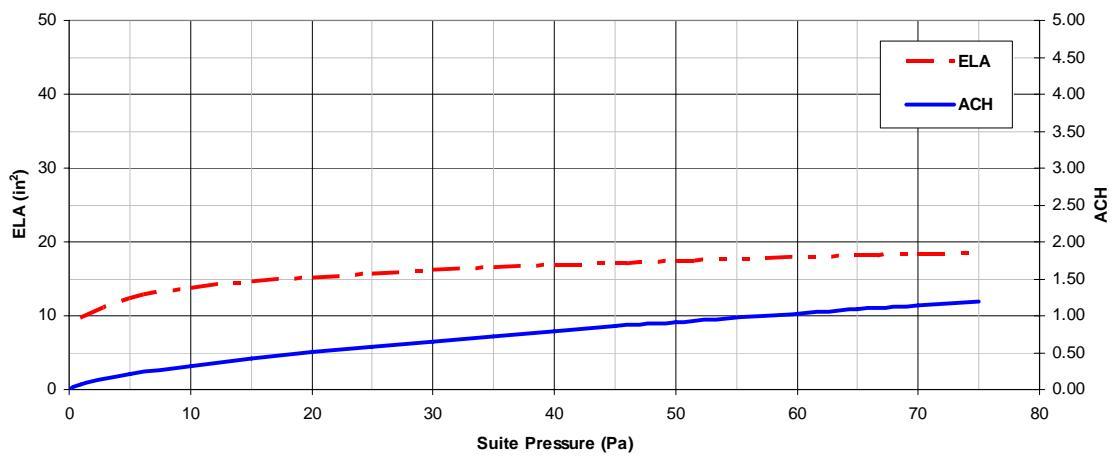
Figure 7-16: Exterior Wall ELA and ACH Relationships for Suite 802, Building A

The majority of air leakage into this suite occurs through unintentional openings in the hallway wall (37%). Leakage between suites is small (solid concrete walls) at 5%, however significant leakage occurs between floors (23% total). The remainder (35%) is through the exterior walls.

The impact of taping the bathroom and kitchen exhaust fan inlets was tested by performing a series of additional tests. At 50 Pa, when the bathroom duct inlet was sealed with plastic tape, the equivalent leakage area dropped by 18 cm², when both bathroom and kitchen ducts were sealed this total dropped to 29 cm² from a total exterior enclosure leakage of 115 cm².

The exhaust ducts were cast into the concrete floor slab and have an unknown area, however typical 2.5 cm x 250 cm $(1" \times 10")$ ducts would have only an area of 63 cm² each (126 cm² total) and something similar was likely used here. It is also possible that the ducts were damaged or partially constricted during installation reducing the area. Sealing the bathroom/kitchen fans may also only have a minimal impact, as air may be drawn from other openings (electrical outlets) which are attached to the pressurized plenum created by the fan. The remainder of the leakage to the exterior is assumed to occur around windows, and penetrations through the building enclosure, which was the tightest of the six tests performed.

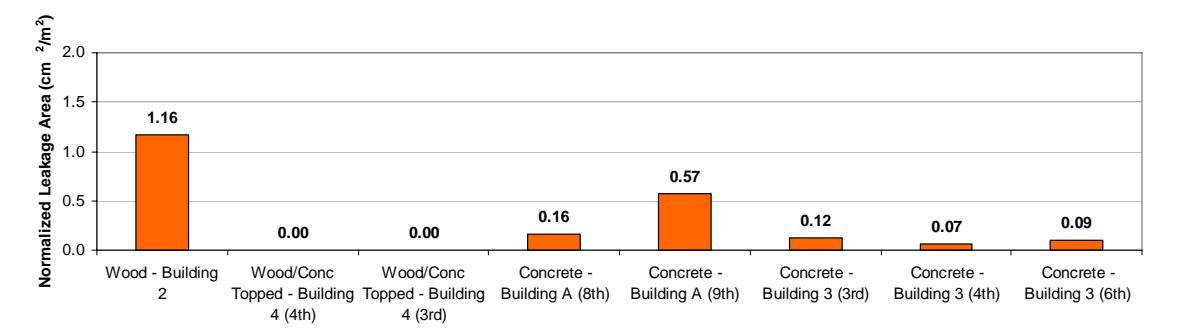
Figure 7-19: Comparison of Normalized Air Leakage through Floors by Type

The tightest system was the concrete topped wood frame wall followed by the concrete slab floor. The wood frame floor had the highest air leakage. The air leakage through a floor slab depends largely on how well the penetrations were fire/smoke sealed. It appears in Building A, one or several of the penetrations were poorly sealed, contributing to the higher than average leakage through this solid concrete slab. The wood frame floor as could be expected had a higher leakage area, due to penetrations, gaps, or shrinkage of the plywood and wood joist floor.

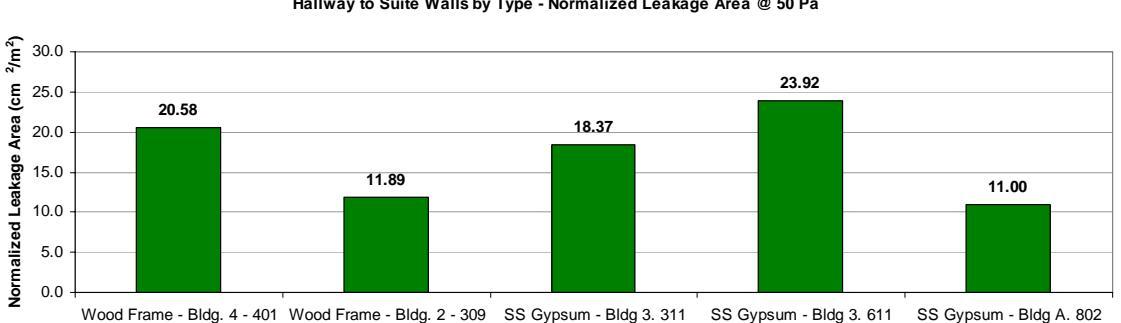
Figure 7-21: Comparison of Normalized Air Leakage through Hallway Walls

Air leakage through the hallway door is excluded from these tests, which has a leakage area is in the order of $50 \text{ cm}^2/\text{m}^2$ for a standard entrance door with a 1 cm door undercut normalized over the total area of the door frame. Therefore the measured leakage here is potentially through unintentional openings such as plumbing penetrations, cracks, gaps, or electrical boxes/switches.

The hallway demising walls were significantly leakier than the suite demising walls, possibly as openings were more frequent or poorly sealed. While the leakage area is unintentional (not through passive vents or door undercuts) it may be beneficial for suite supply air in cases where suite owners intentionally block the door undercut.

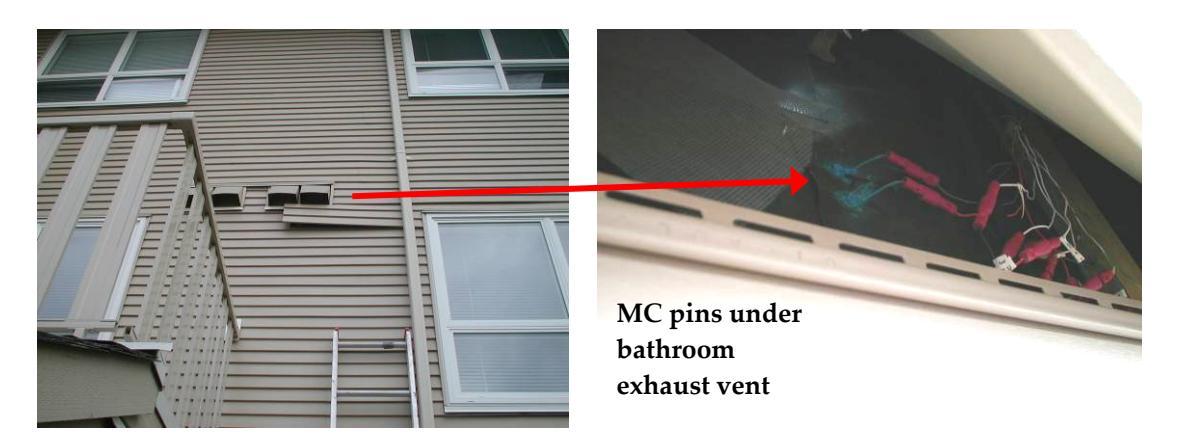
Figure 8-7: Location of Monitored Wall #5, Below Exhaust Vent

At only one wall location in the monitoring study was an observable leak detected by the sensors. The leak was noted in Building 1 below a bathroom exhaust vent (Figure 8-7) in January 2001 during the first winter after the sensors were installed. The moisture content of the sheathing was appreciably higher than other wall locations of the same building and ranged between 20-30% during January and February (Figure 8-8).

It appears that rain water leakage into the cavity at the corner of the vinyl J-trim combined with a reverse lapped building paper detail, contributed to the abnormally high moisture levels at this location. As a result of this monitoring project, repairs were made quickly in mid February to correct the detail before moisture damage could occur. In March, the moisture content dropped down to normal seasonal levels, similar to seasonal trends observed at the sensor in the center of the wall. No damage was observed at time of repair (however only a few months of wetting had occurred). Based on observations for this location as presented in Figure 8-1 and Figure 8-2 it appears that some moisture may still getting into the cavity at this location in 2002.

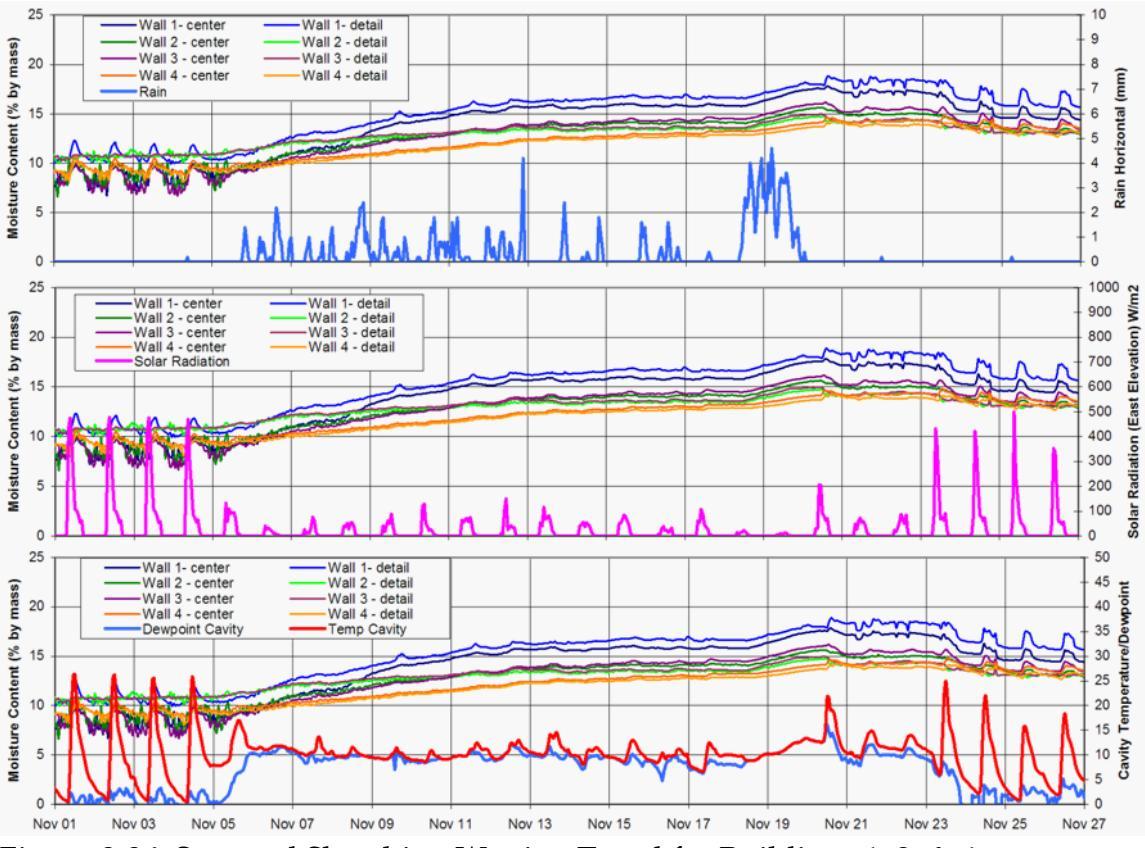
Figure 8-36: Seasonal Sheathing Wetting Trend for Buildings 1, 2, & 4

The seasonal wetting trend is highlighted in Figure 8-36, showing the influence of rainfall, solar radiation, and cavity dewpoint/relative humidity.

While raining during the moisture increase, the rain does not directly impact the sheathing moisture content. However during rainy weather the relative humidity outdoors is at 100%. The reduced cavity temperature and solar heating results in the relative humidity within the cavity space to be near outdoor conditions. As a result, the sheathing moisture content increases to reach equilibrium with the relative humidity within the cavity (between 80-90% on average). If the relative humidity drops (over a daily average), the sheathing moisture content also drops.

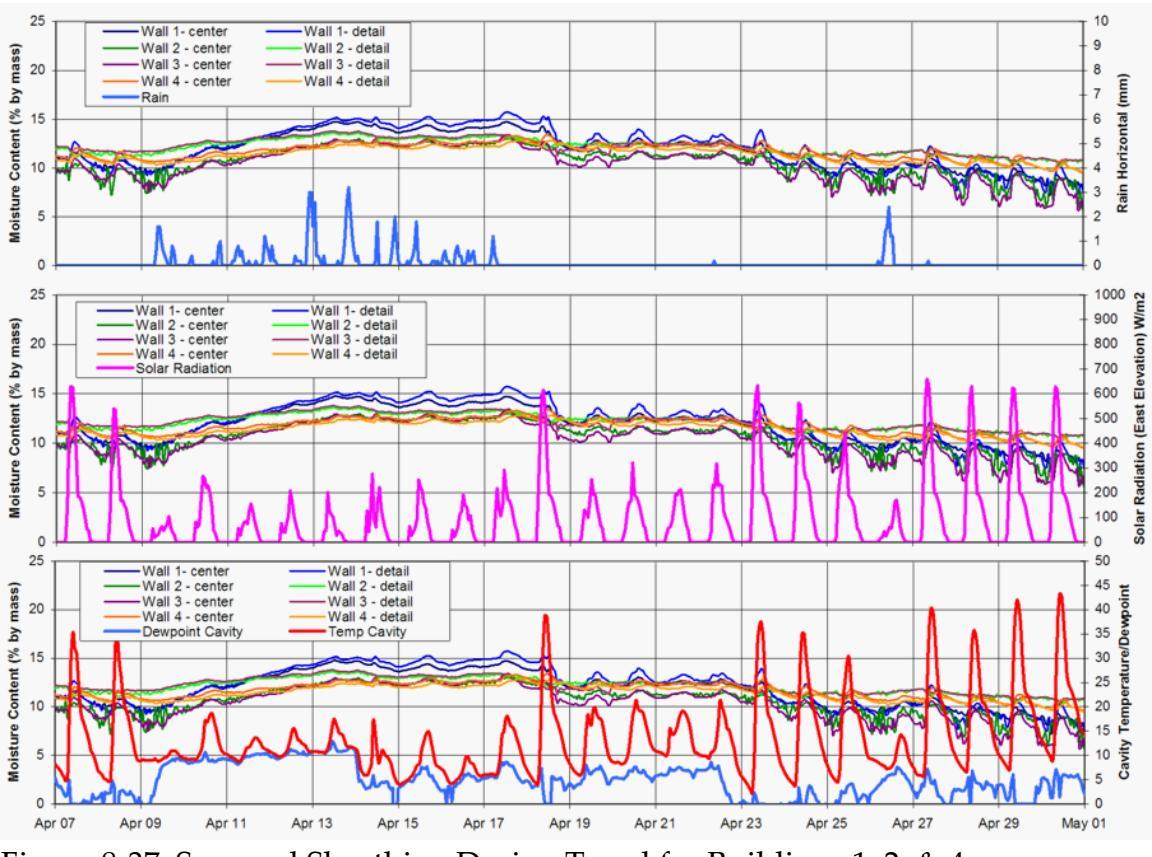
Figure 8-37: Seasonal Sheathing Drying Trend for Buildings 1, 2, & 4

The spring drying trend is highlighted in Figure 8-37, showing the strong influence of solar radiation on the cavity temperatures which reduces the relative humidity within the space and dries the sheathing. Cavity temperatures of up to 40-50°C result in evaporation of moisture from the sheathing which is subsequently carried away by ventilation flow.

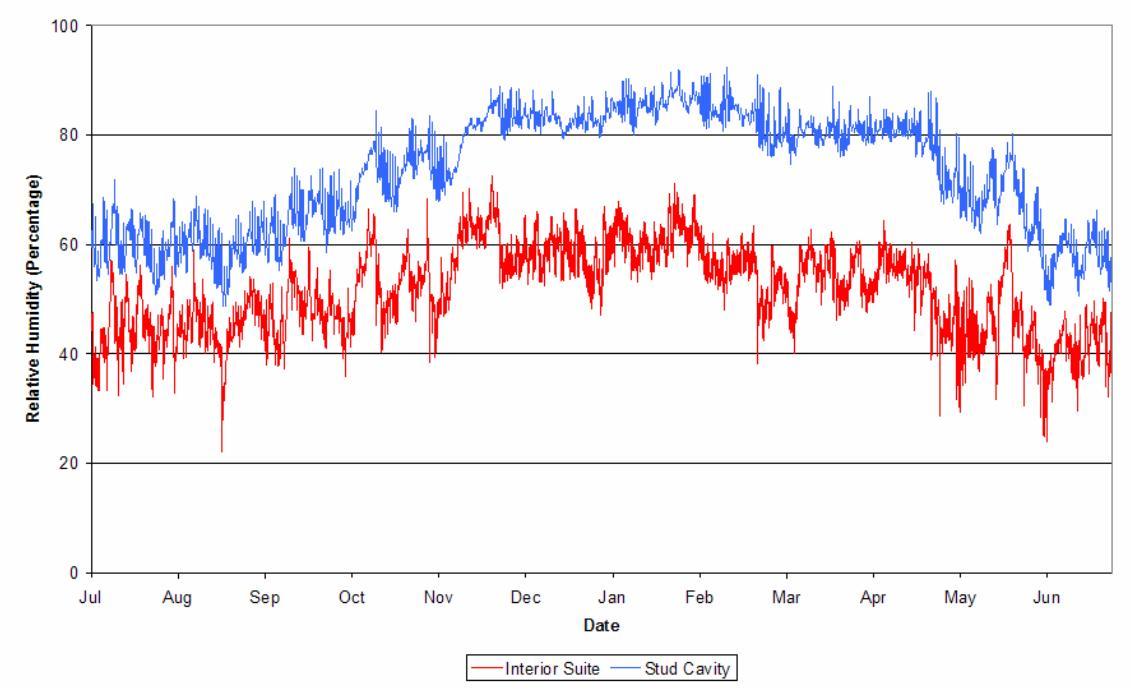
Figure 9-4: Building 3, Suite 611 Interior RH and RH in Stud Cavity, Wall #7

Without interior vapour control, the relative humidity within the insulated stud cavity is also elevated, from 80% to 90% (measured at the center of batt insulation) for six months of the year (Figure 9-4).

The elevated RH within the stud cavity is of concern for corrosion of the steel studs and possibly microbial growth on the gypsum sheathing or interior drywall.

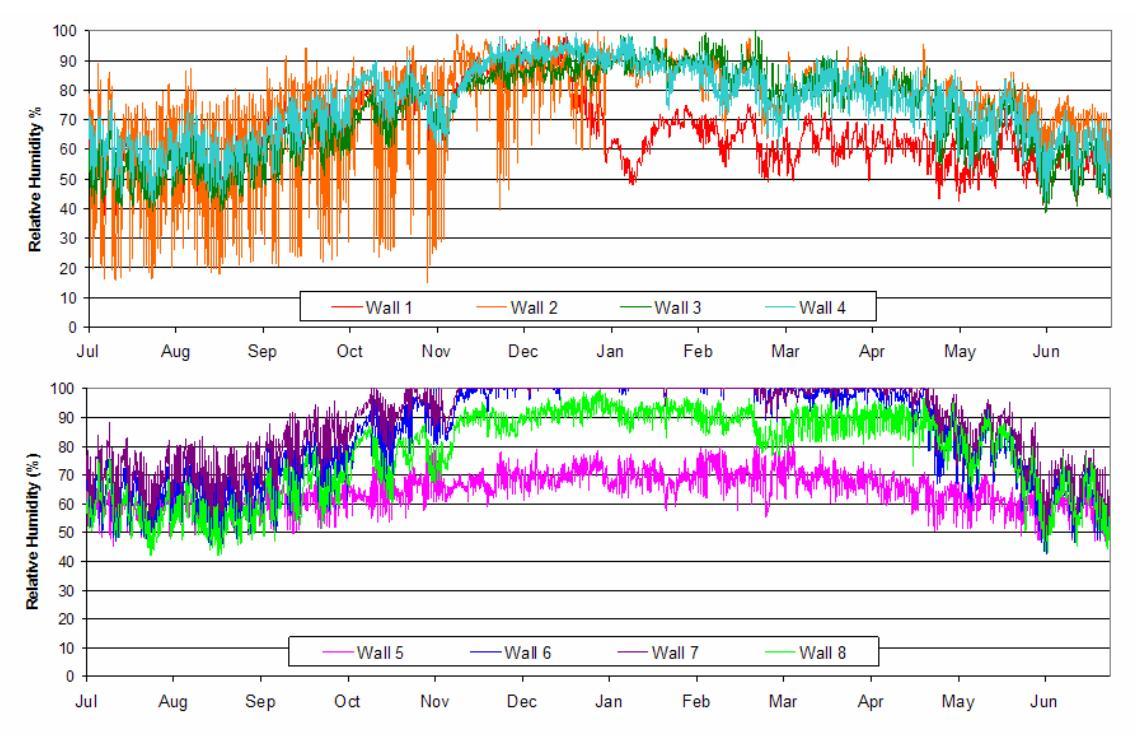
Figure 9-5: Building 3, Wall Locations 1-8 – RH at exterior sheathing

The RH at the interior surface of the exterior sheathing tracks around 50-80% during the summer months (May through August). In September the RH rises to up to 90-100% and remains at these higher levels until May when it decreases to 50-80% again. Analysis of data from 2002 to 2007 indicates that this same wetting

and drying trend repeats annually. A year over year trend of increasing moisture content was not observed as the moisture within the stud cavity largely dries out during the summer months.

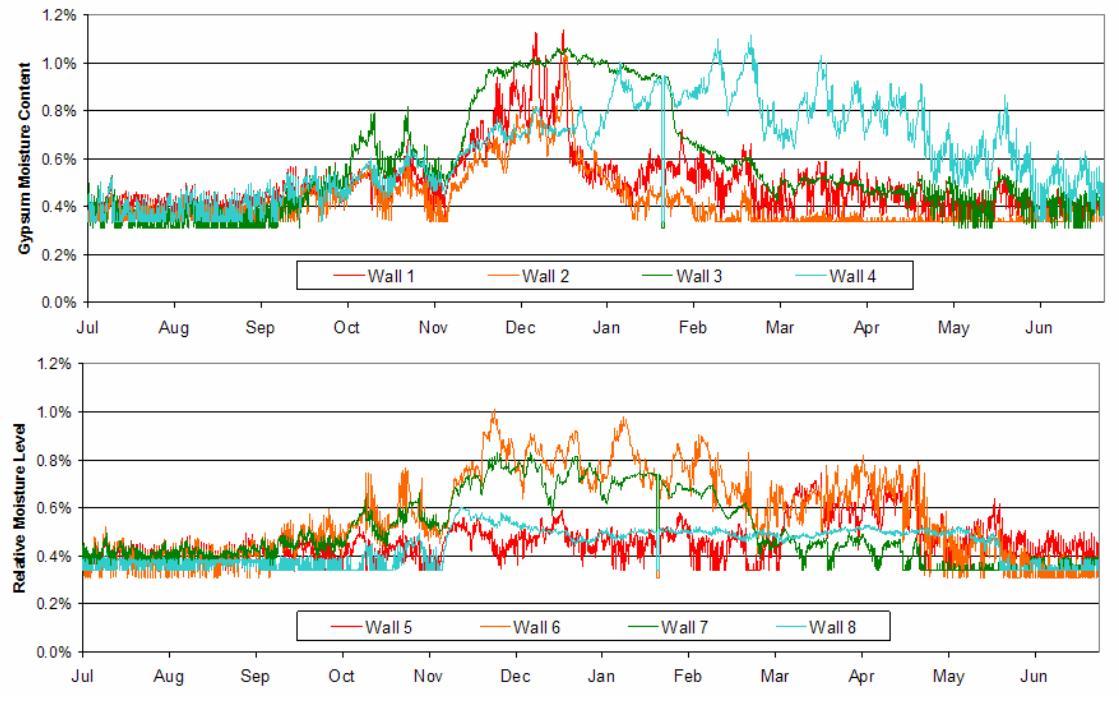
Figure 9-6: Building 3, Wall Locations 1-8 – Gypsum Sheathing Moisture Content

The gypsum moisture content and relative wetness readings correlate directly with the high stud cavity relative humidity levels. Gypsum moisture contents (up to 1%) are expected to be higher based on the sorption isotherm, however it is possible that moisture distribution and drying of the gypsum is occurring preventing very high levels from being attained. The developed moisture content correlation may also be different for the gypsum sheathing at this location (however a similar sample was correlated in the lab testing), as it appears to be under-predicting the sheathing moisture content.

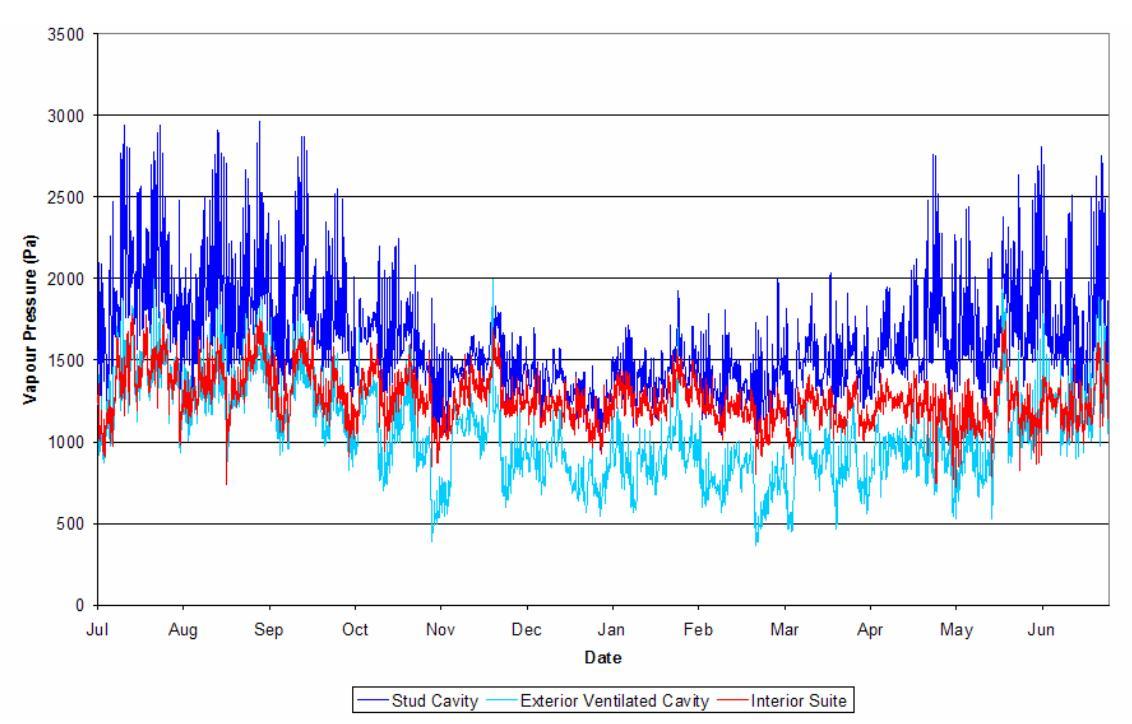
Figure 9-8: Building 3 – Wall Location 7, Vapour Pressures Across Wall

The vapour pressures within the stud cavity, interior suite, and exterior ventilated cavity are compared in an attempt to understand the high interior humidity levels observed within the walls. Hourly vapour pressures for an entire year are shown in Figure 9-8 indicating that the vapour pressure within the enclosed stud cavity are elevated above the exterior and interior for the entire year, possibly suggesting entrapped moisture within the stud space.

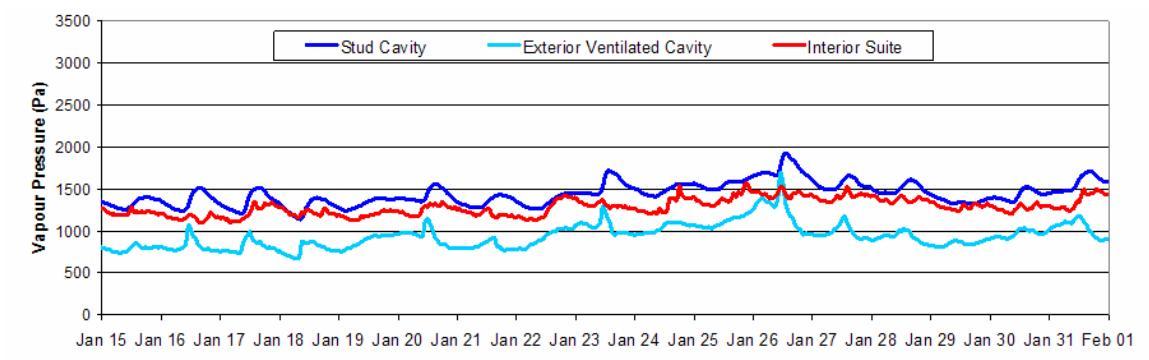
Figure 9-9: Building 3 – Wall Location 7, Vapour Pressures – Winter Typical

During the winter months, the vapour pressure in the stud cavity is actually higher than the interior suite, which would indicate a steady vapour flow drying to the interior. However as shown the stud cavity remains humid over the entire winter, this indicates that potentially air leakage from the interior into the stud cavity is overpowering the reverse diffusion drying to the interior. Potentially moisture as a result of a rainwater leak could also be trapped within the stud cavity and unable to dry out, however as observed in the field openings in the next section, appears unlikely.

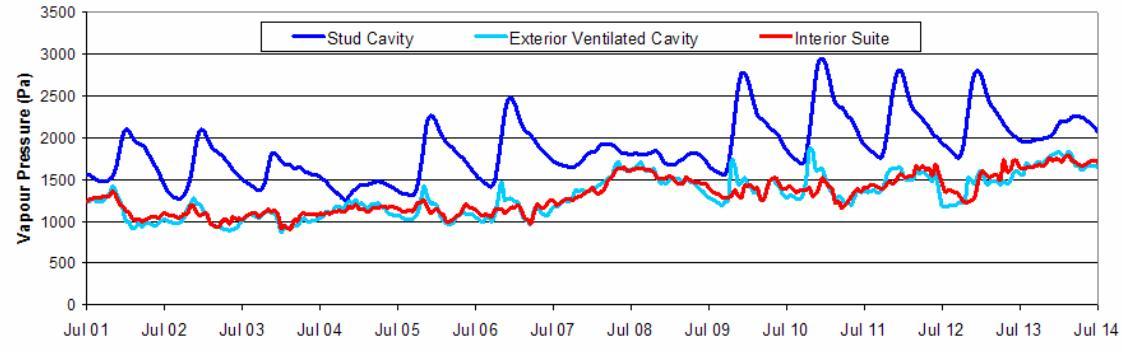
Figure 9-10: Building 3 – Wall Location 7, Vapour Pressures – Summer Typical

In the summer the vapour pressure within the stud cavity remains above the interior or exterior, indicating entrapped moisture within the stud space or an inability to completely dry out. During the summer the cavity relative humidity drops to between 50-80% and the air still contains more water vapour than the interior or exterior.

The vapour pressure analysis suggests that moisture potentially as a result of vapour diffusion and exacerbated by air leakage is wetting the exterior sheathing.

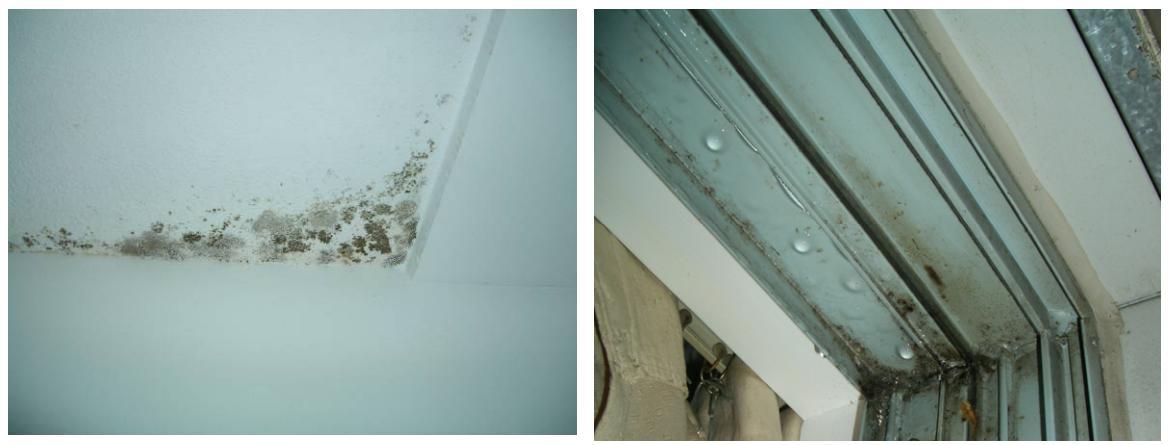
Figure 9-17: Interior Mould Growth and Condensation Observed in Suite 602

Note that the RH sensor in suite 602 peaked and went offline in October when interior relative humidity levels approached 100%. The sensor continued to malfunction until physically removed from the suite in January, and when it was, began to work again. When the sensor was removed from the suite, mould growth was observed on the ceiling at a slab edge thermal bridge, and the aluminium framed sliding glass door frame was dripping with condensation moisture (Figure 9-17).

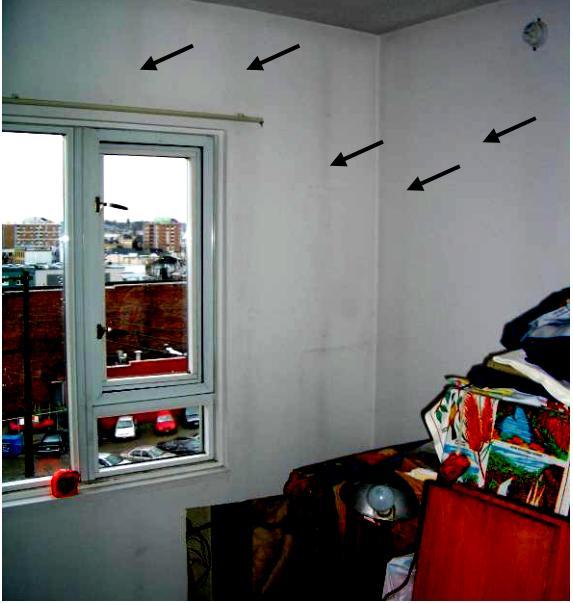
Thermal Dusting at interior steel studs

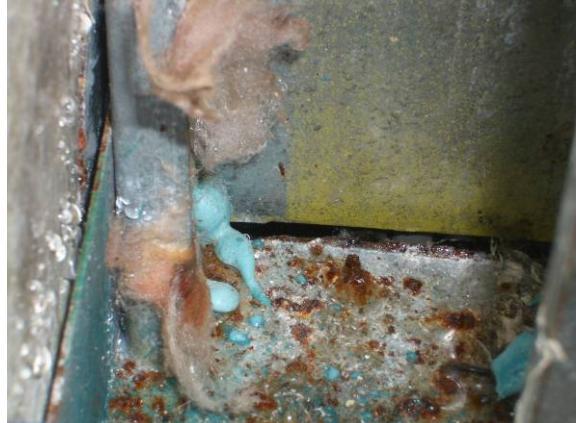
Mould growth on backside of gypsum sheathing

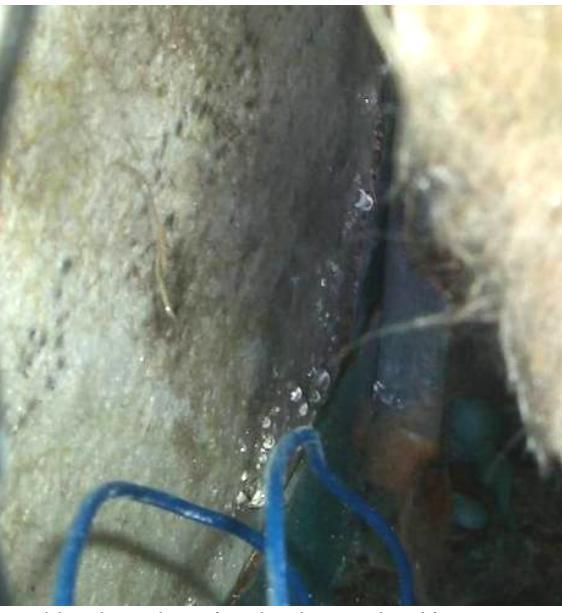
Mould and Condensation droplets on sheathing

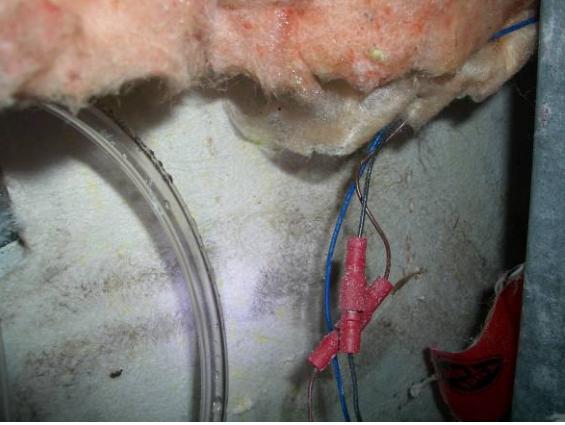
- Light corrosion is observed on the surface of the steel stud flanges. Mild to surface corrosion is observed on the exposed fastener threads.

Condensation and corrosion on steel stud Figure 9-21: Photographs from Opening #1

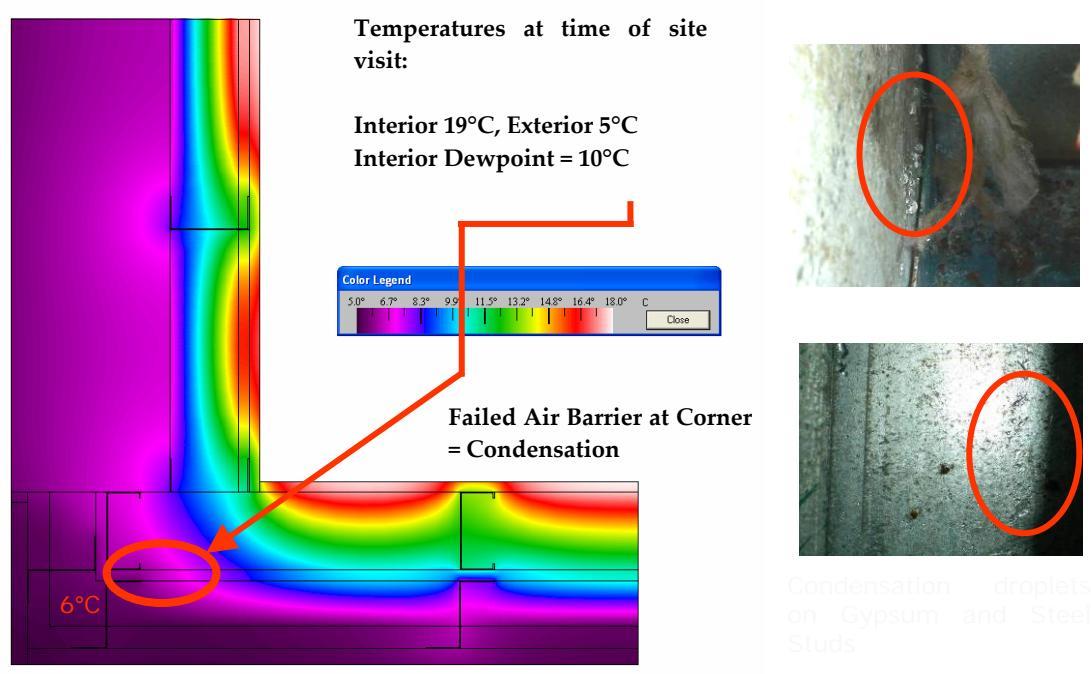
Figure 9-23: Thermal Model Showing Condensation Potential and Observed Condensation at Corner Detail.

The conditions within the stud cavity were significantly worse at the corner (also away from sensors). To determine the potential cause for this, a two-dimensional thermal model was made using THERM 5.2, which highlighted the lower corner temperatures and increased condensation potential (Figure 9-23).

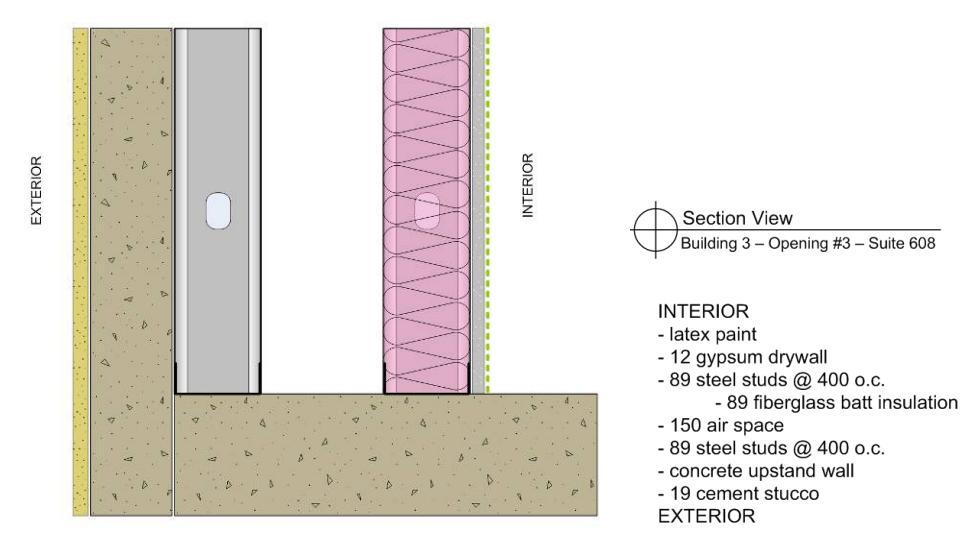
Figure 9-24: Wall Assembly Details at Opening #3

Evidence of moisture penetration was observed on the exposed concrete slab emanating from the exterior edge (see photo). No damage to the exposed gypsum drywall or corrosion of steel studs was observed. No interior vapour retarder was located at this location, even though the assembly here differed from the typical wall assembly for this building.

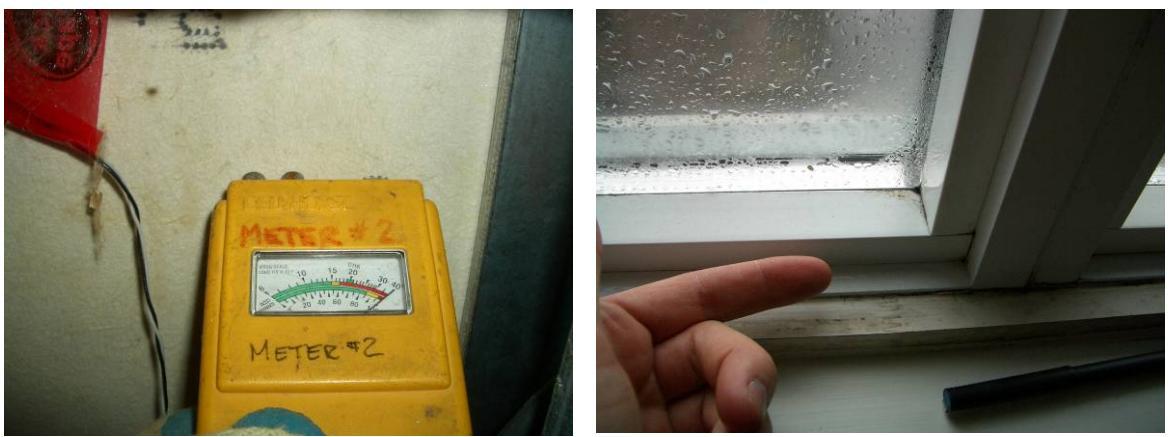
Figure 9-26: Photographs from Opening #4

Opening 4 is located in suite 311 at monitored wall location #3. The suite here has elevated interior relative humidity levels (up to 80-85%) prior to the test openings. The following observations were made during the review:

- The monitored room consists of a secondary bedroom with the furniture away from the exterior walls. Temperature within suite is 18°C and 75% RH.
- Severe condensation is observed the bottom half of the window glazing and frame (see photo). The tenant reports wiping down the windows every morning to remove condensation moisture. Black mould growth is observed on the frame and glazing corners and the wood trim is discoloured and damaged from the moisture.
- The opening is made below the window and exposes monitored location #3 sensors.
- Sensors all appear to be in good working order with signs of minor corrosion on exposed wires.
- Light mould growth is observed on the backside of the gypsum sheathing in some isolated locations (see photo). Liquid condensation is observed at a few locations on the backside of the sheathing near the window frame. The cavity smells slightly musty.

- Liquid water droplets are also observed on the exterior face of the interior gypsum drywall.
- Gypsum sheathing is very soft to probe and a relative moisture reading of 100 is recorded (see photo). A small sample is taken from the back half of the gypsum sheathing including half of the core and the interior fiberglass facer. The sample is weighed then dried (back at laboratory) and weighed again to determine an approximate moisture content of 6%.
- Light corrosion is observed on the surface of the steel stud flanges. Mild to surface corrosion is observed on the exposed fastener threads.

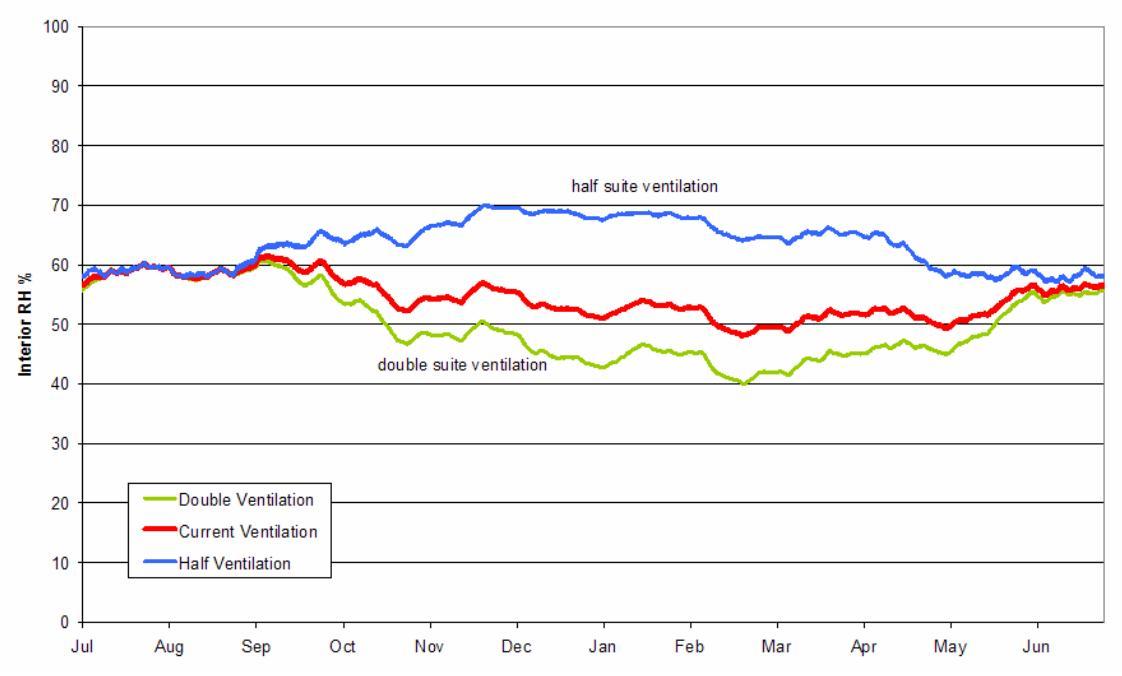
Figure 9-27: Impact of suite Ventilation Rate on Interior RH

The interior relative humidity for the three modeled cases is presented in Figure 9-27 and the relative humidity at the sheathing surface is shown in Figure 9-28.

As shown, a wintertime average RH above 50% results in very high (80-100%) RH levels at the sheathing, whereas the double ventilation case (where interior RH is between 40-50% during the winter) results in safer sheathing RH levels, and subsequently gypsum moisture content. Further hygrothermal modeling scenarios are compared in Chapter 10.

The high interior humidity was shown to have a direct impact on the wall performance, and that doubling the current ventilation levels would reduce the relative humidity within the stud cavity to safe levels. Further improvements could still be made to improve the performance and are discussed in Chapter 10. Exterior conditions such as driving rain and orientation had little effect on the performance of this wall assembly

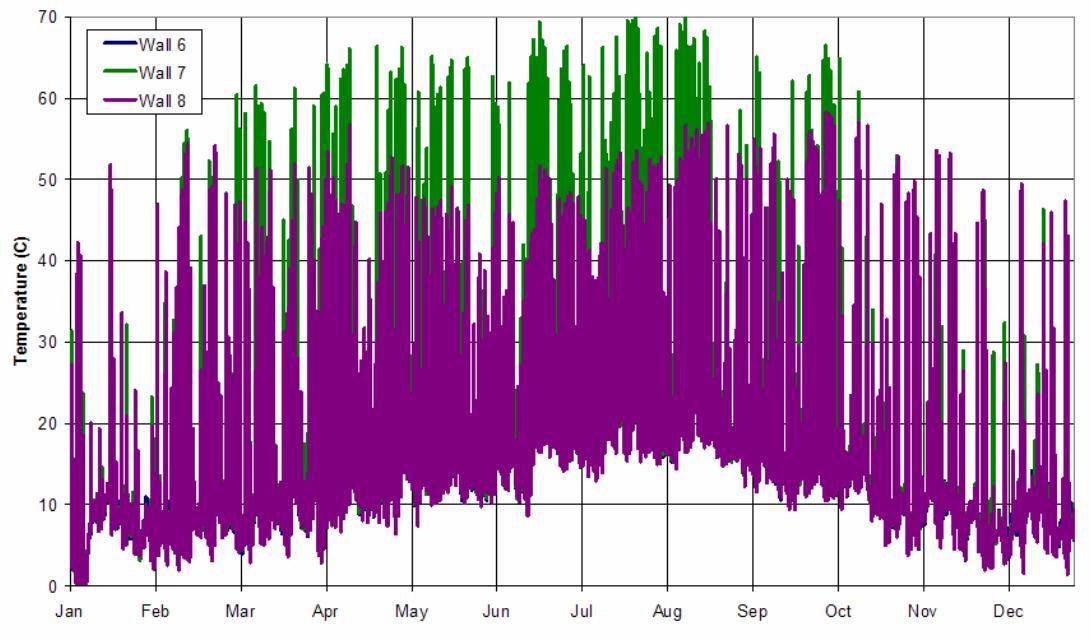
Figure 9-38: Building 5 – Spandrel Panel Temperatures, Jan-Dec 2004

potentially challenging conditions. The temperatures observed within the spandrel cavity reach up to 70°C for several hours on numerous occasions and are shown in Figure 9-38 for the entire year and in Figure 9-39 during a peak event in August. Solar radiation on a horizontal surface is also plotted to show the impact it has on the spandrel cavity temperatures.

As shown, temperatures within the spandrel cavities are up to 50°C higher than ambient air temperatures. Note that walls 6 and 7 are on the southeast, while wall 8 is at the southwest, again with a later peak temperature.

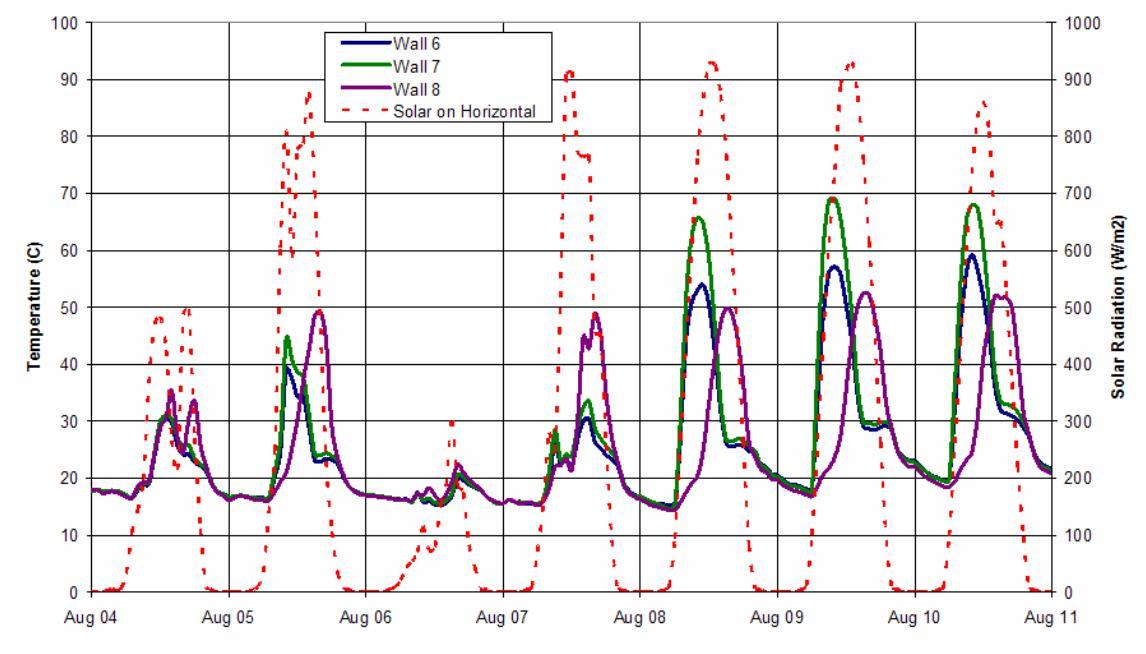
Figure 9-39: Building 5 – Spandrel Panel Temperatures, Aug 4-11, 2004.

The significant impact of solar radiation is shown on August 6th, which was a cloudy day where the walls were only exposed to diffuse radiation. On this day the spandrel cavity temperatures remained close to the ambient air temperature. In contrast the days following with full direct solar radiation saw the highest temperatures, immediately up to 30-50°C higher.

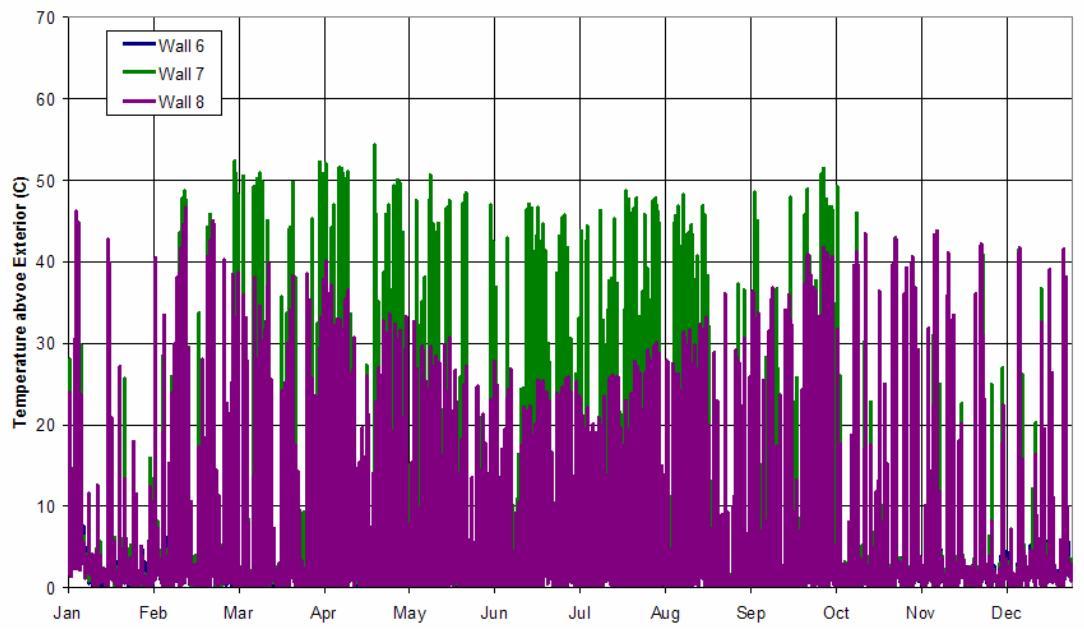
Figure 9-40: Temperature Difference between Spandrel Panel and Exterior

The hourly temperature difference between the spandrel space and exterior ambient conditions is shown in Figure 9-40, showing regular peaks between 40-50°C above ambient conditions.

The peak temperature differences between the spandrel cavity and exterior air occur in spring and fall as a result of high solar radiation combined with lower exterior temperatures.

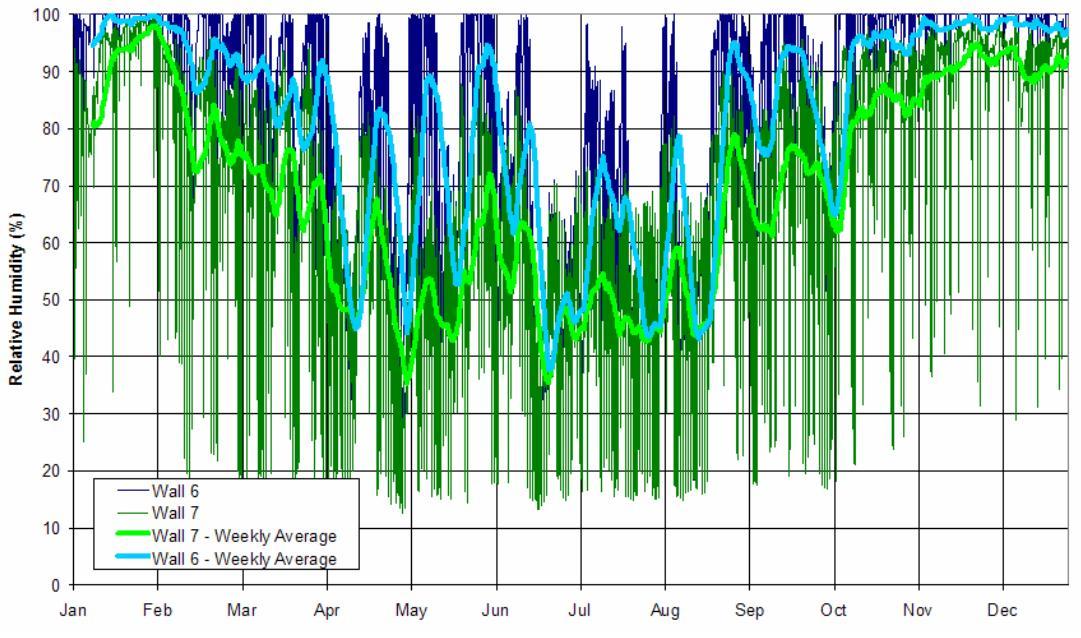
Figure 9-41: Relative Humidity within Spandrel Cavity

The relative humidity levels within the two spandrel cavities is also shown in Figure 9-41, and observed to be between 90-100% for most of the year. The spandrel panels are not ventilated; however some small drainage holes were provided which may have provided some venting of the air space. The source of

moisture is potentially entrapped moisture or as a result of small water leaks into the assembly. The concrete slab edge may also be partially exposed allowing the evaporation of construction moisture into the cavity.

The high relative humidity within the spandrel cavities are potentially of concern for corrosion of some elements. The insulation when damp will also have reduced performance, however could not be measured here. Potentially allowing ventilation within this space would reduce the relative humidity levels however may have implications for design.

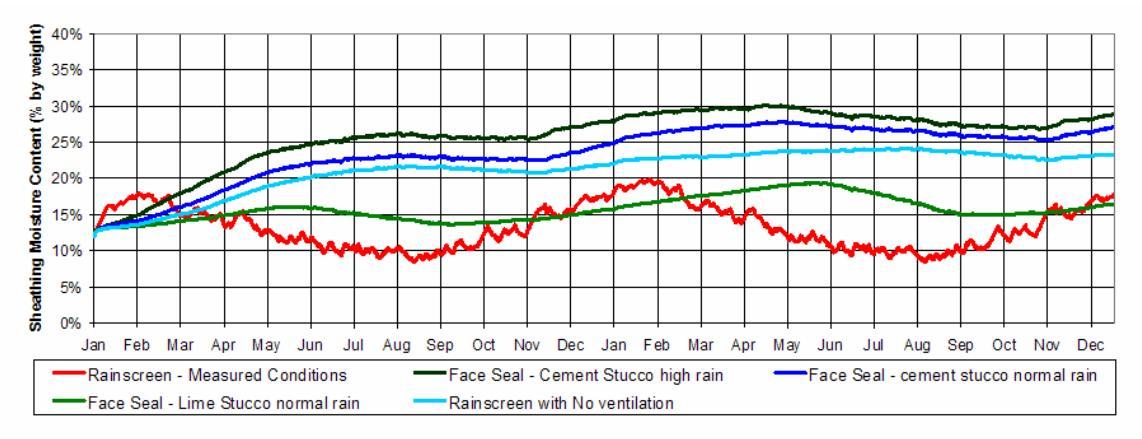
Figure 10-2: Comparison of Rainscreen to Historical Face-Sealed Assemblies

After validating the WUFI hygrothermal model the same boundary conditions are applied to a few historical wall designs, in an attempt to help explain some of the previous wall failures seen in Vancouver. The ventilated rainscreen wall is compared to two direct applied face-seal stucco walls (a cement and lime-stucco case), a rainscreen wall without cladding ventilation, and a case where the rain load is doubled for a face-seal cement stucco wall. Two-year simulations were run to determine if a net annual moisture accumulation occurs and the results are presented in Figure 10-2.

The results show that the cement stucco assemblies accumulate moisture over each year, gradually leading to dangerous moisture contents (>30% within 3 years). The lime-stucco face-seal wall performed better than the cement-stucco as it is approximately two-times as vapour permeable as the cement-stucco. While this is not the reason for the failure of all face-sealed stucco assemblies, it does show the importance of the vapour permeability (and drying potential) of an absorptive cladding in a non-ventilated wall case. Also of note is the onset of the peak moisture loading of the sheathing in the simulated cases, occurring later in the spring-summer, where as with the measured ventilated rainscreen case, the peak moisture content is from January to February.

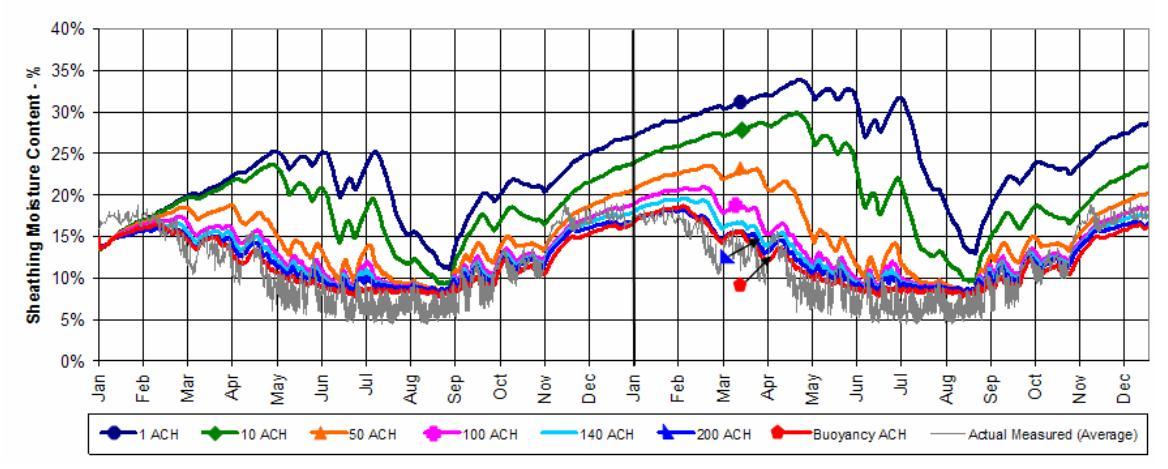
Figure 10-3: Effect of Cladding Ventilation on Moisture Content of Sheathing.

As discussed in Chapter 2, the ventilation rate behind the cladding has an impact on the performance of the wall assembly. The impact of ventilation was investigated with the model for the stucco rainscreen clad walls at Building 2. Fixed ventilation rates of 1, 10, 50, 100, 140, and 200 ACH were considered as well as an hourly varying ventilation rate calculated from the measured buoyancy pressures (refer to Chapter 2 - average 140 ACH) in Figure 10-3.

From the results, it is clear that the cladding ventilation rate can have an significant effect on the modeled performance of rainscreen walls in Vancouver's climate. Lower ventilation rates will result in higher sheathing moisture contents for prolonged periods of time during the warm spring-summer months, which could allow mould growth and decay. Similar observations were made by Karagiozis (2002) using the Moisture-Expert computer model for ventilated stucco walls in Seattle (Figure 10-4).

The results highlight the importance of cladding ventilation for interior insulated wood-frame rainscreen wall assemblies. Modeling shows that higher ventilation rates could improve the performance of wall assemblies, but there appears to be a limit in this case around 200 ACH. For example providing 1000 ACH does not significantly improve the drying under normal conditions. The modeling also shows that if the cavity ventilation rates were lower (more restrictive vent openings); high sheathing moisture contents would likely be observed. Preventing ventilation completely (i.e. blocking vent openings) has a potentially catastrophic effect, and measures should be taken in the field to ensure vent openings at the top and bottom of the wall cavities.
