THE PERFORMANCE OF RAINSCREEN WALLS IN COASTAL BRITISH COLUMBIA

A thesis presented to the University of Waterloo in fulfillment of the thesis requirement for the degree of Master of Applied Science in Civil Engineering

Waterloo, Ontario, Canada, 2007

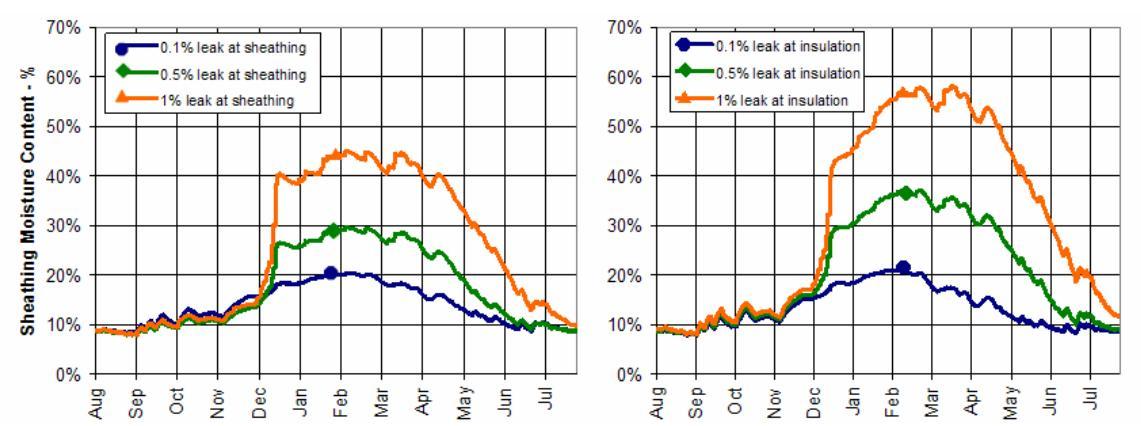
Figure 10-5: Effect of Rainwater Leaks within Stucco Clad Rainscreen Walls in Vancouver, BC

It was found that adding the leak to the exterior surface of the sheathing membrane had a negligible impact on the sheathing moisture content, as the additional moisture was easily removed by ventilation flow for this particular wall assembly. However when the leak occurred at either plywood surface, past the sheathing membrane, the moisture was absorbed and increased the sheathing moisture content. The results for six cases are presented in Figure 10-5. The leak at the exterior side of the sheathing shown in the left plot, and the leak at the interior insulation/sheathing interface is shown in the right plot. Vapour diffusion drying was prevented to the interior by the use of an interior polyethylene vapour barrier, and as no annual storage was observed, all added moisture from the leak was removed from the wall assembly by ventilation to the exterior.

All cases dry-out by the summer in this climate but reach dangerous levels for several months if greater than 0.1% (> 0.4 kg/m^2) leakage occurs. The location of the leak is shown to have an impact on the results, where higher sheathing moisture contents were attained when the leak occurred at the interior face of the sheathing. As suggested the vapour permeance and moisture transport properties of the sheathing can limit or reduce the drying potential.

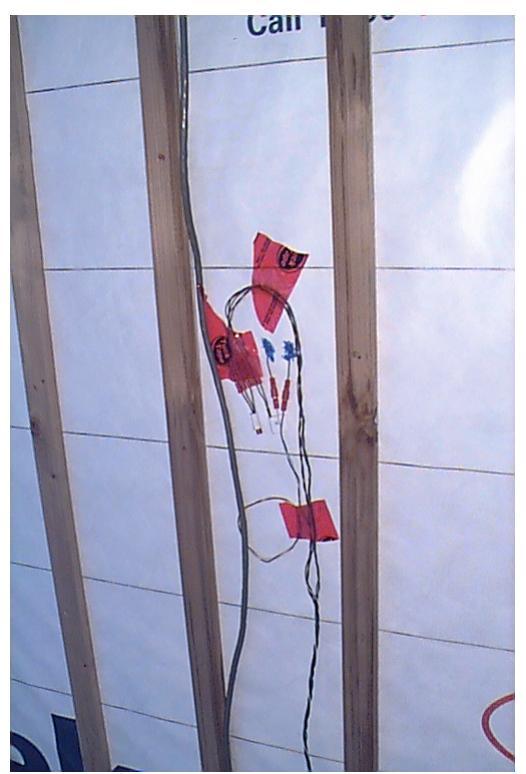
Building 2- 20: Monitored wall location 3, middle of wall, strapping/sheathing and cavity sensors in place

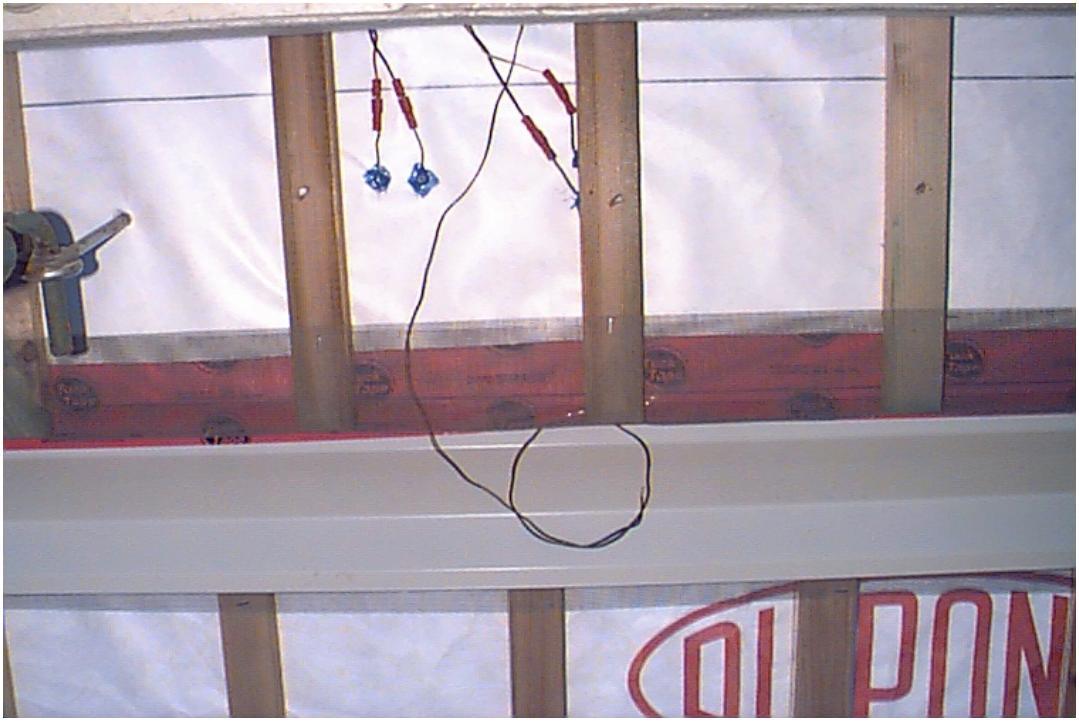
Building 2- 21: Monitored wall location 3, worst case moisture sensors at bottom of wall cavity

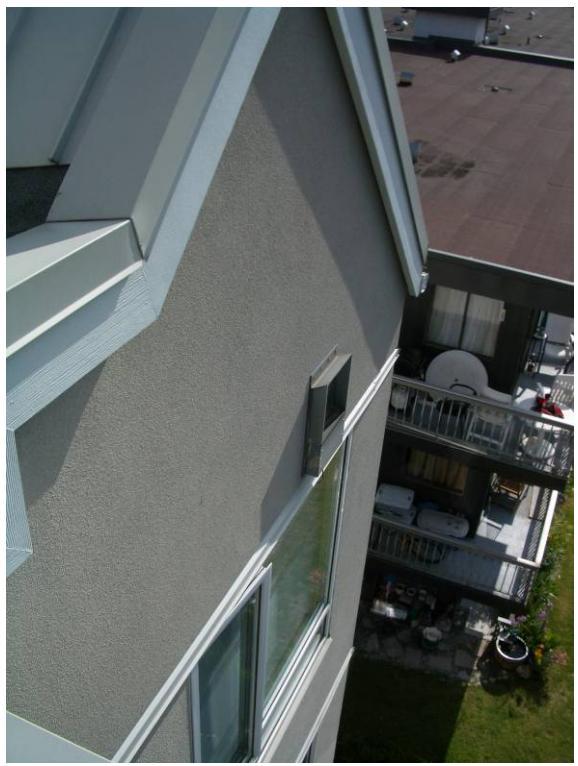
Building 2- 30: South Driving Rain Gauge, note minimal overhang protection

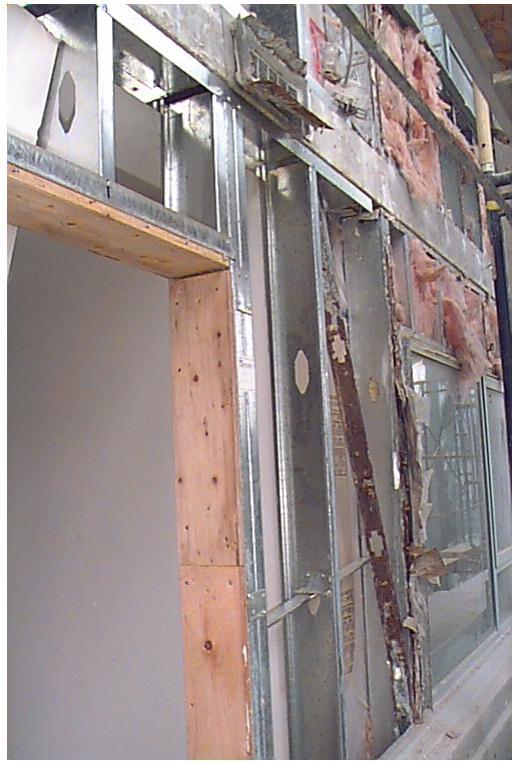
Building 3_ 15: Wall monitoring location 1, below in-slab exhaust vent (3rd floor), during rehabilitation

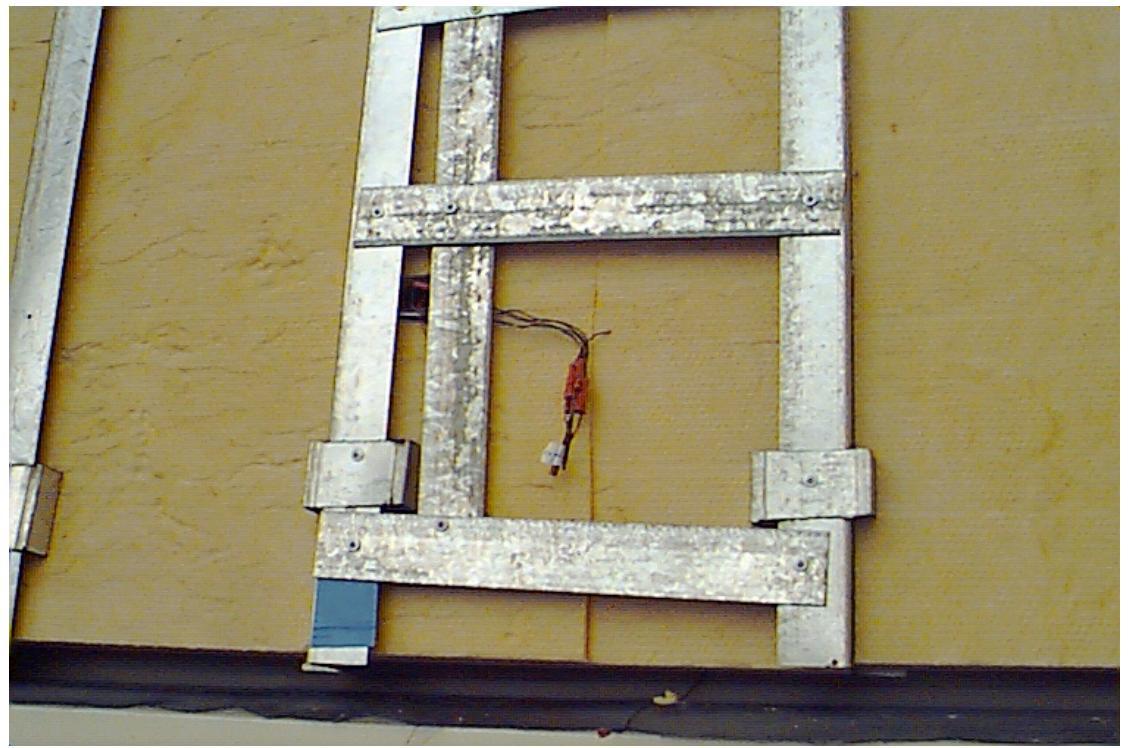
Building 3_ 25: Wall monitoring location 3, cavity insulation and T/RH sensors installed, note unnecessary use of additional steel strapping around sensor

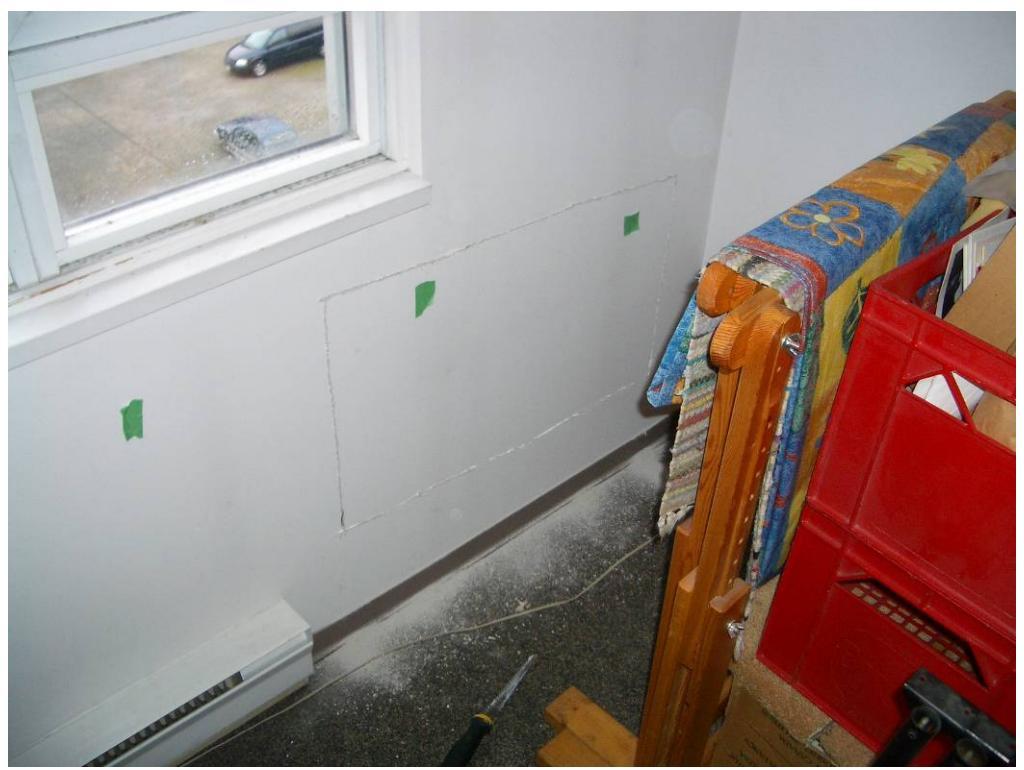
Building 3_ 43: Jan 31/06 Openings – Suite 611 bedroom 2, note foam insulation rolls piled against the exterior walls

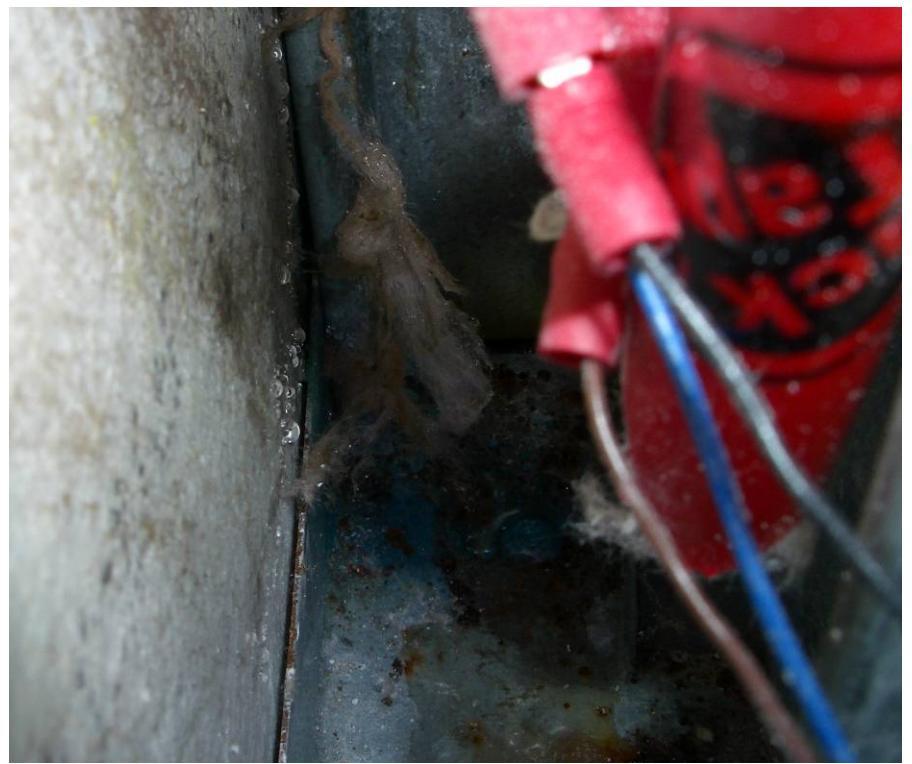
Building 3_48: Jan 31/06 Openings – Suite 611 opening 1 –note liquid water at sill track at bottom of monitored wall location 6

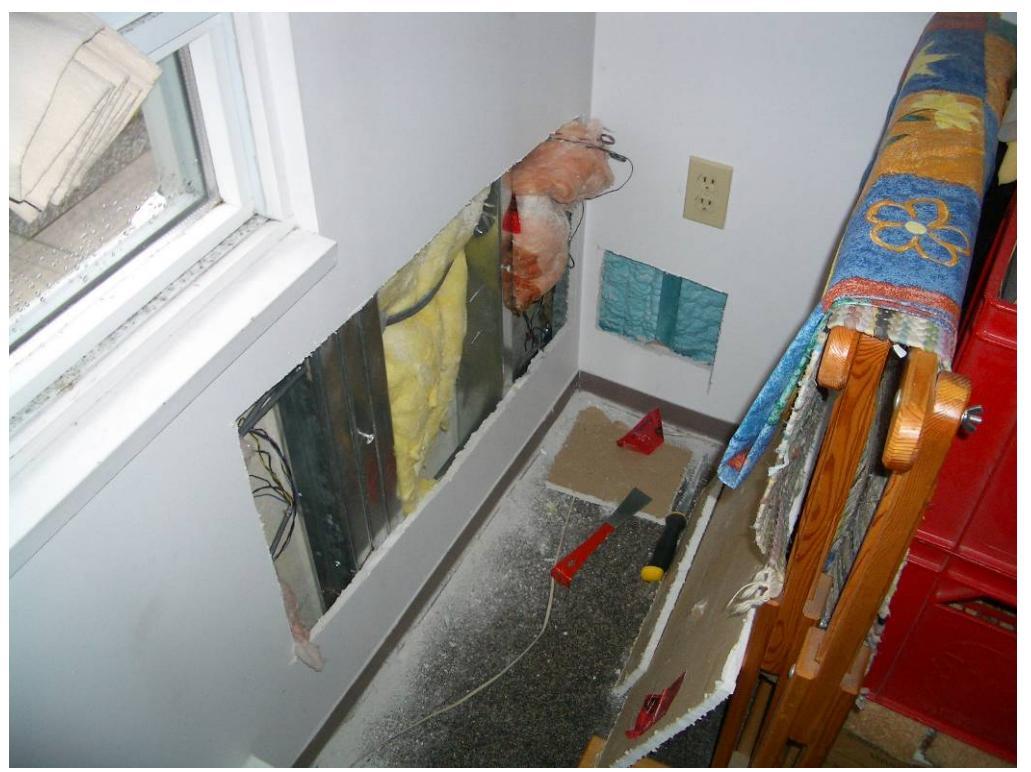
Building 3_ 49: Jan 31/06 Openings – Suite 611 opening 1 – liquid water in sill track, condensation on gypsum, mould growth and light corrosion of studs

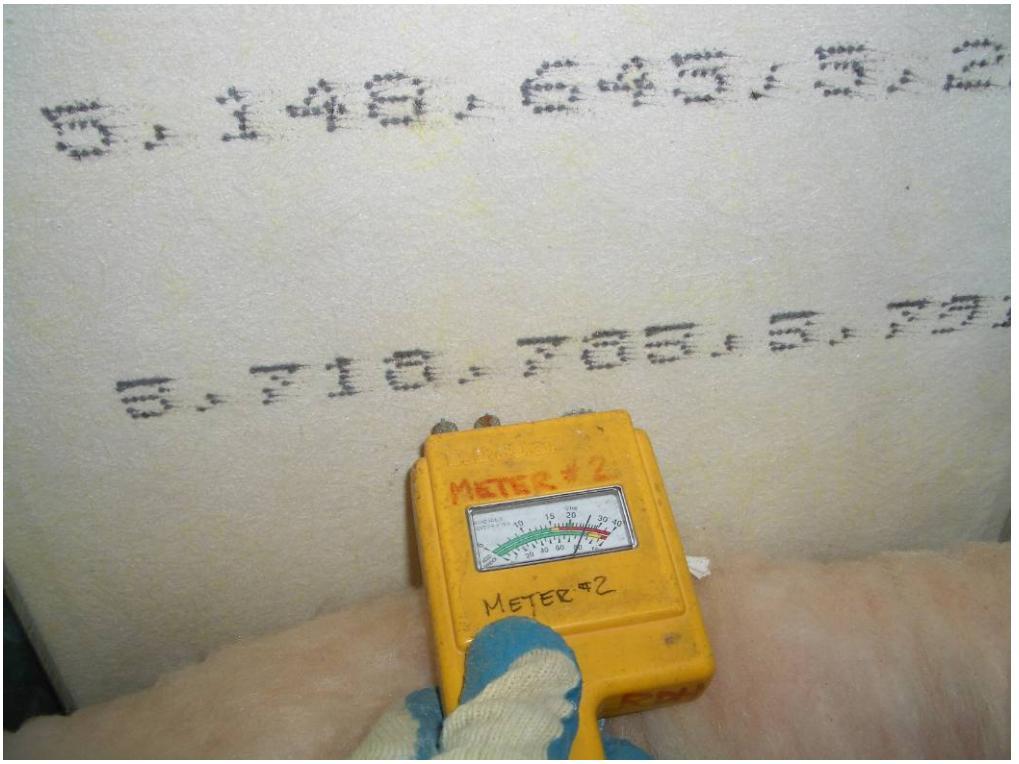
Building 3_ 65: Jan 31/06 Openings – Suite 311 opening 5 – below living room window on east elevation, cavity dry.
