# **Influence of drilling and abrasive water jet induced damage on the performance of carbon fabric/epoxy plates with holes**

## **Abstract**

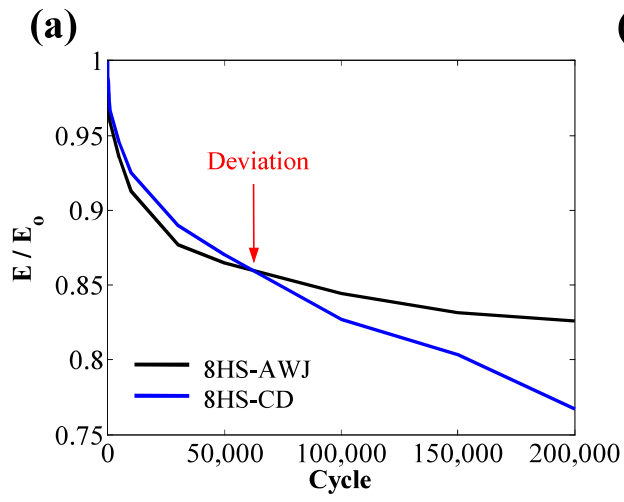
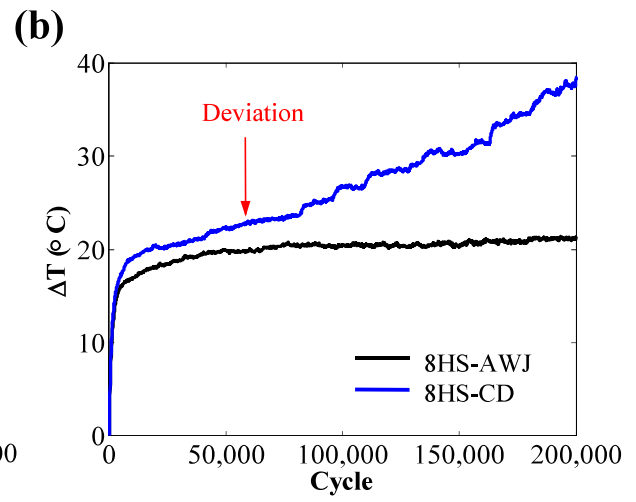
**Fig. 8** Conventional fatigue test data profiles for 8HS-AWJ and 8HS-CD test coupons cycled under a maximum stress of 530 MPa (a) normalized stiffness, (b) temperature rise.

In order to investigate the long-term durability of the 5HS and 8HS woven CFRP plates, conventional tension-tension fatigue tests were conducted under high-stress cyclic loading. The corresponding normalized stiffness and temperature profiles are illustrated in Fig. 8 for 8HS-AWJ and 8HS-CD test coupons that were cycled with a maximum stress of 530 MPa. The stiffness and temperature data for both test coupons correspond well up to approximately 60,000 loading cycles, which further confirms that the short-term fatigue performance is not influenced by the hole machining technique (CD or AWJ). However, once the number of loading cycles

increases beyond this threshold, the stiffness and temperature data begins to deviate as shown in Fig. 8. It is clear that the plate machined by the CD process exhibits greater temperature rise and stiffness degradation when compared to the plates machined with the AWJ technique. After 100,000 cycles, the 8HS-CD test coupon exhibited an additional 3% drop in stiffness and 30% higher temperature rise, which corresponds to an advanced damage state. After 200,000 loading cycles, an additional 8% drop in stiffness and a 78% higher temperature rise was detected in the 8HS-CD test coupon, which is a significant deviation.

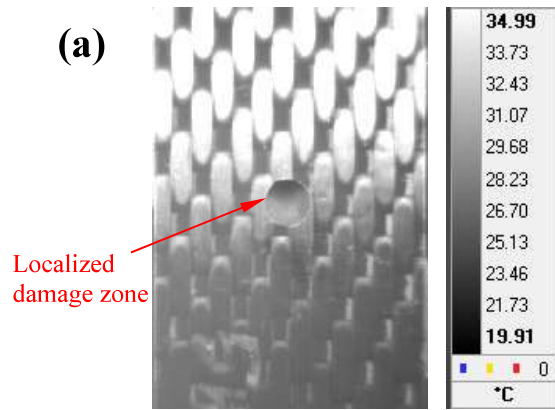
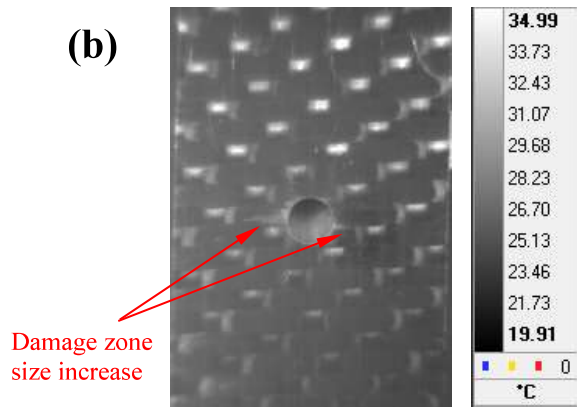
**Fig. 9** Thermographs captured using pulse thermography technique at test coupon exit plane side showing damage regions around holes after 150,000 loading cycles (385 MPa) for (a) 5HS-AWJ, (b) 5HS-CD.

Clearly, the hole machining technique has a direct influence on the long-term fatigue performance of the woven CFRPs. In order to assess the damage zone size around the machined holes of the tested coupons, the same PT technique described previously was used. Acquired thermographic images for 5HS-AWJ and 5HS-CD coupons after 200,000 load cycles under a maximum stress of 385 MPa are shown in Fig. 9. The fatigued AWJ coupons did not exhibit notably larger damage zones (compare Figs. 9(a) and 3(a)), which shows that inter-ply delamination cracking was limited until this stage. On the other hand, the fatigued CD coupons exhibited notably larger damage zones after 200,000 cycle (see Fig. 9(b)), which corresponds to an advanced delamination region. Montesano et al. [38] reported that cyclically loaded 5HS and 8HS CFRPs exhibited three distinct stages of damage evolution. During the first stage weft yarn cracking initiated and multiplied, causing rapid stiffness degradation, which eventually saturated. This signified the onset of the second stage where localized intra-ply yarn interface cracks initiated, which was followed by the final stage involving delamination crack growth and crack interaction. In this study, the AWJ test coupons follow the same three-stage damage progression during cyclic loading in the regions near the central hole. However, the CD coupons exhibit delamination cracking much sooner, which results from the machining induced damage at the
